Tootill Bleachworks, Seven Acres Park, Bolton

Archaeological Investigation

Document Title: TOOTILL BLEACHWORKS, SEVEN ACRES PARK, BOLTON

Document Type: Archaeological Investigation

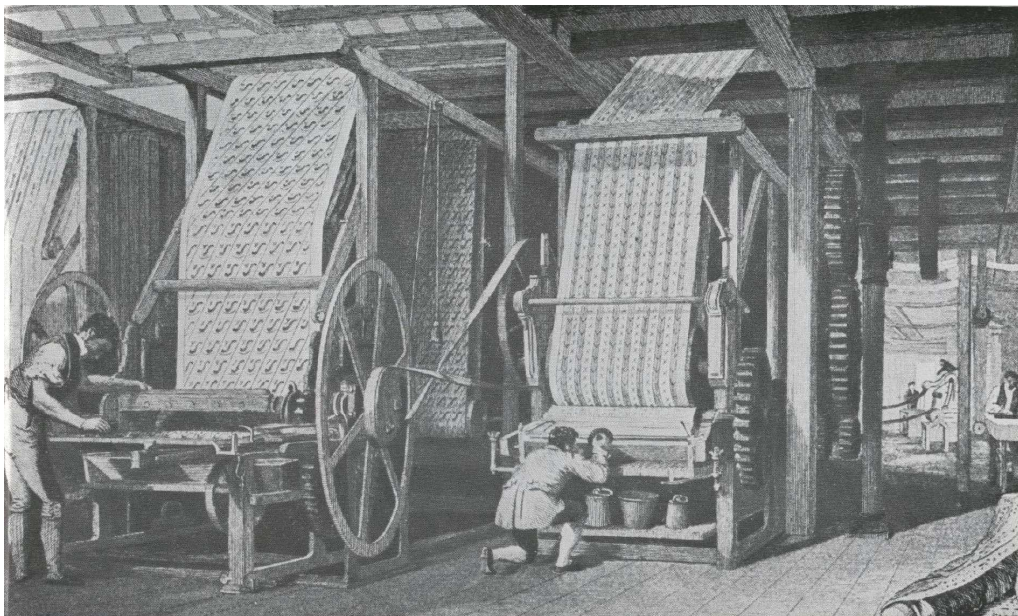
Plate 2: The mechanised calico-printing process in a cotton mill during the 1830s, showing on the left a machine with engraved copper rollers transferring the pattern onto the cloth, and on the right is a block printer using a hand-carved wooden block. (drawn by T Allom and engraved by J Carter, and taken from Chaloner and Musson 1965)

- 3.2.5 Cloth was passed continuously from an overhead roller through the nip between the engraved roller and a plain roller called a pressure bowl. The lower part of the engraved roller dipped into a colour trough, and as it revolved its surface was wiped clean by a doctor knife before the cloth reached it. Colour was thus left only in the engraved lines, which transferred the pattern onto the cloth. The pattern was printed full width, and repeated itself in the distance equal to the circumference of the copper roller. At first, single colours only were printed, but soon multi-colour machines were invented with several rollers, each carrying part of the pattern and fitted with its own colour trough and doctor knife. The cloth passed each roller in sequence, building up the final multi-coloured design (Baines 1835). The cloth moved continuously through the machine and, unlike block printing, was much quicker. There were many ways of making the pattern on the copper roller: hand engraving; mill engraving where the pattern is pressed into the copper; or etching, where the pattern is cut into the copper surface by acid.

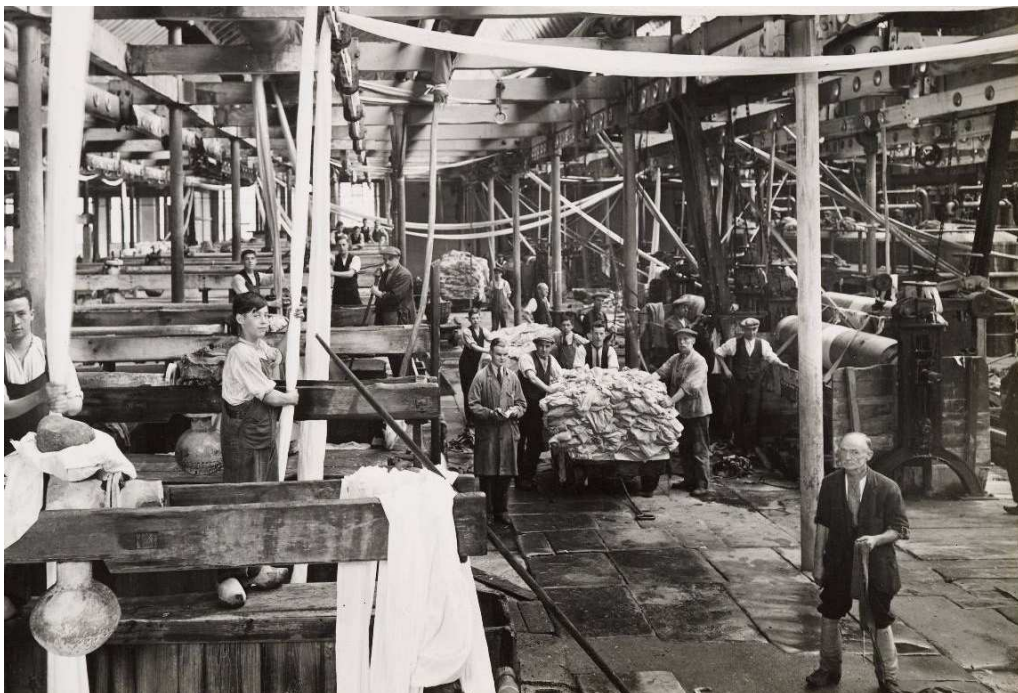
Plate 3: Early twentieth-century view of the interior of a bleachworks

- 3.3.7 The next process was the bleaching, or chemicing, process that was intended to destroy what remained of the natural colouring matters in the fibre. This was achieved by passing the cloth through a clear solution of chloride of lime, or bleaching powder. It was then allowed to lie for several hours whilst the necessary chemical reactions took place. The cloth was passed through a dilute solution of sulphuric acid, a process known as the 'white sour', followed immediately by a final washing in clean water, which rendered the cloth perfectly pure. The cloth was then passed through padded squeezing rollers and drying cylinders. The drying process was completed in the 'Hanging Stove'. Stretching machines rectified any shrinking in the cloth. The finishing process also required the cloth to be evenly and finely damped, fulfilled by the damping machine.

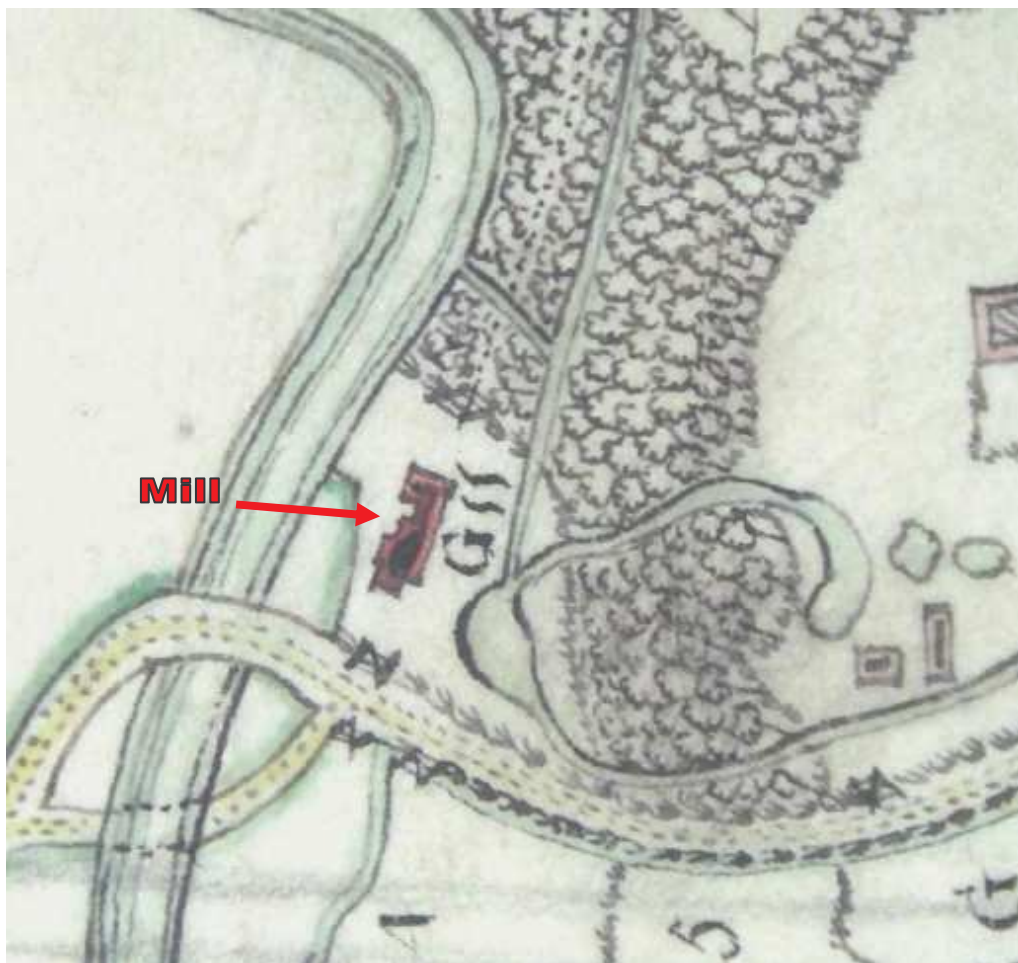
Plate 4: Tootill Bridge Mill, depicted on an estate plan of *c* 1764

- 3.4.3 The site is depicted on a plan of the area, which has been dated to *c* 1764. This plan shows the mill as a relatively small structure (Plate 4), which appears to have been served by two millraces that were connected with a millpond on the east side of the mill. One commenced just above Thicketford Bridge, *c* 1km upstream on the Bradshaw Brook. The other leat was formed by a tributary stream which flowed into that brook from the east. It is possible that this mill was the location of Brightmet's medieval corn mill, although there is no firm evidence to confirm this.

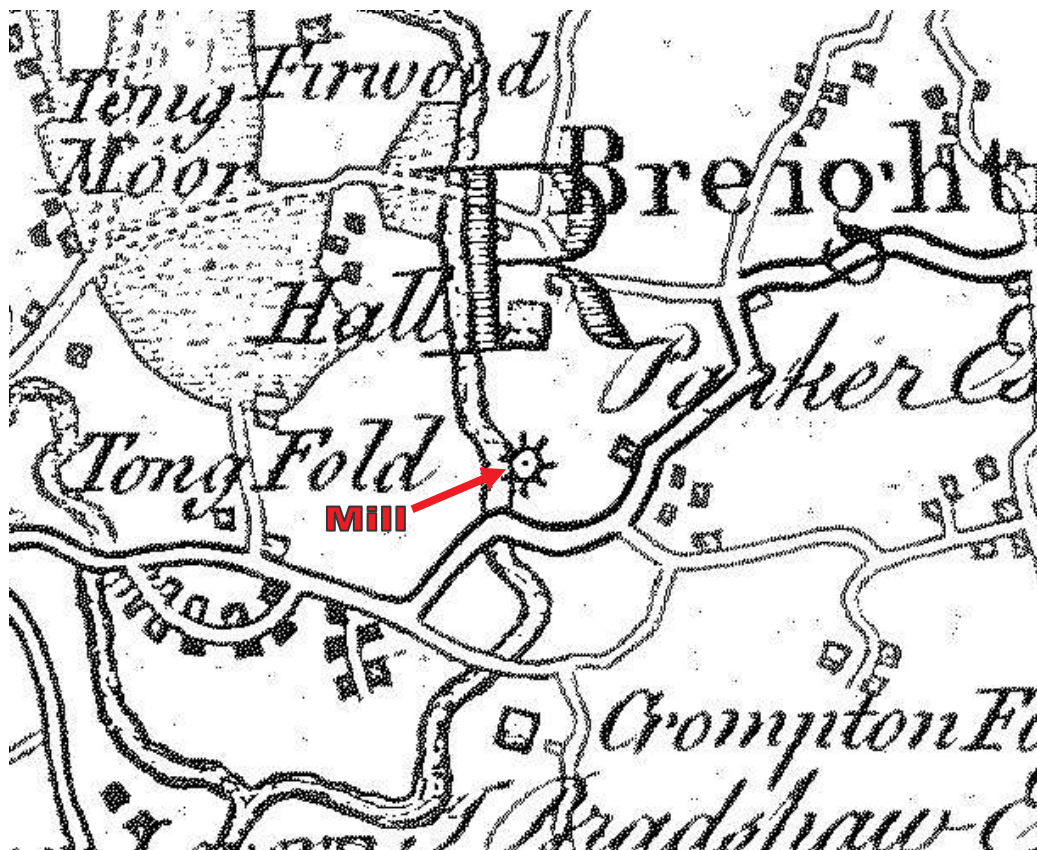
Plate 5: Extract from Yates' *Map of Lancashire* of 1786, depicting a water-powered mill

- 3.4.5 William Yates' *Map of the County Palatine of Lancaster*, which was published in 1784 but surveyed during the 1770s, shows a water-powered mill on Bradshaw Brook to the south-west of Brightmet Hall (Plate 5). Although it is not named on Yates' map, it is almost certainly that within the present study area.

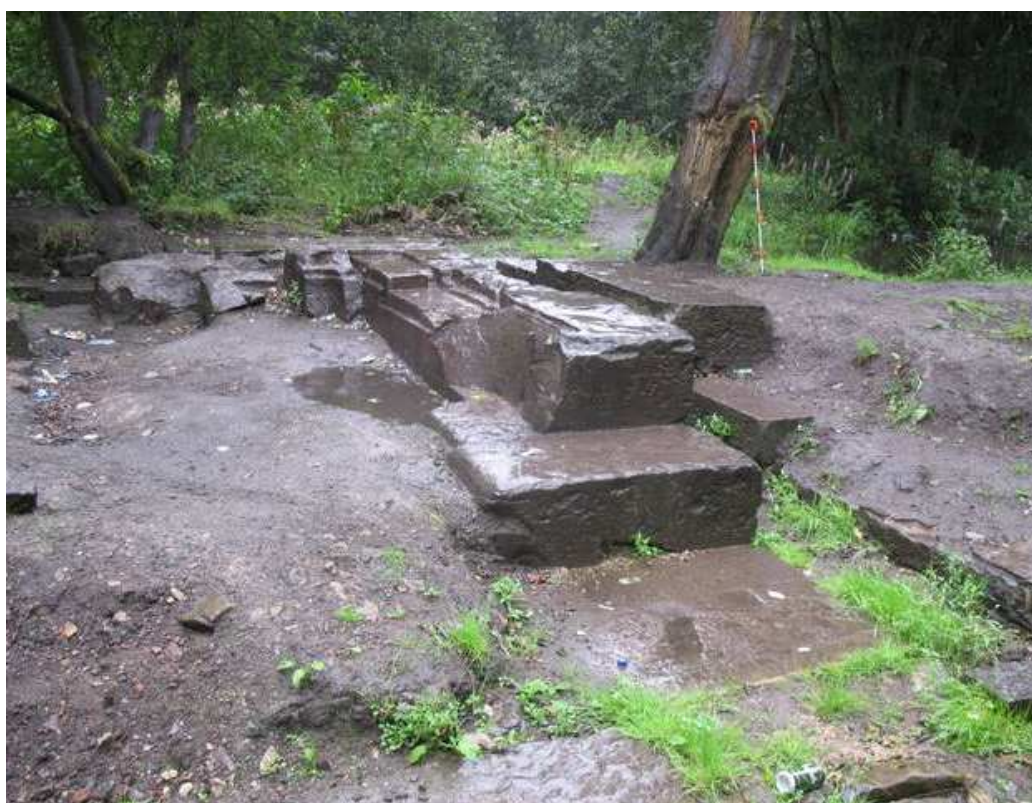
Plate 9: Exposed remains of the engine bed, prior to the excavation

- 4.1.5 Three principal structural elements were revealed during the archaeological investigation of the main area. These comprised: the stone foundation beds for a steam engine, which had been exposed by the initial excavation work (Plate 9), and the remains of the associated engine house; a room containing several bleaching tanks; and a large yard to the east of the former building. The exposed remains appeared to comprise three main constructional phases, all relating to the nineteenth/twentieth-century bleachworks, and which appear to correspond broadly to the detail shown on Ordnance Survey mapping of the site. A final phase of post-demolition activity was also identified.

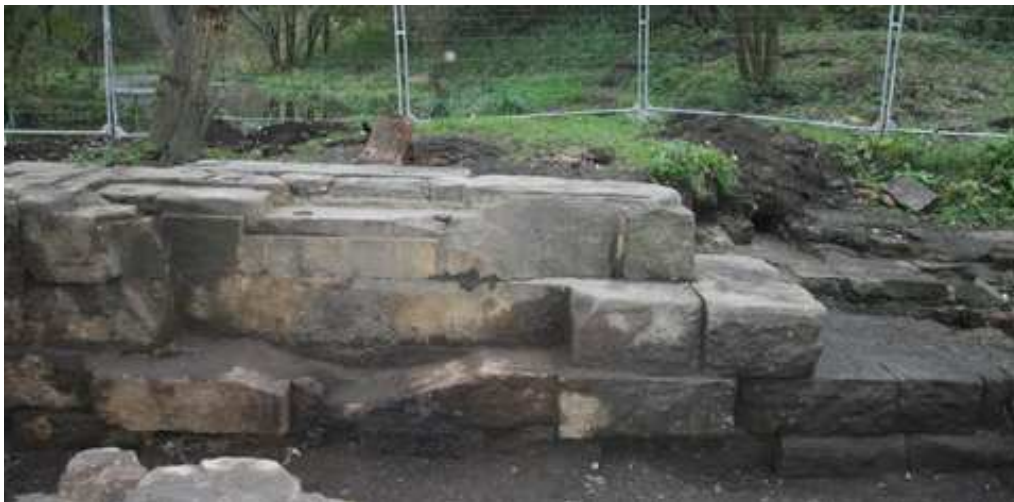
Plate 10: Dressed stone blocks of the engine bed, with cut-away for the crank

- 4.2.2 Excavation revealed that the stone foundation beds for a steam engine (**003**) comprised large, well-coursed, dressed blocks of local sandstone, bonded in a pale lime mortar. The bed comprised a large, L-shaped base, measuring 7m long and 1.2m wide, with a 3m southern return of a similar width at its western end (Fig 4). The individual blocks varied in size (Plate 10), with the larger blocks having been used where heavier anchor points were required, and had maximum dimensions of 1.2 x 0.7 x 0.4m. A further T-shaped base (**020**), situated 1.85m to the west (Fig 4), was of similar construction, and almost certainly formed part of the same foundation bed at a lower level. A gap on the upper level probably housed the condenser, several fixing points for which had been drilled into the western face of the L-shaped engine bed (Plate 11).

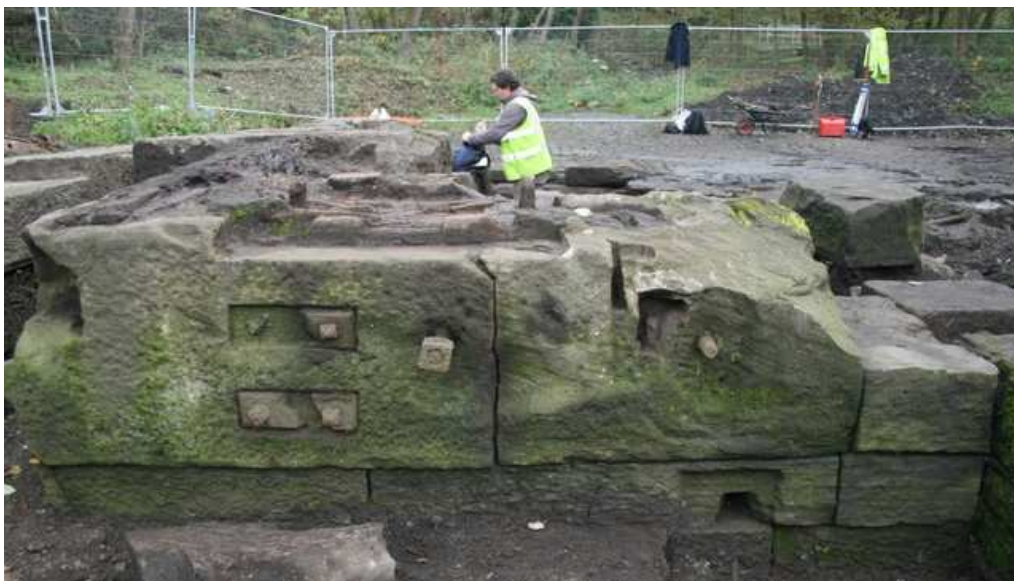
Plate 11: Fixing bolts in the engine bed, for column (top) and condenser

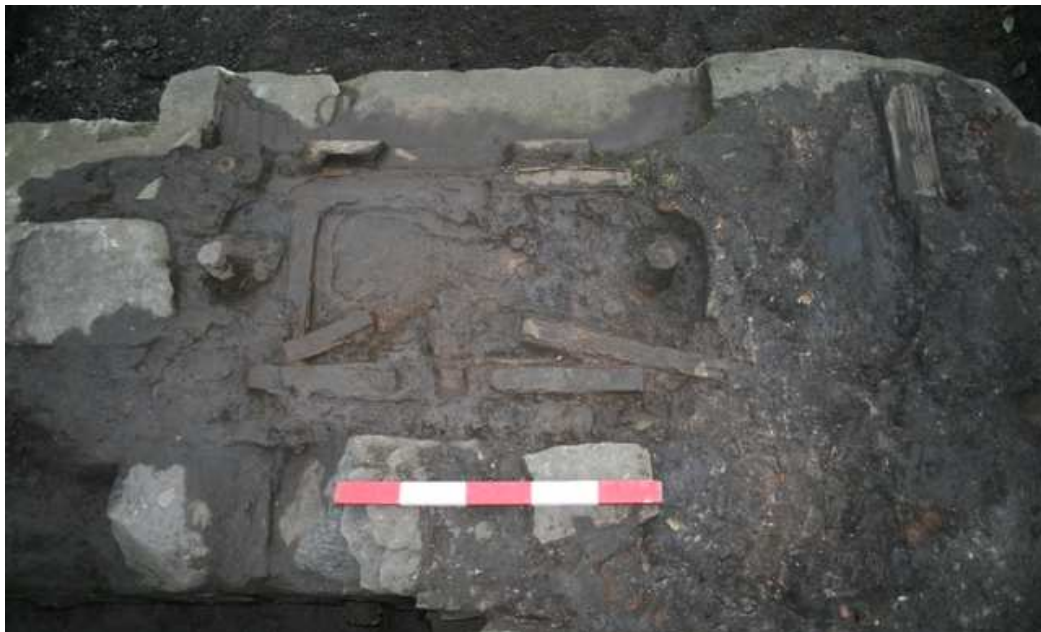
Plate 12: Housing and fixing bolts for the column supporting the entablature beam

4.2.3 Both bases also incorporated housings for fixtures, or rebates for various parts of the engine, with their upper surfaces retaining both lead-lined sockets, and protruding ironwork suggesting that this part of the structure survives to its original height. The T-shaped section of stonework at the west of the engine bed (020) had four large, cast-iron bolts projecting from the surface, each 40mm in diameter, and almost certainly representing the anchor fixings for a cylinder associated with the engine. A semi-circular rebate, on the south face of the L-shaped stonework, represents a cut-away for the crank, at the base of the main connecting rod to the beam, or where a crank and crank shaft was placed. A series of adjacent bolt-holes on the upper surface of the engine bed would have anchored the end bearing of the crank shaft. A cast-iron lined rebate and two bolts projecting from the surface of the western end of the bed (Plate 12), would have fixed a column supporting the entablature beam, to which the main beam was fixed.

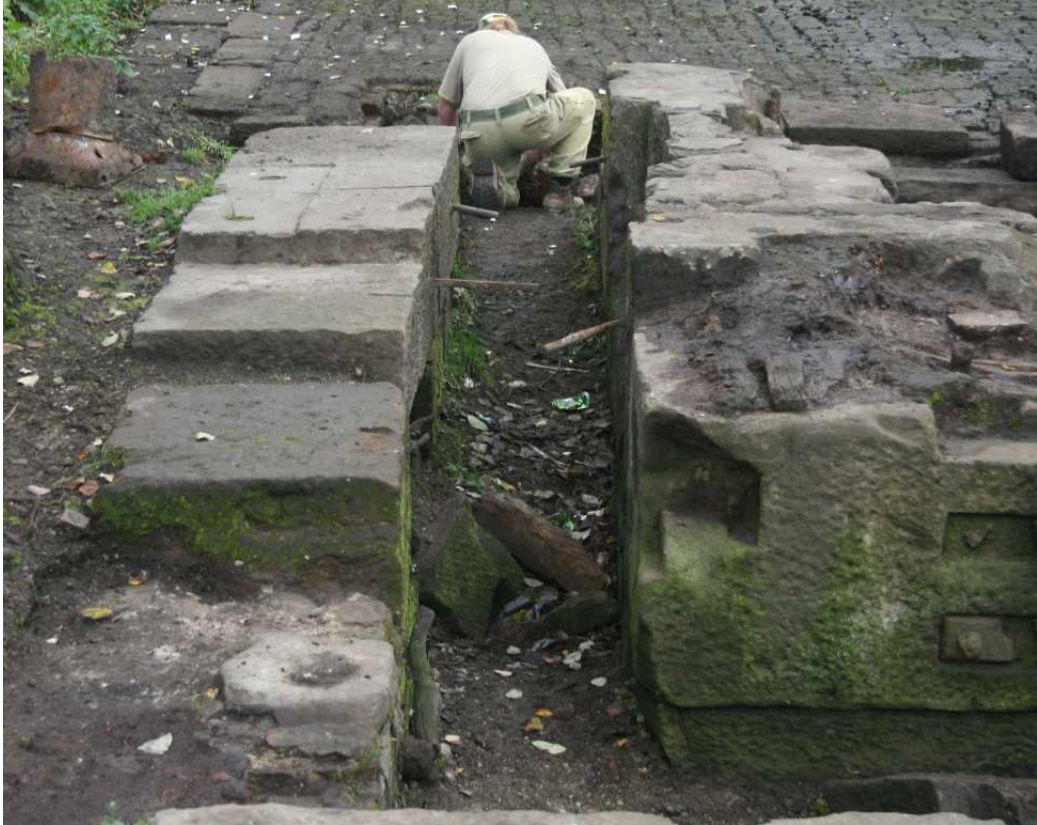
Plate 13: The engine flywheel pit

4.2.4 To the north of the engine bed (003), a narrow void, 0.61m wide, would have housed the engine flywheel (Plate 13). The wall to the north (024), which formed the north wall of the engine house (Fig 4), had its central section constructed in dressed sandstone block, similar to the engine bed, and with a large single capping stone, measuring 4.6 long. This would have supported the bearing for the axle of the flywheel, and had two large bolt-holes in its upper face (Plate 14). Two rectangular voids in the southern face of the wall, immediately below this large block, corresponded to the position of these bolt-holes, and would have allowed the securing nuts to have been tightened or released, as necessary.

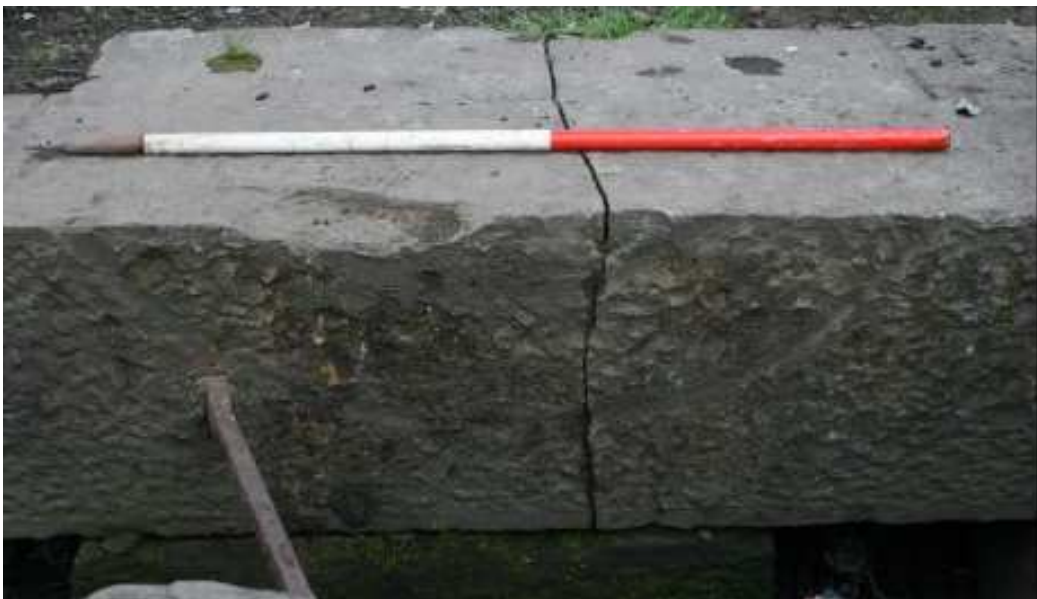
Plate 14: Detail of bolt-holes for axle bearing, and flywheel scar

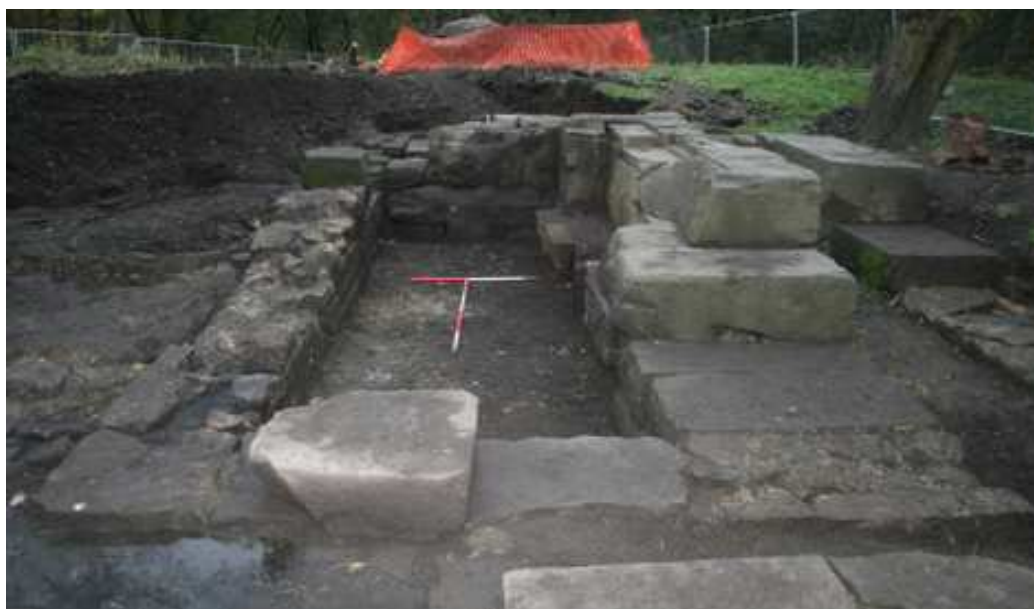
Plate 15: Engine bed **003**, walls of engine house **024**, and ash backfill **002**

- 4.2.6 These walls (**024**) formed a small, rectangular engine house, measuring 11.16 x 3.66m, which appeared to have been intended to house a small vertical steam engine. The area between the large masonry beds within the engine house was infilled with a deposit of boiler ash, **002**. This was excavated to a maximum depth of 1.2m, but continued beyond this depth of excavation (Plate 15); it was not possible to establish the full depth of the deposit, nor establish whether a floor surface survived below the engine bed.

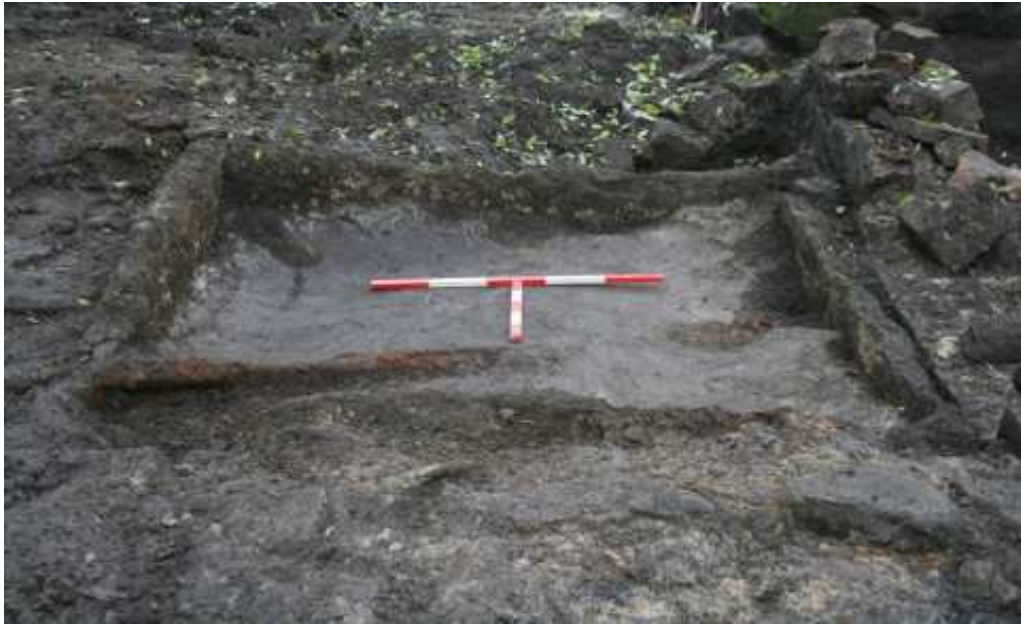
Plate 16: Bleaching tank **004**, with edge-set flagstone sides, and Phase 2 base and pipe

- 4.2.7 Immediately to the south of the engine house, and butting its southern wall, was a series of stone-built tanks, which had almost certainly been intended to contain bleaching solution used as part of the bleaching process (Fig 4). The stone-built tank at the eastern end (**004**) was the best preserved, and measured approximately 2.05m² with side-walls constructed of large edge-set sandstone flags (Plate 16), which were typically 0.12m wide and 2.1m in length. These projected approximately 0.1m above a later concrete floor, and appear to have been heavily truncated. Similar, less well-preserved remains of two further tanks **008** and **009**, were also revealed to the west (Plate 17), with a probable fourth tank having originally been placed in the gap between tanks **004** and **008** (Fig 4).

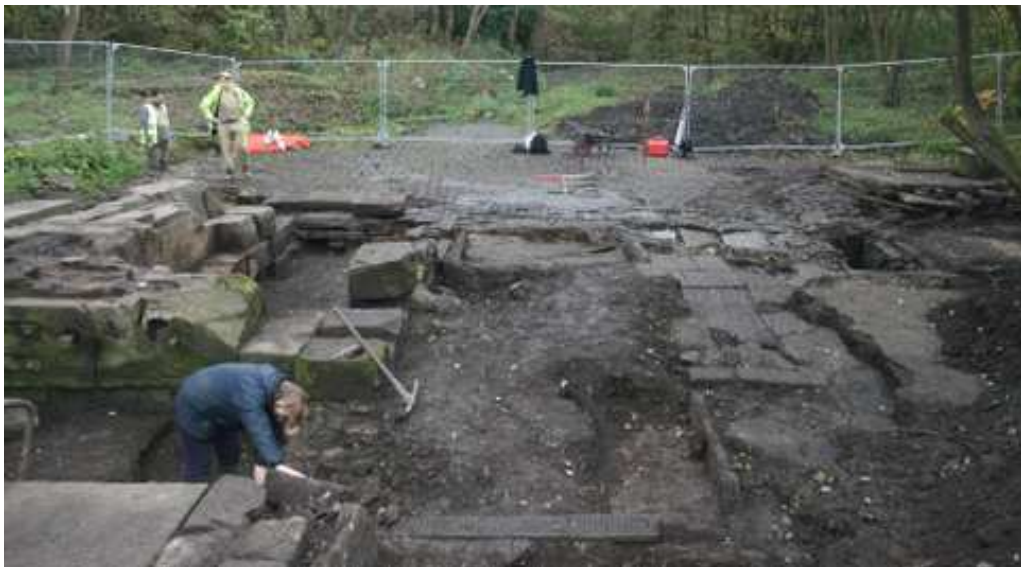
Plate 17: General view from the west showing engine house (left), bleaching tanks (centre), Phase 1 and 2 floors and culvert (right), Phase 3 platform (top right), and yard (top)

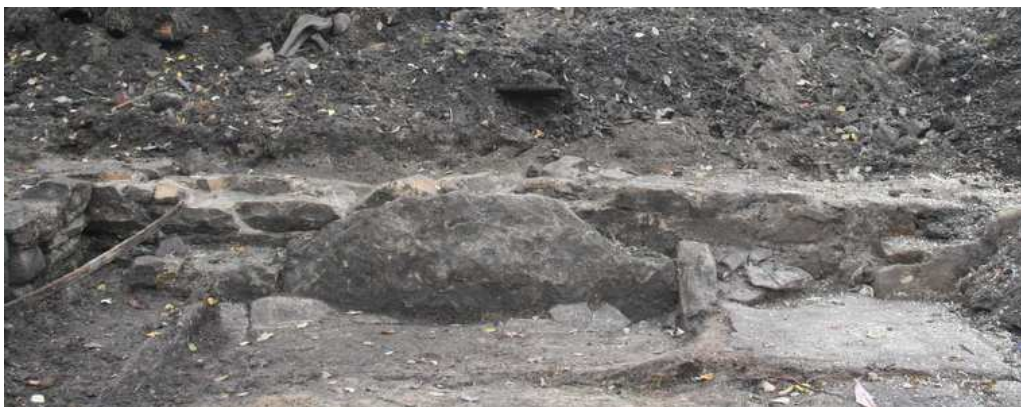
Plate 18: Bleaching tank **012**, with further edge-set flagstone continuing beyond excavation

- 4.2.8 A further bleaching tank, **012**, was placed 3.66m to the south of **004**, on a slightly different alignment, parallel to a wall immediately to the south, **017**. This tank also contained the remnants of a later concrete base. It was of similar construction to the tanks to the north, although the flagstone that formed its southern edge, survived, in part, to a much greater height (Plate 18). A further edge-set flagstone, partially exposed immediately to the west (Plate 18), suggests that a further row of four tanks, mirroring those to the north, were provided within the original layout of this area of the bleachworks complex.

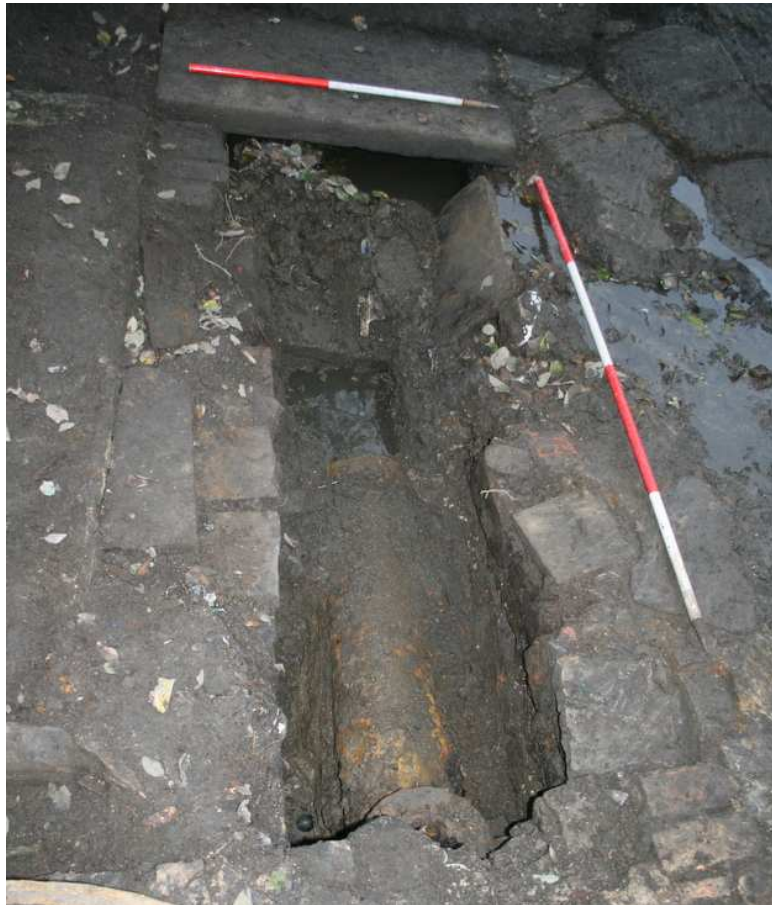
Plate 19: Culvert **010**, with flagstone capping and floor **014**, and Phase 2 pipe

4.2.9 Immediately to the north of tank **012**, and butting the edge-set flagstone forming its northernmost face, was stone culvert **010** (Fig 4; Plate 19). This measured 0.75m wide and 1.2m deep, and was capped in part with large flagstones, the easternmost of which had collapsed into the culvert. It was constructed of local, roughly dressed sandstone rubble, on a parallel alignment to the dye tank to the south (Fig 4), bonded in a pale grey lime mortar. Its base retained infrequent flagstones, possibly relating to its apparent later remodelling to house a large cast-iron pipe, 0.22m in diameter. Below the level of this later pipe, at a depth of 0.8m below the floor, a smaller pipe entered the southern side of the culvert from tank **012**. This presumably represented the drain from the original base of the tank, which became obsolete following the Phase 2 remodelling of the tanks.

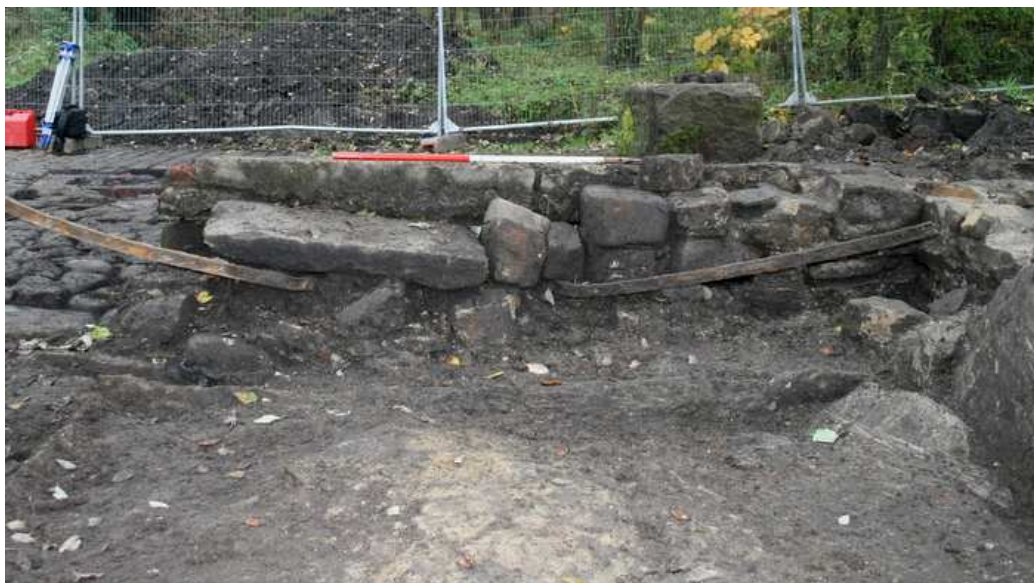
Plate 20: East wall of bleachworks, with possible tramway rails, overlain by platform **015**

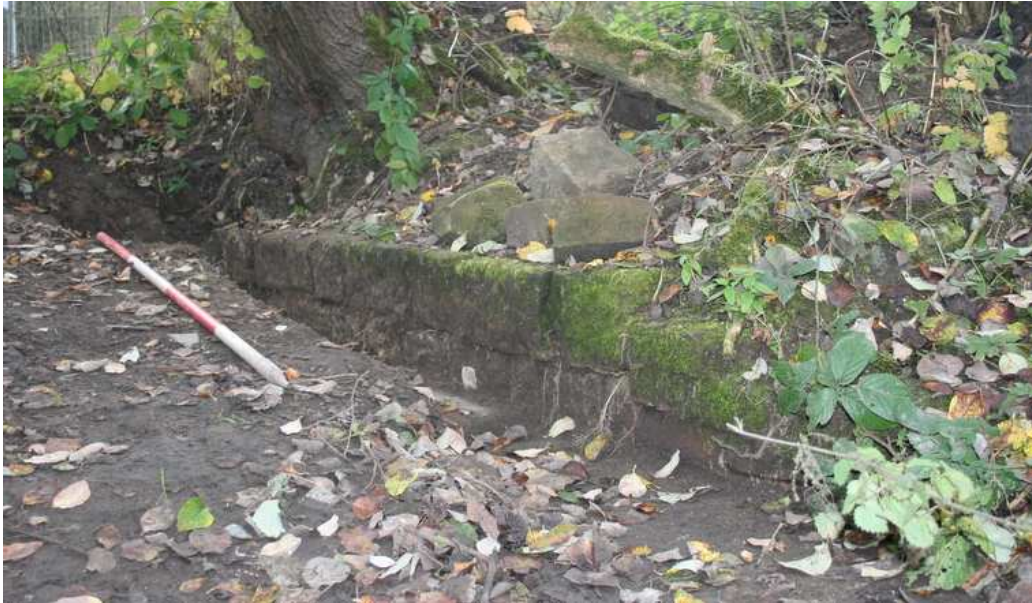
Plate 21: East wall of bleachworks, 022, with dressed and coursed external stone facing

- 4.2.13 A further stone wall **025** was observed beyond the limit of excavation, at the south-eastern corner of the site, and heavily overgrown with vegetation (Plate 16). It survived for a length of at least 2.75m, to a maximum height of 0.3m above present ground level, and had a slight eastwards return at its southern end (Fig 4). It appears to represent the further survival of the eastern external wall of the bleachworks complex at this date, and had well-dressed sandstone blocks forming its external, eastern, face (Plate 21).

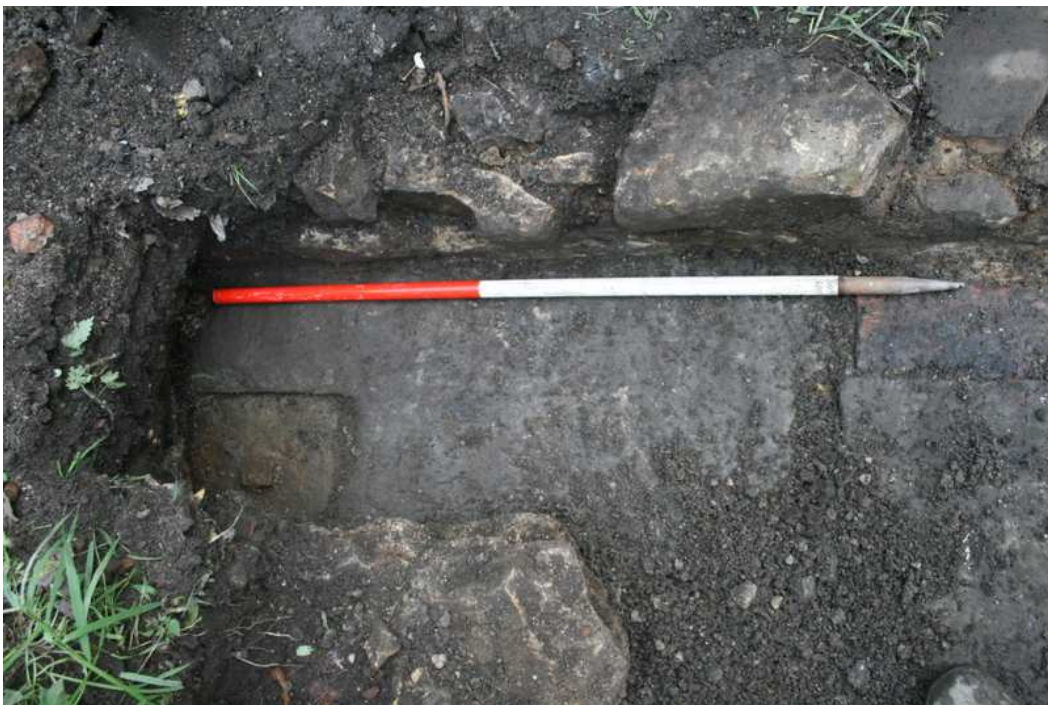
Plate 22: Floor 018, to north of wall 024, incorporating column/bearing base

4.2.14 Only limited excavation was possible to the north of the engine house (024), although this revealed a well-preserved sandstone flag floor, which incorporated the footing for a cast-iron column (Plate 22). Given its position, adjacent to the wall, this is extremely unlikely to have been a column supporting ceiling beams, and is far more likely to have been associated with a bearing relating to the power transfer from the engine house, immediately to the south (Fig 4). Further remnants of this flagstone floor survive to the north, below the reservoir, which was recently extended as part of drainage management works (Bill Farrell *pers comm*).

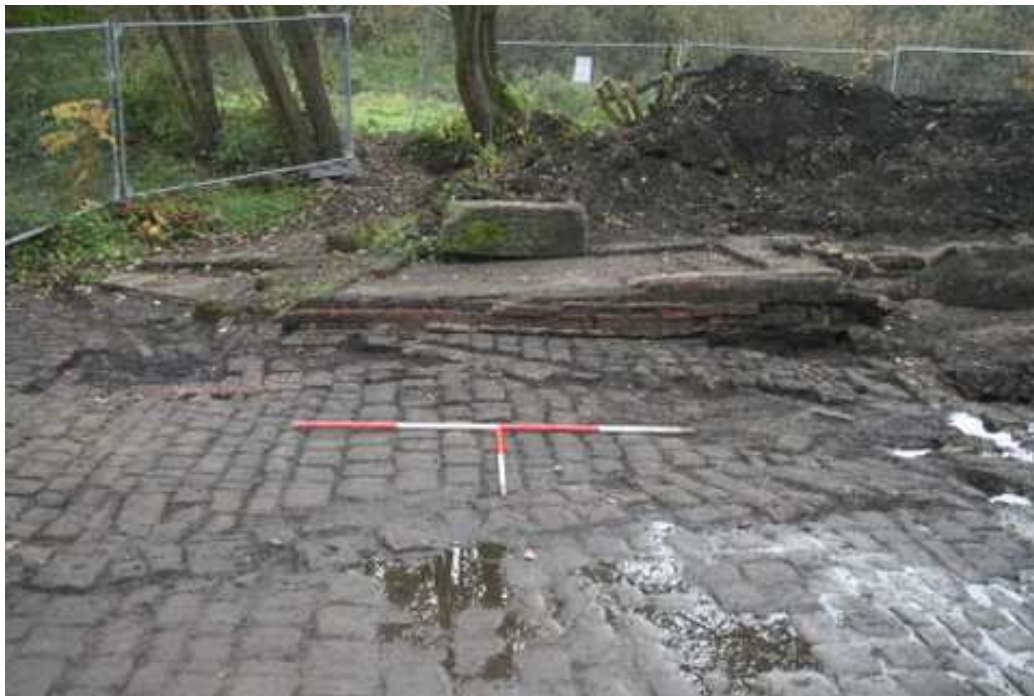
Plate 23: Loading platform, **015**, remodelled yard, **016**, and Phase 3 man-hole, **006** (left)

- 4.4.2 The platform, **015** (Plate 23), was placed at the south-eastern corner of the site (Fig 4), at the southern exposed edge of the cobbled yard (**016**), and was constructed using frogged brick and concrete. It was 3.5m in length, and 2.5m wide, and was constructed to form a counter-slope from the yard, to the east external wall of the bleachworks (**017**), and overlay, and badly damaged, what appear to be earlier tramway tracks below (Plate 20). The platform was presumably used in a loading/unloading capacity, and incorporated ridged tiles and a raised lip at its western end, presumably serving as a guide for reversing vehicles.

- 4.4.3 Several repairs were observed within yard surface **016**, to the north (Plate 23). In its south-western corner, a patch of rounded, water-worn cobbles within the more regular, rectangular sandstone setts, presumably represented an area of repair. A row of east/west-aligned setts, situated within the central part of the surface, was raised slightly (Plate 23), suggesting they had been relaid above a drain. The surface also incorporated a row of refractory tiles, presumably originating from the boiler house and re-used during Phase 4. These were aligned north-west/south-east, an extended from the north-east corner of platform **015** (Plate 23). An approximately square manhole (**006**), situated to the north-east of platform **015**, also appeared to date to Phase 3. It was

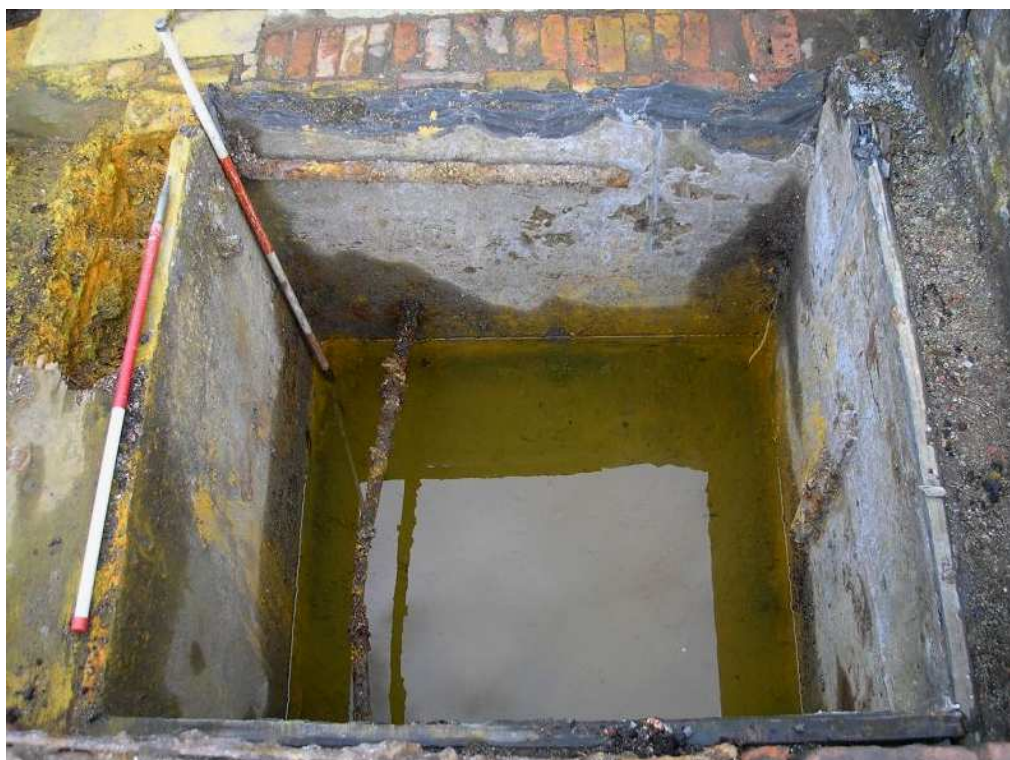
Plate 25: Excavated mid-nineteenth-century dye tank at Adelphi Street Dyeworks

- 5.1.3 Stone-built tanks at textile-finishing works have also been recorded during recent archaeological excavations at Cheadle Bleachworks near Stockport (OA North 2008a), and at the Adelphi Dyeworks in Salford (Plate 25; OA North 2008b). However, in both of these cases the remains were destroyed during redevelopment.

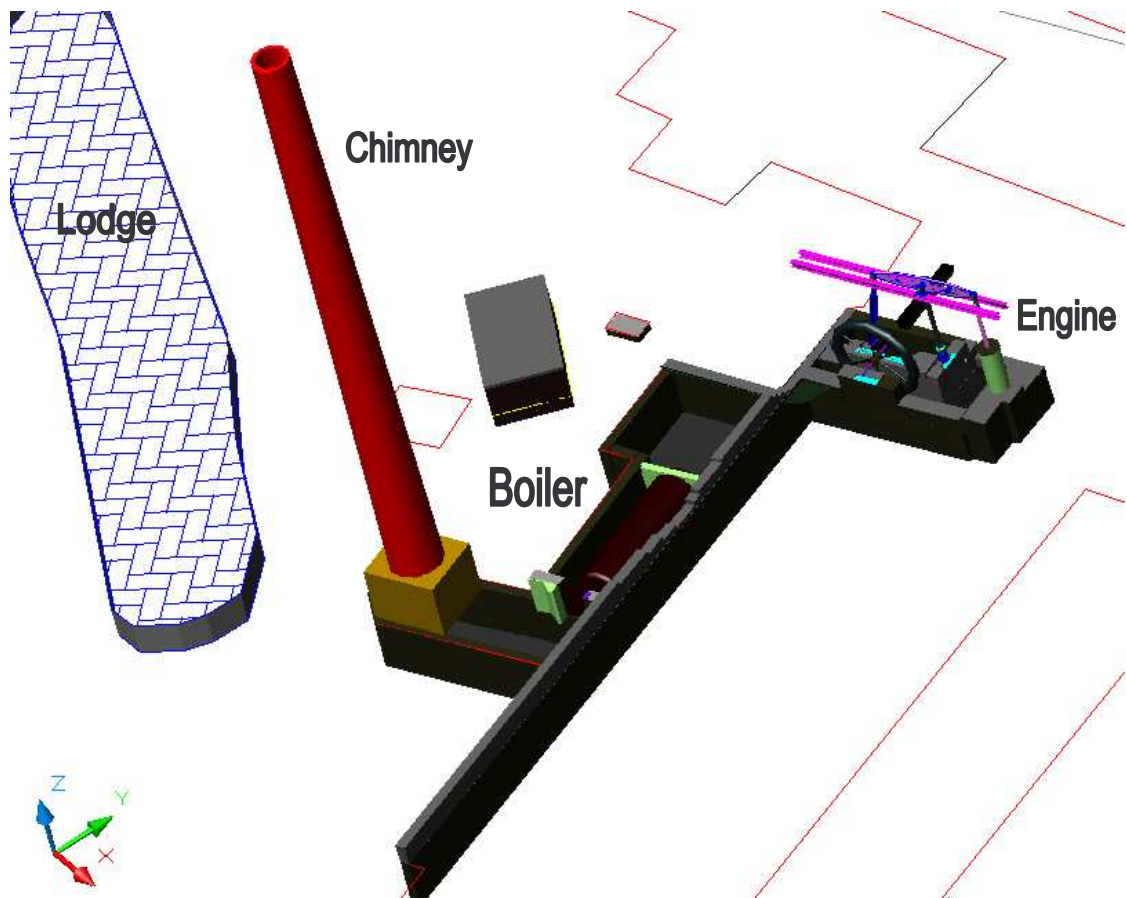
Plate 27: Extract of a measured survey and reconstruction of the bleachworks by Ian Johnson

- 4.1.3 Following the removal of the majority of the silts, extensive and well-preserved remains were exposed and cleaned manually by volunteers from the local community, and particularly members of the Bolton Archaeological Society (Plate 8). The investigation was focused on the stone foundation beds for a nineteenth-century steam engine that had been exposed by initial, but unauthorised, excavation. The initial investigation also generated a measured survey of above-ground remains of the bleachworks across the site, allowing a reconstruction drawing of the works to be compiled (Plates 27 and 28).

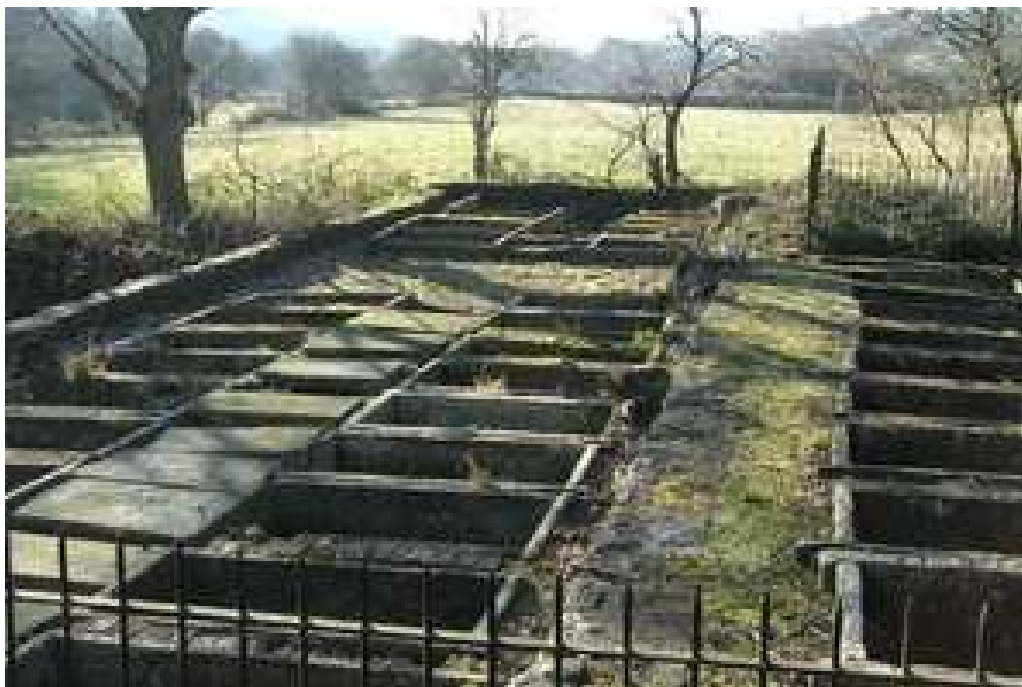
Plate 28: Consolidated dye tanks at Hodge Printworks in Tameside

- 6.2.6 A larger-scale presentation of the monument could include the re-excavation and consolidation of salient features, most notably the engine house and bleaching tanks, as has been achieved at Hodge Printworks (Plate 28). With appropriate associated signage, this would prove an invaluable educational resource for the area, presenting rare yet tangible physical remains of this important local industry.

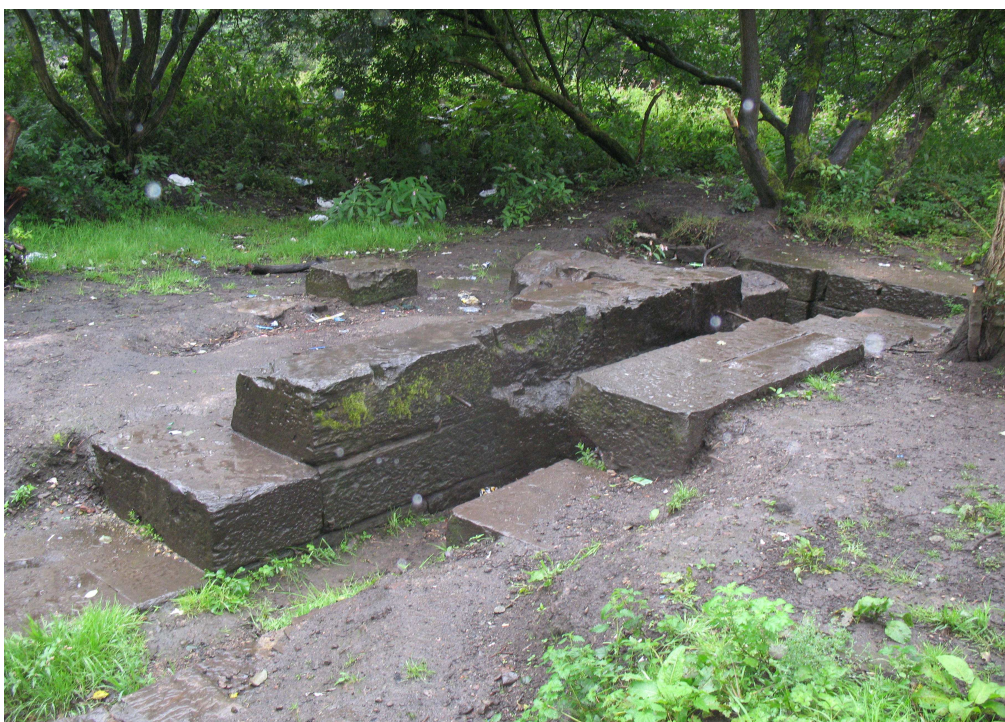
Plate 2: The exposed remains of stone machine beds
