Tootill Bleachworks, Seven Acres Park, Bolton

Archaeological Investigation

Document Title: TOOTILL BLEACHWORKS, SEVEN ACRES PARK, BOLTON

Document Type: Archaeological Investigation

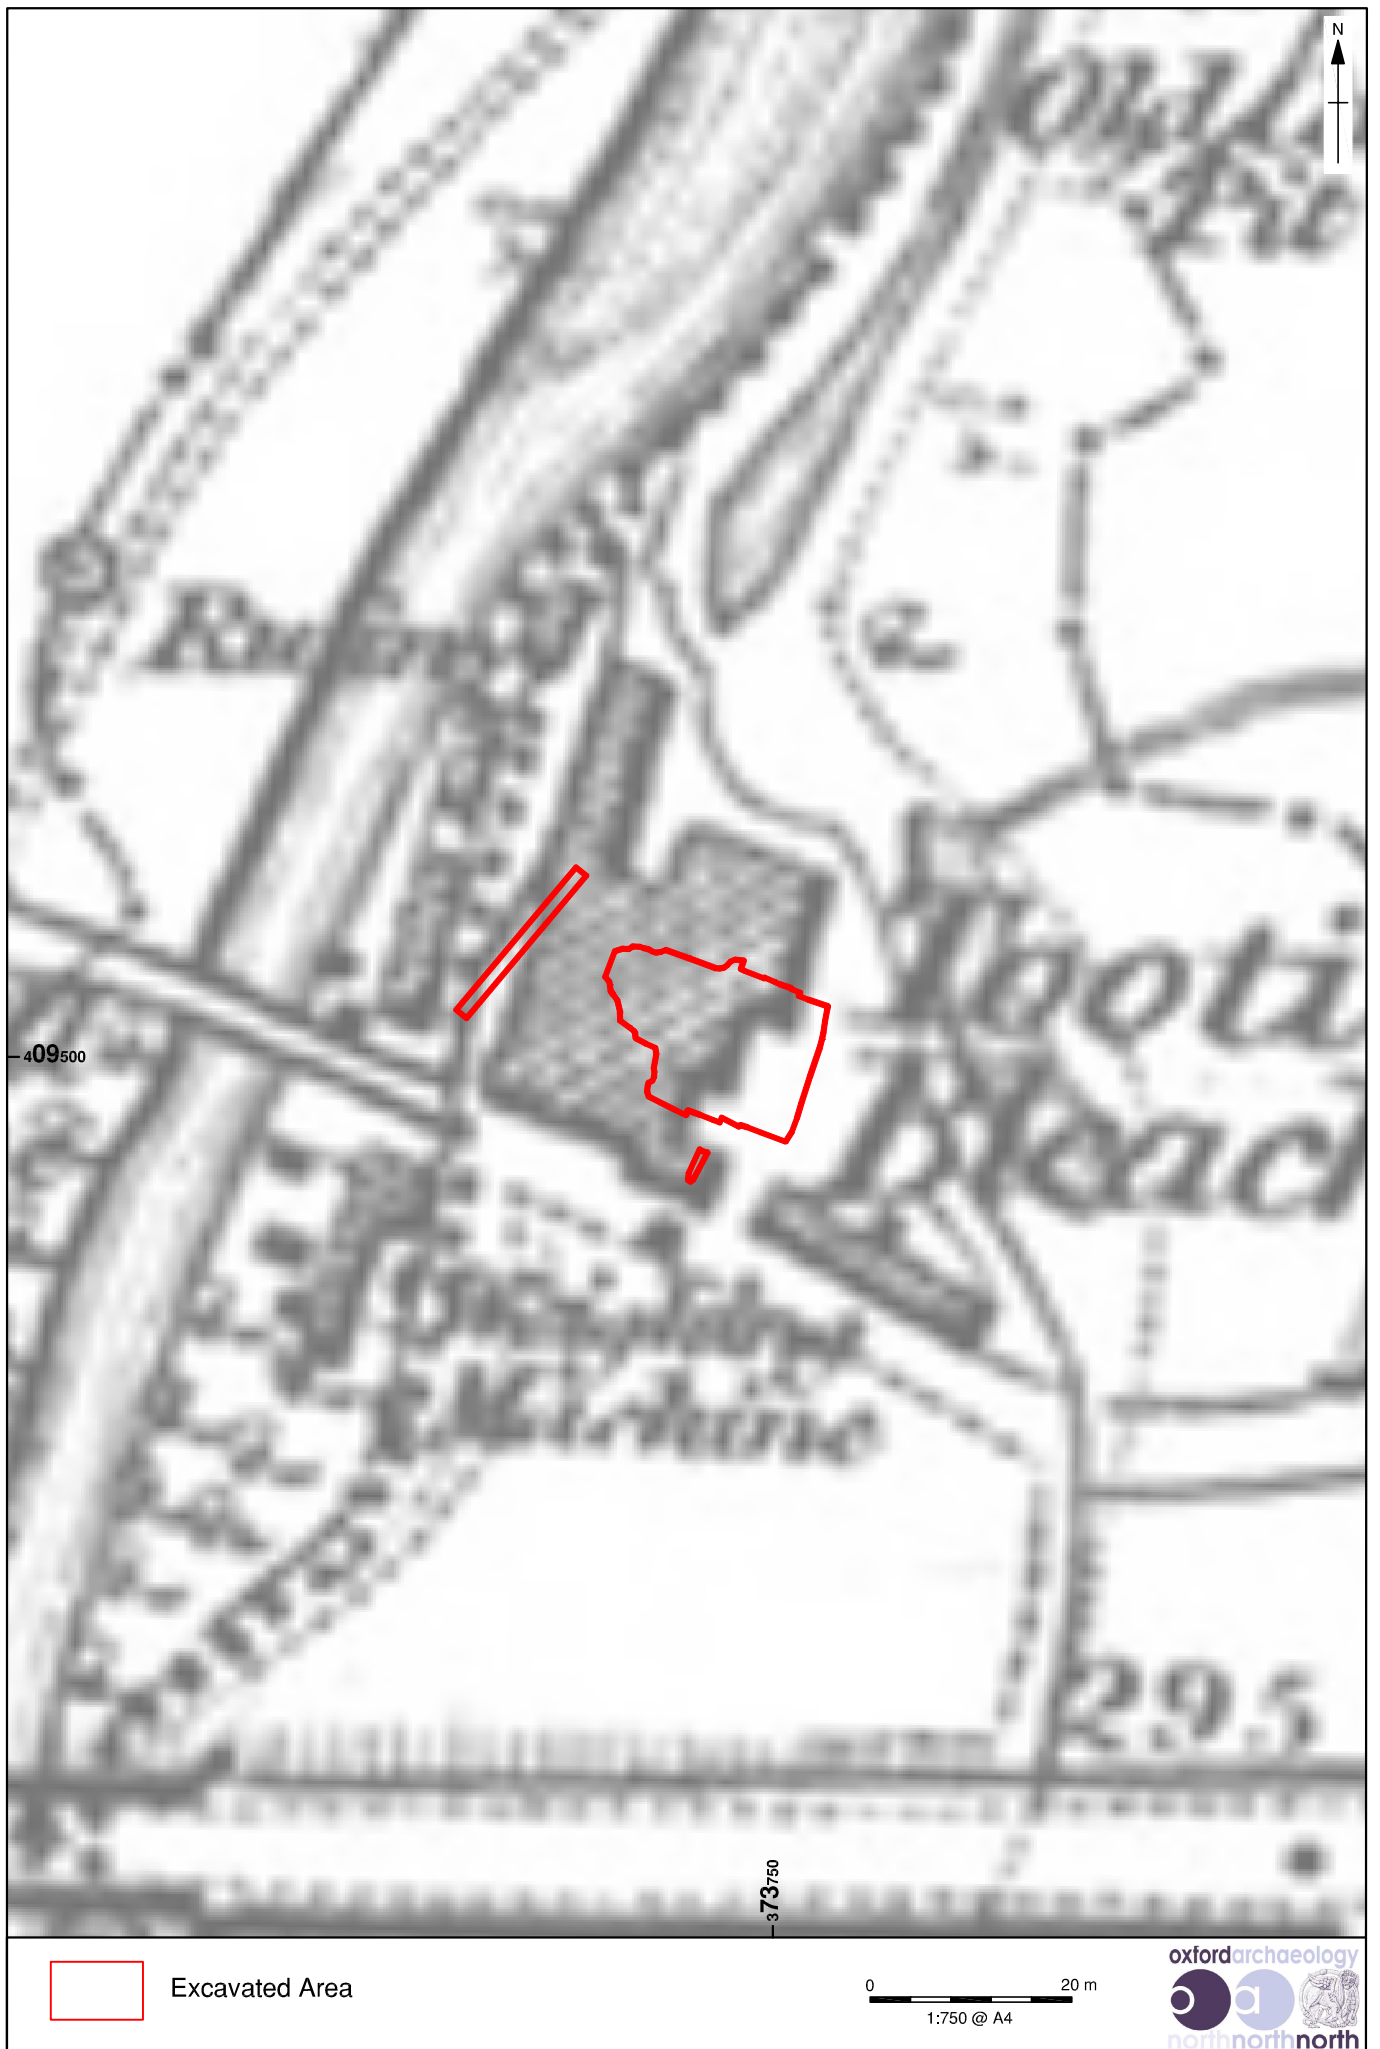
Figure 2: Extract from the Ordnance Survey 6": 1 mile map of 1850, showing location of excavated areas

- 5.2.2 The engine house probably contained a single-cylinder beam engine (Plate 26), the primary driveshaft from which ran to the north into a large range of buildings, shown on the Ordnance Survey maps of 1850 and 1893 (Figs 2 and 3). It is almost certain that the associated steam-raising plant lay to the north-east of the excavation area, and remnants of historic fabric pertaining to these structures were captured by a measured survey carried out by local enthusiasts during the initial investigation of the site, allowing a reconstruction of the power arrangements in the bleachworks to be formulated (Plate 27). These remains comprised a small section of extant brickwork, which contained refractory brick and a portion of a large metal plate, which probably represents a damper, utilised as part of a flue system between a boiler and a chimney. This suggests that the chimney, and possibly an economiser, lay to the north of the boiler, which appears to have had its charging platform positioned in the north-west corner of the yard. This area is shown on historic mapping as an extension attached to the eastern wall of the bleachworks, and on the 1893 Ordnance Survey map a chimney appears to be located further to the east.

- 5.2.4 The building that housed the bleaching tanks was served by a large yard on its eastern side, which presumably also afforded access to both the engine house and the boiler house. The presence of what appeared to be tramway tracks into the room containing the bleaching tanks from the yard, also demonstrates that access was provided to the main processing areas from the yard. It seems likely that materials were almost certainly stored in the range of buildings along the southern side of this yard, depicted on both the 1850 and 1893 Ordnance Survey maps (Figs 2 and 3).
