# **SALISBURY LAWN CHATSWORTH HOUSE**

**DERBYSHIRE**

## **Archaeological Evaluation Report**

January 2008

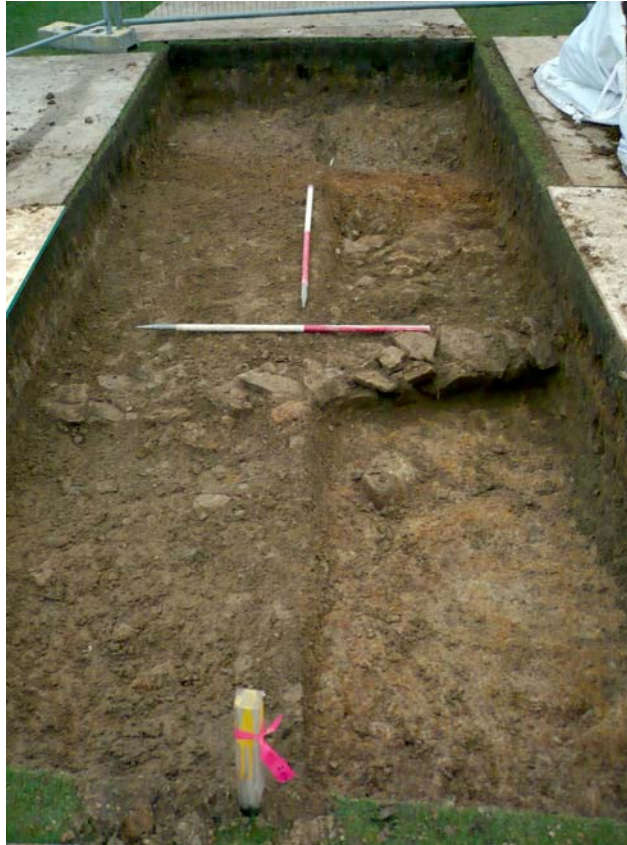
Plate 5: Trench 2 viewed from the west, sough **204** is in the foreground with wall **212** behind

- 3.3.1 Trench 2 (Fig 11; Plates 4-6) was situated some 30m north of the central path dividing Salisbury Lawn, near the west side. It was aligned east/west and was positioned to examine a north/south aligned anomaly thought to represent the lower, western terrace as depicted on the Kip and Knyff engraving (Fig 8). The trench was excavated to a maximum depth of 0.60m with the base of the trench at 127.65m OD. The present ground level lay between 128.45m OD to the east and 128.05m OD in the west. The first significant archaeological features were found at a depth of 0.32m below present ground level (PGL) (128.22m OD). The natural substrate was located a depth of 0.44m below PGL (127.66m OD).

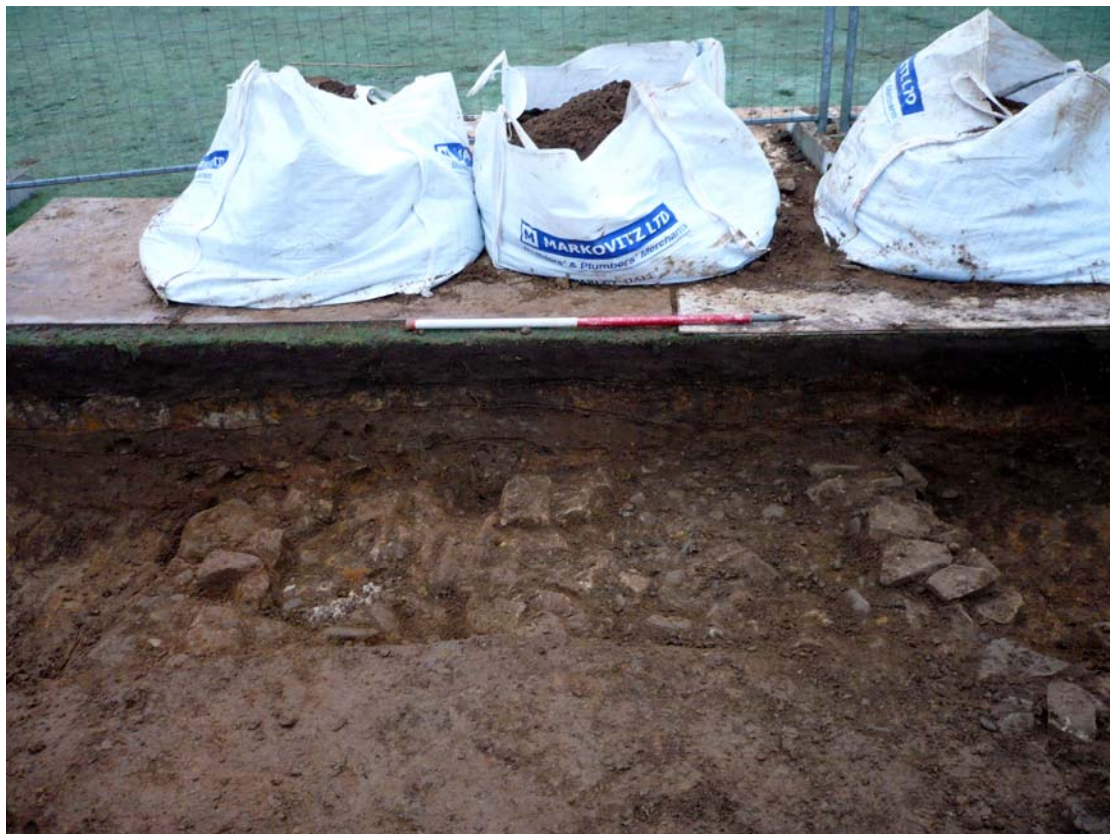
Plate 6: Detail of Trench 2, with wall **212** on the left with gravel deposit **208** to the right flanked by sough **204**

- 3.3.2 **Phase 1:** the earliest features in the trench comprised a 1.12m wide stone foundation (212) that was aligned north/south, located in the eastern half of the trench, and within a vertical sided cut (214). The foundation, which was located a depth of 0.45m below PGL (127.91m OD), was composed of local limestone and gritstone, with larger stones placed on the western edge; no bonding material was noted. This feature coincides with the orientation and location of the retaining wall for the garden terrace, as shown on the Kip and Knyff engraving (1707 (drawn 1699)), and is believed to be a surviving remnant of that wall.

- 3.3.3 Abutting the foundation to the west was a similar north/south aligned strip of gravel (208), which was 0.85m wide and truncated by a later feature to the west. However, the gravel deposit may have originally been nearly 2m wide, as there existed a shallow cut feature (215), which extended to the west. Although this was filled by a later deposit, the basal component was quite stony, perhaps indicating that it was in part the remnants of the original gravel path as depicted on the Kip and Knyff engraving. This feature was thought to be an element of the parterre immediately below the terrace.

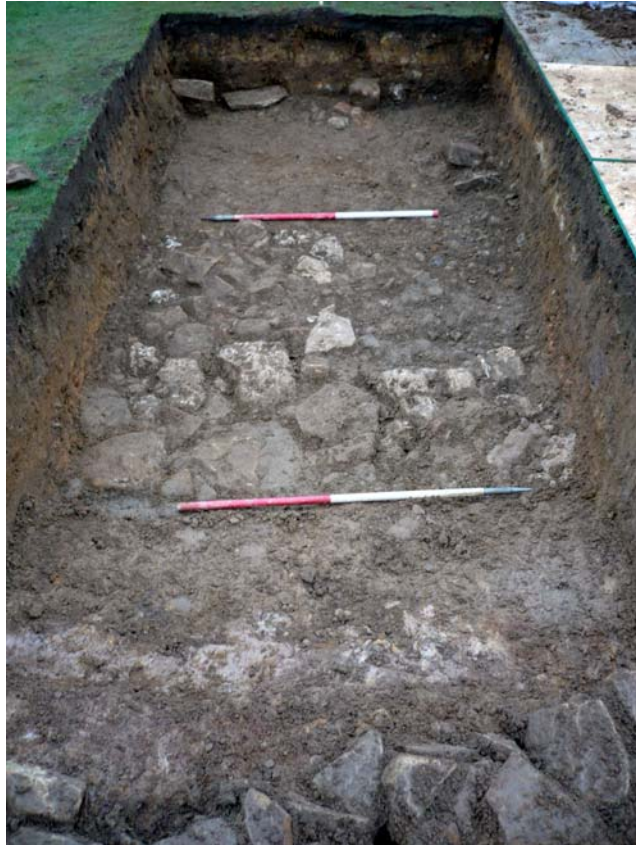
Plate 7: Trench 3 viewed toward the east. Sough **312** can be seen in the foreground with wall **305** and gravel surface **306** in the centre. Wall **317** can be seen in the background

- 3.2.1 Trench 3 (Fig 12; Plates 7 and 8) was situated some 20m south of Trench 2 and was positioned so as to examine the southern element of the same north/south aligned anomaly that been high lighted by the resistivity survey (Fig 8). The trench was aligned east/west and was excavated to a maximum depth of 0.64m with the base of the trench at between 128.11m and 128.66m OD. The present ground level lay between 129.02m OD in the east and 128.95m OD in the west. The first significant archaeological deposits were found at a depth of 0.19m below PGL (128.72m OD), and Phase 1 features were located at a depth of 0.61m below PGL (128.27m OD).

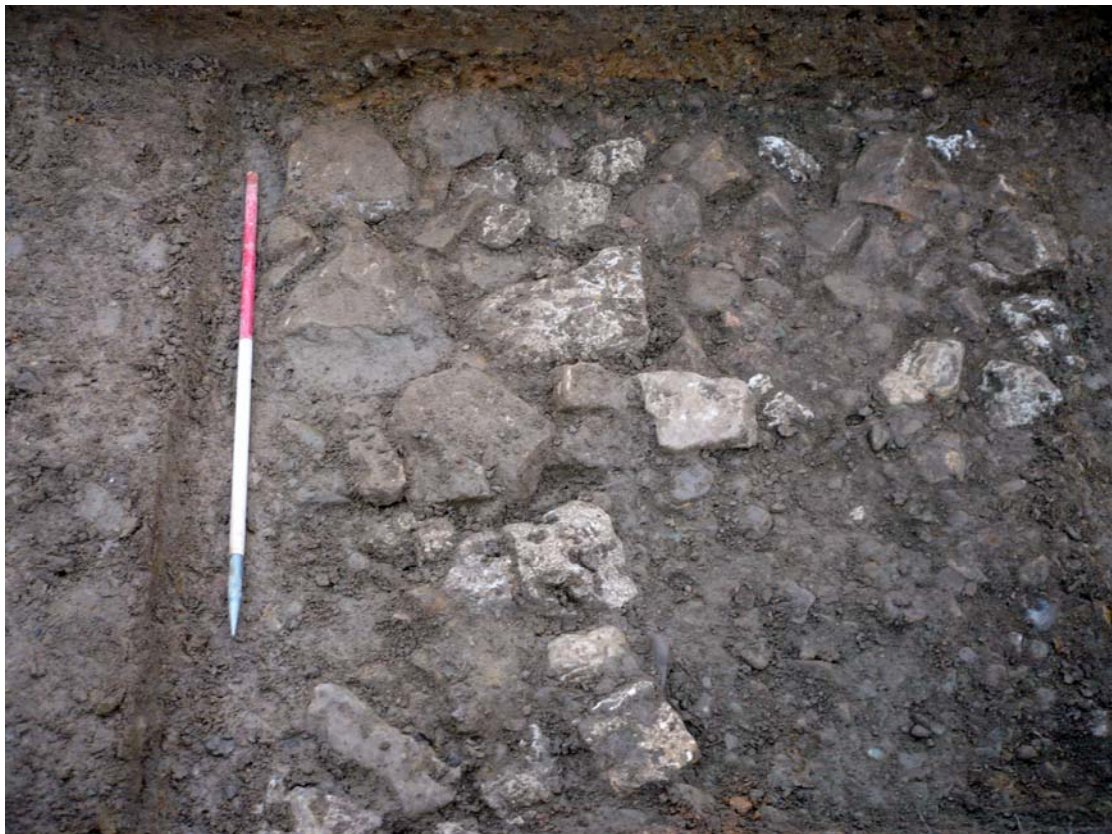
Plate 8: Detail of wall **305** and gravel surface **306** within Trench 3, seen from the north

- 3.2.3 A more substantial wall foundation (**305**) was noted to the east, and it was L-shaped, aligned north/south with a short east/west return to the west. The wall was 0.80m wide and composed of a mixture of roughly-hewn limestone and gritstone blocks, which contained no evidence of any bonding material. Within the crook of the wall (**305**) was a gravel deposit (**306**) thought to represent an element of parterre. It is clear that wall foundation **305** was the southern extent of wall **212** found in Trench 2, and was the retaining wall for the lower terrace as shown on the Kip and Knyff engraving. It was not clear what the L-shaped element of **305** was; however, it did appear to mirror the arrangement of wall foundations **317** and **318** and may be an indication that they were related. There does not appear to be any similar shaped structure illustrated on the Kip and Knyff engraving, although the remains revealed within this trench may pre- or post-date those shown on the drawing.

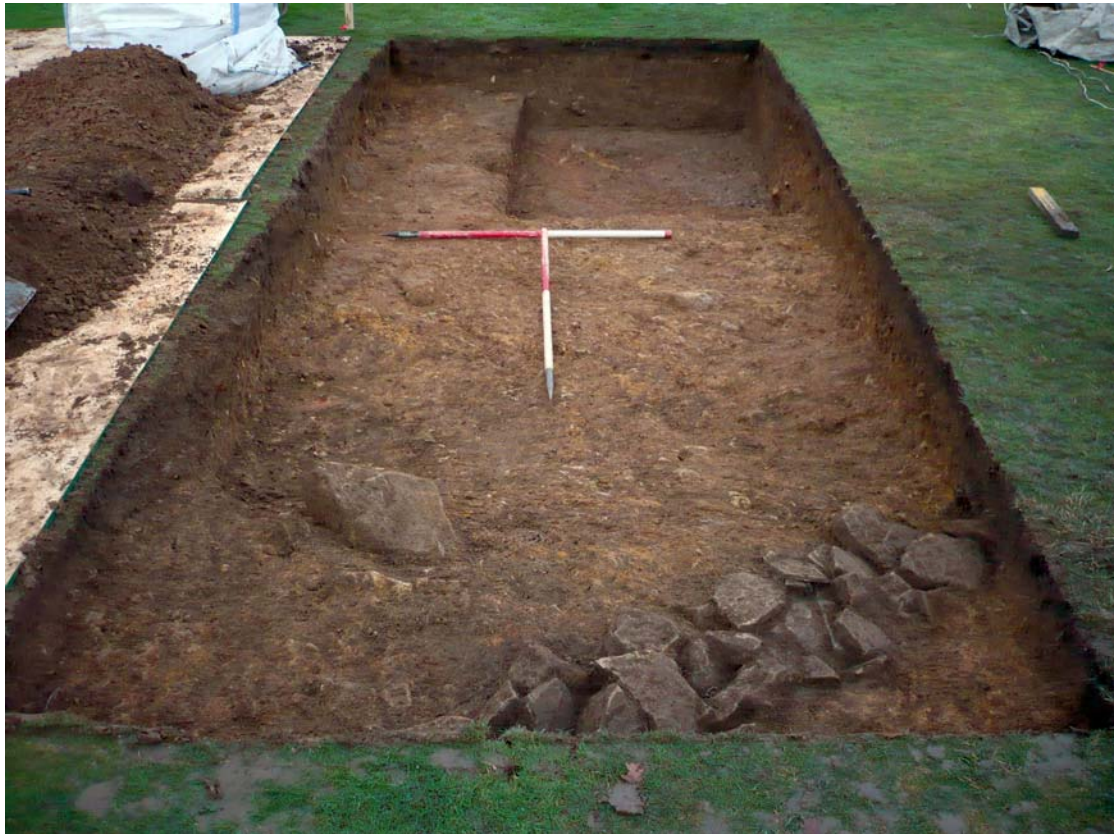
Plate 9: Trench 4 viewed toward the north with sough **401** in the foreground and ditch **407** beyond

Trench 4 (Fig 13, Plate 9) was located towards the northern end of Salisbury Lawn and was sited on the middle terrace as depicted on the Kip and Knyff engraving. The trench was located so as to examine an east/west resistance anomaly that had the potential to be the path of a parterre (Fig 8). The trench was aligned north/south and was excavated to a maximum depth of 0.60m (129.35m OD). The present ground level (PGL) lay between 129.89m OD in the north and 128.99m OD in the south. The first significant archaeological deposits were found at a depth

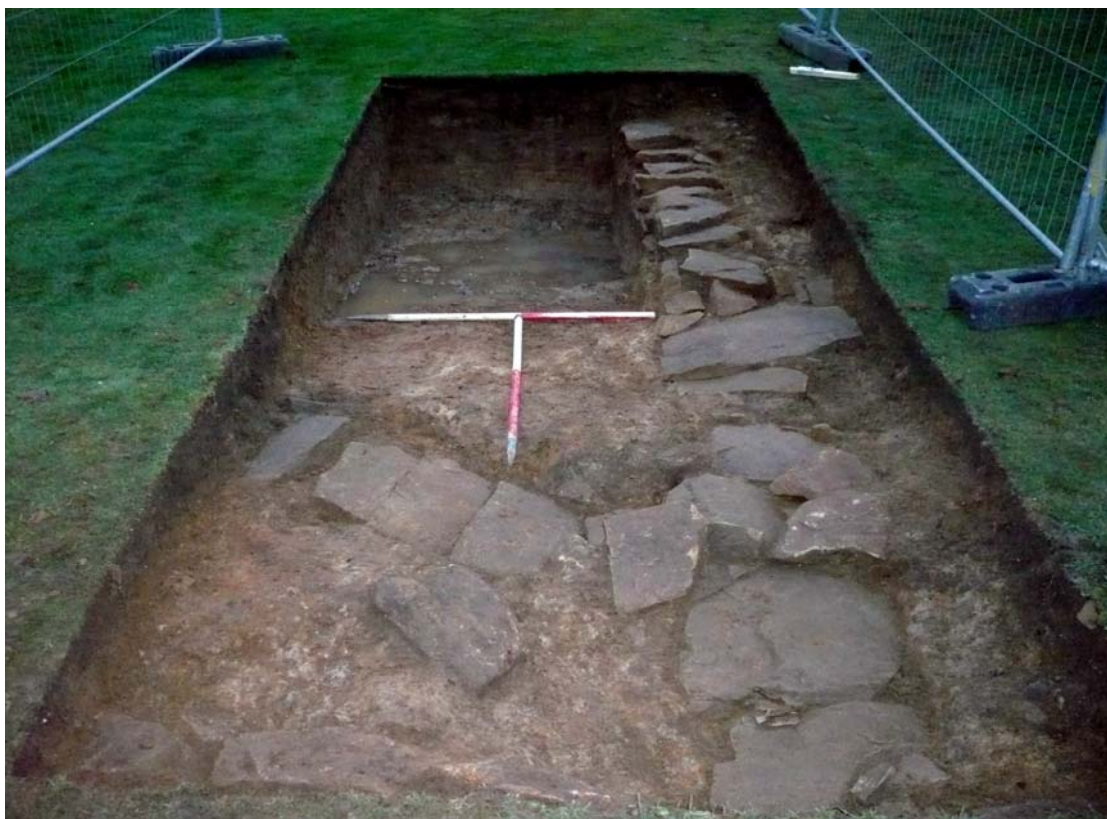
Plate 11: the interconnecting culverts **605** in Trench 6, with cut feature **607** in the background. Just visible in the foreground is the garden border feature **606**

- 3.7.1 Trench 6 (Fig 14; Plates 11 and 12) was located on the centre/west side of Salisbury Lawn and was intended to examine a magnetic, rectilinear anomaly that surrounded what had been provisionally suggested to be an area of possible dumped brick/ fired material, and also an 'L' shaped resistance anomaly (Fig 7). The trench was aligned east/west and was excavated to a maximum depth of 0.74m (132.01m OD). The present ground level (PGL) lay between 132.75m OD in the east and 132.23m OD in the west. Archaeological features were noted at 0.14m (132.53m OD) below PGL and natural was located at 0.26m (132.18m OD) below PGL.

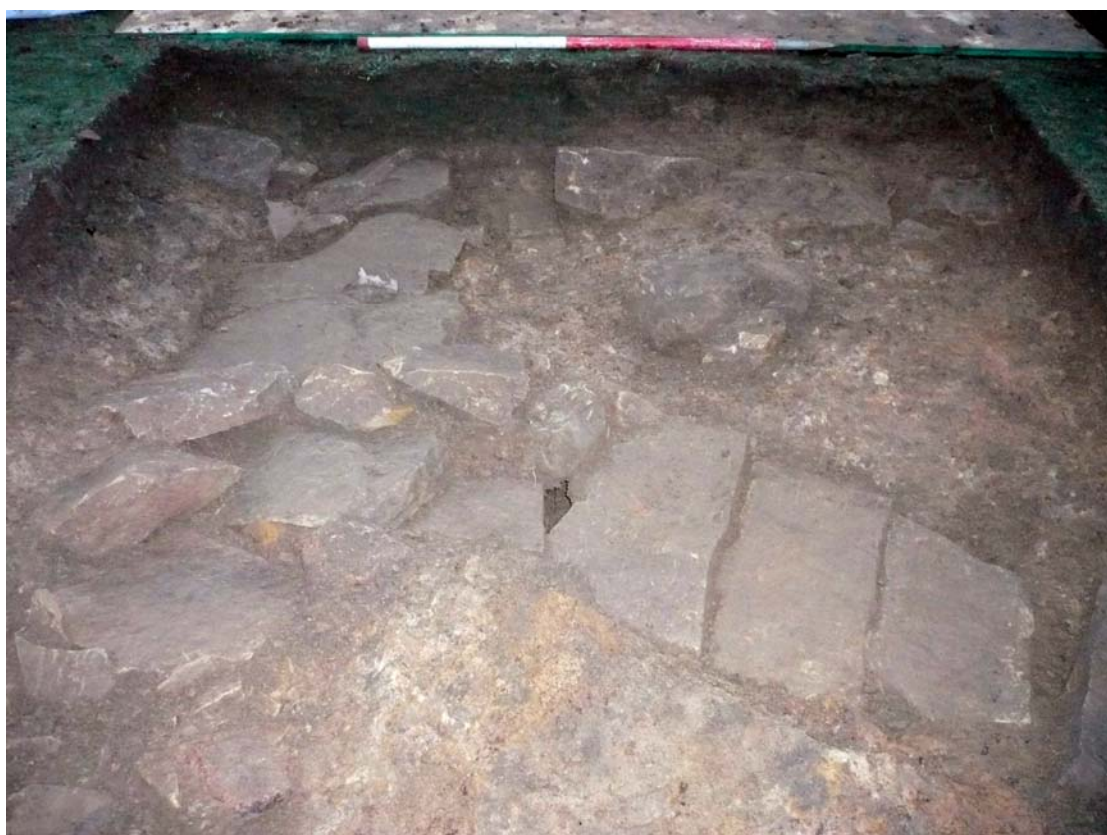
Plate 12: Detail of culverts **605**, in Trench 6, cutting the earlier garden feature **606**

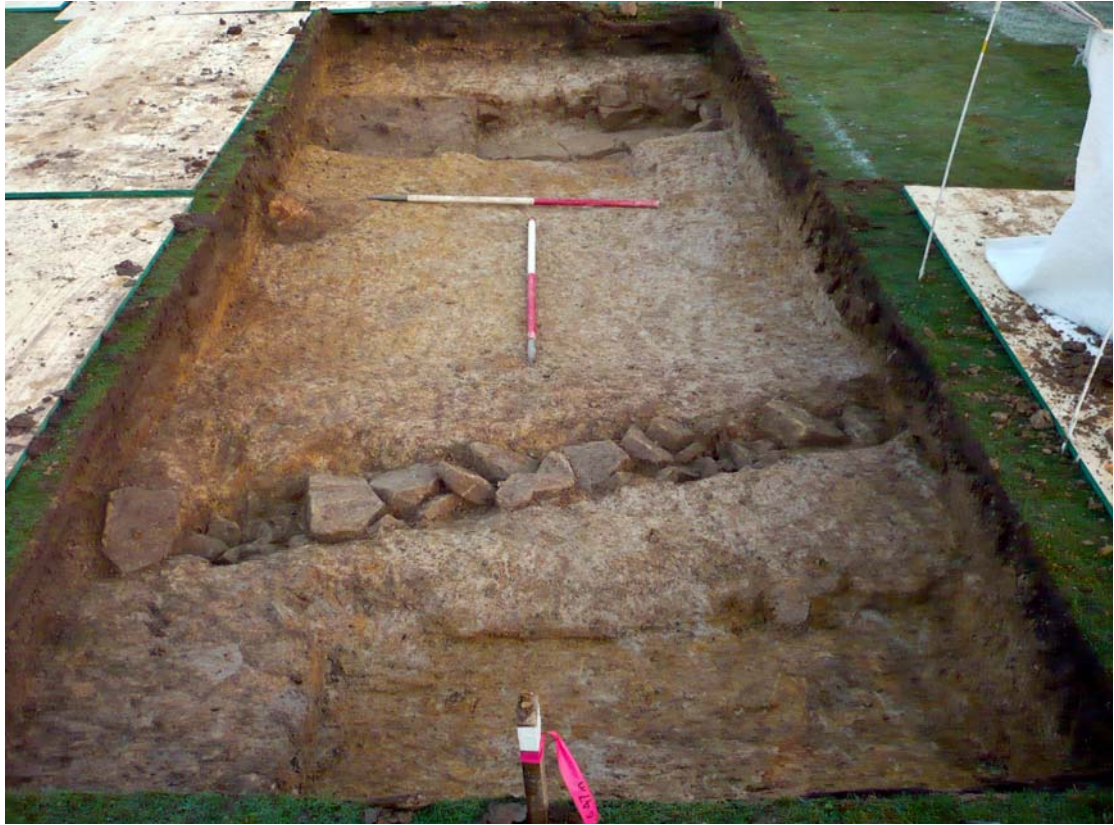
Plate 13: Trench 7 viewed from the west. Sough **707** can be seen in the foreground with garden feature **705** beyond

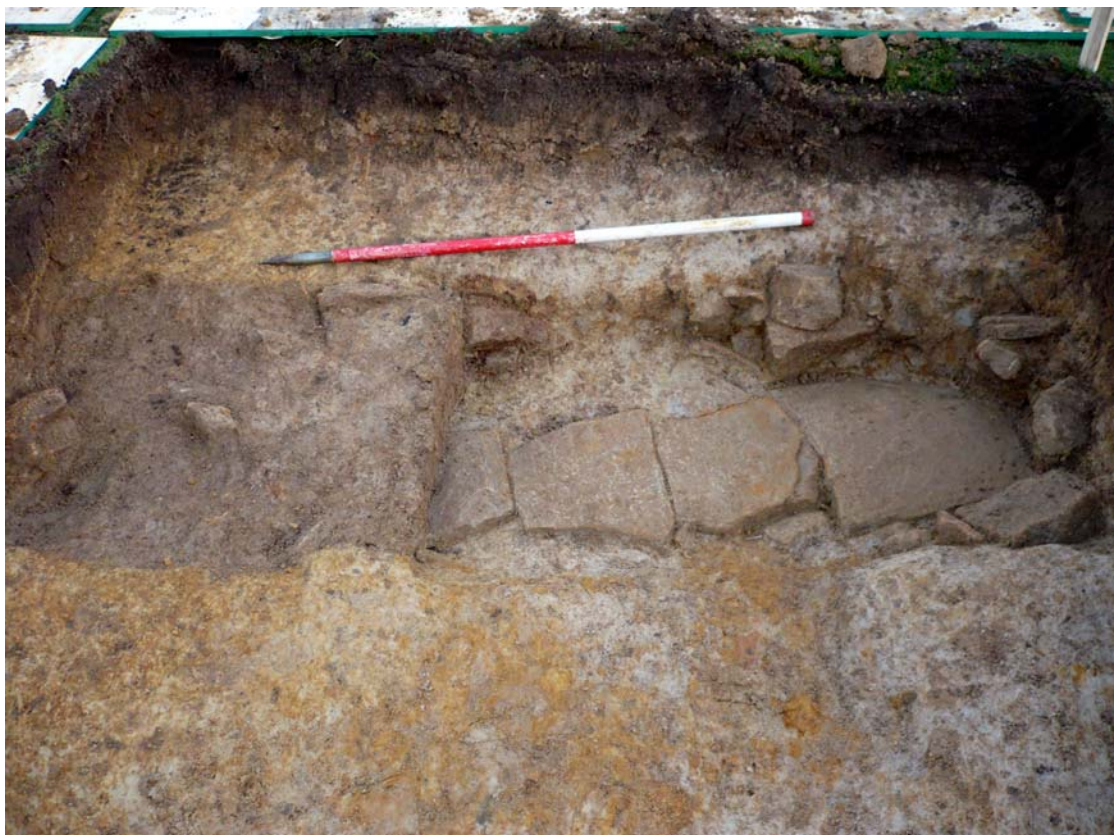
Plate 14: Trench 7 - detail of garden feature **705** viewed toward the east

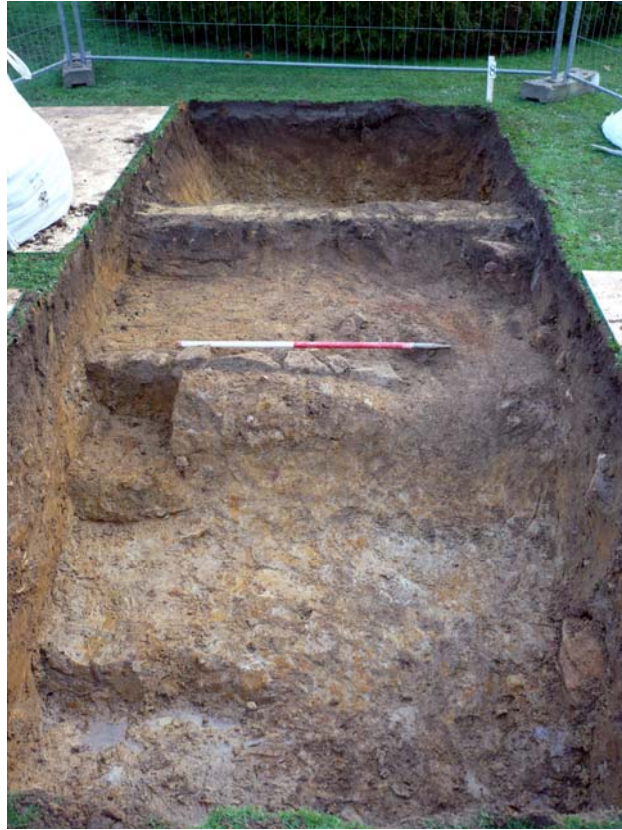
Plate 15: The terrace **809** in Trench 8 seen from the west. The raised linear feature in the background is a modern alarm cable

- 5.1.6 The lower step of the second terrace (**809**), below the cascade, was also found to be intact, in Trench 8, and was preserved when the upper sections of the terrace were landscaped and the resulting material was deposited in front of it. Indeed it may be possible to tie this event in with an alteration to the gardens recorded in the Chatsworth archives in 1736-37, when 'removing earth to make part of the slope below the cascade steps' was noted (Barnatt and Williamson 2005, 96). Immediately east of the front of the terrace was a north/south-aligned stone drain, which had clay packed against its west side to ensure its water retention qualities and to allow it to carry water away from the terrace.

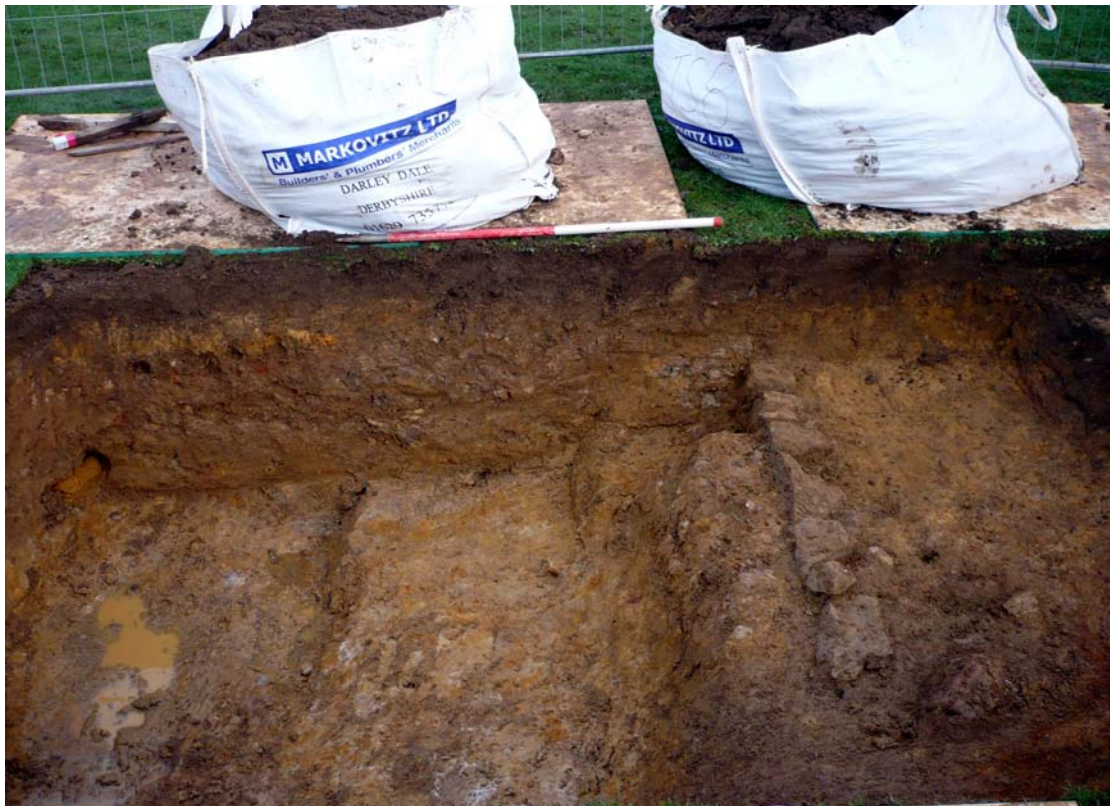
Plate 16: Trench 8 - detail of the terrace (**809**) seen in profile, with its associated clay lined drain (**807**) running parallel to it

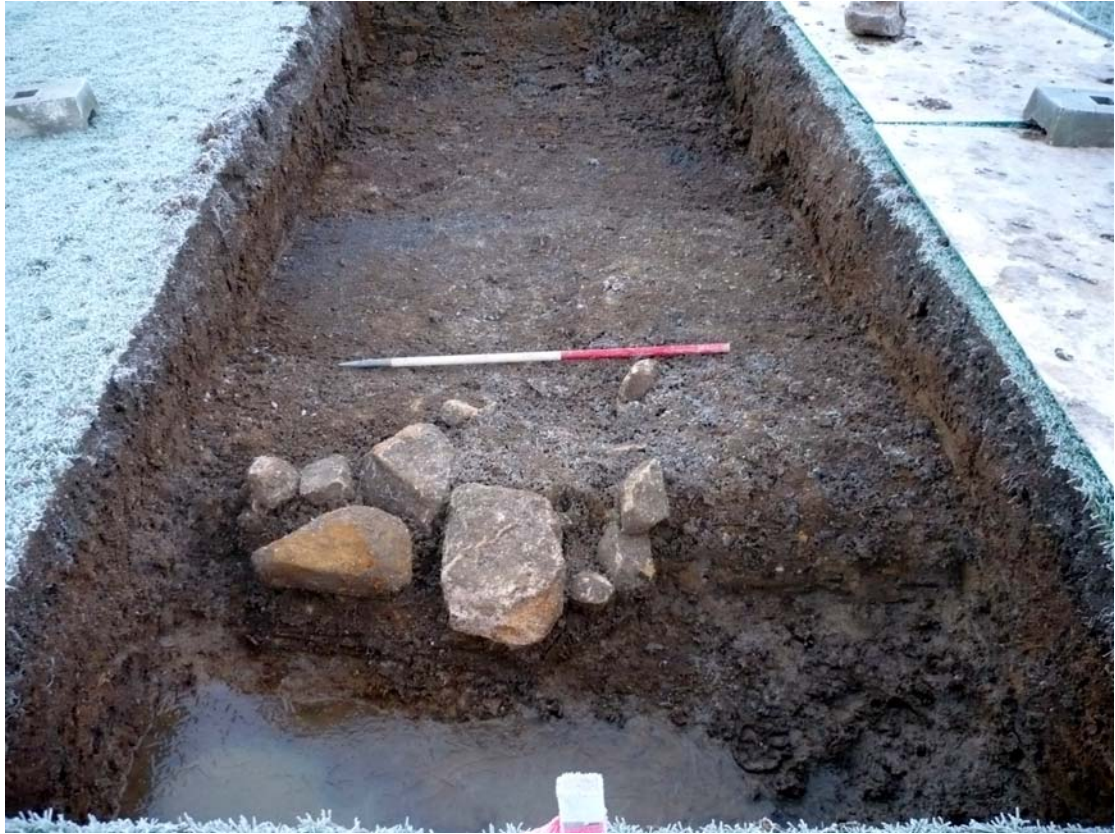
Plate 17: Trench 9 - the east/west aligned garden feature (904) within the south end of Trench 9

- 3.10.1 Trench 9 (Fig 17; Plates 17 and 18) was located immediately south of the central pathway, on the western half of Salisbury Lawn. The trench had been placed to examine an east/west aligned resistance anomaly that was thought to be part of a parterre (Fig 8). The trench was aligned north/south and was excavated to a maximum depth of 0.82m (132.27m OD); the present ground level (PGL) lay between 133.17m OD in the south and 133.05m OD in the north. Significant archaeological features were noted at a depth of 0.38m (132.79 OD) below PGL, and natural was located at 0.40m (132.45m OD) below PGL.

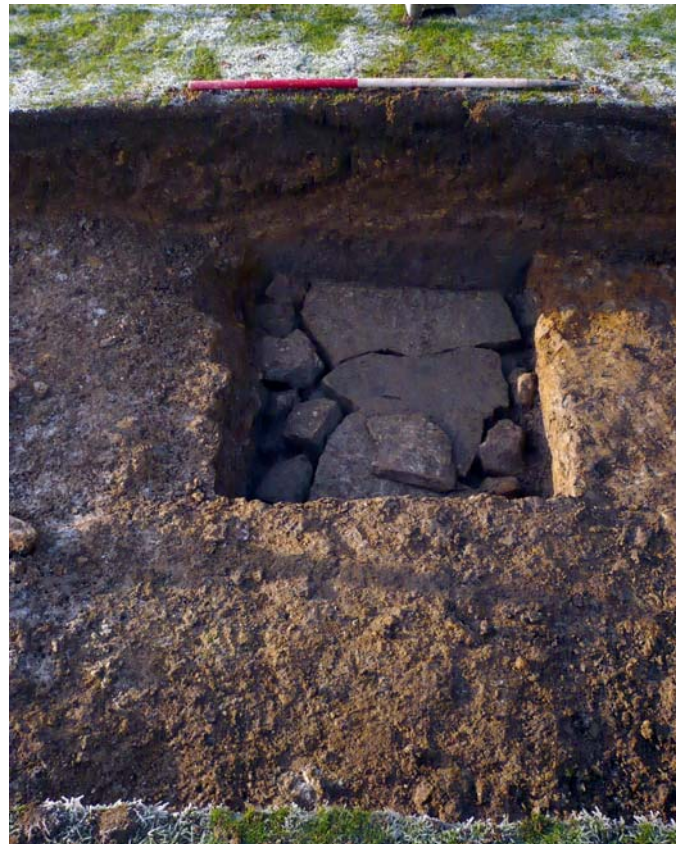
Plate 18: detail of the east/west aligned culvert (908) within Trench 9

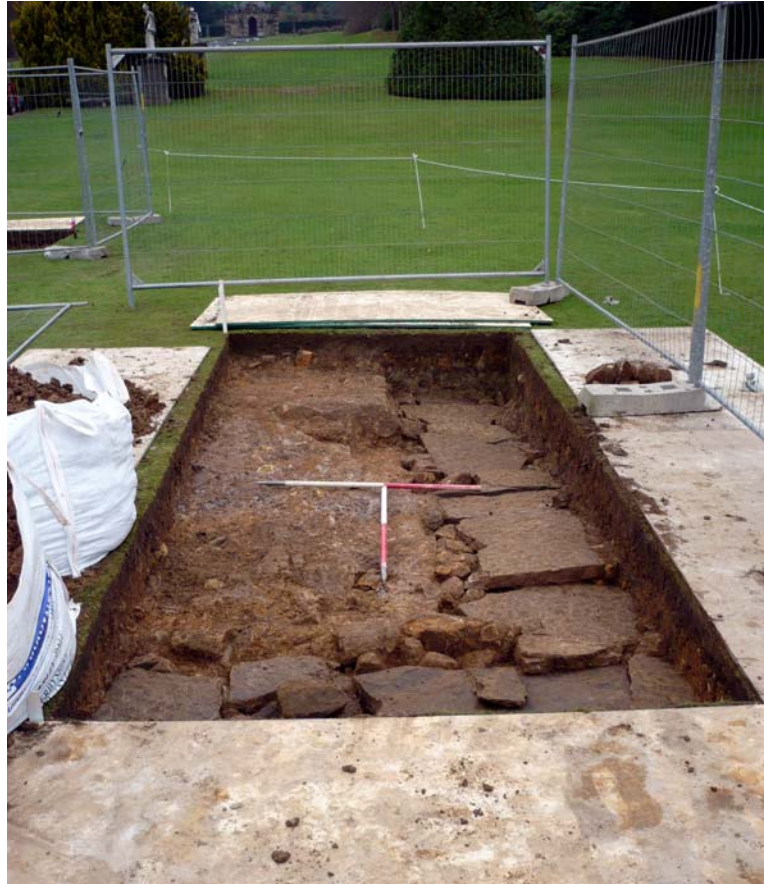
Plate 19: Trench 10 viewed toward the east. The trench is dominated by culverts *1003/1007*. A possible garden feature is represented by a single stone (*1005*) which can be seen in the background

- 3.11.1 Trench 10 (Plate 19) was located south of the central pathway, on the western half of Salisbury Lawn, south-west of Trench 9. The trench had been placed to examine a north/south aligned resistivity anomaly thought to be part of a parterre (Fig 8). The trench was aligned east/west and was excavated to a maximum depth of 0.52m (132.21m OD). The present ground level (PGL) lay between 132.74m OD in the west and 132.35m OD in the east. Significant archaeological features were noted at a depth of 0.46m (132.28 OD) below PGL, and natural was located at 0.30m (132.20m OD) below PGL.

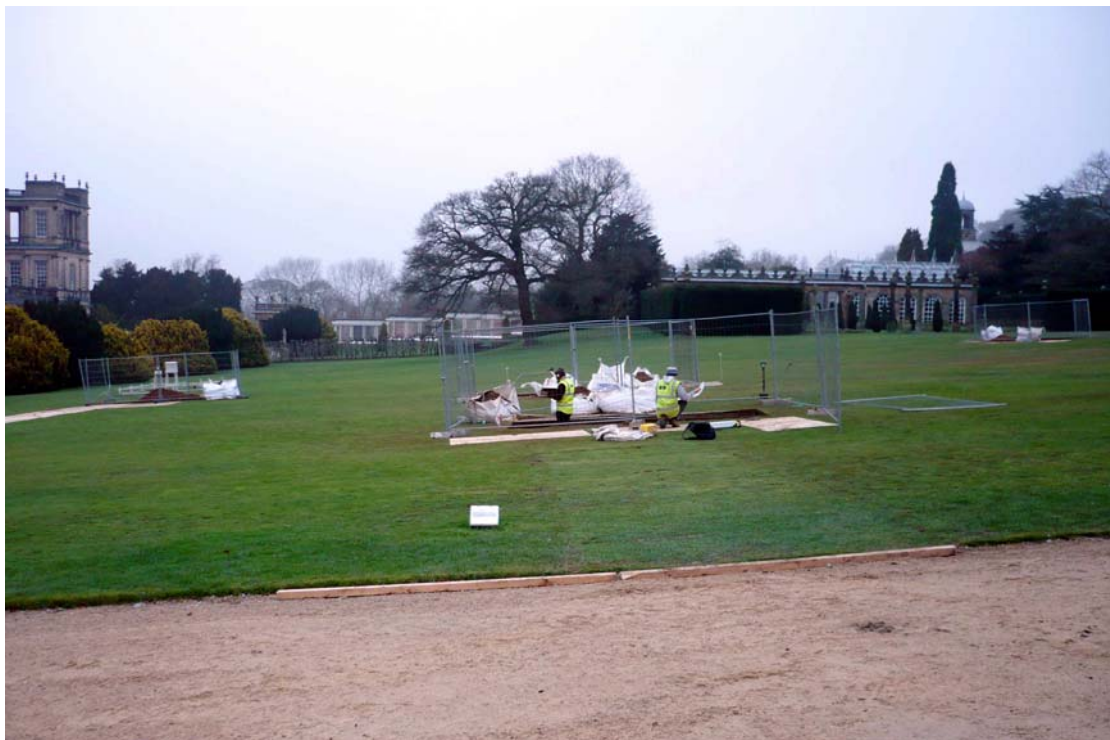
Plate 20: Trench 3 during excavation viewed towards the north. The surviving element of the terrace can be seen to the left of the Rose Garden marked by the large tree

- 5.1.3 Trenches 2 and 3 revealed the remains of the retaining wall foundation for the lower north/south aligned terrace, part of which may still remain intact immediately west of the Rose Garden (Plate 20). The feature survived as a 0.9m to 1.8m wide stone foundation (**212** and **305**), which could be traced for over 35m between Trenches 2 and 3, and this corresponds to a clear resistivity anomaly that continued north into the general area of the Rose Garden. In Trench 3 the foundation (**305**) was found to be L-shaped with a short return to west. This deviation to the north/south alignment was difficult to explain, other than it appeared to mirror a similarly-aligned but less well preserved wall (**317**) that abutted an east/west return (**318**). The Kip and Knyff engraving shows the terrace as a stepped, but continuous wall. It is possible, however, that the remains relate to an earlier or indeed later phase of the garden that was not visible when Kip and Knyff produced the engraving. To the west of the wall foundations were deposits of gravel (**208** and **306**), that were interpreted as the paths below the terrace.
