# **The Dye House, Hallthwaites, Millom, Cumbria**

## **Supplemental Archaeological Watching Brief**

**Oxford Archaeology North**

September 2009

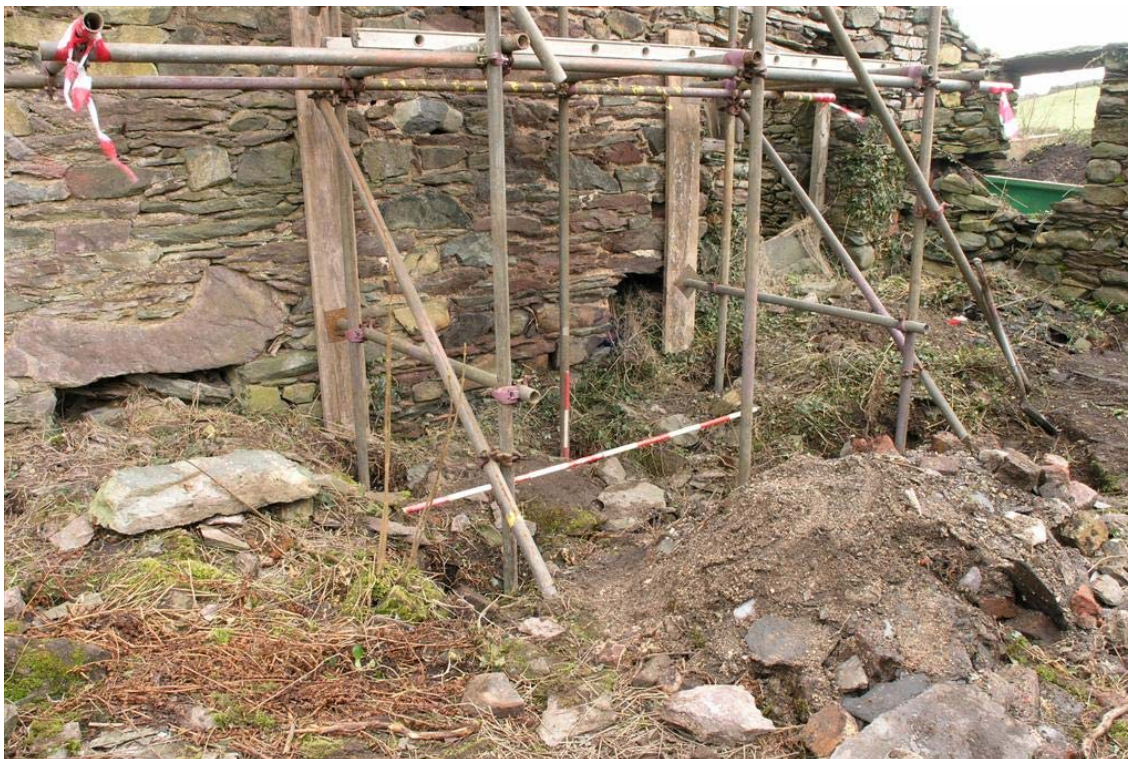
- 4.1.1 The watching brief monitored works within the northern extent of Room 7 (Fig 3), which were previously inaccessible due to the presence of scaffolding (Plate 1).
- 4.1.2 Following removal of the scaffolding, this area was excavated and recorded. Manual cleaning revealed a series of sunken features, four of which appeared to be hearths (Plate 3).

Plate 1: Area below scaffolding in Room 7 prior to excavation in 2007

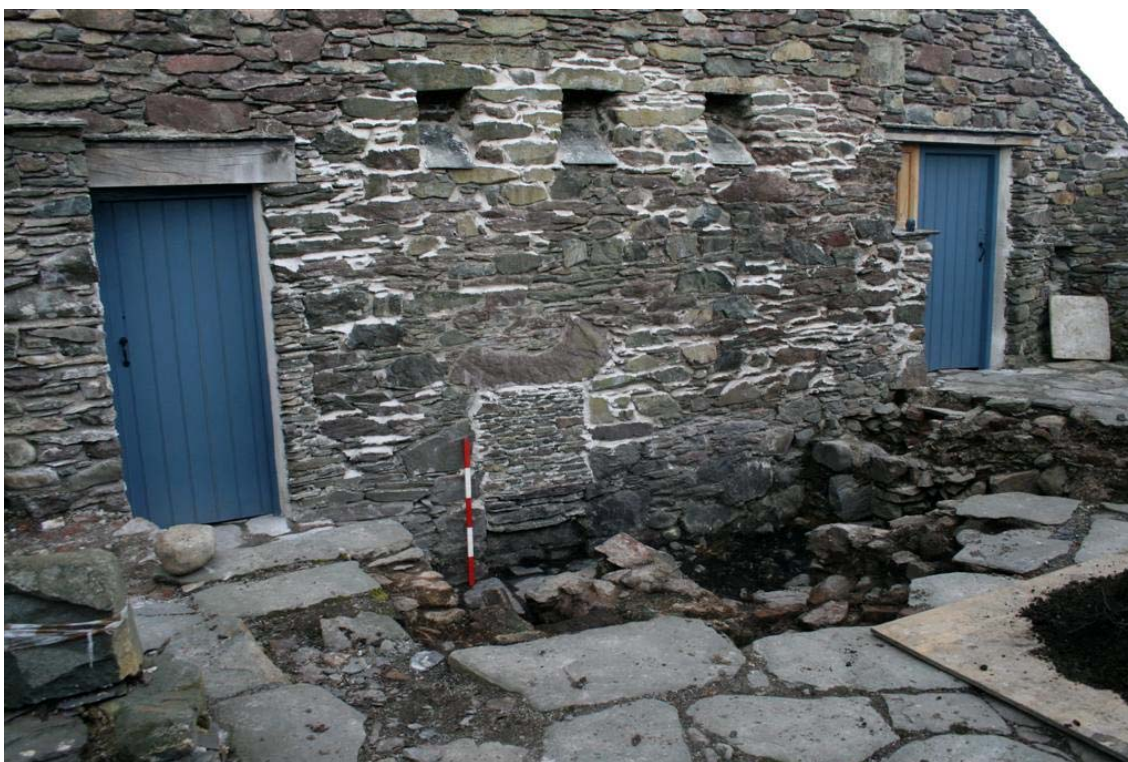
- 4.2.9 **Hearth (09)**: a blocked aperture in the north wall of Room 7 possibly represents a further, but much smaller hearth (Plates 2 and 8). It measures 2ft 8ins (0.8m) wide x 4ft 4ins (1.3m) high. This corresponds with a similar-shaped aperture in Room 5. Its specific function within the wall remains unclear.

- 5.1.1 Following the watching brief in 2007 (OA North 2007), the nature of the area at the base of the north wall of Room 7 remained unknown. This section of the wall was seen to contain three flues (Plate 2). During this final phase of investigation several features relating to the dyeing process were revealed, a number of which appear to be hearths.

- 5.1.2 Of the four hearths (**01** to **04**), three (**02** to **04**) appear to be served by flues visible in the north wall of Room 7 (Plate 2). A hood or canopy may have channelled the smoke and fumes through the flue openings, although no evidence for such remains. All of the hearths appear to have undergone some modification and alteration.

Plate 2: Area below scaffolding in Room 7 following removal of scaffolding and excavation

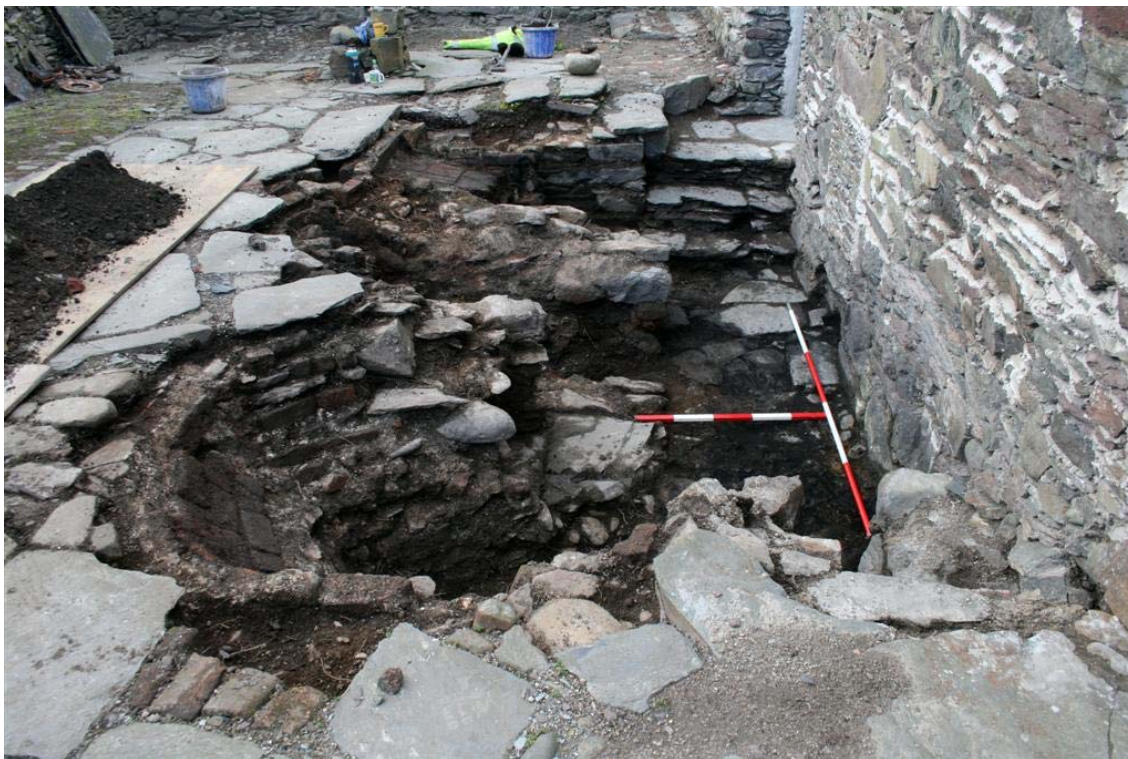
- 4.2.7 **Access Passage (07)**: the access passage was located at the base of the stone steps (05) and along the line of the north wall of Room 7 (Fig 3; Plate 3). For the most part, the floor of the passage comprised cobbles laid in a silty, compacted matrix. The relationship between the cobbles and the flags (06) at the base of the steps (05) is unclear. It is likely that the hearths were fuelled and maintained from this passage.

Plate 3: General view of the excavated area illustrating the series of sunken hearths

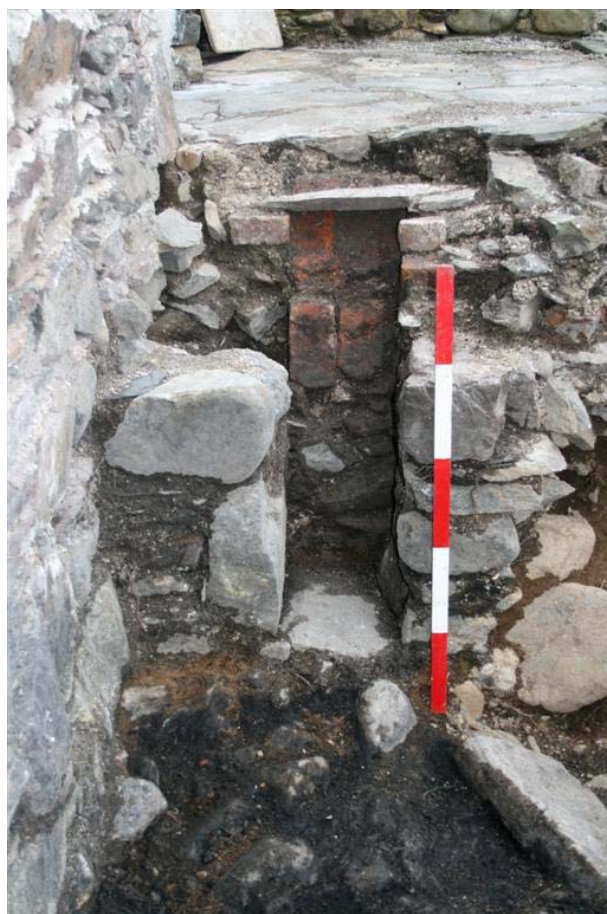
- 4.2.1 **Hearth (01)**: this is located in the north-east corner of Room 7, and comprises a 1ft (0.3m) wide x 2ft (0.6m) deep rectangular-shaped hearth, with a brick and stone-lined angled flue (Plate 4). The bricks are handmade and the mortar is lime-based. The hearth cheeks survive to a height of approximately 2ft (0.6m) and similar bricks as those lining the flue are visible. There is a slate cap to the flue, which was presumably inserted as a cover. There is some damage to the north side of the flue, probably caused by scaffolding (from an earlier repair to the adjacent wall). The base of the hearth is approximately 3ft (1m) below the floor level of Room 7.

Plate 4: The easternmost of the hearths (01)

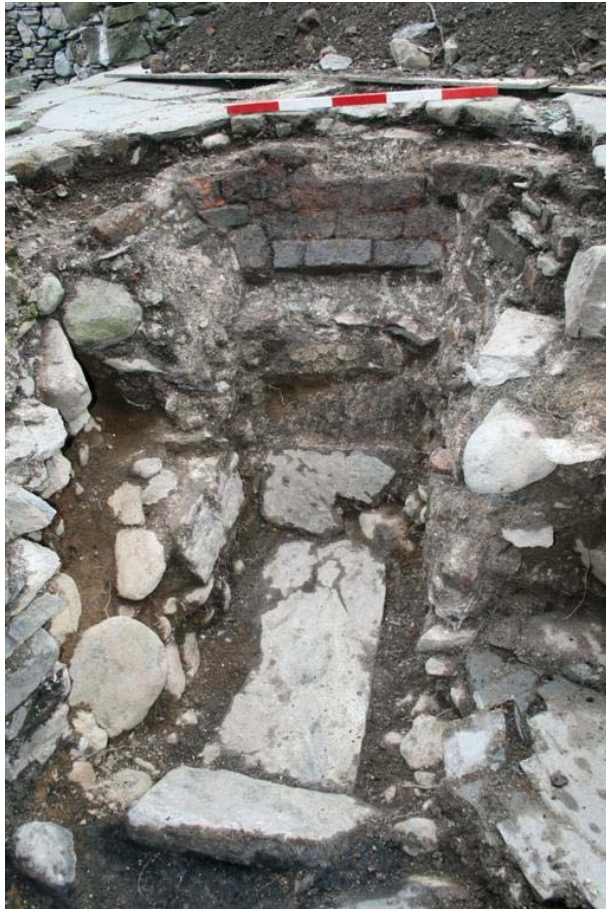
- 4.2.2 **Hearth (02)**: this is a second, larger hearth, lying adjacent to hearth **01** (Plate 5; Fig 3). It measures 2ft (0.6m) wide and is approximately 3ft (0.9m) deep at the base, which is approximately 4ft (1.2m) below the current floor level of Room 7. It is of stone and brick construction with a brick-lined round head, which is conical in plan, suggesting that it was used to hold a circular dye vat.

- 5.1.3 Two of the hearths (**02** and **03**) appear to originally have been conical in shape, and probably held large dye vats. The remaining hearths (**01** and **04**) may have housed square tanks or other such smaller containers. A set of flagstone steps allowed entry into the access passage from which the hearths were fuelled and maintained. This also appears to have undergone some modification and repair.

Plate 5: Hearth (02)

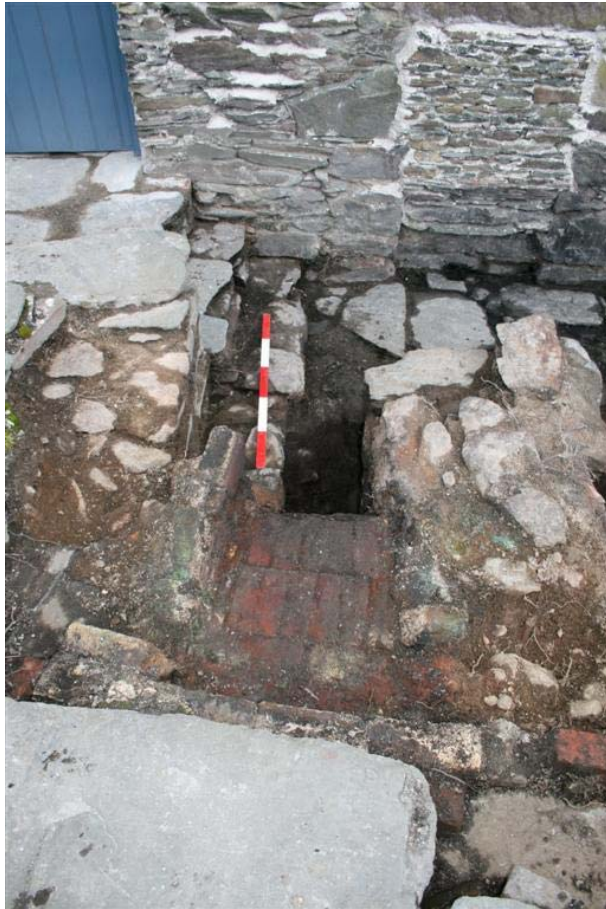
- 4.2.4 **Hearth (04)**: this hearth is approximately 1ft (0.3m) wide and 3ft (0.9m) deep. It is stone-built and has an almost vertical back wall with a rough cobble base (Plate 6). There is a 1ft (0.3m) wide bench on the west side, the top of which is 2ft 3ins (0.7m) below the floor surface of Room 7, and up to 1ft 6ins (0.5m) above the base level. Above 2ft 3ins (0.7m), the back of the hearth has a sloping floor of edge-set handmade bricks, with a single-skin re-facing brick wall around the sides. There is green staining on the hearth, probably relating to dye or copper from the dye vats.

Plate 6: Hearth (04)

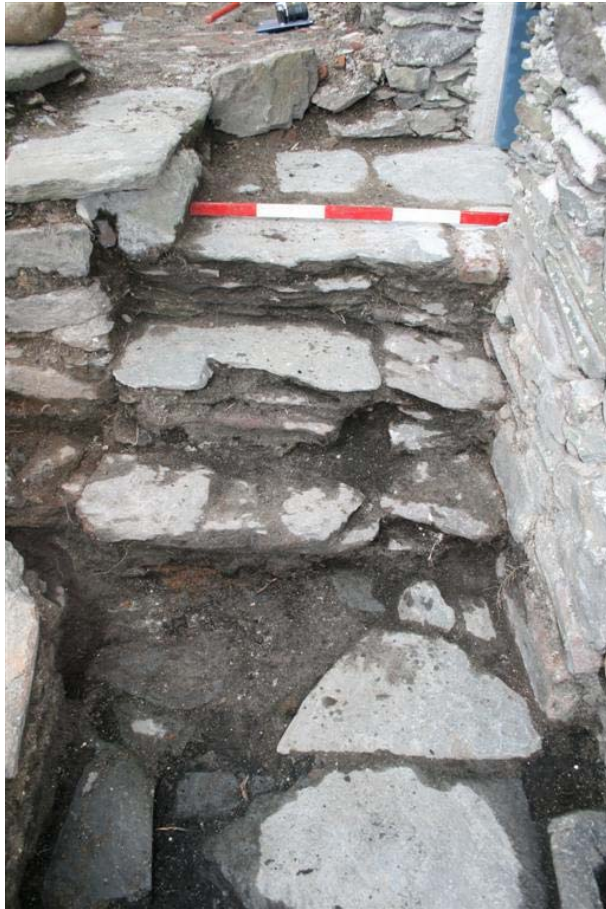
- 4.2.5 **Stone Steps (05)**: a series of stone steps (Plate 7) lead down into the access passage (**07**) (*Section 4.2.7, below*). These are constructed from flagstones of similar appearance to the main floor of Room 7. Access to Room 5 is provided via a small step down at the top of these steps, from the floor level in Room 7, as observed during the watching brief of 2007 (OA North 2007).

Plate 7: Stone steps (05) providing access to the hearths

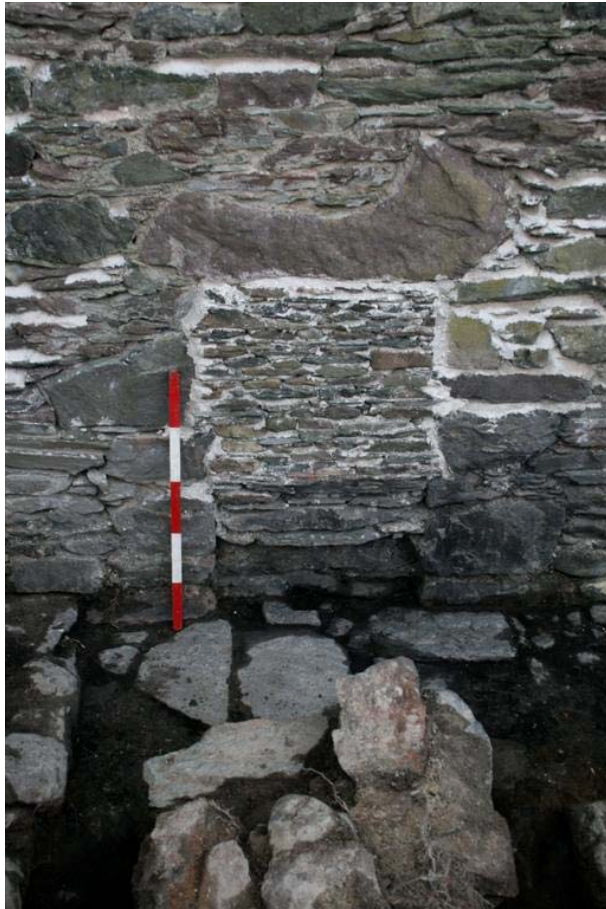
Plate 8: Blocked hearth (09) in the north wall of Room 7

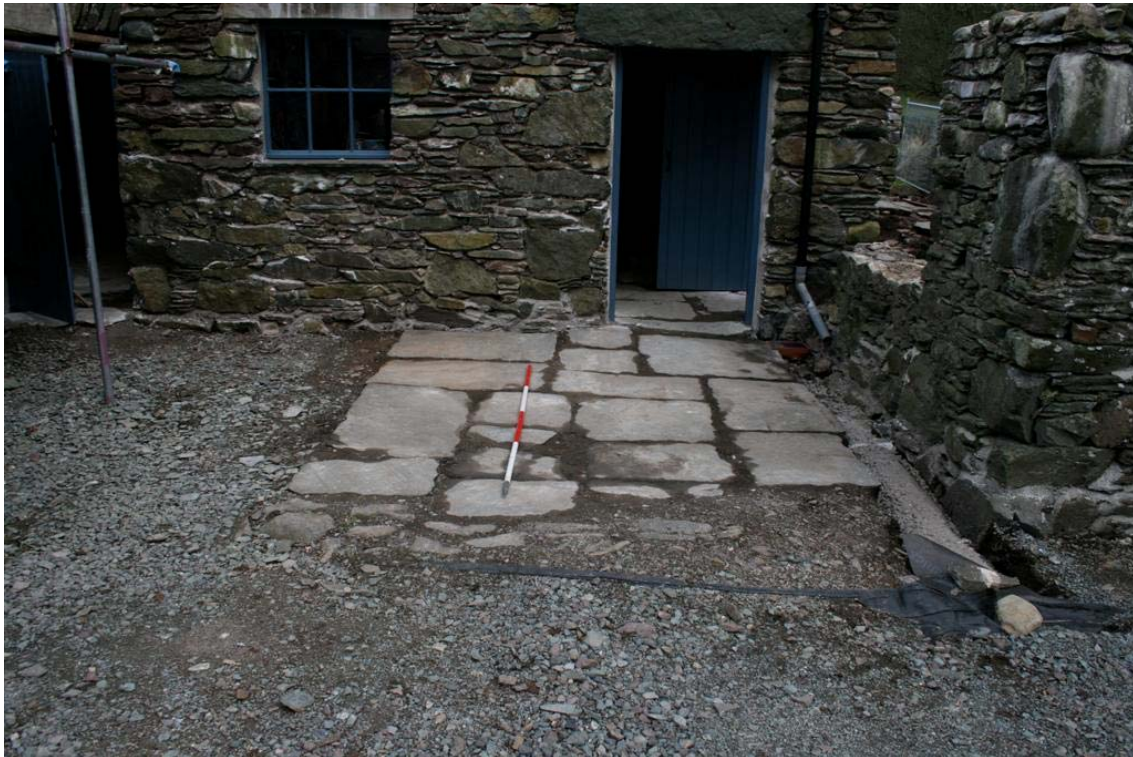
- 4.2.10 **Floor (10)**: this comprises a 10ft (3m) by 9ft (2.7m) external flagged floor, located to the north-west of Room 7 (Plate 9). There is a drain along the southern side, and it is bounded to the west side by cobbles.

Plate 9: External flagged floor (10)
