# **DIDSBURY FLOOD STORAGE BASIN, GREATER MANCHESTER**

## **Archaeological Watching Brief Report**

**Oxford Archaeology North**

August 2009

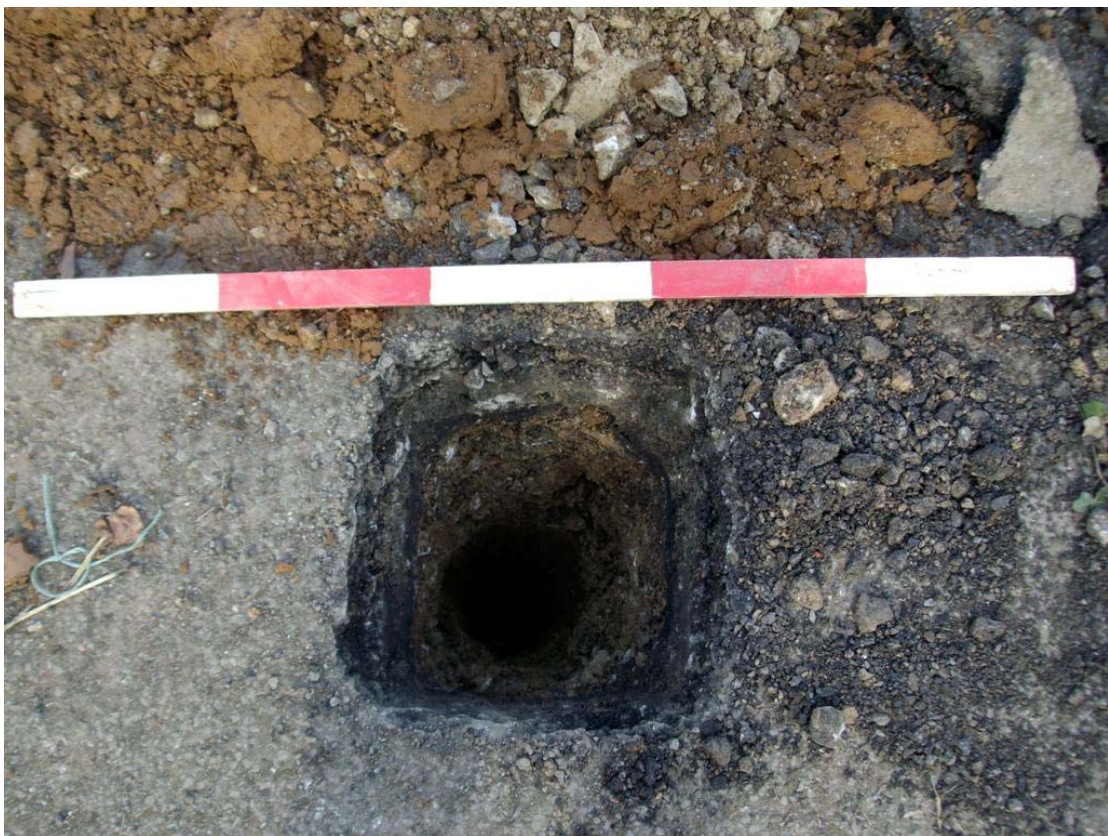
Plate 2: View of WS110

- 3.1.2 WS101 to WS104 and WS110 were excavated initially through tarmac (Plate 2) and hardcore, onto a dark organic silty-clay subsoil **101**. This subsoil was present across the whole site, except for WS104, WS106 and WS108, with little variation, and was seen to contain modern building material and general refuse; no subsoil was present in WS106 and WS108 and a deposit of mid grey-brown silty-clay with modern brick fragments (**108**) was seen in WS104 below the modern overburden. WS103, WS104 and WS110 were situated on the paths surrounding the allotment, and WS101 and WS102 were within the Rugby Club car park. WS111 was also situated in the car park but did not contain any surfacing material. In the remainder of the pits the subsoil was overlain by a dark brown topsoil, **100** (Plate 3).

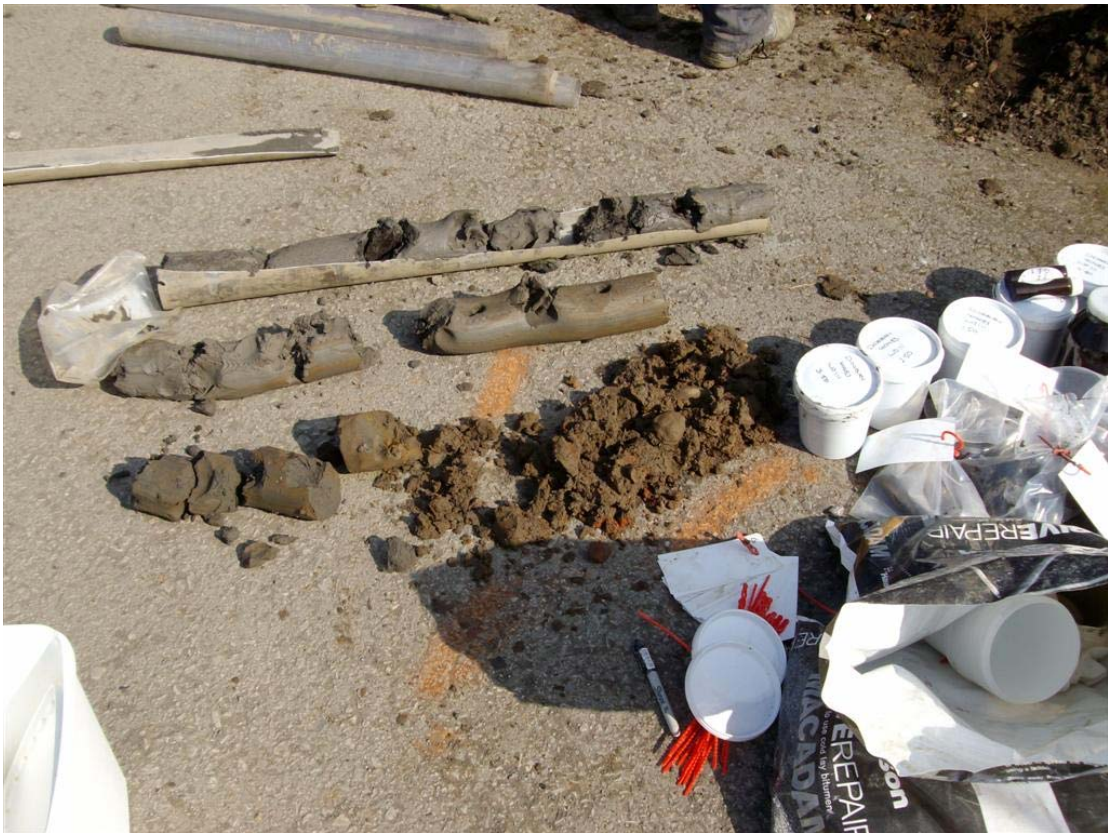
Plate 4: View of the extracted cores from WS111

- 3.1.3 The subsoil deposits, **101** and **108**, were seen to vary in depth and consistency, from a sandy-gravel to a silty-clay at 0.5m depth to 1.9m depth. The underlying deposits beneath the subsoil varied around the site, and included waterlogged clays, sand, gravel, and pebbles, which are likely to be fluvial deposits associated with a palaeochannel of the River Mersey. Some of these deposits, specifically **105** (seen in WS101 and WS102), **107** (seen in WS109), and **109** (seen in WS111), at depths of 2m to 5.9m (see *Appendix 1*), contained preserved plant material. These were, therefore, sampled from the extracted cores (Plate 4), and were visually examined by the OA North environmental archaeologist for comment.

- 3.1.4 Deposits **105**, **107** and **109**, at depths of between 2m-3m, 4.7m-5.9m, and 4m were all organic silty-clays and were seen to contain frequent wood and herbaceous plant stem fragments. From their appearance, it is believed that the deposits probably accumulated in a low energy backwater channel.

4.2.1 The watching brief maintained across the site did not appear to disturb any archaeological features, but the relatively restrictive size of the investigations for archaeological purposes may have also hindered this. The identification of sediment sequences from a former channel of the River Mersey is significant, however, and it is recommended that further works should again be archaeologically monitored, and any deposits that are revealed that are thought to be of archaeological potential should be systematically sampled for environmental remains and scientific dating purposes.
