# **Burnley Campus (Barden High School), Heald Road, Burnley, Lancashire**

## **Archaeological Building Recording Survey**

**Oxford Archaeology North**

March 2010

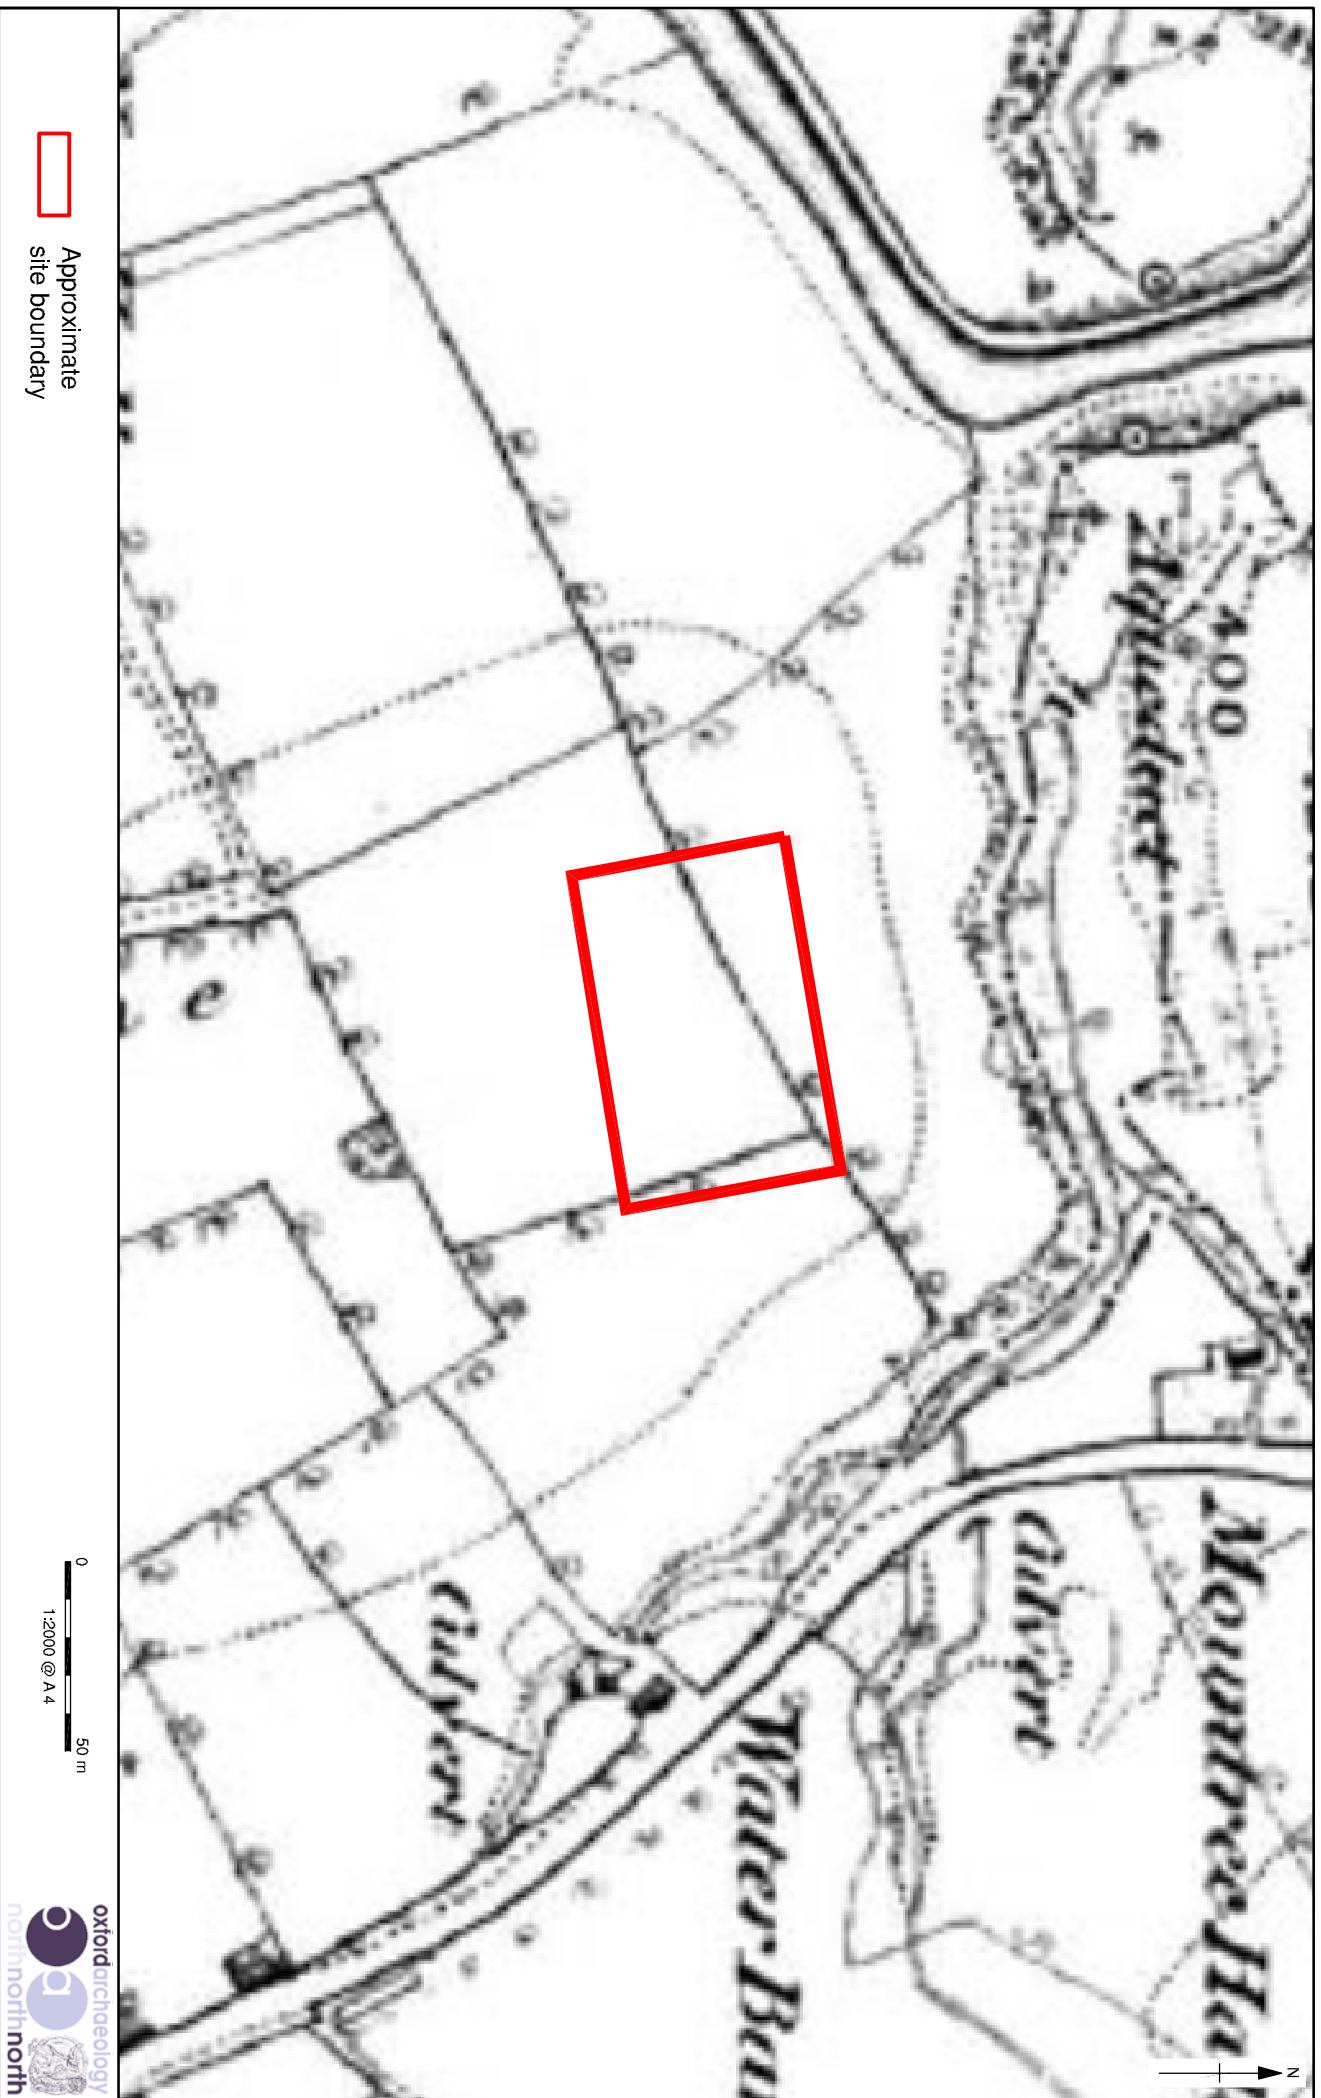
Figure 3 : Ordnance Survey First Edition 6" to 1 mile map, 1847

3.4.2 **Ordnance Survey First Edition 6" to 1 mile map, 1847 (Fig 3):** this map is more detailed than Hennet's but still shows the area to be undeveloped. The site of the school is open fields at the end of Burnley Old Lane.

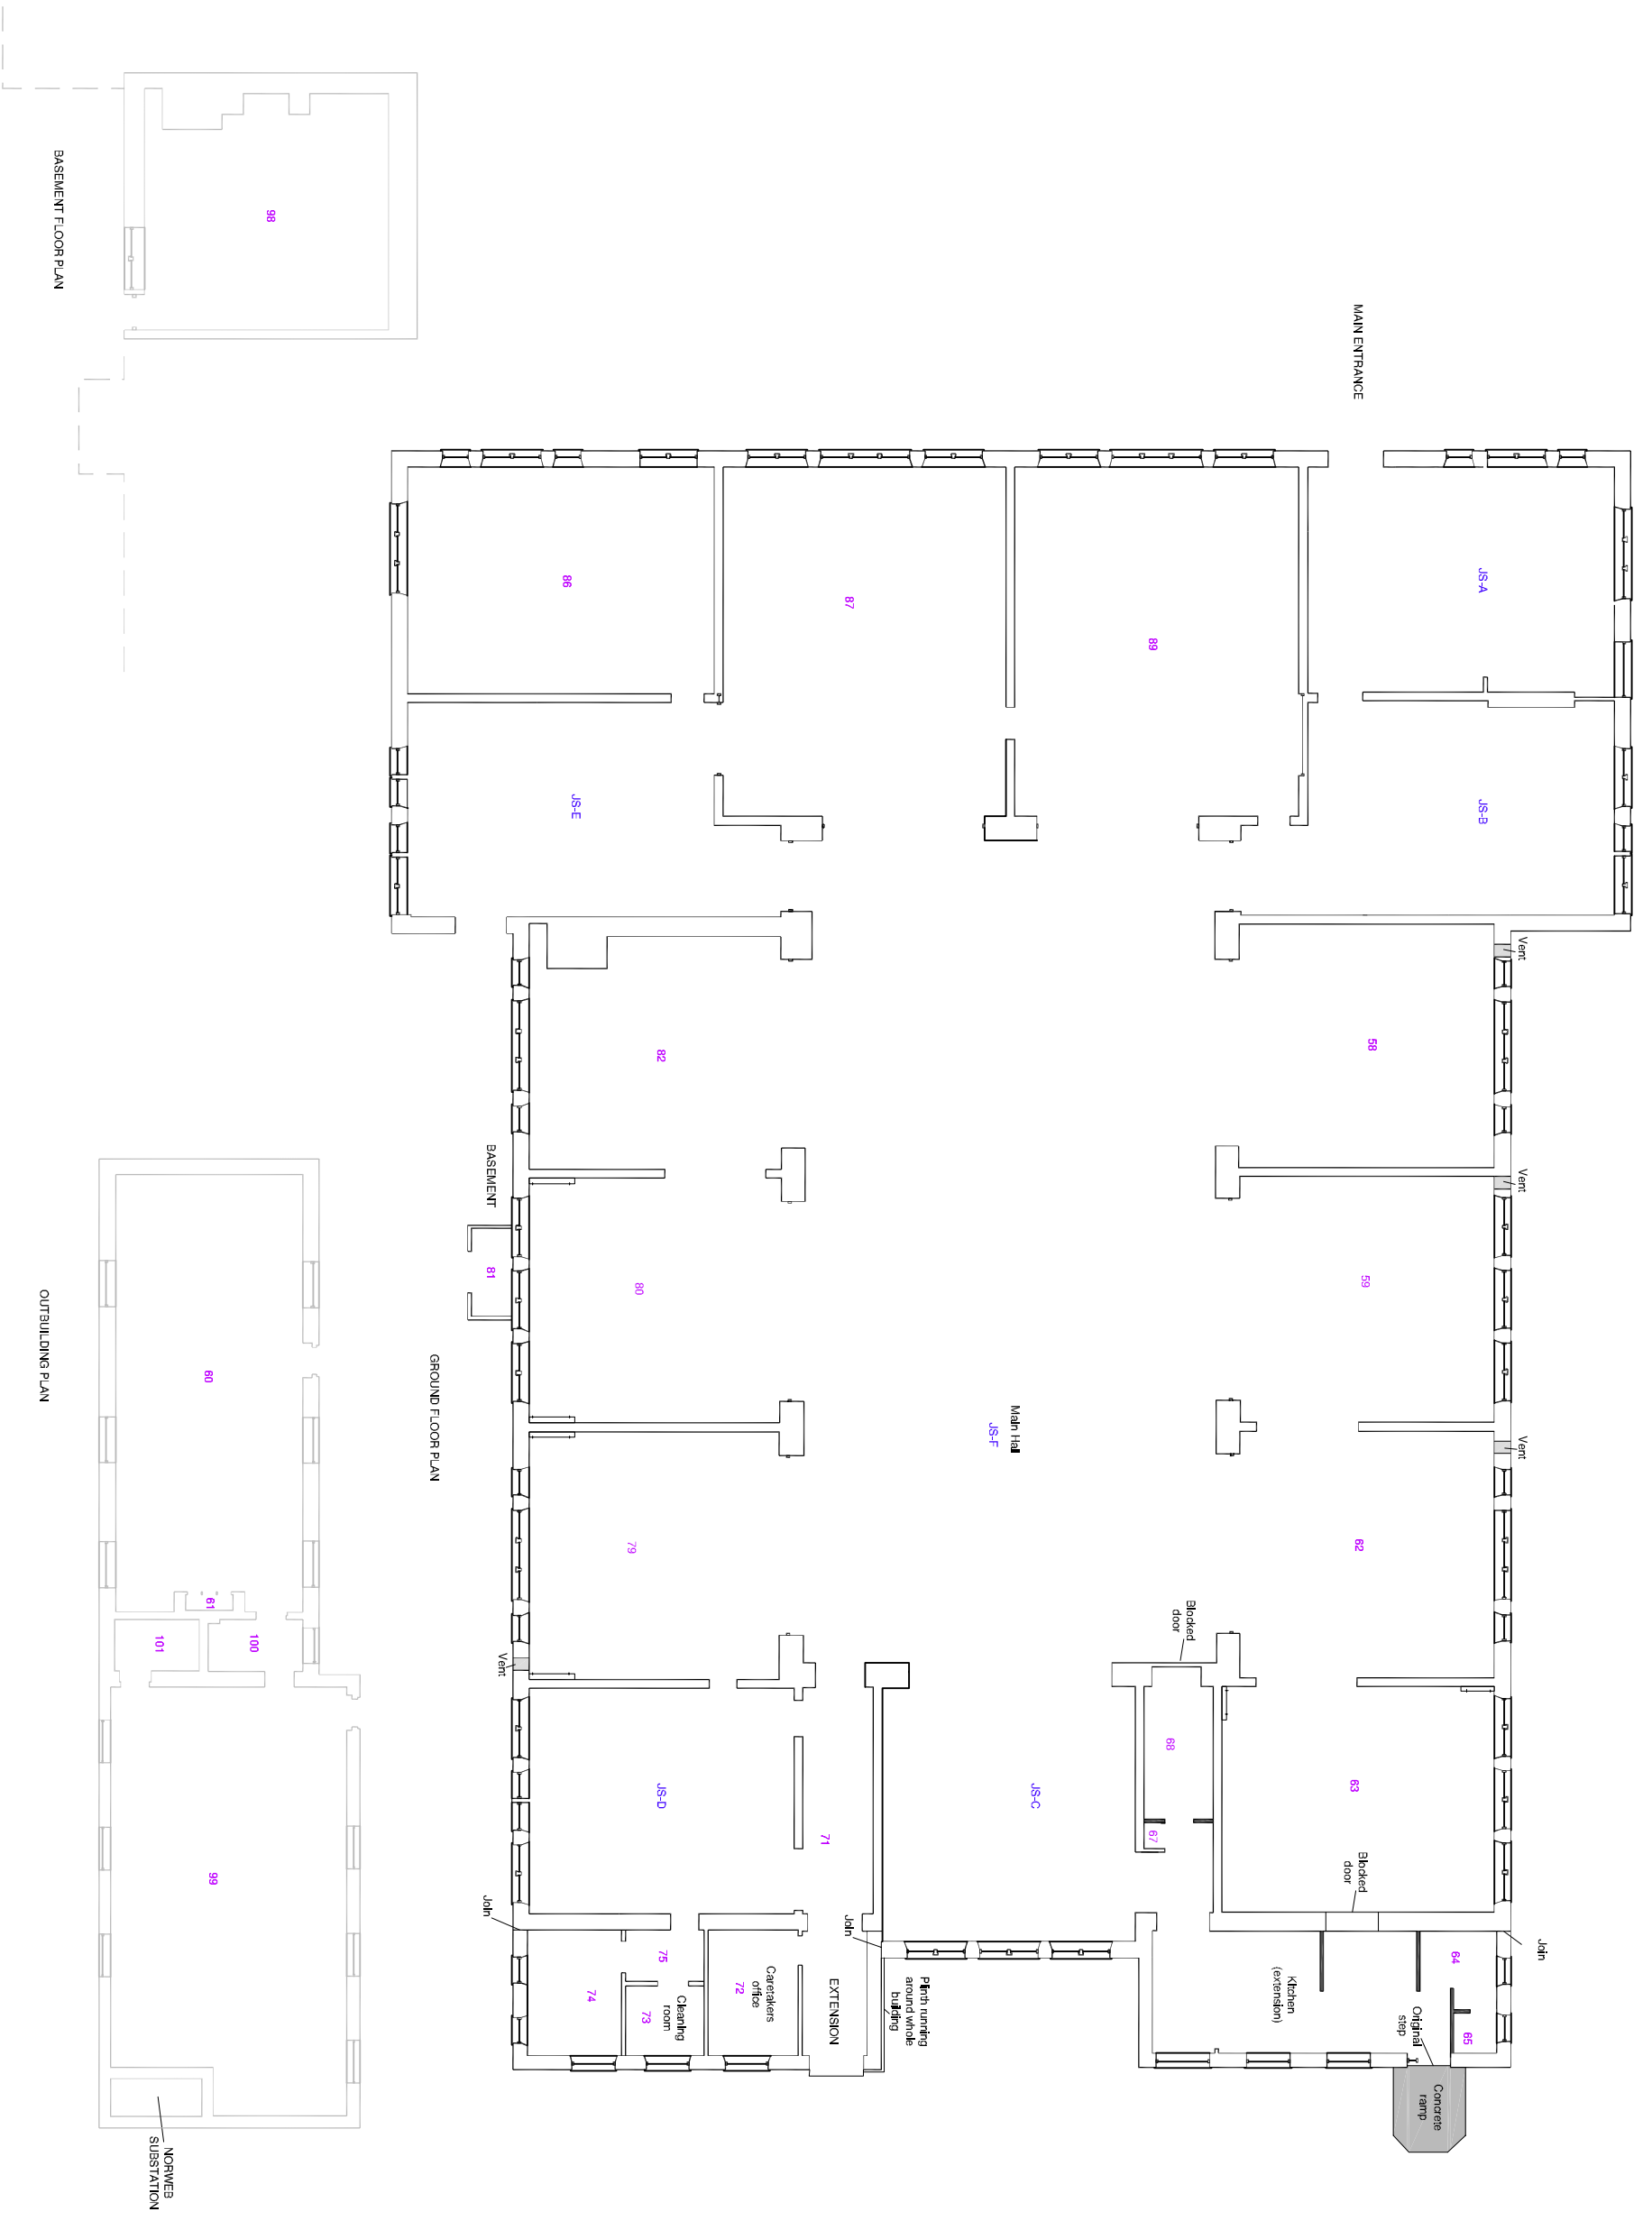
Figure 10: Ground floor plan of the Junior School and Science Building after soft strip

- 4.3.19 Following the internal strip, all of the partition walls that divided these rooms were found to be modern and were removed (Fig 10). This revealed that, structurally, the rooms had been created from a single large space (Room JS-A, Fig 10, Plate 18). This revealed the original height of the ceiling to be approximately 4.1m and divided into two parts by twin RSJs. The larger part of the ceiling has canted sides, whilst the other is pitched and follows the line of the roof over the former Boys' entrance. The full height of the fenestration was revealed, and the whole floor was laid down to herringbone wooden blocks over concrete and fixed with bitumen. There was a hearth (with brown square tiles) located at the east side of the room, indicating the presence of a fireplace. A similar hearth was present in the adjacent room.

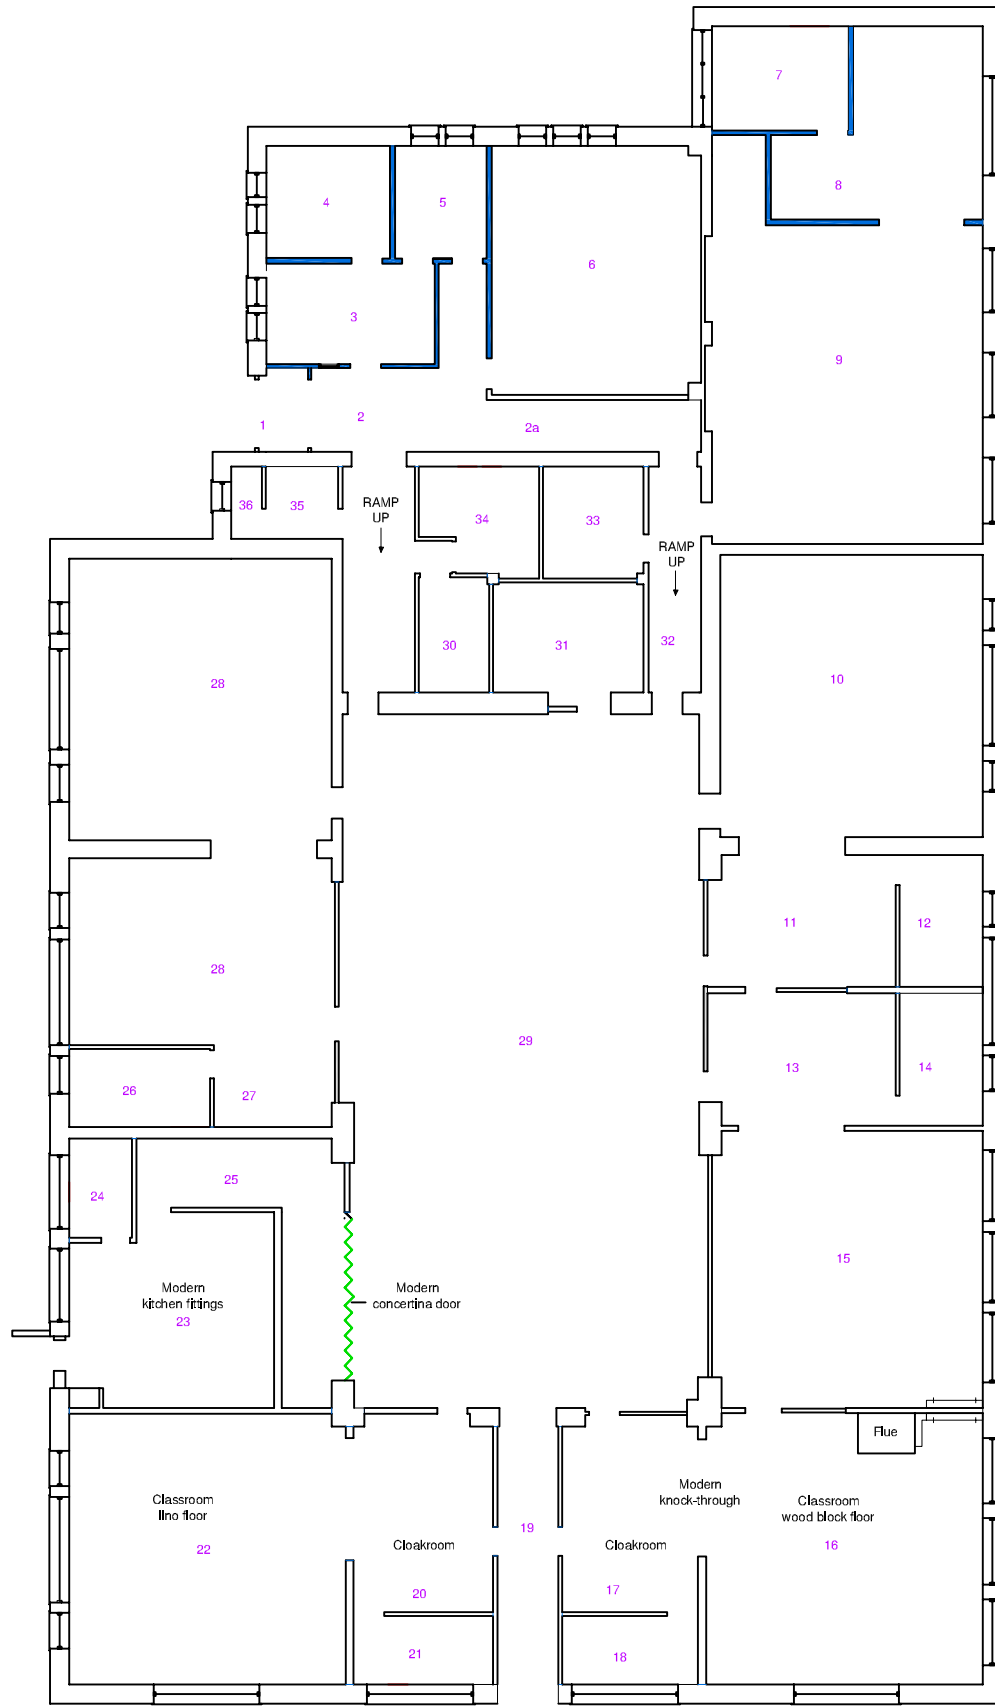
Figure 13: Ground floor plan of the Infant School prior to soft strip

4.4.30 **Rooms 11-14 (Room IS-C):** prior to soft stripping, these rooms consisted of toilets and cloakrooms (Fig 13). These were all of late twentieth century appearance and identical to those already described. The floors in Rooms 12 and 14 were laid down to vinyl, whilst Rooms 11 and 13 had herringbone block floors. There was a small section of checkerboard wooden block floor in Room 13 that appeared to have been inserted later and suggested either the floor was repaired or that there had been an additional smaller room.

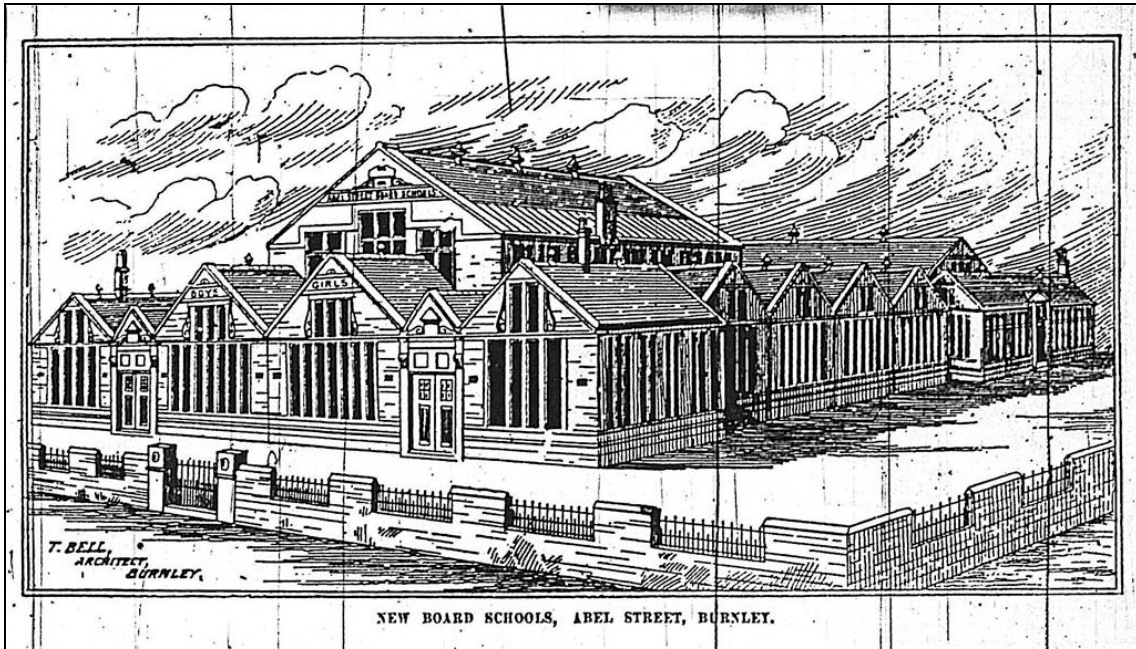
Plate 1: Illustration of Abel Street Board School from the Burnley Gazette, 12<sup>th</sup> September 1891

- 3.3.14 **Illustration of Abel Street School from Burnley Gazette 12<sup>th</sup> September 1891, Plate 1:** this illustration was supplemental to a detailed article of Abel Street School published in the Burnley Gazette in December 1891, and clearly presents a view of the school buildings, probably when they had just been completed (the Infant School is not illustrated). When compared to the current external appearance of the school, it is immediately apparent that little modification has taken place in the intervening years (Plates 6 and 9). Roof ventilation cowls, described in the article are visible (all but one have since been removed), and details, such as the upper window jambs on the front elevation, have remained unchanged. The current science block is not illustrated, but it is shown on the 1893 map (Fig 4). Chimneystacks are present on each of the northern and southernmost roofs, which obviously indicate that fireplaces/boilers were present in these rooms. The low railings on the boundary wall have been replaced by high security fencing (although a short section still remains (Plate 50)).

5.1.1 The assessment revealed that Abel Street Board School was constructed in 1891 and, as the illustration of the Junior School in the Burnley Gazette, dated 12<sup>th</sup> September 1891 (Plate 1), shows the general outward appearance of the school has changed little over the intervening century. Most of the changes have, predictably, been internal modifications, in order to accommodate the changing nature of education practices over the years. The following sections describe the nature of the changes and also outline the evidence for the original layout of the buildings.

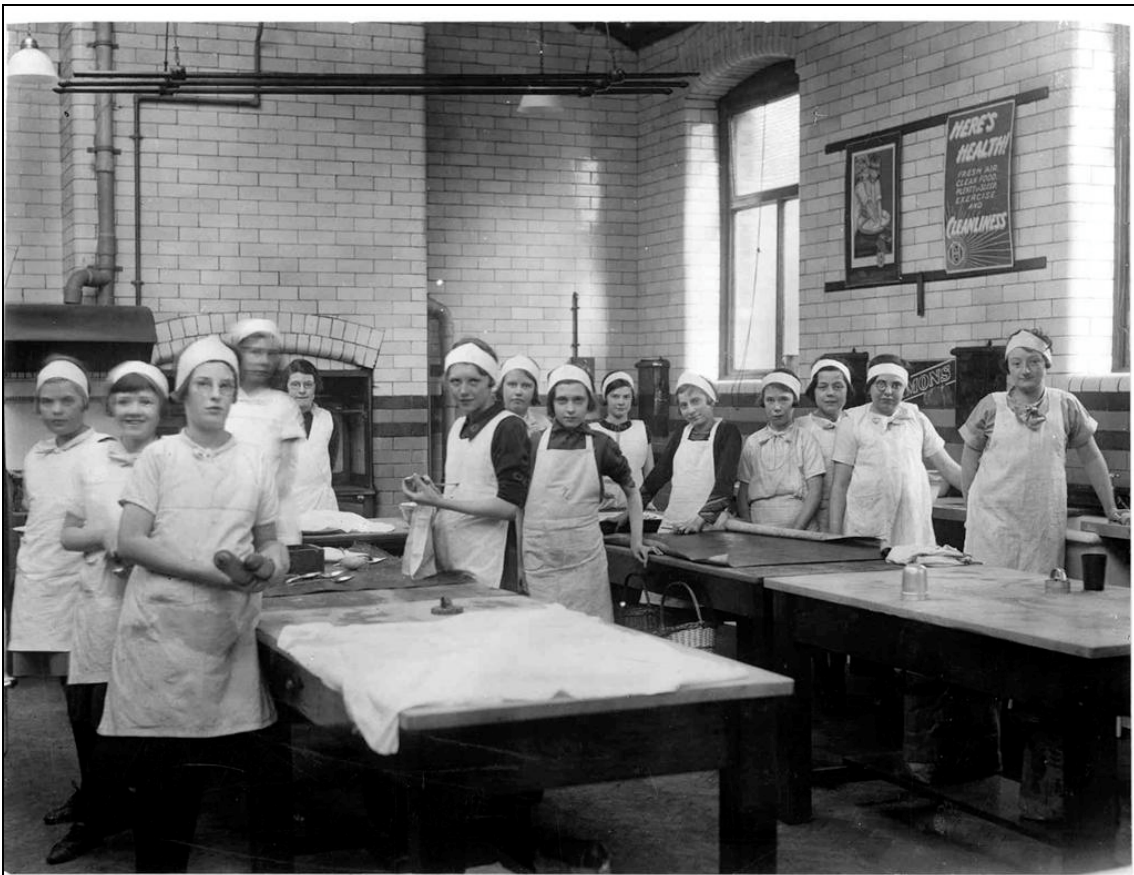
Plate 4: Photograph of Room 60, undated (possibly 1920s)

- 3.3.17 **Photograph of Room 60 undated (possibly 1920s), Plate 4:** this photograph is undated, but the general appearance suggests a mid-twentieth century date. This shows the appearance of one of the rooms in the science block (Room 60), which has changed little since this photograph was taken. One major change is the removal of the range cooker in the fireplace that has been replaced by a cupboard. There appear to be sinks and work surfaces along the wall, which are no longer present.

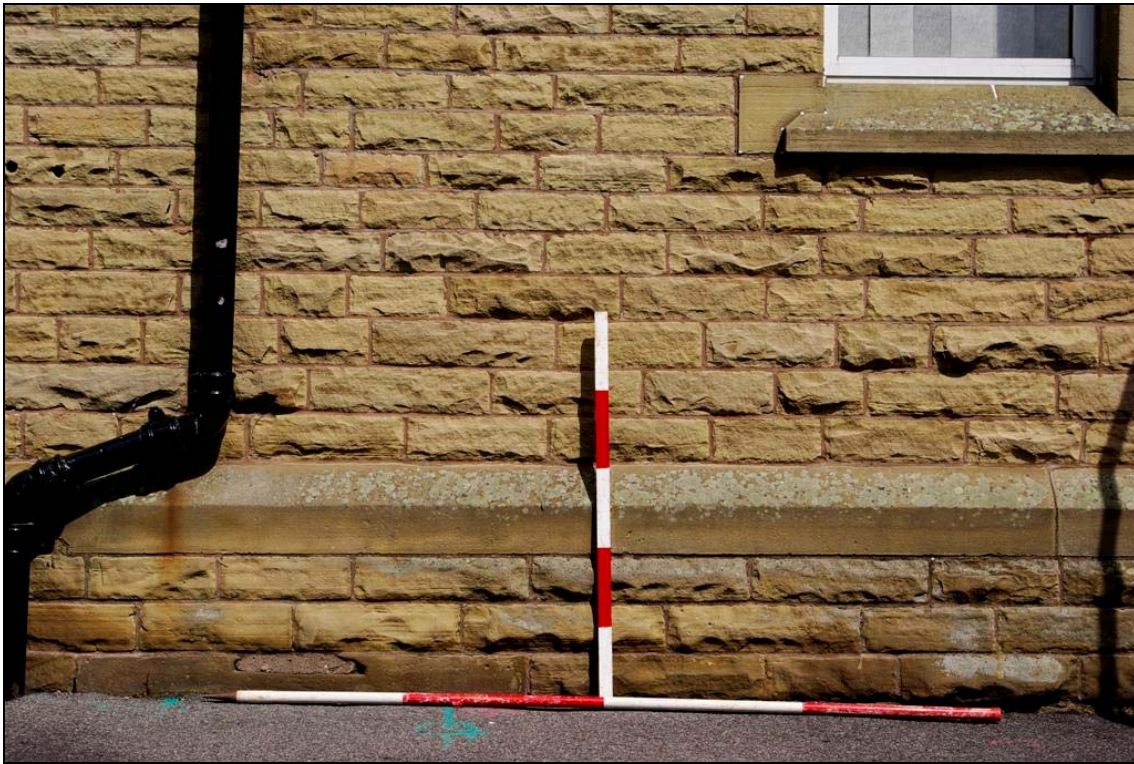
Plate 7: Construction details of the exterior fabric of the Junior and Infant Schools

- 4.3.4 **Fabric:** in common with many buildings of the period in Burnley, the school was constructed from rock-faced local gritstone blocks, described as ‘Catlow parpoints’ (Appendix 3) (Plate 7). The maximum size of each block was approximately 11 inches long by 3 ½ inches tall. The external walls were compound cavity walls and lined with brick. All the dressings, including window sills and lintels, were of finely-finished sandstone. The roofs were covered with welsh slate and terracotta ridges. There were two asphalt flat roofs at the rear (east side) of the building. All of the windows were PVCu, and most of the rain water goods were iron. There were a number of cast iron ventilation grilles set into each of the main walls.

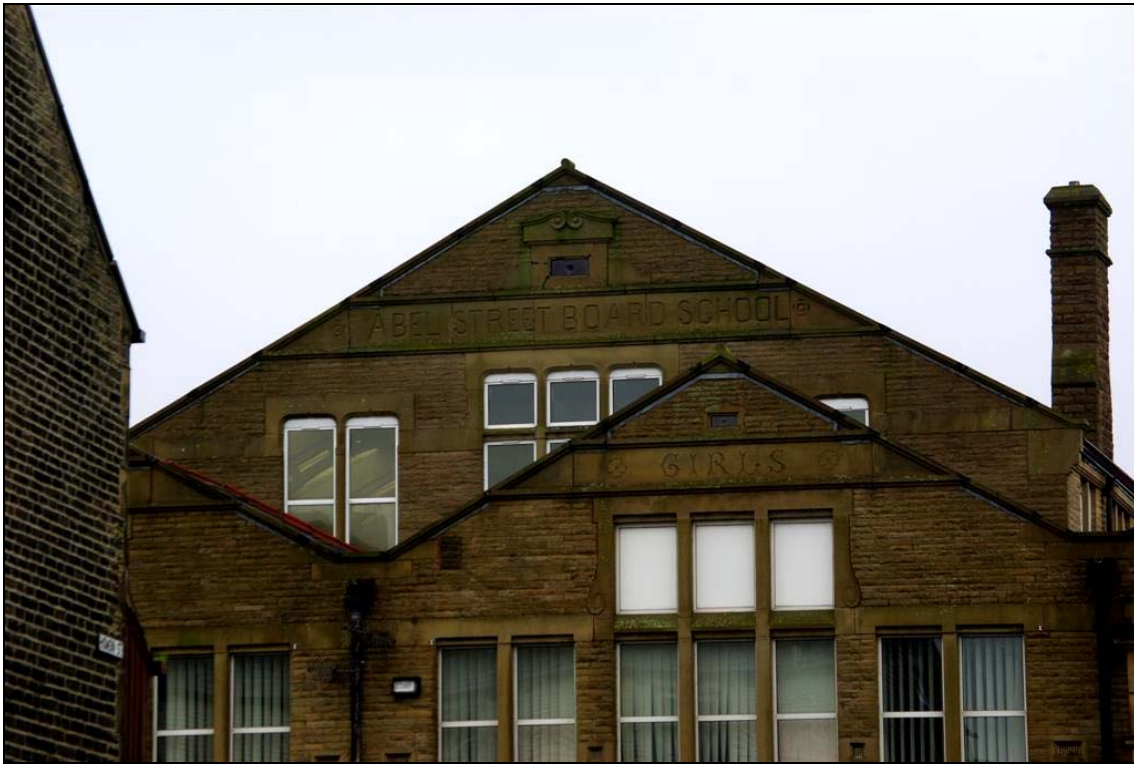
Plate 12: View of west elevation of the main hall of the Junior School

- 3.2.1 The school was originally called Abel Street Board School, the name adorning the upper west gable of the same structure (Plate 12). It was located at the northern end of the Daneshouse area of Burnley, to the south of the historic township of Reedley Hollows, and within the Forest of Pendle (Farrer and Brownbill 1912). This area was mainly developed in the latter part of the nineteenth century, as can be seen by comparing the Ordnance Survey (OS) maps of 1847 and 1893 (*3.4.2 and 3.4.4*, Figs 3 and 4). By 1882 Daneshouse was a suburb detached from the main town (LCC 2005), although rapid development of the Daneshouse Mills area led to its expansion and eventual submergence with the expanding industrial town of Burnley by around 1893 (Farrer and Brownbill 1912, 489).

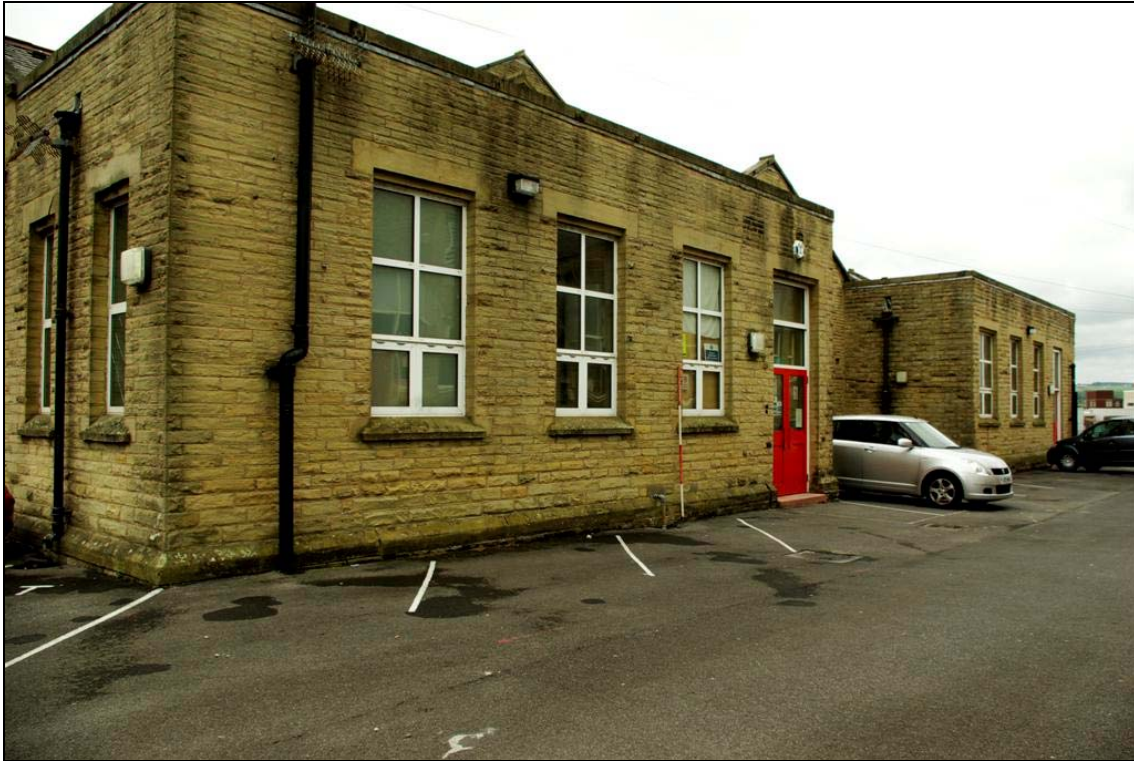
Plate 14: The east elevation of the Junior School

- 4.3.14 Both extensions were almost identical, with three windows and a doorway in the east elevation (Plate 14). The door in the northern extension appeared to have been inserted later, unlike the other doorway in the southern extension, which appeared to be contemporary with the construction of this extension. However, internal inspection (4.3.30) appeared to suggest that this replaced an original rear doorway that had a small gablet roof possibly similar in appearance to the main entrance of the infant school (4.4.9).

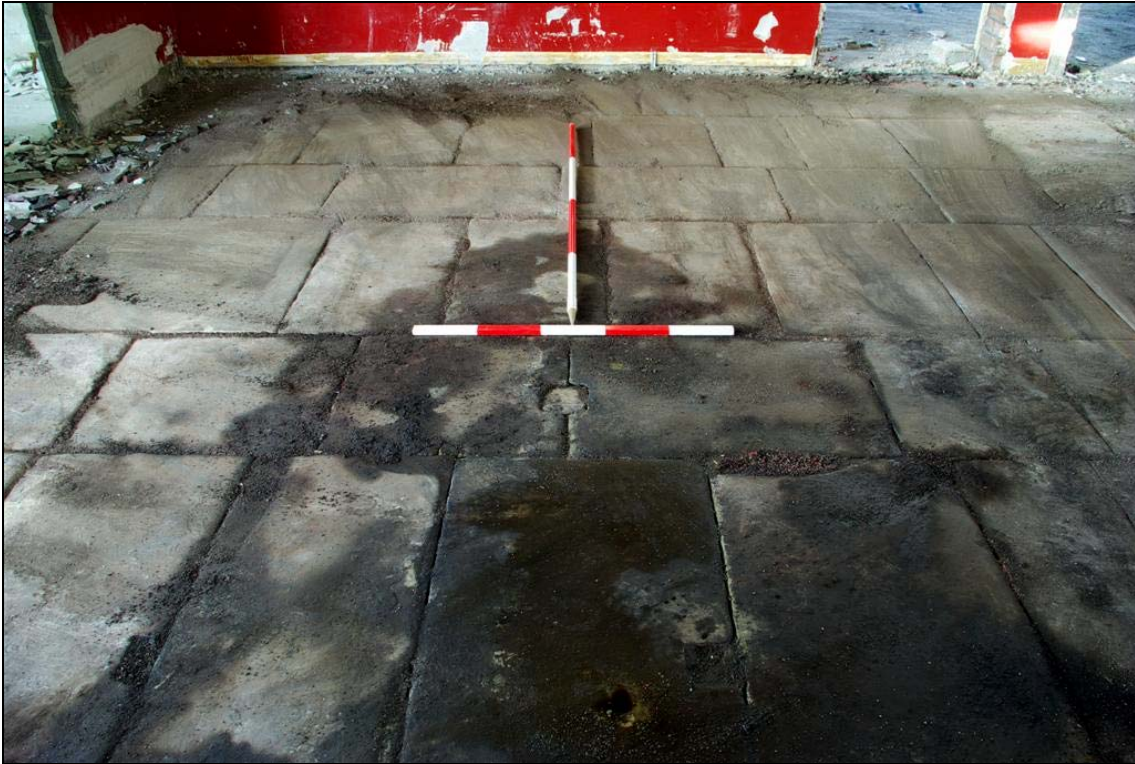
Plate 34: Flagged floor in Room 83 (JS-E)

Rooms 84 and 85 were not removed during the strip their cinder block construction was clearly visible. There was a large full height aperture leading into Room 87, which was of similar appearance to the partially blocked opening in Room JS-B. This had been modified and it was not possible to ascertain whether it was original. However, there was a tall opening leading into the main hall that was probably original. During the stripping, the vinyl floor was removed to reveal a flagged floor in good condition, albeit for some holes and notches relating to former fixtures (Plate 34). The average size of the flags was approximately 0.9m by 0.6m.

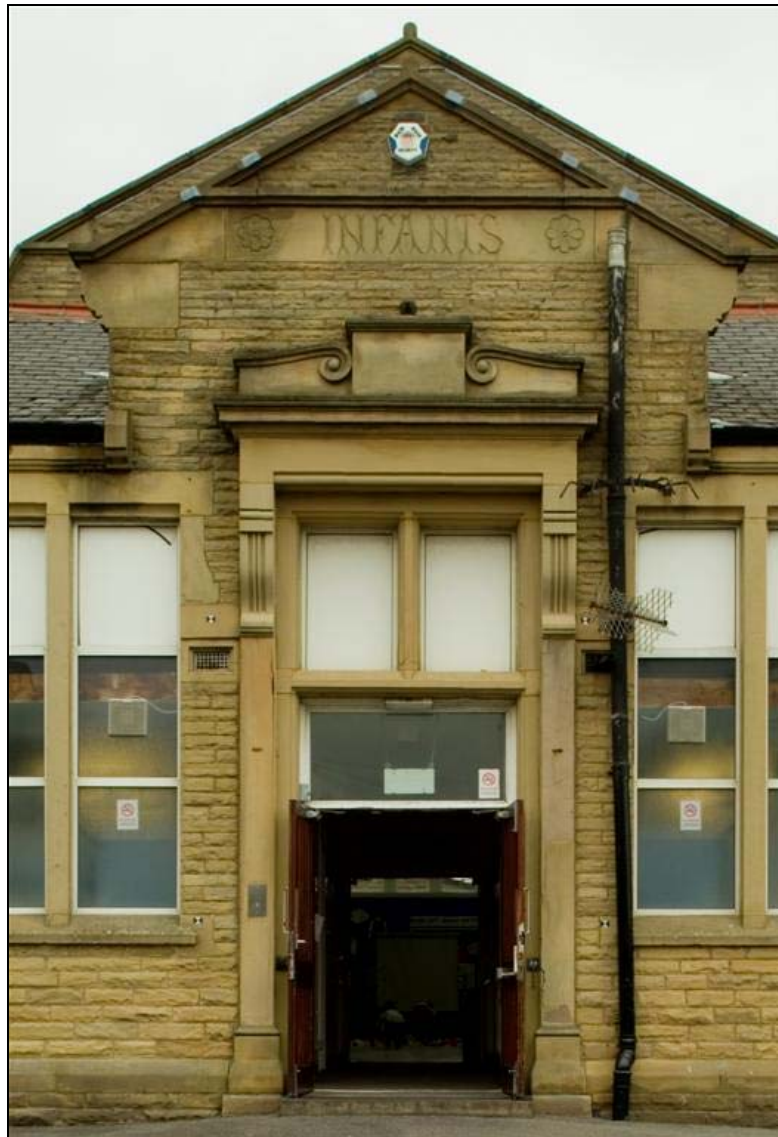
Plate 45: Main Entrance of the Infants School

- 4.4.9 The doorway was decorative in a manner similar to those on the Junior School (see 4.3.10) principal elevation, albeit with some slight differences (Plates 10, 11 and 45). There was a stone mullion transom light above the door, over which is a hood mould with scrolled volutes and centre block (pediment missing). Above the door is a small gablet with kneelers, and a flat panel inscribed with 'INFANTS' in the same script as those on the main elevation of the Junior School, although the two flower motifs differ slightly.

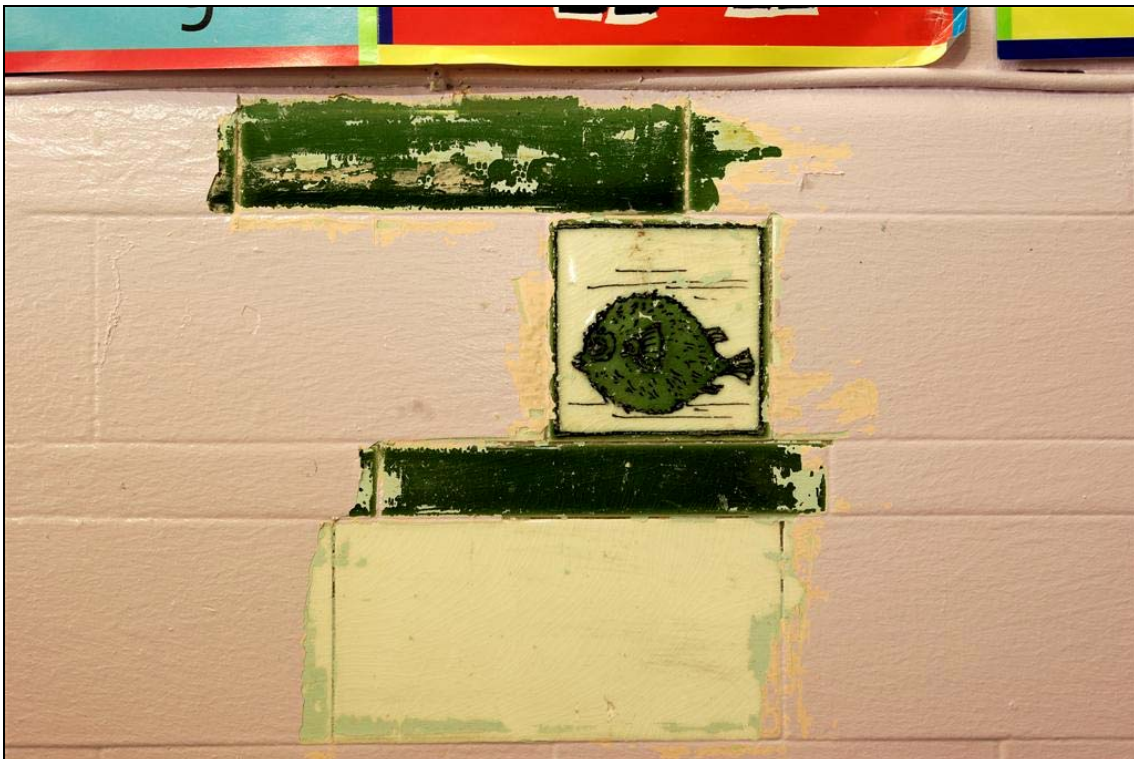
Plate 59: Decorative tiles in Room 9

4.4.38 Upon closer inspection it was revealed that all the rooms contained areas of wall tiles that were painted over and/or concealed. Most of these were plain red or white, but the tiles in Room 9 were found to be patterned and comprised mainly cream tiles with a green band and trimmer, and individual tiles with illustrations of various animals (Plate 59). The tiles covered the walls up to dado height (0.92m) (Plate 60).

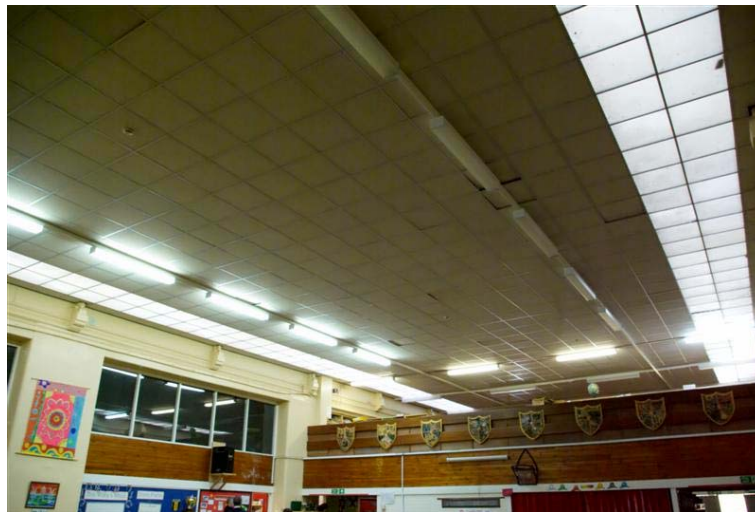
Plate 1 Type of ceiling to be removed

1. The most obvious feature obscuring original fabric are the suspended ceilings found in most of the classrooms and both the main halls of each building. These are constructed of a steel framework with polystyrene tiles with strip lighting (Plates 1 and 2). All the variants of this ceiling type should be removed. Any ceilings and other fabric above these **must be left in situ** as they may part of the original fabric. These, as with all the other fabric outlined for removal, should be removed carefully and cause as little disturbance as possible to surrounding fabric.
