A66 Temple Sowerby Bypass and Improvements at Winderwath

Topographic Survey, Evaluation and Watching Brief Report

Oxford Archaeology North

August 2005

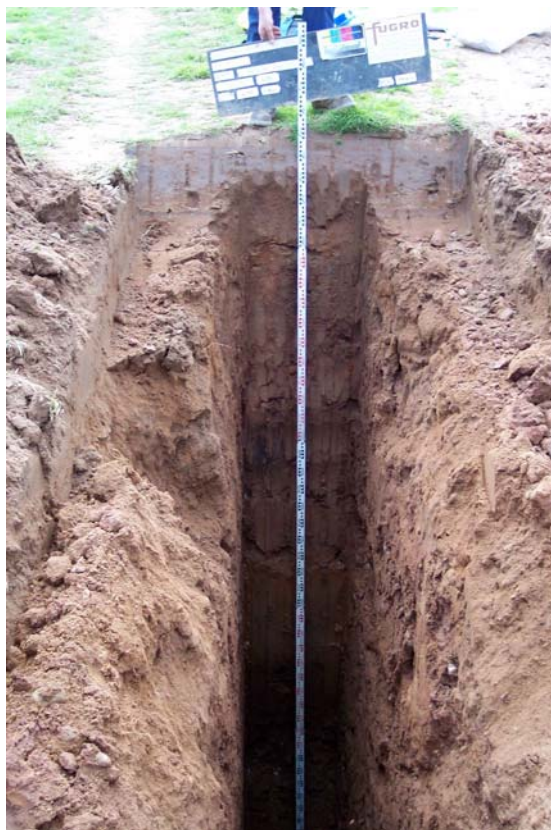
Plate 3: Example of Geotechnical Inspection Pit

In total, 70 Geotechnical Inspection Pits were observed along the length of the route. On average they were 4m by 0.6m and over 3m deep. No archaeological remains were encountered in any of the pits.

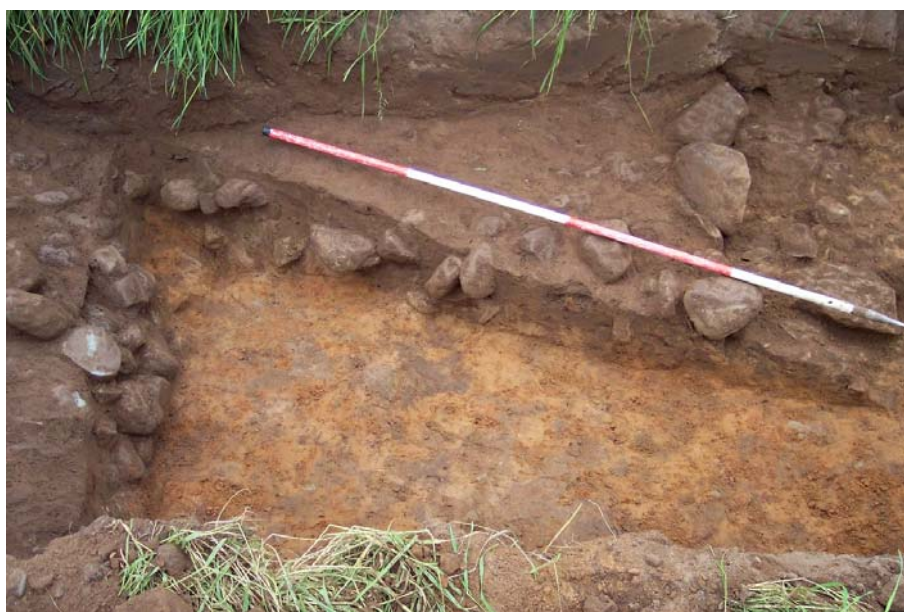
Plate 6: Trench 43, cobble bank / cairn 1703

- 5.4.9 **Trench 43** had several interesting results. Below both the topsoil and the subsoil at the southern end of the trench was a dense concentration of medium, rounded cobbles, 1703, which extended across an area of approximately 2m by 2m (Fig 14; Plate 6), and was 0.34m thick (Fig 12). As the deposit was at the very end of the trench it was not possible to determine the overall form of the feature but it possibly a cobble bank or perhaps a denuded clearance cairn. No dating material was recovered from the excavation section. Underneath the

bank / cairn was a deposit of mottled brownish yellow sand, 1704, which seemed to fill a slight natural depression, 1705 (Fig 12).

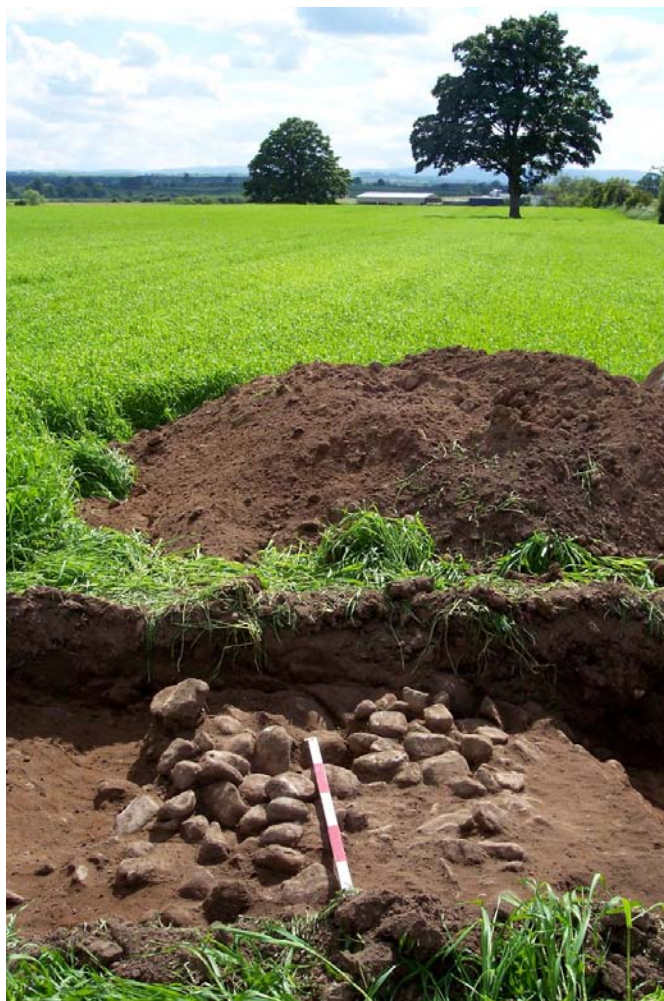
The topsoil **1623** extended throughout the trench and was on average 0.30m deep. Below this was a dense concentration of small to medium cobbles, **1626**. They were deliberately packed in a north-east / south-west aligned linear spread, that extended north and south beyond the limits of excavation. The deposit, **1626** was approximately 2.2m wide and 0.48m thick. The eastern and western boundaries of the cobbles were fairly well defined and the overall nature of the feature was consistent with the remains of a ploughed out dry stone cobble wall. From within the soil matrix of the wall a single, reasonably unabraded, base fragment of medieval pottery was recovered. The lower part of the wall was essentially within the subsoil, **1624**, which was 0.60m thick and a mid orangey brown sandy silt in nature. Underneath the eastern side of the wall was an earlier linear feature, **1632**. It was on the same alignment as the wall and measured 0.51m in width by 0.33m in depth. It had a symmetrical stepped V-shaped profile, and was filled with a pale greyish brown clayey sand, **1633**. Only a small section of this feature was revealed and although tenuous, it did appear to be a probable ditch. No dating material was recovered from the ditch. The underlying drift geology **1625**, was a mid pinkish orange sandy silt that had 5-10% medium-sized, rounded stones throughout.

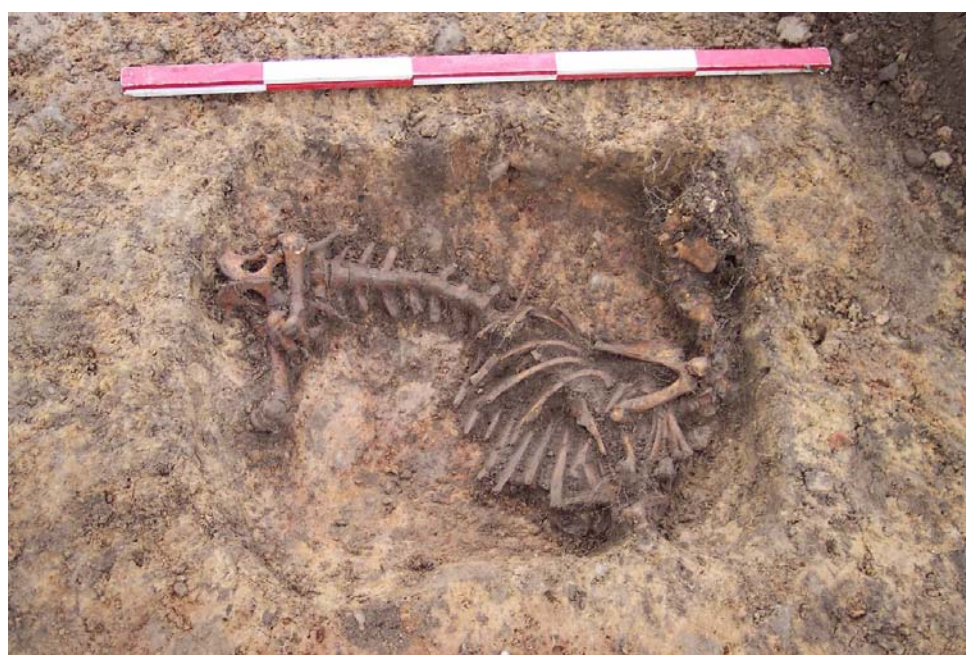
- 5.4.16 Towards the eastern end of Trench 48 was a second discrete feature, 1636, which was sub-square in plan and measured 0.75m by 0.65m by 0.32m deep; it had vertical sides and a flat base. The feature was a small pit which contained a complete articulated sheep burial (Plate 8), beneath a mid greyish brown sandy clay backfill. The bone was in good condition, suggesting a fairly recent date to the activity.

Plate 7: Trench 44, cobble wall 1626

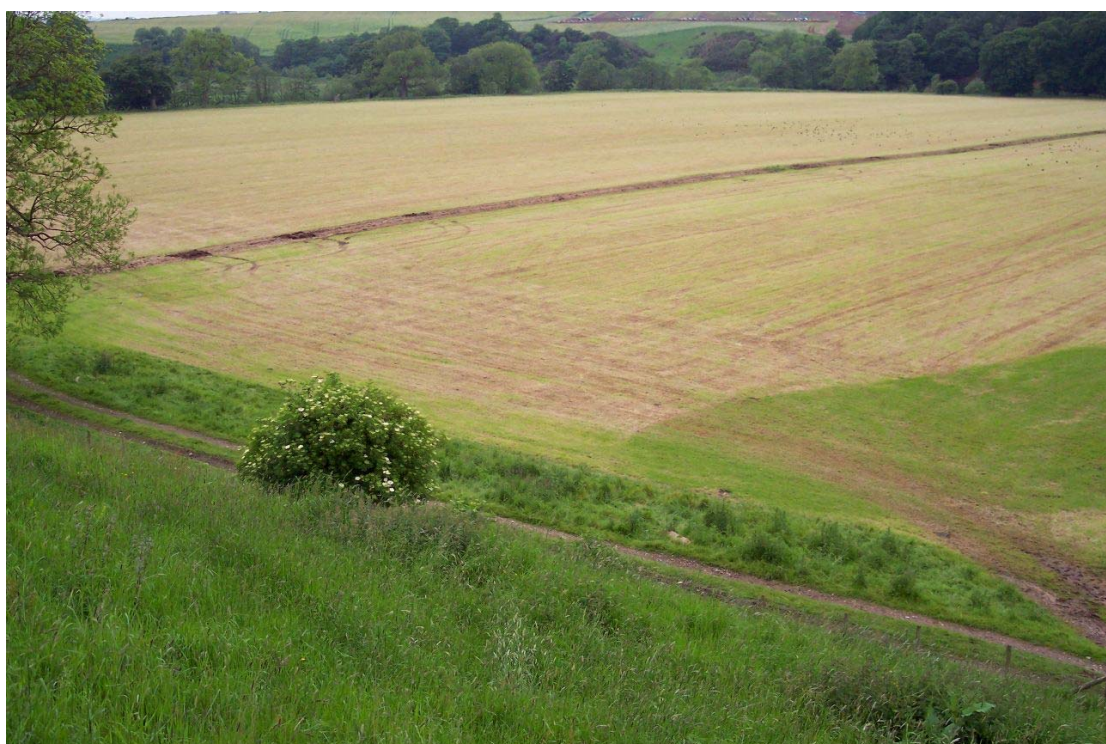
Plate 12: Field House, Site 18, looking south-west

4.3.1 This site consisted of the ephemeral remains of a structure marked on a map of 1838, on the west side of a track leading down the eastern escarpment of the Eden onto the valley floor of the river (Fig 20; Plate 12). The track itself forked immediately north of the structure and branched both west onto the flood plain and continued southwards along the eastern side of the structure.

4.3.2 The structure had overall dimensions of 32m by 4.5m (Fig 21). At its western end there was a pronounced pile of rubble material, 5m in diameter. Within this were several earthfast rounded boulders which possibly formed the north-western corner of the foundations. There appeared to be little survival of the eastern elevation but a sharp drop was noted from the trackway bed approximately 0.5m from the present track edge. Within the eastern wall alignment was a single roughly squared undressed block (Plate 13). The block measured 1.5m by 0.32m by 0.28m and was composed of local red sandstone. It was probably the remains of a flat lintel for a door. A 0.5m wide by 0.15m high ridge, aligned east / west and located 13m from the north end of the structure may be the remains of a cross-wall.

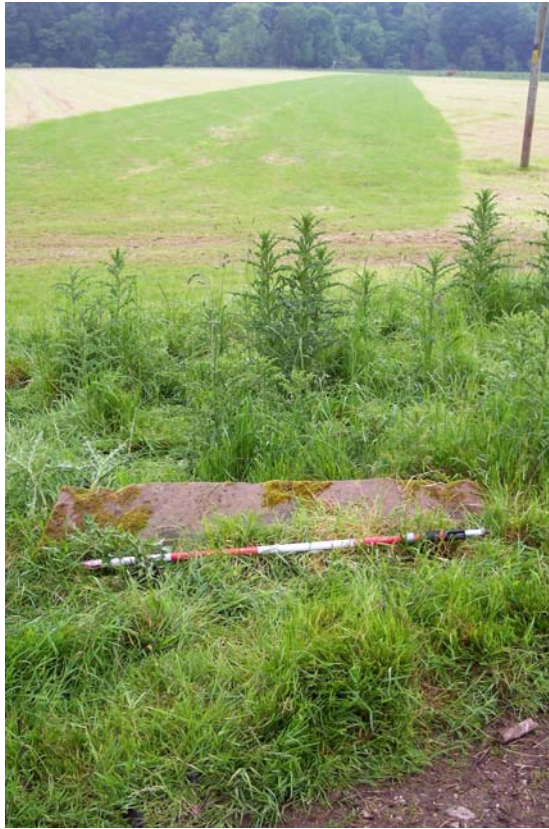
Plate 13: Field House, possible lintel / door jamb, looking west

Field House (Site 18 NY 604 271) was just to the east of the River Eden. The site consisted of the ephemeral remains of a rectangular structure, on the west side of a track leading down the escarpment onto the valley floor of the River Eden. The structure had overall dimensions of 32m by 4.5m. It appeared to be composed of earthfast boulders forming the foundations of the walls. Although they were obscured the walls may have been 0.5m to 0.75m wide and there was a possible cross wall 13m from the northern end of the structure subdividing the internal space. There was also a single, roughly-squared undressed block of local red sandstone that may have been the remains of a flat lintel for a wide door, or a door jamb. This was found within the eastern wall alignment.

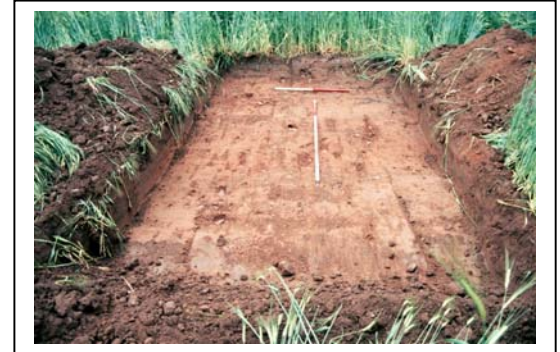
Looking south

Trench 1 was located in Field 3. It measured 4m by 2.5m and was excavated to a maximum depth of 0.29m. The trench was aligned north / south and was targeted to investigate two isolated pit-type anomalies highlighted in the geophysical results, in addition to the potential for Roman activity associated with the Roman road.

The topsoil **1129** extended throughout the trench and was 0.18m deep. Below this was a lighter mid orangey grey sandy silt subsoil, **1130**. At the base of the revealed stratigraphic sequence in this trench was the underlying drift geology **1131**, which was a mid reddish, orange coarse sand with 10-20% small- to medium- sized, rounded stones throughout, interspersed with patches of pale grey sand and orangey brown sand with manganese flecks. There were no identifiable features within the confines of the trench.

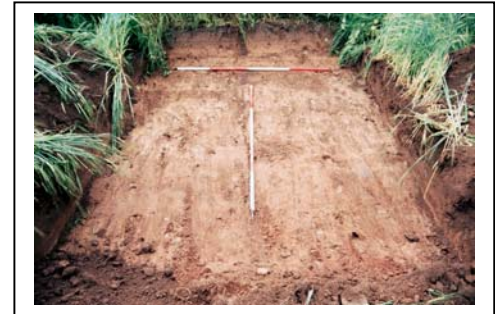
Looking south

Trench 2 was located in Field 3. It measured 5m by 2.8m and was excavated to a maximum depth of 0.4m. The trench was aligned north / south and was targeted to investigate a linear anomaly aligned north-east / south-west highlighted in the geophysical results. In addition to this, there was the potential for Roman activity associated with the Roman road.

The topsoil **1126** extended throughout the trench and was 0.15m deep. Below this was a lighter mid brown sandy silt subsoil, **1127**. At the base of the revealed stratigraphic sequence in this trench was the underlying drift geology **1128**, which was a mid reddish, orange coarse sand with 10-20% small- to medium- sized, rounded stones throughout, interspersed with patches of pale grey sand and orangey brown sand with manganese flecks. There were no identifiable features within the confines of the trench.

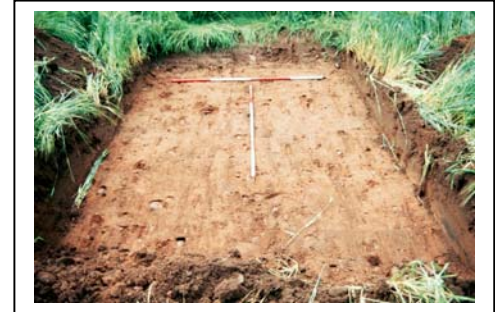
Looking south

Trench 3 was located in Field 3. It measured 5m by 2.8m and was excavated to a maximum depth of 0.51m. The trench was aligned north / south and was targeted to investigate a pit type and a linear anomaly highlighted in the geophysical results. In addition to this, there was the potential for Roman activity associated with the Roman road.

The topsoil **1120** extended throughout the trench and was 0.15m deep. Below this was a 0.20m thick lighter mid brown sandy silt subsoil, **1121**. An uncertain, irregular, linear feature **1123**, aligned east / west had a U- shaped profile that was 0.72m wide by 0.16m deep. It was filled with a mid reddish brown silt, **1124**. There was no dating material and no certain interpretation could be made of the feature. At the base of the revealed stratigraphic sequence in this trench was the underlying drift geology **1122**, which was a mid reddish, orange coarse sand with 10-20% small- to medium- sized, rounded stones throughout, interspersed with patches of pale grey sand and orangey brown sand with manganese flecks.

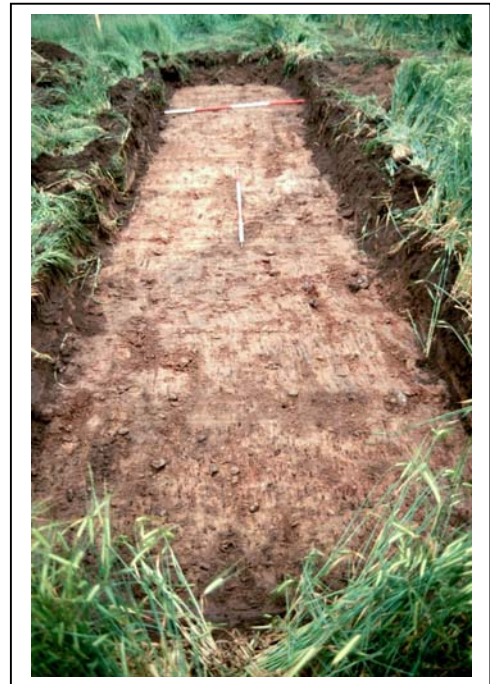
Trench 4
Looking north

Trench 4 was located in Field 4, along with Trenches 6-9. It measured 10m by 2m and was excavated to a maximum depth of 0.4m. The trench was aligned north / south and was located as a topographic situation with the potential for previously unknown activity.

The topsoil **1168** extended throughout the trench and was 0.20m deep. Below this was at the base of the stratigraphic sequence revealed in this trench was the underlying drift geology **1169**, which was a mid orangey brown gravelly sand with 30% small- to medium- sized, rounded stones throughout, and evidence of root disturbance.

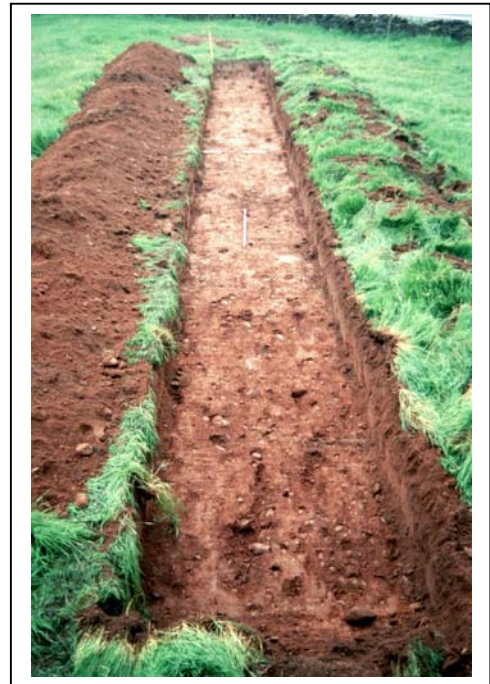
Looking north-west

Trench 5 was located in Field 2. It measured 25m by 2m and was excavated to a maximum depth of 0.63m. The trench was aligned north-west / south-east and was located as site with the potential for activity related to the Roman road or the development of Whinfell House farm.

The topsoil **1160** extended throughout the trench and was 0.33m deep. Below this was a mid orangey brown clayey silt subsoil, **1161**, that was 0.33m thick. Beneath the subsoil and truncating the natural was a single feature **1164**. The feature measured 1.2m in length by 0.9m in width with a maximum depth of 0.22m. In plan **1164** was roughly oval with fairly steep sides and a concave base. The feature was filled with, **1163**, a dark brownish grey, silty clay. A single stone 0.44m by 0.30m by 0.23m was found within the fill. The feature was too irregular to be the base of a pit and there were no associated features or any other evidence to suggest human activity. The feature is likely to have been a stone throw; where a stone is dragged by ploughing and the subsequent hollow formed, in fills with surrounding material, usually topsoil or subsoil. Underlying this was the drift geology **1162**, which was a mid brownish red sandy clay, which contained about 10-15% sub-rounded stones throughout.

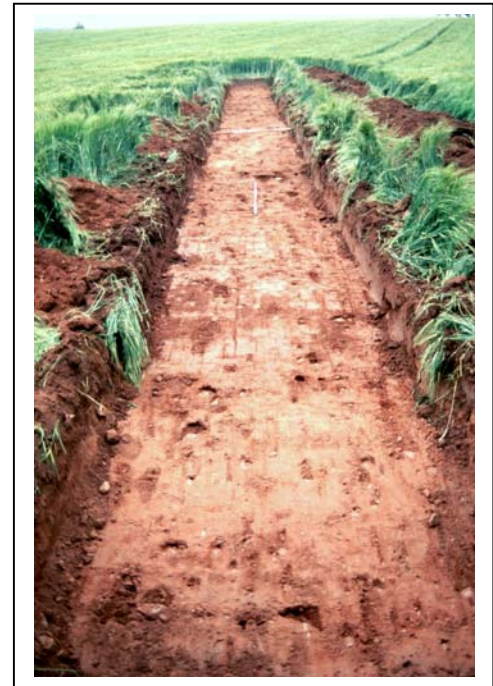
Looking west

Trench 6 was located in Field 4, along with Trenches 4, 7, 8 and 9. It measured 30m by 2m and was excavated to a maximum depth of 0.5m. The trench was aligned north / south and was targeted to investigate a cluster of linear trends highlighted in the geophysical results. In addition to this, there was the potential for Roman activity associated with the Roman road.

The topsoil **1165** extended throughout the trench and was 0.30m deep. Below this was a lighter mid greyish brown sandy silt subsoil, **1166**, that was 0.2m thick. Underlying this was the drift geology **1167**, which was a mid orangey brown gravely sand with 30% small- to medium- sized, rounded stones throughout, and evidence of root disturbance. There were no identifiable features within the confines of the trench.

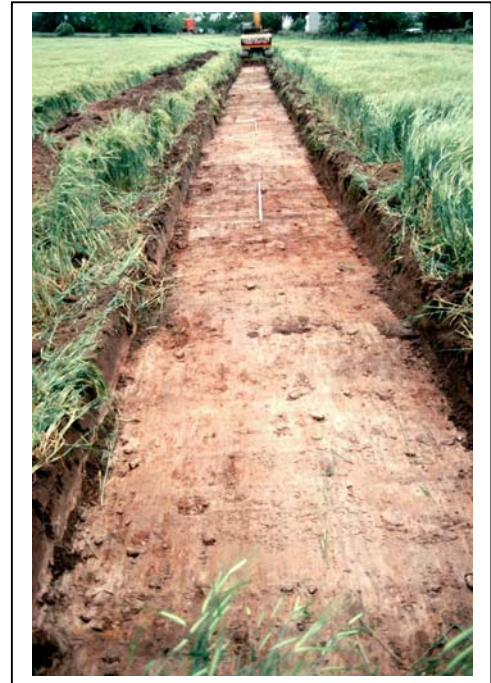
Looking west

Trench 7 was located in Field 4 along with Trenches 4, 6, 8 and 9. It measured 50m by 2m and was excavated to a maximum depth of 0.75m. The trench was aligned east / west and was targeted to investigate two isolated pit-type anomalies and a linear anomaly aligned north / south, highlighted in the geophysical results. In addition to this, there was the potential for Roman activity associated with the Roman road.

The topsoil **1157** extended throughout the trench and was 0.25m deep. Below this was a lighter mid greyish brown sandy silt subsoil, **1158**, that was 0.15m thick. Underlying this was the drift geology **1159**, which was a mid orangey brown sand with 30% small- to medium- sized, rounded stones throughout, and bands running north / south of reddish sandy clay and lighter greyish brown sandy clay. The only identifiable features within the confines of the trench were two land drains, aligned north / south, 11m apart.

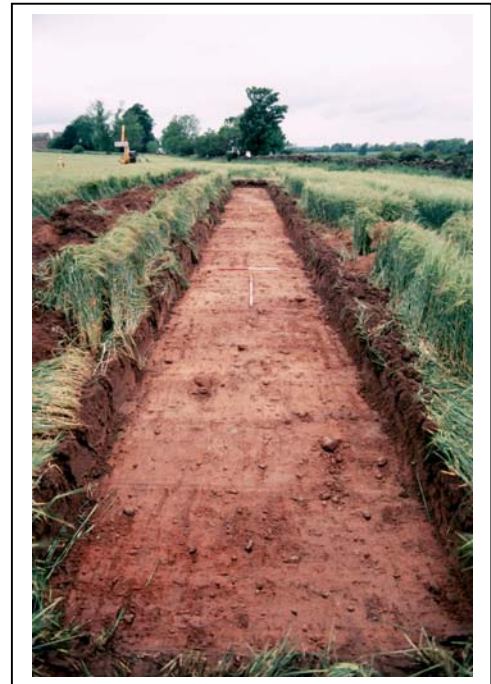
Looking west

Trench 8 was located in Field 4, along with Trenches 4, 6, 7, and 9. It measured 30m by 2m and was excavated to a maximum depth of 0.4m. The trench was aligned east / west and was targeted to investigate pit-type anomalies and a linear anomaly highlighted in the geophysical results.

The topsoil **1154** extended throughout the trench and was 0.3m deep. Below this was a lighter mid brown sandy silt subsoil, **1155**, that was 0.15m thick. Underlying this was the drift geology **1156**, which was a mid brownish orange sand with 5-10% small, rounded stones throughout.

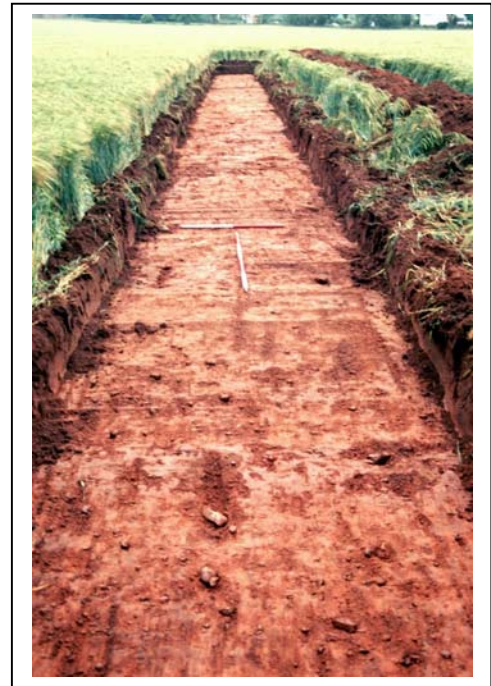
Looking west

Trench 9 was located in Field 4, along with Trenches 4 and 6 - 8. It measured 40m by 2m and was excavated to a maximum depth of 0.3m. The trench was aligned east / west and was located as a topographic situation with the potential for previously unknown activity.

The topsoil **1149** extended throughout the trench and was 0.20m deep. Below this was an orangey grey sandy silt subsoil, **1150**, that was 0.10m thick. Beneath the subsoil and truncating the natural was a single feature **1152**. The feature measured 0.43m in length by 0.34m in width with a maximum depth of 0.20m. In plan **1152** was oval and in section it had a smooth U-shaped profile and a concave base. The feature was filled with, **1153**, a mid greyish brown sandy silt with small rootlets penetrating it. The origin and function of the feature remained ambiguous and could have been either a post hole or the result of root disturbance. Underlying this was the drift geology **1151**, which was a mid red sand, which contained 5% small sub-rounded stones throughout.

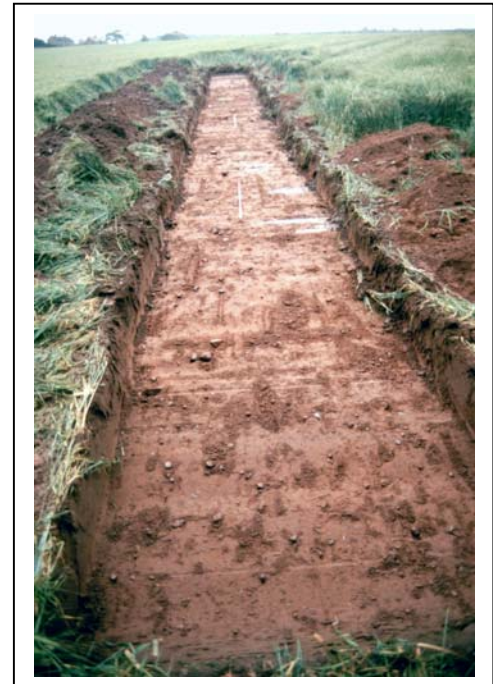
Looking south

Trench 10 was located in Field 5, along with Trenches 11 - 13. It measured 50m by 2m and was excavated to a maximum depth of 0.4m. The trench was aligned north / south and was located to investigate two linear trends recorded in the geophysical survey, as well as being in an area of potential activity near the Roman road.

The topsoil **1117** extended throughout the trench and was 0.15m deep. Below this was a mid greyish brown sandy silt subsoil, **1118**, that was 0.15m thick and had 10-15% small sub-rounded stones throughout. Beneath the subsoil and truncating the natural were two features **1110** and **1112**. The first feature was roughly circular and had a diameter of 0.3m with a maximum depth of 0.08m. Feature **1110** had a smooth U-shaped profile, broader than deep with a concave base. The feature was filled with, **1109**, a mid greyish brown sandy silt with <10% small stones throughout. The second feature, **1112**, formed an irregular semi-circular feature in plan that continued beyond the western limit of excavation. The profile, although incomplete appeared to be an uneven broad U-shape with gradual breaks of slope. The fill, **1111**, was a mid greyish brown silty sand with 10-15% small stone inclusions throughout. The origin and function of the features were unclear and feature **1112** was interpreted as a possible plough scar or the result of bioturbation. Feature **1110** was suggested as a post hole but of relatively modern date due to the colouration, but there was no clear evidence of human activity in either instance. Underlying this was the drift geology **1119**, which was a mid reddish orange sand, which contained 15-20% small to medium sub-rounded stones throughout.

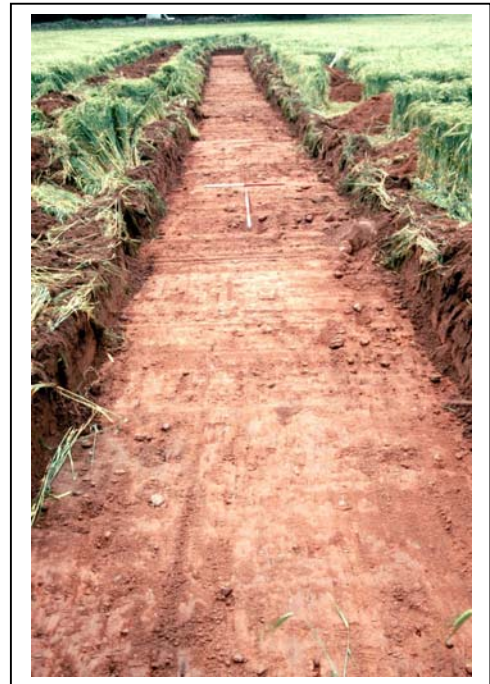
Looking north

Trench 11 was located in Field 5. It measured 50m by 2m and was excavated to a maximum depth of 0.3m. The trench was aligned north-east / south-west and was located as part of the random sample.

The topsoil **1142** extended throughout the trench and was 0.20m deep. Below this was a light greyish brown sandy clay subsoil, **1143**, that was 0.10m thick. Beneath the subsoil and truncating the natural were two features **1145** and **1147**. The first, **1145**, measured 1.0m in length by 0.4m in width with a maximum depth of 0.22m. It was roughly oval with a smooth U-shaped profile. The feature was filled with, **1146**, a dark greyish brown, sandy clay. The second feature, **1147**, had overall dimensions of 0.55m by 0.28m, with a depth of 0.22m. It was sub-circular in plan with a smooth U-shaped profile, filled with a dark greyish brown sandy clay, **1148**, similar to the subsoil above. Neither of the features showed any evidence of human origin and were interpreted as stone throws; where a stone is dragged by ploughing and the subsequent hollow formed, in fills with surrounding material, usually topsoil or subsoil. Underlying them was the drift geology **1144**, which was a mid orangey brown sandy clay, that contained about 10% sub-rounded stones throughout.

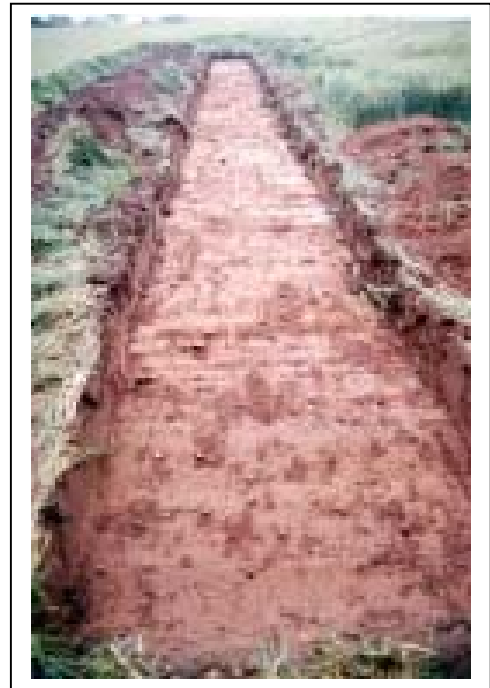
Looking south-west

Trench 12 was located in Field 5. It measured 50m by 2m and was excavated to a maximum depth of 0.4m. The trench was aligned north-east / south-west and was located as part of the random sample.

The topsoil **1137** extended throughout the trench and was 0.20m deep. Below this was a mid brown sandy subsoil, **1138**, that was 0.20m thick. Beneath the subsoil and truncating the natural was a single feature **1140**. The feature, **1140**, measured 0.48m in length by 0.44m in width with a maximum depth of 0.20m. In plan it was roughly circular with an asymmetrical profile, both sides were steeply sloped but on the western side it was stepped slightly. The base was mostly flat but undulated on the western side. The feature was filled with, **1141**, a light greyish brown, sand with 5-10% sub-rounded stones. The isolated feature showed no evidence of human origin and was probably the result of a boulder being removed, there were no roots to suggest a shrub / tree bowl and it was determined that the feature was unlikely to be a post hole. Underlying the feature was the drift geology **1139**, which was a mid orangey brown sand, that contained about 15-20% sub-rounded stones throughout.

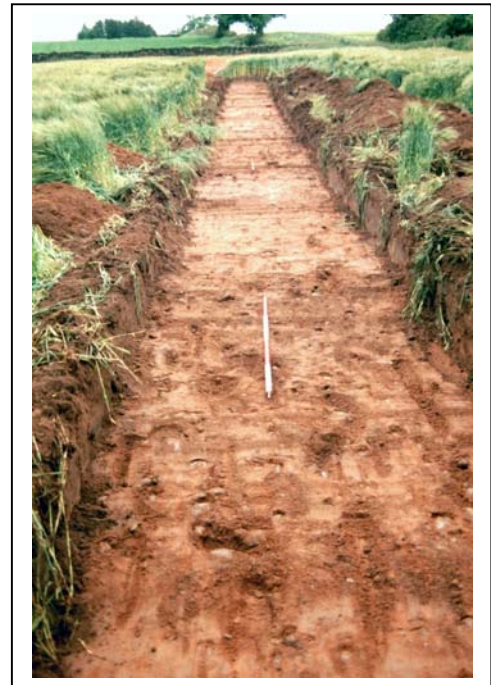
Looking south

Trench 14 was located in Field 7. It measured 40m by 2m and was excavated to a maximum depth of 0.35 m. The trench was aligned north-east / south-west and was targeted to investigate a pit-type anomaly and a linear anomaly highlighted in the geophysical results.

The topsoil **1099** extended throughout the trench and was 0.25m deep. Below this was a dark orangey brown silty sand subsoil, **1100**, that was 0.10m thick. Underlying this was the drift geology **1101**, which was a mid brownish orange sand with 20% small, rounded stones throughout. There were bands of sandy gravel and sandy clay interspersed within the natural, each had moderately diffuse boundaries. There were no identifiable features within the confines of the trench.

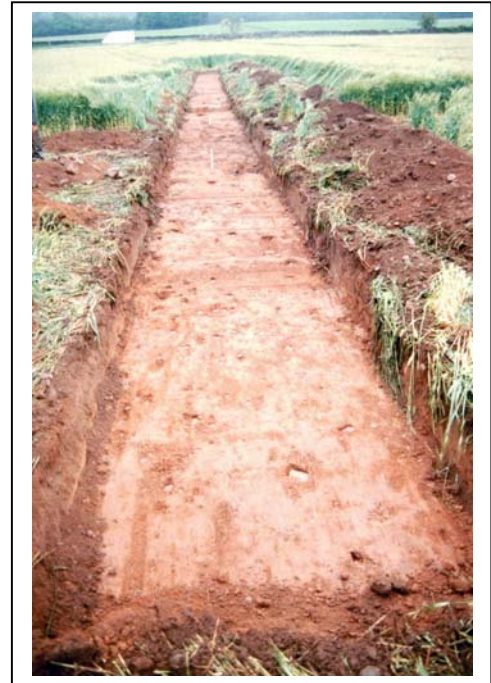
Looking north-east

Trench 15 was located in Field 7. It measured 50m by 2m and was excavated to a maximum depth of 0.4m. The trench was aligned north-east / south-west and was located as a topographic situation with the potential for previously unknown activity.

The topsoil **1102** extended throughout the trench and was 0.25m deep. Below this was a reddish brown sandy clay subsoil, **1103**, that was 0.10m thick. Beneath the subsoil and truncating the natural were three features **1106**, **1108** and **1115**. The first, **1106**, measured 0.8m in diameter by 0.18m in depth. In plan it was roughly circular with a smooth U-shaped profile. The feature was filled with, **1105**, a dark grey, sandy silt. A single stone, 0.10m by 0.10m by 0.10m, was found within the fill. The second feature, **1108**, had overall dimensions of a 1.0m diameter, with a depth of 0.20m. It was oval in plan with a smooth U-shaped profile, filled with a dark grey sandy silt, **1107**, similar to the subsoil above. The third feature, **1115**, measured 0.9m in diameter by 0.37m in depth and had a circular plan, with a U-shaped profile. There were two fills, the lower, **1116**, was a 0.20m thick light greyish brown contained a moderate frequency of small stones. The upper fill, **1114** was a darker greyish brown with no stone inclusions. None of the features showed any evidence of human origin and were interpreted as stone throws; where a stone is dragged by ploughing and the subsequent hollow formed, in fills with surrounding material, usually topsoil or subsoil. Underlying them was the drift geology **1104**, which was a mid orangey brown clayey sand, that contained about 10% sub-rounded stones throughout.

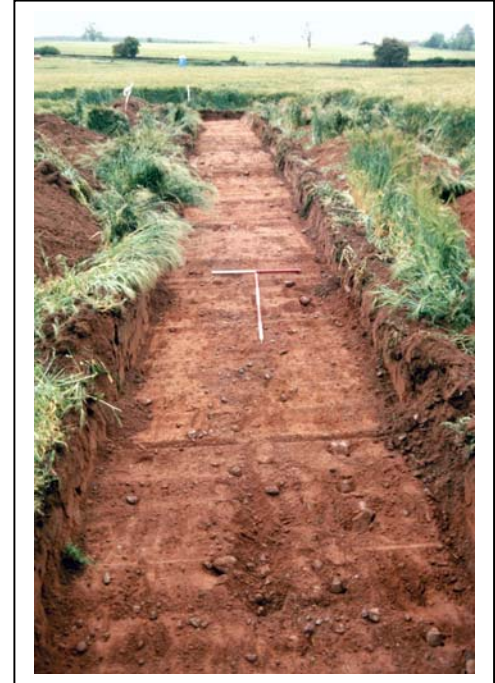
Looking south-east

Trench 16 was located in Field 7, along with Trenches 14, 15 and 18. It was T-shaped and the north / south arm measured 10m by 2m, while the east / west arm measured 30m by 2m and was excavated to a maximum depth of 0.3m. The trench was targeted to investigate pit-type anomalies and a linear anomaly, recorded in the geophysical survey. The trench was also in a location adjacent to potential Roman activity related to the road.

The topsoil **1094** extending throughout the trench, was 0.10m deep. It had a diffuse boundary with the underlying subsoil, **1095**, which was 0.20m thick. Below the subsoil was one discrete feature **1098**, the cut of which was 0.20m in diameter and 0.09m deep. It was roughly circular, with steep sides and an even base. The profile was slightly asymmetrical with the eastern side being stepped. The fill, **1097** was a mid greyish brown silty sand. The feature was somewhat ambiguous and could either have been the remains of a post hole or a stone throw. Underlying this was the natural drift geology, **1096**, a mid brownish orange clayey sand with occasional large stones throughout.

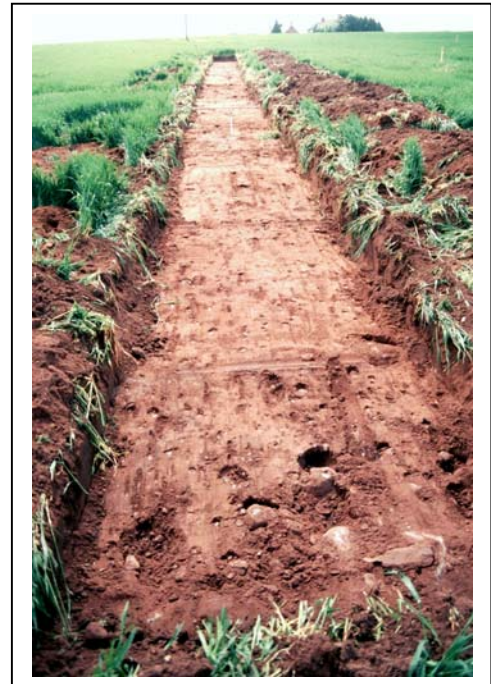
Looking south-west

Trench 17 was located in Field 6. It measured 50m by 2m and was excavated to a maximum depth of 0.6m. The trench was aligned north-east / south-west and was located as a topographic situation with the potential for previously unknown activity.

The topsoil **1089** extended throughout the trench and was 0.20m deep. Below this was a mid reddish brown sandy subsoil, **1090**, that was 0.15m thick. Beneath the subsoil and truncating the natural was a single feature **1093**. The feature measured 0.92m in length by 0.84m in width with a maximum depth of 0.34m. In plan **1093** was roughly circular with fairly steep, irregularly stepped sides in an uneven V-shaped profile. The feature was filled with, **1092**, a mid brown silty sand, that became grittier towards the base. The feature seemed too irregular to be a pit and there were no associated features or any other evidence to suggest human activity. The feature is likely to have been a stone throw; where a stone / boulder is dragged by ploughing and the subsequent hollow formed, then in filled with surrounding material, usually topsoil or subsoil. Underlying this was the drift geology **1091**, which was a mid brownish red sand, which contained about 10-15% sub-rounded stones throughout.

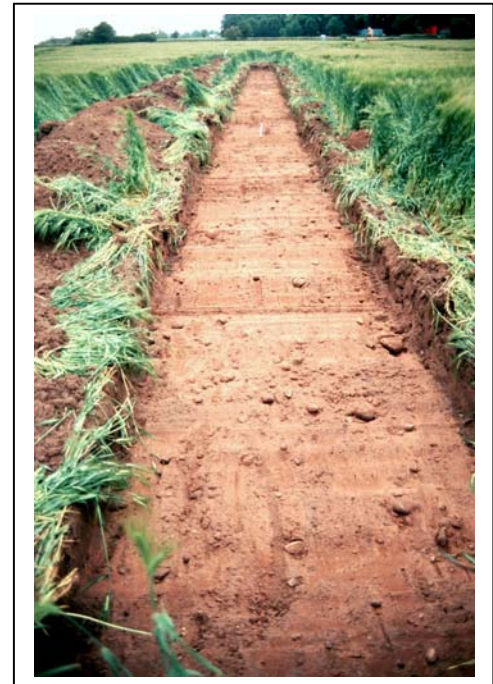
Looking north-west

Trench 18 was located in Field 7. It measured 45m by 2m and was excavated to a maximum depth of 0.4 m. The trench was aligned north-west / south-east and was targeted to investigate a pit-type anomalies, and a linear response and weak linear trends, highlighted in the geophysical results.

The topsoil **1086** extended throughout the trench and was 0.20m deep. Below this was a mid brown silty sand subsoil, **1087**, that was 0.10m thick. Underlying this was the drift geology **1088**, which was a mid red sand with 5-10% small, rounded stones throughout. At the eastern end was a patch of stoney natural, 10-15% sub-rounded stones (<0.2m diameter), within a more reddish grey sand matrix.

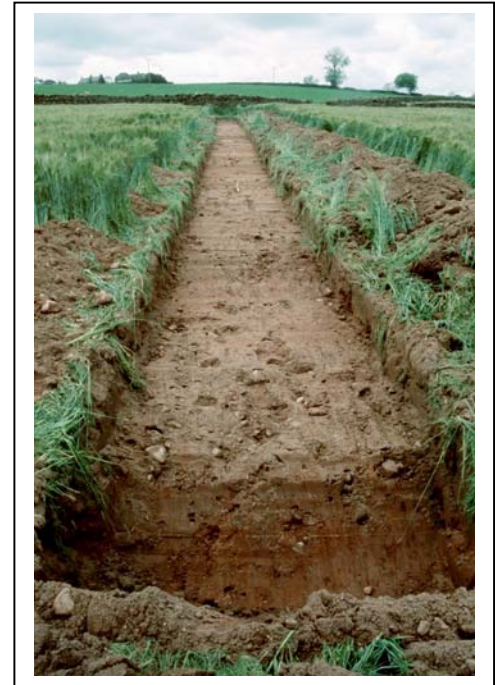
Trench 19 was located in Field 8 along with Trenches 20 - 25. It was aligned east / west and measured 49m by 2m and was excavated to a maximum depth of 0.69m. The trench was targeted to investigate a cluster of pit-type anomalies, highlighted in the geophysical survey.

The topsoil **1083** extending throughout the trench, was 0.40m deep. It had a diffuse boundary with the underlying, lighter reddish brown sandy clay subsoil, **1084**, which was 0.29m thick. Below the subsoil was a linear ditch **1080**, aligned north/south. It was 1.95m wide, 0.36m deep and contained two fills. The profile of the ditch was a very broad U-shape. The uppermost fill, **1082** was a mid brown, sandy clay, 0.20m thick. The lower fill, **1081**, was a mid reddish brown sandy clay. The distinguishing element between the two was that the lower fill contained a higher proportion of small stones throughout. The linear feature was interpreted as a ditch, one which probably represents an earlier field boundary and possibly acted as a drainage ditch as well. There was also a single land drain aligned north-west / south-east within the confines of the trench. Underlying these features was the natural drift geology, **1085**, a mid reddish brown sand with 10-15% medium- to large- stones throughout.

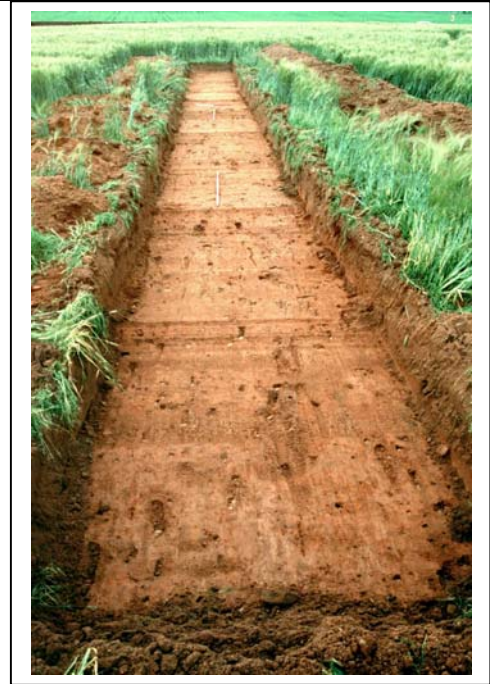
Trench 20 was located in Field 8. It measured 30m by 2m and was excavated to a maximum depth of 0.5 m. The trench was aligned north-east / south-west and was located as a topographic situation with the potential for previously unknown activity.

The topsoil **1067** extended throughout the trench and was 0.23m deep. Below this was a mid greyish brown silty sand subsoil, **1068**, that was 0.12m thick. Underlying this was the drift geology **1069**, which was a mid brownish orange silty sand with 10-15% small, rounded stones throughout. There were no identifiable features within the confines of the trench.

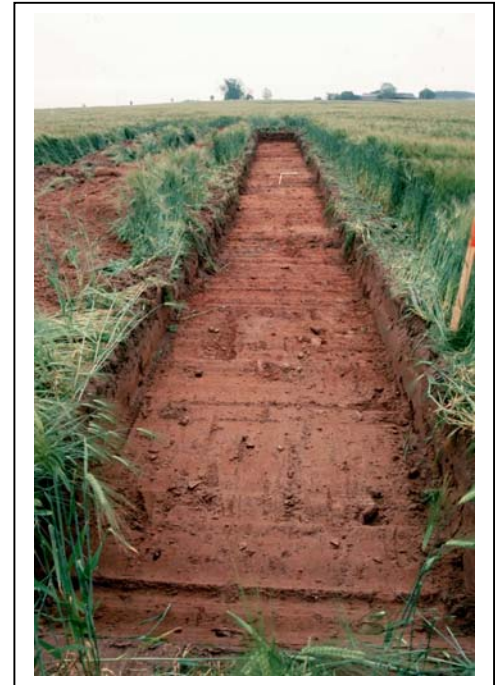
Trench 21 was located in Field 8 along with Trenches 19, 20 and 22 - 25. It was aligned north-west / south-east and measured 30m by 2m and was excavated to a maximum depth of 0.58m. The trench was targeted to investigate pit-type anomalies and poorly defined linear trends, highlighted in the geophysical survey. The trench was also in a location adjacent to potential Roman activity related to the road.

The topsoil **1070** extending throughout the trench, was 0.23m deep. Stratigraphically below the topsoil was a linear feature, **1073**, aligned north / south and with overall dimensions of 0.32m wide by 0.08m deep. In profile the feature had a symmetrical U-shape and it truncated the subsoil **1071**. It was filled by **1074**, A dark greyish brown silt with small stone inclusions. The underlying, mid orangey brown sandy silt subsoil, **1071**, which was 0.28m thick. Below the subsoil was another linear feature, **1075**, also aligned north / south. It was 0.42m wide, 0.08m deep and contained a dark greyish brown silt, **1076**, with small stone inclusions, similar to **1074**. The profile of **1075** was a broader U-shape with imperceptible breaks of slope, in comparison to **1073**. The origin and function of the two features was unclear but they may have been related to ploughing and therefore be of a fairly recent date, although stratigraphically not contemporary. Underlying these features was the natural drift geology, **1072**, a pale brownish orange sand with 20% medium to large stones throughout.

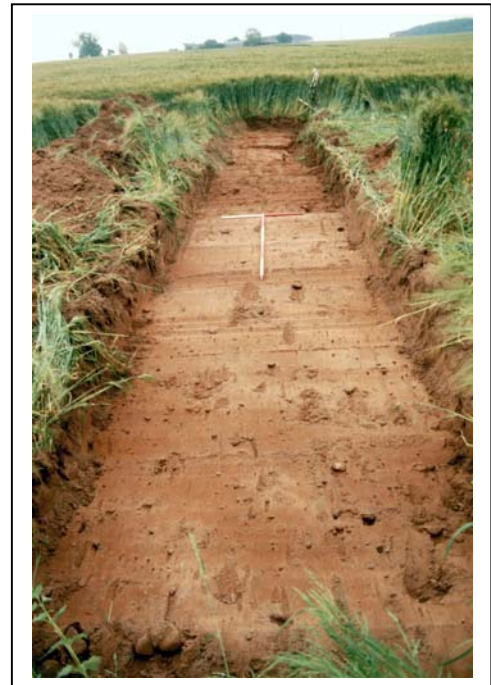
Trench 22 was located in Field 8. It measured 15m by 2m and was excavated to a maximum depth of 0.6 m. The trench was aligned north / south and was located to investigate a linear anomaly highlighted in the geophysical results. In addition to this there was the potential for Roman activity associated with the Roman road.

The topsoil **1077** extended throughout the trench and was 0.20m deep. Below this was a mid brown silty sand subsoil, **1078**, that was 0.20m thick. Underlying this was the drift geology **1079**, which was a mid brownish orange silty sand with 20-30% small, rounded stones throughout. There were no identifiable features within the confines of the trench.

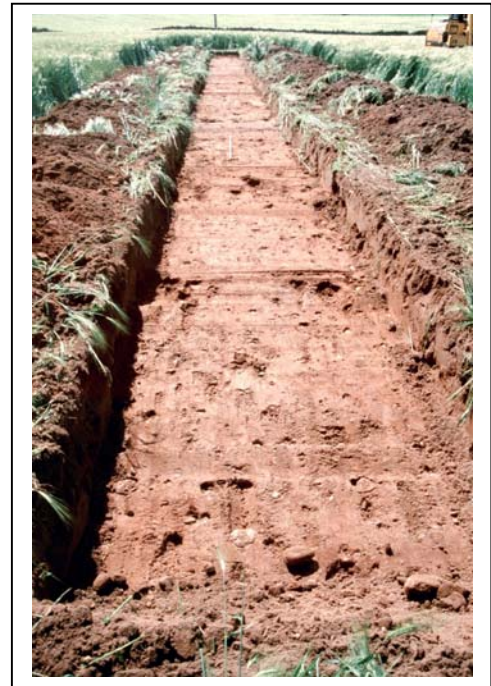
Trench 23 was located in Field 8. It measured 40m by 2m and was excavated to a maximum depth of 0.45 m. The trench was aligned north-west / south-east and was located to investigate slight linear trends highlighted in the geophysical results. It was also located as a topographic situation with the potential for previously unknown activity.

The topsoil **1064** extended throughout the trench and was 0.25m deep. Below this was a mid reddish brown silty subsoil, **1065**, that was 0.20m thick. Underlying this was the drift geology **1066**, which was a mid brownish orange silty sand with a moderate frequency of small, rounded stones throughout. Bands of reddish clay and yellowish brown silty sand were noted within the natural. There were six identifiable features within the confines of the trench, all land drains aligned north-east / south-west and spaced at approximately 5.5m intervals.

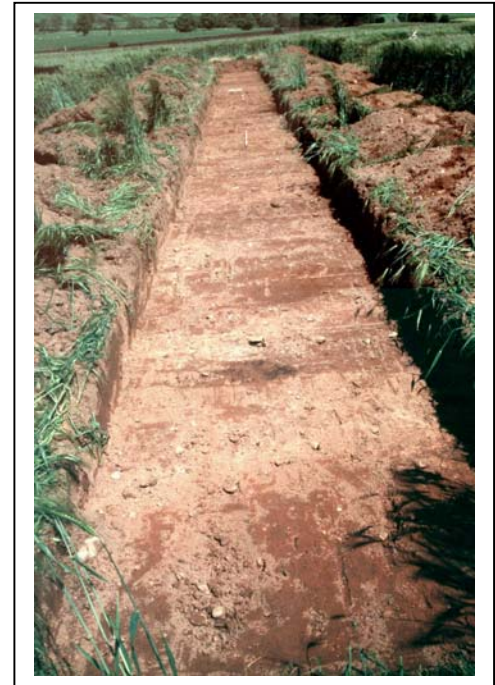
Trench 24 was located in Field 8 along with Trenches 19 -23 and 25. It was aligned north-east / south-west and measured 40m by 2m and was excavated to a maximum depth of 1.28m. The trench was targeted to investigate a pit-type anomaly, highlighted in the geophysical survey, and three linear trends suggested to be ridge and furrow. The trench was also in a topographic situation with the potential for previously unknown activity.

The topsoil **1059** extending throughout the trench, was 0.30m deep. The underlying, mid reddish brown sandy clay subsoil, **1060**, was 0.20m thick. Below this were two features **1063** and **1058**. Feature **1063** was a discrete feature, the cut of which was 0.20m by 0.12m and 0.04m deep. It was roughly oval, with shallow sides and an even base. The profile was a symmetrical U-shape. The fill, **1062** was a dark blackish brown, sandy silt. The feature was somewhat ambiguous and could either have been the remains of a post hole or a stone throw. The second feature, **1058**, was linear and aligned north / south. It was 3m wide at the top, 0.5m wide at the base and 0.82m deep. The profile of the ditch was a very broad U-shape at the top before stepping and becoming a vertical sided cut with a flat base. There were two fills; the uppermost fill, **1049** was a mid greyish brown, silty sand, 0.28m thick. The lower fill, **1057**, was a mid greyish brown gritty silt. The distinguishing element between the two was that the lower fill contained a higher proportion of small to medium stones, smaller ones at the top larger ones at the bottom. The linear feature was interpreted as a land drain, the upper part had probably become a larger depression that subsequently infilled. Underlying these features was the natural drift geology, **1061**, a pale brownish red sand with 5-10% small to medium stones throughout.

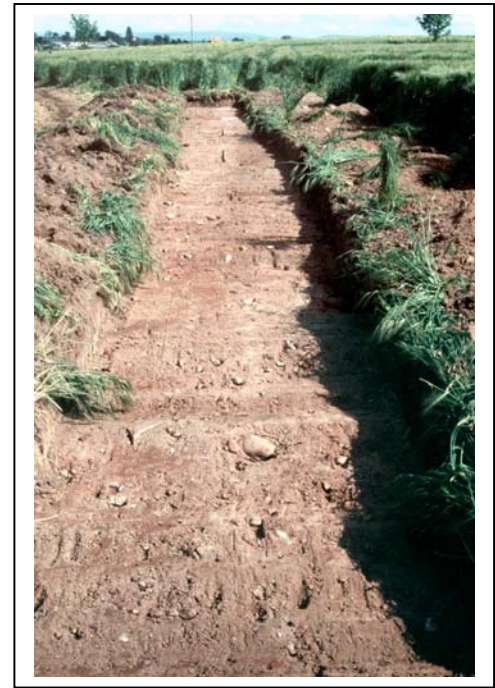
Trench 25 was located in Field 8 along with Trenches 19 - 24. It was T-shaped and the north-east / south-west arm measured 28m by 2m, while the north-west / south-east arm measured 35m by 2m and was excavated to a maximum depth of 0.4m. The trench was targeted to investigate a pit-type anomaly adjacent to an increased magnetic response, highlighted in the geophysical survey. It was also located in a topographic situation with the potential for previously unknown activity.

The topsoil **1050** extending throughout the trench, was 0.30m deep. The underlying subsoil, **1084** was a lighter reddish brown sandy clay, that was 0.20m thick. Below the subsoil was a linear ditch, **1053**, aligned north/south and it measured 1.55m wide by 0.64m deep. It had a broad, slightly asymmetrical U-shape with only one fill, **1054**. The fill was a dark greyish brown sandy silt with occasional stones. The linear feature was interpreted as a ditch, one which probably represents an earlier field boundary. A second linear feature, **1055**, was seen aligned roughly east / west but did not traverse the entire trench width. The cut was a U-shaped profile and was filled by **1056**, a dark brown coarse sandy clay. The feature was interpreted as a plough scar and therefore likely to be of recent date. There were also five land drains within the confines of the trench, three aligned north / south, one east / west and one north-east / south-west. Underlying these features was the natural drift geology, **1052**, a mid reddish brown sand with 10-15% medium to large stones throughout.

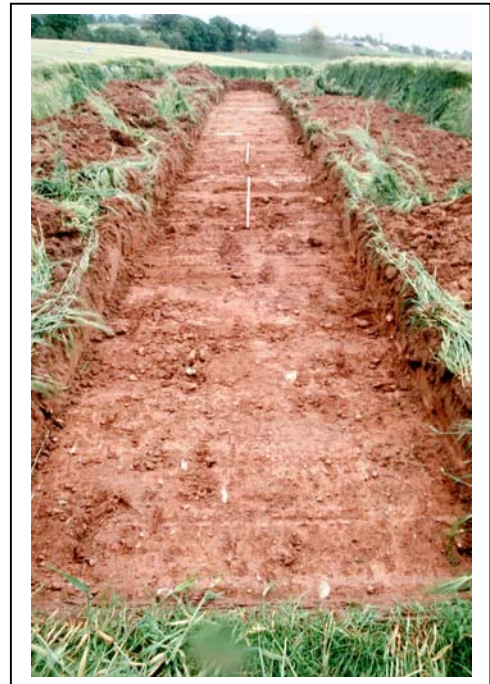
Trench 27 was located in Field 10. It measured 40m by 2m and was excavated to a maximum depth of 0.45m. The trench was aligned north-east / south-west and was located to investigate pit-types anomalies recorded in the geophysical survey.

The topsoil **1026** extended throughout the trench and was 0.20m deep. Below this was a mid brownish grey sandy subsoil, **1027**, that was 0.20m thick. Beneath the subsoil and truncating the natural was a single feature **1032**. The feature measured 0.95m in length by 0.88m in width with a maximum depth of 0.18m. In plan **1032** was roughly semi-circular, continuing south beyond the trench edge. It had fairly steep, irregular sides and an uneven gently concave base. The feature was filled with, **1031**, a mid greyish brown silty sand, with a gritty element. The fill also had patches of reddish brown and flecks of manganese throughout. The feature seemed too irregular to be a pit and there were no associated features or any other evidence to suggest human activity. The feature may have been a stone throw or disturbance form root activity or animal burrowing. Underlying this was the drift geology **1028**, which was a mid reddish brown sand, which contained about 20% sub-rounded stones throughout. There was also one land drain, aligned north-east / south-west at the northern end of the trench.

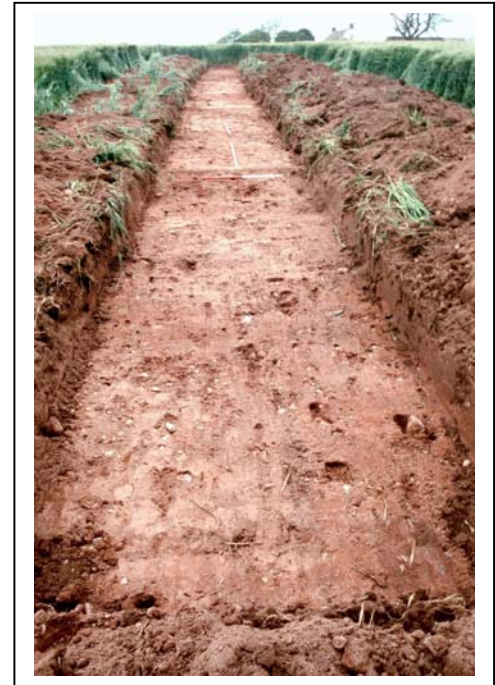
Trench 28 was the only trench located in Field 10, along with Trenches 27, 29 and 32. It measured 40m by 2m, was excavated to a maximum depth of 0.4m and was aligned east / west. The trench was located in a topographic situation with the potential for previously unknown activity and also targeted linear trends seen in the geophysical survey.

The topsoil **1023** extending throughout the trench, was 0.30m deep. The underlying subsoil, **1024** was a lighter reddish brown sandy clay, that was 0.10m thick. Below the subsoil were two features **1039** and **1041**. The first feature, **1039**, was a discrete feature, the cut of which was 0.20m by 0.15m and 0.11m deep. It was roughly circular, with reasonably steep sides and a concave base. The profile was a symmetrical U-shape. The fill, **1038** was a mid brown, silty clay with manganese flecks visible. The feature was somewhat ambiguous but was probably the remains of modern a post hole. The second feature, **1041**, was elongated in shape, aligned north-east / south-west, and did not traverse the entire width of the trench. It had overall dimensions of 1.0m by 0.61m and was 0.11m deep. The cut was a shallow and uneven U-shaped profile and was filled by **1040**, a mid greyish brown, silty sand. The feature was interpreted as a plough scar and therefore likely to be of recent date. There was also one land drain within the confines of the trench that was orientated north-east / south-west and was located towards the western end. Underlying these features was the natural drift geology, **1025**, a mid reddish brown silty sand with 20% small to medium stones throughout.

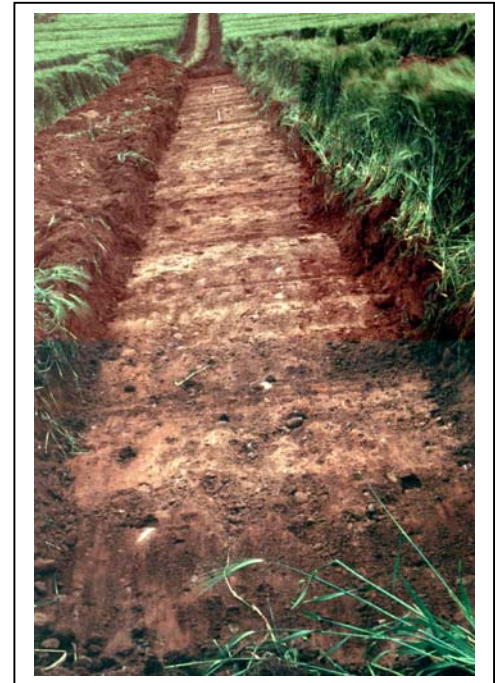
Trench 29 was located in Field 10, along with Trenches 27, 28 and 32. It measured 40m by 2m, was excavated to a maximum depth of 0.8m and was aligned north-west / south-east. The trench was targeted to investigate pit-type anomalies seen in the geophysical survey.

The topsoil **1020** extending throughout the trench, was 0.20m deep. The underlying subsoil, **1021** was a lighter brown sandy silt, that was 0.15m thick. Below the subsoil was a single feature **1037**. The feature, **1037**, was a linear feature aligned north-west / south-east, the cut of which was 0.80m wide and 0.08m deep. The profile was a symmetrical, shallow uneven U-shaped profile. The fill, **1036** was a n orangey grey sandy silty with 1% charcoal flecks visible. The feature was interpreted as a possible plough scar or the very base of a furrow. Underlying this was the natural drift geology, **1022**, a mid brown silty sand with 15-20% small stones throughout.
