A66 Temple Sowerby Bypass and Improvements at Winderwath

Topographic Survey, Evaluation and Watching Brief Report

Oxford Archaeology North

August 2005

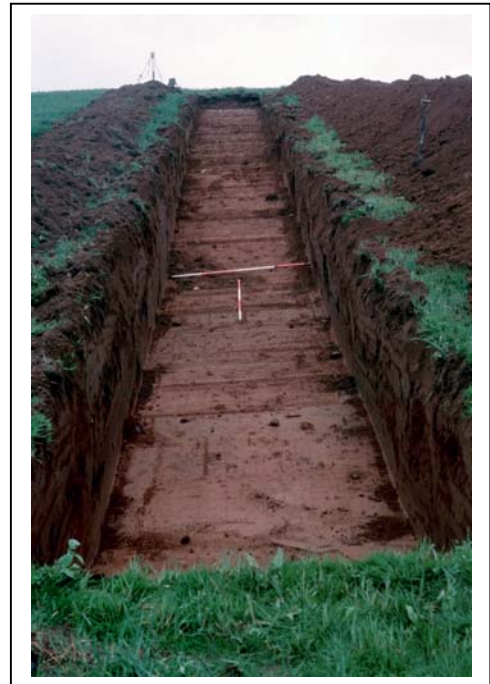
Trench 30 was located in Field 11. It measured 30m by 2m and was excavated to a maximum depth of 1.4 m. The trench was aligned north-east / south-west and was located as a topographic situation with the potential for previously unknown activity.

The topsoil **1011** extended throughout the trench and was 0.47m deep. Below this was a mid brownish grey silty subsoil, **1012**, that was 0.90m thick. The boundary between the two horizons was diffuse. Underlying this was the drift geology **1013**, which was a light brown silty sand. A large patch of natural paler brown sandy matrix with 25-35% medium-sized stone inclusions was noted at the south-western end of the trench. There was only one identifiable feature within the confines of the trench and that was a land drain, aligned north / south.

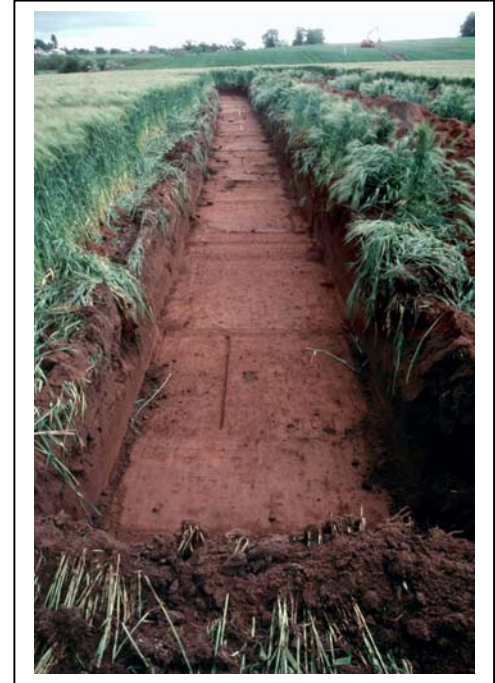
Trench 31 was located in Field 10, along with Trenches 27 - 29 and 32 and was aligned north-west / south-east. It measured 40m by 2m, was excavated to a maximum depth of 0.7m. The trench was located in a topographic situation with the potential for previously unknown activity.

The topsoil **1017** that extended throughout the trench, was 0.30m deep. The underlying subsoil, **1018** was a lighter reddish brown sandy clay, that was 0.40m thick. Below the subsoil was a distinct deposit, **1048**. The deposit extended over an area 0.78m by 0.15m and had a maximum thickness of 0.09m. It was an amorphous deposit of mid brown sandy silt with 80% inclusions of charcoal flecks. The dense concentration of charcoal and the position of the deposit appeared to be consistent with a modern bonfire event or burning of excess rubbish. Underlying this was the natural drift geology, **1019**, a mid reddish brown sandy clay with occasional small stones throughout.

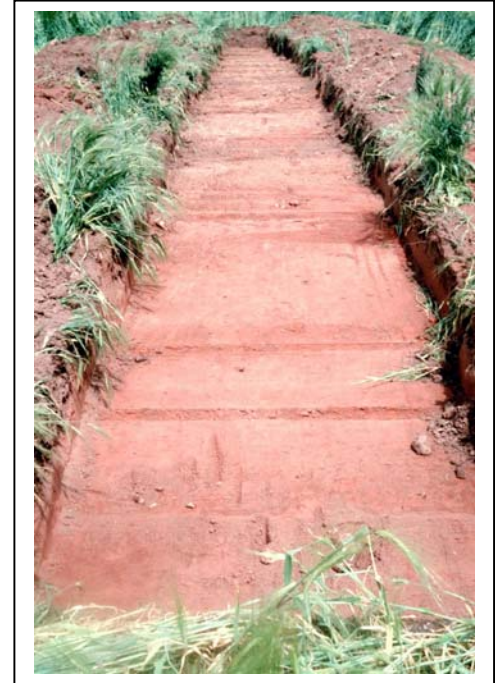
Trench 32 was located in Field 10, along with Trenches 27 - 29 and 31 and was aligned north-west / south-east. It measured 30m by 2m, was excavated to a maximum depth of 0.75m. The trench was targeted in order to investigate pit-type anomalies seen in the geophysical survey.

The topsoil **1014** that extended throughout the trench, was 0.30m deep. The underlying subsoil, **1015** was a lighter reddish brown sandy clay, that was 0.15m thick. Below the subsoil was a linear feature aligned roughly east / west, **1035**. The feature was 1.10m wide and 0.48m deep. It had a very gradual shallow, U-shaped symmetrical profile and contained a single fill. The fill, **1034**, was a mid orangey grey sandy silt with occasional flecks of what appeared to be charcoal. The linear feature was interpreted as a ditch, probably an earlier field boundary that represents part of a defunct field system. Underlying this was the natural drift geology, **1016**, a mid red sand with occasional small stones throughout, interspersed with thin gravel bands and paler yellow sand lenses.

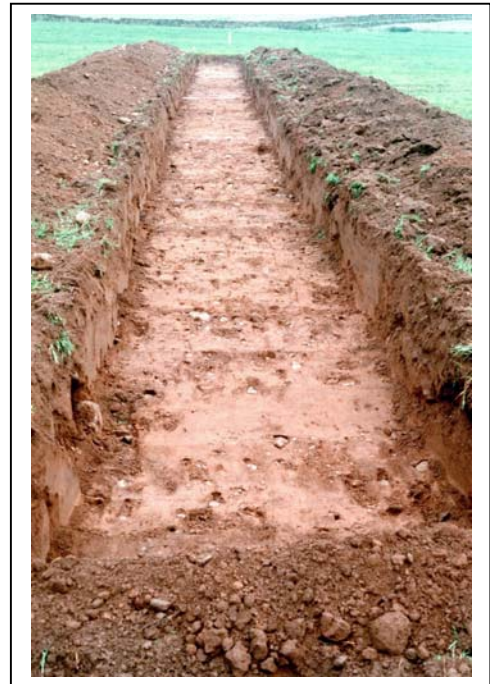
Trench 33 was located in Field 11. It measured 40m by 2m and was excavated to a maximum depth of 0.8 m. The trench was aligned east / west and was targeted to investigate pit-type anomalies and faint linear trends highlighted in the geophysical results.

The topsoil **1008** extended throughout the trench and was 0.3m deep. Below this was a mid reddish brown clayey silty subsoil, **1009**, that was 0.45m thick. Underlying this was the drift geology **1010**, which was a mid orangey red sandy clay. Both the subsoil and the natural contained about 10-15% sub-rounded stones throughout. There were two identifiable features within the confines of the trench, both land drains aligned north-east / south-west and 15m apart.

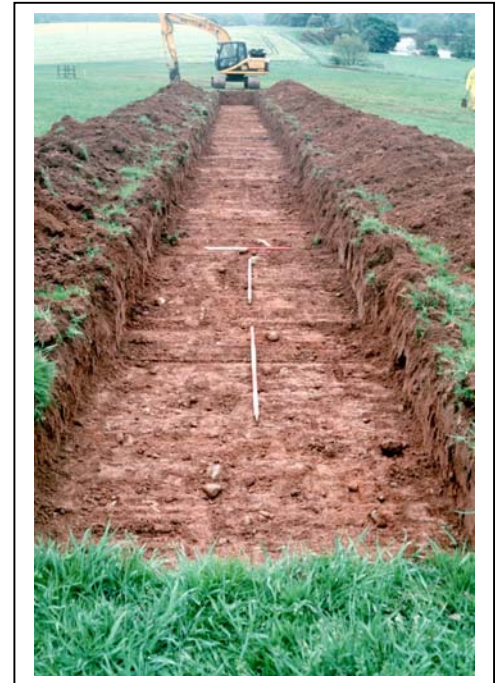
Trench 34 was located in Field 11, along with Trenches 33 and 35 and was aligned north / south. It measured 50m by 2m, was excavated to a maximum depth of 0.7m. The trench was located as a topographic situation with the potential for previously unknown activity.

The topsoil **1003** that extended throughout the trench, was 0.40m deep. Below the topsoil was a single oval feature, **1007**. The feature was over 1.02m long, 0.85m wide and 0.36m deep. It had a U-shaped symmetrical profile and contained a single fill. The fill, **1006**, was a reddish brown sandy silt with 20% of, what appeared to be, charcoal flecks throughout. The feature was interpreted as a pit and suggested by the stratigraphy to be of fairly modern date. The pit truncated the underlying subsoil, **1004**, which was a 0.30m thick layer of lighter reddish brown sandy clay. Underlying this was the natural drift geology, **1005**, a mid orangey red sand with occasional small stones.

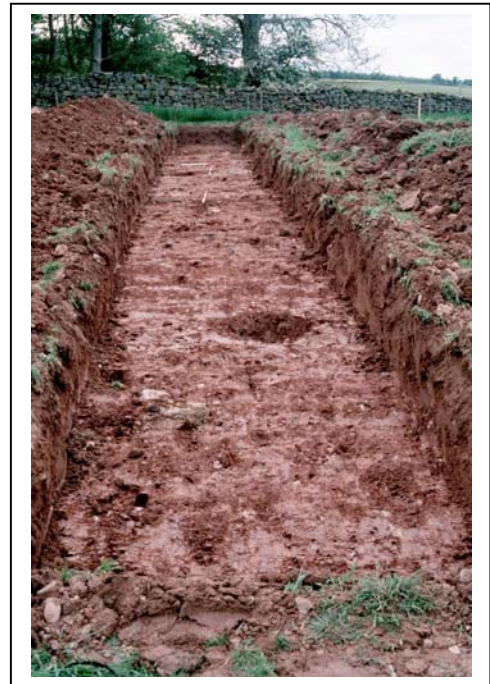
Trench 35 was located in Field 11. It measured 20m by 2m and was excavated to a maximum depth of 0.7m. The trench was aligned east / west and was located as a topographic situation with the potential for previously unknown activity.

The topsoil **1000** extended throughout the trench and was 0.50m deep. Below this was a mid reddish brown clayey silty subsoil, **1001**, that was 0.20m thick. Underlying this was the drift geology **1002**, which was a mid orangey red sandy clay. Both the subsoil and the natural contained about 10-15% sub-rounded stones throughout. There was only one identifiable feature within the confines of the trench and that was a north-east / south-west aligned land drain.

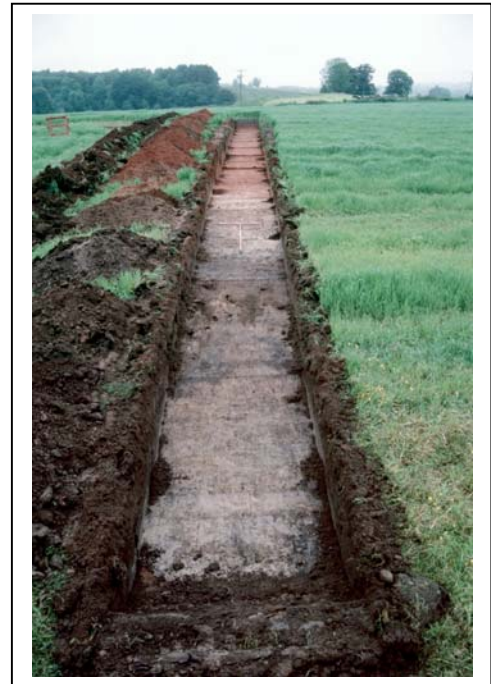
Trench 38 was located in Field 14, together with Trench 39. The trench measured 40m by 2m and was excavated to a maximum depth of 0.64m. It was aligned north-west / south-east and was targeted to investigate a cluster of anomalies suggestive of occupation activity highlighted in the geophysical survey.

The topsoil **1693** extended throughout the trench and was on average 0.55m deep. Below the topsoil at the eastern end of the trench was a north-west / south-east aligned linear feature, **1702**. It was 4m long and 0.48m wide and filled with a mottled brownish yellow clayey silt, **1701**. The feature was a land drain and it truncated the upper fills of two earlier ditches, **1696** and **1699**. The two ditches were adjacent to each other and aligned north-east/south-west. Ditch **1697** lay west of ditch **1700** both had two fills, a lower stonier fill, **1695** and **1698** respectively, and an upper fine grey silt fill **1696** and **1699**. The ditches had similar shallow U-shaped profiles and had similar depths of 0.52m. Ditch **1697** was slightly wider at 1.05m, while ditch **1700** was 0.8m. No stratigraphic relationship could be established between the two ditches, neither clearly cut the other and the upper fills were essentially the same deposit. The deposit being a gradually accumulated, water-lain one indicated that both ditches went out of use and infilled at about the same time. Both ditches were boundary ditches demarcating the earlier small fields. At the base of the revealed stratigraphic sequence in this trench was the underlying drift geology **1694**, which was a mid reddish, orange coarse sand with 10-20% small to medium sized, rounded stones throughout, interspersed with patches of pale grey sand and orangey brown sand with manganese flecks.

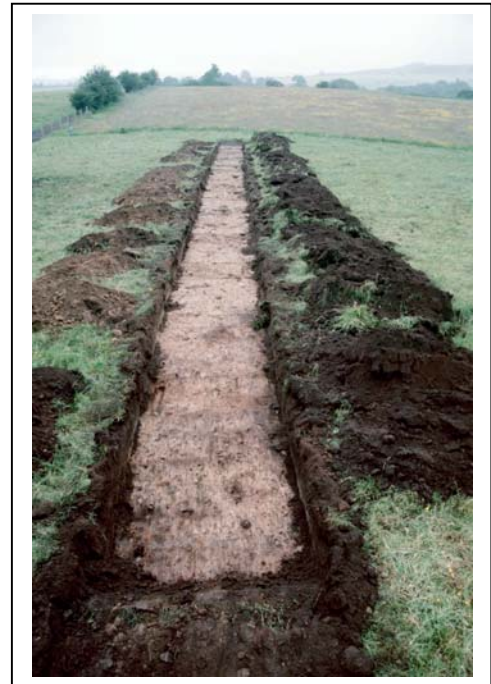
Trench 39 was located in Field 14, together with Trench 38. The trench measured 40m by 2m and was excavated to a maximum depth of 0.7m. It was aligned north-east / south-west and was located as part of the random sample.

The topsoil **1714** extended throughout the trench and was 0.48m deep. Below this was a mid reddish brown sandy subsoil, **1715**, that was 0.15m thick. Overlain by the subsoil were three features, **1689**, **1690** and **1687**. Feature **1689** was an amorphous shallow area with overall dimensions of 0.58m by 0.35m by 0.20m deep. It had an irregular profile with a reasonably flat base and was filled with, **1692**, a greyish brown gritty sand. The lack of a well-defined shape clearly indicated that the feature was the result of root disturbance. The second feature, **1690**, was circular in plan with a diameter of 0.5m but a depth of only 0.05m. It had a shallow U-shaped profile with imperceptible breaks of slope. The fill, **1691** was a mottled greyish, browny orange, gritty sand. The feature was probably either a stone throw or a root hollow. At the southern end of the trench the third feature, **1687** was seen aligned north / south and within the fill **1688** a segmented orange ceramic drain was seen. The land drain, **1687** truncated an earlier linear feature, **1720**. The feature was 1.02m wide and 0.20m deep. It had a broad U-shaped profile, which had been disturbed along the southern side by the land drain. The fill, **1719**, was a mid grey sandy silt which contained no dating evidence. The feature appeared to be an earlier ditch had obviously gone out of use by the time the land drain was put in. The ditch may have been a drainage ditch rather than a boundary ditch. There were two other land drains identified, both to the north and on the same alignment as **1687**. The first lay 8m away and the second was a further 3.5m away. At the base of the revealed stratigraphic sequence in this trench was the underlying drift geology **1716**, which was a mid reddish, orange coarse sand with 10-20% small- to medium- sized, rounded stones throughout, interspersed with patches of pale grey sand and orangey brown sand with manganese flecks.

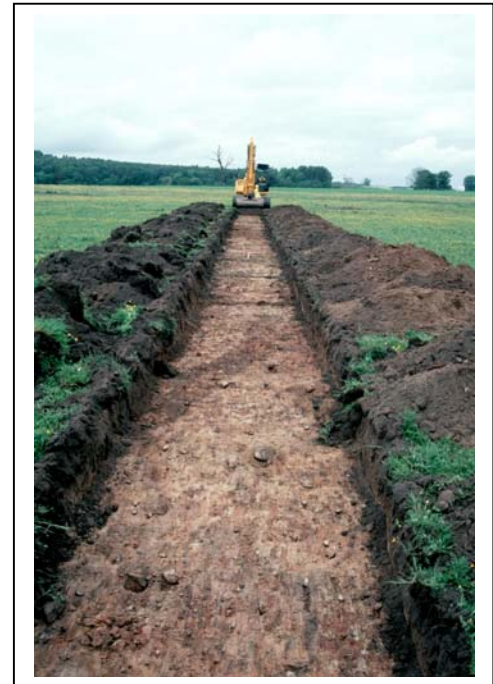
Looking east

Trench 40 was the sole trench located in Field 15. The trench measured 40m by 1.85m and was excavated to a maximum depth of 0.5m. It was aligned north-west / south-east and was located to investigate weak magnetic trends highlighted in the geophysical survey.

The topsoil **1534** extended throughout the trench and was 0.30m deep. Below this was a mid greyish brown sandy subsoil, **1535**, that was 0.15m thick. Beneath the subsoil were two features, **1600** and **1537**. Feature **1537** was a north / south aligned linear feature that measured over 1.10m in length, 0.50m in width and 0.30m in depth. It had vertical sides and a flat base. The fill, **1538**, was a mottled greyish pinkish orange sandy clay with small to medium stones packed at the base. The feature was a land drain. The second feature, **1600**, was a roughly linear band of pale greyish brown sandy clay, 0.70m wide with diffuse boundaries and 0.50m deep at the extreme. It was overlain with a dense patch of cobbles, **1599**, all less than 0.20m in diameter. The feature was a variation in the natural, perhaps glacial patterned ground, with no evidence of human origins. In addition to land drain **1537**, there were another three, to the west at approximately 6m intervals. The alignments varied slightly from north-west / south-east to north-east / south-west. The underlying drift geology **1536**, which was a pale brownish orange sandy clay with 5% small to medium sized, rounded stones throughout.

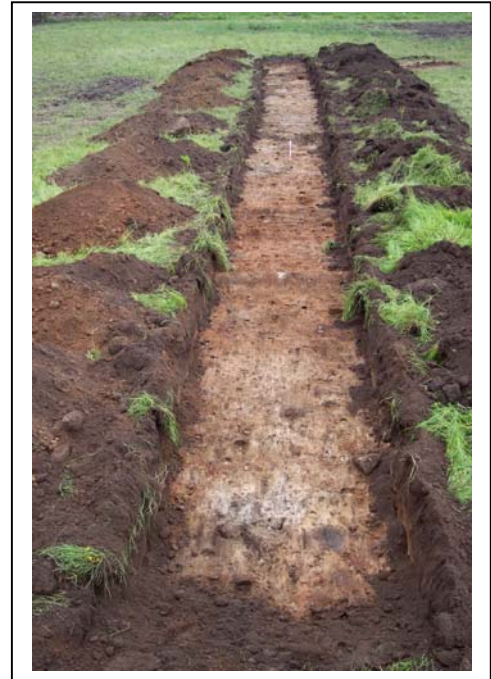
Looking north

Trench 41 was the sole trench located in Field 16. The trench measured 30m by 1.85m and was excavated to a maximum depth of 0.6m. It was aligned north-east / south-west and was located as part of the random sample.

The topsoil **1680** extended throughout the trench and was 0.20m deep. Below this was a mid greyish brown sandy subsoil, **1535**, that was 0.20m thick. Below the subsoil were two linear features **1684** and **1686**. Feature **1684** was aligned north-east / south-west and lay to the north of **1686**. It was 0.25 wide by over 15m long, with an overall depth of 0.35m. It had a single fill, **1683**, that was a greyish brown sandy silt, with small stone inclusions. The cut **1684** had vertical sides, a symmetrical profile and a flat base with sharp breaks of slope. Feature **1686** contained one pale grey fill, **1685**, with 90% stone inclusions less than 0.13m thick. Feature **1684** and was definitely a land drain and feature **1686** may have been the very truncated remains of a stone-filled drain, which had been mostly ploughed out, or a stoney patch of natural. The underlying drift geology **1682**, which was a pale grey sandy gravel with brownish orange patches and 5-15%, small- to medium- sized, rounded stones throughout.

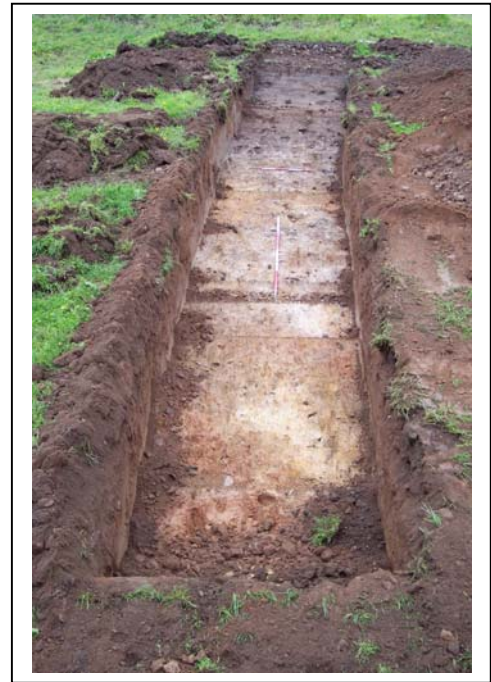
Looking south

Trench 42 was the sole trench located in Field 17. The trench measured 10m by 2m and was excavated to a maximum depth of 1.2m. It was aligned north-east / south-west and was located as a site with potential for activity related to a sixteenth century trackway.

The topsoil **1667** extended throughout the trench and was 0.25m deep. Below this was a dark grey stoney layer, **1668**, composed of 80-90% small to medium rounded and sub-angular stones, intermixed. The layer extended across the entire trench area and varied from approximately 0.23m thick at the northern end to 0.4m at the southern end of the trench. Within the layer were frequent fragments of modern bricks and the layer was essentially hardcore material deliberately laid down to form a stable ground surface. Underneath the hardcore layer was the subsoil, **1669**, which was a mid orangey brown sandy silt, that reached a maximum thickness of 0.60m. Below the subsoil was a dark grey clayey silt layer, **1670**. This deposit was only seen towards the southern end of the trench within a natural depression. It extended across an area 2.30m wide. Along the southern side of this deposit was an underlying thin lens of darker grey silt, **1671**, which may have been the remains of a small patch of vegetation. The deposits all had a fine texture consistent with possible waterlain deposition and the topography in the vicinity would suggest this. The trench was located at the bottom of a gentle slope and the original ground surface may have been even more pronounced but subsequent colluvial processes have gradually been bringing material from the top of the slope to the bottom. The underlying drift geology, **1672**, which was a pale whitish yellow clayey silt.

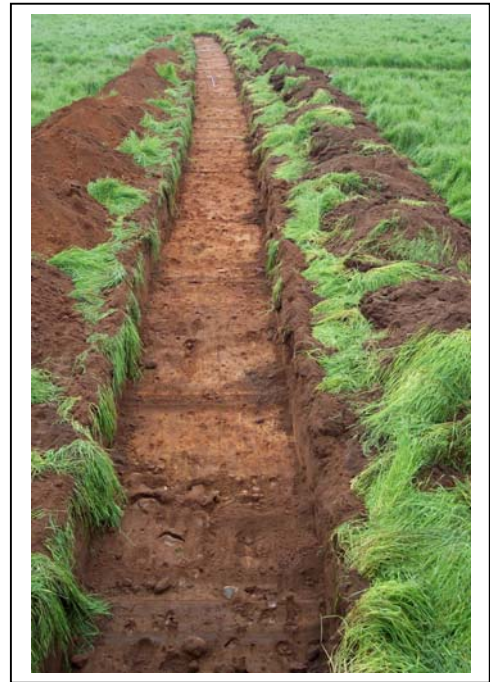
Looking north

Trench 43 was located in Field 18. The trench measured 50m by 2m and was excavated to a maximum depth of 0.9m. It was aligned north / south and was located due to the presence of linear trends that indicated possible ridge and furrow. The ridge and furrow was in fact visible as surface features while the vegetation was short within Field 18 although it became more obscured the longer the vegetation became.

The topsoil **1677** extended throughout the trench and was on average 0.40m deep. Below this was a mid reddish brown sandy subsoil, **1678**, that was 0.15m thick. Below the subsoil was a dense concentration of medium-sized, rounded cobbles, **1703**, found at the southern end of the trench and extending across an area of approximately 2m by 2m; it was 0.34m thick. It was not possible to determine the overall form of the feature since it extended beyond the trench edges, but it was probably a cobble bank or perhaps a clearance cairn. No dating material was recovered from the excavation section. Underneath the bank / cairn was a 0.12m thick deposit of mottled brownish yellow sand, **1704**, which seemed to fill a slight linear depression **1705**, which was aligned north-west / south-east and had a shallow profile with very gradual breaks of slope. The depression was probably natural. At the northern end four broad but very shallow linear features were uncovered. The linear features were from north to south; **1664**, **1666**, **1674** and **1676**. Each varied slightly in width, ranging from 0.75m to 2.5m and all were on the same north-east / south-west alignment. The boundaries of each linear were ephemeral but sufficiently distinct. The maximum depth of any was 0.08m and they were all filled with a mid brownish grey sandy silt but no finds were recovered. The features were the remains of furrows, only the very bases survived, truncating the underlying natural drift geology. Within the field (Field 18) there were visible remains of the ridges surviving as earthworks. The underlying drift geology **1679**, was a mid reddish, orange sand had 10-20% small- to medium- sized rounded stones throughout, interspersed with patches of pale grey sand and orangey brown sand with manganese flecks.

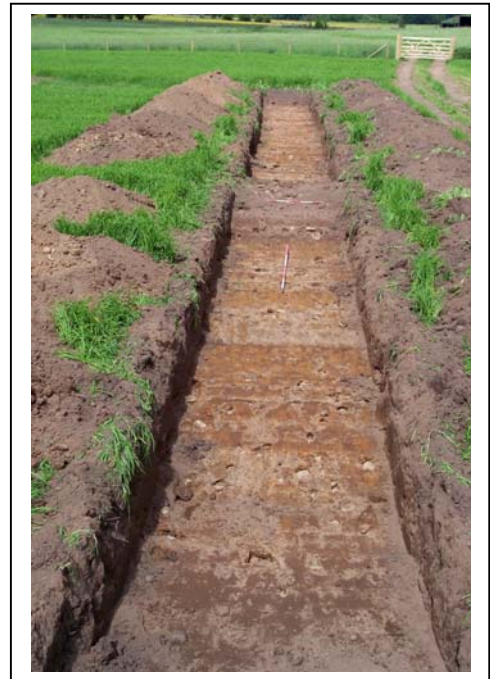
Looking west

Trench 44 was located in Field 20 along with Trench 45. The trench measured 30m by 2m and was excavated to a maximum depth of 1.05m. It was aligned north-west / south-east and was located due to the presence of a linear trend suggested to be the remains of a ploughed out earthwork.

The topsoil **1623** extended throughout the trench and was on average 0.30m deep. Below this was a dense concentration of small to medium cobbles, **1626**. They were deliberately packed in a north-east / south-west aligned linear spread, that extended north and south beyond the limits of excavation. The deposit, **1626** was approximately 2.2m wide and 0.48m thick. The eastern and western boundaries of the cobbles were fairly well defined and the overall nature of the feature was consistent with the remains of a ploughed out dry stone cobble wall. From within the soil matrix of the wall a single, reasonably unabraded, base fragment of medieval pottery was recovered. The lower part of the wall was essentially within the subsoil, **1624**, which was 0.60m thick and a mid orangey brown sandy silt in nature. Underneath the eastern side of the wall was an earlier linear feature, **1632**. It was on the same alignment as the wall and measured 0.51m in width by 0.33m in depth. It had a symmetrical stepped V-shaped profile, and was filled with a pale greyish brown clayey sand, **1633**. Only a small section of this feature was revealed and although tenuous, it did appear to be a probable ditch. No dating material was recovered from the ditch. The underlying drift geology **1625**, was a mid pinkish orange sandy silt that had 5-10% medium-sized, rounded stones throughout.

A number of finds were recovered from the subsoil in this trench including a second, fragment of medieval pottery and one Roman sherd. Two flints were found in the topsoil and an additional flint was recovered from the base of the subsoil. Despite their casual recovery the grouping of the flint finds suggests some level of prehistoric activity within the vicinity.

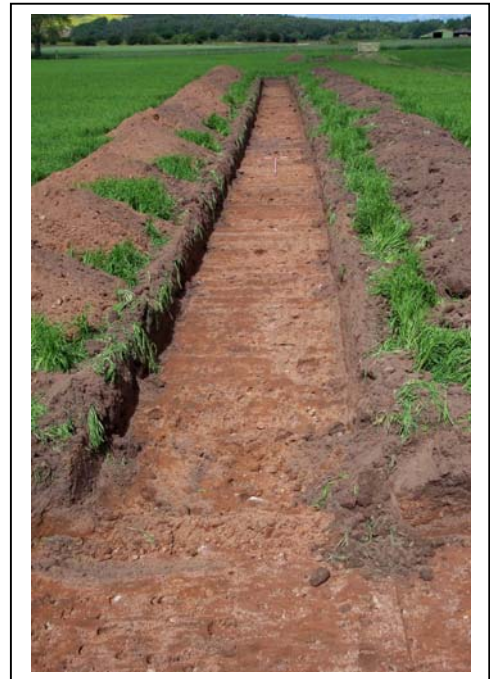
Looking west

Trench 45 was located in Field 20m together with Trench 44. The trench was T-shaped and the north-west / south-east arm measured 50m by 2m, while the east / west arm measured 40m by 2m and was excavated to a maximum depth of 0.6m. It was positioned to target the possible remains of an L-shaped enclosure indicated in the geophysical survey.

The topsoil **1629** extended throughout the trench and was on average 0.30m deep. The underlying subsoil, **1630** was a lighter orangey brown sand, that was 0.40m thick. Below the subsoil was an amorphous feature, **1628**, 4.02m by 1.05m and 0.07m deep, probably the remains of a tree throw. It had a very irregular profile with numerous narrow protrusions into the underlying natural, and contained a single fill. The fill, **1627**, was a mid greyish brown sand. The underlying drift geology **1625**, was a mid pinkish orange sandy silt that had 5-10% medium-sized, rounded stones throughout.

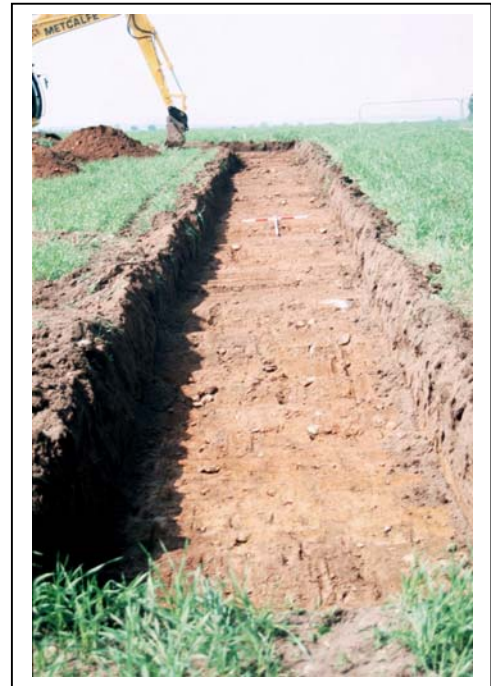
Looking south

Trench 46 was located in Field 21, along with Trench 47. The trench was aligned north-east / south-west, measured 30m by 2m, and was excavated to a maximum depth of 0.6m. It was located as part of the random sample.

The topsoil **1594** extended throughout the trench and was 0.20m deep. The underlying subsoil, **1595** was a lighter brownish grey sandy silt, that was 0.35m thick. Below the subsoil was a single feature, **1598**. The feature was 0.85m by 0.73m and 0.22m deep. It had a very irregular U-shaped profile with numerous narrow protrusions into the underlying natural, and contained a single fill. The fill, **1597**, was a mid brownish grey sandy silt. The feature was the remains of root disturbance since numerous fine roots were found within the fill. The underlying drift geology **1596**, varied from brownish orange at the south end to more orange at the north end and was essentially silty sand with 10-15% medium-sized, rounded stones and 1% manganese throughout.

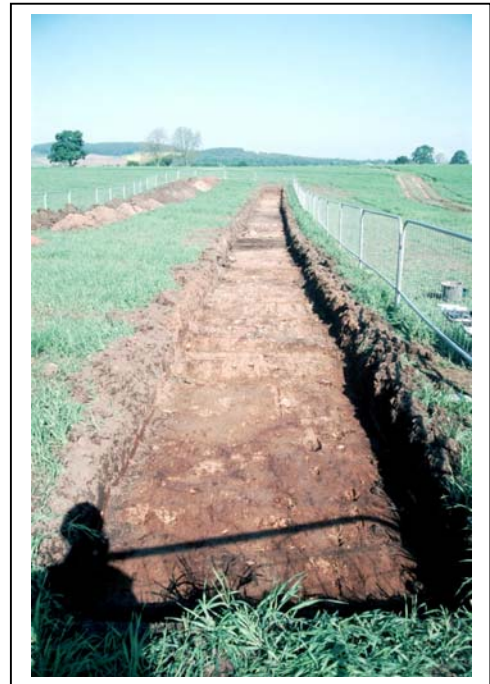
Looking west

Trench 47 was located in Field 21, along with Trench 46. The trench was aligned north-west / south-east, measured 50.5m by 2m, and was excavated to a maximum depth of 0.55m. It was located to investigate the suggested occupational activity indicated by the geophysical survey.

The topsoil **1559** extended throughout the trench and was 0.30m deep. Below the topsoil were four features, only two of which were manmade, a land drain at the eastern end, **1561** and a pit, **1593**, at the western end. The pit was circular in plan with gently curved sides and a flat base. The pit had an average diameter of 1.75m and was 0.35m deep. The pit had two fills; the uppermost **1591**, was a dark greyish brown sandy silt; while the lower one, **1592**, was a lighter greyish brown with 10-20% small, sub-angular stones, mostly towards the base, perhaps as a lining. This lower fill also contained a fragment of a jug handle dated to the fourteenth century. The function of the pit was unclear, it may have been a rubbish pit rather than a storage pit of some kind. The land drain, **1561** was aligned northeast / southwest and had a stoney grey fill, **1562**. Another feature, **1587**, measured 2.50m by 1.50m and was very irregular in plan with a shallow U-shaped profile. It contained two fills **1588**, the upper fill was a dark brown organic clay and **1589** below was a greyish clay. The feature was interpreted as a root hollow, infilled with waterlain deposits. There were also two features that appeared to be natural. One, **1563**, was roughly circular and extended slightly beyond the trench edges, both north and south and the second was a wide area. Both features were moderately shallow at about 0.40m deep and they contained similar fills of grey clayey silts and bands of brown organic matter, slightly peaty in nature. These deposits were both within slight depressions in the lowest part of the field. It is likely that these areas have always been subject to waterlogging and the deposits were consistent with water lain material. The brown peaty material probably results from either the inundation of vegetation by standing water or organic matter settling to the base of the standing water. The underlying drift geology **1560**, was a mid yellowish orange sand with 5% medium-sized, rounded stones throughout.

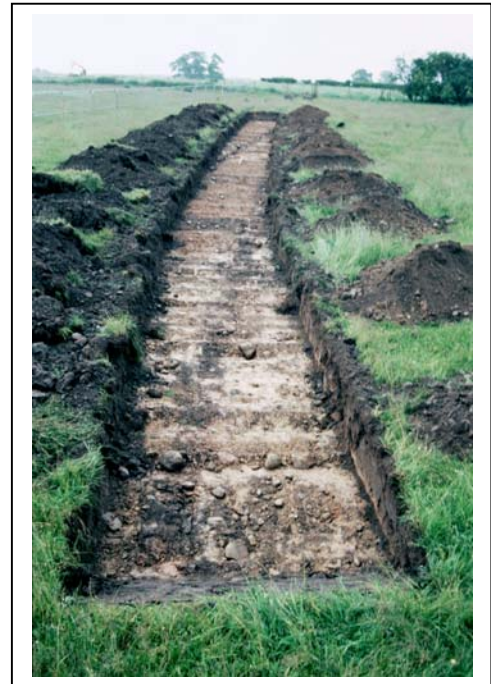
Looking west

Trench 48 was the sole trench located in Field 23. The trench measured 40m by 2m and was excavated to a maximum depth of 0.45m. It was aligned north-west / south-east and was located as part of the random sample.

The topsoil **1634** extended throughout the trench and was 0.20m deep. Below the topsoil were two features, **1641** and **1636**. Feature **1641** was aligned north-east / south-west, had vertical sides, a symmetrical profile and a flat base. It was 0.25 wide, with an overall depth of 0.24m. It had a single fill, **1642**, that was a greyish brown sandy clay. It was clearly a land drain and it truncated an earlier land drain, **1639**. The earlier land drain **1639** was at right angles to the later one. It ran along the length of the trench for over 17.5m and, in turn, it truncated an earlier feature **1643**. The feature was linear, aligned north / south and was 1.02m wide, 0.10m deep with a single fill, **1644**. The profile of the feature was a very broad W-shape. The fill, **1644**, was a mid grey silty sand and a single sherd of nineteenth century pottery was recovered from the upper part of the fill. The linear was a ditch, either a drainage ditch or an earlier field boundary ditch. A second discrete feature, **1636** at the eastern end was sub-square in plan and measured 0.75m by 0.65m and 0.32m in depth. It had vertical sides and a flat base. The feature was a small pit which contained a complete articulated sheep burial, **1638**, beneath a mid greyish brown sandy clay backfill, **1637**. The bone was in good condition suggesting a fairly recent date to the activity. The underlying drift geology **1635**, which was a mid brown orange sandy clay with 10%, small to medium sized, rounded stones throughout.

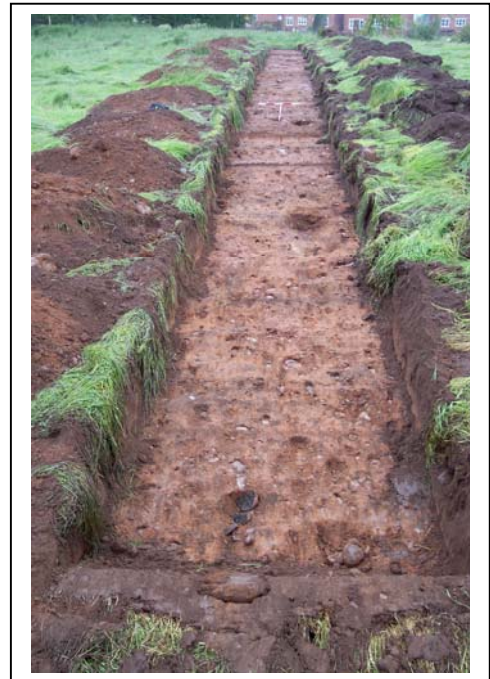
Looking north

Trench 49 was the sole trench located in Field 24. The trench measured 40m by 2m and was excavated to a maximum depth of 0.35m. It was aligned north / south and was targeted to investigate a linear trend orientated north-east / south-west.

The topsoil **1647** extended throughout the trench and was on average 0.30m deep. Below the topsoil were two features, **1709** and **1711**. The first, **1709**, measured 0.75m in length by 0.70m in width with a maximum depth of 0.27m. It was roughly circular with a smooth U-shaped profile. The feature was filled with, **1708**, which contained patches of grey silty sand, but was on the whole reddish to orange. There were two lenses of manganese within the fill and although the upper boundaries were clear they became more diffuse towards the base. The feature was consistent with a glacial / post-glacial infilled hollow. The second feature, **1711**, had overall dimensions of 0.50m by 0.38m, with a depth of 0.06m. It was oval in plan with an asymmetrical profile, filled with a dark greyish brown clayey silt, **1710**, similar to the subsoil above. Neither of the features showed any evidence of human origin and the second was interpreted as a stone throw. At the base of the revealed stratigraphic sequence in this trench, was the underlying drift geology **1648**. This was a mid pink clayey silt interspersed with mid orange silty sand with 10-20% small- to medium- sized, rounded stones throughout.

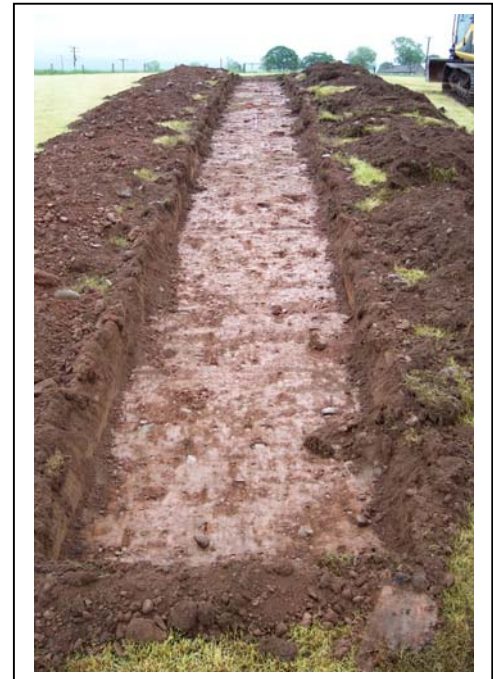
Looking north-east

Trench 50 was the sole trench located in Field 25. The trench measured 30m by 2m and was excavated to a maximum depth of 0.3m. It was aligned north-east / south-west and was targeted to investigate a possible linear trend.

The topsoil **1712** extended throughout the trench and was on average 0.30m deep. Below the topsoil was one linear feature **1721**. It measured 2.10m in length by 0.30m in width with a maximum depth of 0.12m. It was aligned north-west / south-east and had an irregular U-shaped profile. The feature was filled with, **1722**, which was a mid greyish brown silt. The central part of the feature was much more ephemeral due to the increased stoniness of the geology at that point. The feature was probably a plough scar. At the base of the revealed stratigraphic sequence in this trench, was the underlying drift geology **1713**. This was a mid pink clayey silt interspersed with bands of mid orange sand, almost certainly components of patterned ground.

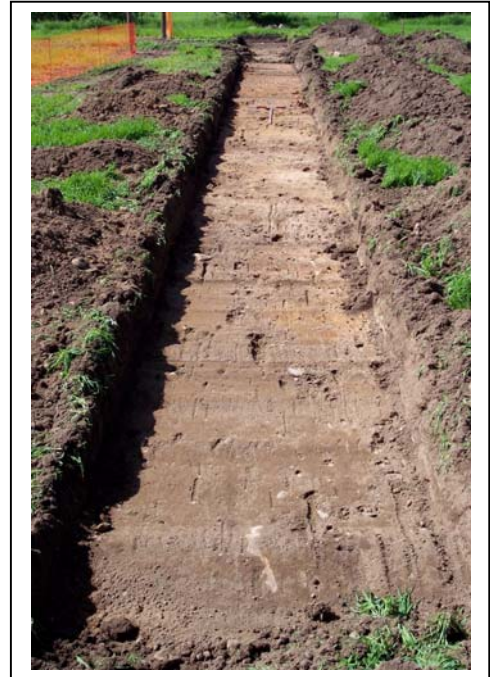
Looking south

Trench 51 was located in Field 26, along with Trenches 52 and 53. The trench measured 28.6m by 2m and was excavated to a maximum depth of 0.46m. It was aligned north / south and was located as part of the random sample Trench 51 was moved approximately 9m west of the original location in order to avoid excavating under an overhead cable. Since the original aim of the trench was as a random sample it was possible to move the trench with no impact on the evidence being sought.

The topsoil **1584** extended throughout the trench and was on average 0.46m deep. Below the topsoil were three features, **1610**, **1612** and **1608**. Feature **1608** was a linear aligned roughly north / south at the north end of the trench. It was 1.67m wide and 0.28m deep and had a very gradual and shallow U-shaped symmetrical profile that contained two fills. The upper fill, **1586**, was a 0.18m thick, mid greyish brown silty sand with a small proportion of small rounded stones. The lower fill, **1607**, was a 0.10m thick, pale yellowish grey sand that probably the primary fill. This fill also contained one very large boulder. The upper fill **1586**, contained two sherds of mid to late eighteenth century pottery indicating that the ditch was infilling at that time. The feature was interpreted as a ditch and was probably the southern continuation of ditch **1570** in Trench 52. Feature **1610** had overall dimensions of 0.85m by 0.50m by 0.18m. It was irregular in plan with an uneven, asymmetrical profile. The fill, **1609** was a reddish brown sandy silt. South of this was feature **1612**, which was also irregular in shape and profile, and measured. 0.60m by 0.55m by 0.08m. The fill, **1611** was also a reddish brown sandy silt and both features were probable root disturbances. The underlying drift geology **1585** was a yellowish orange sand at the northern end and changed to a reddish orange clay at the southern end.

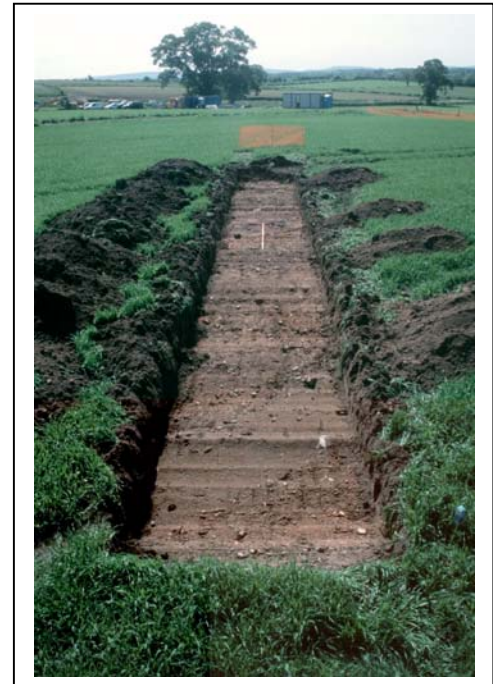
Looking south-east

Trench 52 was located in Field 26, along with Trenches 51 and 53. The trench measured 30m by 2m and was excavated to a maximum depth of 0.62m. It was aligned north-west / south-east and was located to target a well defined linear response and weak linear trends seen in the geophysical survey.

The topsoil **1566** extended throughout the trench and was on average 0.30m deep. Below the topsoil were six features, **1602**, **1604**, **1606**, **1614**, **1568** and **1572**. Feature **1568** was a north / south aligned linear feature that measured 0.60m in width and 0.31m in depth. It had vertical sides and a flat base. The fill, **1569**, was a mottled pink silty clay. The feature was a land drain. Feature **1572** was another north / south aligned linear land drain, located west of **1568**. It measured 0.52 in width and 0.38m in depth and had vertical sides and a flat base. The fill, **1573**, was a mid pink silty clay. Land drain **1572** truncated an earlier ditch, **1570**. It was 0.98m wide and 0.32m deep and aligned north / south. It had a broad U-shaped profile, disturbed along the western side by the land drain. The fill of the ditch, **1571**, was a mid grey sandy silt that contained a small fragment of clay tobacco pipe, dating the infilling of the ditch to the seventeenth century or later, although the origin of the ditch itself is earlier. Feature **1602** had overall dimensions of 0.60m by 0.55m by 0.19m. It was oval in plan with a symmetrical U-shaped profile. The fill, **1601** was a brown sandy silt. To the west of this was feature **1604**, which was also oval in shape but had an asymmetrical profile, and measured 0.63m by 0.40m by 0.15m. The fill, **1603** was also a greyish brown sandy silt. Feature **1606**, measured 0.85m by 0.73m by 0.30m. The cut / interface was roughly oval with an asymmetrical, U-shaped profile, more gentle on the northwestern side. The fill, **1605**, was mid brownish grey with orange sand patches. Feature **1614**, the western most of the cluster, had overall dimensions of 1.12m by 0.58m by 0.35m and was roughly oval in plan. The profile was asymmetrical and the fill, **1613** consisted of a mottled dark blackish grey sandy silt with paler grey and orange patches. With all the features there was no evidence of human origin and they were probable root disturbances, perhaps with material decaying in situ resulting in darker fills, or infilled stone throws. The underlying drift geology **1567** was a yellowish orange sandy silt, with 10% small stones throughout.

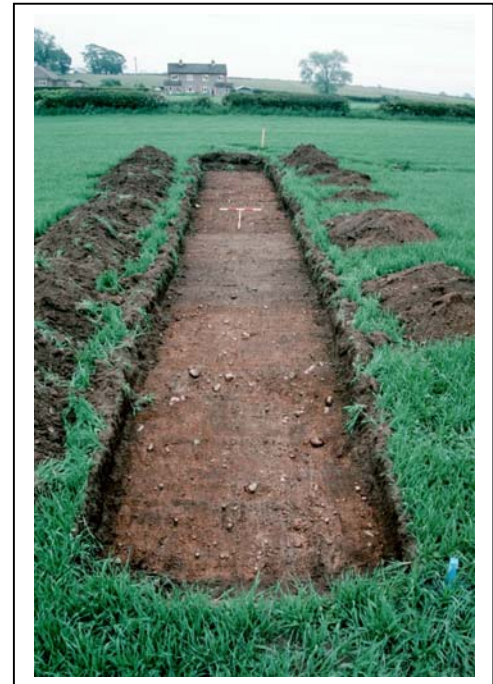
Looking east

Trench 53 was located in Field 26, along with Trenches 51 and 52. The trench measured 18m by 2m and was excavated to a maximum depth of 0.4m. It was aligned north-west / south-east and was located to target weak rectangular anomalies seen in the geophysical survey.

The topsoil **1615** extended throughout the trench and was on average 0.32m deep. Below the topsoil were three features, **1617**, **1619** and **1621**. Feature **1617** was a linear aligned roughly northeast / southwest at the western end of the trench. It was 2m wide and 0.50m deep and had a very gradual shallow V-shaped symmetrical profile that contained a single fill, **1618**. The fill, **1618**, was a dark brown silt with a small proportion of small rounded stones. The feature was interpreted as a ditch and was probably the northern continuation of ditch **1570** in Trench 52. Feature **1619** was circular in plan with a diameter of 0.20m and a depth of 0.20m. It had an even, symmetrical U-shaped profile. The fill, **1620** was a blackish brown gritty sand. Near this was a very similar feature **1621**, also circular in plan with a diameter of 0.18m and a similar depth of 0.21m. The fill, **1622** was also a blackish brown gritty sand and both features were interpreted as possible post holes, although not associated with the ditch. The underlying drift geology **1616** was a pinkish orange sand with gritty patches throughout.

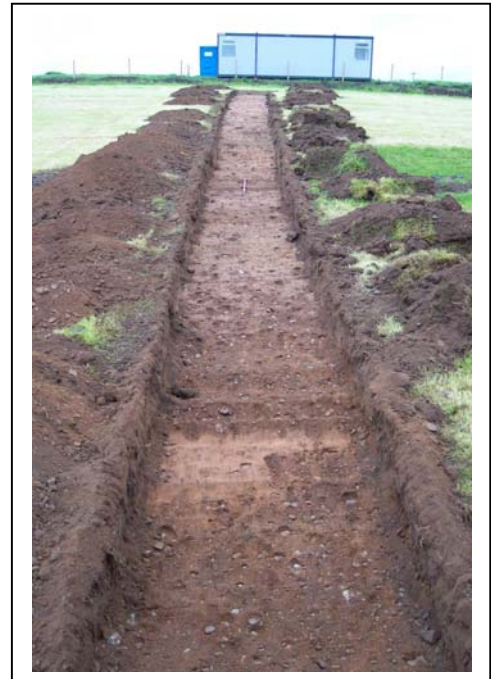
Looking north

Trench 54 was located in Field 28. It measured 40m by 2m and was excavated to a maximum depth of 0.45m. The trench was aligned north-east / south-west and was located as a topographic situation with the potential for previously unknown activity.

The topsoil **1645** extended throughout the trench and was 0.40m deep. Beneath the topsoil and truncating the natural was a single feature **1707**. The feature measured 0.50m in length by 0.28m in width with a maximum depth of 0.03m. In plan **1707** was oval and in section it had a broad, shallow U-shaped profile with irregular sides and a gently concave base. The feature was filled with, **1706**, a dark brown silt. Despite the regular and clear boundaries in plan the feature was almost certainly a stone throw rather than the base of an anthropogenic feature. Underlying this was the drift geology **1646**, which was a mid orangey brown sandy clay, which changed to a sandy gravel towards the lower southern part of the trench, probably as a result of colluvial activity.

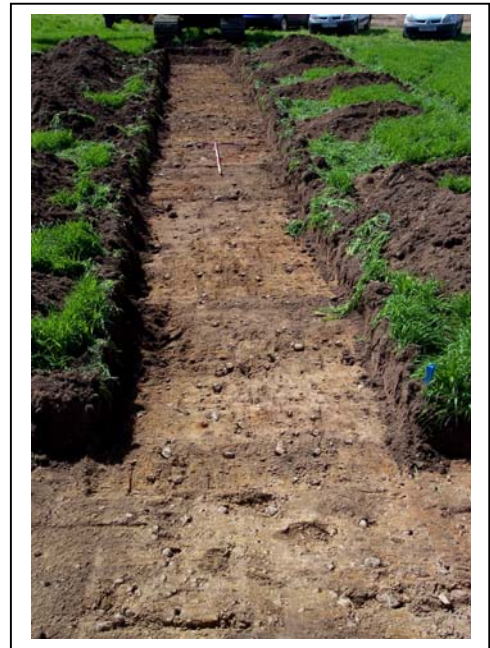
Looking south

Trench 55 was located in Field 27. The trench was L-shaped and measured 15m by 2m in an east / west direction and 18.5m by 2m in a north / south direction. It was excavated to a maximum depth of 0.4m. The trench was targeted to investigate a cluster of anomalies highlighted in the geophysical survey. The anomalies were suggested to be a hearth or modern dumps.

The topsoil **1574** extended throughout the trench and was 0.35m deep. Below the topsoil were five linear features, **1577**, **1579**, **1581**, **1583** and a fifth unexcavated land drain, all extended beyond the confines of the trench. Feature **1577** was orientated north-west / south-east and measured 0.34m wide by 0.24m deep. It had a symmetrical profile with straight sides and a flat base. The fill, **1576** was 70% small to medium stones which showed variation in type and size. The feature was a stone-packed land drain. Feature **1579**, was aligned north-east / south-west, measured 0.45m wide by 0.72m deep with a symmetrical profile; straight-sided and flat-based. The fill, **1578** was a highly mixed, compact, clayey sand. Despite the lack of a ceramic drain the feature was still consistent as land drain. The third linear below the topsoil, **1583** was orientated north-east / south-west, measuring 0.44m wide by 0.20m deep with a symmetrical U-shaped profile. The fill, **1582** was 50% small to medium stones, deliberately packed. The feature was a stone-packed land drain. Land drain **1579** truncated an earlier linear feature, **1581**, aligned north-east / south-west and measured 0.50m wide by 0.12m deep. It had a broad, asymmetrical U-shape with only one fill, which had been disturbed along the eastern side by the land drain, **1579**. The fill, **1580**, was a mid greyish brown silty sand with minute fragments of clinker and ceramic building material. Neither could provide clear dating. There were clear boundaries with the underlying drift geology **1575**, which was a stoney, mid brownish orange sand. There was also a fourth land drain, 2.5m west of **1583**, aligned north / south.

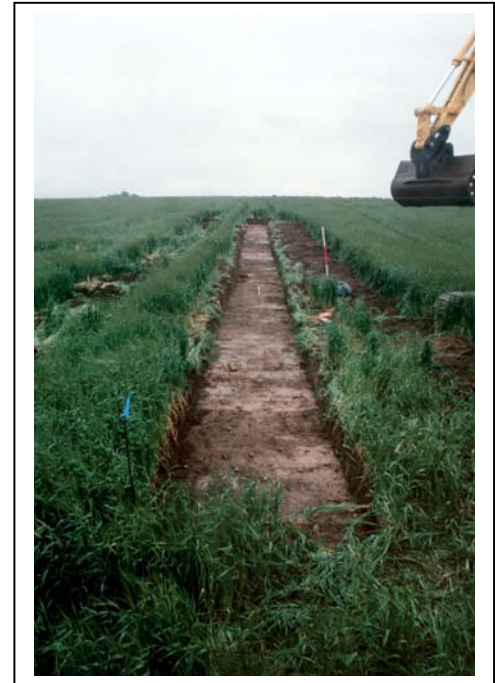
Looking east

Trench 56 was located in Field 29, along with Trenches 57, 58 and 59. It measured 4m by 1.9m and was excavated to a maximum depth of 0.48m. The trench was aligned north-west / south-east and was targeted to investigate linear trends, aligned north-east / south-west, recorded in the geophysical survey. The trench was also in a location adjacent to potential Roman activity.

The topsoil **1500** extending throughout the trench, was 0.2m deep. It had a diffuse boundary with the underlying subsoil, **1501**, which varied from 0.2 to 0.4m thick. Below the subsoil were two linear features, **1516** and **1519**, both on a north/south alignment. Feature **1516** lay to the west of **1519**, and was 0.19 wide by 2.05m long, with an overall depth of 0.69m. It had two fills, the upper fill was an orangey pink clayey silt, **1517**, (0.49m thick) and below this was a mid greyish brown sandy silt, **1518** (0.2m thick). The cut **1516** had vertical sides, a symmetrical profile and a flat base with sharp breaks of slope. Feature **1519** contained two fills, the upper fill, **1520**, was an orangey pink clayey silt and 0.33m thick (the same as **1517**); while the lower fill **1521**, was a 0.12m thick mid greyish brown sandy silt, with stones at the base to aid drainage. Features **1516** and **1519** were both land drains. Within the trench there was one other linear feature with an identical fill and on the same alignment. Although it was not excavated it was also identified as a land drain.

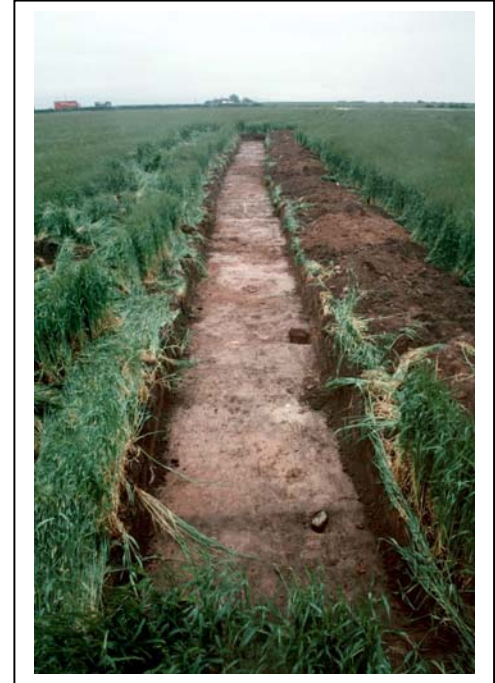
Looking east

Trench 57 was located in Field 29, along with Trenches 56, 58 and 59. It measured 4m by 2m and was excavated to a maximum depth of 0.5m. The trench was aligned north-west / south-east and was targeted to investigate a linear trend recorded in the geophysical survey. The trench was also in a location adjacent to potential Roman activity.

The topsoil **1503** extending throughout the trench, was 0.2m deep. It had a diffuse boundary with the underlying subsoil, **1504**, which was also 0.2m thick. Below the subsoil was a linear feature **1506**, 0.5m wide, which extended 2m across the trench, on a north/south alignment and had a total depth of 0.6m. The feature contained three fills. The uppermost fill, **1507**, was a brownish orange silty sand, below this was **1508**, a dark grey silty sand and finally at the base of the feature was a packed deposit of subangular stones, **1509**, no more than 0.1m thick. The cut, **1506**, had vertical sides, a symmetrical profile and a flat base with sharp breaks of slope. Feature 1506 was a land drain. Within the trench there were two other linear features with identical fills and on the same alignment. Although they were not excavated they could easily be identified as land drains. No dating evidence was recovered from the trench.

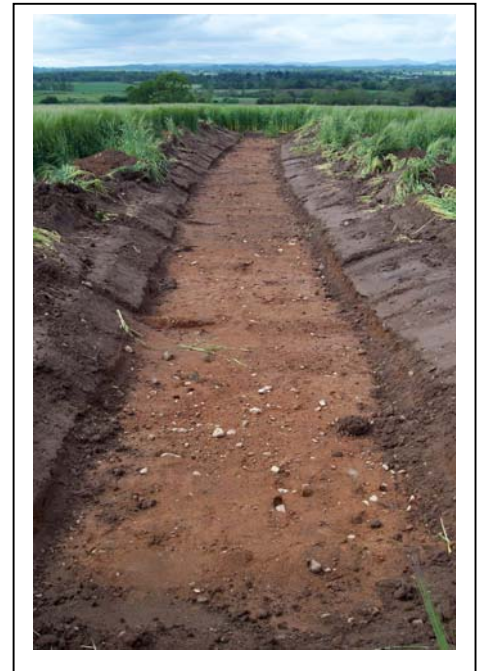
Looking south

Trench 58 was located in Field 29, along with Trenches 56, 57 and 59. It measured 45m by 2m and was excavated to a maximum depth of 0.45m. The trench was aligned north-east / south-west and was targeted to investigate curvilinear trends recorded in the geophysical survey. The trench was also in a location with some potential for uncovering Roman activity, due to its proximity to the Roman road alignment.

The topsoil **1522** extending throughout the trench was 0.45m deep. Below the topsoil was a linear feature **1718**, 0.48m wide and extending 2.3m across the trench, on a north/south alignment. The feature was filled with a mid pinkish clayey silt **1717**. The feature was identical to several others that had been excavated within this field, in Trenches 56 and 57. Thus although **1718** was not excavated, it was identified as a land drain. Land drain **1718**, truncated an earlier, linear ditch feature, **1513**, which was 1.5m wide by over 2.12m long and was aligned east/west. The uppermost truncated fill, **1513** was a light brownish grey, sandy silt and was concentrated along the north-west side of the feature. Below this was a mid orangey grey, sandy clay fill, **1514**. Both fills contained a small proportion of stones but no dating evidence. The cut **1515**, was slightly asymmetrical, with an overall broad, shallow U-shaped profile.

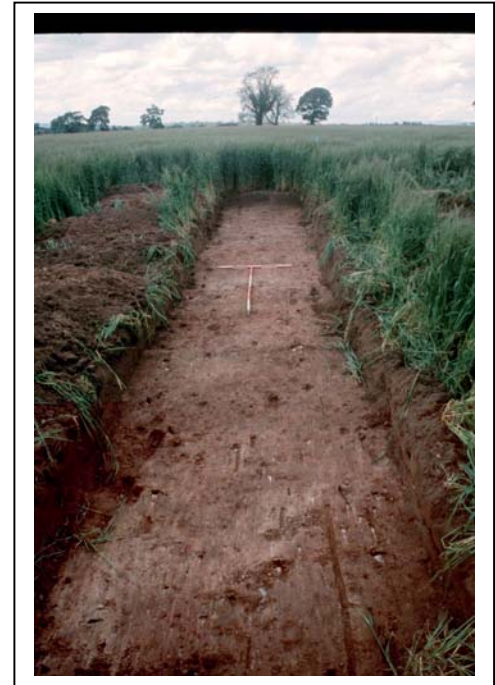
Looking north

Trench 59 was located in Field 29, along with Trenches 56, 57 and 58. It measured 12m by 2m and was excavated to a maximum depth of 0.3m. The trench was aligned north-west / south-east and was targeted to investigate the projected line of a possible trackway, orientated north-east / south-west.

The topsoil **1510** extended throughout the trench and was 0.2m deep. It had a diffuse boundary with the underlying subsoil, **1511**, which was 0.1m thick. This directly overlay the drift geology **1512**. There was no evidence of any trackway within the trench.

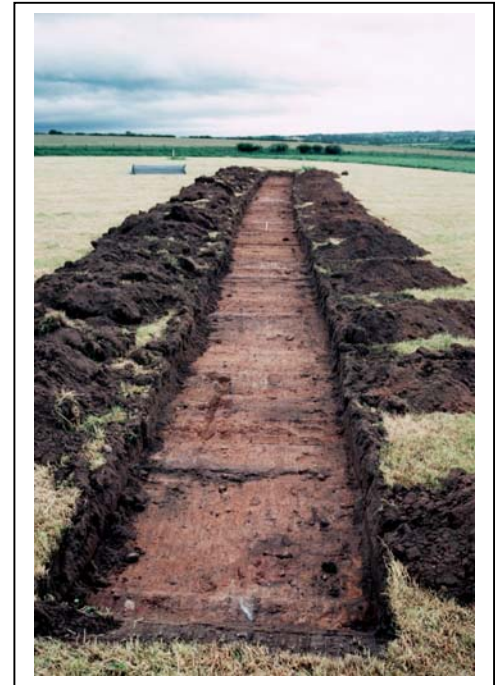
Looking south-east

Trench 60 was the sole trench located in Field 30. It measured 43.5m by 2m and was excavated to a maximum depth of 0.4m. The trench was aligned north-west / south-east and was targeted to investigate linear and pit-type anomalies recorded in the geophysical survey as well as being adjacent to an area of potential Roman activity.

The topsoil **1524** extended throughout the trench and was 0.30m deep. Below the topsoil was a linear feature, **1528**, aligned north-west / south-east and measuring 1.8m long by 0.30m wide, with an overall depth of 0.8m. The feature had vertical sides and a flat base. It had two fills, the upper fill, **1526**, being a reddish brown sandy clay, 0.30m thick and the lower fill, **1527**, was a dark greyish brown silty sand. The feature was a land drain and there was a second located 2.5m to the east. Land drain **1527** truncated an earlier natural feature **1530**. Feature **1530** was 0.40m by 0.20m by 0.10m deep with an irregular shape in plan and profile. It was filled by **1529**, a dark greyish brown silty sand. The feature was interpreted as a stone throw. The drift geology **1525** was a mid orangey brown sandy clay. There was no evidence of any trackway within the trench.

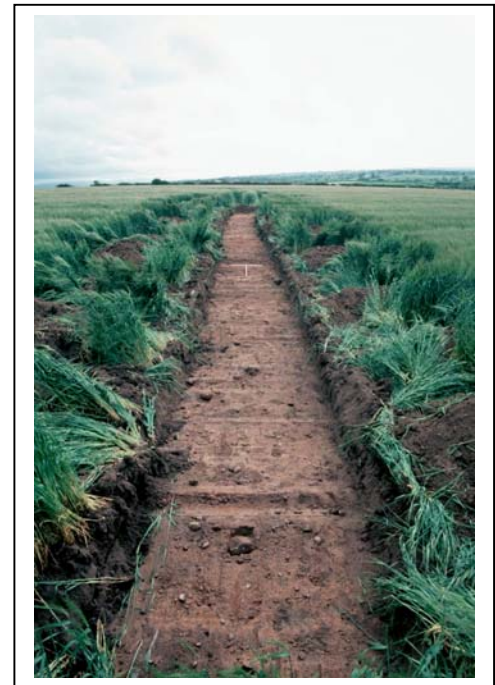
Looking east

Trench 61 was located in Field 31, along with Trench 62. It measured 37.5m by 1.9m and was excavated to a maximum depth of 0.4m. The trench was aligned north-west / south-east and was targeted to investigate rectilinear anomalies recorded in the geophysical survey as well as being adjacent to an area of potential Roman activity.

The topsoil **1541** extended throughout the trench and was 0.4m deep. It had a clear boundary with the underlying drift geology **1542**, which was a moderately stoney, sandy clay. There was no evidence of any features within the trench.
