A66 Temple Sowerby Bypass and Improvements at Winderwath

Topographic Survey, Evaluation and Watching Brief Report

Oxford Archaeology North

August 2005

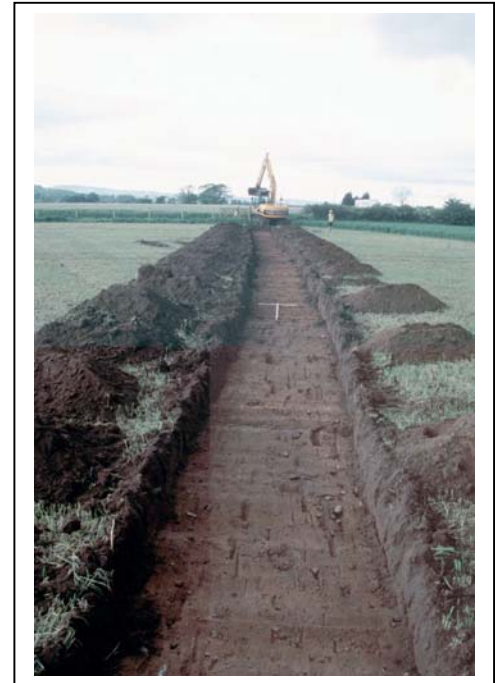
Looking north-west

Trench 63 was the sole trench located in Field 32. It measured 50m by 2m and was excavated to a maximum depth of 0.4m. The trench was aligned north-west / south-east and was targeted to investigate a linear anomaly, orientated north / south, a curvilinear trend in the geophysical survey and the projected line of a possible earthwork to the north-east, as well as being adjacent to an area of potential Roman or later activity, such as that which maybe associated with the medieval message of Spitals.

The topsoil **1539** extended throughout the trench and was 0.4m deep. Below the topsoil were two features. The first, **1532**, was roughly circular and 0.3m in diameter, with a shallow U-shaped profile only 0.06m deep. It was filled by **1533**, a mid greyish brown clayey sand. The feature was probably the result of a stone throw or root disturbance. The feature was not associated with any others. The second feature in this trench was a vaguely linear concentration of cobbles / stones, **1531**, which was aligned north-east / south-west. The stones varied in size from 0.03m to 0.2m and were concentrated in the central part dispersing to either side. The feature appeared to be a natural band of stones within the drift geology but could have been the base remains of a ploughed-out cobble land drain. There was a clear boundary with the underlying drift geology **1540**, which was a sandy clay with occasional stones.

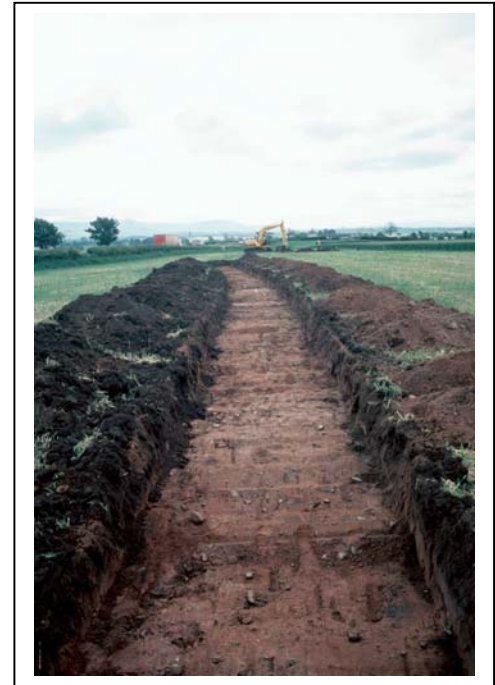
Looking north-east

Trench 64 was located in Field 33, along with Trenches 65 and 66. It measured 50m by 1.85m and was excavated to a maximum depth of 0.45m. The trench was aligned north-west / south-east and was targeted to investigate the projected line of cropmarks as well as being adjacent to an area of potential Roman or later activity, such as the medieval message of Spitals.

The topsoil **1545** extended throughout the trench and was 0.4m deep. Below the topsoil was a single feature, **1547**. It was roughly circular and 0.45m in diameter, with a slightly irregular U-shaped profile 0.18m deep. The fill, **1548**, was mid reddish brown grey, clayey sand which had some darker mottling throughout and white flecking. It was suggested that the material may have been burnt. The feature was not associated with any others and there was no evidence to show that it was a manmade feature. There was a clear boundary with the underlying drift geology **1546**, which was a sandy clay with occasional large stones.

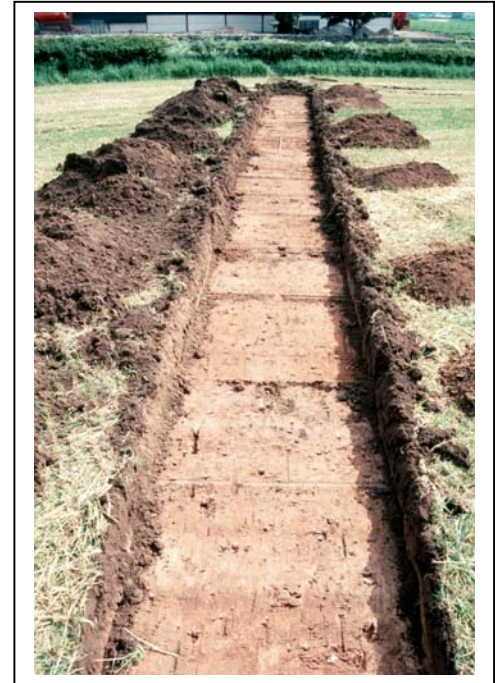
Looking north

Trench 65 was located in Field 33, along with Trench 64 and 66. It measured 24m by 2m and was excavated to a maximum depth of 0.45m. The trench was aligned north-west / south-east and was targeted to investigate linear and pit-type anomalies, as well as being adjacent to an area of potential Roman or later activity, such as the Roman road or the medieval message of Spitals.

The topsoil **1551** extended throughout the trench and was 0.4m deep. Below the topsoil was a single feature, a linear ditch aligned roughly north / south in middle of the trench. The ditch, **1550** was 1.51m wide and 0.48m deep. It had a gradual and shallow U-shaped symmetrical profile and contained one fill. The fill, **1549**, was a mid reddish brown silty sand with occasional flecks of what appeared to be charcoal. There was a clear boundary with the underlying drift geology **1552**, which was a sandy clay with occasional large stones.

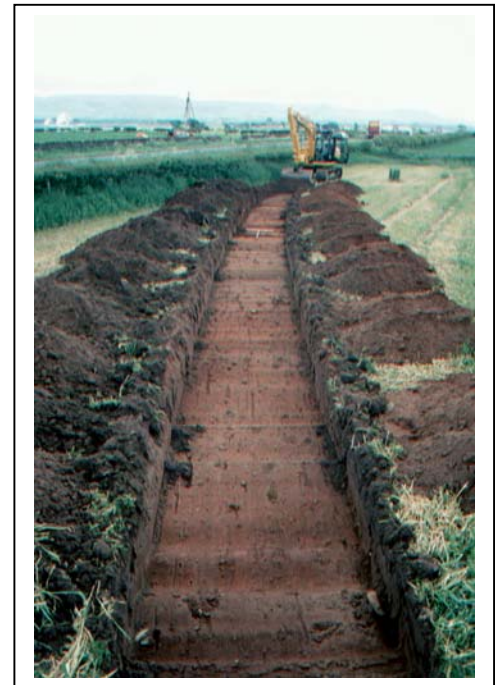
Looking north-east

Trench 66 was located in Field 33. It measured 30m by 2m and was excavated to a maximum depth of 0.64m. The trench was aligned north-west / south-east and was targeted to investigate an area of increased magnetic response, highlighted in the geophysical survey, as well as being adjacent to an area of potential Roman activity, associated with the Roman road.

The topsoil **1553** extended throughout the trench and was 0.36m deep. Below the topsoil at the eastern end of the trench was a spread of material, **1555**. It was quite extensive and appeared to be filling the gentle depression left as the final phase of the ditch and showed the edge of the ditch clearly on the western side. It extended as far as the eastern end of the trench, almost forming a layer, 0.12m thick, sealing the ditch rather than being the uppermost fill. Notably, it contained 2-5% small mortar fragments, one piece of clinker and a single highly abraded rim fragment of Romano-British oxidised pottery. Below this was **1556**, a mid brown sandy silt, 0.34m thick fill that was slightly thicker towards the west side of the ditch. The fill beneath that was **1557**, a dense deposit of small to medium rounded cobbles. The deposit sloped slightly downwards north-east to south-west. The cobbles appeared to be a deliberate deposit within the ditch perhaps made to level the area. At the very base of the ditch was the earliest deposit in the ditch, **1590**. This fill was a pale brownish grey sandy silt which was 0.45m thick on the eastern side but shallower on the western side. This deposit may represent the initial silting of the ditch and was probably a water borne deposit. The ditch cut, **1558**, was aligned north/south, and measured 3.4m wide and 0.86m deep. It had a symmetrical, broad U-shaped profile with a flat base. A possible recut was identified on the western side as a step in the profile but it was slightly tenuous.

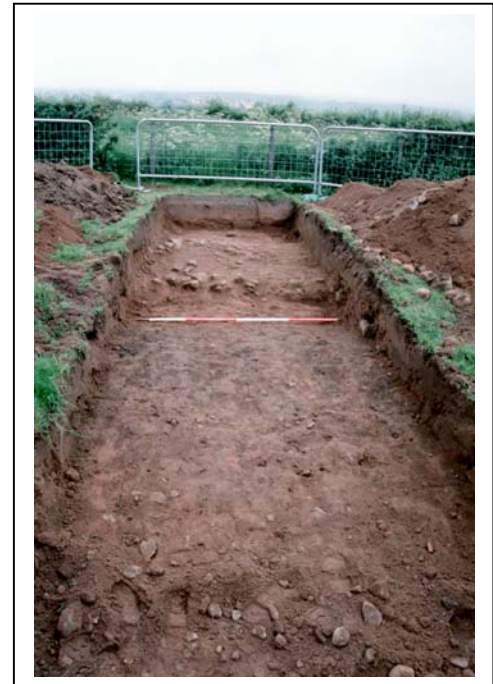
Looking south

Trench 67 was located in Field 34. It measured 8m by 2m and was excavated to a maximum depth of 0.76m. The trench was aligned north-east / south-west and was targeted to investigate a slight earthwork running parallel to the A66.

The topsoil **1657** extended throughout the trench and was 0.2m deep, below this was a mid reddish brown 0.1m thick subsoil **1658**. At the southern end of the trench, was a deposit of moderately concentrated small to medium rounded stones, **1660**. The 0.12m thick, deposit extended into the trench for 3.5m and east and west, beyond the limits of excavation. The layer of cobbles undulated slightly and was fractionally lower at the south end. Although not highly concentrated, it did appear to form an external surface, but it was not possible to determine its function. Below this was a mid brownish grey sandy silt layer, **1662**, the darker colouration suggested possible organic content. The layer covered the same area as the cobble spread above and varied in thickness from 0.1m to 0.3m. The boundaries of this horizon were somewhat diffuse and small rootlets were visible throughout. The layer may have been an earlier layer of vegetation onto which the cobbles were laid or could represent some form of soil process such as localised leaching. Towards the north end of Trench 67 a similar deposit, **1661**, was uncovered. The two deposits could potentially be the same but there was a distinct break across the trench between the two, which may have resulted from some later interference. Aside from that possibility the deposit itself was a dark brownish grey sandy silt, which appeared to have an organic content. The layer was 2.4m wide, 0.3m thick and continued east and west beyond the trench edges. Although the boundaries were somewhat diffuse this layer seemed to be forming a slight bank. The deposit certainly appeared to have had some element of vegetation involved in its formation due to the darker colouration of it. It may have been an earlier turf line or a possible hedgerow. **1659** was the natural drift geology, exposed in the sondage.

- 9.2.13 **Roman activity:** no definitive evidence was found of Roman features along the route of the scheme. The cobbled surface uncovered in Trench 67, immediately north of the current A66 has the potential to be part of the Roman road, but no dating material was recovered and the surface cannot be determined as Roman. The only Roman finds recovered were three abraded fragments of Romano-British oxidised wares. The sherds were undiagnostic and neither the vessel form nor the date could be recovered. Two came from the subsoil in Trench 44, 1624, and one from an uppermost ditch fill, 1555, in Trench 66.

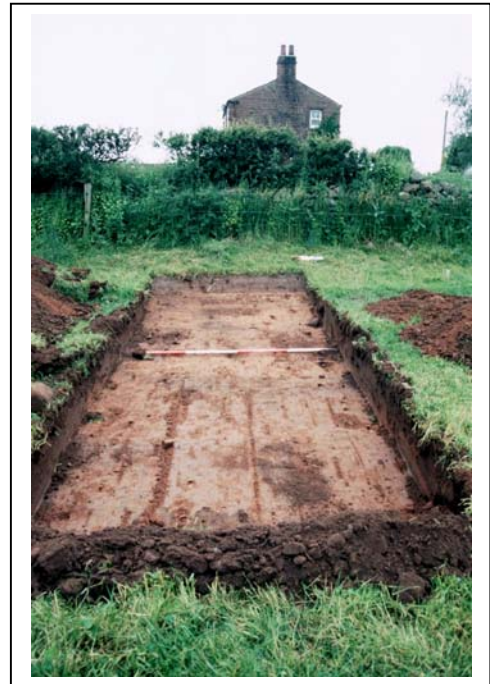
Looking south

Trench 68 was located in Field 35. It measured 5.5m by 2m and was excavated to a maximum depth of 0.3m. The trench was aligned north-east / south-west and was targeted to investigate an area of potential Roman activity associated with the Roman road.

The topsoil **1653** extended throughout the trench and was 0.32m deep. Below the topsoil were two features. The first, **1656**, was an amorphous feature 0.6m by 0.4m, with an undulating shallow asymmetrical profile only 0.08m deep. It was filled by **1655**, a dark greyish brown silty sand. The feature was the result of root disturbance. The second feature in this trench, to the north of **1656**, was a narrow linear, **1652**, aligned east / west. The linear measured 0.4m wide by 0.1m deep and extended beyond the trench edges. The profile was a symmetrical U-shape with gradual breaks of slope and a concave base. The feature lined up with a current depression in the field that was orientated towards a field gate. The feature was interpreted as a wheel rut. There was a clear boundary with the underlying drift geology **1654**, which was a mid brownish orange sand with a gravelly component.

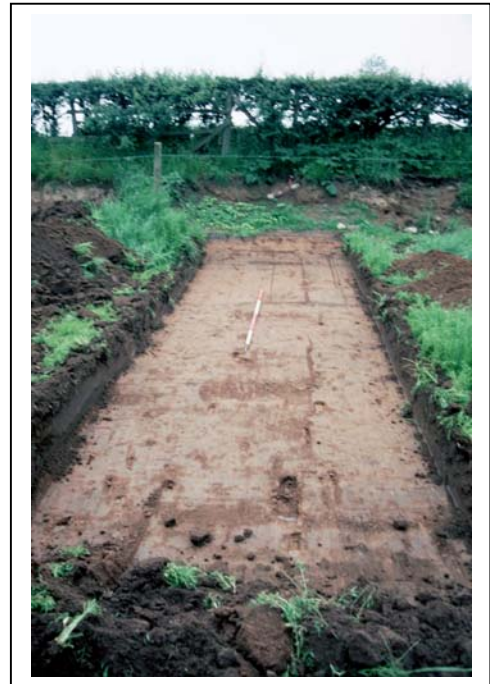
Trench 69 was located in Field 36. It measured 7.5m by 2m and was excavated to a maximum depth of 0.28m. The trench was aligned north-east / south-west and was targeted to investigate the extension of the trackway and linear earthworks visible on aerial photographs in addition to the potential for Roman activity associated with the Roman road.

The topsoil **1649** extended throughout the trench and was 0.28m deep. There was a clear boundary with the underlying drift geology **1650**, which was a mid brownish orange sand with a gravelly component. There were no identifiable features within the confines of the trench.
