# The Floral Pavilion, New Brighton Wirral

## Archaeological Building Assessment

**November 2007**

**Tweeds Construction  
Consultancy**

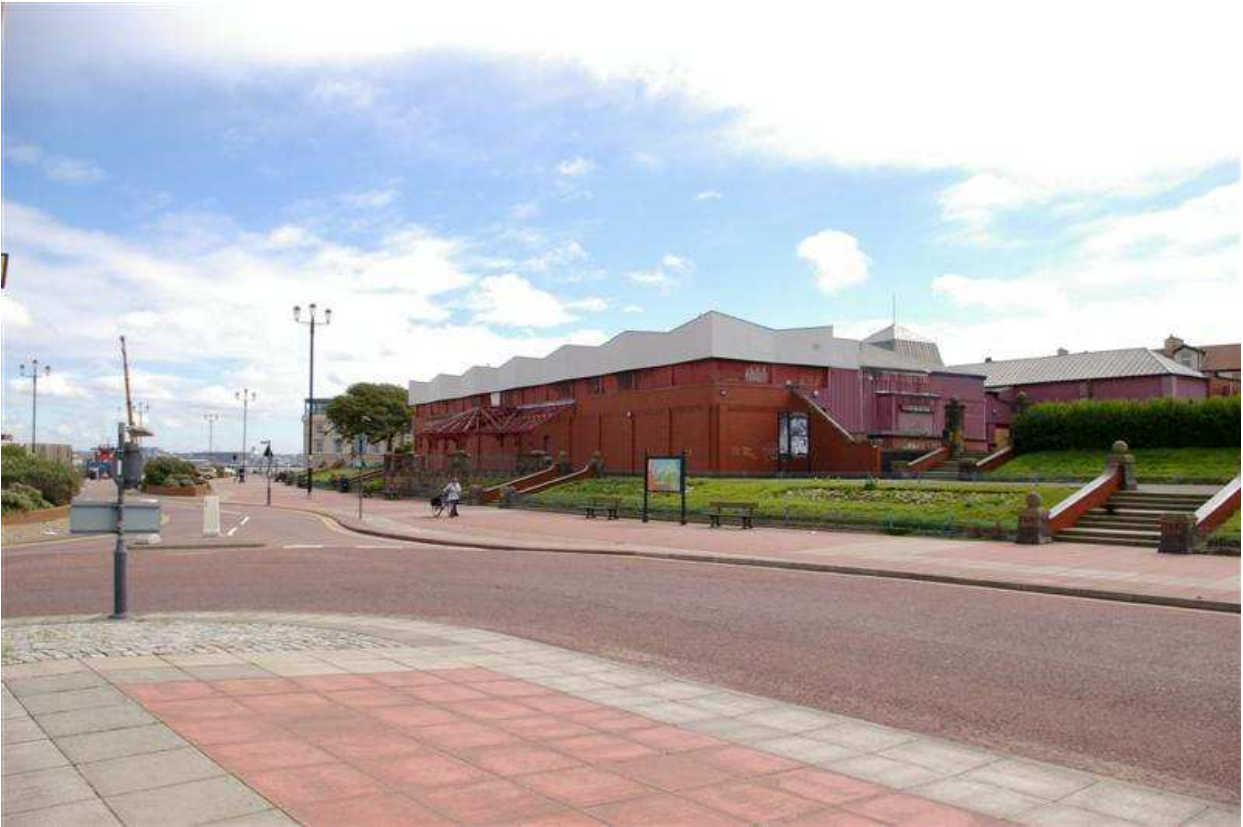
Plate 1: General view of the front of the Floral Pavilion

- 3.1.1 The Floral Pavillion is situated on the sea front (SJ 310 941) at New Brighton, with the front of the building facing Marine Promenade (Plate 1, Fig 1). The site lies on level ground and is approximately 5m OD.
- 3.1.2 The solid geology of the area comprises Permian and Triassic sandstones. The drift deposits are predominately Till and blown sand ([www.bgs.ac.uk](http://www.bgs.ac.uk)).

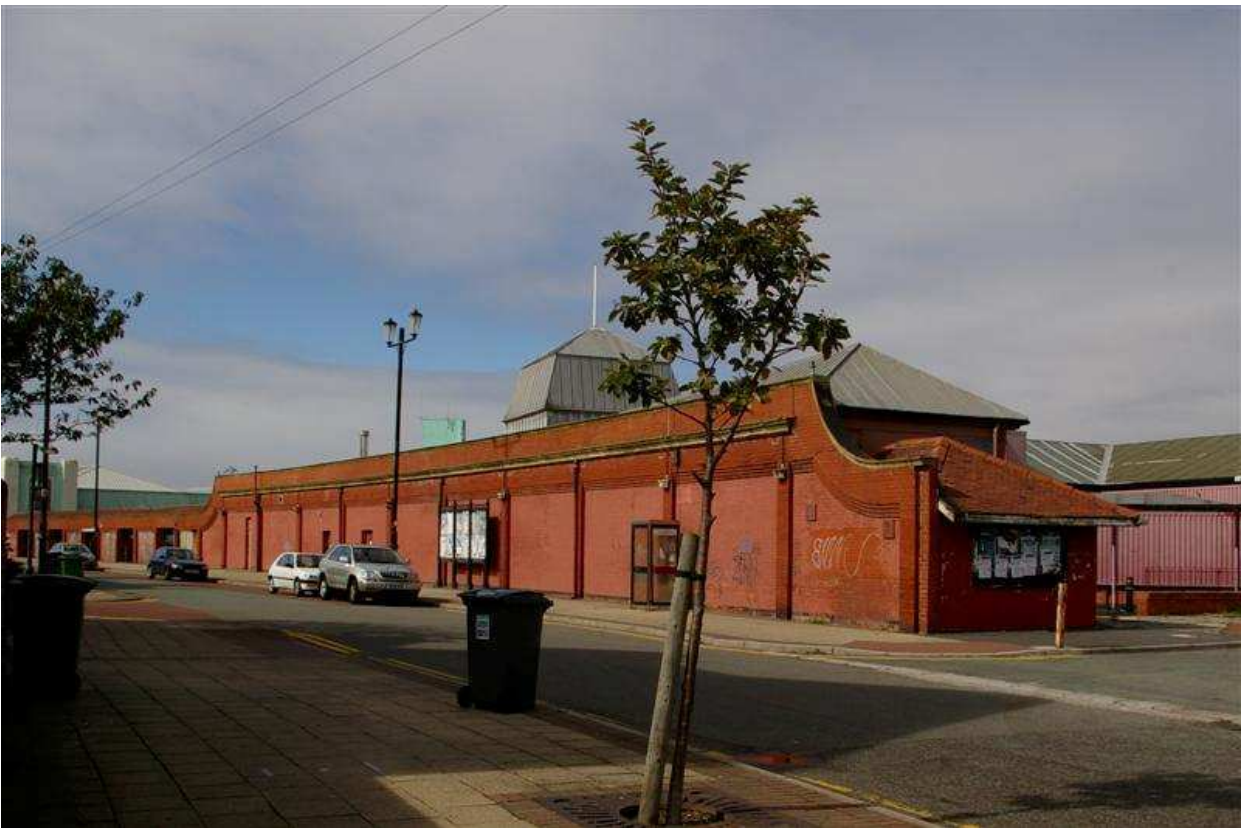
Plate 2: General view of the rear of the Floral Pavilion

- 4.2.11 The south elevation of the pavilion is similar in detail to the north elevation but appears to be earlier in date (Plates 2 and 6). It is of brick construction, which is laid in English garden wall bond. It follows the curve of Virginia Road. There are eleven blind bays, three of which contain blocked or boarded doors. There is a sandstone drip-mould and sandstone coping stones over a low parapet. A small brick-built outshut is attached to the eastern end (Plate 3), and is roofed with modern tiles.

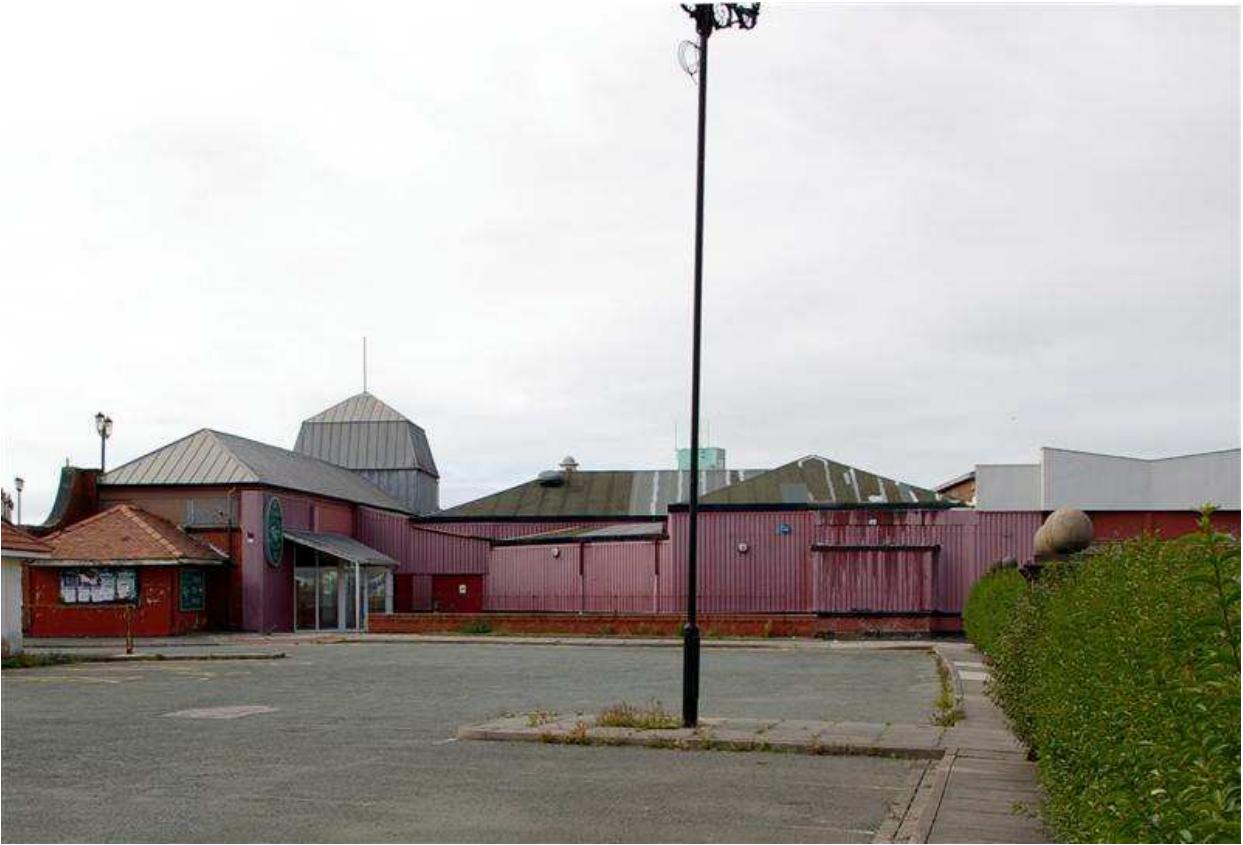
Plate 3: View of the east-facing elevation

- 4.2.2 The most recent main access into the building was via a glass outshut built against the north elevation of the east ‘wing’ (Plate 3). Current access to the building is via a fire escape located in the east elevation. A terrace with a stone balustrade and cast-iron canopy is present at the north of the building. This is accessed via stone steps from Marine Promenade (Plate 4).

- 4.2.6 Both the east and west elevations of the auditorium and the north elevations of the projecting wings are clad with pressed steel sheets (Plate 3). The lower parts of the walls are brick with sandstone coping.

- 4.2.10 The east elevation of the auditorium is confused and comprises various smaller projections and extensions (Plate 3). The southern end of the elevation is identical in construction to the north elevation of the pavilion. The remainder of the wall is clad with pressed steel sheeting, and this rests on a low brick wall with sandstone coping. The west elevation is treated in a similar manner.

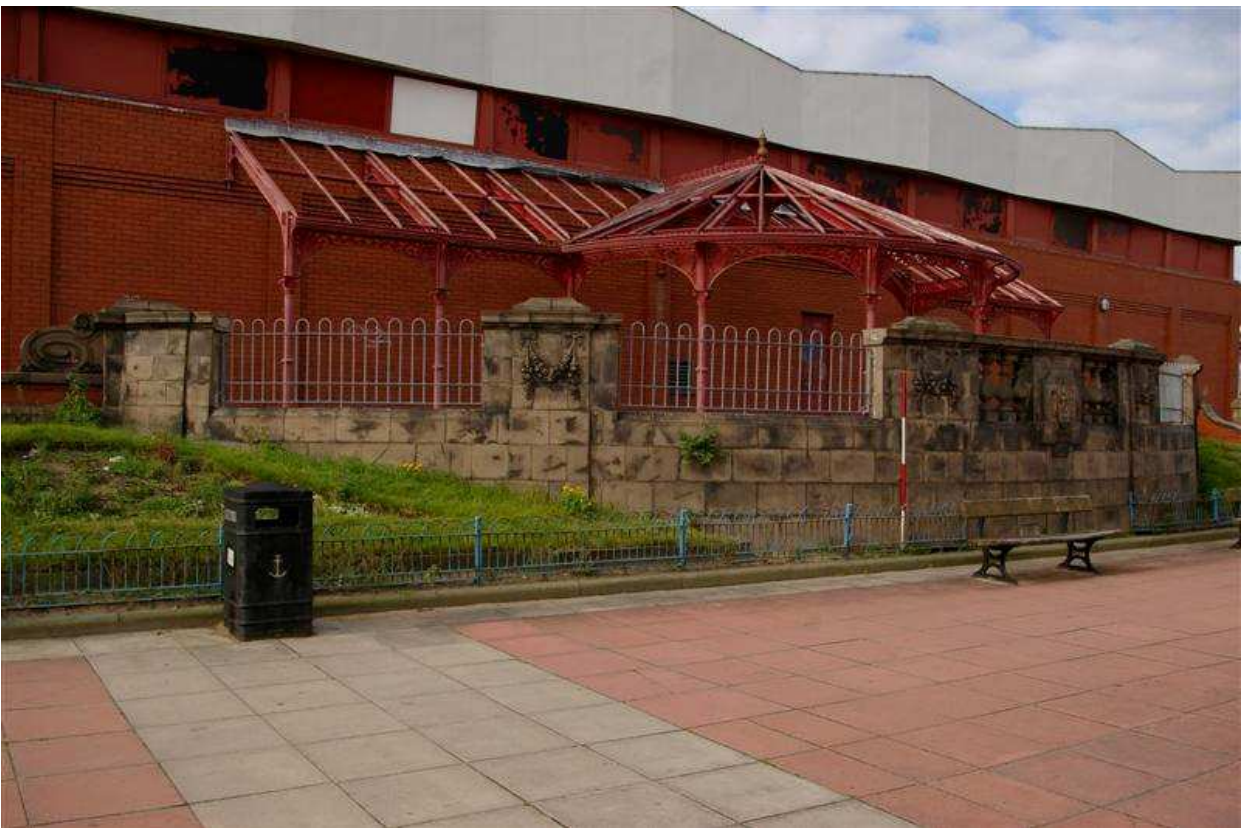
Plate 4: Terrace and cast iron canopy

- 4.2.5 The walls and balustrade of the terrace at the front of the building are constructed from grey/yellow sandstone ashlar blocks (Plate 4). Some of the balustrading has been replaced with metal fencing. Retaining walls and steps at the front of the building are of brick with sandstone copings and sandstone ball finials. The canopy is of cast-iron.

- 5.1.3 **Victoria Gardens:** the cast-iron canopy and stone balustrade, located at the northern end of the building, appear to be the remains of the Victoria Gardens bandstand. The low walls, with coping stones visible in both the east and west elevations of the auditorium, are also likely to date to this first phase, and possibly represent the limits of garden or seating areas. Both the southern wall of the box office and the cast-iron elements of the covered arcade extending to the west of the building date to this phase.

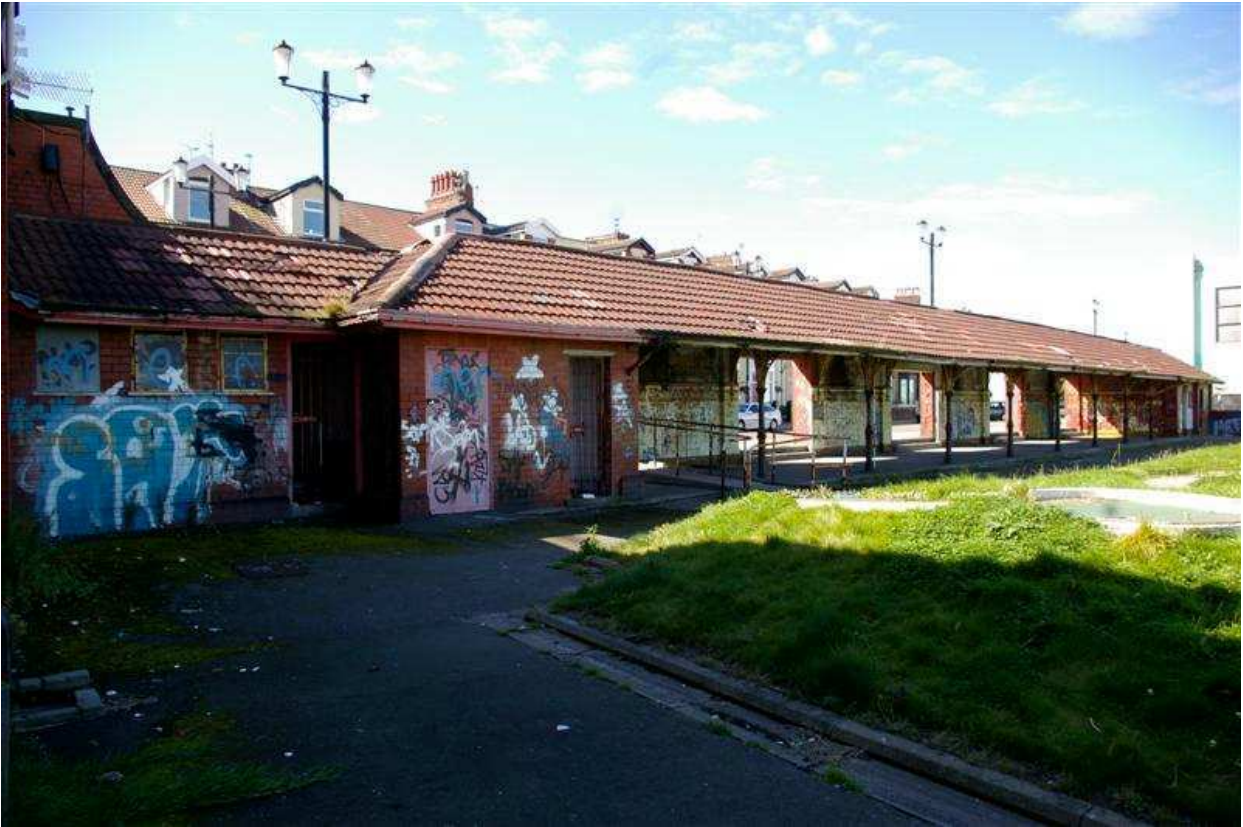
Plate 5: Covered arcade on the west of the building

- 4.2.3 Two outbuildings are present, located to the east and west of the projecting wings of the box office. That to the west consists of a long covered arcade, which extends from the south elevation (Plate 5). The one to the east appears to have last been used as toilets and storage. A car park is located at the east side of the building and a disused crazy golf area is located at the west side.

- 4.2.12 Extending from the western side of the reception section of the pavilion is the covered arcade building (Fig 2; Plates 5 and 10). The south elevation of this arcade has twelve bays, six of which have been blocked with rough brickwork. Construction details are similar to the south elevation already described. The north side of the arcade is open and faces the crazy golf course. The interior has decorative tiles (Plate 11) and cast-iron columns with decorative fretwork trusses (Plate 12). It has a modern terracotta roof, which is hipped at one end.

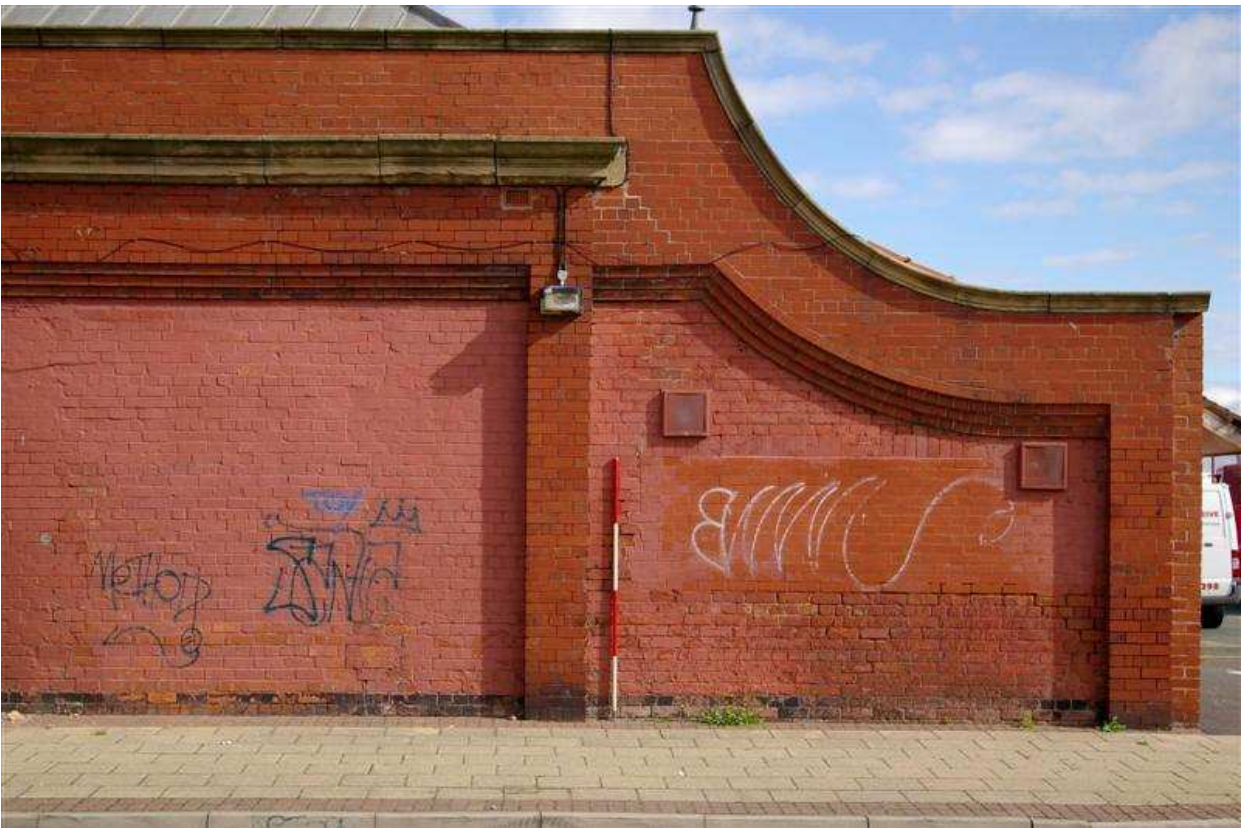
Plate 6: Example of construction details

- 4.2.4 **Fabric:** most of the building, together with the two outbuildings, is constructed from high quality red brick of varying types and ages (Plate 6). All of it appears to be machine cut and most appears to date from the nineteenth century. The north elevation of the main building appears to date to the late twentieth century. Some infilling of various areas has been carried out with inferior material. The south elevation has grey/yellow sandstone copings. (Plate 6)

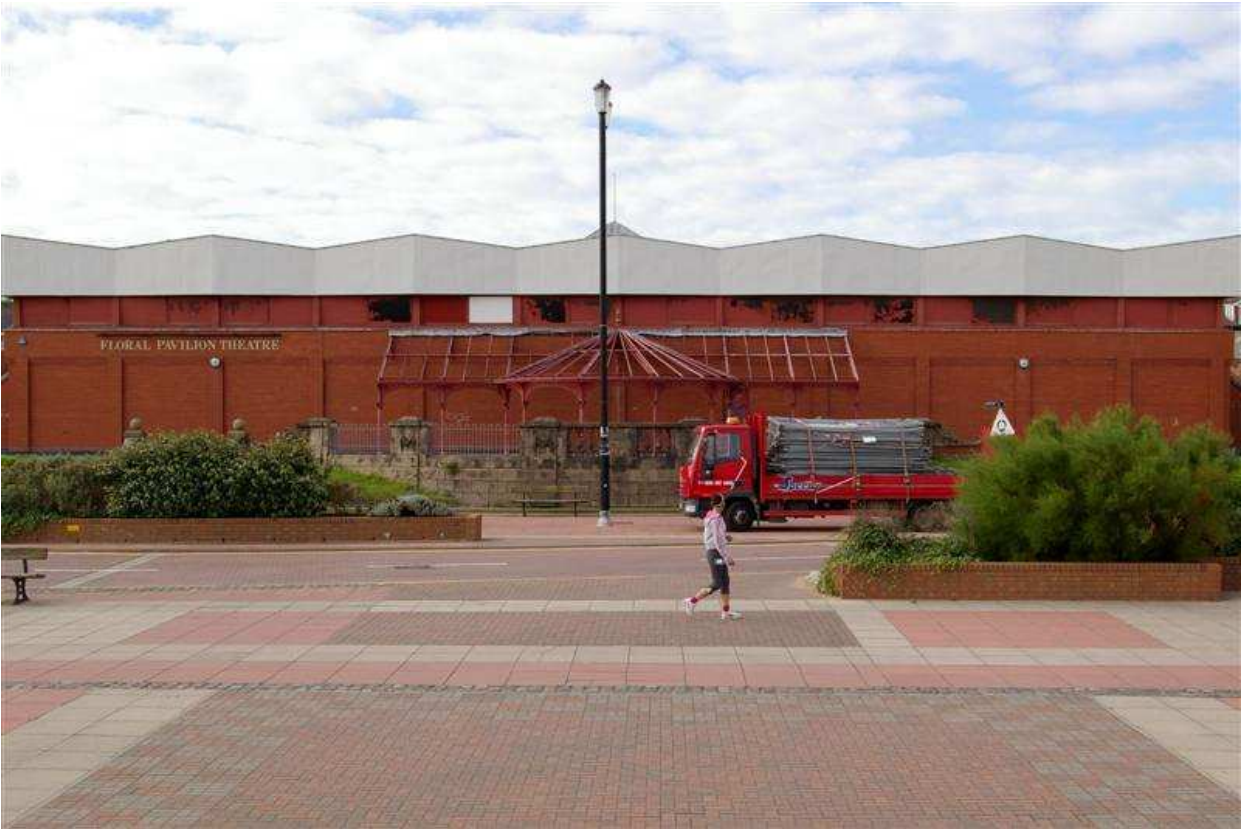
Plate 7: The front elevation

- 4.2.8 **External Details:** the north elevation of the pavilion is of modern brick construction (stretcher bond) (Plate 7) divided into twelve blind bays with corbelled heads (Plate 4). This was evidently carried out to match the south (rear) elevation (Plate 6). There are no windows or doors present. Steel cladding extends down from the line of the modern roof (Plate 7). A cast-iron canopy projects out from the central area of the elevation and has decorative columns and fretwork (Plate 9). It has no roofing material but it is likely that this was constructed of glass, and this be the remains of the original bandstand from the Victorian Gardens phase of the development. The canopy extends out over a terrace (*Section 4.2.9*).

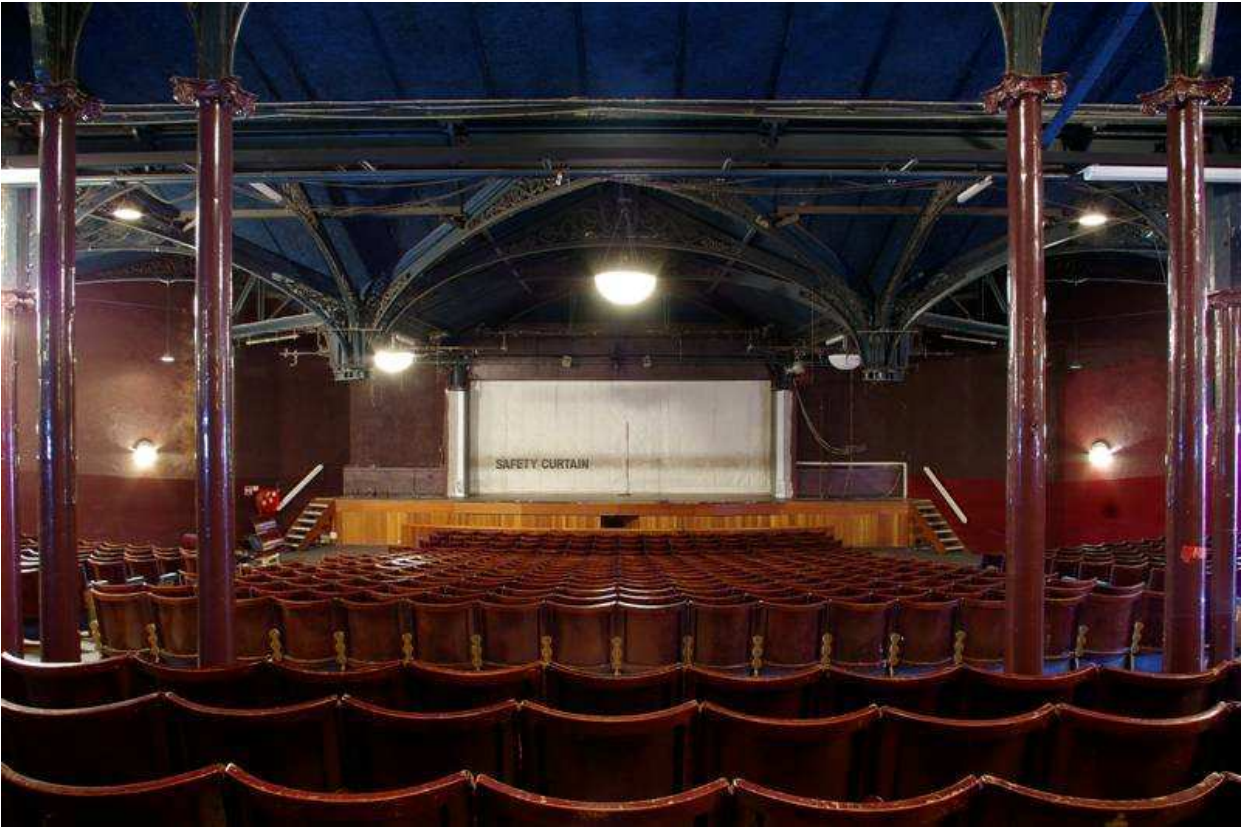
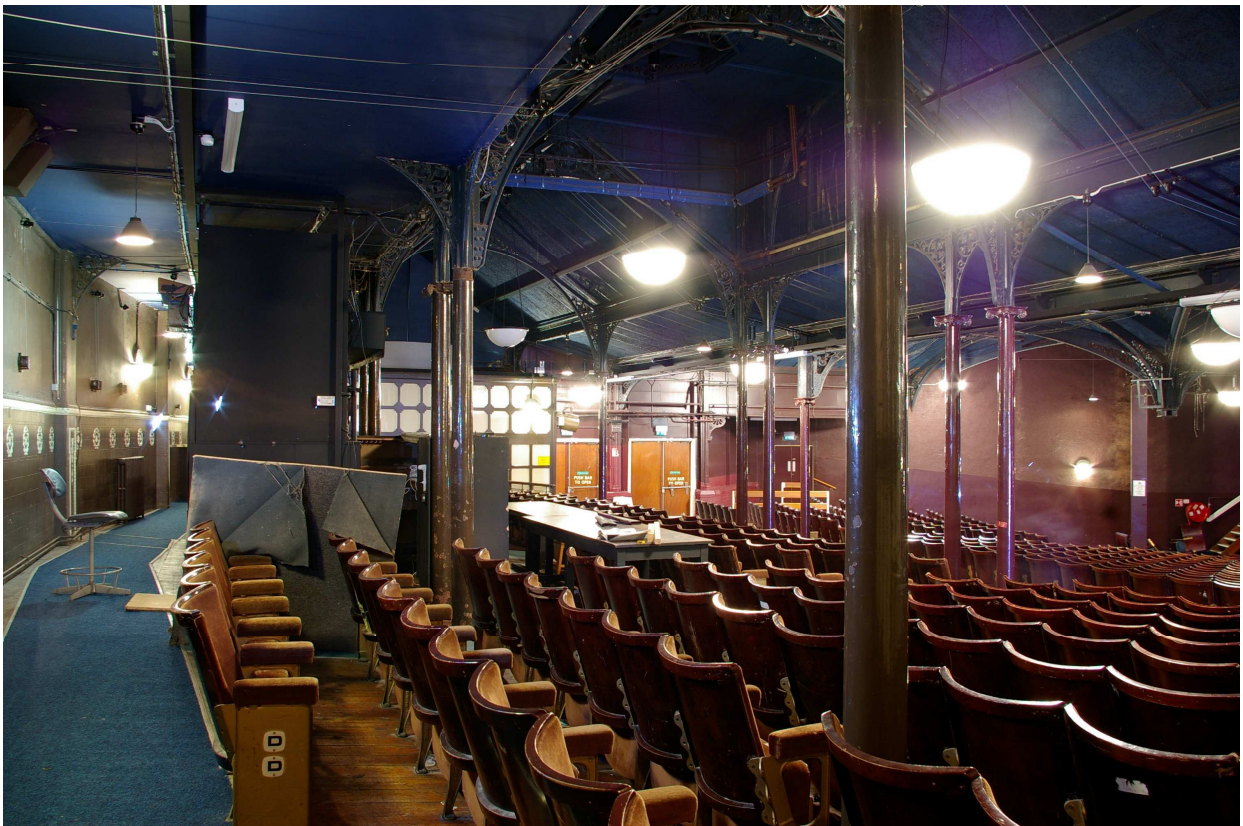
- 4.2.14 **Internal Details:** the large auditorium occupies most of the internal space of the pavilion (Plates 13 and 14). It has three large blocks of curved seating sloping towards the stage. Behind these three smaller blocks of seating are present. Most of the walls are of brick construction and all are painted. There are decorative wall tiles at the rear of the auditorium, which exhibit floral motifs. (Plate 15) Timber partition walls form corridors leading to the box office and bar areas. The floor is mainly laid down to floorboards with tiles at the main access areas and aisles.

Plate 13: The auditorium facing north

Plate 14: The auditorium facing west

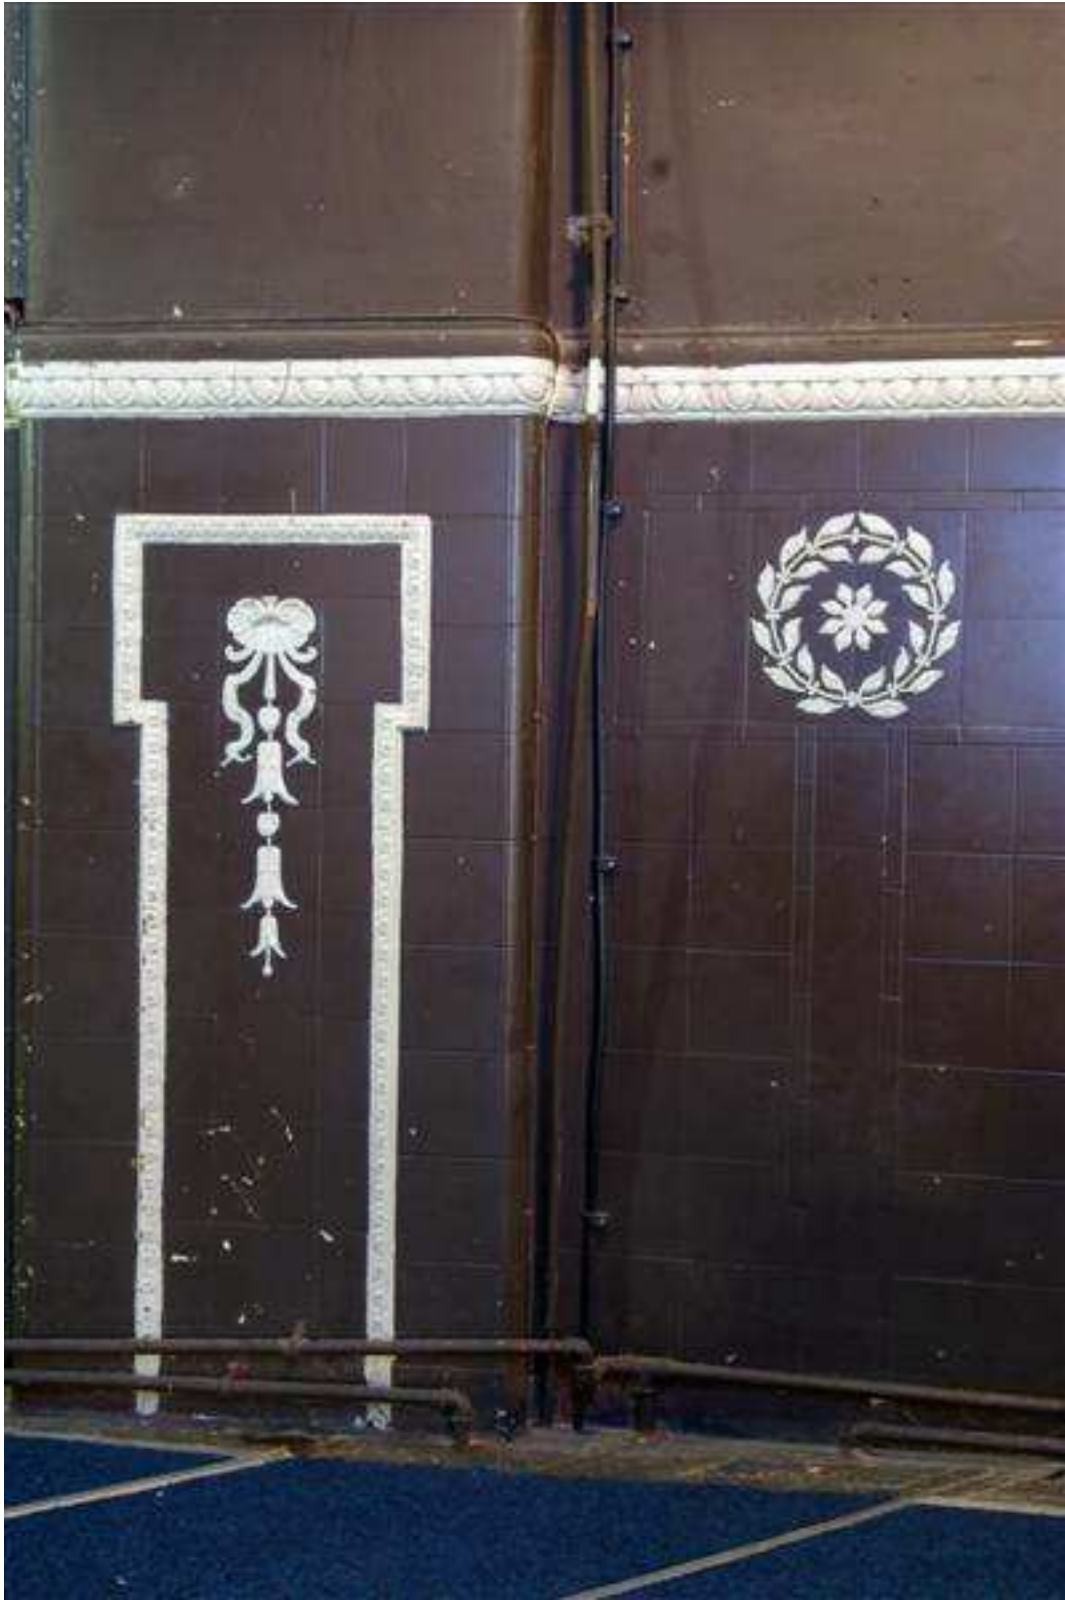
Plate 15: Decorative tiles at the rear of the auditorium

- 5.1.4 **Floral Pavilion:** the ornate cast-iron roof frame and associated columns observed within the auditorium are the remains of the 1920s glass roof, which joined the pavilion to the south and the bandstand to the north to create a covered theatre. The decorated tiles (Plate 15) are also likely to date to this phase.

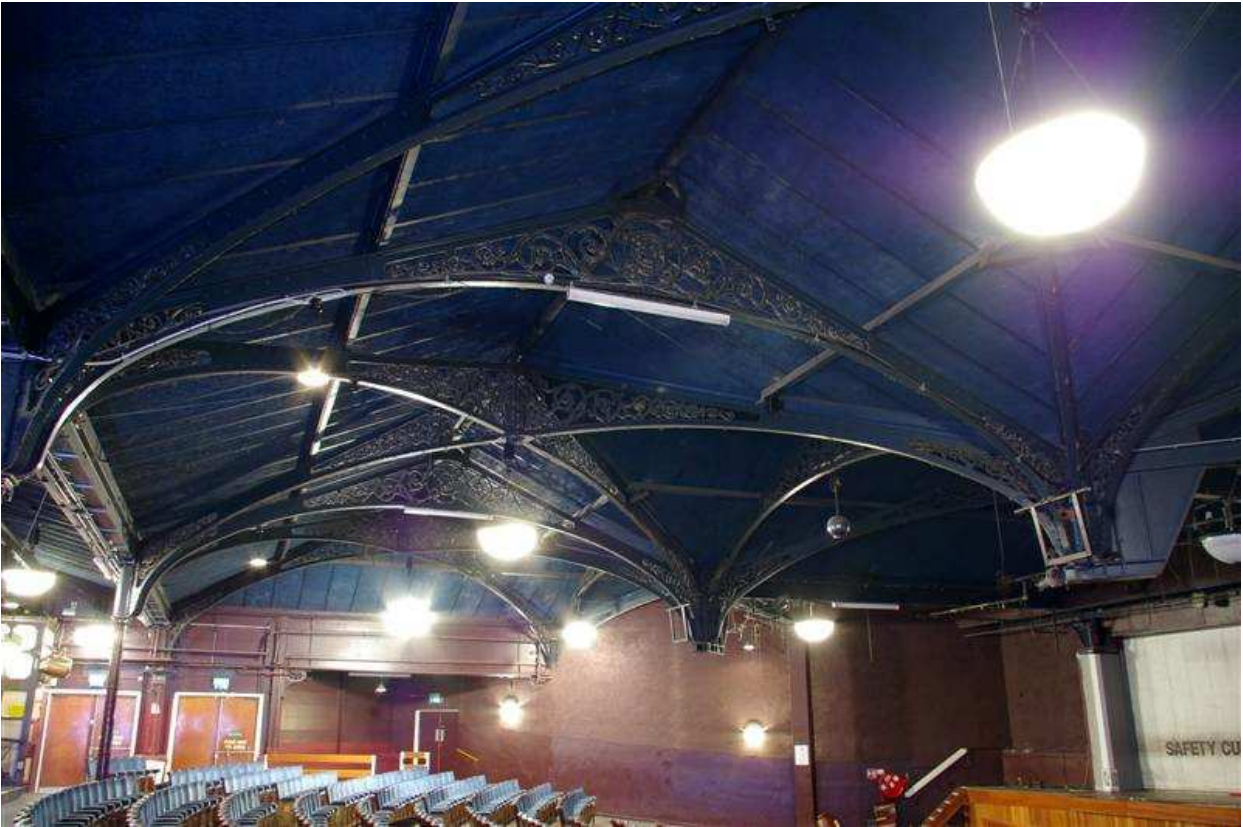
Plate 16: View of the cast-iron roof structure in the auditorium

- 4.2.16 The most interesting feature of the auditorium is the cast-iron column and truss roof structure, which originally would have supported the glass roof. The cast-iron framework for housing the glass is still visible within the trusses. The highly decorated, fretwork trusses are supported on a series of columns. The style of the fretwork is almost identical to that in the covered arcade (*Section 4.2.13* Plate 17). Two columns have been removed to make way for seating (Plate 16).

- 5.2.1 Although limited in scope, the building assessment has revealed that the Floral Pavilion originally consisted of separate structures subsequently joined together by continuing alterations, and in particular the cast-iron roof frame. It is strongly recommended that the cast-iron roof frame is subject to further investigation and detailed recording.
