# **Gin Pit, Tyldesley, Greater Manchester**

## **Building Investigation and Excavation Draft Report**

**Oxford Archaeology North**

June 2008

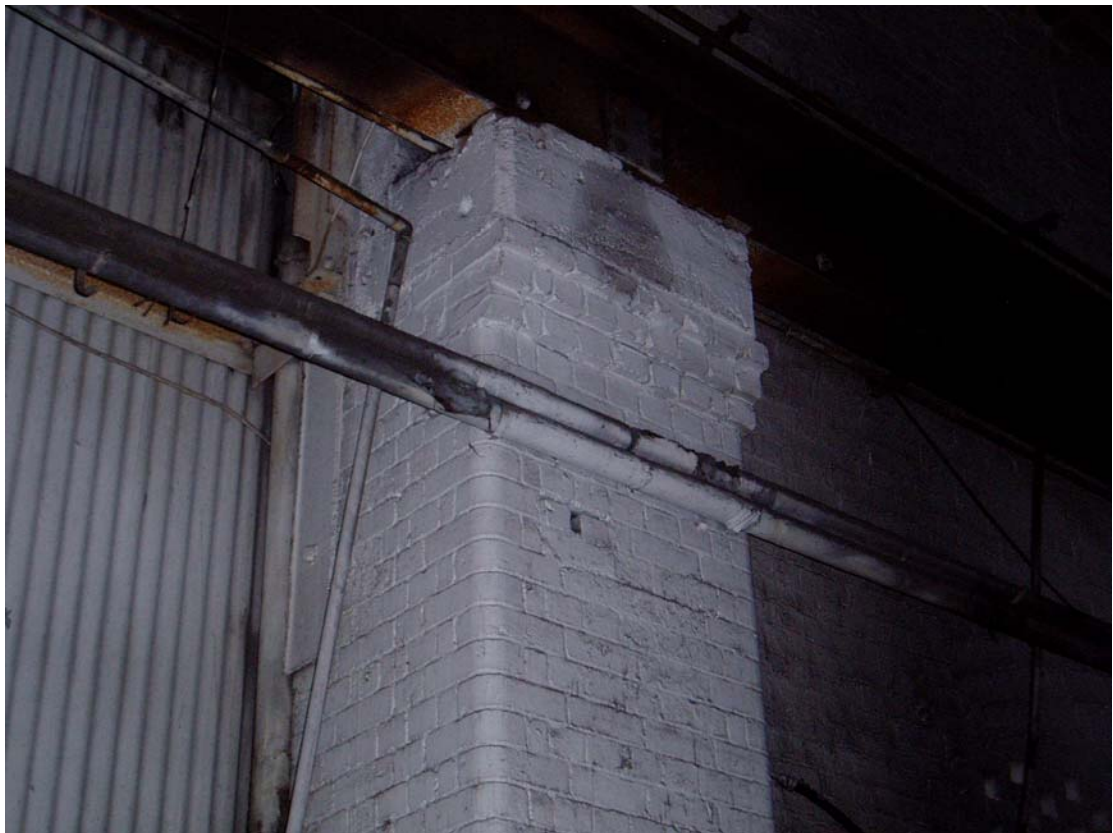
- 4.2.6 The internal northern buttresses within each wall are bull-nosed, with that in the eastern wall also having a three-step brick corbel on its western face (Plate 6), suggesting that the northern elevation of the structure was open, with arches supporting the gable. Corrugated sheeting surviving on the north face of the northern truss suggests that the structure had a sheet gable following the replacement of the trusses, prior to the addition of Building 1.

Plate 6: Corbelled buttress within Building **2**

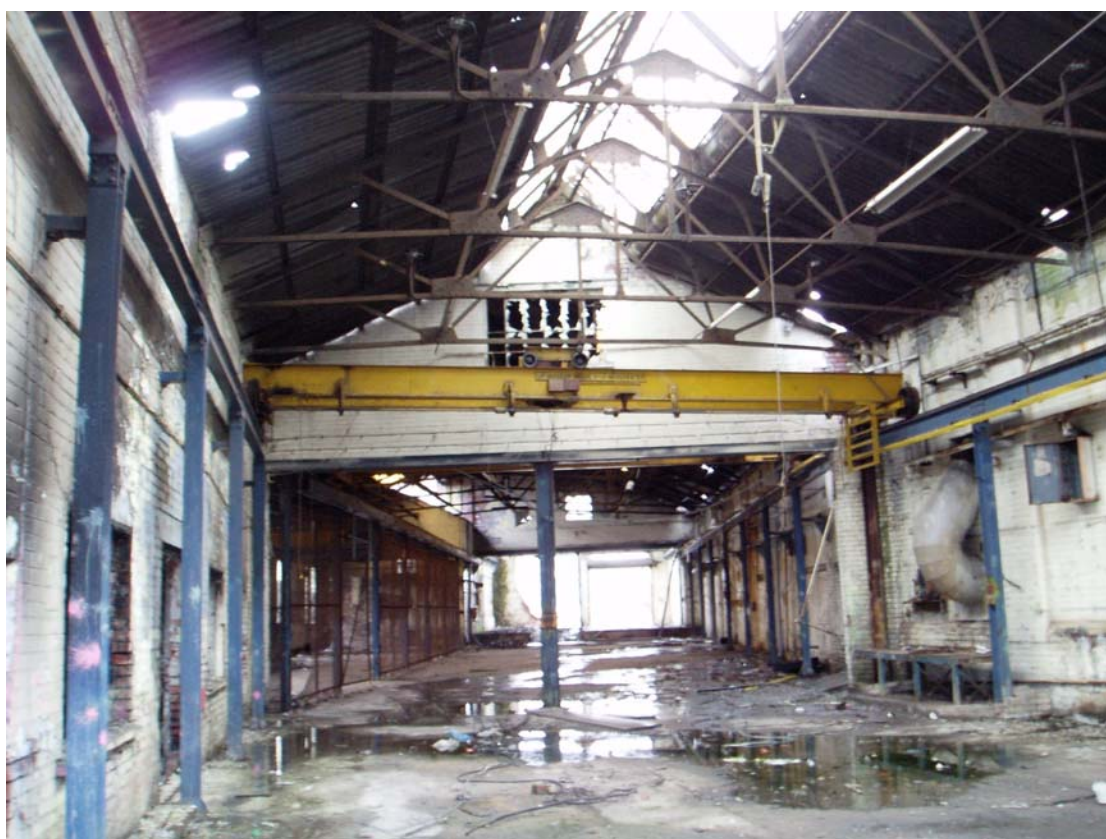
- 4.2.17 An internal inspection was not possible for either parts of the structure, although typical metal lattice trusses were observed through the external doorway in the north elevation.

Plate 10: Lattice trusses, Building 5

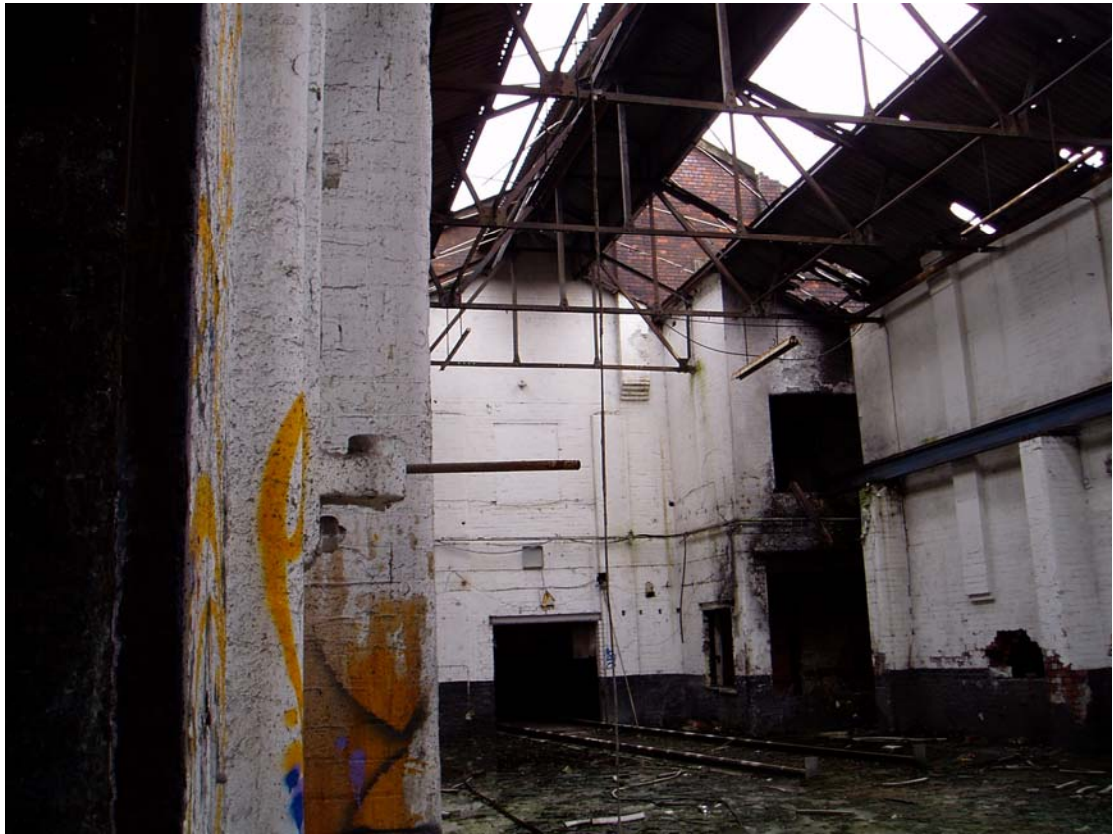
Plate 15: Interior, Building **9**, showing lattice trusses and tiered flues

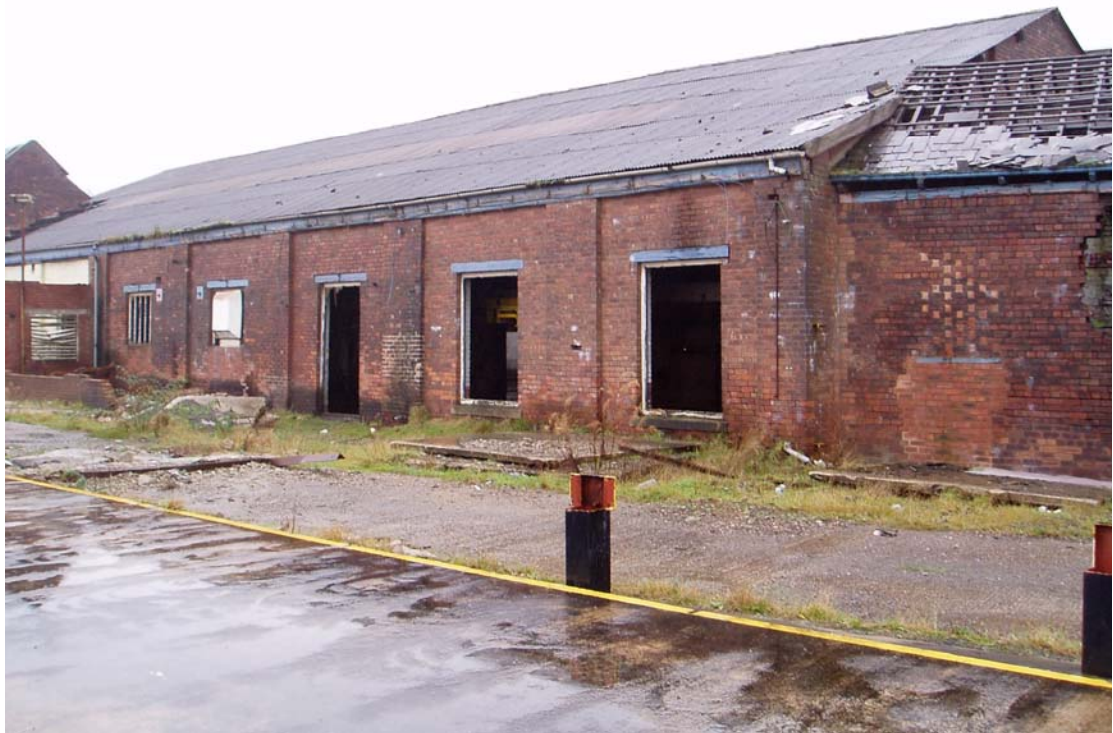
- 4.2.20 **Building 10, engine shed/offices:** low, wide single storey, eight-bay shed with a pitched corrugated sheet roof, butted onto the eastern side of Building **9** (Plate 16). It originally appears to be broadly contemporary with Building **6** to the north, having been erected prior to 1907, with the Ordnance Survey edition of that year clearly depicting railway tracks running through the structure, suggesting that it was an engine repair shed. The eastern elevation forms the edge of the workshop complex, and has large rectangular windows with projecting sandstone sills, in all but the third bay from the northern end, which has a doorway of similar proportions. Each bay is divided by brick piers, similar to, but plainer than, the pilasters in the western elevations of Buildings **2** and **8**. The southern bay of the eastern elevation forms part of a much narrower, and presumably earlier structure, similar in width to Building **14** to the south, and comprising a two-storey office. The northern and western walls survive within the expanded structure (Plate 17), each having windows at first floor level, and suggesting that the structure was retained as an office. The northern wall also had a door at ground level, presumably originally providing external access, but subsequently affording access into the larger shed. Access to the upper floor was originally afforded by an external stair in the southern elevation (now obscured by the engine shed Building **14** to the south), but following further construction in this position, an internal stair was inserted through the buttress at the northern end of the eastern elevation (Plate 18).

Plate 16: Building **10** from the east

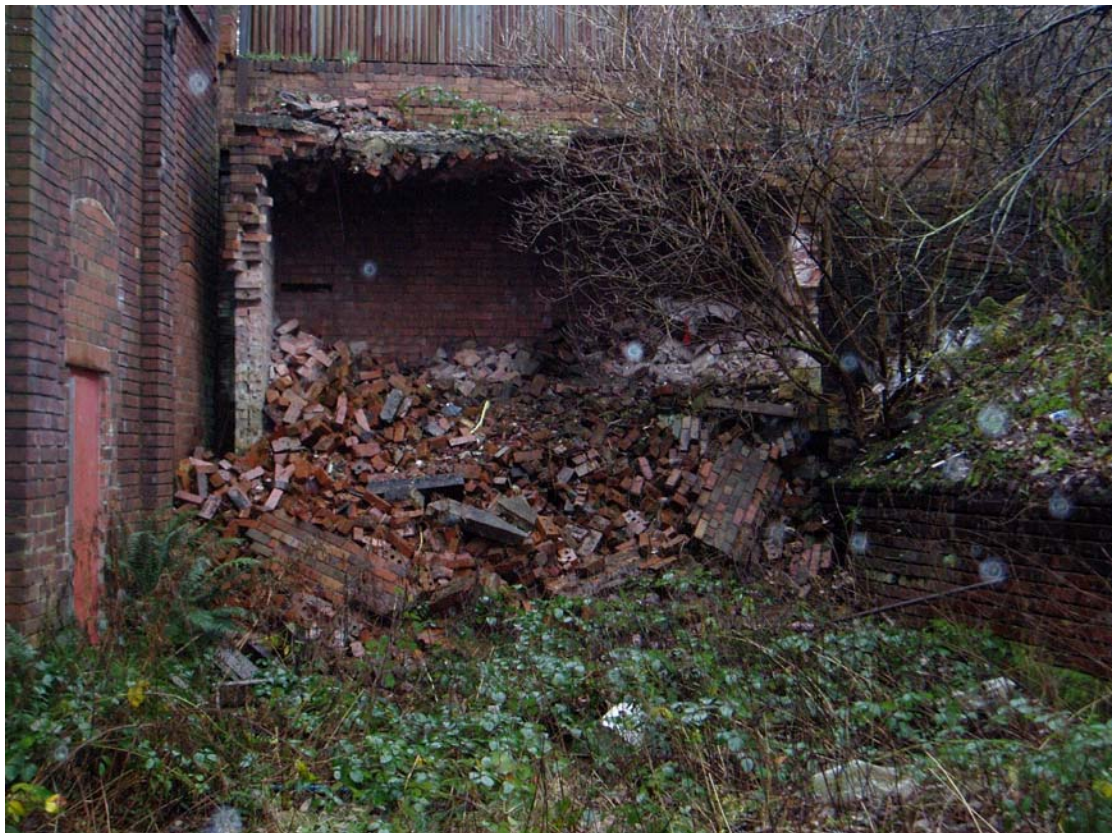
- 4.2.37 **Building 22, Engine shed:** only the badly decayed remains of the southern and possibly the western elevation survive of this narrow, brick structure. What is of most interest is that it was constructed only c0.3m to the west of Building **15**, rather than butting onto it, suggesting that it may be contemporary with the blocking of the windows in the western elevation of the earlier building (Plate 34). It was most probably constructed as a free-standing structure for the stability of the roof. Its narrow width and length, which the remains of the western elevation suggest was similar to Building **15**, suggest it housed only a single railway track, presumably used as an engine shed, rather than a workshop.

Plate 34: Remains of Building **22**

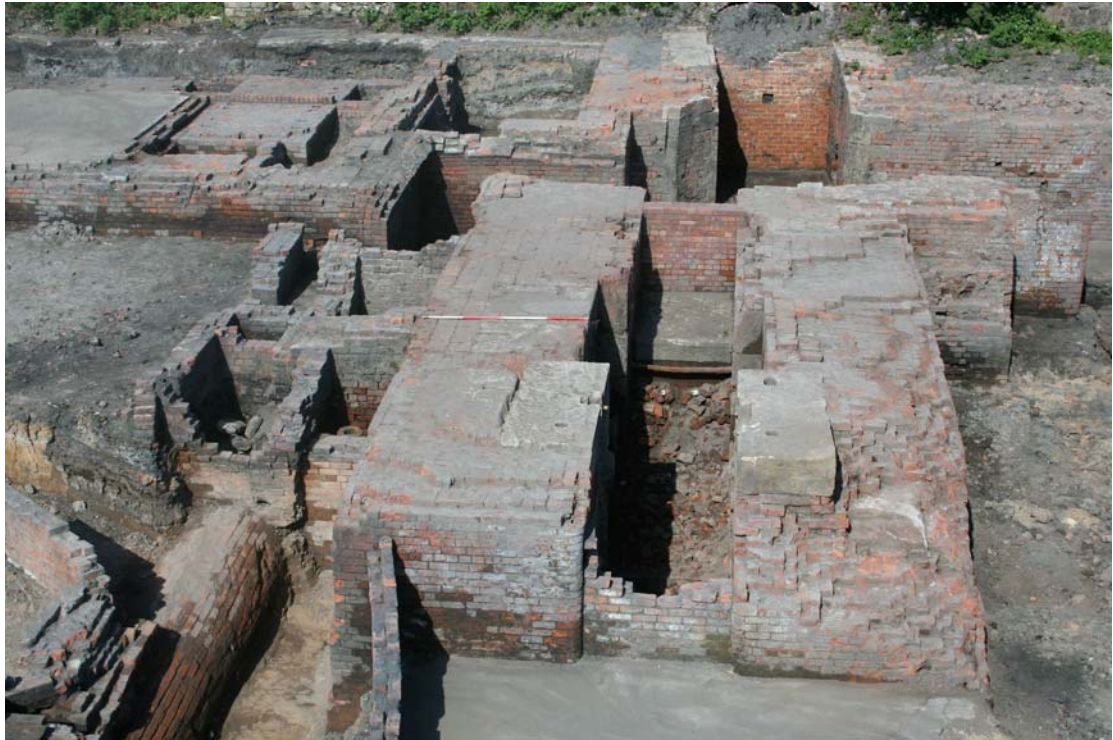
- 5.3.7 **The Pit Brow:** the pump engine house (**2404-2406**) (Figs 14 and 16, Plate 38) was aligned east/west, and extended slightly to the south of centre of the shaft, on its eastern side. This is thought to have housed a beam engine as described by Hayes (Section 3.3.15), however, the arrangement of the engine given, does not correspond with the archaeological record. The engine bed foundation walls were constructed of red brick (**2405**) and survived to a height of over 3m. The pit between the foundation walls was excavated to a depth of 2.5m from the original ground surface. Stone anchor engine beds were present at the eastern end of the foundations. At the west end two rows of vertical restraining bolts were observed. A cast iron steam pipe entered the pit between the foundation walls from the south (Plate 39), bringing steam to the engine, either from the original boiler or the later boiler house. It is possible that the original boiler was housed in the area referred to as **2412** and **2416** (see below 5.3.8) but no evidence for this was seen.

Plate 38: west-facing view of pump house **2404**

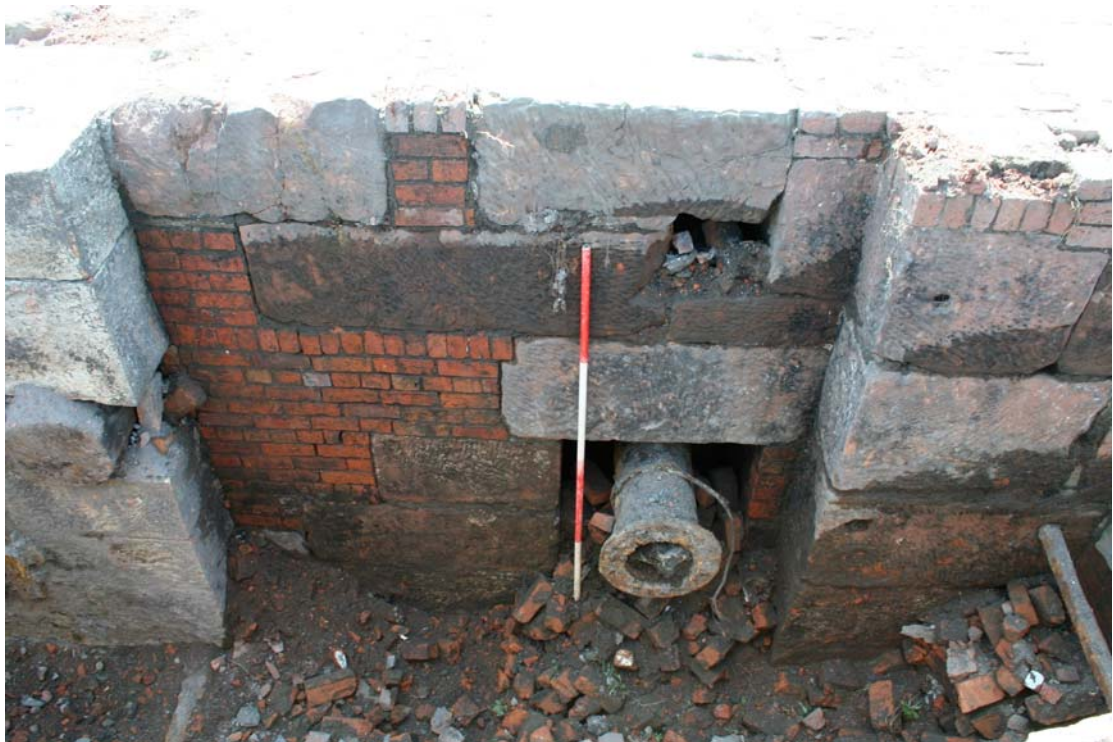
Plate 39: south-facing view of steam pipe in pump house **2404-2406**

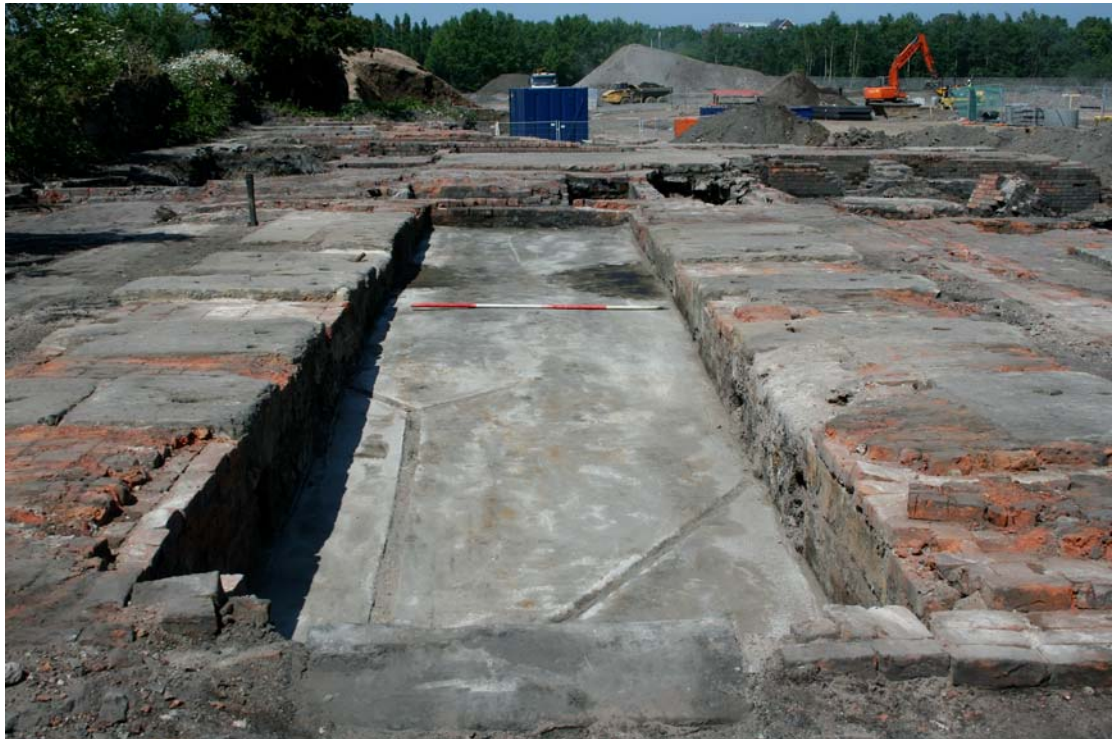
- 5.3.10 The winding engine house (**2429**) (Figs 14 and 17; Plate 40) was aligned north/south to the south of the shaft and measured 13.13m x 7.75m. The winding engine is detailed in *Section 3.3.16*. The walls were constructed in red brick, and measured 0.60m in width. The central part of this structure comprised a pit with concrete floor measuring 2.3m in width, this was flanked by stone anchor engine beds set into the brick engine bed foundation walls. A large number of restraining bolts (Plate 41) survived *in situ*, in the stone engine beds. The rebuild or blocking wall at the northern end of the pit suggests that there may originally have been a small opening in the northern elevation. Beyond this, the winding drum would have been housed (**2407**, **2504**), around which the steel ropes would have been coiled as part of the winding action. The original flat rope drum was 10" in diameter, being replaced by a 12" drum for rounded steel ropes (Hayes 2004).

Plate 40: north-facing-view of winding engine house **2429**

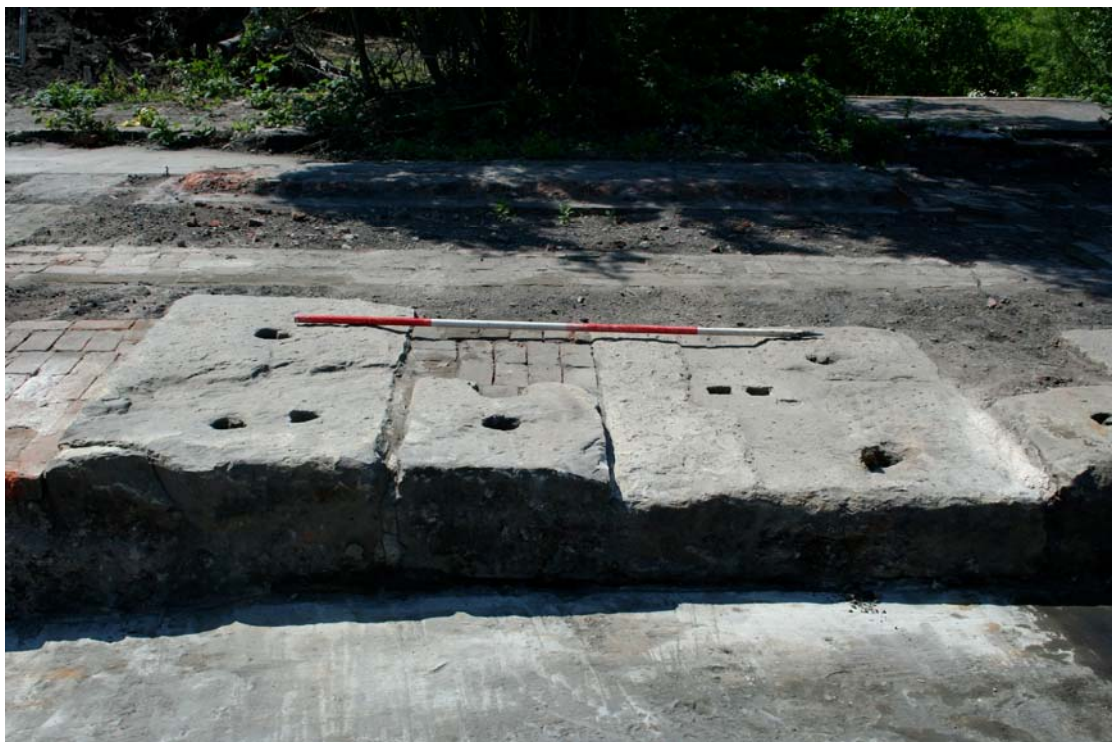
Plate 41: detail of mounting bolt settings in engine house **2429**

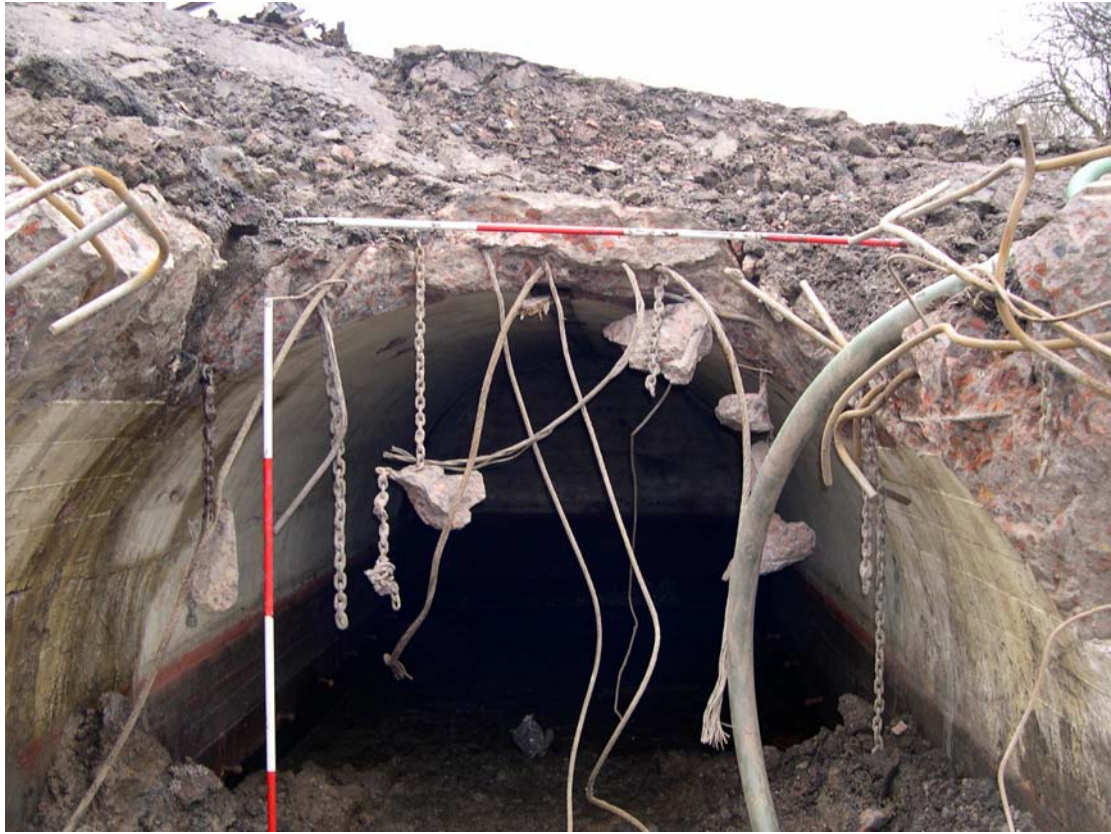
- 4.2.39 **The Air Shelter:** this was located to the west of the colliery buildings, and aligned north/south. The build features a series of curved concrete panels with steel reinforcement rods (Plate 46) and a central steel beam, and this basic structure was then probably bolted along the ridge and covered with earth. The concrete was seen to be reinforced with scrap metal from the colliery, including lengths of steel rope and chains. This ‘Stanton’ type construction (Osborne 2004, 185), or a variant thereof, was more commonly found within military installations, but it was by no means exclusive to these sites and would have been an ideal means of protecting the large colliery workforce.

Plate 46: Section through exposed chamber of the air raid shelter showing reuse of steel ropes for strengthening

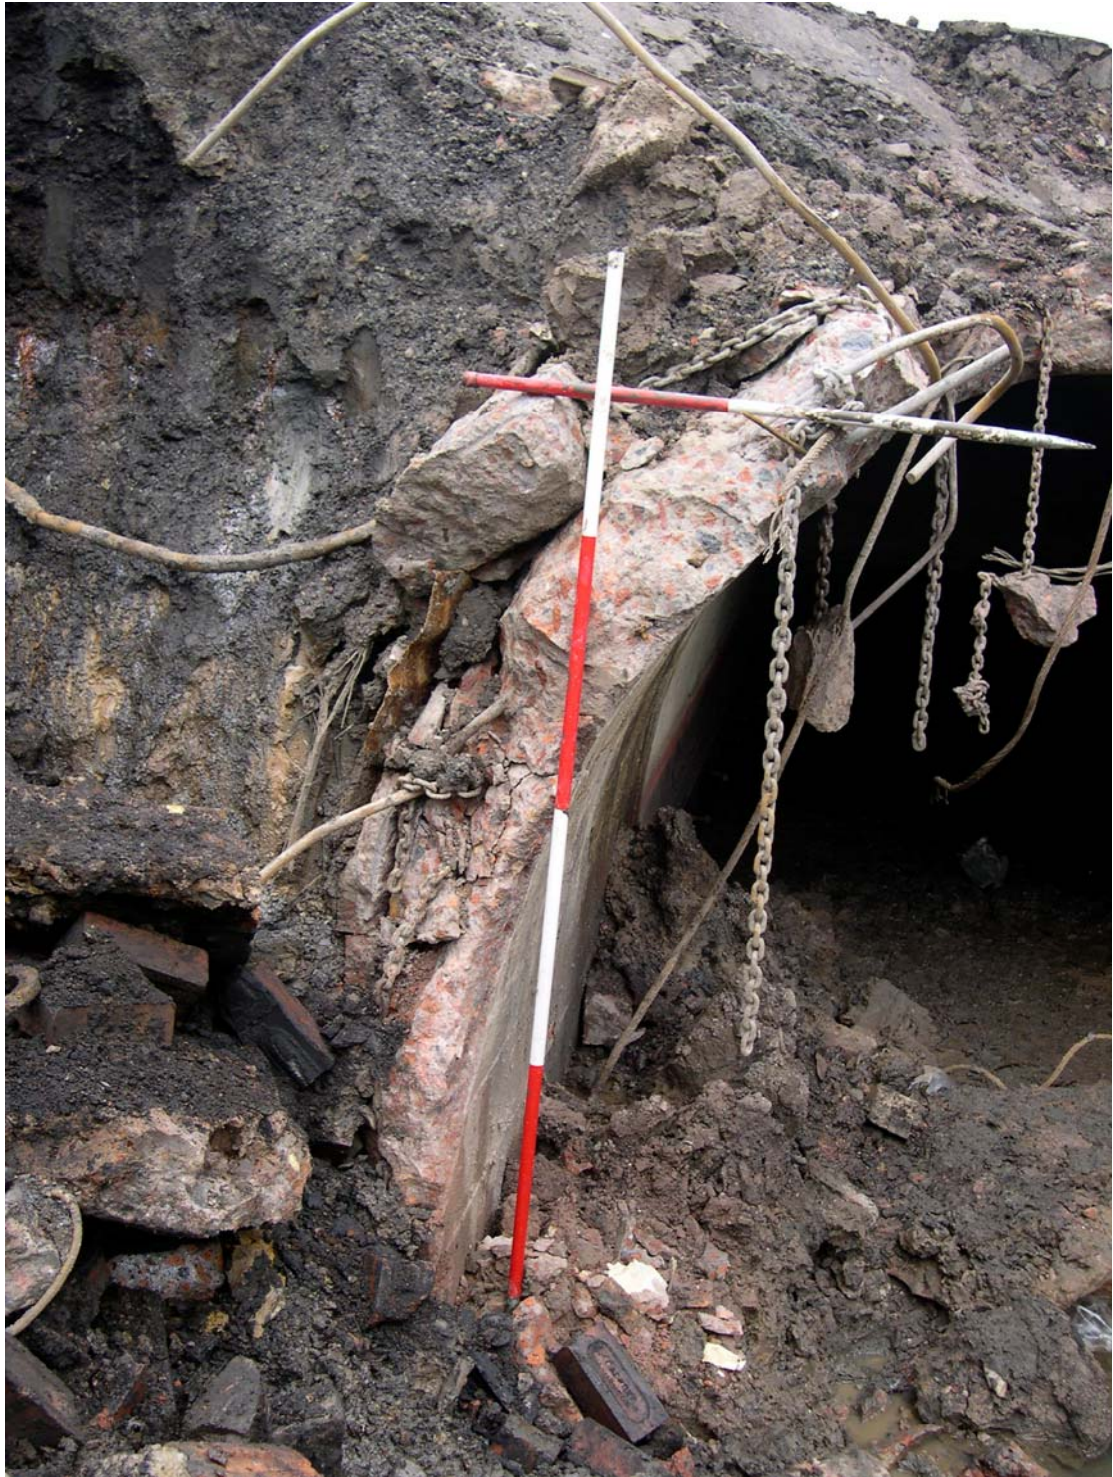
Plate 47: Construction detail of the exposed air raid shelter showing make-up of concrete

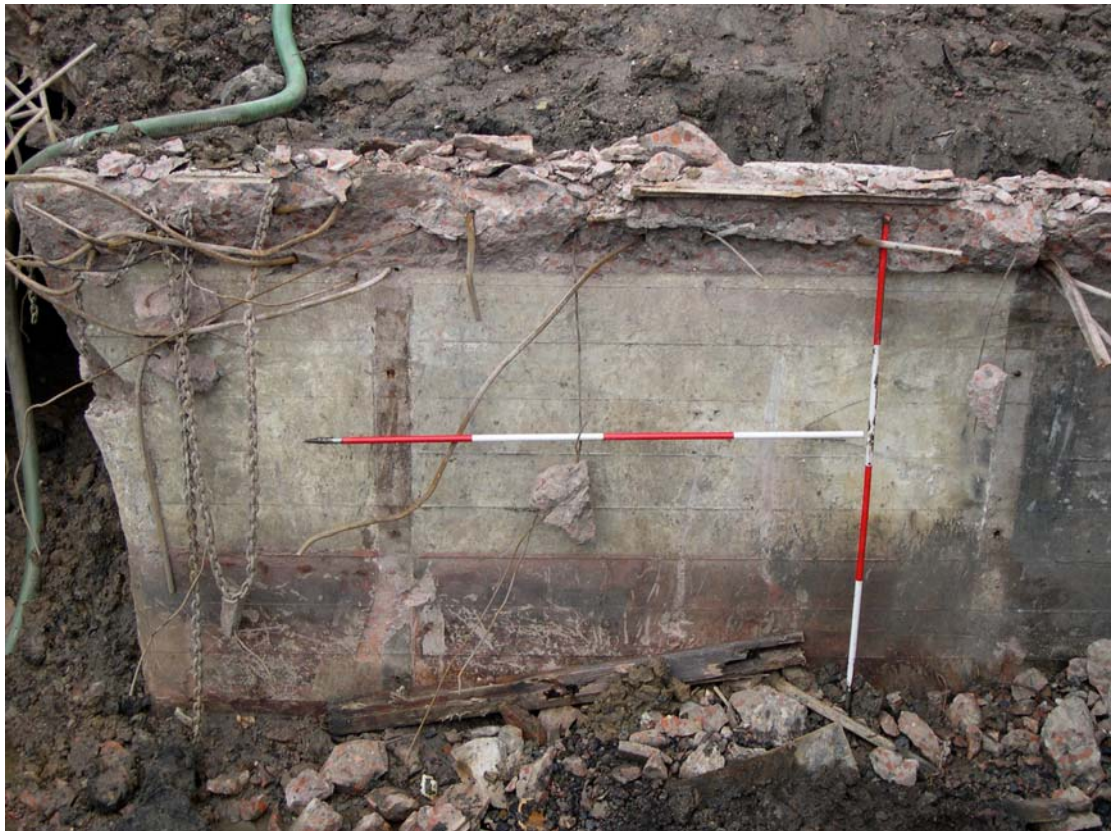
Plate 49: Exposed wall of the air raid shelter showing lines from shuttering

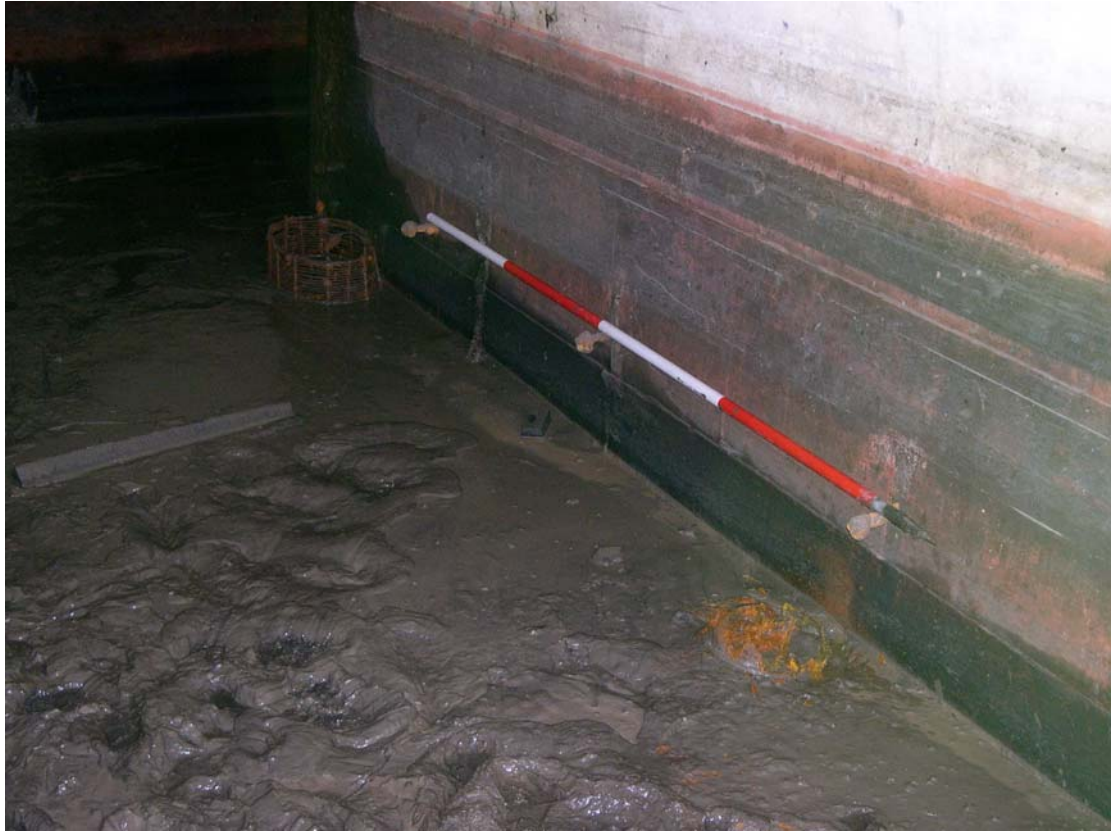
Plate 50: Bolt fastenings for a bench and internal paint finish within the air raid shelter.

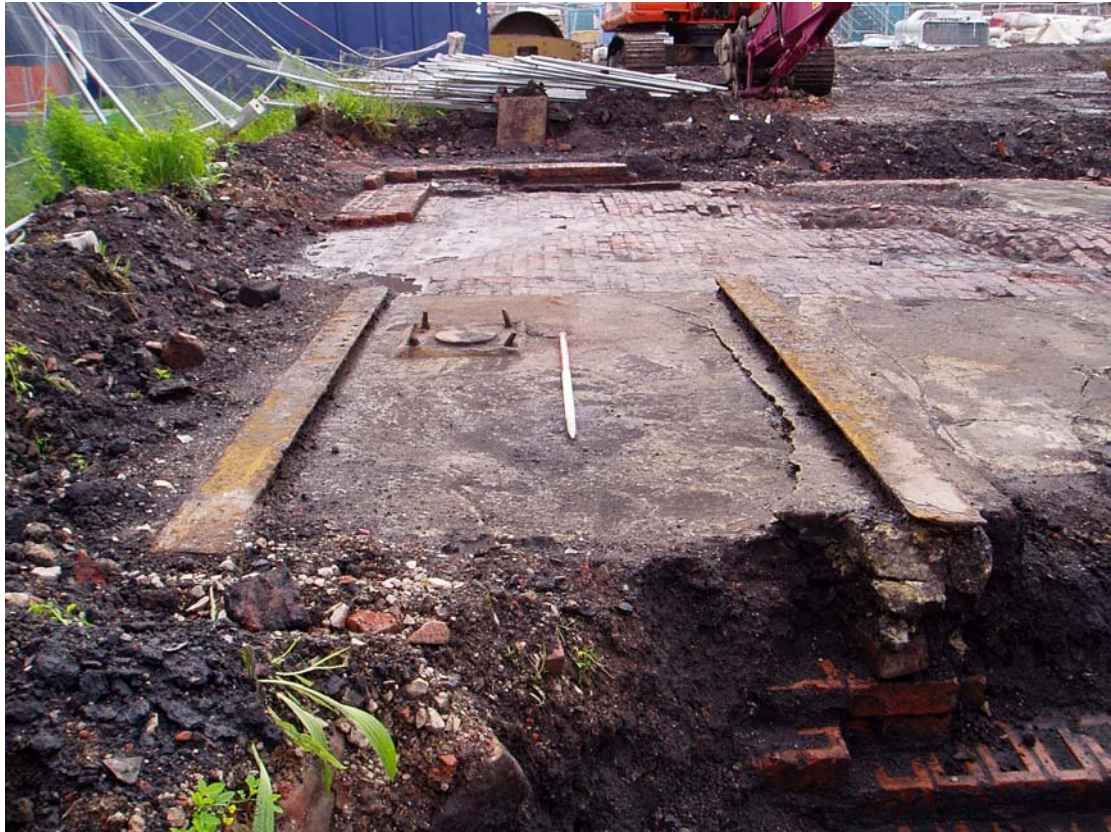
Plate 55: Metal plates and stanchion set into concrete. Coal waste was utilised as a levelling layer for the stone dust plant
