**LAND FRONTING  
AGARD STREET,  
DERBY**

**Archaeological Evaluation and  
Watching Brief Report**

Planning application Number: 12/08/01676  
National Grid Reference Number: SK 3472 3644  
AB Heritage Project no: 10008  
Date: 29 April 2011

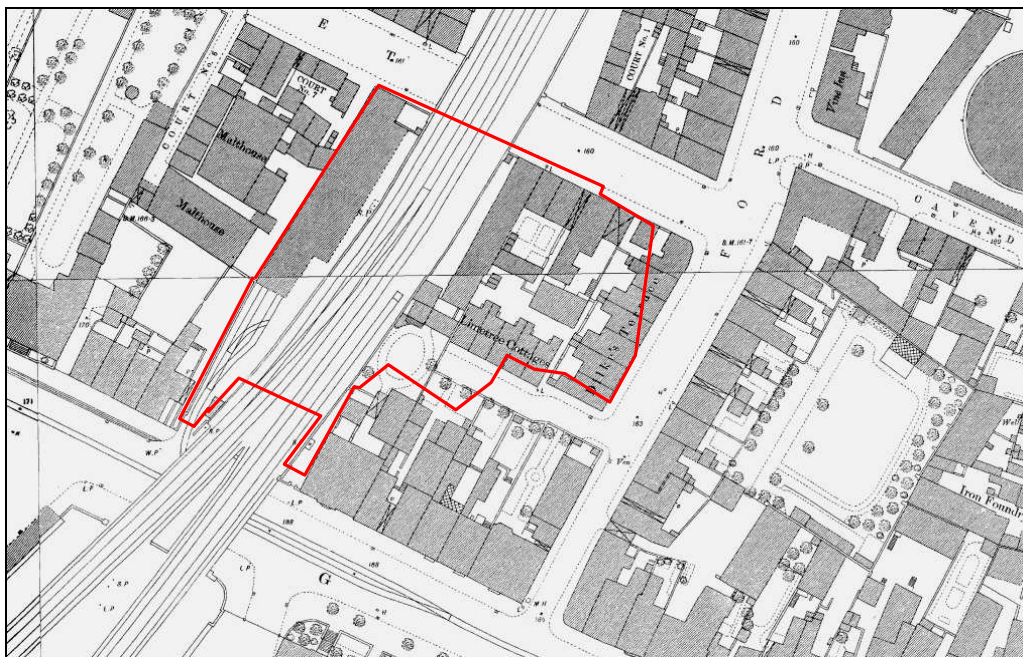
Plate 2: Extract from the Ordnance Survey map of 1882, showing the boundary of the study area

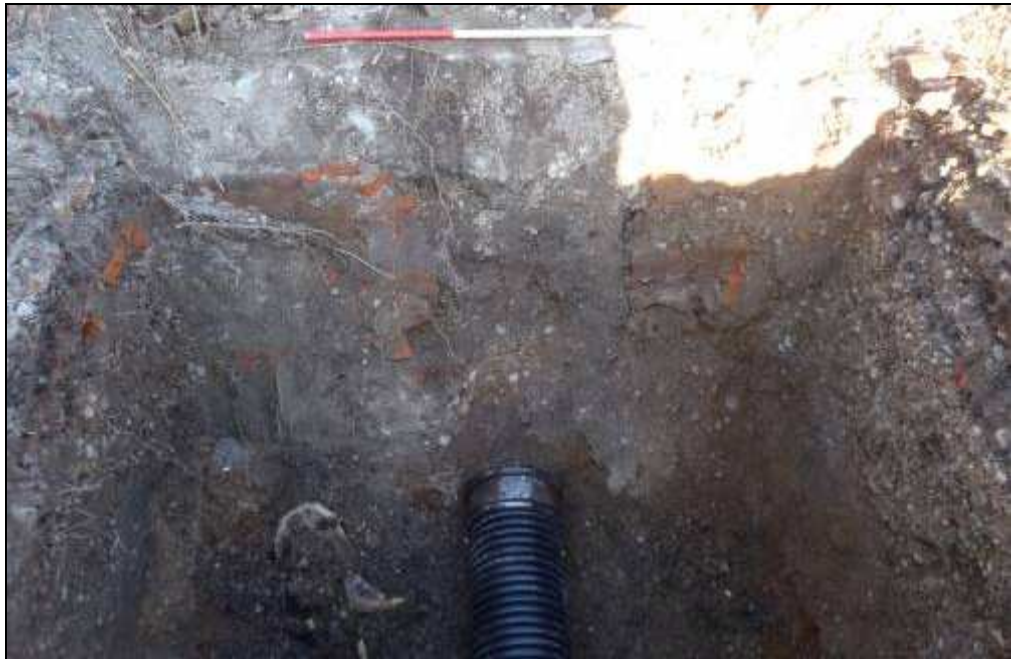
4.2.4 A wall (**106**) composed of red bricks, truncated by the service trench, was observed within the south-west-facing section of the trench, below concrete **101** (Fig 6; Plate 3). Its discovery was made during the works carried out by Cleggs to repair the drain prior to backfilling. It is thought to be the same wall recorded as masonry **105** in Trench 2B. Historical mapping does not help identify the structure this wall was associated with, but it probably formed a boundary wall for properties fronting Agard Street.

*Plate 3: Trench 1B looking north-east, showing wall **106** truncated by pipe trench **108***

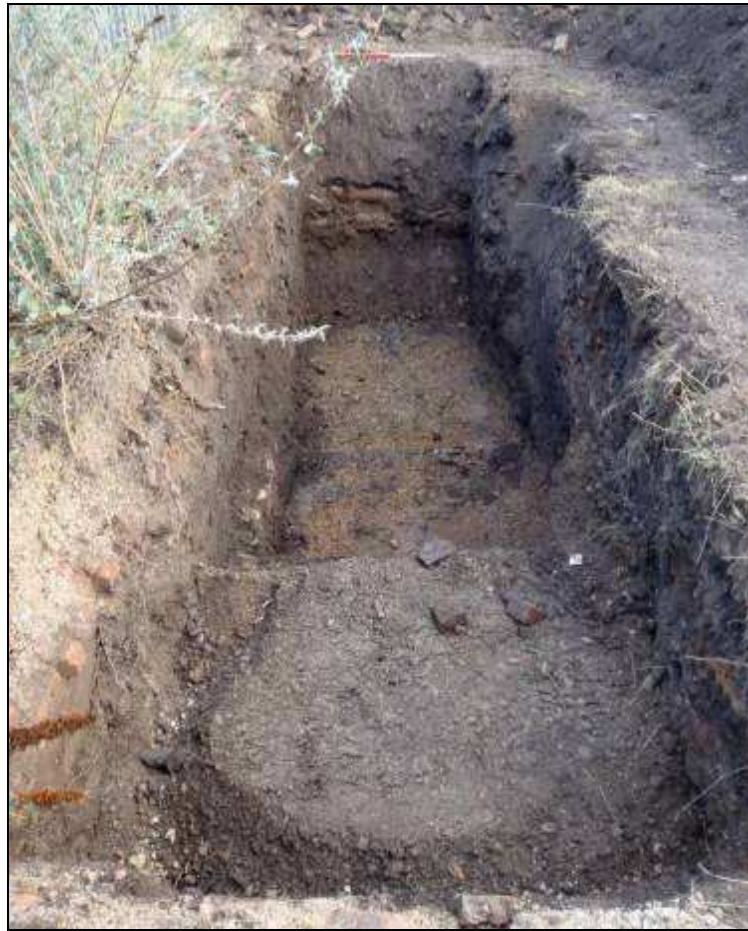
- 4.2.5 **Trench 1B:** was excavated to a maximum depth of 2.18m (Fig 6; Plate 4), although the trench was not entered for health and safety reasons, and was recorded from the present ground surface. The mechanical excavator removed 1.10m of levelling deposits **102**, and at the south-eastern end a further 1.0m of levelling deposits (**103**). Both of these deposits contained nineteenth-century pottery, although a fragment of roof tile to which a late medieval date has been provisionally ascribed was recovered from layer **102**.
- 4.2.6 The south-eastern end of the trench had evidently suffered a greater degree of truncation, recorded as cut **104** (Plate 5). River gravels (**110**) were located at the base of the trench. Nineteenth-century pottery was recovered from directly above these gravels.

*Plate 4: Trench 1B looking south-east, with a main drain visible at the far end*

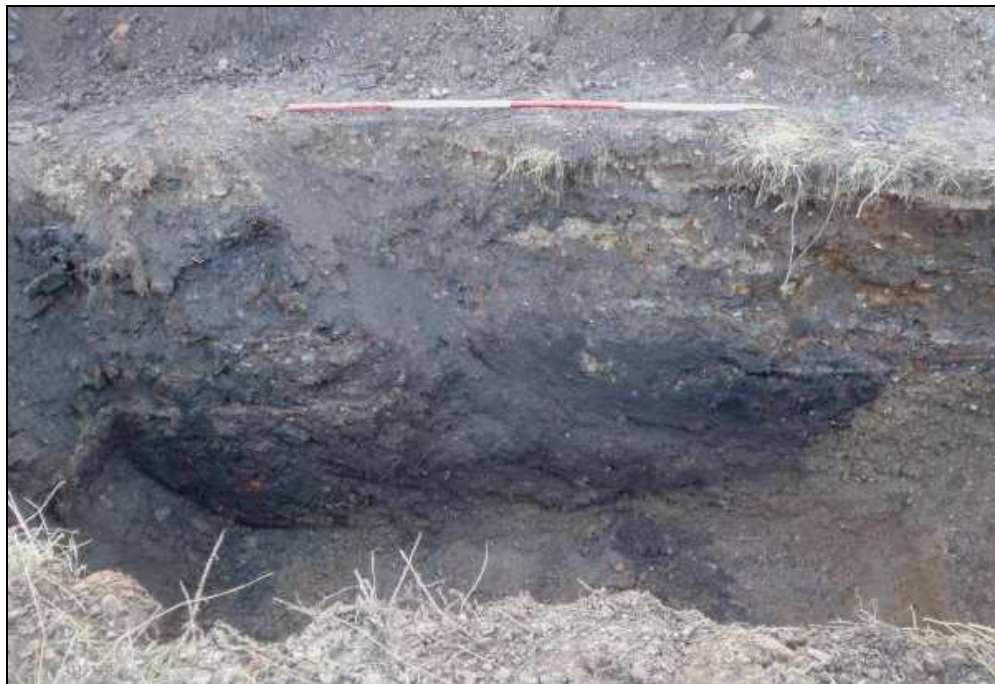
*Plate 5: North-east-facing section of Trench 1B at its south-western end, showing addition truncation, **104**, of river gravels **110***

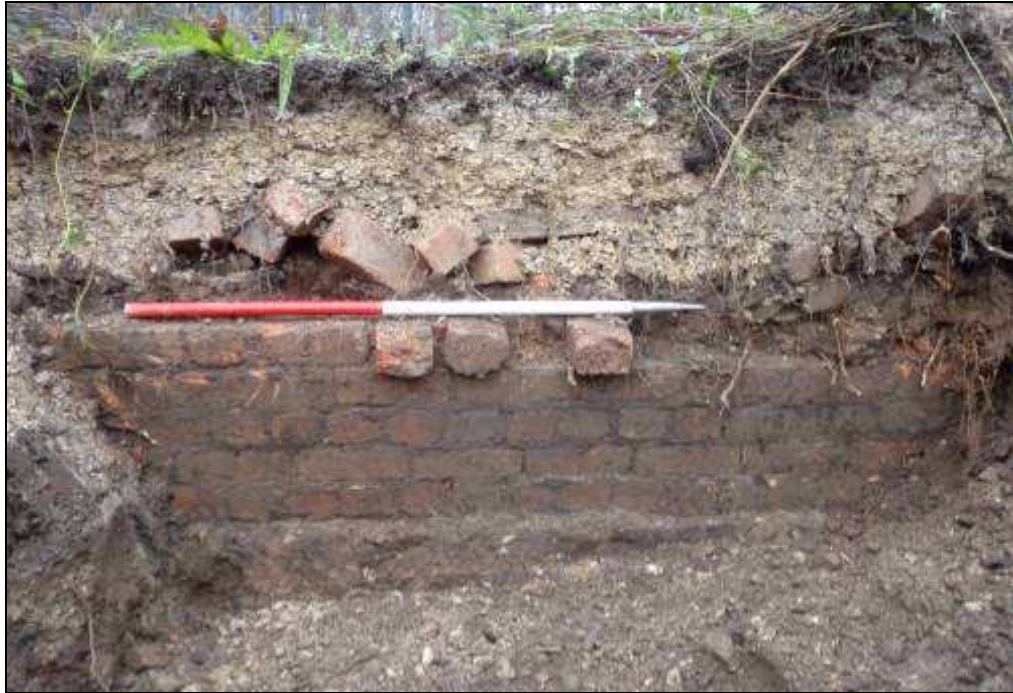
- 4.2.7 Wall **105** was located in the south-west-facing section at the north-western end of the trench, and is probably the same as wall **106** in Trench 1B (Plate 6). It comprised an English Bond pattern, bonded by a dark grey sandy cement mortar. As stated for **105** in Trench 1A, historical mapping was of no assistance in this instance, but **105/106** probably formed a boundary wall for properties fronting Agard Street.

*Plate 6: Trench 1B looking north-east, showing wall 105*

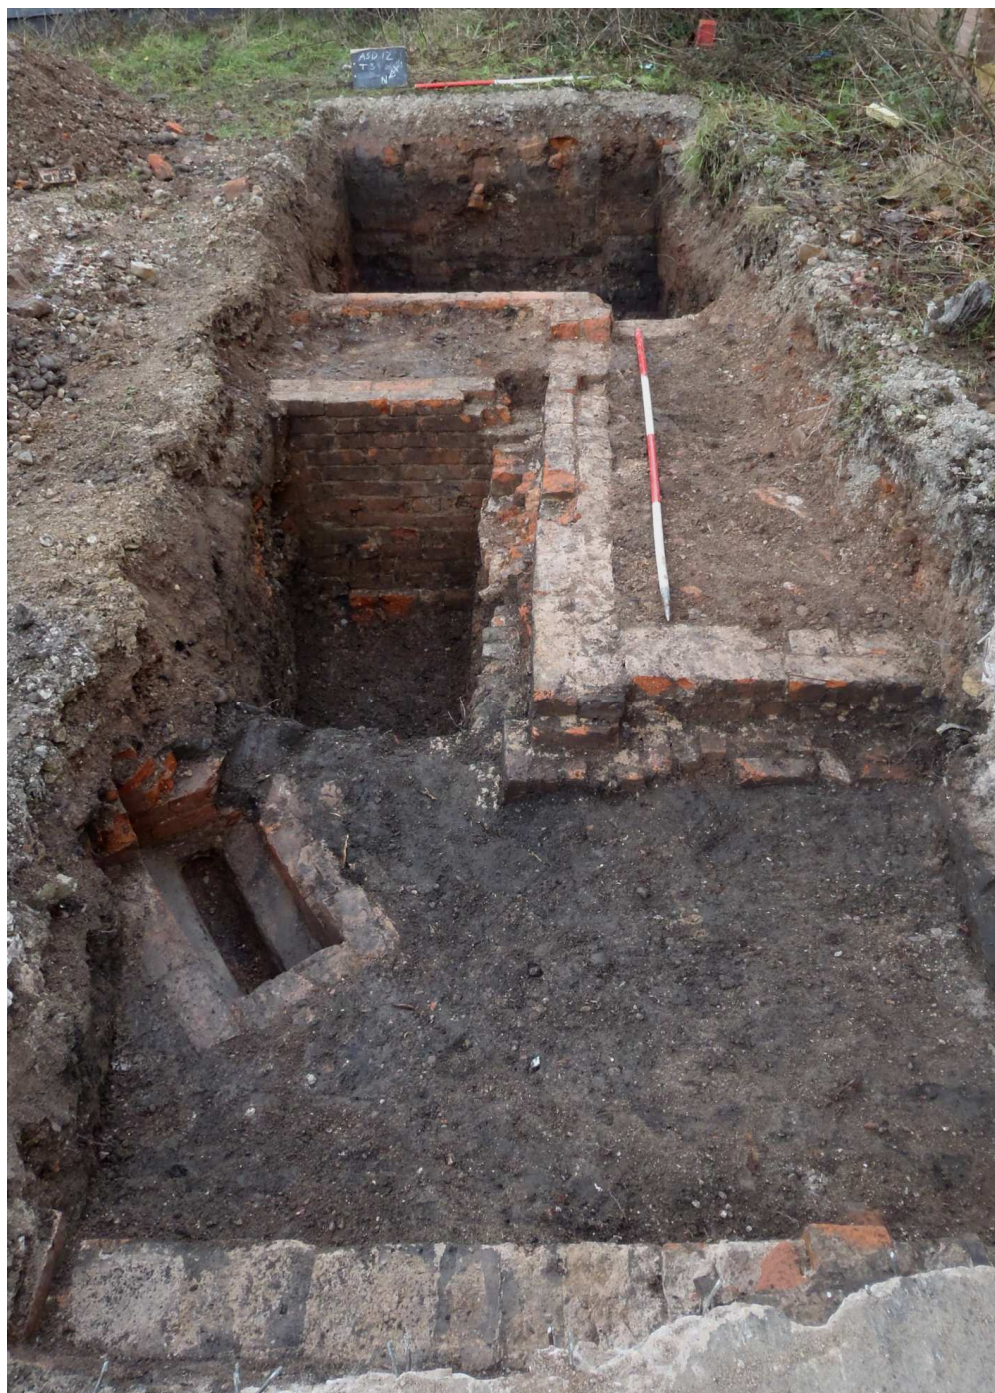
- 4.3.1 Trench 3 was excavated on a north-east/south-west alignment, positioned adjacent to the eastern boundary of the study area (Figs 2 and 7; Plate 7). It incorporated the rear of a building and its associated garden depicted on Rogerson's map of 1819 (Plate 1), and the footprint of a building shown on the Ordnance Survey map of 1882.
- 4.3.2 The trench also intended to investigate a row of terrace houses annotated as Limetree Cottages on historical mapping. It was intended to excavate a trench measuring 15 x 2m, but this was shortened to a length of 7.5m to avoid cutting of any access to this part of the site, which excluded uncovering any buried remains of Limetree Cottages.

*Plate 7: Trench 3, looking south-east*

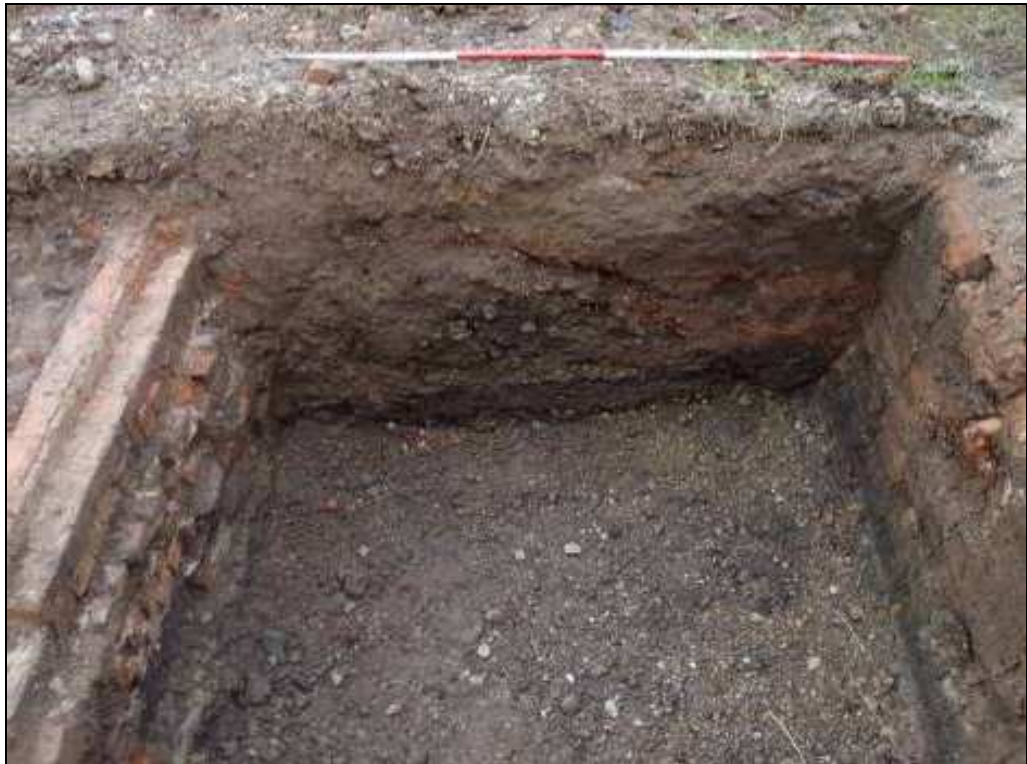
- 4.3.3 At the south-eastern end of the trench, the mechanical excavator removed 1.20m of deposits to expose the river gravels (**310**) at a depth of 1.34m below the ground surface (Plate 8). Overlying the gravel, at the south-eastern end of the trench was 0.18m of what was possibly a truncated soil horizon, layer **308**. Overlying **308** was 0.92m of levelling deposits (**304** and **305**), and 0.28m of stone chippings, **311** (Plate 8). Layers **304**, **305** and **308** all contained nineteenth-century pottery. A sondage in the centre of the trench adjacent to wall **309** produced almost identical levelling material, recorded as deposit **302**, overlying the river gravels.

*Plate 8: South-west-facing section of Trench 3, at its south-eastern end, looking north-east*

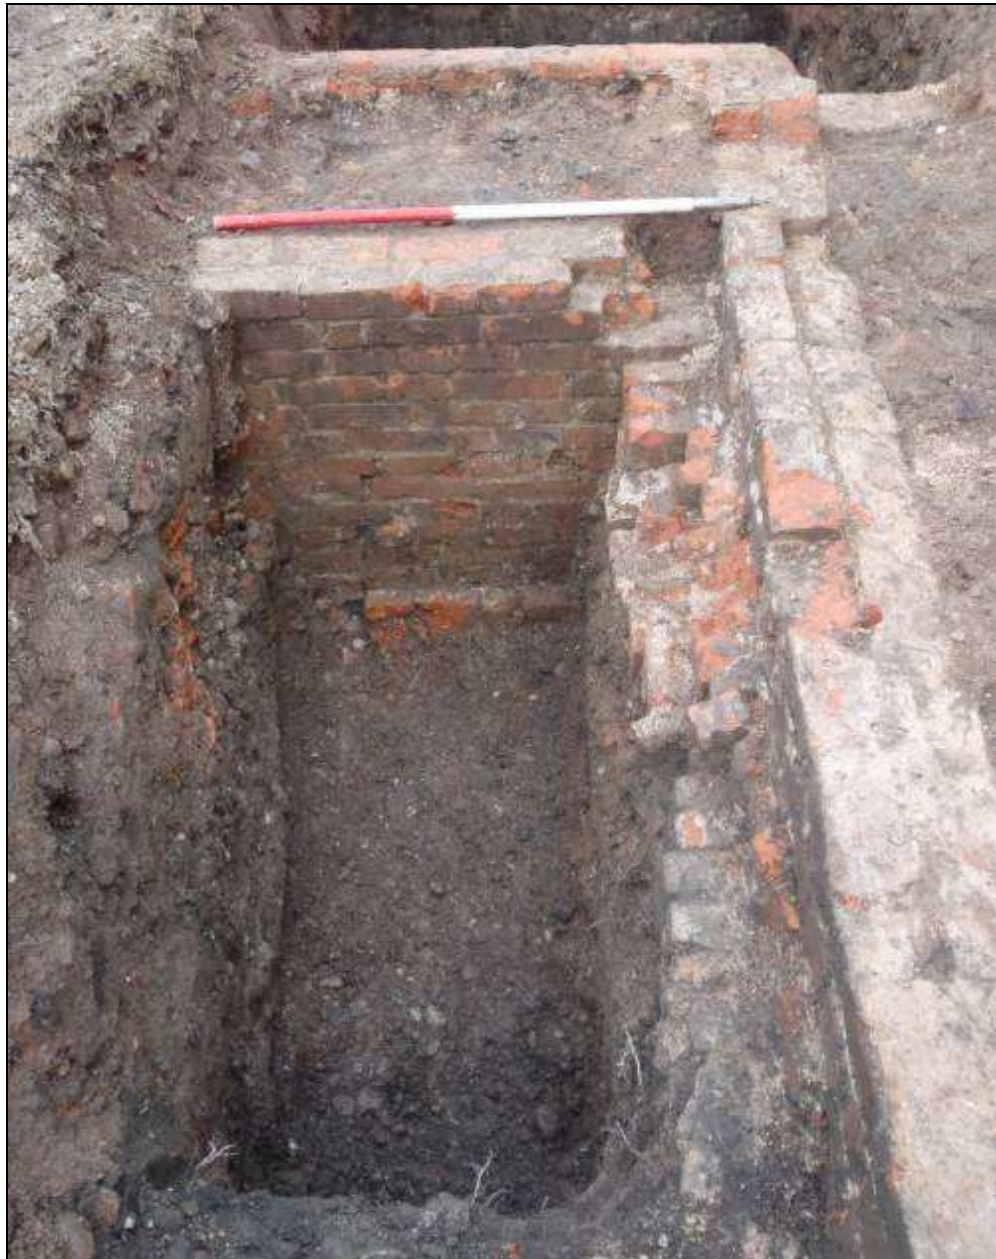
- 4.3.4 The foundations of three walls were located within the trench, structures **301**, **303** and **309**, in addition to a small inspection hole for a nineteenth-century drain (**306**). The earliest of these structures appeared to be wall **309**, located in the centre of the trench (Plate 9). It was constructed of red bricks laid predominantly as stretchers, with the occasional apparently random header used to tie to the two sides of the wall together, bound by a light grey cement mortar. It appeared to be truncated by wall **303**. The position and alignment of foundation **309** corresponds with a boundary wall depicted on the Great Northern Railway plan of 1871 (Fig 3).

*Plate 9: Wall 309, looking south-east*

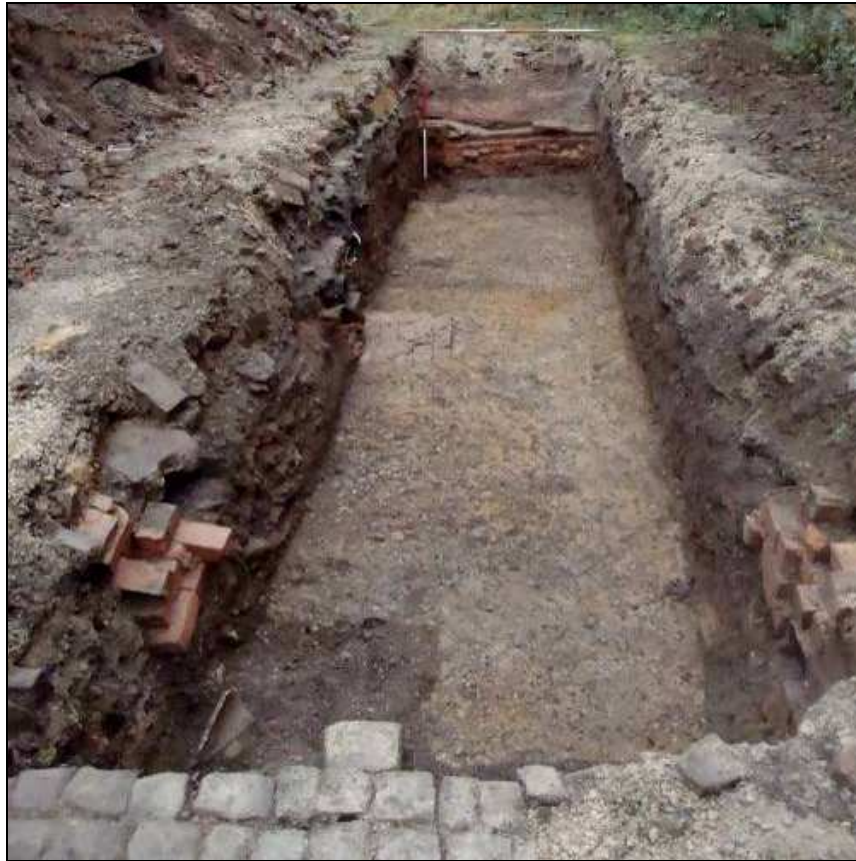
- 4.4.1 Trench 4 was aligned north-east/south-west across the south-western part of the study area, measured 10 x 2.0m, and was excavated to a maximum depth of 1.3m (Fig 2 and 8; Plate 10). The trench targeted the eastern edge of Short Street depicted on Rogerson's map of 1819 (Plate 1).

*Plate 10: Trench 4, looking south-east*

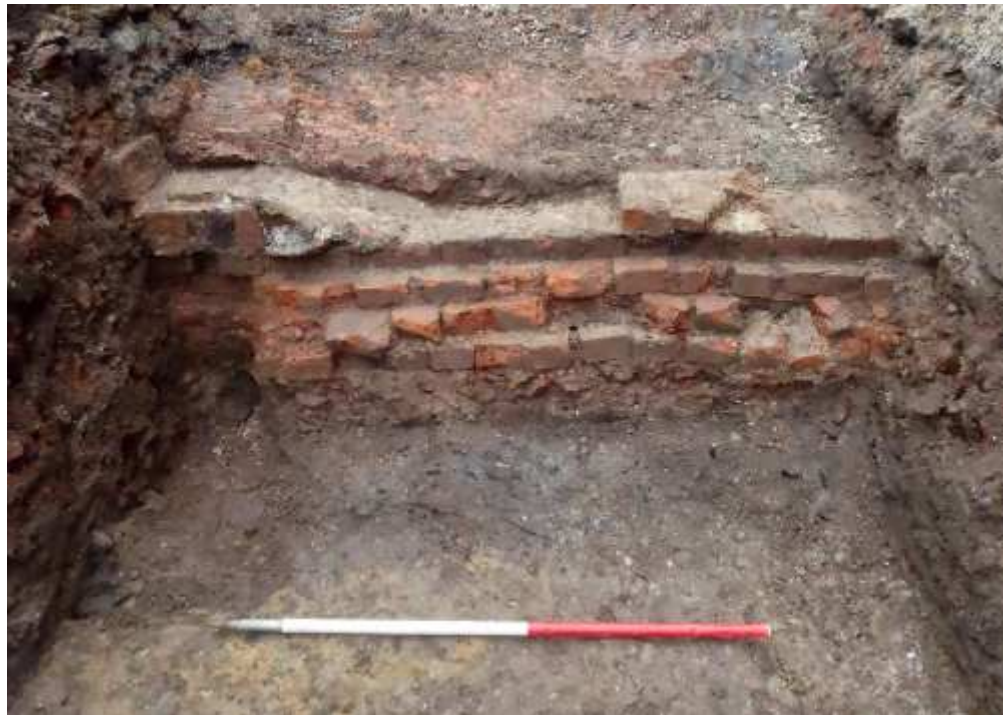
- 4.4.3 Structural remains within Trench 4 included an inspection chamber for nineteenth-century ceramic drains (**407**), and brick foundations (**404** and **409**). The earliest of these appeared to be wall **409**, located at the south-eastern end of the trench (Plate 11). The footing of this wall comprised red brick laid predominantly as headers, followed by a row of alternate headers and footers bound by a mid-grey lime mortar. It corresponds with the position of a south-eastern wall of a building depicted on the Great Northern Railway plan of 1871 (Fig 3). This wall was cut by a late nineteenth- or twentieth-century pit (**411**).

*Plate 11: Wall 407 of Trench 4, looking south-east*

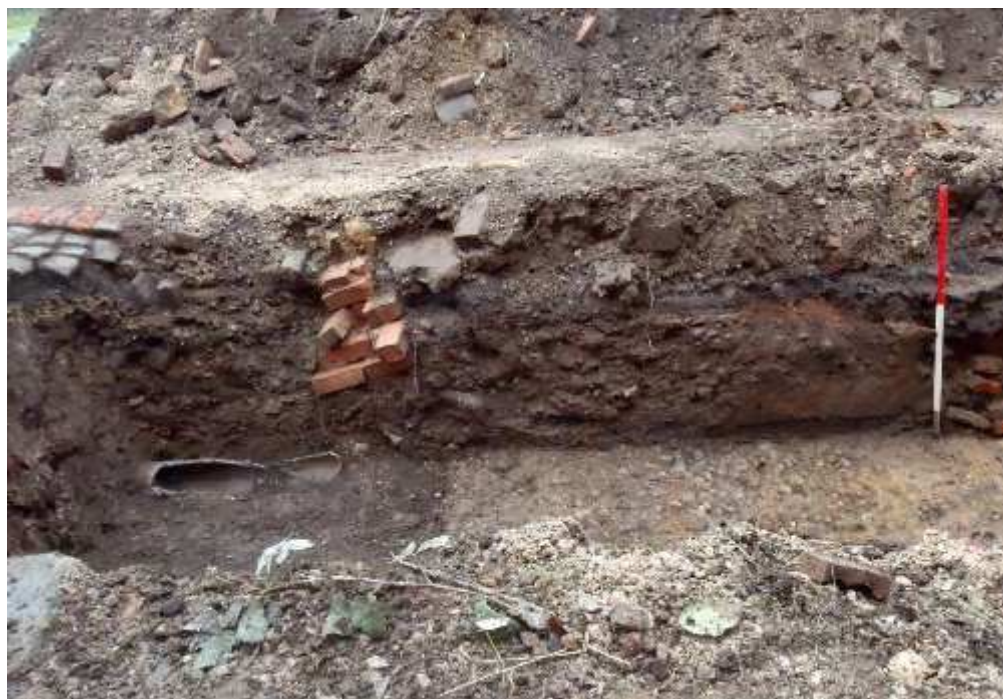
- 4.4.4 At the north-western end of the trench, foundation **404** was a later construction, although mapping evidence does not help in this instance. It comprised of twentieth-century machine-pressed bricks, bound by a hard mid-orangey brown sandy cement mortar, built above a nineteenth-century ceramic drain (Plate 12). It appeared to create the western limit of stone setts **402**.

*Plate 12: Wall 404 and ceramic drain within Trench 4, looking north-east*

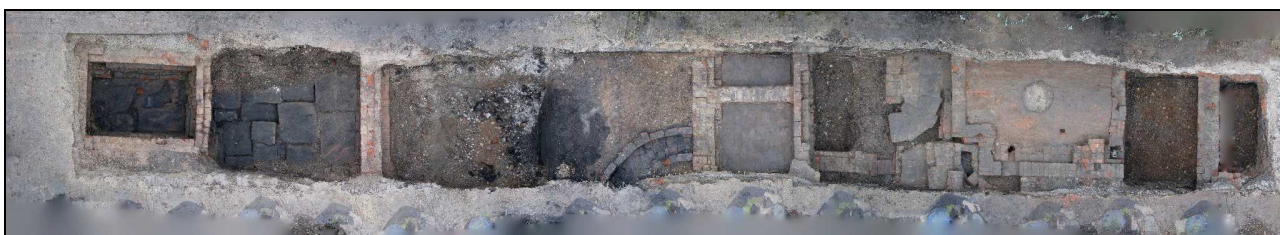
- 4.5.1 Trench 5 was excavated on a north-east/south-west alignment across the central part of the study area, initially incorporating areas that do not appear on historical mapping to have been subject to intensive development. It was moved from its intended position to the south-east to avoid an existing building, incorporating buildings depicted in the Great Northern Railway plan of 1871. The trench measured 20 x 2m (Figs 2 and 9; Plate 13).

*Plate 13: Trench 5 produced from rectified photographs, the north-eastern end of the trench to the right*

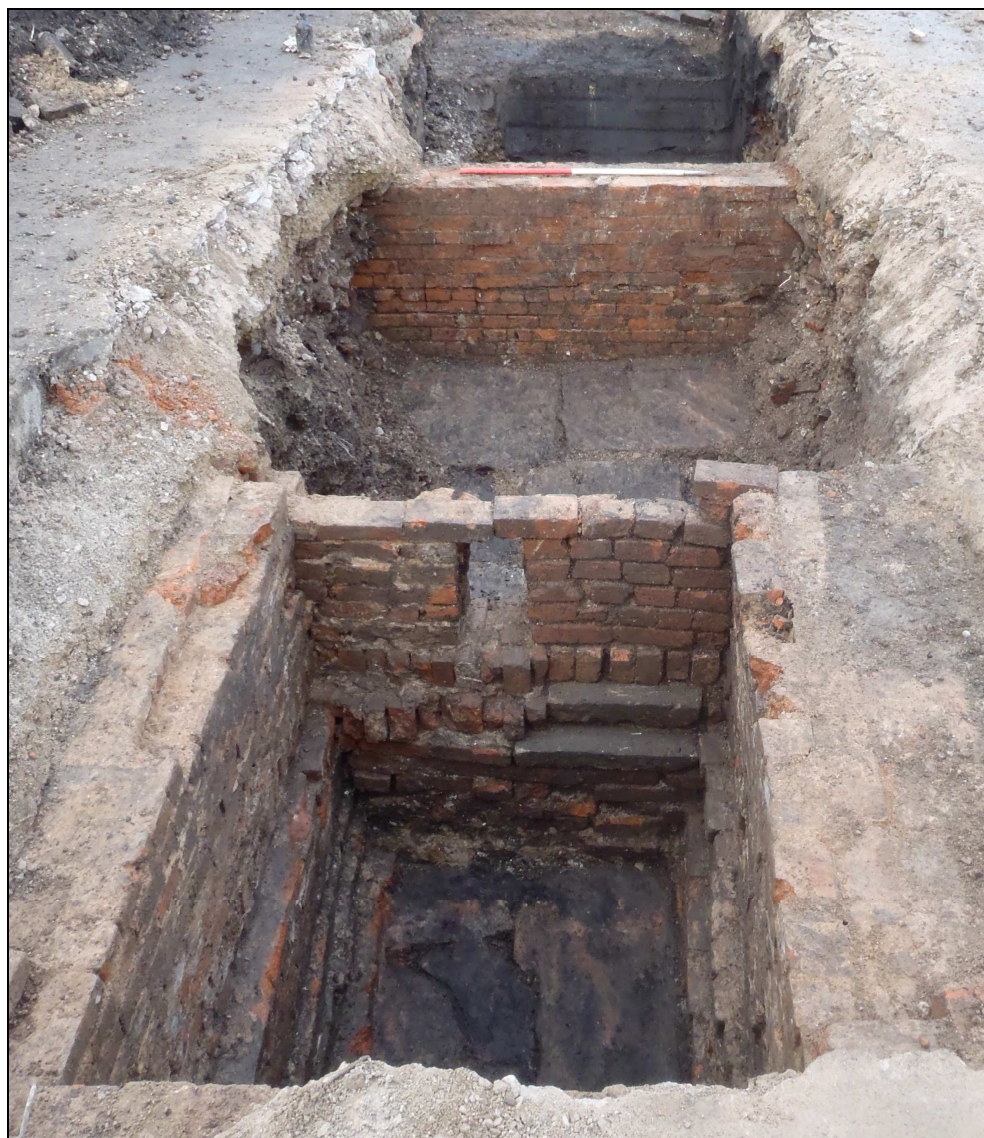
*Plate 14: Cellar located at the south-western end of Trench 5, looking north-east*

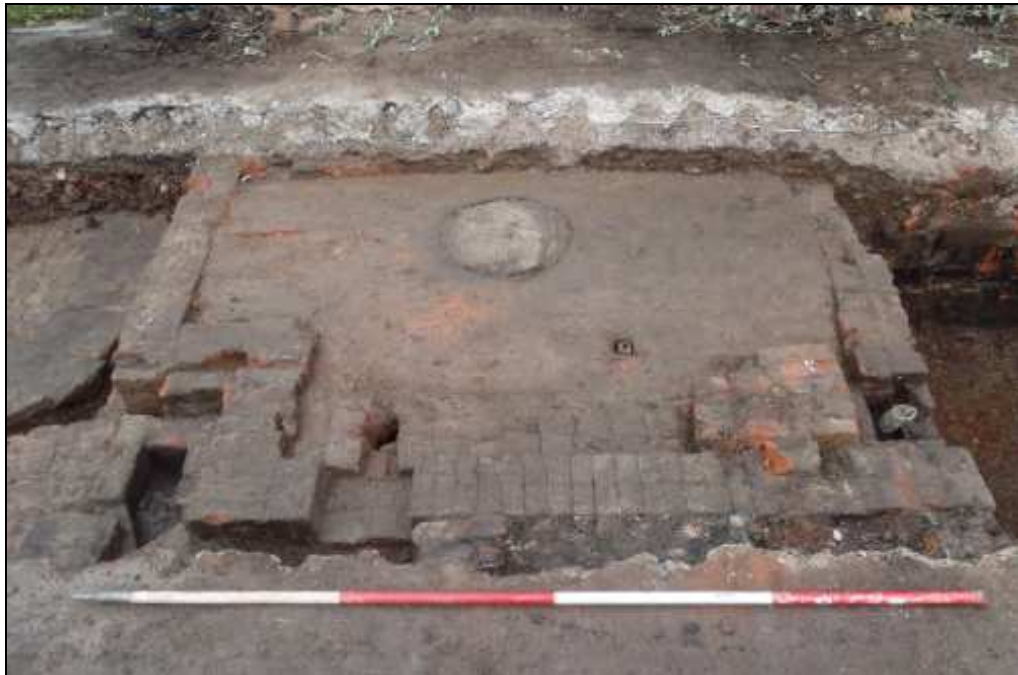
- 4.5.5 Structures located at the north-eastern half of the trench correspond to buildings first depicted on the Great Northern Railway plan of 1871 (Figs 3 and 9; Plates 13 and 15), some of which have evidently been modified by the time of the 1882 Ordnance Survey map of the area (Fig 4). The position of walls **523** and **508** correspond to the north-eastern and south-western walls of a small building, located between to larger buildings, depicted on the 1871 plan (Fig 3). A vaulted cellar was located within this building, created by walls **517**, **519** and **512**, with a vaulted ceiling (**520**; Plate 15). A circular hole, measuring 0.53m in diameter, had been plugged by concrete in the centre of this ceiling possibly a coal chute. A 3 inch lead water-pipe and a second 2 inch iron pipe were also located entering this cellar, with a small hole in the roof suggesting a third pipe may have been removed. Two coins, one bearing a date of 1861, were recovered from sediment around the lead water pipe.

*Plate 15: Vaulted cellar at north-eastern end of Trench 5, looking north-east.*

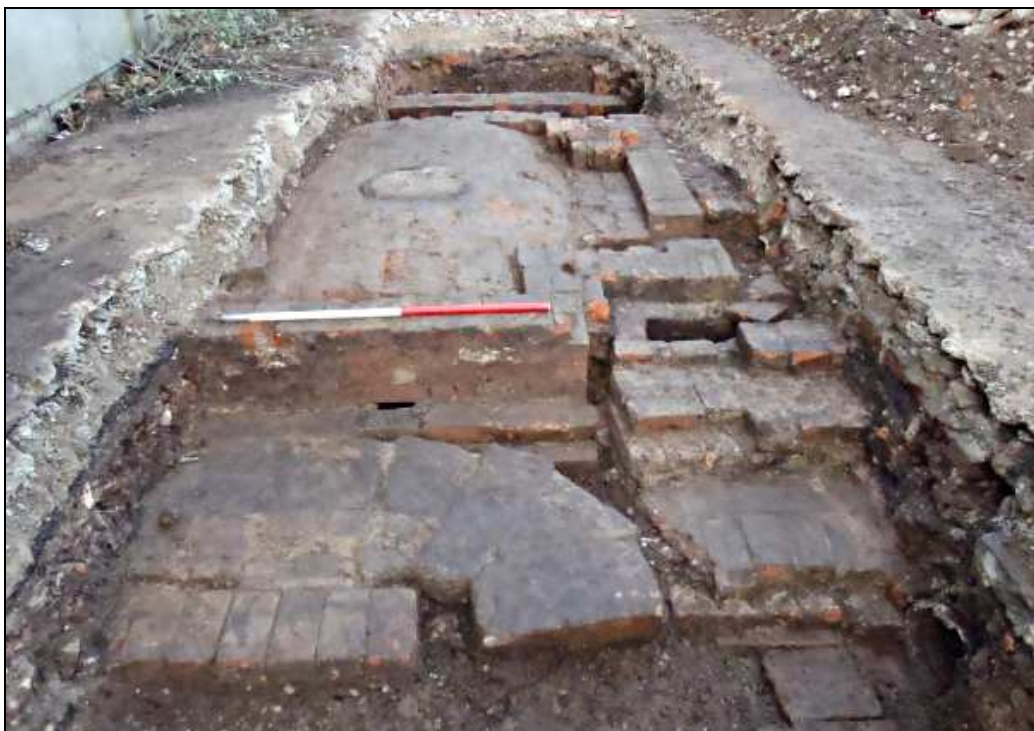
- 4.5.6 To the south-east of the vaulted cellar, a brick and masonry floor (**525**, **513** and **528**) was exposed (Plate 16). Within the stone element of this surface (**513**), two iron fittings measuring 20mm in diameter were present; presumably where a machine had been secured to the floor. It was speculated that **514** and **515**, to the right in Plate 16, formed steps down to level of **513**.

*Plate 16: View of stone flags **513** and surrounding brick work to south-west of vaulted cellar, **502**, looking north-east*

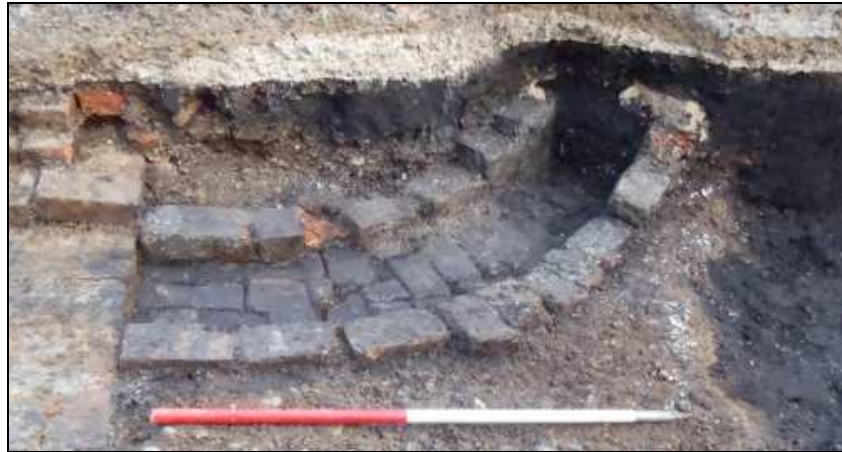
4.5.8 Two drainage features were located. Drain **516** was constructed adjacent to the vaulted cellar, constructed of red brick sides and with a tile floor and base, measuring 0.40m wide and draining water to the south-east (Fig 9). Drain **507** was located in the centre of the trench, constructed with brick sides and floor, and sandstone capping stones (Fig 9; Plate 17). Drain **507** butts up to wall **508**, and would also have drained water to the south-west.

*Plate 17: Drain 507, looking south-west*

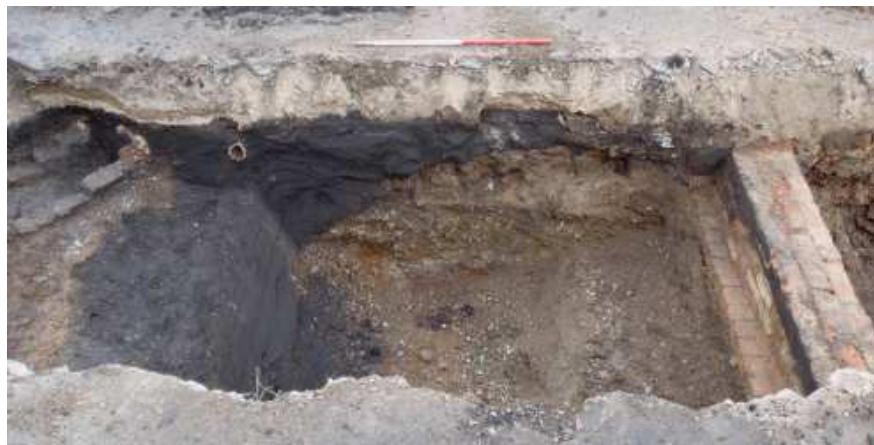
4.5.9 Pit **505**, located in the centre of the trench, is thought to be a relatively late feature located directly below the stone chippings used as levelling for the current concrete surface (Fig 9; Plate 18). It measured 1.6m wide and 1.12m deep, although the upper 0.10 to 0.20m of its fill (**504**) was spread over most of the trench between walls **508** and **503**. The original excavation of this pit appears to have removed several of the capping stones of drain **507**. No finds were recovered from this feature, but its very dark silty fill suggests that it had been a soak-away.

*Plate 18: North-east-facing section of pit 505*

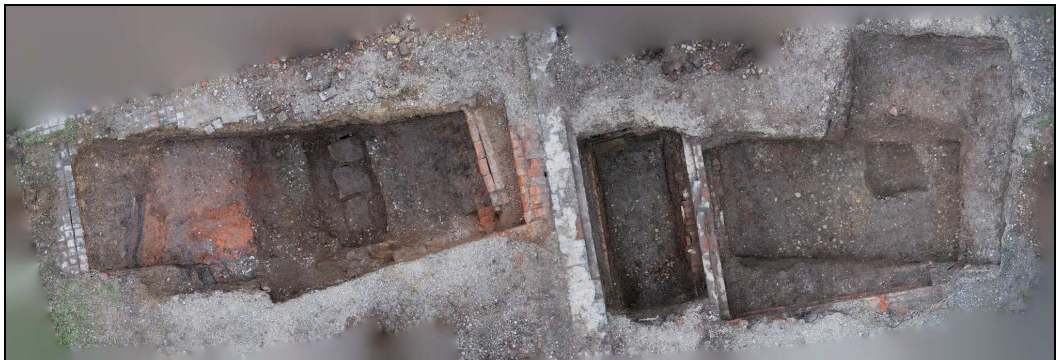
4.6.2 **Trench 6A:** was excavated to a maximum depth of 1.5m. River gravels, **608**, were located at this depth in both ends of the trench (Fig 10; Plate 19). These had been overlain with eighteenth or nineteenth-century levelling deposits containing lenses of clinker and crushed red brick, deposits **612** and **613**. Several structures were located within the trench. The two earliest of these are wall **604** and culvert **605**, both constructed on a north-east/south-west alignment, located at the west-north-western half of the trench (Fig 10).

*Plate 19: Trench 6B reproduced from rectified photographs, with the north-western end of the trench to the left*

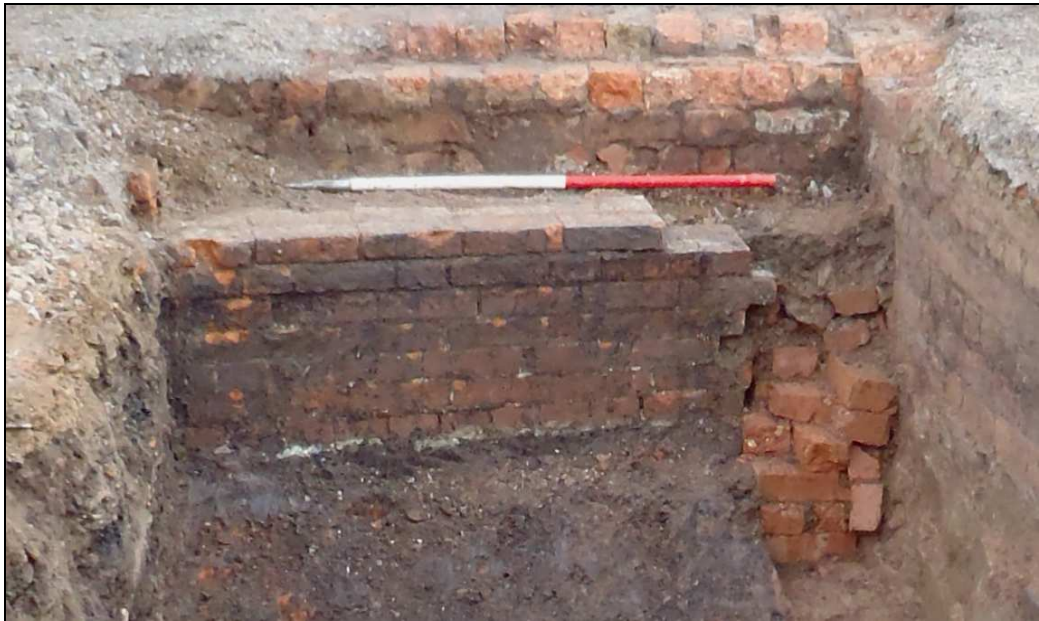
4.6.3 The position and alignment of wall **604** closely matches that of a boundary wall depicted in the Great Northern Railway plan of 1871, and which formed the south-western boundary of Short Street (Plate 20). The first course of bricks of this wall were laid as headers upon a bed of lime mortar, followed by four courses of stretchers, and then changing to a Flemish Bond bonding pattern. Wall **604** has clearly been truncated by the construction of wall **615**, with the gap between **604** and **615** filled by loosely laid bricks **610** (Fig 10).

*Plate 20: Wall 604, looking west-south-west*

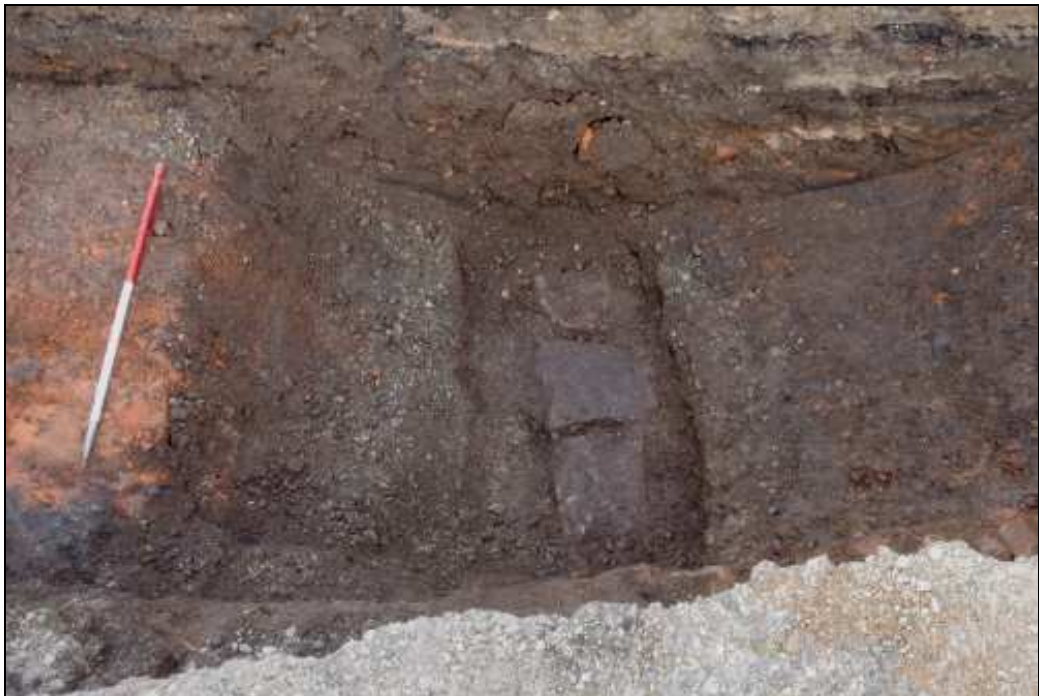
- 4.6.4 Culvert **605** was located at such a depth it could not be fully investigated (Fig 10; Plate 21). It was constructed using red brick for its sides, and roughly hewn sandstone used as capping stones.

*Plate 21: Culvert 605, within construction cut 606, looking east-north-east*

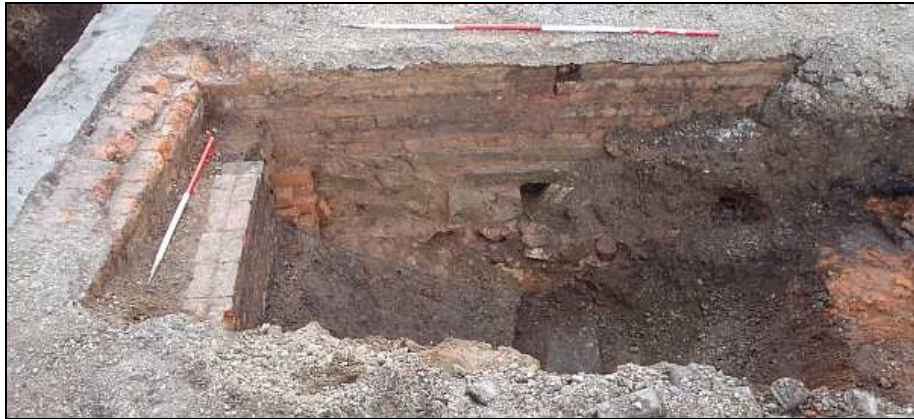
the viaduct would have been built, is at a slight angle to the north-west/south-west-aligned viaduct. Despite this, wall **611** is a substantial construction (Plate 22). Large, randomly coursed and roughly hewn sandstone blocks have been used as a footing for this wall where it crosses culvert **605**, measuring 0.50m high. The brick component of this wall comprised a further 0.70m of red brick utilising an English Bond bonding pattern.

*Plate 22: Wall 611, looking south-west*

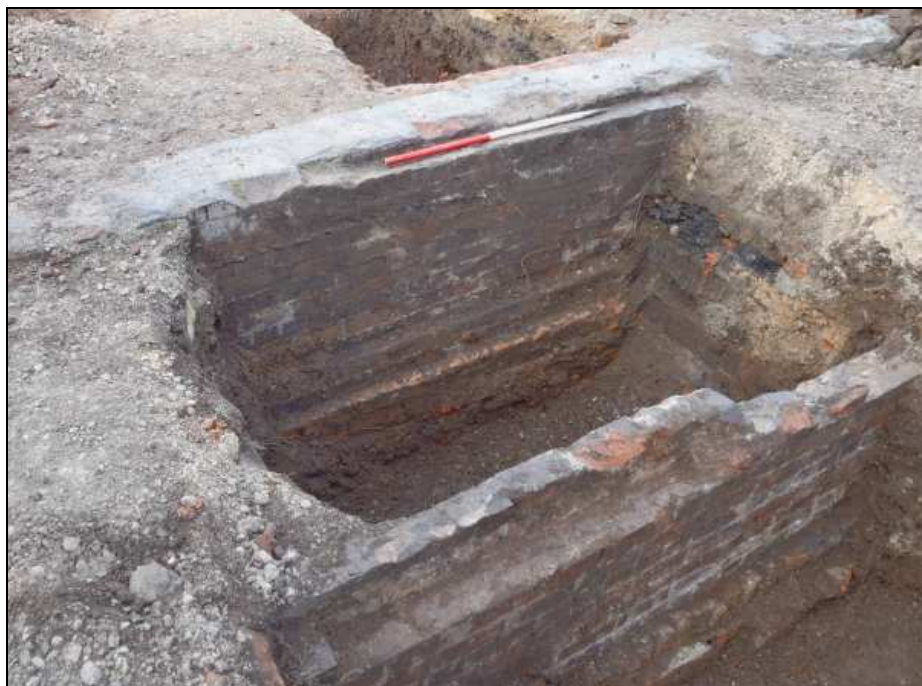
4.6.6 The position of wall **603**, to the south-east and parallel to wall **615**, matches the position of a building depicted on the 1901 Ordnance Survey map of the area, constructed adjacent to the viaduct (Figs 5 and 10; Plate 23). It was constructed of red brick utilising a English Bond bonding pattern, and measured 0.40m wide and 1.25m high. Wall **602** (Fig 10; Plate 23), to the south-east of and parallel to **603**, and wall **609** at the south-eastern end of the trench, are thought to be an internal divisions within this building.

*Plate 23: Walls 602 and 603, looking north*

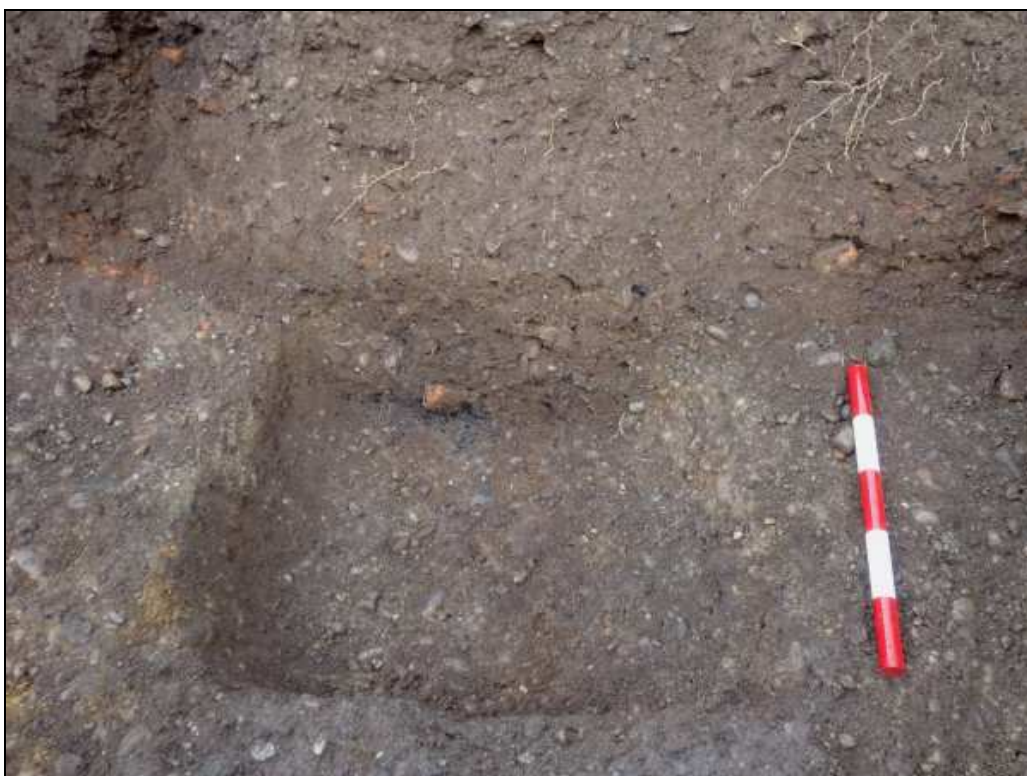
- 4.6.7 At the south-eastern end of the trench of the trench a linear feature cut into the river gravels, feature **601** (Fig 10). It clearly must pre-date the construction of wall **609**, but its fill contained fragments of cement mortar and red brick fragments, and it is not, therefore, considered to be of any great antiquity (Plate 24). Its function, however, remained unresolved.

*Plate 24: Linear feature 601, looking north-east*

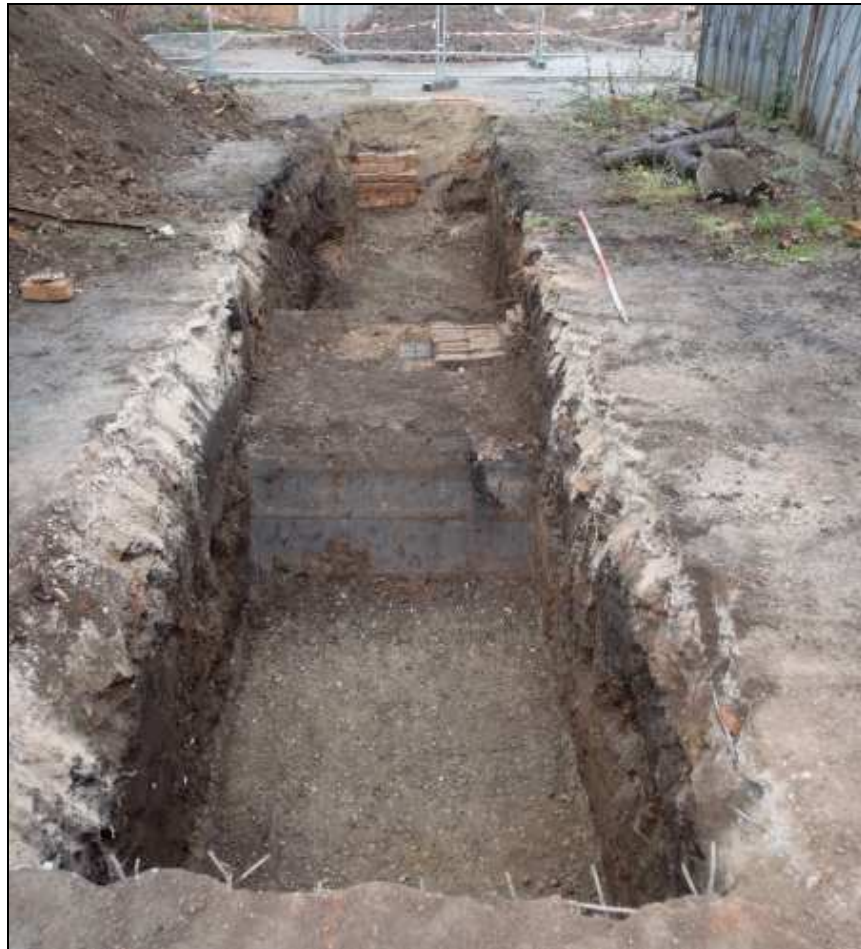
*Plate 25: Trench 6b, looking south-west*

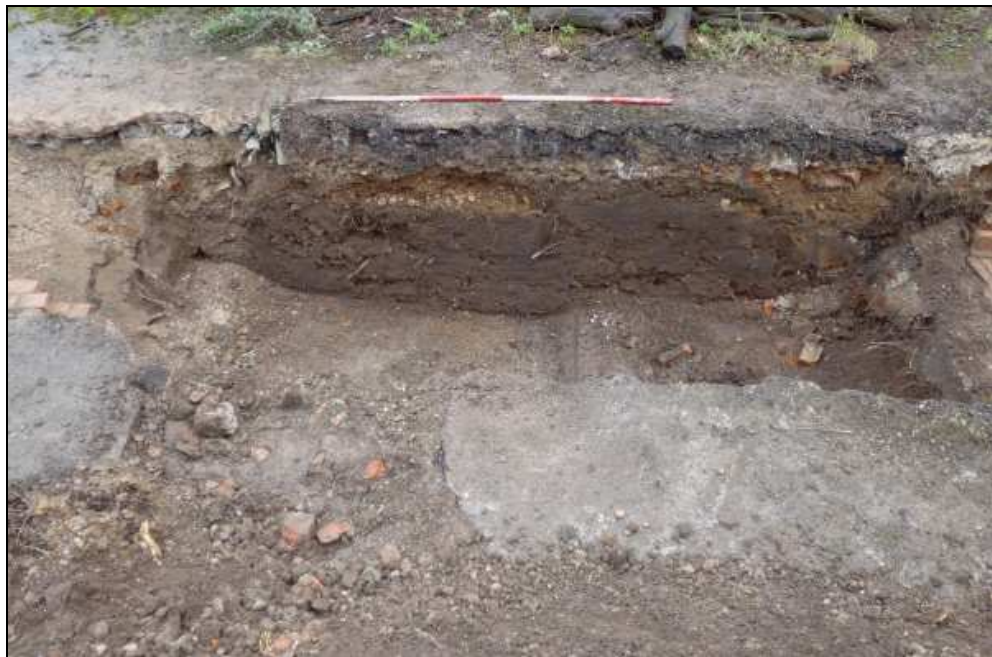
*Plate 26: North-western end of Trench 6b, looking south-east, showing garden soils  
**622** and levelling **620***

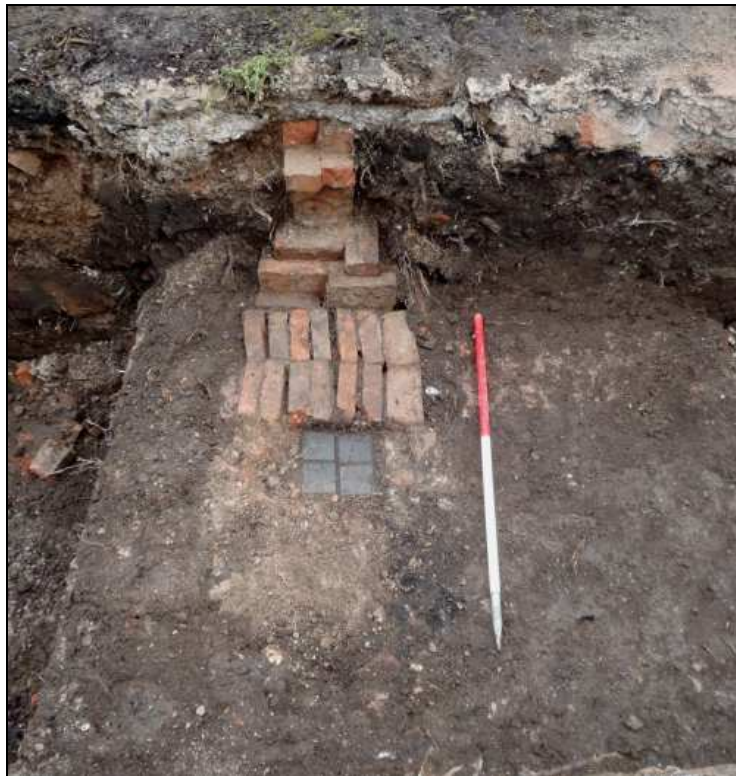
*Plate 27: Wall **623** and linear **628**, looking south-east*

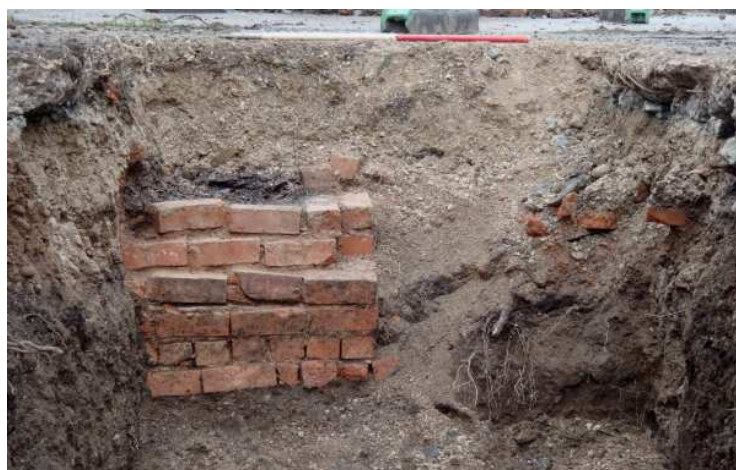
- 4.6.10 Footing **625** was located at the north-eastern end of the trench, forming the south-eastern corner of a structure (Fig 11; Plate 28). No exact match for this structure was located, but it is thought to be of a late nineteenth-century or twentieth-century date.
- 4.6.11 One final feature was located to the south-west of wall linear **623**, truncating garden soil **622**, was located. Linear **628** comprised a shallow feature filled with clay, found on a north-east/south-west adjacent to the south-eastern edge of the trench (Fig 11; Plate 27). Its purpose was not clearly resolved, but it may have formed solid base or footing for a garden feature.

*Plate 28: Wall **625**, looking north-east*
