**LAND FRONTING  
AGARD STREET,  
DERBY**

**Archaeological Evaluation and  
Watching Brief Report**

Planning application Number: 12/08/01676  
National Grid Reference Number: SK 3472 3644  
AB Heritage Project no: 10008  
Date: 29 April 2011

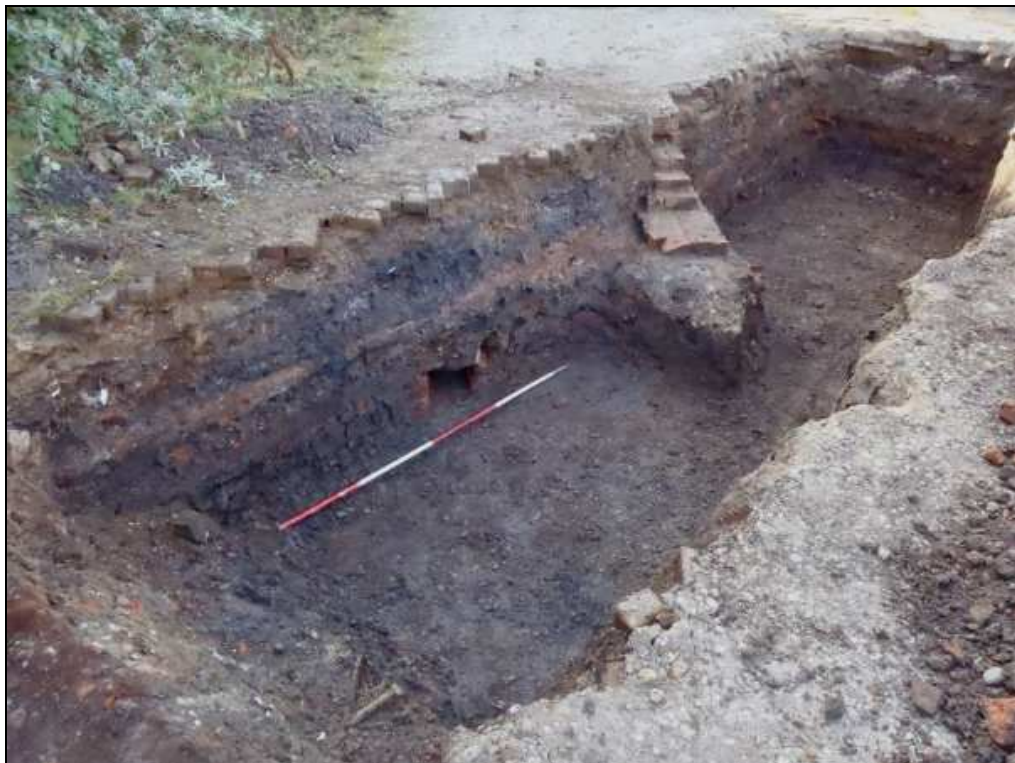
- 4.7.2 Trench 7 was excavated to a maximum depth of 1.42m, whereupon river gravel, **706**, was located (Fig 12; Plate 29). Directly overlying the gravel was 0.60m of dark grey soils mixed with stone and fragmented bricks and containing nineteenth-century pottery, layer **705**. In the north-eastern half of the trench, truncating layer **705**, was culvert **702**. It measured 0.50m wide and 0.40m deep, constructed with red brick sides, a tile base, and roughly hewn sandstone capping stones. This culvert was aligned north-east/south-west, with a connecting arm of its network from the north-west (Fig 12; Plate 30).

*Plate 29: Trench 7, looking south-west*

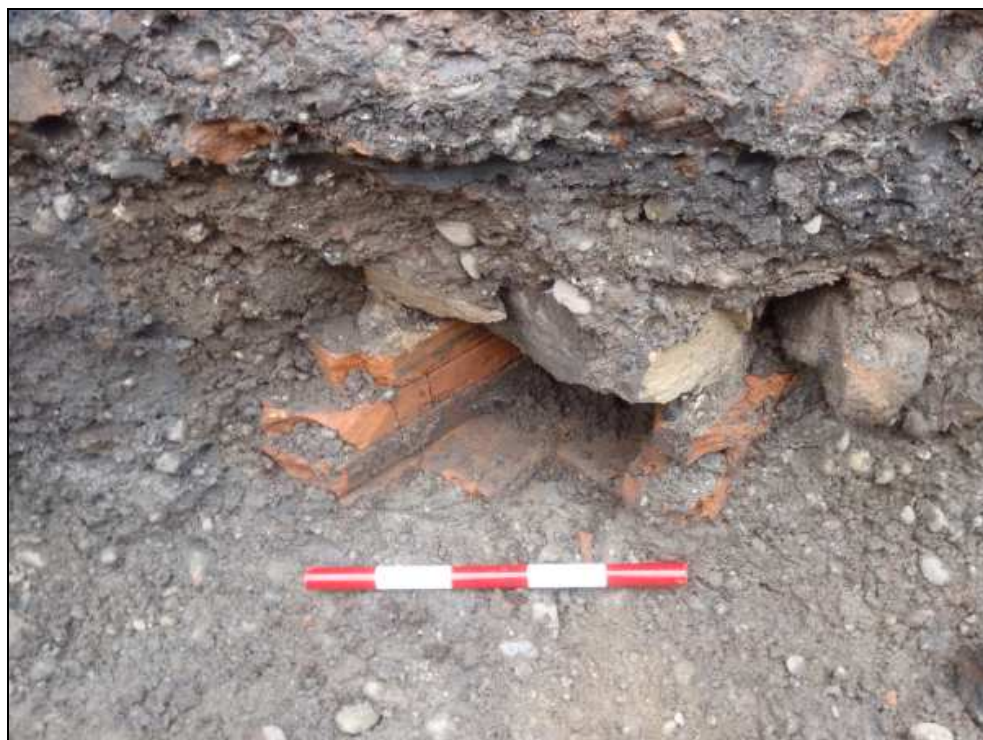
- 4.7.3 Overlying the culvert was layers of orangey grey clay, **704**, and dark grey levelling deposits, **703**, over which the sand, sets and stone chippings of the areas current surface had been placed. Truncating layer **703** was footing **701** (Plate 31). It measured 0.47m wide at its base, and 0.60m high, constructed upon a concrete sill. Its position matches the north-western outer wall of a building depicted on the 1882 Ordnance Survey map of the area, although its does not continue across the entire trench.

*Plate 30: Culvert 702, looking south-west*

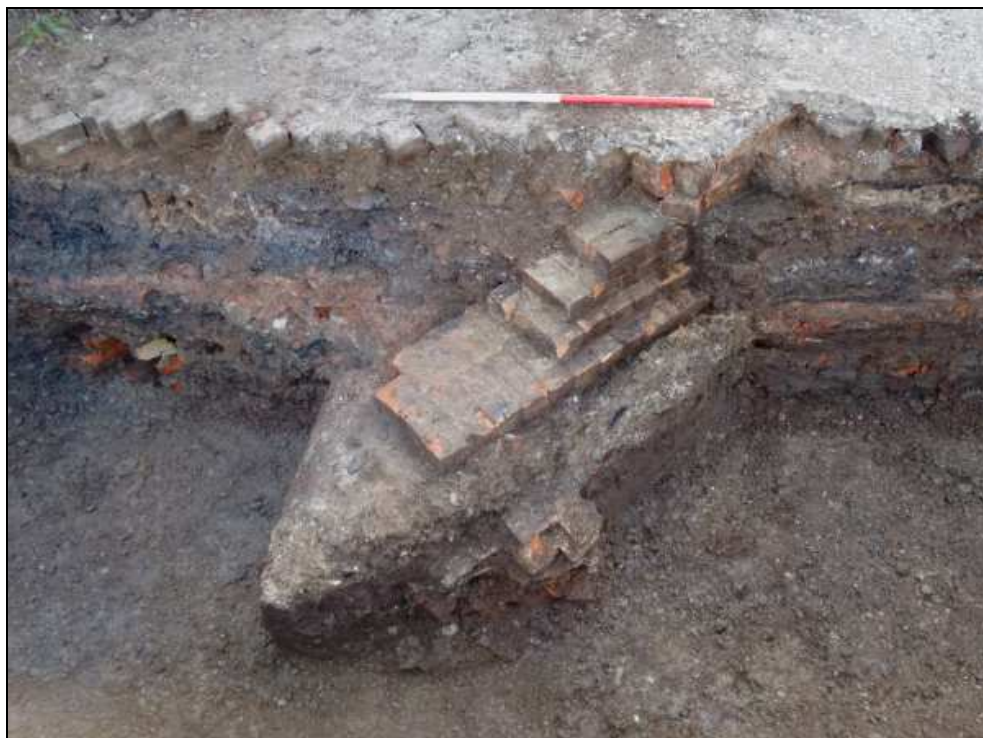
*Plate 31: Wall 701, looking south*

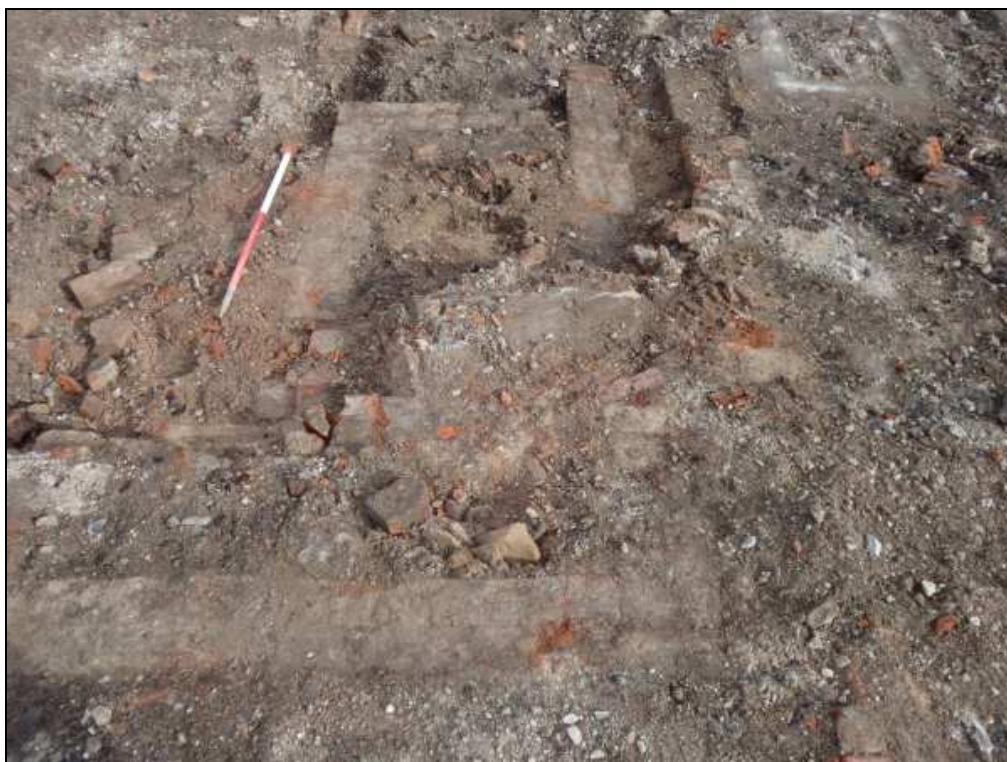
*Plate 32: Walls **9015** and **9023** truncated by Dilke's Terrace, looking north-east*

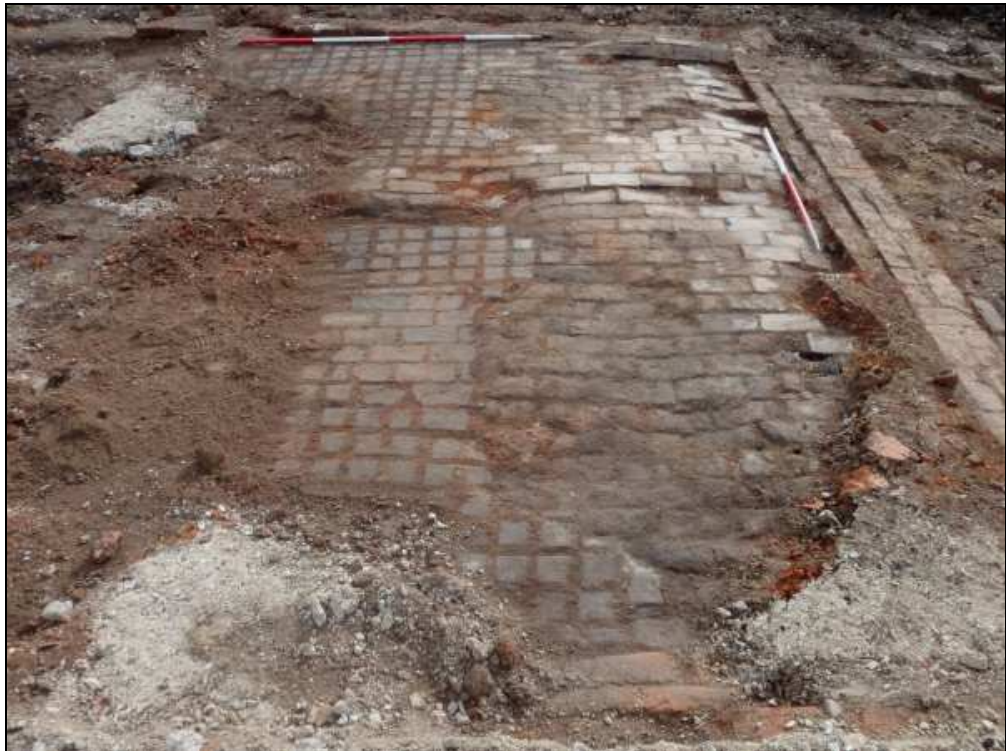
*Plate 33: Brick floor, **9001**, and wall, **9002**, of the larger rectangular-shaped building, looking south-east*

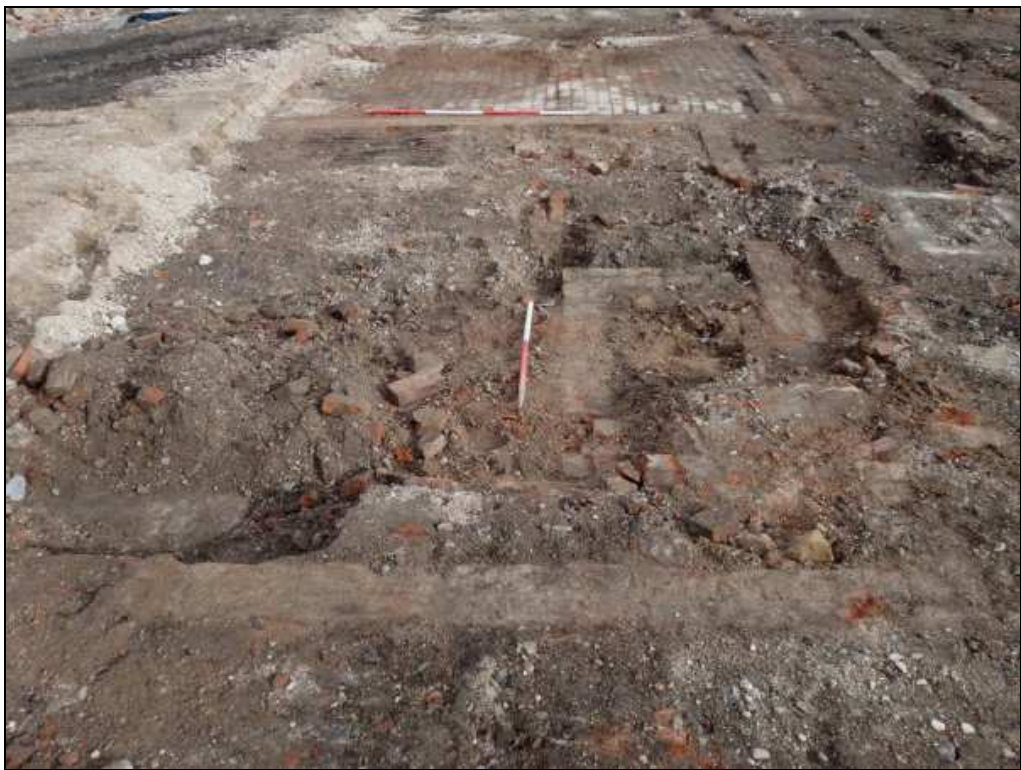
*Plate 34: Smaller rectangular building defined by walls **9002** and **9003**, looking north-east*

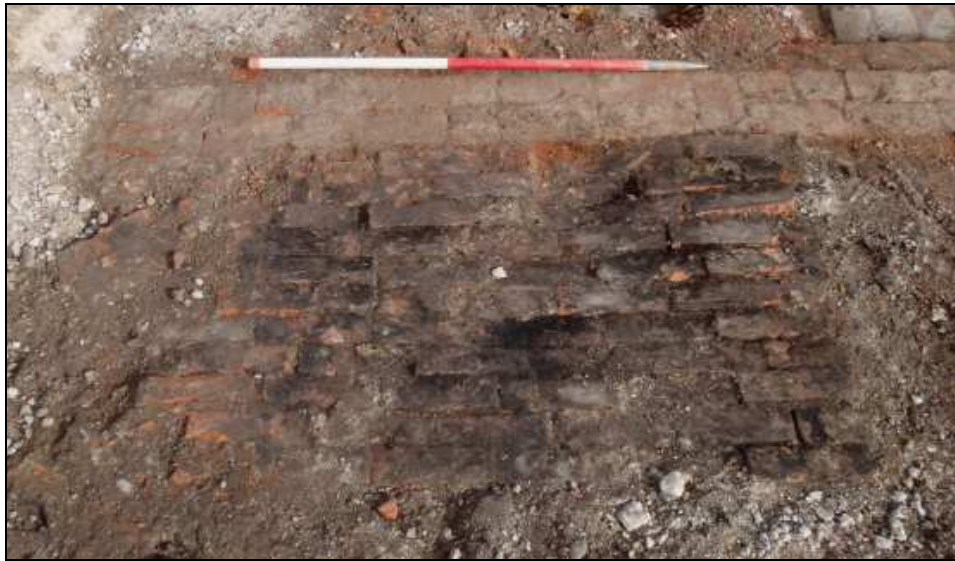
*Plate 35: Red brick floor **9004**, looking north-east*

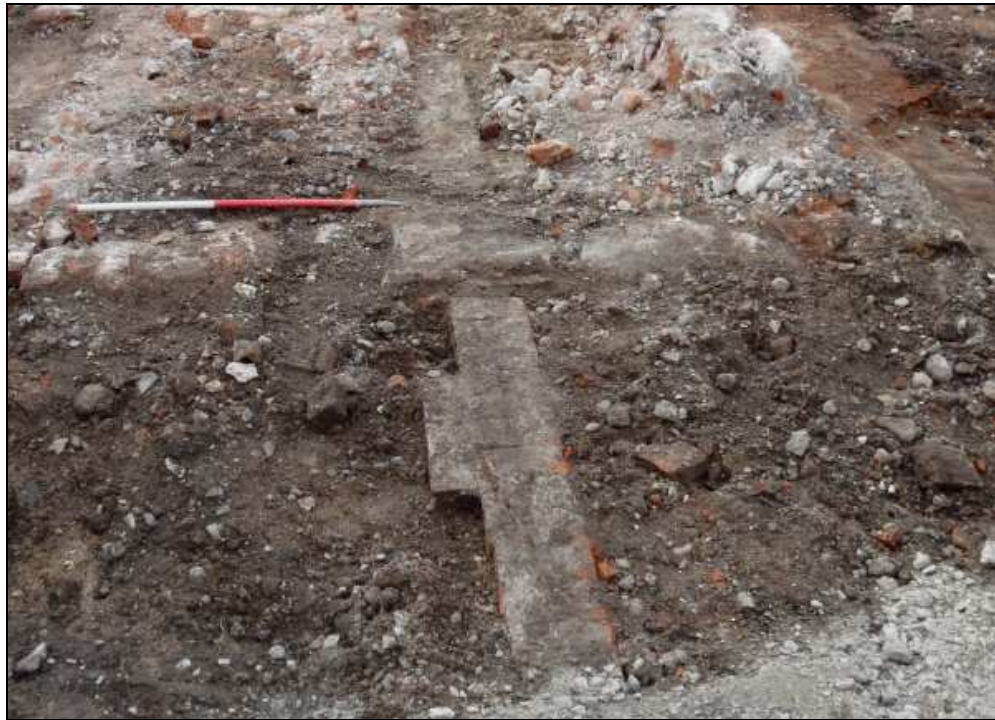
*Plate 36: Walls **9018** and **9019**, truncated by Dilke's Terrace, looking south-west*

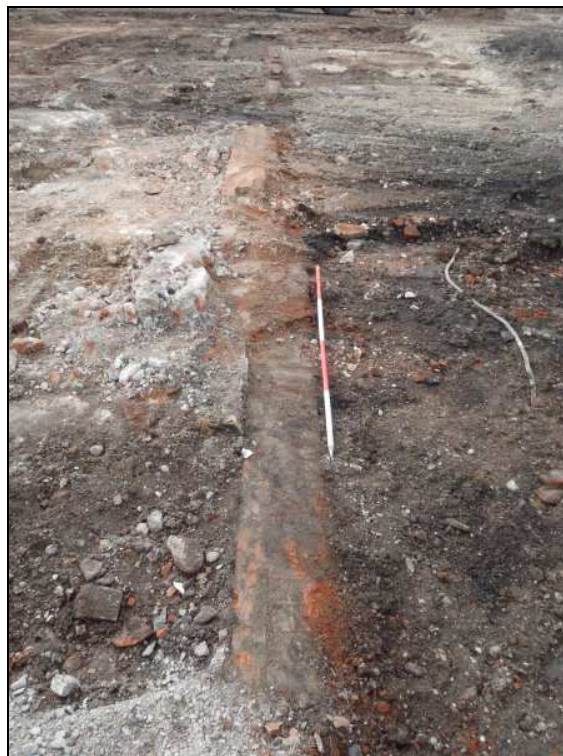
*Plate 37: Wall **9020**, looking south-west*

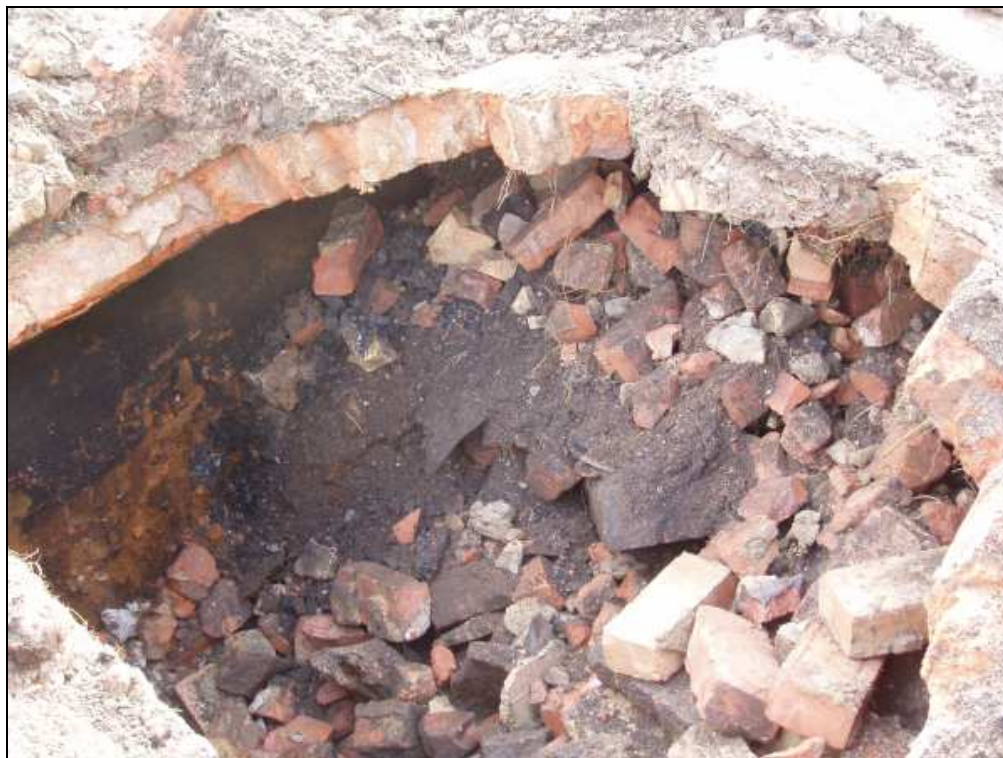
5.2.8 In addition to these structures, the vaulted cellar previously described in Trench 5 (see Section 4.6.5) was disturbed by the mechanical excavator (Plate 38). Little further could be added to the description of the cellar, except that the both the lead and iron pipe observed in the trial trench appear to have been cut off within the cellar

*Plate 38: Vaulted cellar of Trench 5, looking south-east*

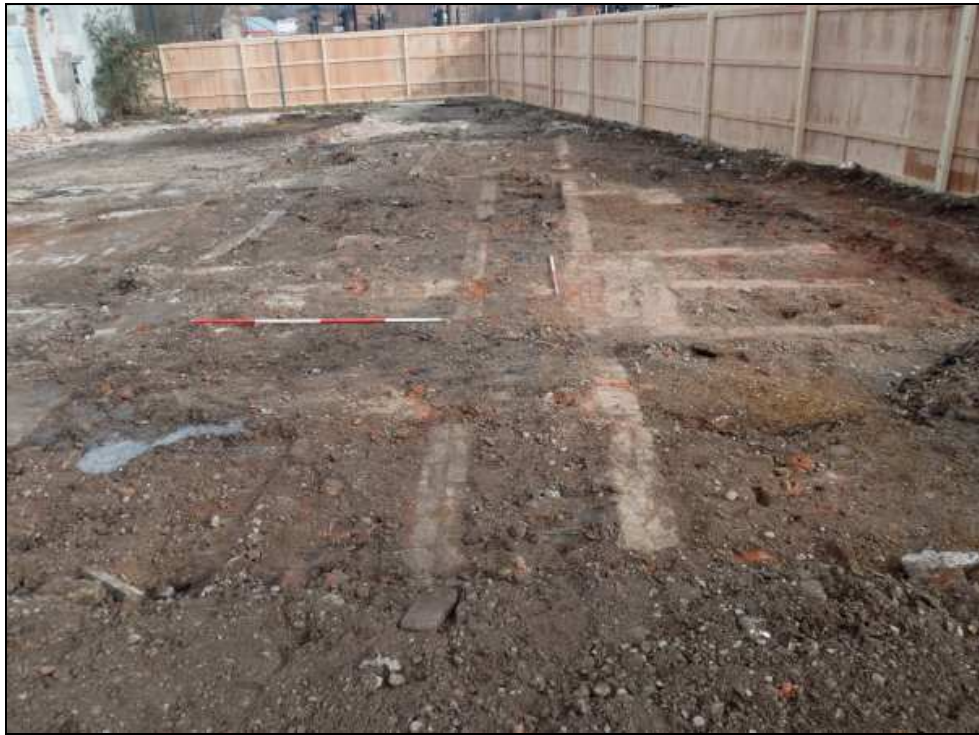
*Plate 39: Walls of the rear of Dilke's Terrace, looking north-east*

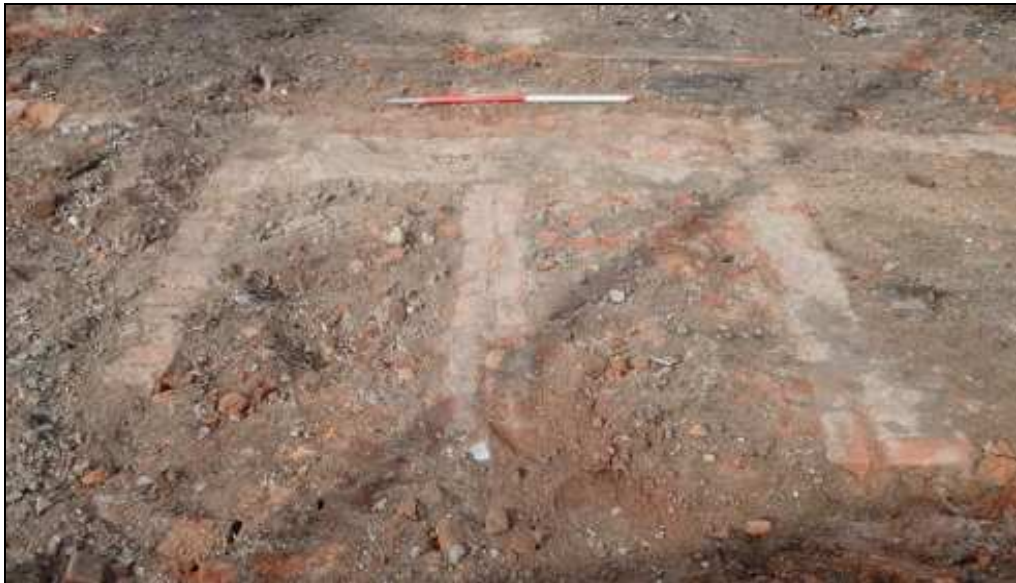
*Plate 40: Footings of two possible stairwells of Dilk's Terrace, looking north-west*

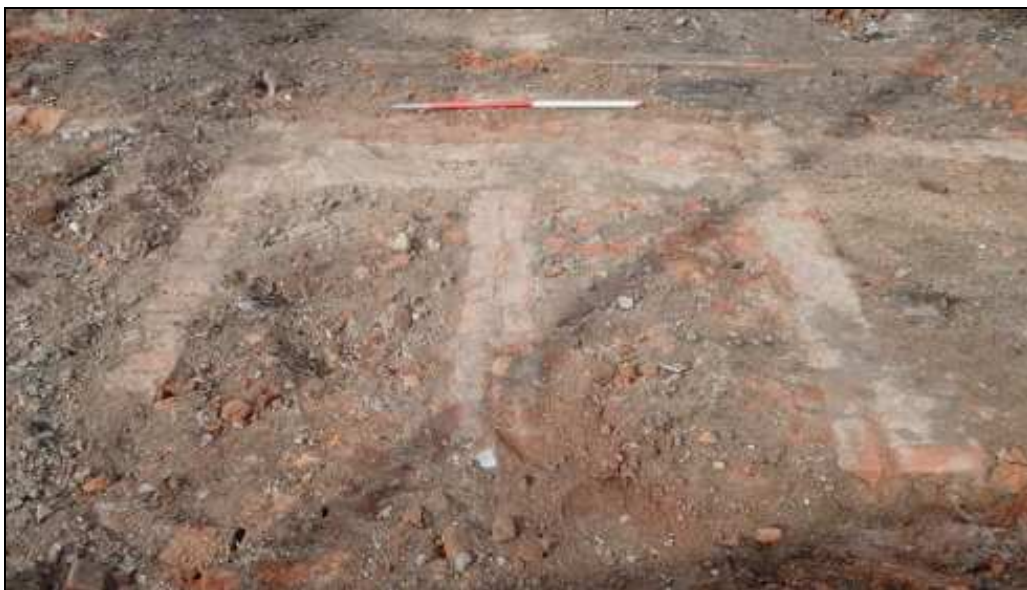
*Plate 41: Walls of Limestreet Cottages, **9012**, looking north-west*

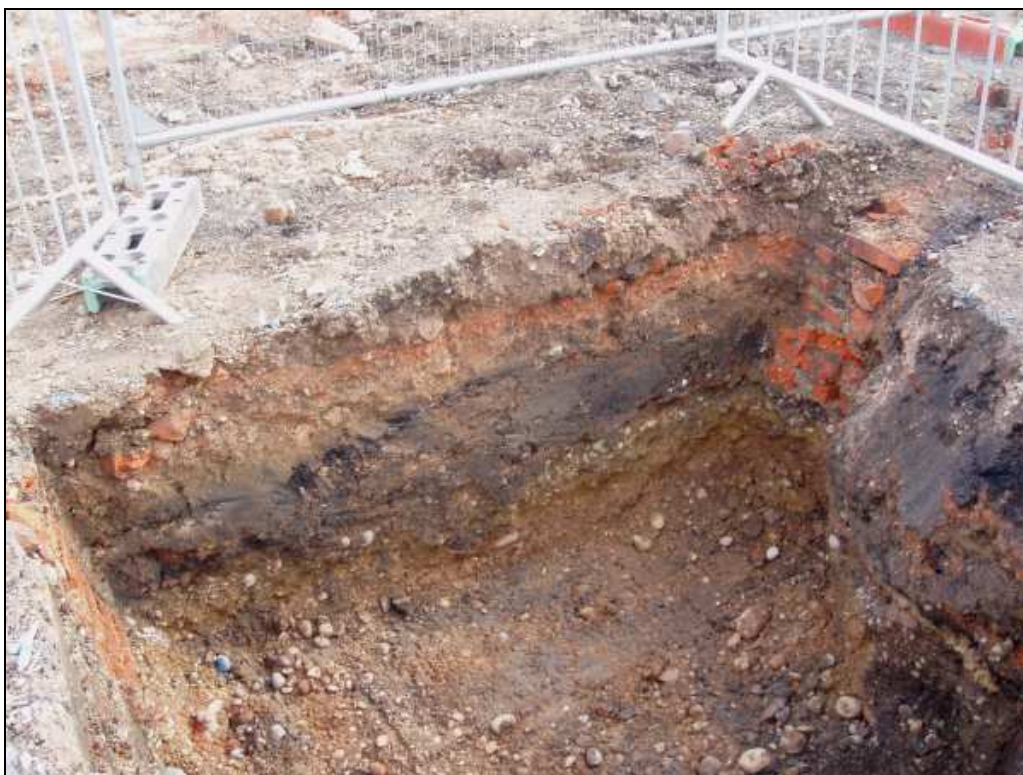
*Plate 42: Pile Cap 1, looking south-east*

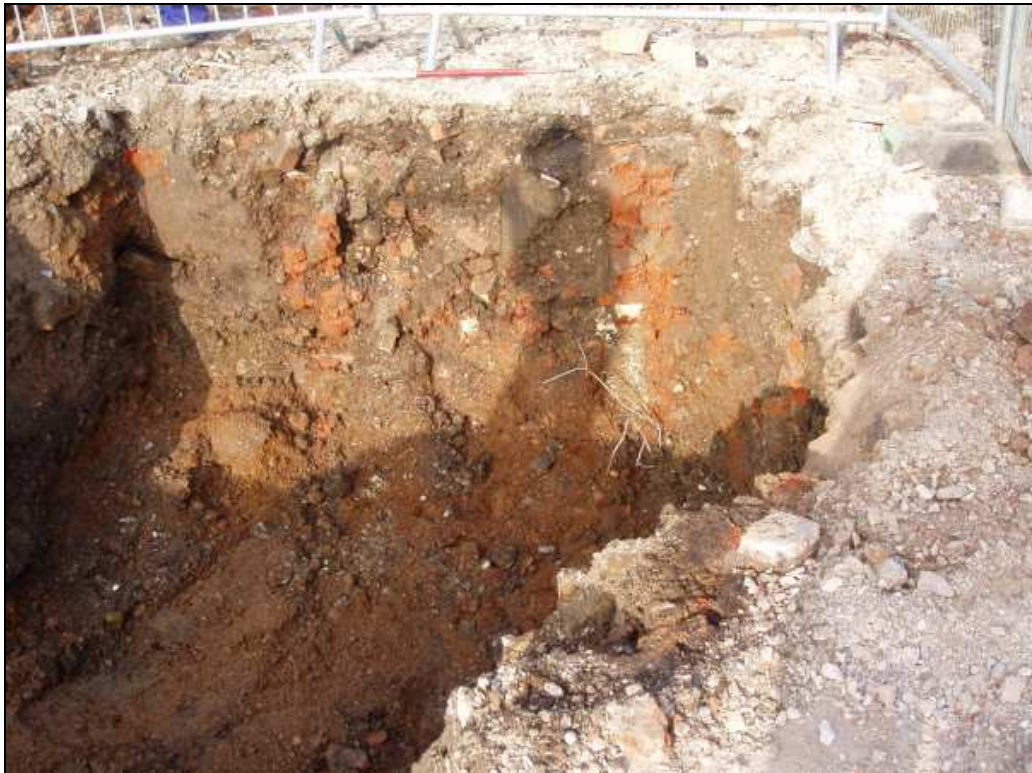
- 5.3.5 Wall **2001** follows the same orientation as **2003**, with a south-eastern return just visible within the excavation (Fig 13; Plate 43 and 44), and the two buildings appear to respect each other. No obvious match for this structure was found when compared to historical mapping, but it presumably is of a similar period to those on the 1871 plan. Wall **2002** is on a north-west/south-east alignment, and truncated both walls **2001** and **2003** (Fig 13; Plate 43). It would appear to be a twentieth-century construction, and probably dates to the modification of these earlier buildings to the form in which they appear on the 1914 OS map.

*Plate 43: Pile Cap 2 showing walls **2001** and **2003** in the south-west-facing section, looking north-east*

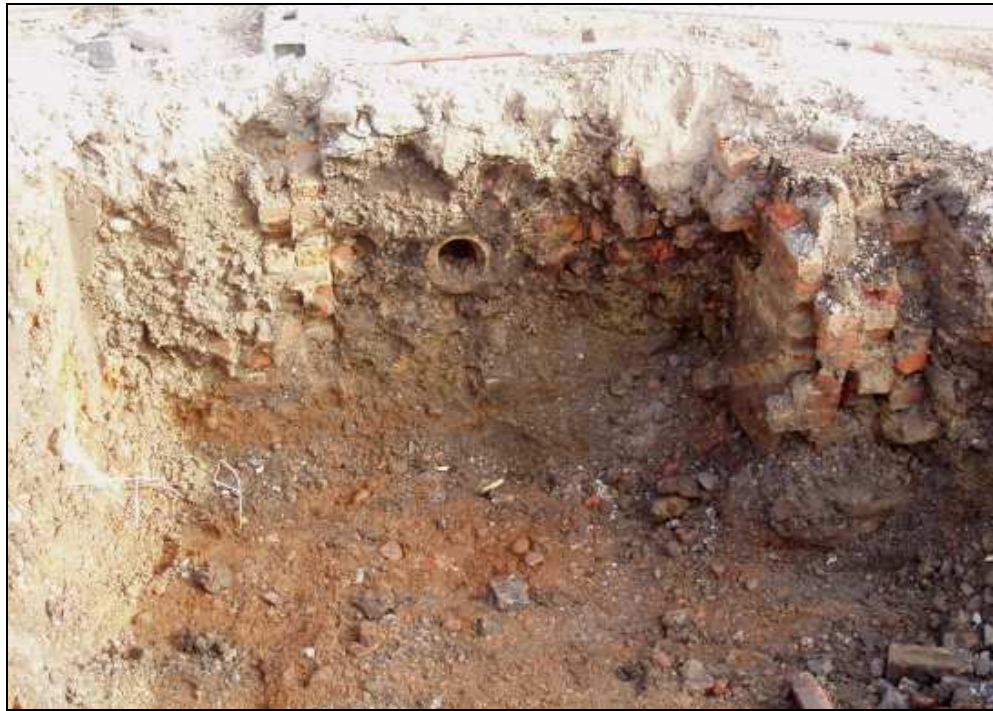
*Plate 44: Pile Cap 2 showing walls **2001** and **2002** in the north-west-facing section, looking south-east*

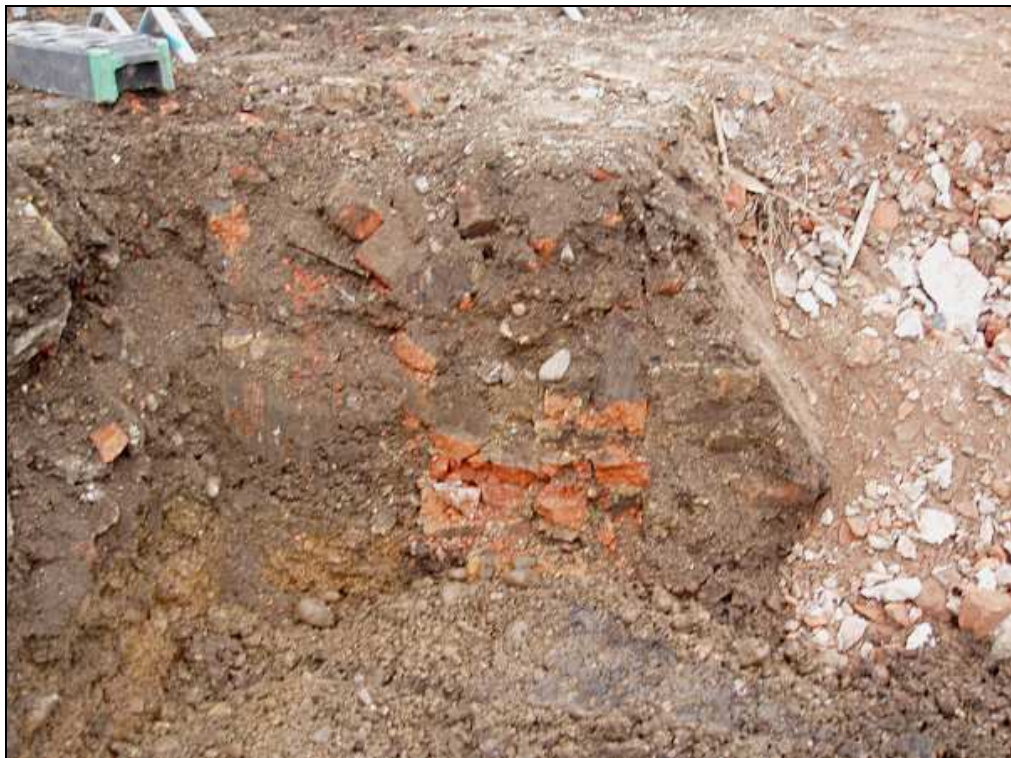
*Plate 45: Pile Cap 3 showing wall **2006** in the north-east-facing section, looking south-west*

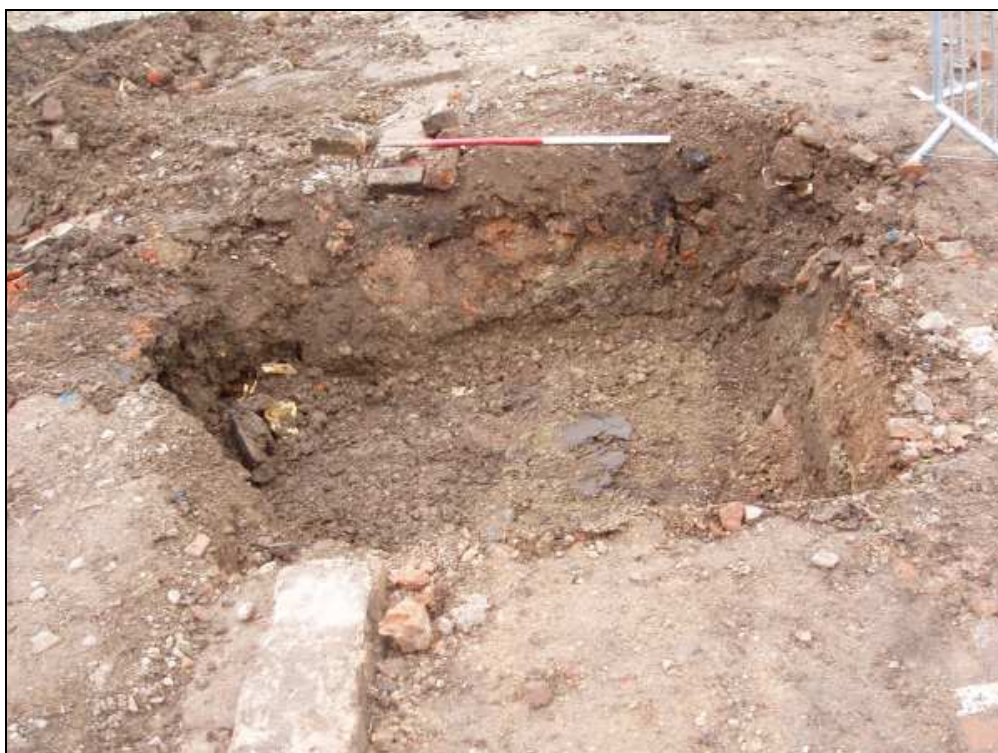
- 5.3.8 At the base of the excavation River Gravel **4009** was located, over which were a series of levelling deposits recorded as **4008, 4007, 4006, 4005, 4004, 4003** and **4002**. Truncating the upper levelling layer, **4002**, and cutting across the excavation on a north-east/south-west alignment, was the boundary wall between Dilk's Terrace and its rear alleyway, wall **4001**. This was previously recorded as wall **9009** during the watching brief on the reduction of the ground surface (See Section 5.2.11). Only one course of brick was present, laid upon a foundation comprising a single course of roughly squared sandstone blocks (Plate 46).

Plate 46: Wall **4001** truncated by the excavation of Pile Cap 4, looking north-east

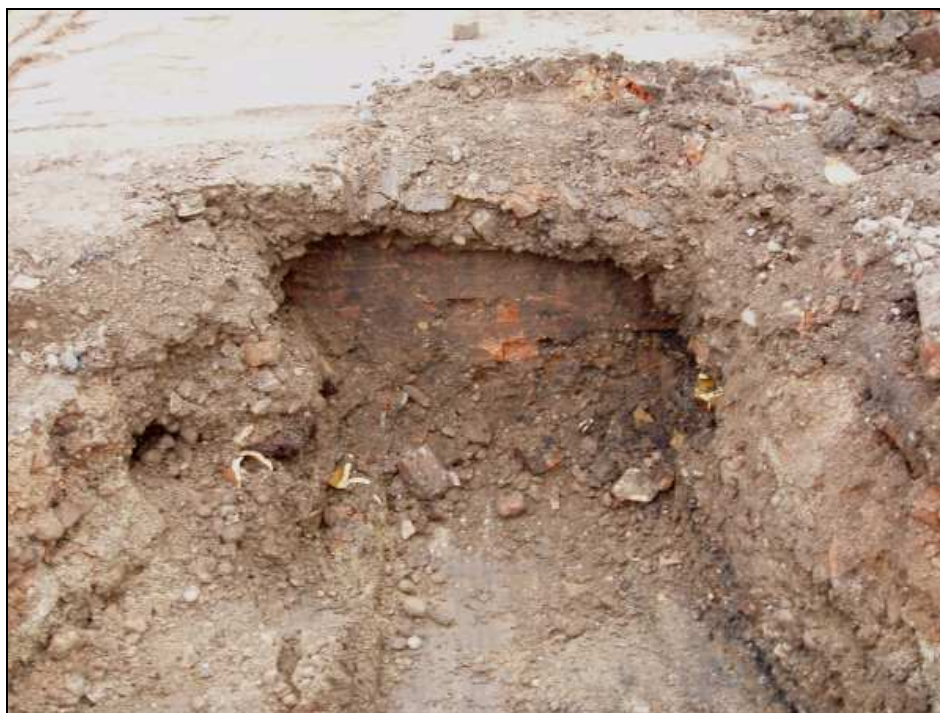
*Plate 47: Wall 9002 in the south-east facing section of Pile Cap 4, looking north-west*

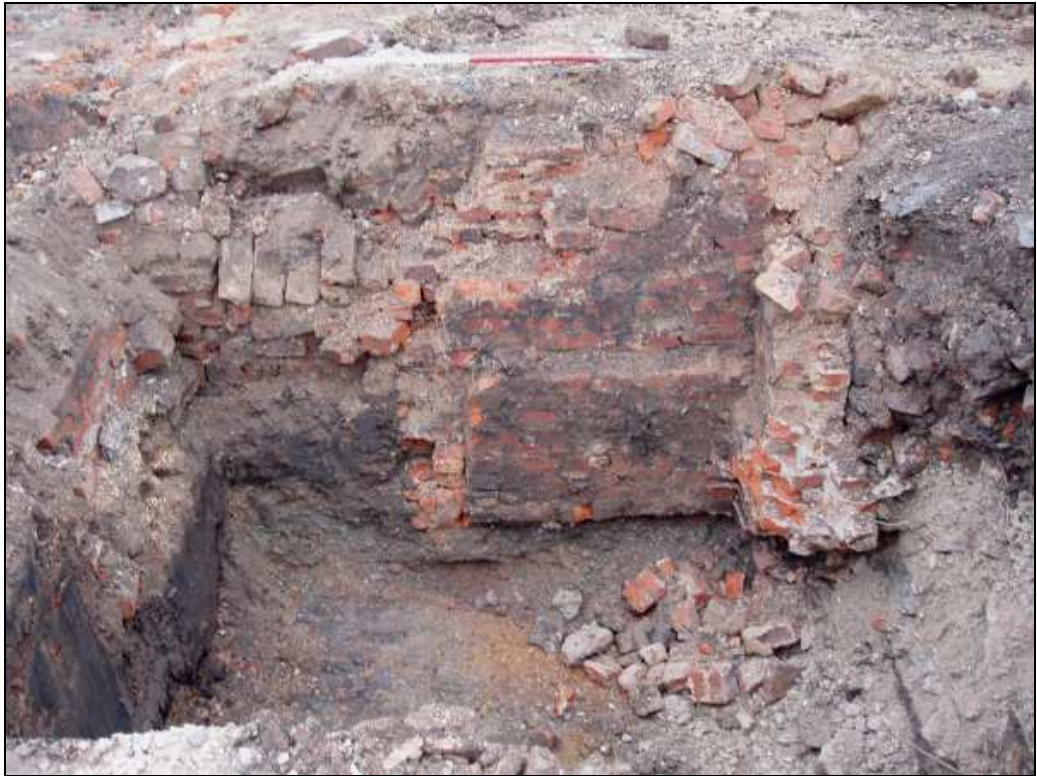
*Plate 48: Cellar 5007, previously excavated at the south-western end of Trench 5, and wall 5003 to the south-east, looking south-west*

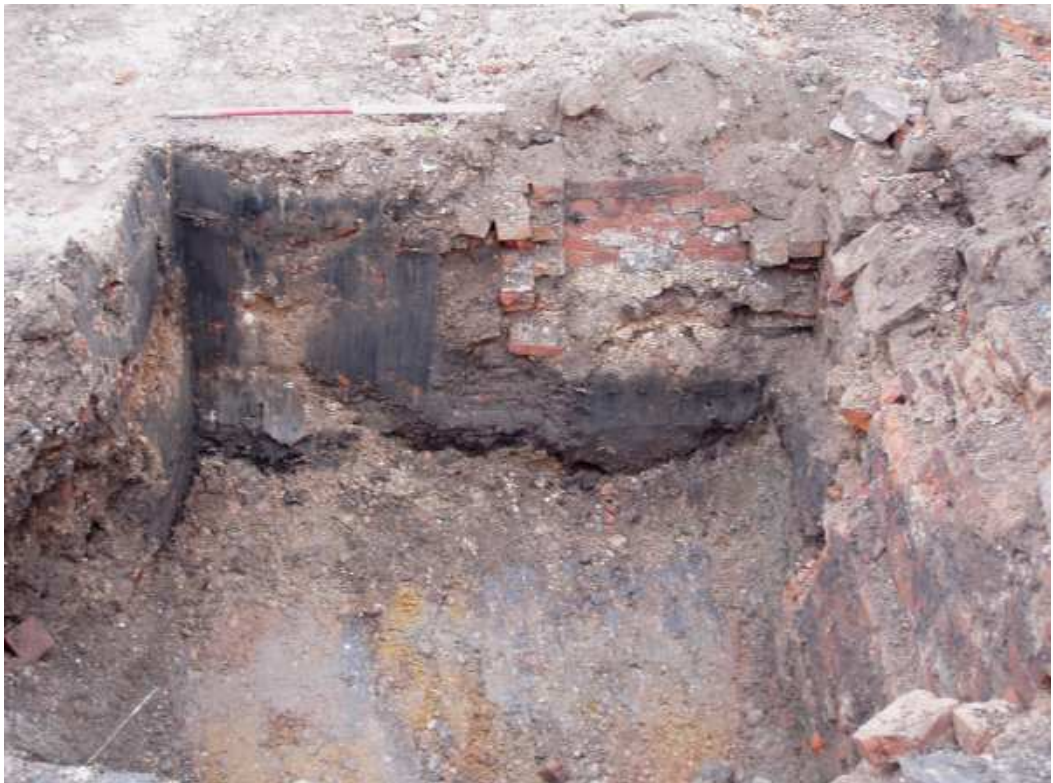
*Plate 49: Wall 5009 in the north-west-facing section of Pile Cap 5, looking south-east*

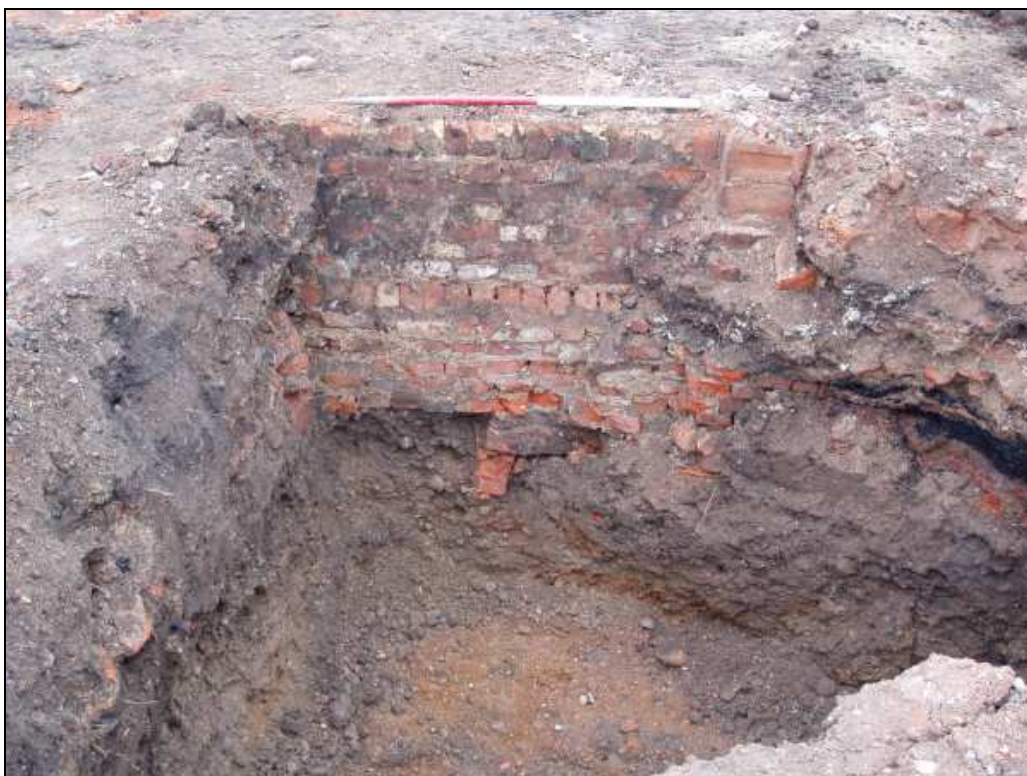
*Plate 50: Culvert 6002 and wall 6001 within Pile Cap 6 looking south-west*

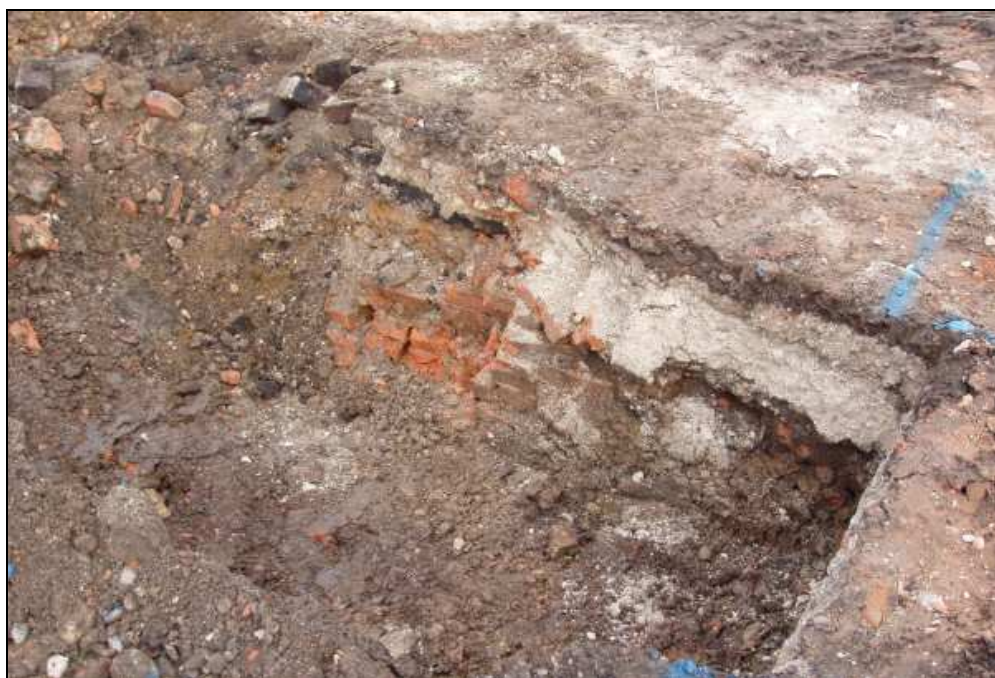
*Plate 52: Wall 8001 in excavations for Pile Cap 8, looking east*

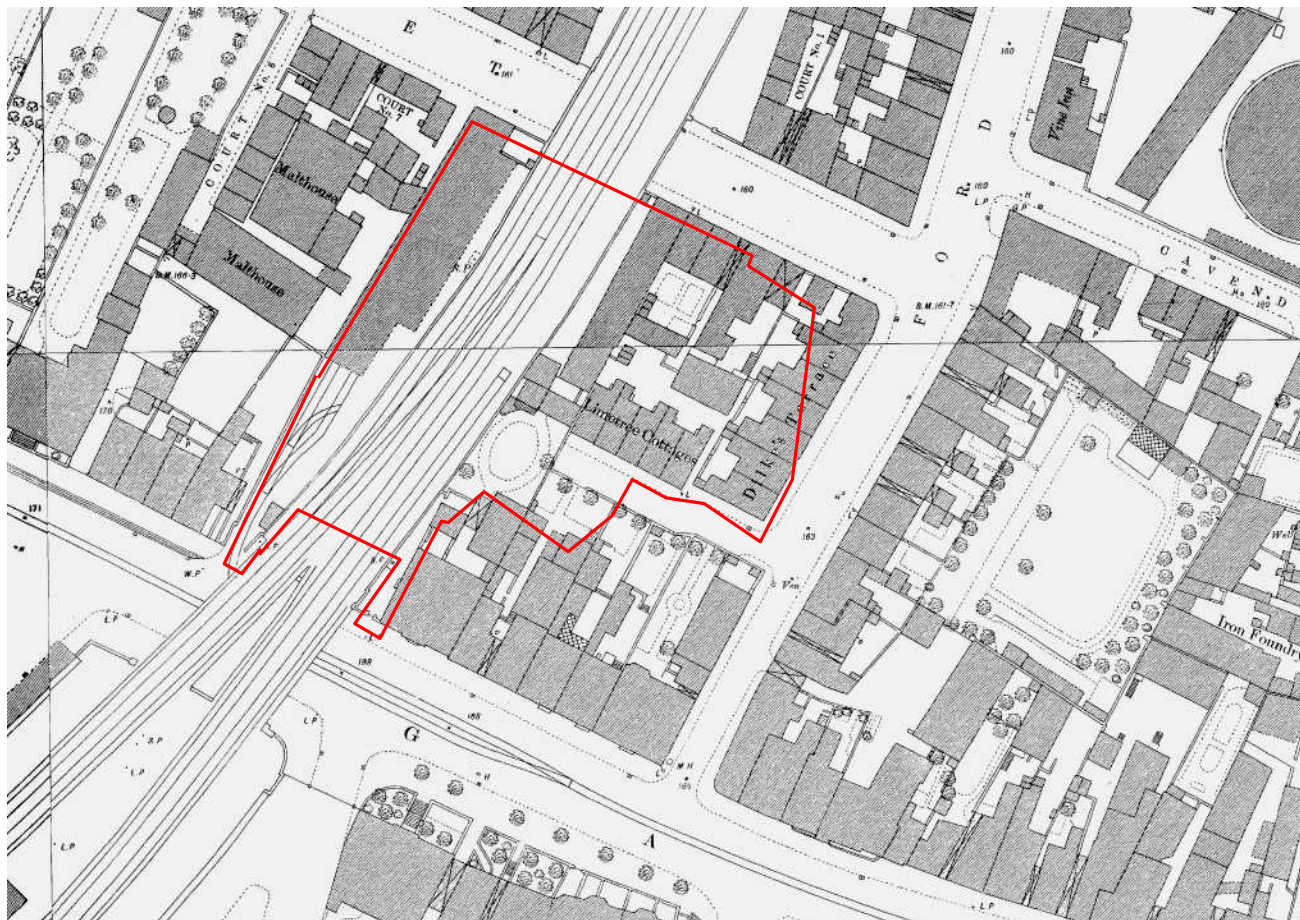
Plate 2: Extract from the Ordnance Survey map of 1883, showing the boundary of the study area

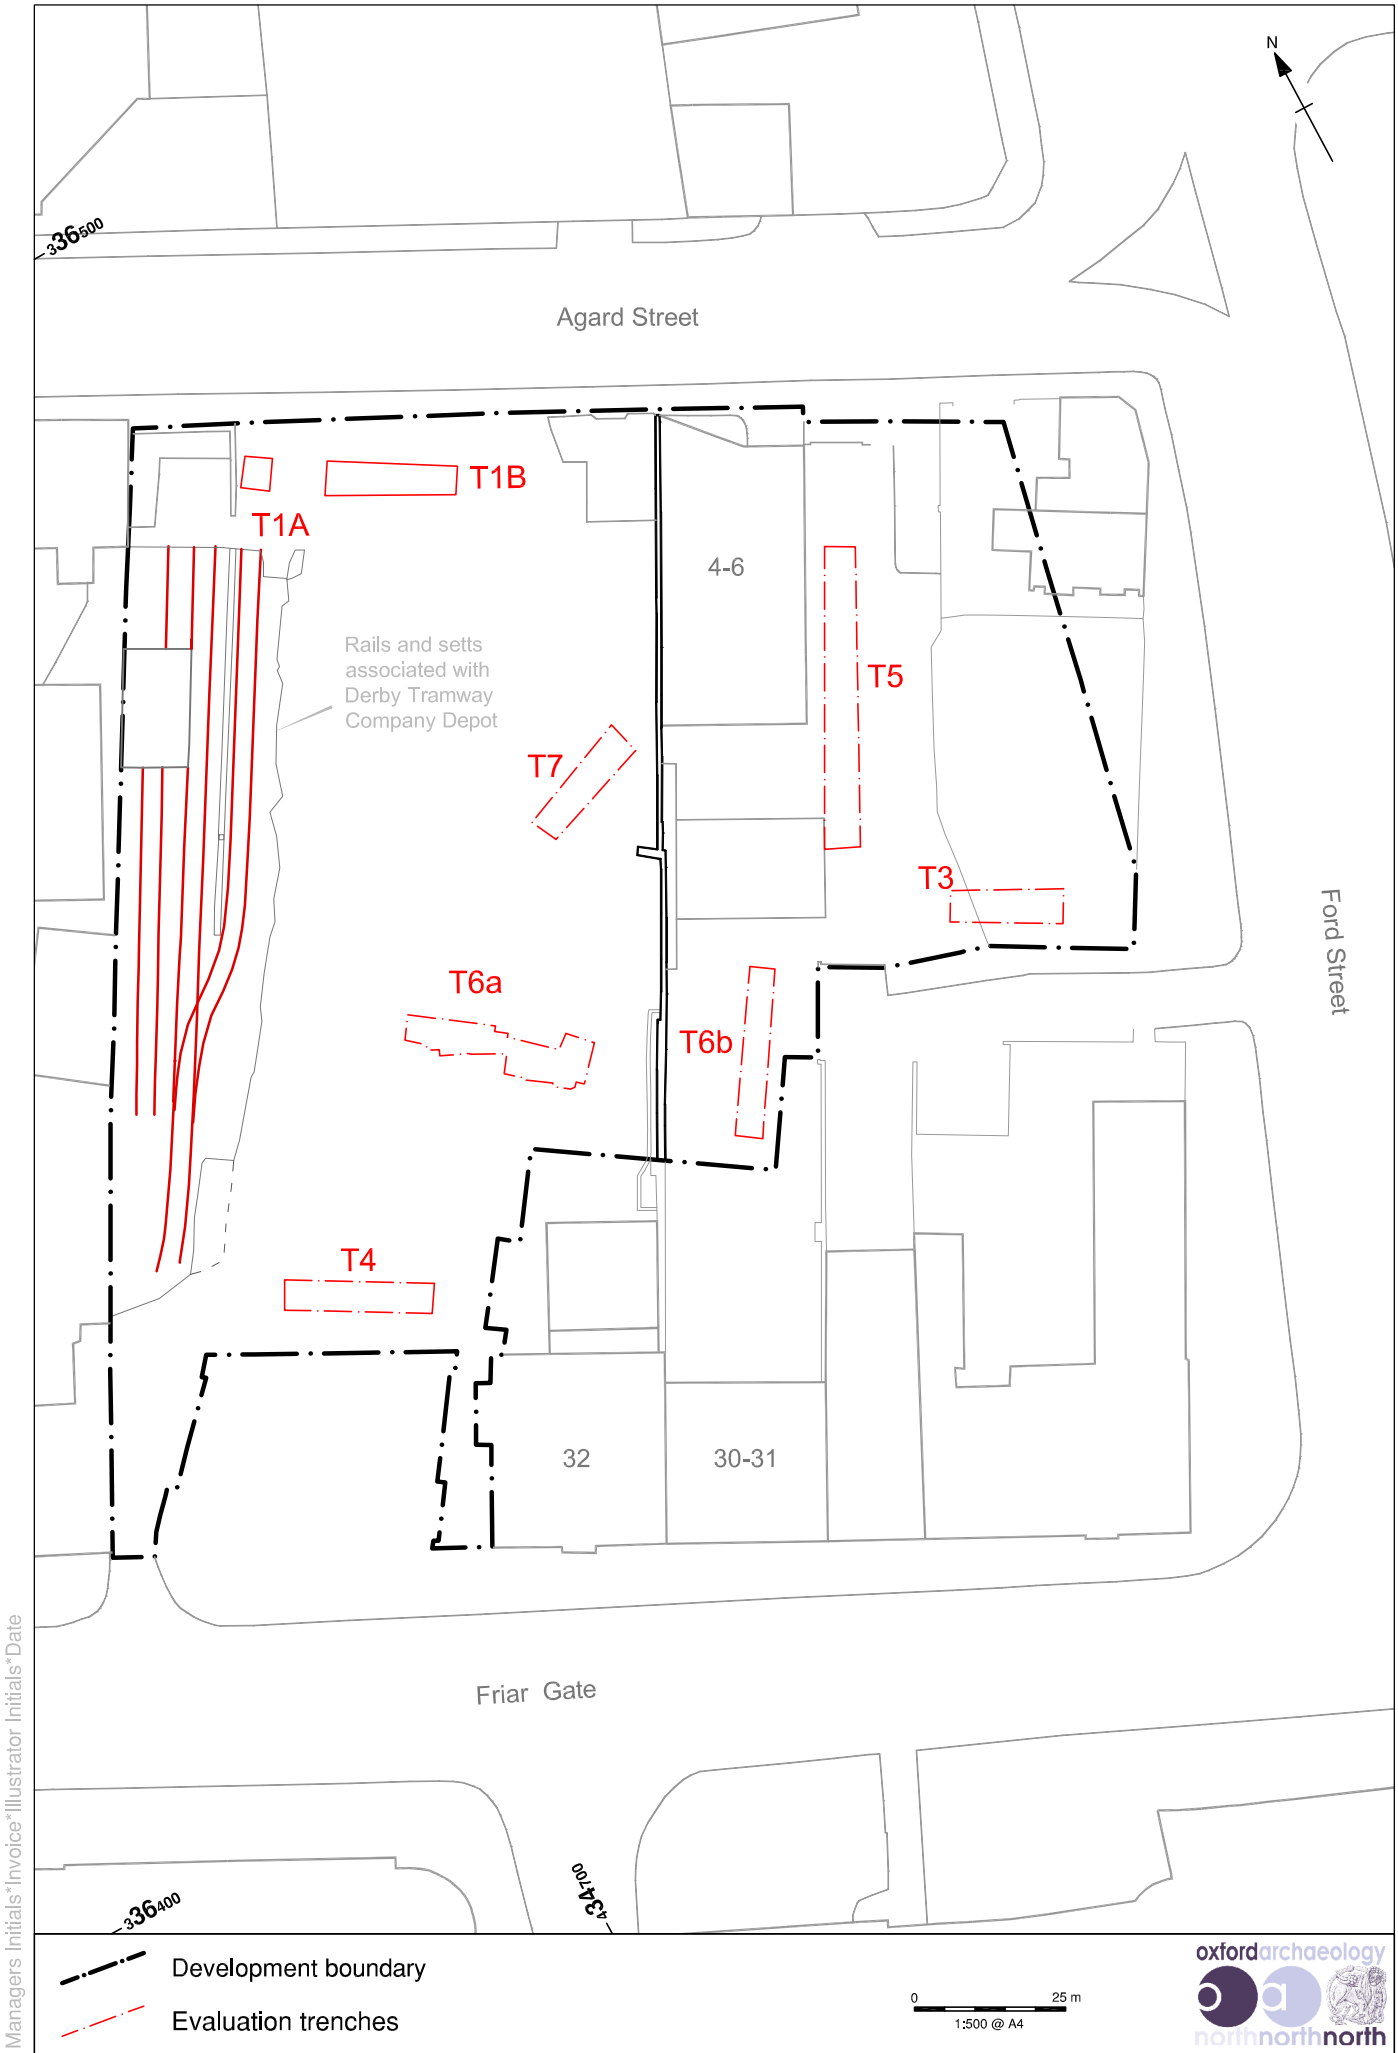
Figure 2: Evaluation trench location plan

4.2.1 Trench 1 was aligned north-west/south-east in the north-western part of the study area. It incorporated part of the footprint of a building and its associated garden to the rear depicted on Rogerson's map of 1819, and the corner of the tram depot shown on the Ordnance Survey map of 1882. The trench also investigated the site of the railway viaduct, and was intended to establish the level of truncation caused by its construction. Prior to excavation, a live underground service was detected using a service locator tool. This trench was therefore divided into two parts, Trenches 1A and 1B, which measured 2.0 x 2.0m and 8.6 x 2.0m respectively (Fig 2 and 6).
