**LAND FRONTING  
AGARD STREET,  
DERBY**

**Archaeological Evaluation and  
Watching Brief Report**

Planning application Number: 12/08/01676  
National Grid Reference Number: SK 3472 3644  
AB Heritage Project no: 10008  
Date: 29 April 2011

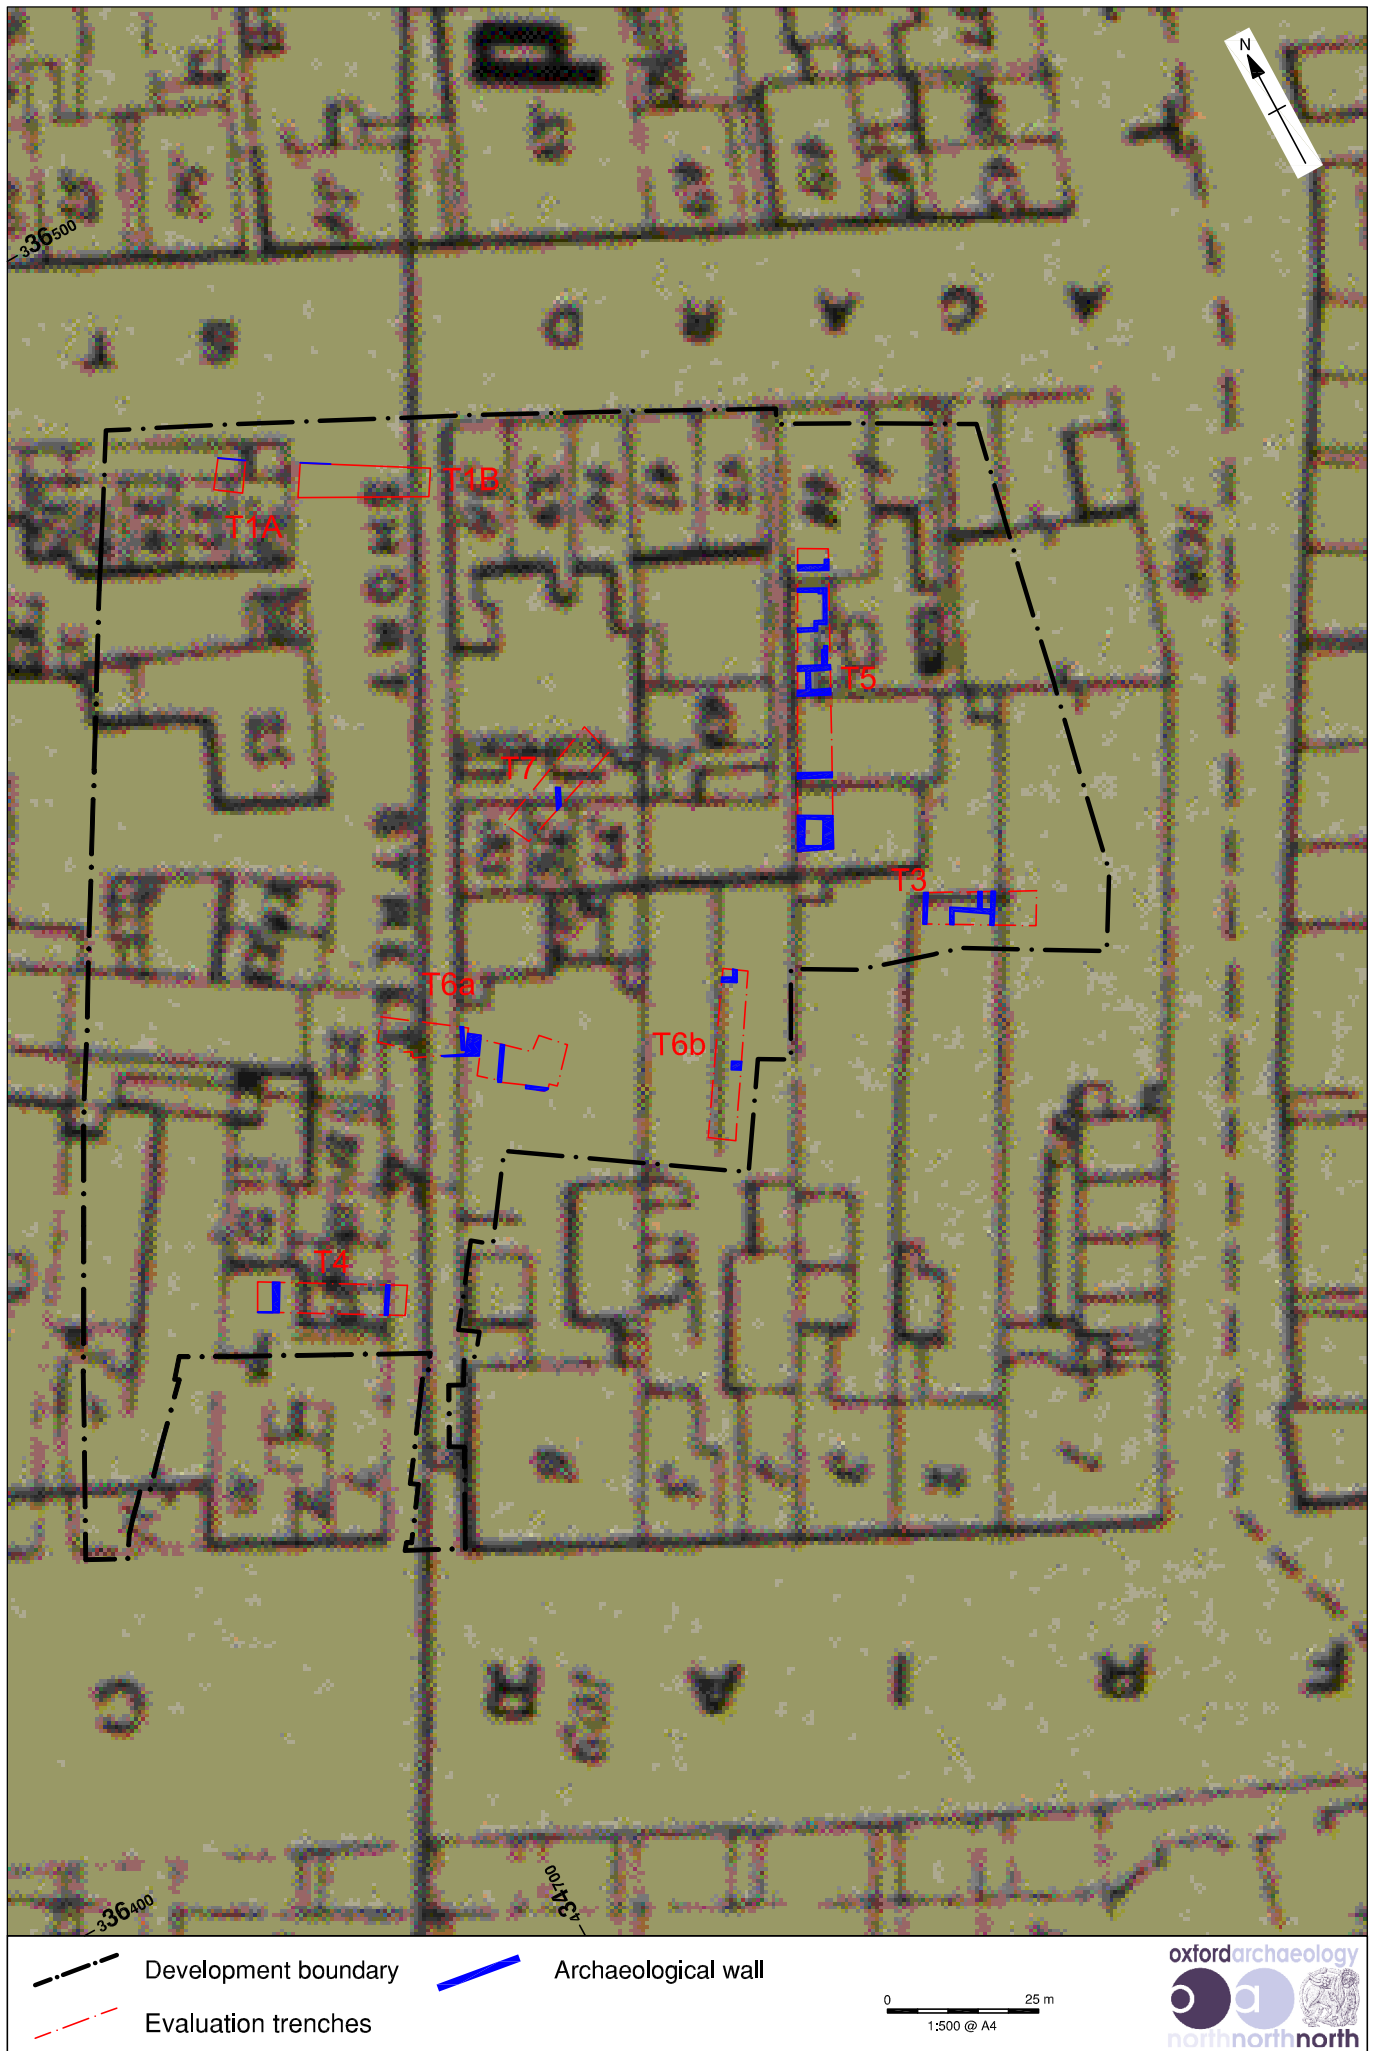
Figure 3: Great Northern Railway Plan of 1871, with trial trenches and archaeological walls marked

- 5.3.14 **Pile Cap 8:** was located in the western part of the watching brief area. It measured 2.8m in length and 1.3m wide, and was excavated to a depth of 1.3m (Fig 13). River gravel was **8003** was located at the base of trench, overlain by 1.3m by levelling deposits **8002** and recent demolition debris. A north-west/south-east-aligned wall was located at the south-western end of the excavation, wall **8001** (Plate 52). This wall aligns closely with the southern exterior wall of a building depicted in the Great Northern Railway plan of 1871 (Fig 3).
