Victoria Hospital, Whinney Heys Road, Blackpool, Lancashire

Archaeological Watching Brief Report

Oxford Archaeology North

April 2013

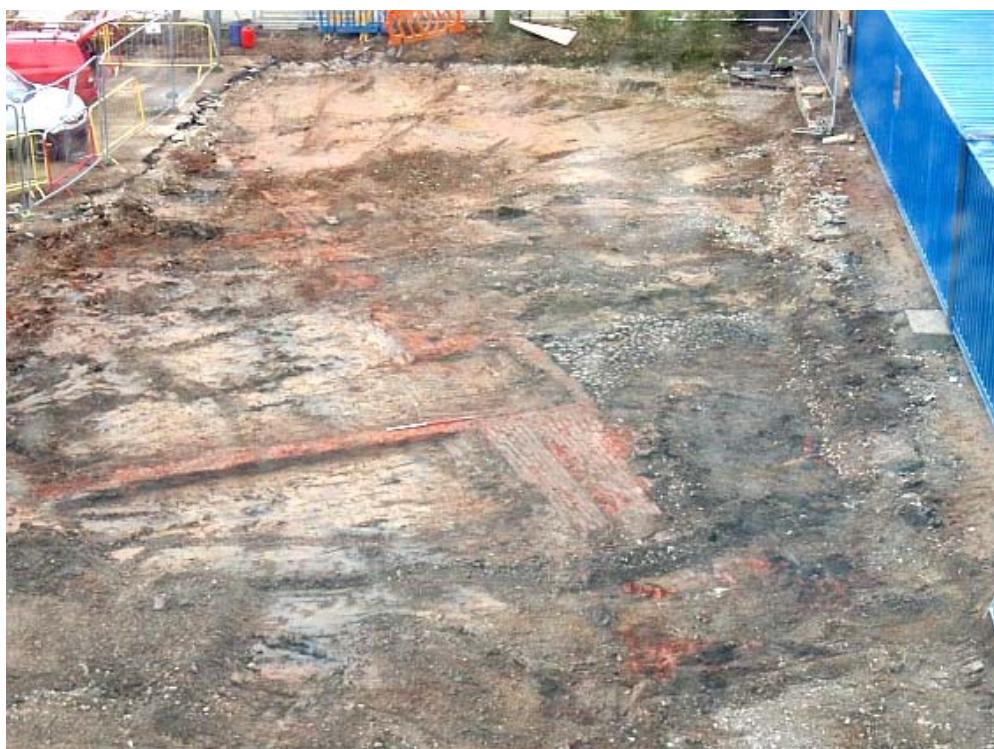
Plate 1: Aerial view of site

3.2.1 The areas of investigation had previously been used as a car park and comprised two deposits; a thin layer of asphalt **107**, roughly 0.1m thick, overlying a hardcore gravel layer, **106**, a further 0.2m deep. Upon the removal of these deposits at an average depth of 0.3m, the archaeological remains of Whinney Heys Hall could be observed (Fig 3). The remains comprised several wall foundations, **100-103** and **111-114** respectively, a substantial patch of cobblestones **104**, and a rectangular-shaped brick surface **105**. These features were recorded to document the extent of the original building and any information that could be gathered regarding the internal layout (Plate 1).

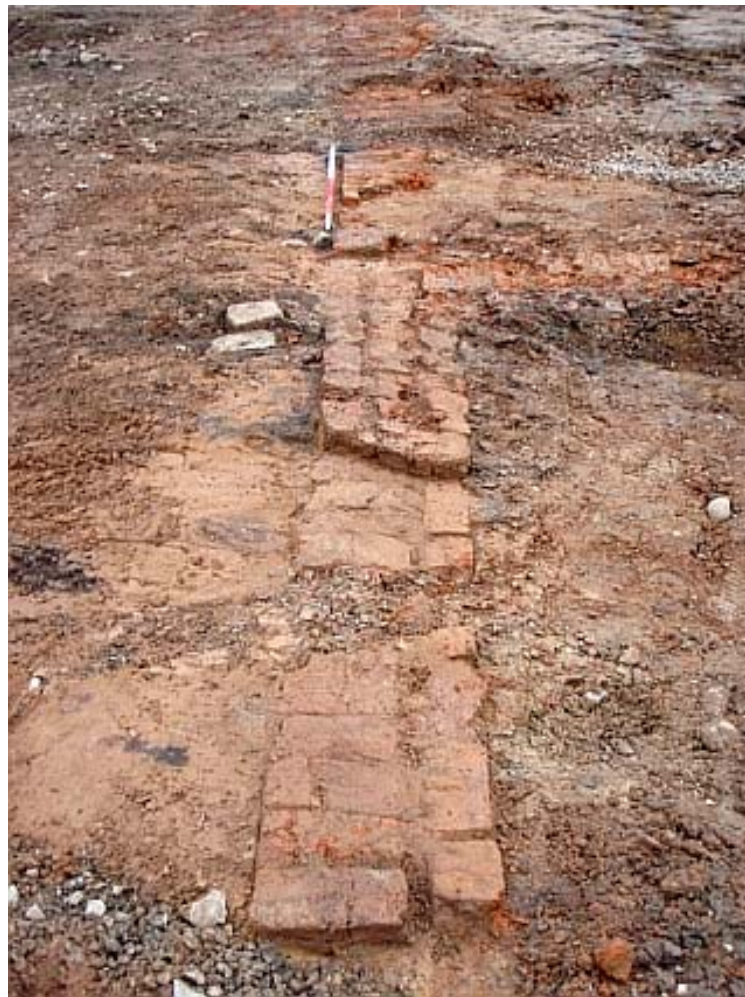
Plate 2: Wall foundations *100*

3.2.2 **Wall Foundations:** several surviving wall foundations were exposed, the majority of which, **100-103**, related primarily to the south-eastern end of Whinney Heys Hall. However, walls **112** and **113** formed a corner of the northern part of the building and wall **114** was the only remnant of the western

external wall. All wall foundations appeared to be constructed from the same handmade red brick and were, in most cases, only a single course high (Plate 2), although *114* is the exception with three intact courses of brick and the only evidence of mortar from all of the surviving brickwork (Plate 3). The bricks were laid in stretcher formation for the majority, with a few examples of header bricks observed. As only a single course of brick survived for most of the wall, and only the lowest parts of the foundations could be observed, the bonding patterns or other construction techniques remain elusive.

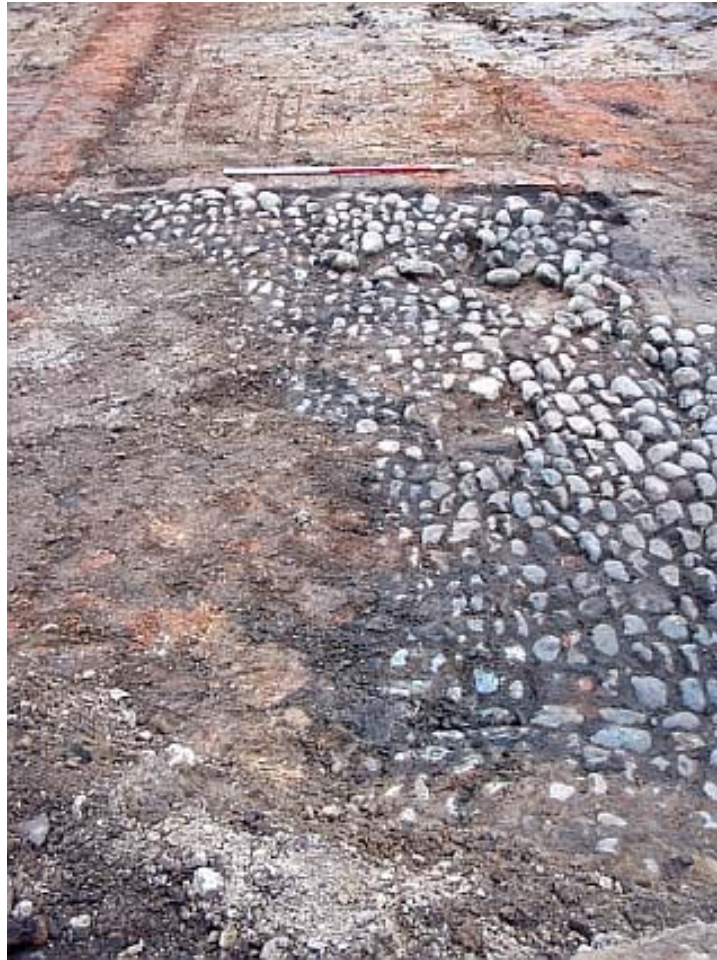
Plate 4: Cobble surface *104*

- 3.2.3 **Cobble Surface:** surface *104* was an extensive patch of natural sub-rounded cobblestones of various sizes (Plate 4), although averaging around 0.2m in circumference. These were likely sourced locally and were set into the underlying natural subsoil, rather than a mortar bed of any sort. The cobbles were covered by a dark compacted deposit, *108*. This deposit was likely a by-product of the demolition process, or perhaps later construction debris, compacted during the progress of works. Removal of the deposit exposed the cobbles and the remains of two wooden posts (Plate 5) set into gaps among the stones. The cobbles were probably an external feature of the building, a yard or work area, and the presence of the posts suggests that it may have been covered, at least in part, by some kind of awning or roof. The cobbles were bordered to the north by wall foundation *111*, this may have been a point of access to the cobbled area, perhaps holding a gate, though no evidence for this was observed. The area recorded measured 10.1m by 4m wide (possibly extending further beyond the limit of excavation). However, sporadic clusters of cobbles were observed stretching along the southern external wall *103*, and heavy disruption by modern services in this area and further south prevented the true extent of the surface to be observed, but it is assumed that the cobbled yard area would have dominated most of the southern end of the hall.

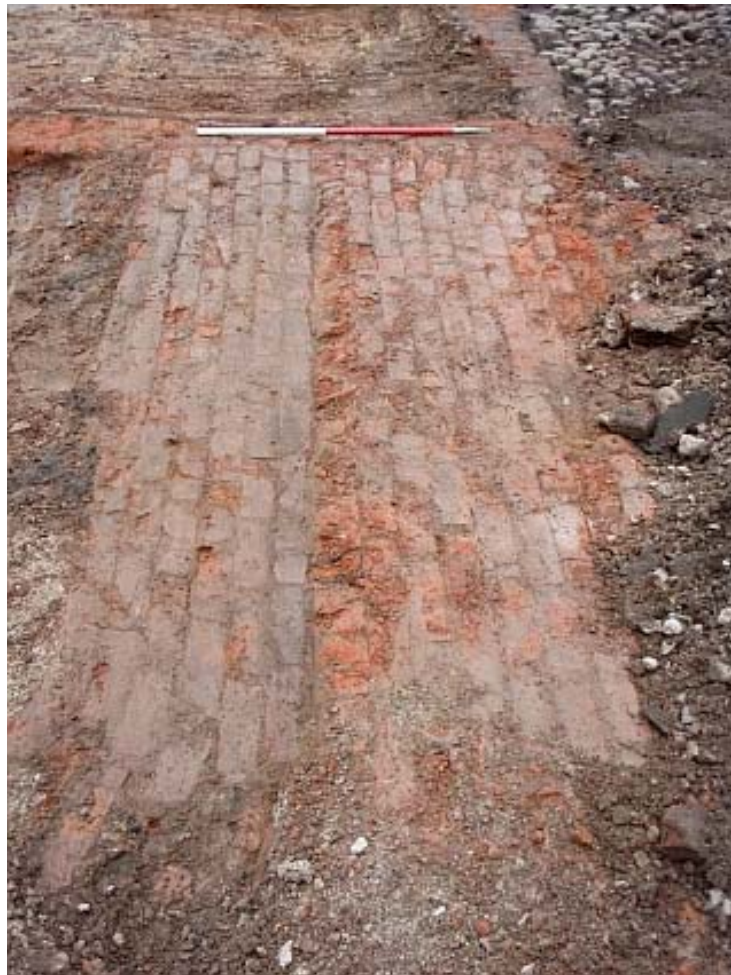
Plate 6: Brick surface **105**

3.2.4 **Brick Surface:** surface **105** was found butting against the southern face of wall foundation **103**, and is butted on the remaining three sides by cobble surface **104**. Measuring 6.3m by 1.5m it was initially thought to resemble the capping of a cellar, although it appeared too narrow for a cellar associated with a building the size of Whinney Heys Hall. Constructed from the same handmade red brick as the wall foundations, this surface has a single brick's depth laid shiner style (Plate 6). Excavation at the southern end of the construct, in an area of truncation by modern services, revealed that this context was not a cellar cap, but simply a series of bricks laid to form a crude surface or path. As this surface appears to be on the outside of the main building, and is bordered by the cobbled area, it is possibly the remains of a floor, perhaps within a small shed-like structure, the remains of which are no longer evident. Alternatively, it may have been a simple path; no evidence remains to prove that it lead to a doorway in the southern face of the building. Judging by the primary use of cobbles as a surfacing material in the area it is perhaps more likely an internal floor surface of some form of outbuilding.
