**ABOVE BECK BARN,
WRAY,
LANCASHIRE**

**Building Survey
Report**

February 2013

Issue No: 2012-13/1360
OA North Job No L10553
NGR: SD 608 670

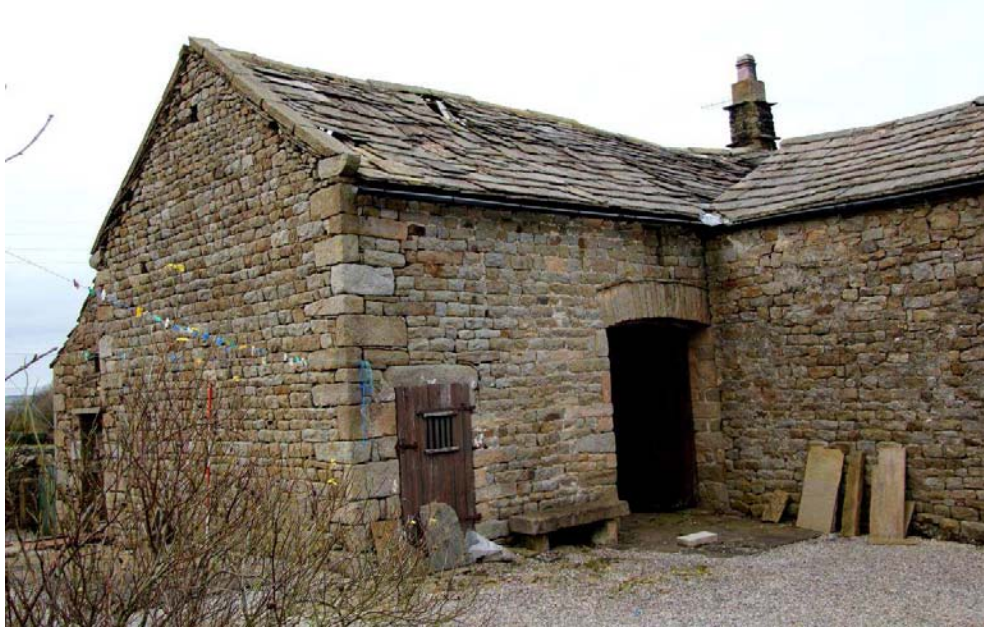
Plate 1: General view of the south side of the barn

- 4.3.1 ***The Barn, East Elevation:*** the main access to the barn is via the cart door with double timber doors set within the east-facing elevation (Plate 1). This has a segmental arched head with 19 voussoirs of fairly regular dimensions and shape. Above the arch is a rudimentary drip moulding formed by flat stones set into the wall. Set in-between the apex of the arch and the eaves is a blocked aperture, which is not visible internally. The jambs of the door are made up of long and short squared quoin stones. At the left side of the north-eastern elevation, is a further smaller doorway, which has a stone lintel. The door is of plank and ledge construction with a small, unglazed light. The door is hung via two long strap hinges on pintles set into the wall. Above, and slightly to the right of this door is a blocked vertical ventilation slit. At the right side of the elevation the butt-joint of the shippon is clearly visible.

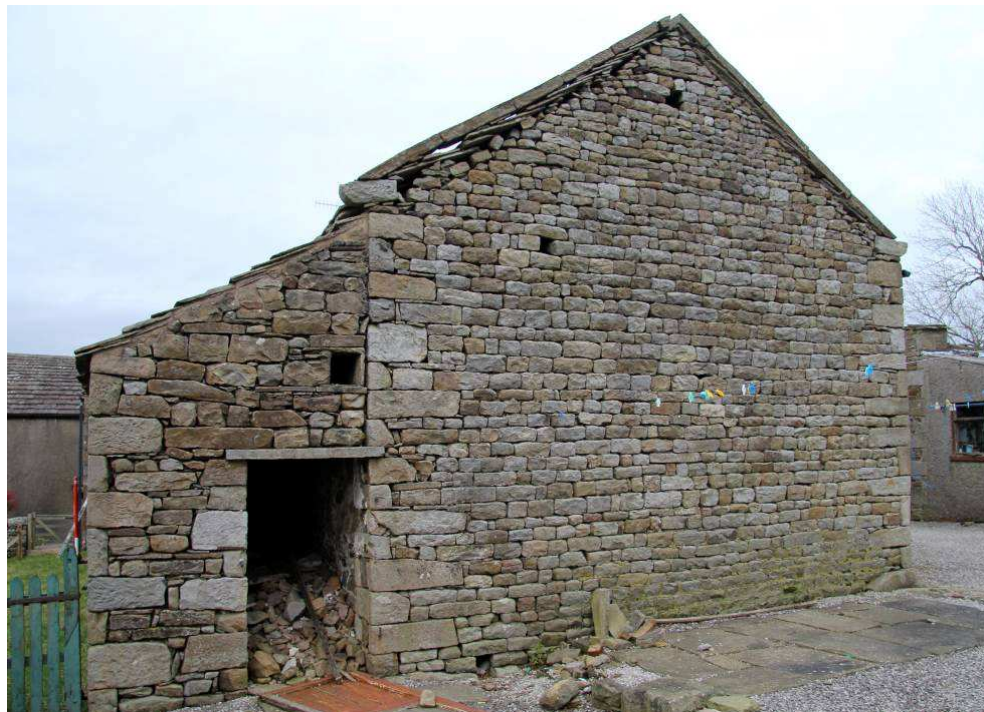
Plate 2: Oblique view of the south elevation of the barn

- 4.3.2 ***The Barn, South Elevation:*** this forms the gable elevation of the barn and is fairly plain in appearance with no doors or windows (Plate 2). The coursing is of higher quality than the other elevations, the courses diminishing towards the

top of the gable, and there is little mortar visible. There are two padstones visible at each end of the base of the elevation. An owl hole is situated close to the apex of the gable, with a further hole lower down and to the left, both of which are visible internally. There are finished sandstone copings on both slopes of the roof which are placed on top of the roofing tiles. The gap between the roof and the wall is filled with random stones, most of which are loose. At the foot of each roof slope is a worked stone kneeler. In front of the elevation, is an area of paving that is approximately 4m long by 2m wide in extent; it consists of substantial flagstones and is of unknown use.

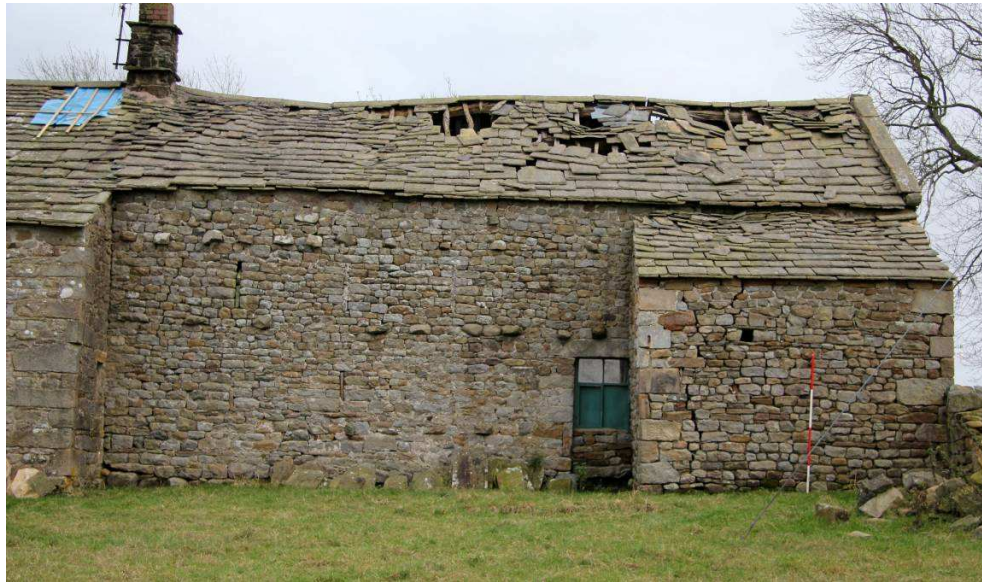
Plate 3: West elevation of the barn and lean-to

4.3.3 *The Barn, West Elevation:* this is the longest visible elevation of the building, the southern third of it being obscured by the attached lean-to (Plate 3). The stonework on this elevation is more random than either of the other elevations of the barn and the courses are less well defined. There are two rows of through-stones visible, as well as two rows of blocked, vertical ventilation slits (six in total). Larger pad stones are visible at the base of the elevation. Lime mortar is present, and some of it is smeared over the stones. A window aperture lies adjacent to the lean-to, which has a sandstone lintel. This is a former doorway that has been partially blocked in order to create the window; the frame is of timber construction.

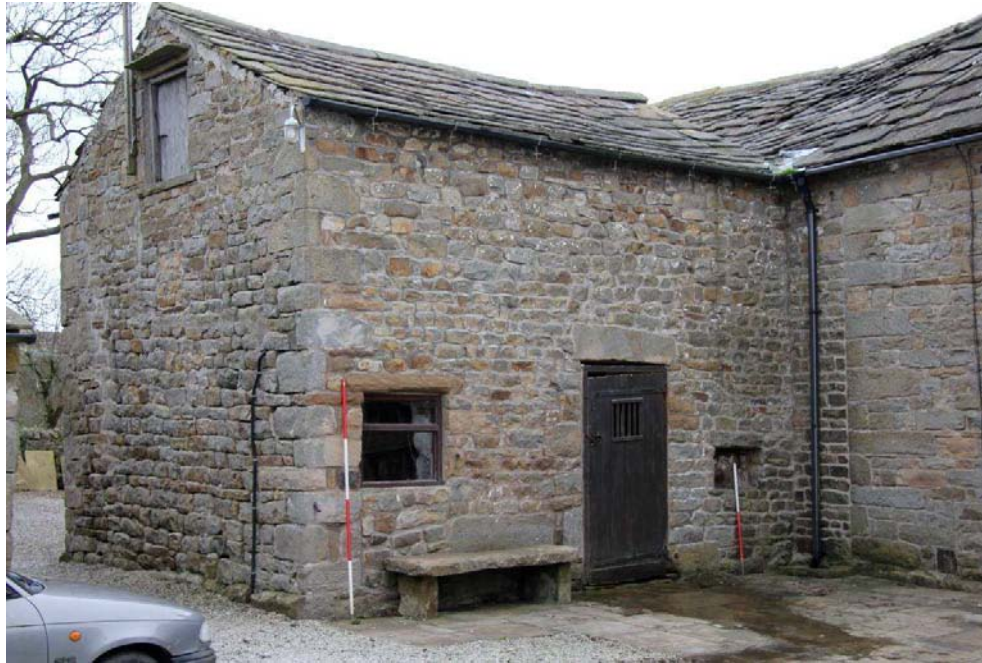
Plate 4: General view of the shippon showing north and east elevations

4.3.4 *The Shippon, North Elevation:* this elevation faces the courtyard at the front of the farmhouse and appears to have been repointed in cement relatively recently (Plate 4). It is of random, rubble construction with variable coursing. There is a single door, just off centre, which has a sandstone lintel. The timber door is similar to that on the east elevation on the Barn, has similar strap hinges, and is also hung on pintles. To the left of this is a single window aperture with sandstone lintel and timber frame; this was formerly a door that has been partially blocked. To the right of the central doorway is a small niche set within the wall. The west side of the elevation butts against the east wall of the barn which, in turn, butts against the front elevation of the farmhouse evidenced by a visible vertical join (Plate 4). Long and short quoins are visible marking the south-east corner of the farmhouse.

4.3.5 *The Shippon, East Elevation:* this forms the gable end of the shippon and is of coursed squared stone construction. The mortar is lime with some recent patching. Close to the apex of the gable is an aperture with a small timber door; it has a sandstone lintel and sill, and above it is a projecting flat sandstone drip stone. Unlike the verge of the gable of the barn, there are no copings or kneelers.

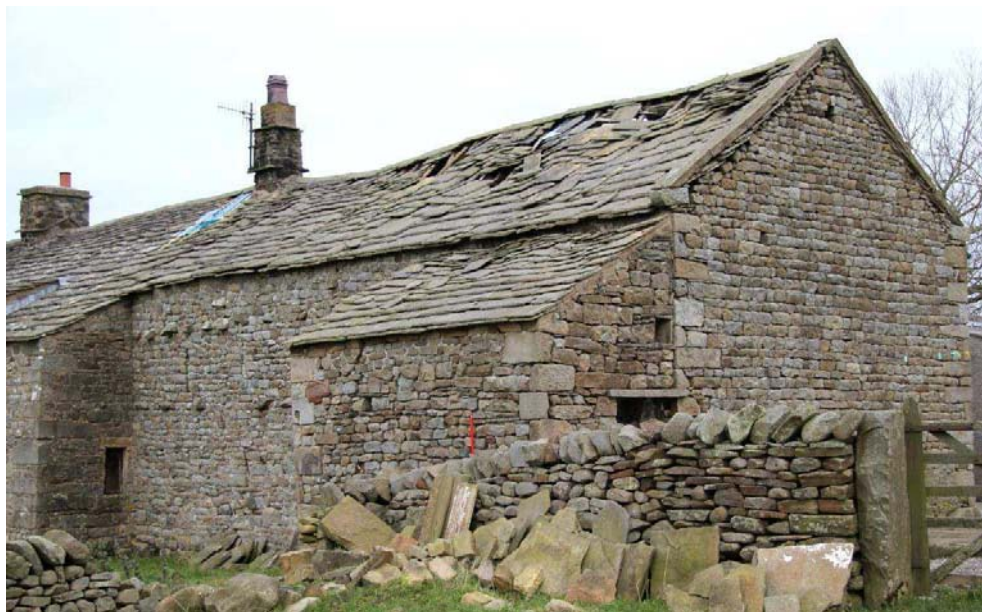
Plate 5: Oblique view of the east side of the barn and the lean-to

- 4.3.7 ***The Lean-to:*** this building is small, and is attached to the west wall of the barn (Fig 7; Plates 2, 3 and 5). There are clear butt joins where it meets the barn and it is constructed of a combination of random rubble, squared, and flat stonework with tool-marked long-and-short quoins. There is a single doorway in the south elevation with a flat sandstone lintel, above which is a small square ventilation aperture. There is a similar small aperture in the west

elevation, to the left of which is a vertical crack running the full height of the wall.

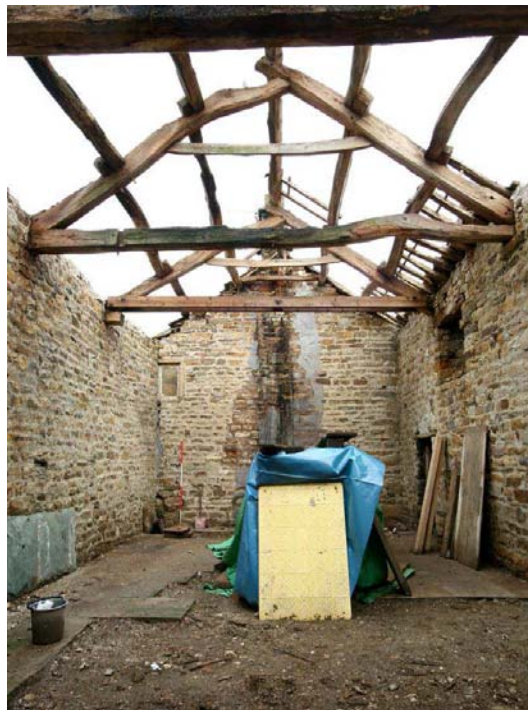
Plate 6: View of the interior of the barn facing north

- 4.4.1 **The Barn:** the interior of the barn consists of a single space open up to the roof (Plate 6). At the time of the survey it was being used as a storage area and several items of building materials were present. The walls are of similar appearance to the external elevations except that most of the joints have smeared lime mortar. There is some evidence of internal partitioning at the south end of the room, where the walls have been limewashed up to the level of a line of joist slots that are set within the south wall at a height of 1.9m (Plate 7).

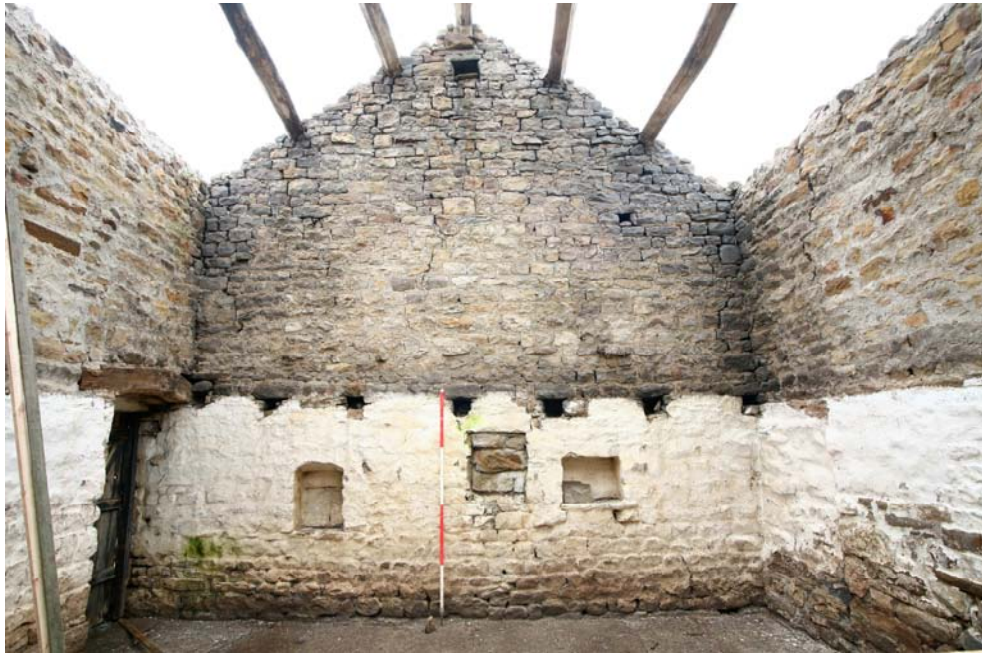
Plate 7: View of the interior of the barn facing south

- 4.4.2 There are also three niches (one blocked) present in the south wall and internal vertical scars suggest the presence of former dividing wall. The layout of the south end suggests that this part of the barn once contained cattle stalls. There

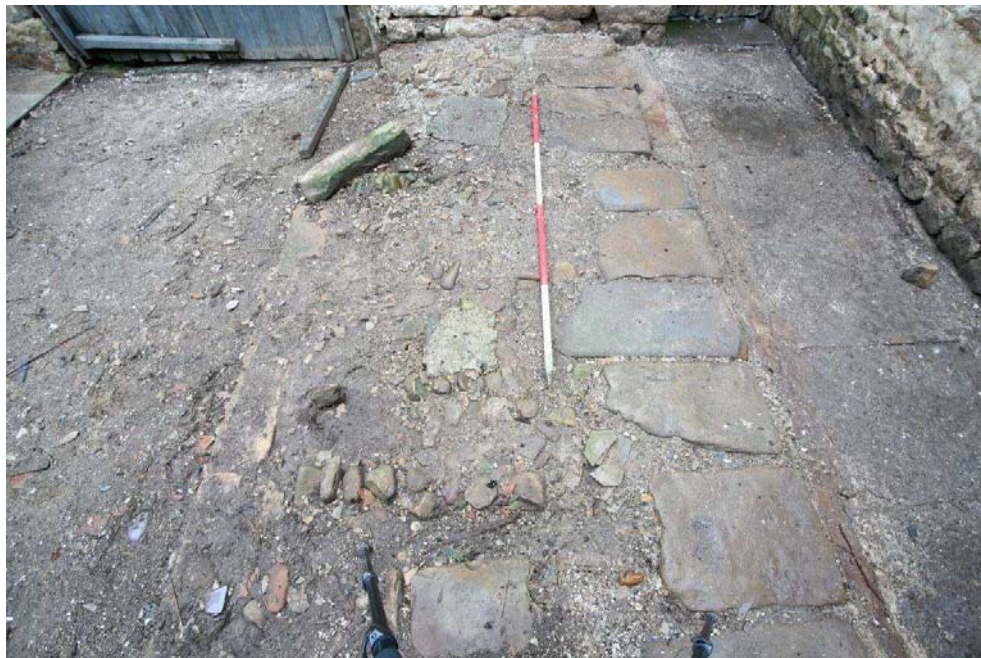
Plate 8: The floor at the south end of the barn

are two opposing entrances (the one in the west wall is now blocked) and the floor is laid down to large sandstone flags with a raised platform of cobbles and kerb of stones where the stalls were situated (Fig 7, Plate 8).

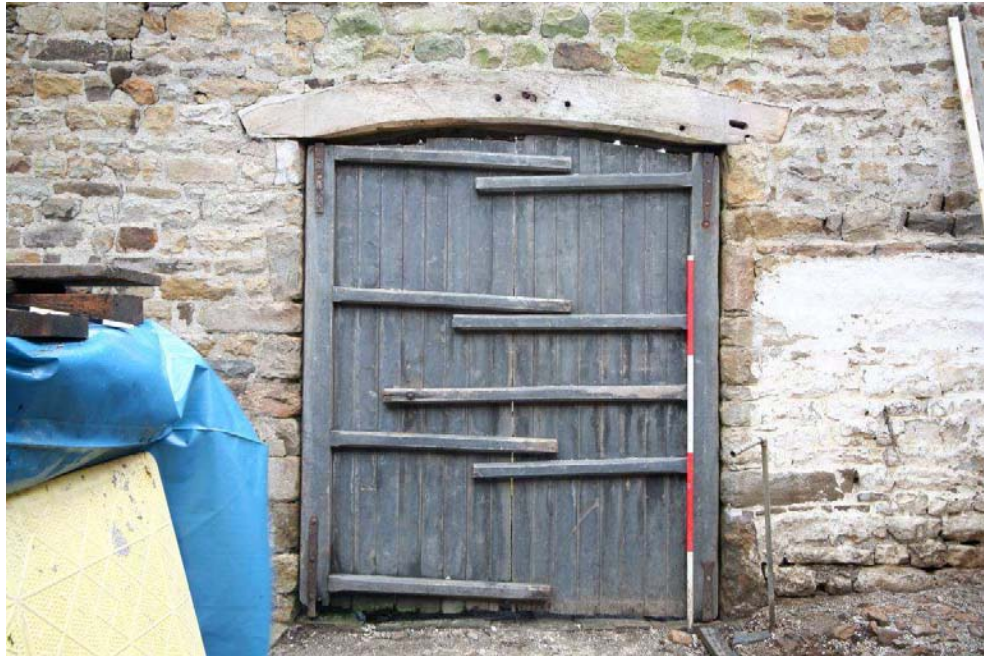
Plate 9: Cart door in the east wall of the barn

- 4.4.3 The east wall has the main cart door entrance, which has a curved oak lintel (Plate 9). The double doors are of plank and chamfered ledge construction and are harr-hung on metal strap hinges into sockets in the floor plate and lintel. The ledges overlap in the middle, reinforcing the doors when they are closed. To the left of, and above, this entrance is an opening into the loft of the adjacent shippon. There is a low level doorway allowing access into the shippon at the north end of the barn which has a simple timber lintel.

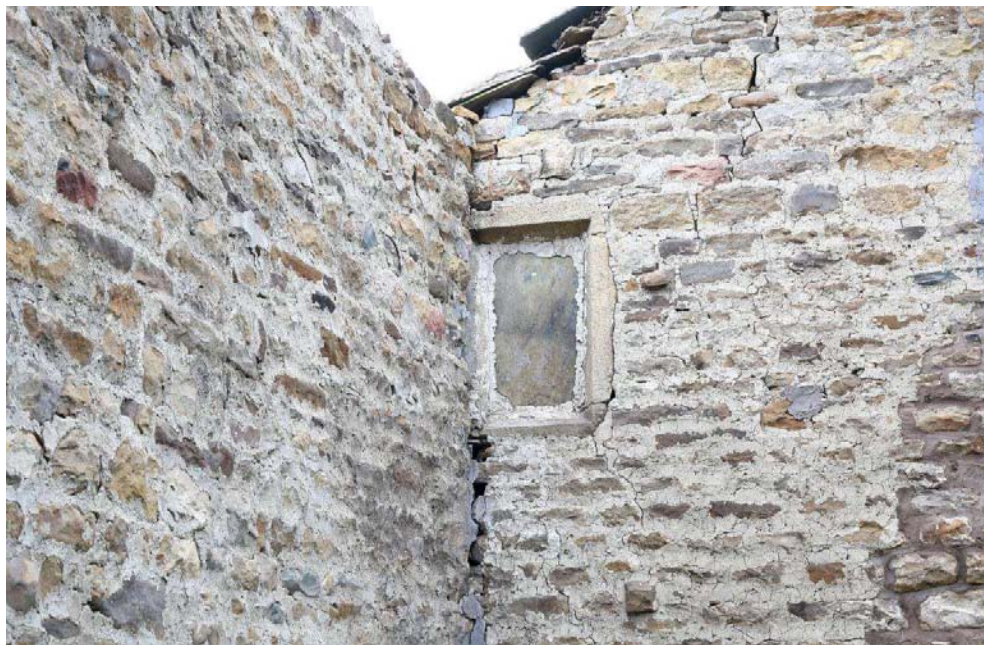
Plate 10: Bisected mullion window in the south elevation of the house

- 4.4.4 It is evident that the barn post-dates the adjacent farmhouse; in the north wall of the barn (the south elevation of the farmhouse) there is a stone mullioned window situated high up on the wall that is bisected by the west wall of the barn (Plate 10). The vertical join is clearly visible and the west barn wall is not bonded to the southern wall of the farmhouse. The west wall of the barn contains a blocked doorway, that has been partially blocked to create a window. At the southern end of the western wall is a further blocked door, most probably blocked when the adjacent lean-to was constructed. To the north of this door are three niches, two of which have been blocked with flat stones and lime mortar.

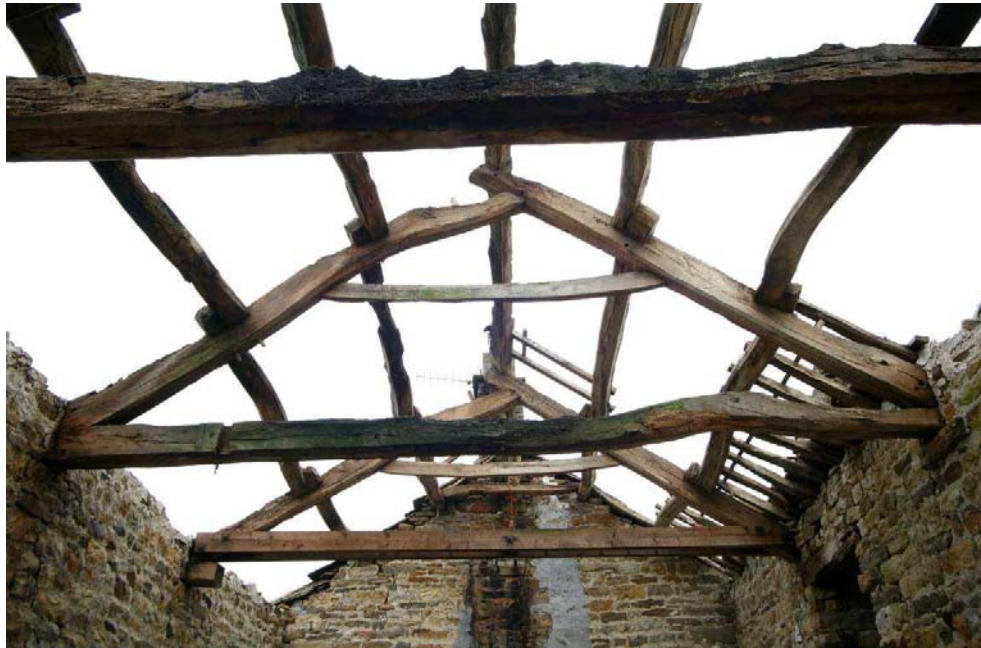
Plate 11: Truss two in the barn

- 4.4.6 *Roof:* the roof structure of the barn consists of three A-frame trusses, all of which have collars that are morticed into the principal rafters (Plate 11, Fig 8). All the members of the structure retain some of their natural shape being squared off where necessary. There are no saw marks visible on any of the members, except the tie beam of the north truss, which is a later repair. There are two rows of purlins on each slope, that are trenched into the principal rafters, and a ridge purlin. Several pegged joints are visible but there are no obvious assembly marks present. The foot of each truss is set with the wall. Resting on the purlins, at the extreme north end of the roof, is a small collar with crown strut. This supports the ridge purlin where it meets a chimney stack situated on the gable of the farmhouse roof. This was probably required because a hole for the ridge purlin could not be inserted into the stack.

- 4.4.7 At the time of the internal inspection of the barn, all of the roof covering and most of the common rafters had been removed for health and safety reasons; however, on the lower part of the north-east section of the roof slope some short rafters remained. These are of the same timber as the trusses and are split with some chamfering and tool marks. The rafters are quite short, just spanning the gap between the purlins and the wall. Preliminary inspection of the interior of the roof, prior to removal of the tiles, confirmed that the whole of the roof was constructed in this manner. A compound rafter separated by a cleat rests on each of the principal rafters, and was necessary due to the purlins projecting out from the trusses. A single batten remained, from which the stone tiles were hung.

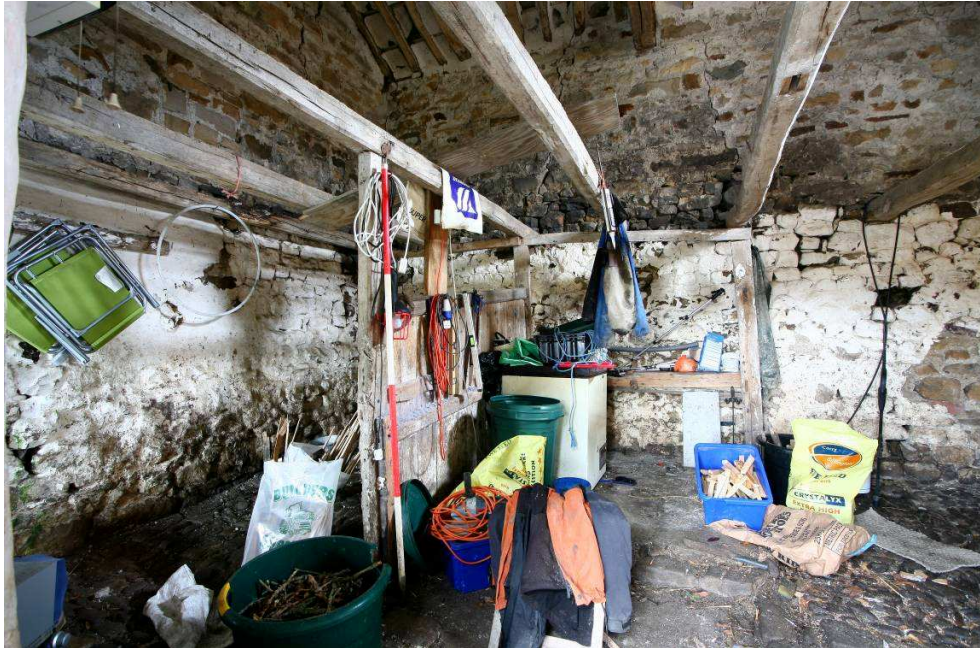
Plate 12: View of the stalls in the shippon

- 4.4.8 **The Shippon:** the shippon is smaller than the barn (Fig 7) and still retains much of the internal timber framework of its stalls (Plate 12). At the time of the survey, the space was being used for storage and some of the fabric was obscured. Access into the shippon is available via the external door at the north side of the building and also via the doorway leading to and from the Barn.

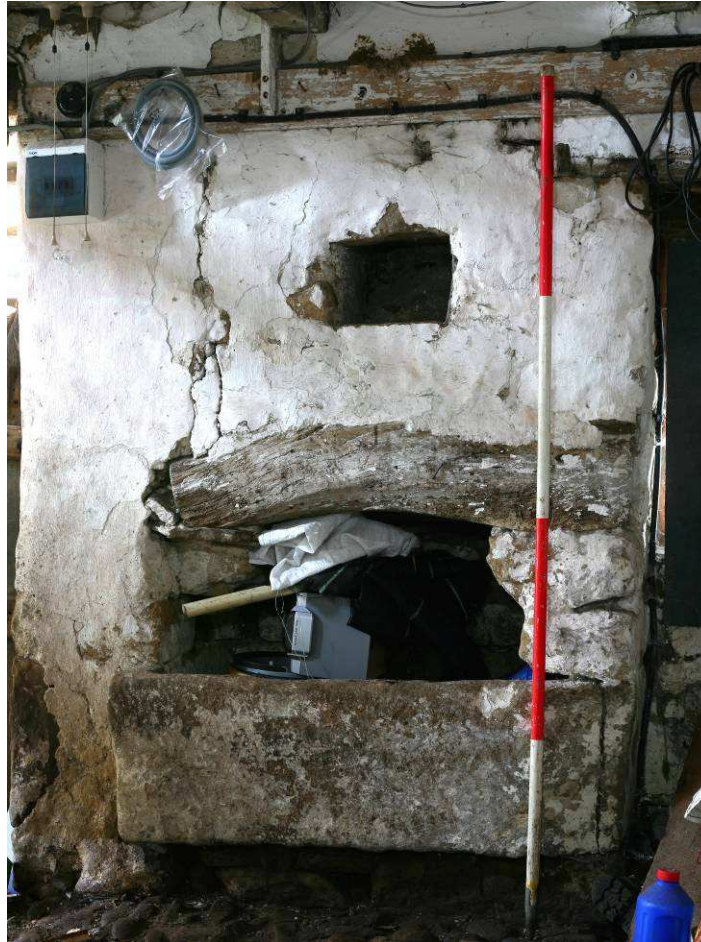
Plate 13: Drinking trough or manger in the north wall of the byre

- 4.4.11 The north wall of the shippon contains, other than the current entrance, a further aperture now containing a window. This was formerly a door, the extent of the blocking being visible externally. To the left of this, and recessed within the wall, is a large sandstone stone trough or manger (Plate 13); this measures approximately 1.2m (4 feet) by 0.58m (2 feet) by 0.4m (1 foot 4 inches). Above it is an opening with a curved timber lintel. The manger

projects slightly from the wall and may have been reused from elsewhere. Above the manger and set into the wall is a small niche.

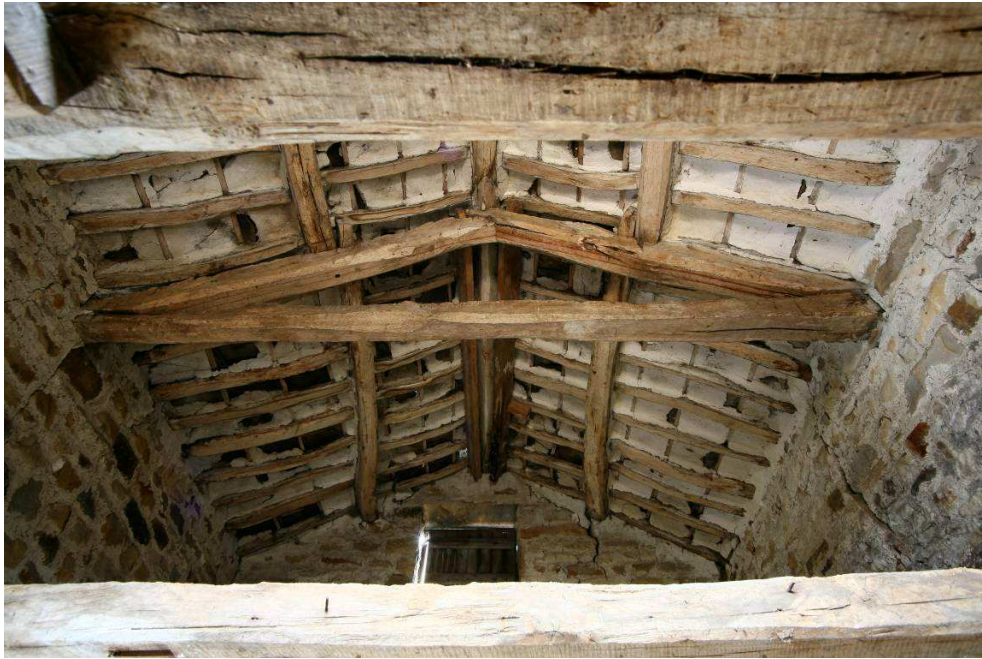
Plate 14: The roof structure in the shippon, facing east

4.4.12 The loft area was not accessible but was visible from ground level revealing the structure of the roof. Situated within each of the gables is a small opening, the east one having a timber shutter or door; the western aperture opens directly into the barn. The roof of the shippon is supported upon a single, centrally placed, triangular truss (Plate 14). There is a row of purlins on each side which are slightly trenched, together with a ridge purlin. All of the main roof members are of the same general appearance and some pegs are visible at the joints. The common rafters are of similar scantling to those in the barn and lime mortar torching was used on the underside of the roof covering (Plate 14).
