**Bottling Wood,
Wigan
Greater
Manchester**

**Archaeological
Investigation**

The Environment Agency

Issue No: 2010-11/1151

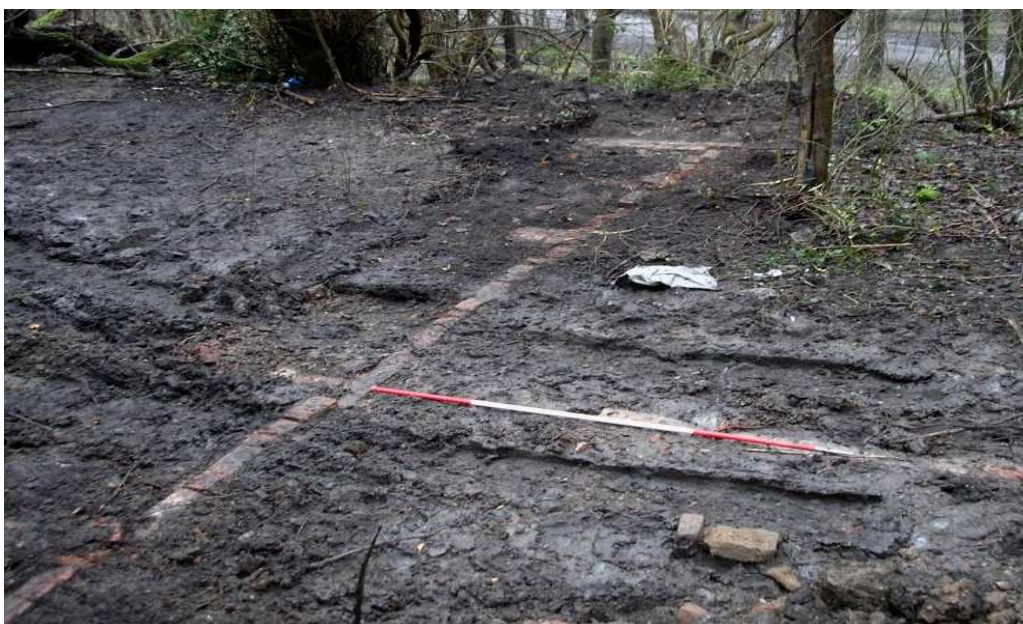
Plate 1: The remains of workers' cottages exposed during the watching brief in January 2009

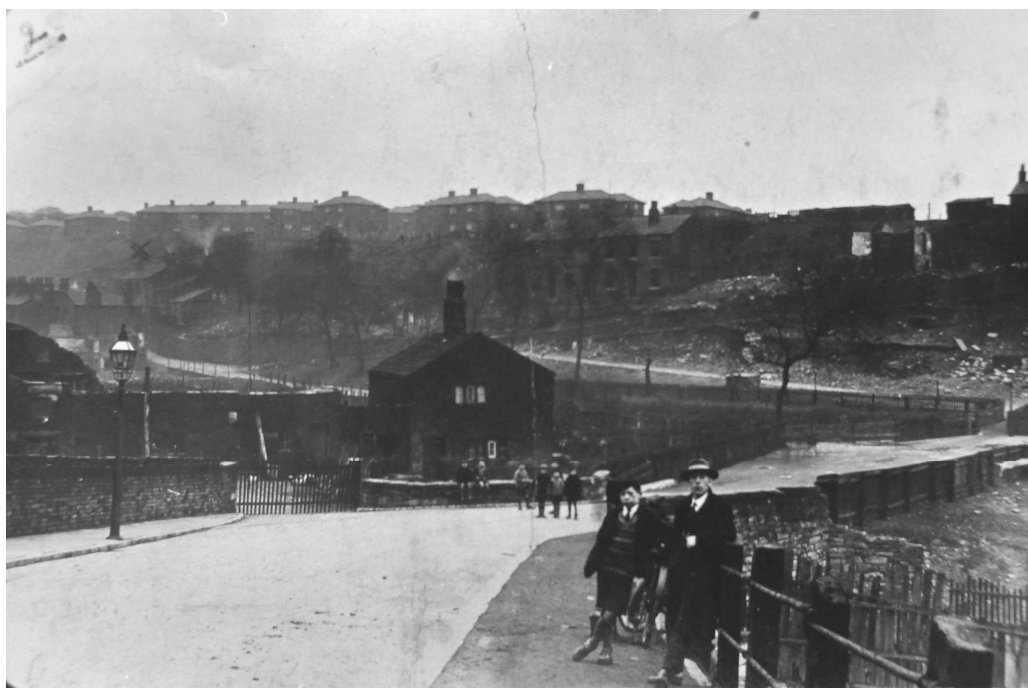
Plate 6: Demolition of houses in Bottling Wood c 1927 (270/34)

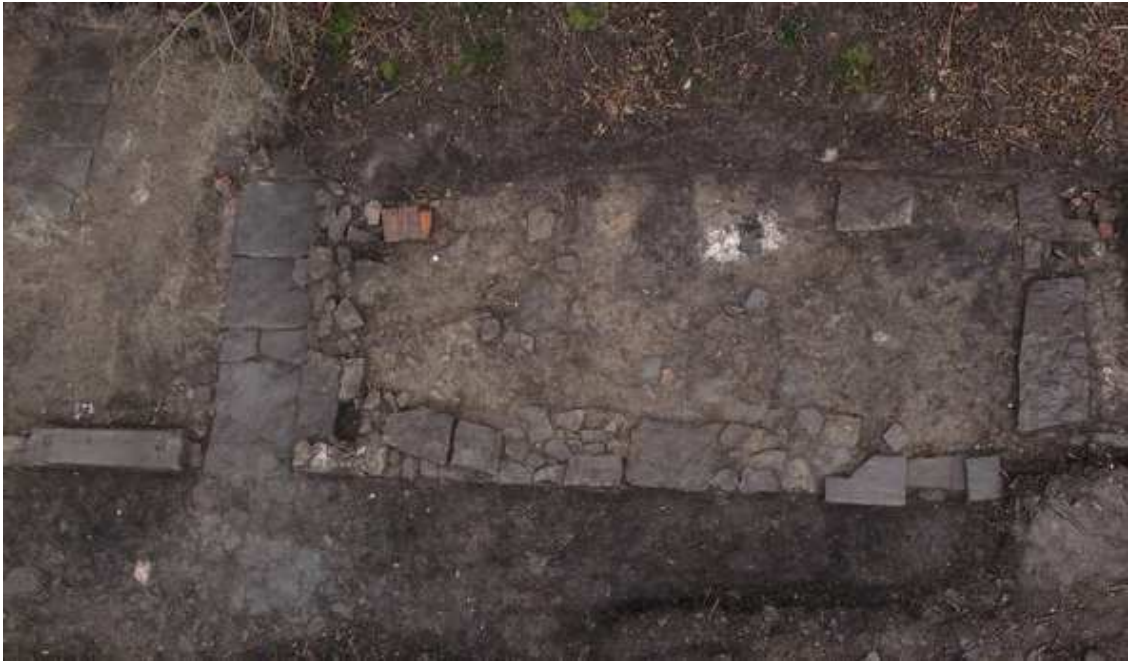
4.2.2 **Phase 1:** the earliest remains excavated comprised the foundations of a sandstone building (**1002** (Plate 7)), located at the southern end of the excavation area. This was only excavated partially, as the majority of the structure lay beyond the eastern limit of excavation (Fig 2). The remains comprised two walls (Plate 7), forming the northern and western external walls of the building. These were exposed for lengths of 2.3m and 4.73m respectively, with both continuing beyond the limit of excavation. Both were constructed of irregular, angular, fragments of sandstone, which varied considerably in size, and appeared only to be faced on the external side. Each wall was approximately 0.5m (1'6") wide, and survived to between two and three courses in height (to a maximum height of 0.27m), and were partially of dry-stone construction and partly bonded with a pale lime mortar. At the southern exposed end of the west wall, three broken stone fragments appeared dressed, and almost certainly represented the remains of an entrance threshold of a doorway measuring approximately 4' (1.22m) wide (Plate 8). A possible internal partition, of similar construction survived in very fragmentary form, 1.1m (3'6") from the north wall (Fig 2), suggesting that the structure contained a narrow room, or store, at its northern end. Two large stone slabs at the southern extent of the exposed structure may have represented the base of a similar wall, dividing the structure to the immediate south of the doorway. The eastern of these two large slabs was butted on its southern side by a hand-made brick pier, of a full-brick width (Plate 7). This possibly represented the cheek of a fireplace, probably a subsequent addition to the structure. A row of bricks, comprising one stretcher, and three edge-set, hand-made bricks, butted the north wall of building **1002**, in a similar position to those to the south, again suggesting the insertion of a fireplace.

Plate 7: Building 1002

5.2.1 The earliest remains excavated comprised the foundations of a sandstone building (**1002**), located at the southern end of the excavation area. The precise date at which this property was erected remains uncertain, although it is likely to have been during the late eighteenth or early nineteenth century. Settlement in the area during this period was focused on Sutton Mill, which may have originated as a medieval fulling mill. The position of the mill is annotated on Yates’ *Map of the County Palatine of Lancaster*, which was surveyed during the early 1780s and published in 1786. Whilst this map was produced at a small scale, and thus cannot be relied upon for details of individual buildings, it does not depict any development within Bottling Wood other than Sutton Mill, suggesting that the excavated property had not been erected (Plate 14). However, Mather’s *Map of the Town of Wigan in the County of Lancaster*, published in 1827, does depict a few houses within the study area, indicating that the hamlet in Bottling Wood had been established by that date.

- 5.2.2 The exposed remains of building **1002** had clearly been remodelled during the nineteenth century, making it difficult to elucidate the true function and character of the original structure. It seems possible, however, that it may have been intended as a domestic workshop, representing an early stage in the development of Bottling Wood as a local centre for the domestic nail-making industry (Blakeman 2006).

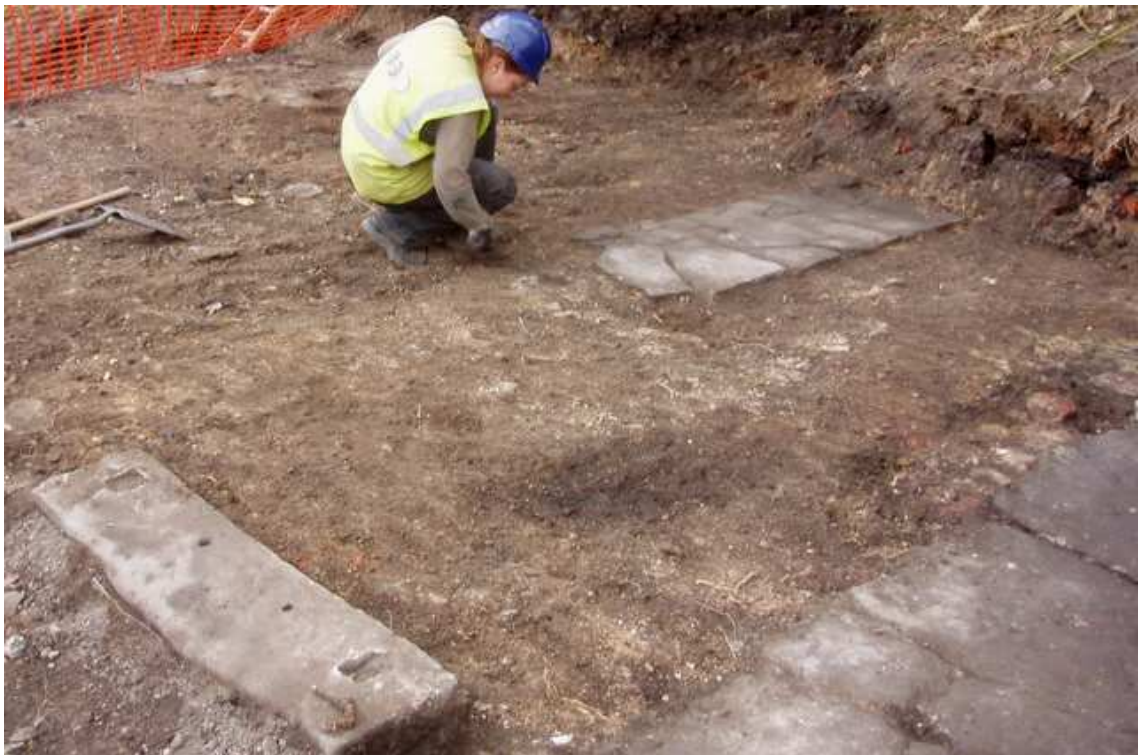
Plate 8: Threshold step in building 1003

- 4.2.3 **Phase 2:** this second phase of construction comprised two brick-built structures (**1003** and **1004** (Fig 3)), divided from structure **1002** by a 0.65m (2'1") wide, sandstone-flagged footpath (**1013** (Plate 9)). These two structures were very similar in construction, and appeared to represent a single build. The well-preserved west wall was of a full-brick thickness, constructed of hand-made brick, laid in stretcher bond, in a pale lime mortar matrix. Two 1.22m (4') long, dressed sandstone threshold steps were incorporated into the wall, the southern example positioned at the southern end of the wall, whilst the other was placed immediately to the north of an internal partition (Fig 4). Both steps were heavily worn, and had square-section sockets for door-framing, whilst the southern example also had two smaller housings for cane bolts, suggesting a double-door in this position.

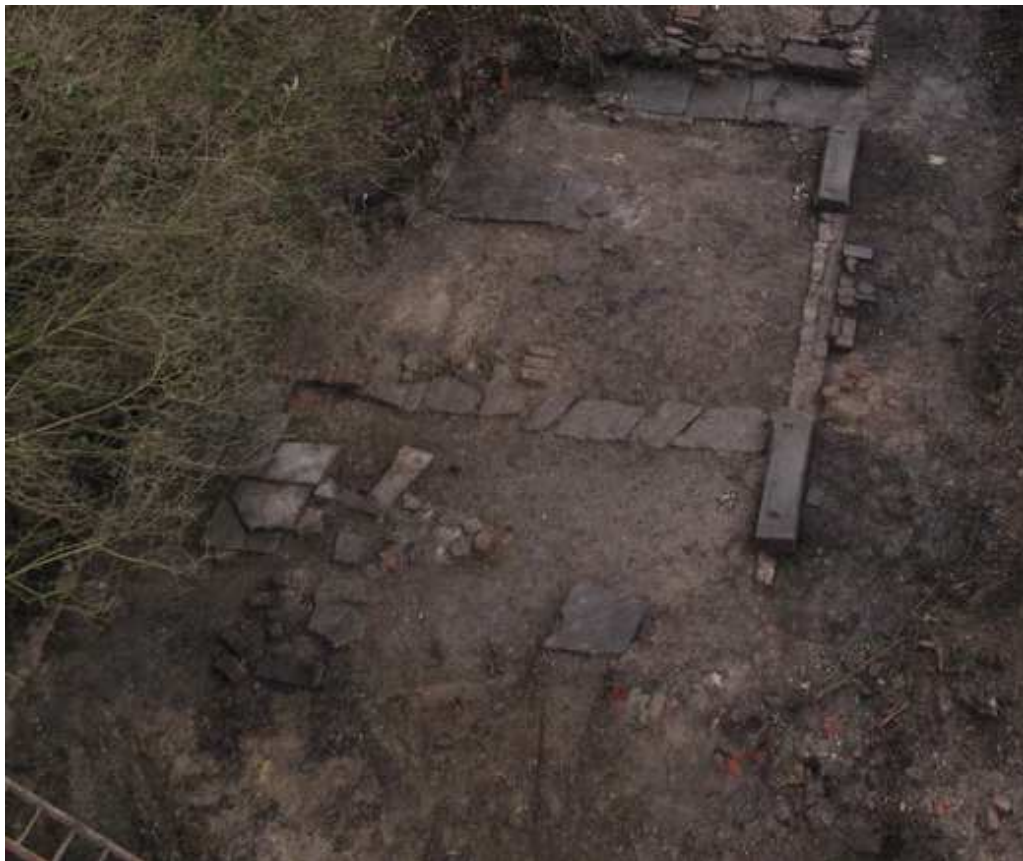
- 4.2.4 The dividing wall between the two rooms comprised a single skin of broken, or possibly half-bat, hand-made bricks, at its eastern end (Fig 3), and as a stone slab foundation for the western 3.3m (10'8"). Both rooms retained areas of sandstone flag flooring (Plate 9). Those within Structure **1003** were laid directly onto exposed, levelled bedrock, whereas those within Structure **1004** were bedded in a layer of re-deposited natural clay. A row of three hand-made bricks abutting the southern side of the partition between Structures **1003** and **1004** almost certainly represented the base of a fireplace cheek, whilst a patch of stone rubble 0.81m (2'8") to the east (Fig 3) appeared to represent the base of the other cheek of an approximately 4' (1.22m) wide fireplace.

Plate 9: Structures **1003** (top) and **1004** (bottom)

- 4.2.5 Neither of these structures (**1003** and **1004**) were exposed fully, due to the narrow limit of excavation (Fig 4), and also because the northern end of the buildings was heavily truncated prior to excavation, presumably during their demolition during the 1920s. However, it was possible to ascertain that the southern of the two structures (**1003**) was 3.7m (12'1") wide.

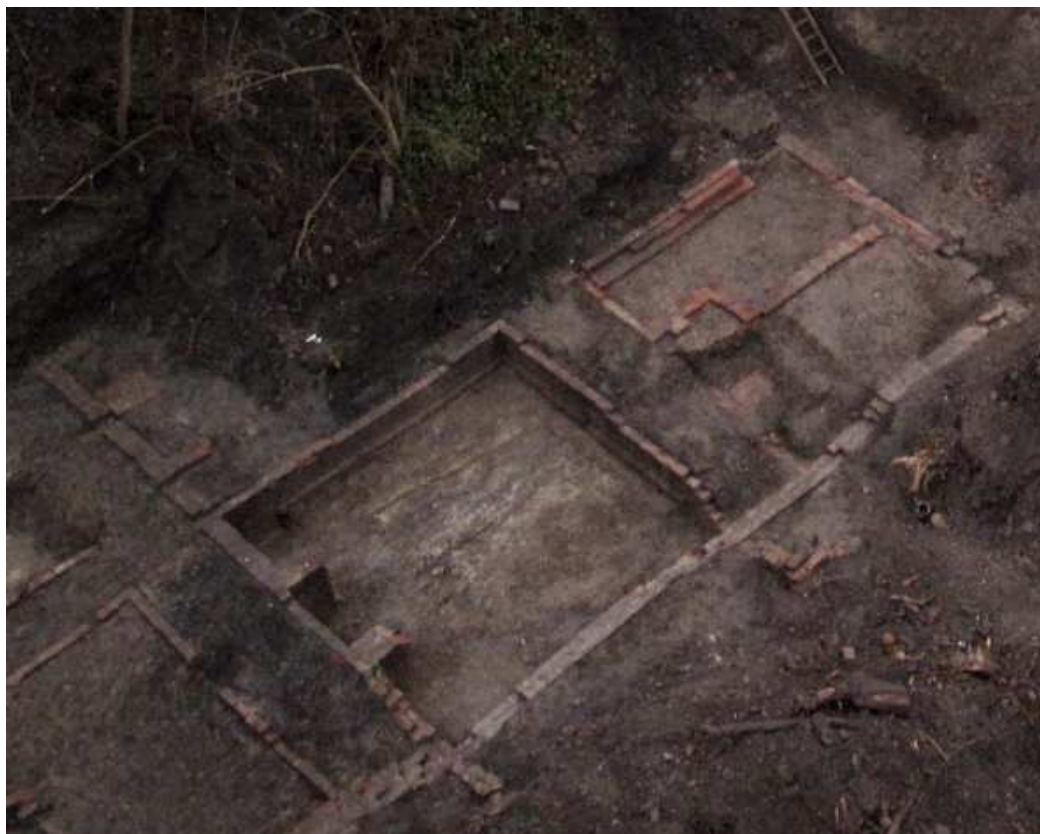
- 4.2.6 **Phase 3:** this phase comprises the construction of another building, divided into two properties (**1005** and **1006**) by a passageway (Plate 10), and may be dated on cartographic evidence to between 1851 and 1889-92. This new building was placed *c* 5' (1.52m) to the north of the extrapolated end of the Phase 2 structures, and was also offset to the west by a similar distance (Fig 4). The construction of the building necessitated the excavation of a large foundation trench (**1010**), cut into the bedrock, presumably to produce a level building platform. This extended 1.35m to the north of the north wall, and was cut by the Phase 4 building to the north (*Section 4.2.12, below*). This terracing of the bedrock placed the foundational level of this new building at 5' (1.52m) below the Phase 2 structures to the south.

Plate 10: The front rooms of properties 1005 (right) and 1006 (left)

- 4.2.10 Property **1005** had the remains of a fireplace on the northern wall, situated slightly off centre. The fireplace measured 1.72 x 0.57m (5'6.4" x 1'8.7"), but had been badly damaged by a later intrusion. The passageway between **1005** and **1006** measured 1.10m (3'6") wide, was aligned east/west, and probably continued through the entire property.

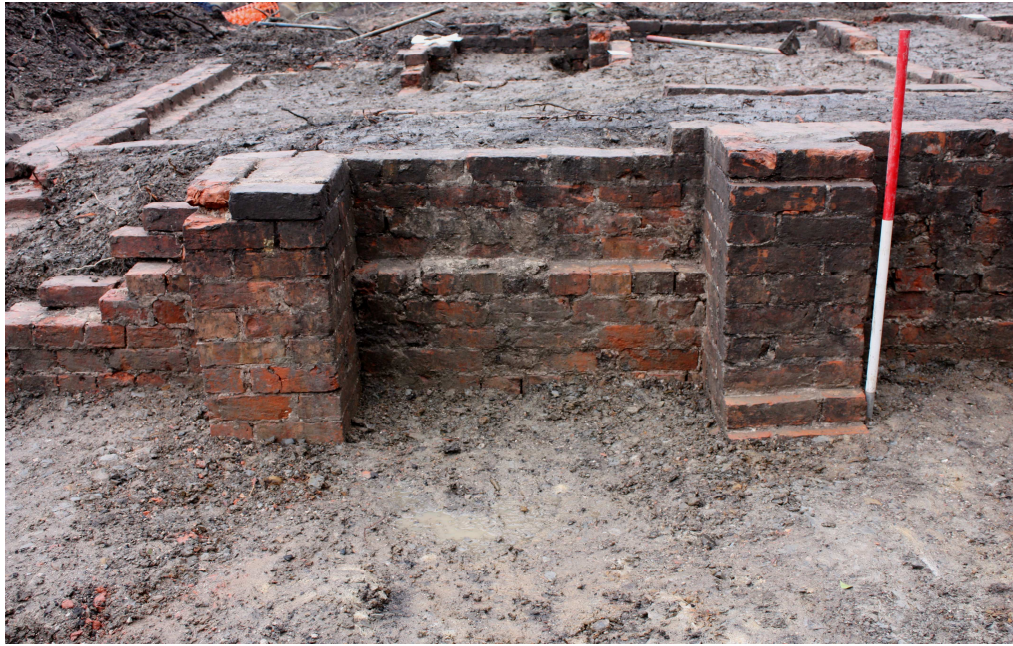
- 4.2.11 Property **1006** had both the front and back rooms exposed; the front room measured 4.05 x 3.84m (13'2.8" x 12'6"), and the back room measured 4.05 x 3.26m (13'2.8" x 10'7"). Both rooms in this property contained fireplaces on the northern wall (Plate 11). The fireplaces were keyed in as two protruding buttresses, and were roughly the same size (1.06 x 0.40m (3'4.7" x 1'3")), despite the rooms being of different dimensions.

Plate 11: Fireplace in front room of structure 1006

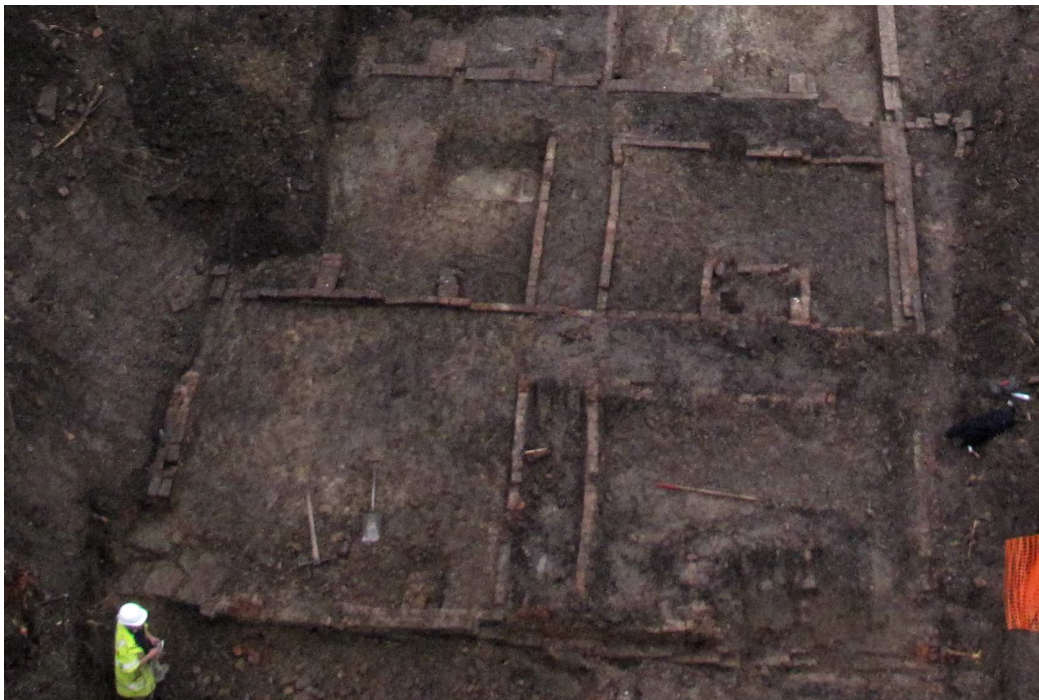
4.2.13 **Phase 4:** an additional building, again comprising two, two-roomed properties (**1007** and **1008**), was added to the north of **1006** during the later nineteenth century (Plate 12). The foundation trench for this new building cut that for properties **1005** and **1006**, demonstrating it to have been a later build. As with the earlier properties, this new building was composed of hand-made bricks bonded with lime-based mortar. The layout of these two properties was almost identical, with a side passage on the most southerly side of the properties, and front and back rooms with a central stair between the two. Within each of the rooms a fireplace was located centrally on the northern wall.

Plate 12: Structures 1007 and 1008

- 4.2.14 Each property (**1007** and **1008**) was 4.27m wide and 8.87m deep (14' x 29'1"), with the front rooms measuring 3.21 x 3.55m (10'5.3" x 11'6.4"), and the back rooms 4.27 x 3.76m (14' x 12'3.3"). The side passage measured 1.06m wide (3'4.7") and is likely to have run only to the eastern wall of the stair, with the stair aligned north/south and measured 3.27 x 0.74m (10'7.2" x 2'4.2").

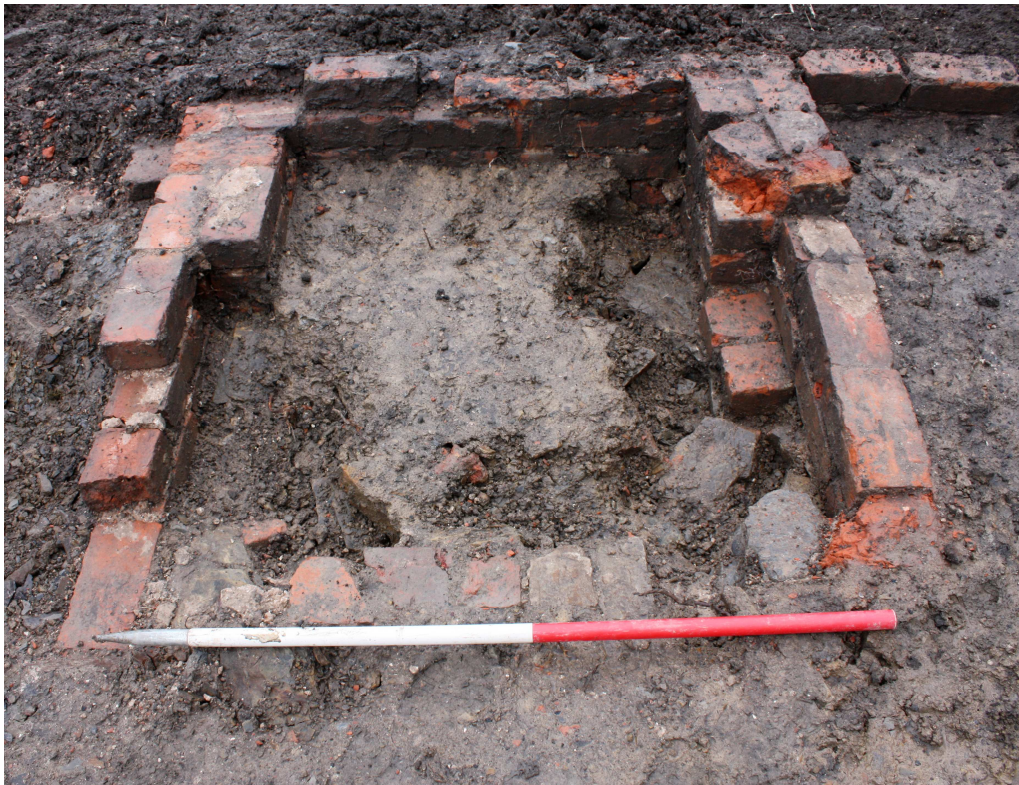
- 4.2.15 Two styles of fireplace were identified in each property. A rectangular, single-skinned fireplace was placed centrally on the northern walls in the front rooms, and measured from 0.94-1.13m x 1.05-1.34m (Plate 13). At the rear of the properties the fireplaces were represented by two buttresses, similar in construction to those in **1006**. These were keyed into the northern walls of each property (**1007** and **1008**), and measured 0.57-0.6m x 1.71-1.89m.

Plate 13: Fireplace in front room of structure **1007**

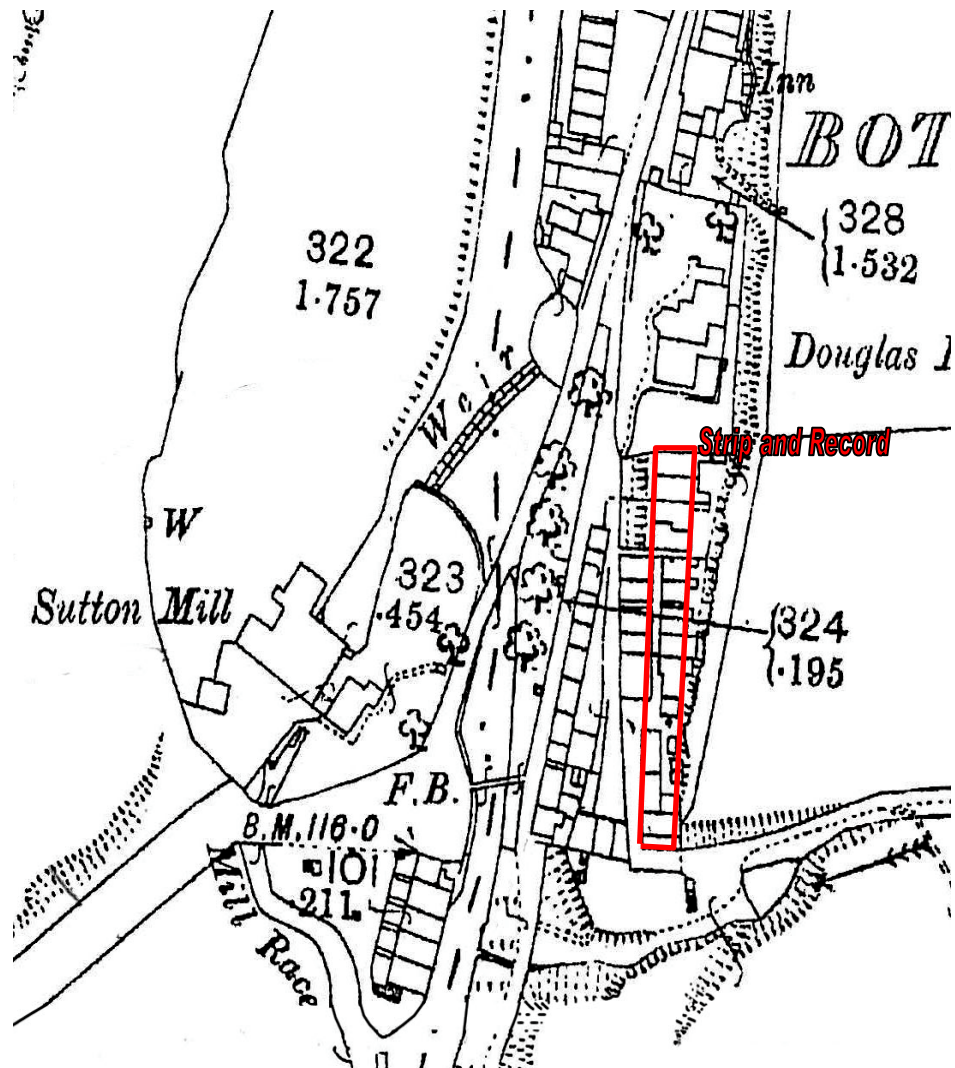
Plate 2: Proposed area for 'strip and record', on the Ordnance Survey map of 1894

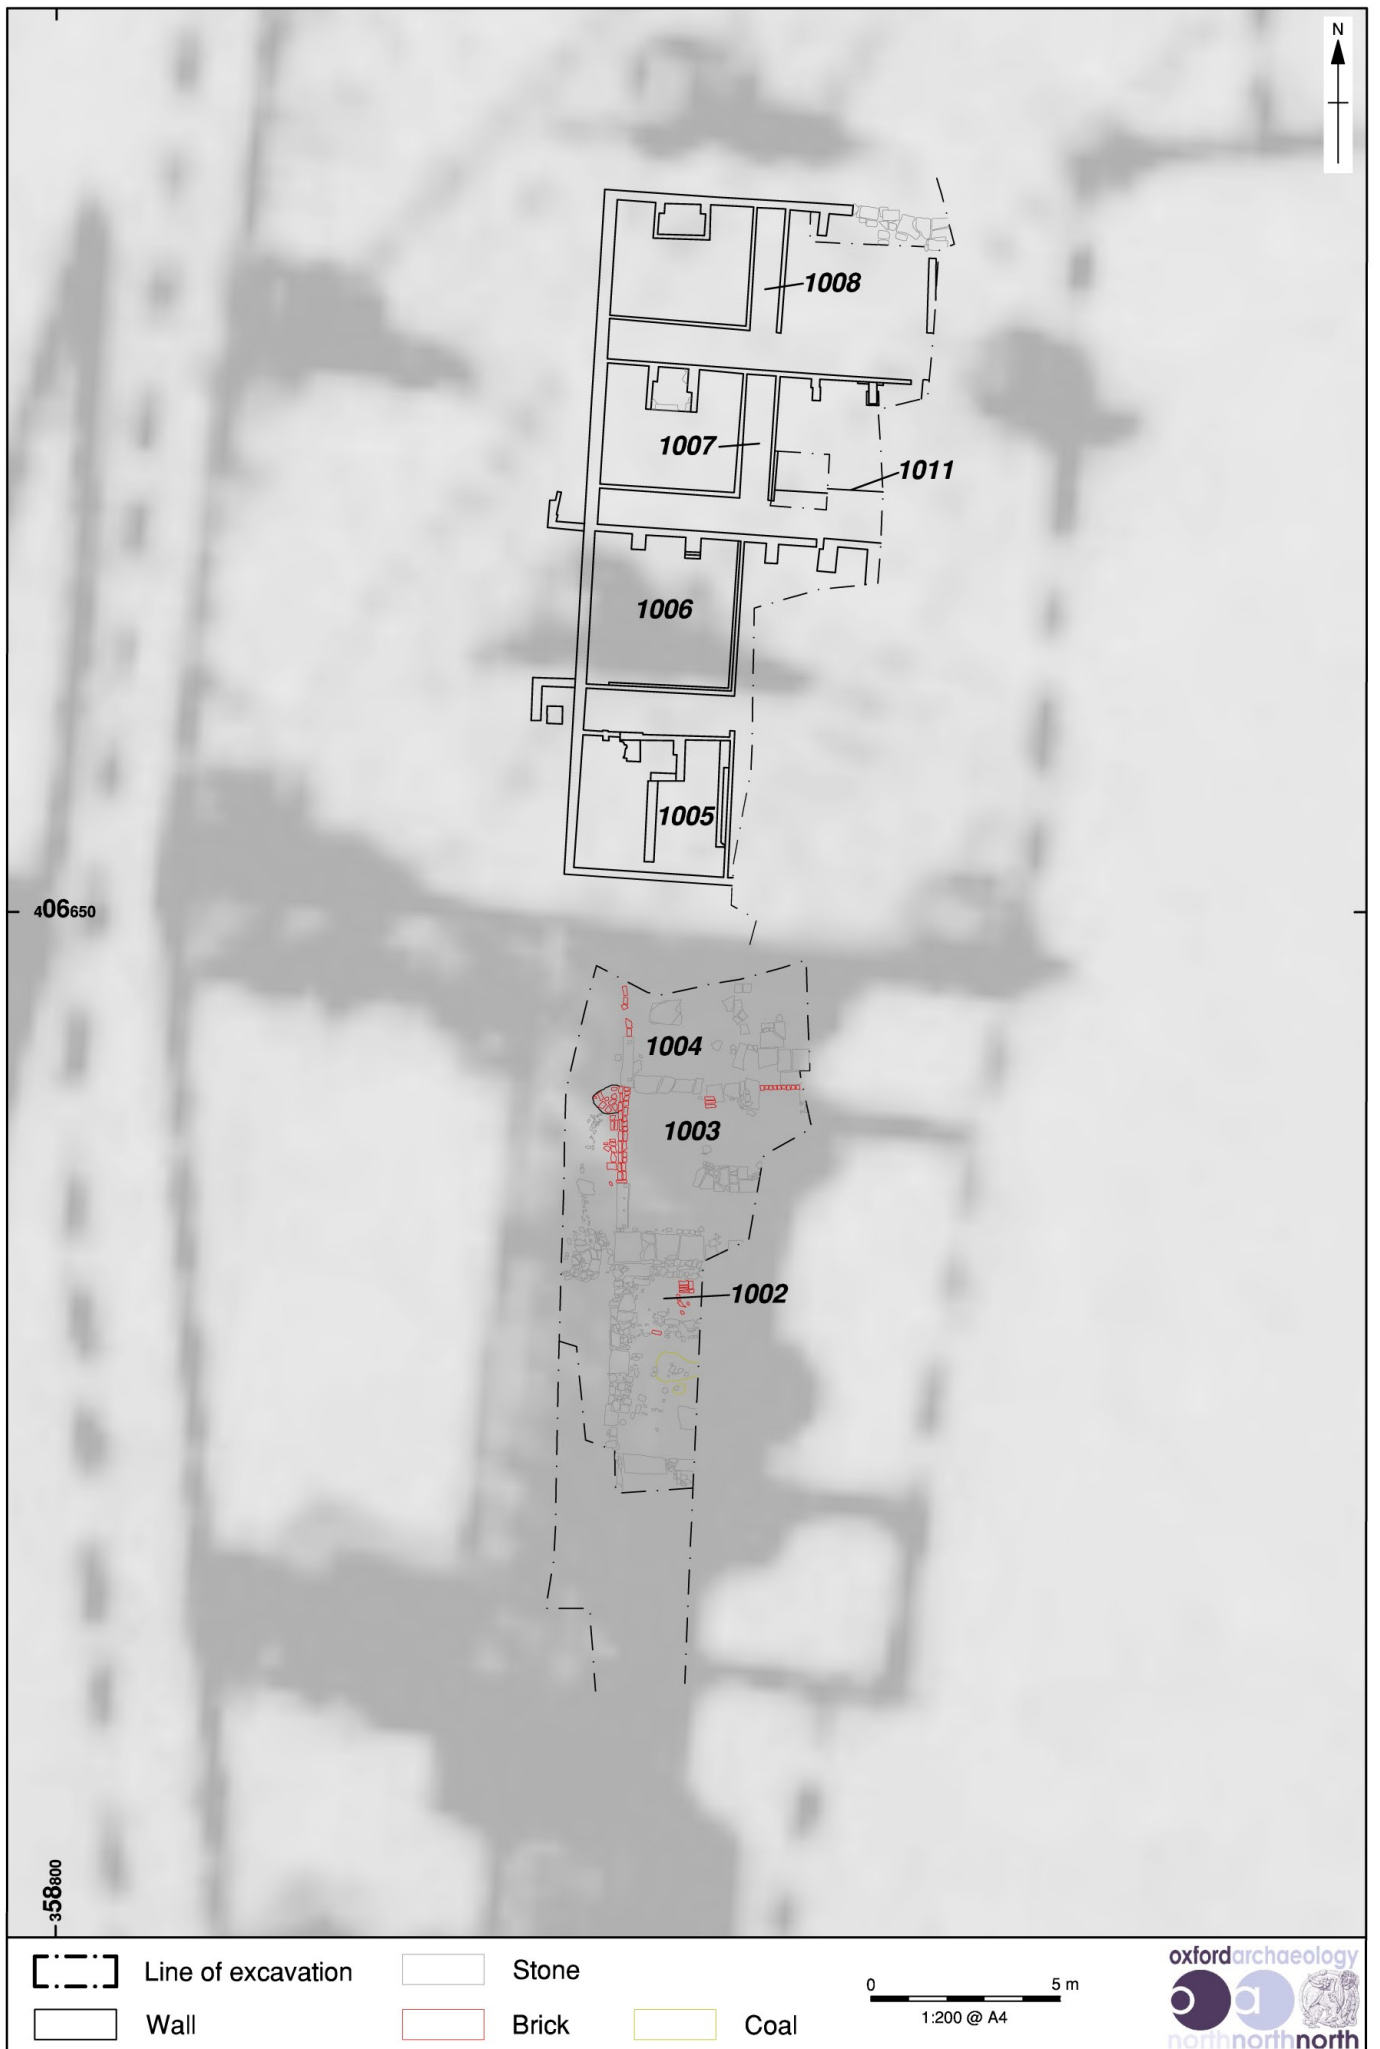
Figure 3: Excavated area superimposed on the 1851 map of Wigan

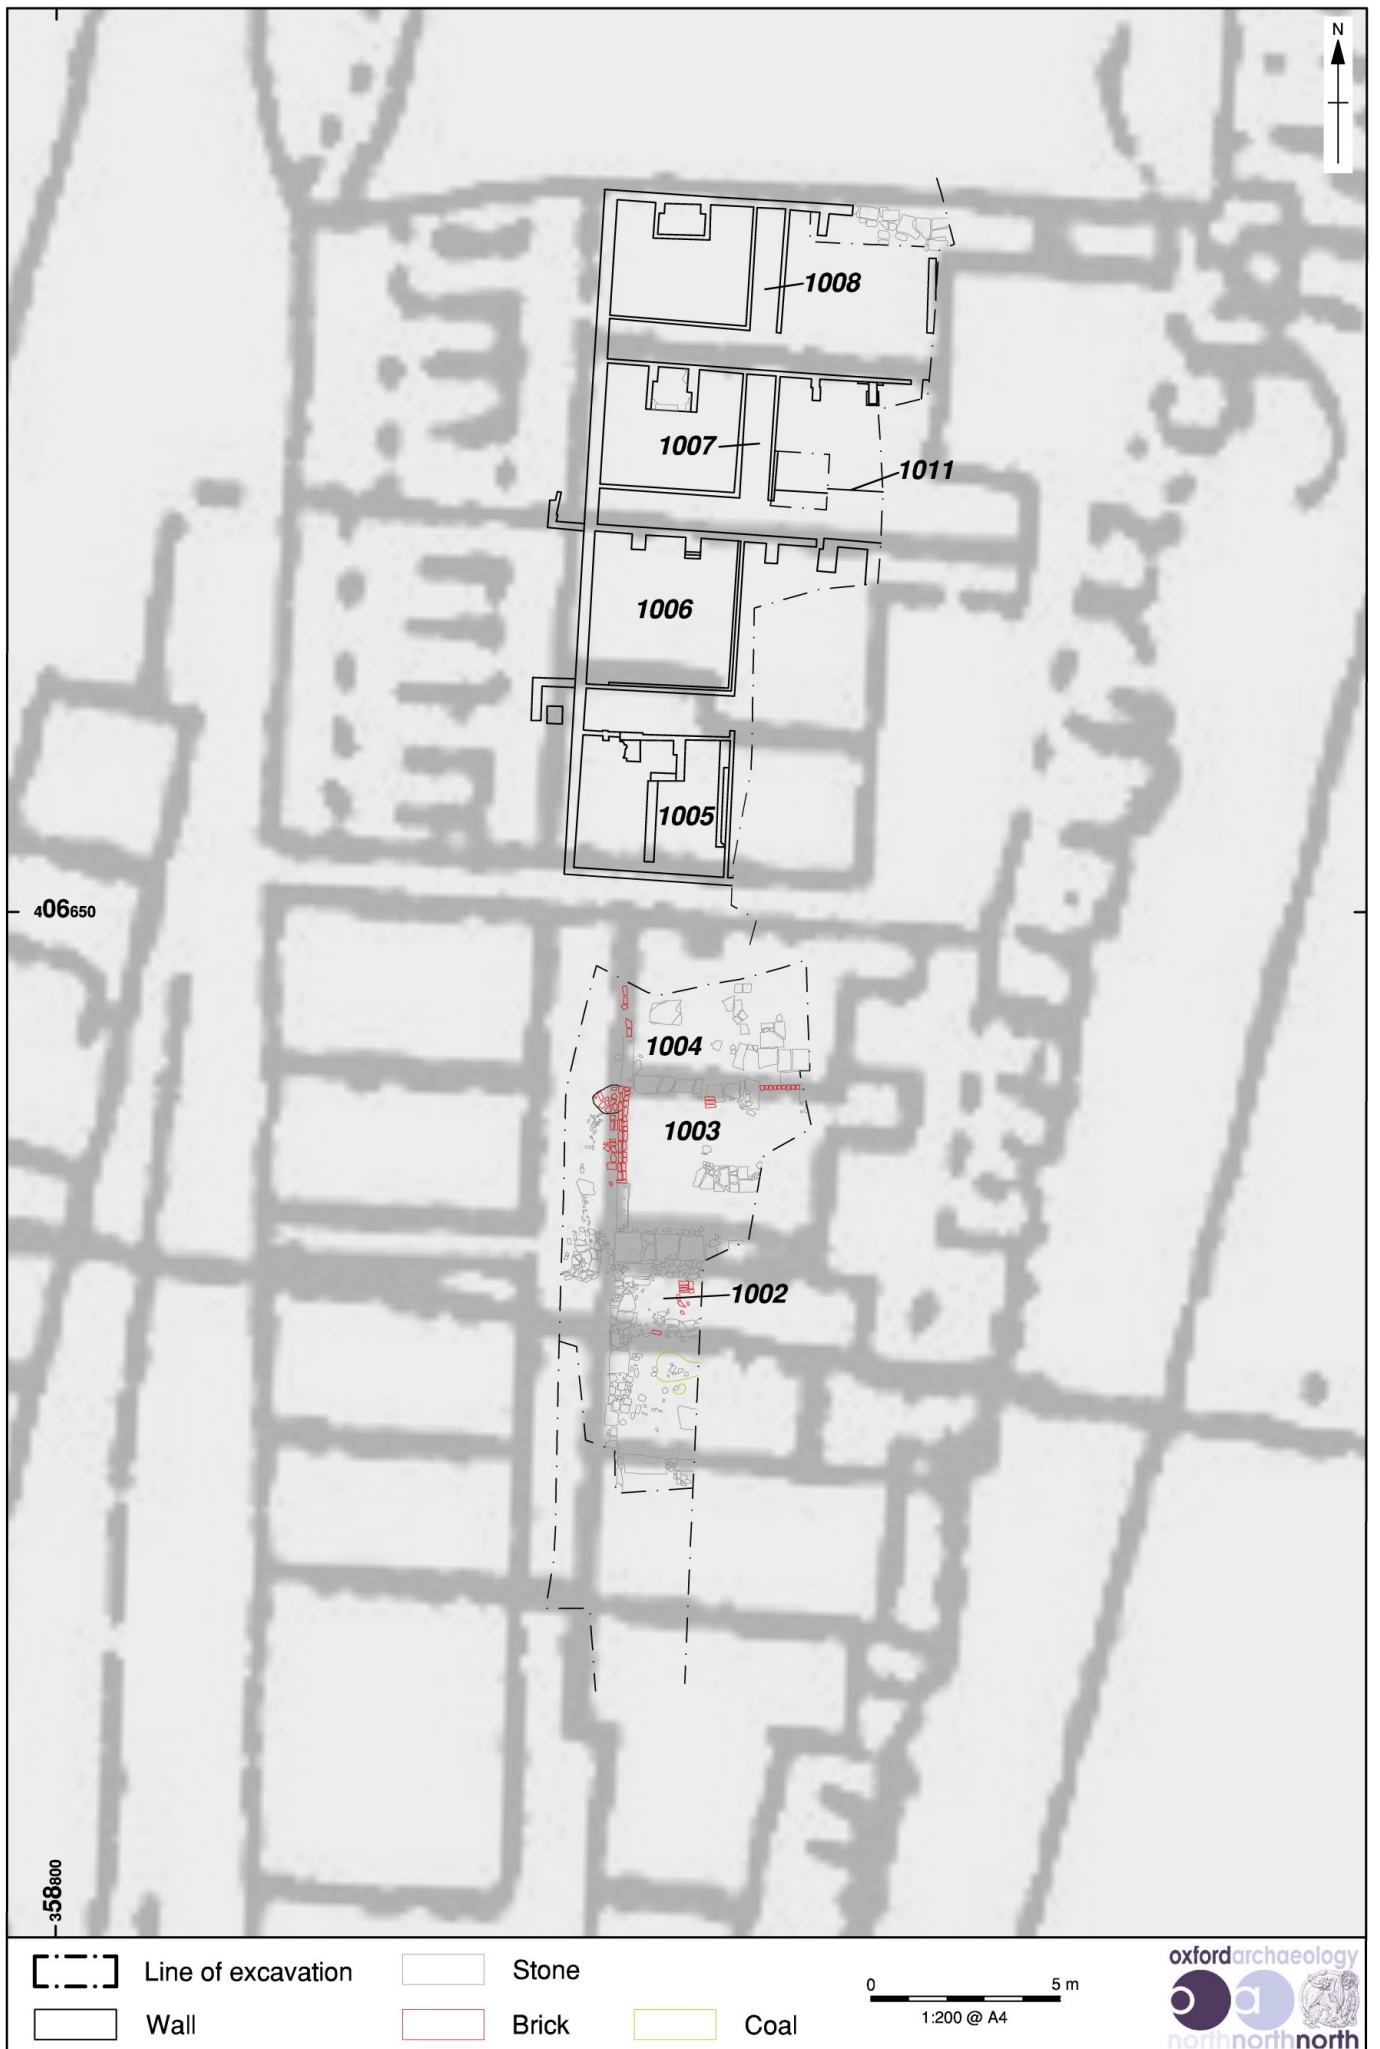
Figure 4: Excavated area superimposed on the Ordnance Survey map of 1889-92

- 4.2.7 The building was 30'6" wide (9.30m) along its western frontage, and was 25'9" (7.85m) deep at its northern end (Fig 4). Although only a small portion of the back rooms was revealed, it appeared that the front rooms were larger, measuring 12'6" (3.86m) deep, as opposed to 10'6" (3.26m). The front room of the northern of the two properties (**1006**) was significantly wider (13'3" (4.05m)) than property **1005** to the south (11'6" (3.51m)); this discrepancy was partly to accommodate a 3'6" (1.06m) wide passageway between the two properties (Plate 10). The presence of a brick from the east wall of **1005** extending beyond the north wall, and evidence from the detail shown on historical mapping, suggest that the passage terminated at this point, with the rooms to the rear presumably having been accessed via their side or rear elevations.
