**Ditherington Flax
Mill,
Ditherington,
Shrewsbury
Shropshire**

**Public-led
Archaeological
Excavation**

July 2013

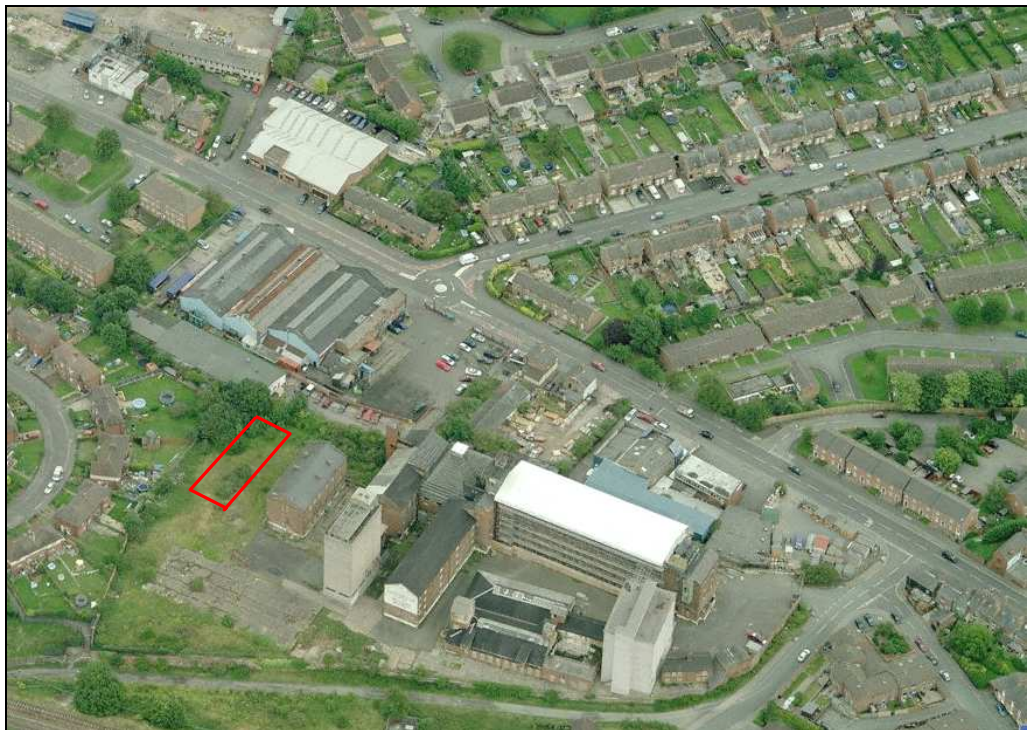
Plate 1: Recent satellite view of the Ditherington Flax Mill, showing the location of the excavation area

- 1.2.1 The study area (centred on NGR SJ 49888 13849) is situated in Ditherington, in the northern part of Shrewsbury (Fig 1). The site occupies a level plot of land, lying at a height of approximately 60m above Ordnance Datum (aOD). It is bounded to the west by the railway line from Shrewsbury to Crewe, to the east by the A5191 (here named Spring Gardens), to the north by housing and a bus depot, and to the south by a twentieth-century housing estate.
- 1.2.2 The excavation area occupies the northern part of the mill complex, situated between the Apprentice House and the site boundary wall (Plate 1). This part of the site is currently open ground with modern hard-surfacing covered by scrub vegetation.

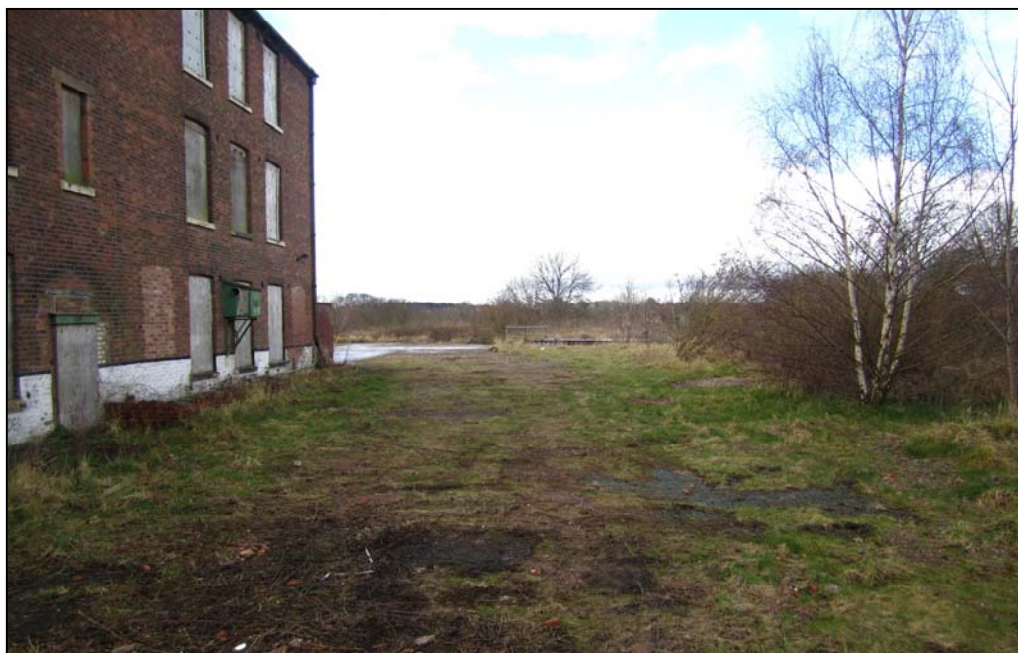
Plate 2: View across the site immediately prior to the excavation

- 4.1.1 An open-area excavation of a single trench was placed across the open ground in the northern part of the site (Plate 2). The trench measured *c* 25 x 12m (Plate 3), incorporating the evaluation trench excavated in 2010, and examined the footprint of the outbuildings shown on a plan dating to 1855 (Fig 2).

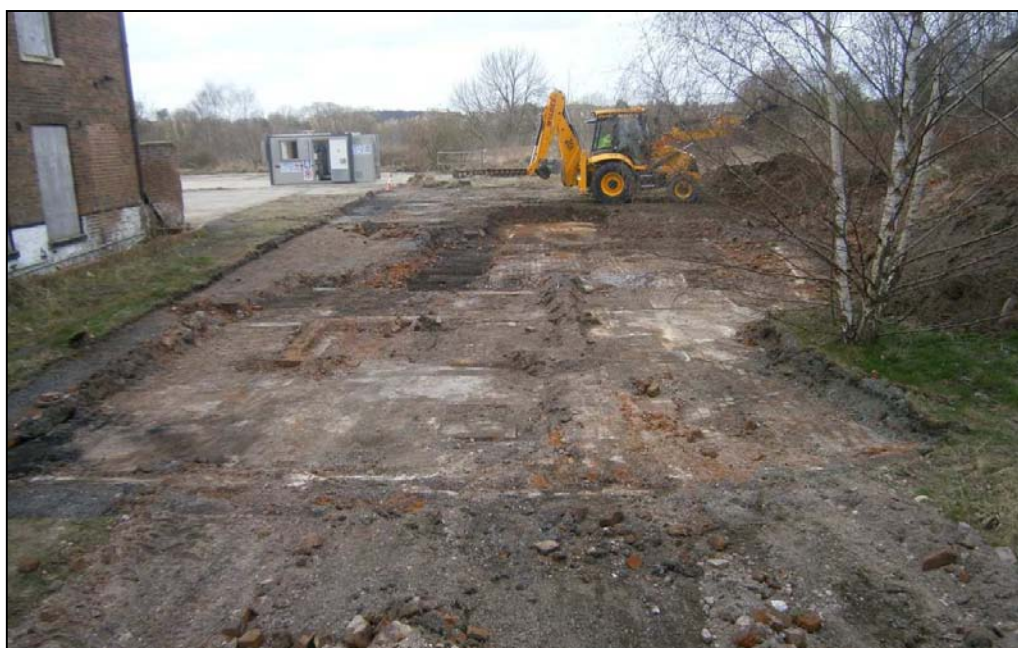
Plate 3: View looking north-west during initial mechanical stripping of the site

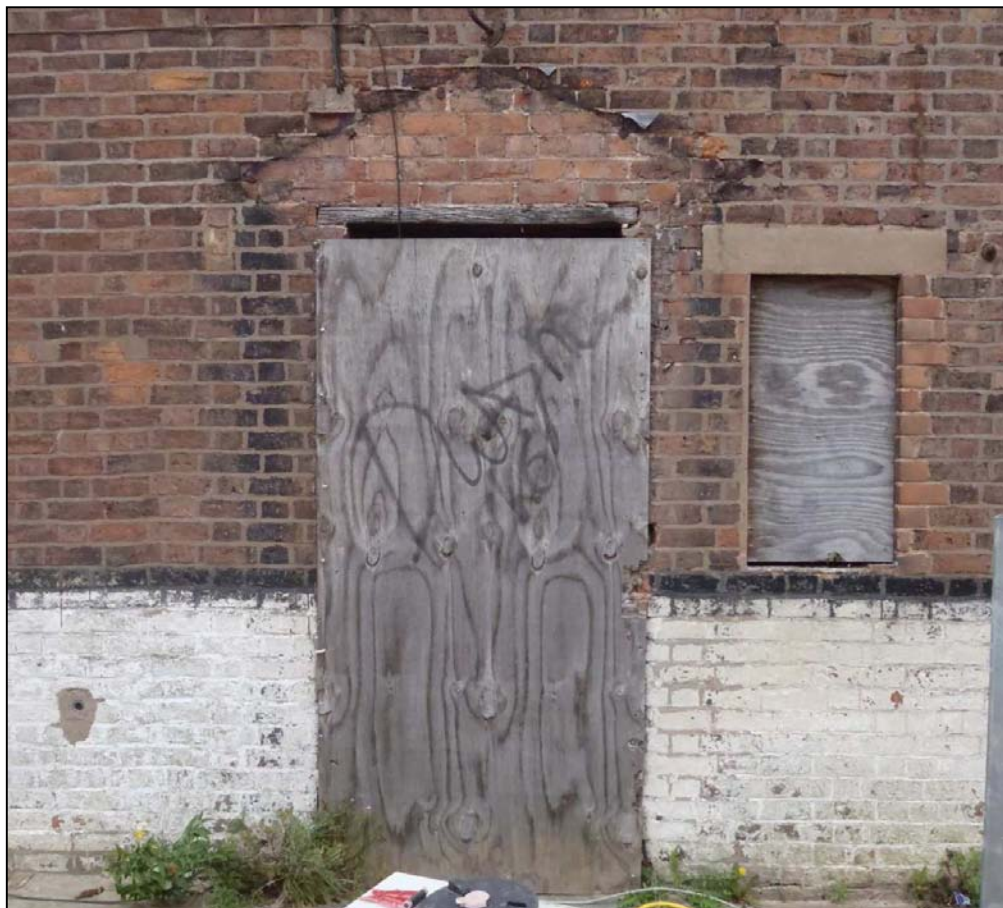
Plate 4: Wall scar 2077 visible on the north wall of the Apprentice House

- 4.2.1 The 1855 map shows a door in the centre of the north side of the Apprentice House facing a door in the south side of the wash house (Fig 2). Initial excavation provided evidence for a corridor connecting the two buildings, and the trench was extended by hand to reveal this area in more detail (Fig 4).

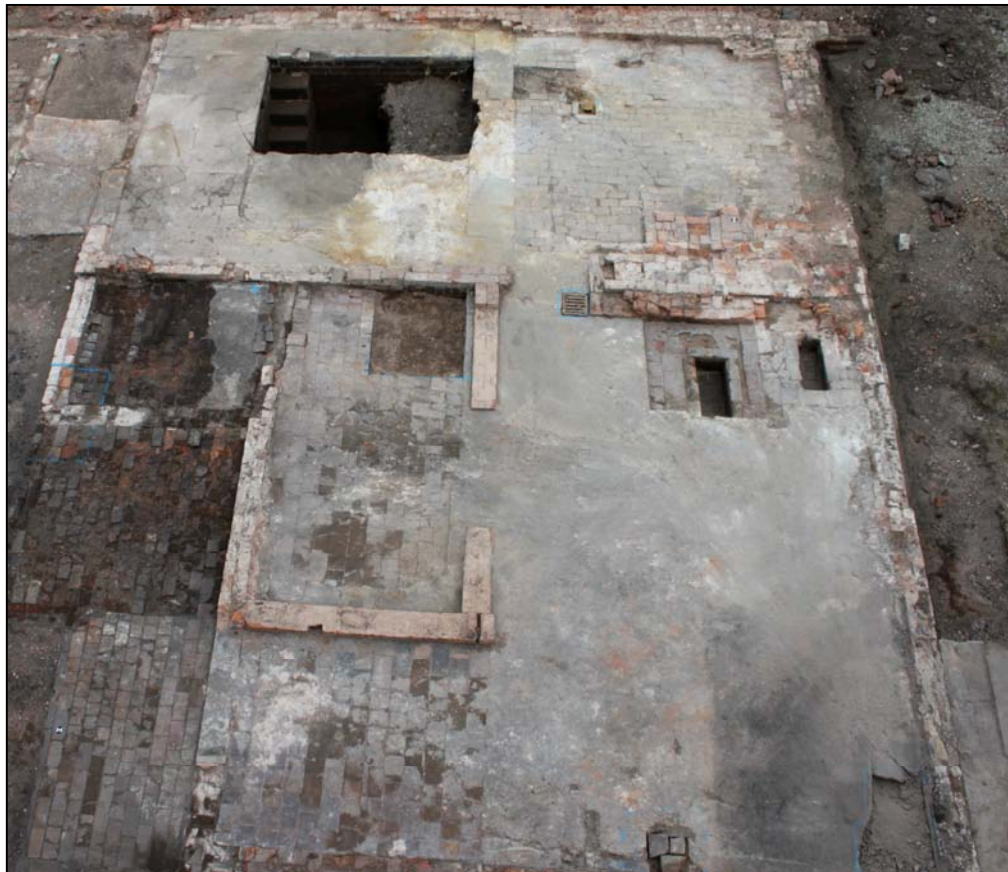
Plate 5: View across Room 1 in the Wash House, showing rectangular pits 2040 and 2042 set into surface 2043, adjacent to the foundation of brick-built chimney 2045

- 4.3.3 The floor surfaces in Room 1 varied. In the south-west and north-east corners there were brick tile surfaces (2018 and 2042), which were set on mortar bedding layers. A layer of concrete (2043) was set on backfill deposit 2057, but broken tiles (2056) were visible beneath concrete 2043 at the southern side of the room. Concrete surface 2043 had a visible crack aligned north/south across the length of the room. The edges of all flooring surfaces sloped upwards to abut the southern wall 2019 and the eastern wall 2037. Brick tile surface 2042 abutted the foundation of a brick chimney structure (2045) at the north side of the room (Plate 5). In floor surface 2042 were set two rectangular ash pits (2040 and 2041; Plate 5), which were excavated by a local school group (Plates 6 and 7).

- 4.3.4 Rectangular ash pits **2040** and **2041** were constructed with brick sides and bases with the southern side at an angle sloping to the base of the pits to permit shovelling of ash. Excavation of pit **2040** revealed walls constructed of fire bricks (**2079**), which was separated from outer wall **2037** by a layer of clay (**2080**) acting as a thermal break. The brick base of pit **2040** was on a layer of floor tiles (**2081**) that were, in turn, on backfill deposit **2057**.

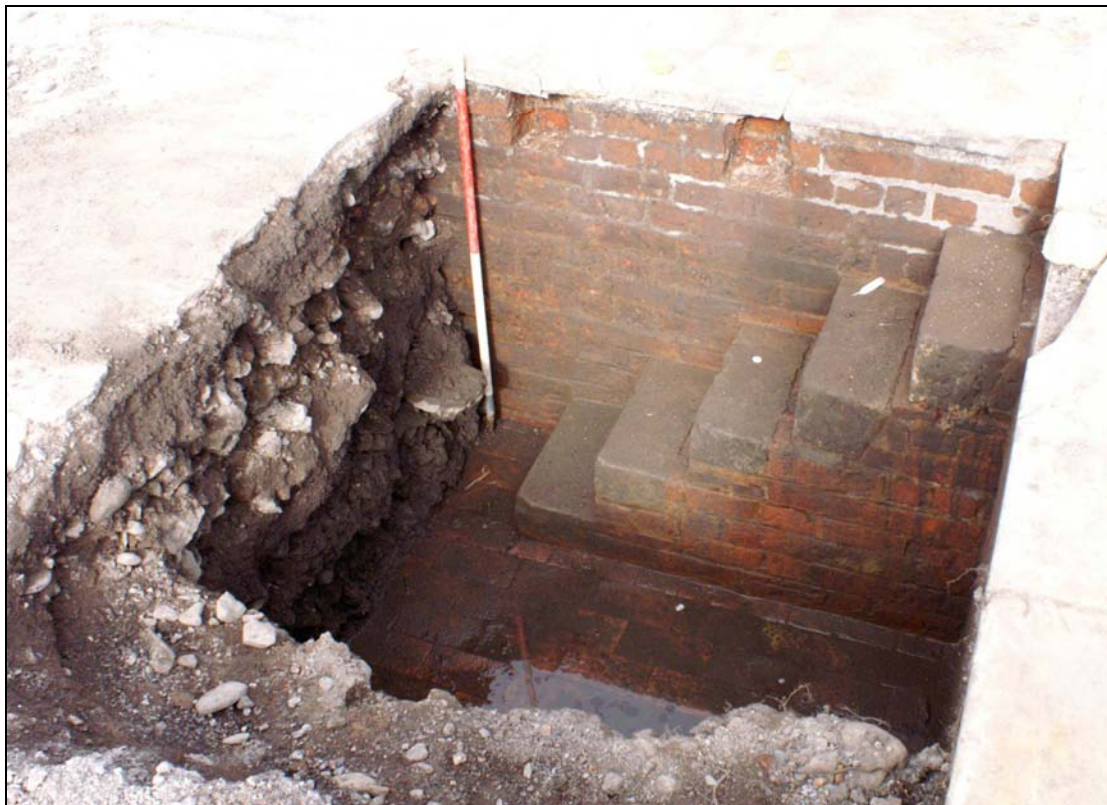
Plate 9: The excavated remains of the steps in the 'bath'

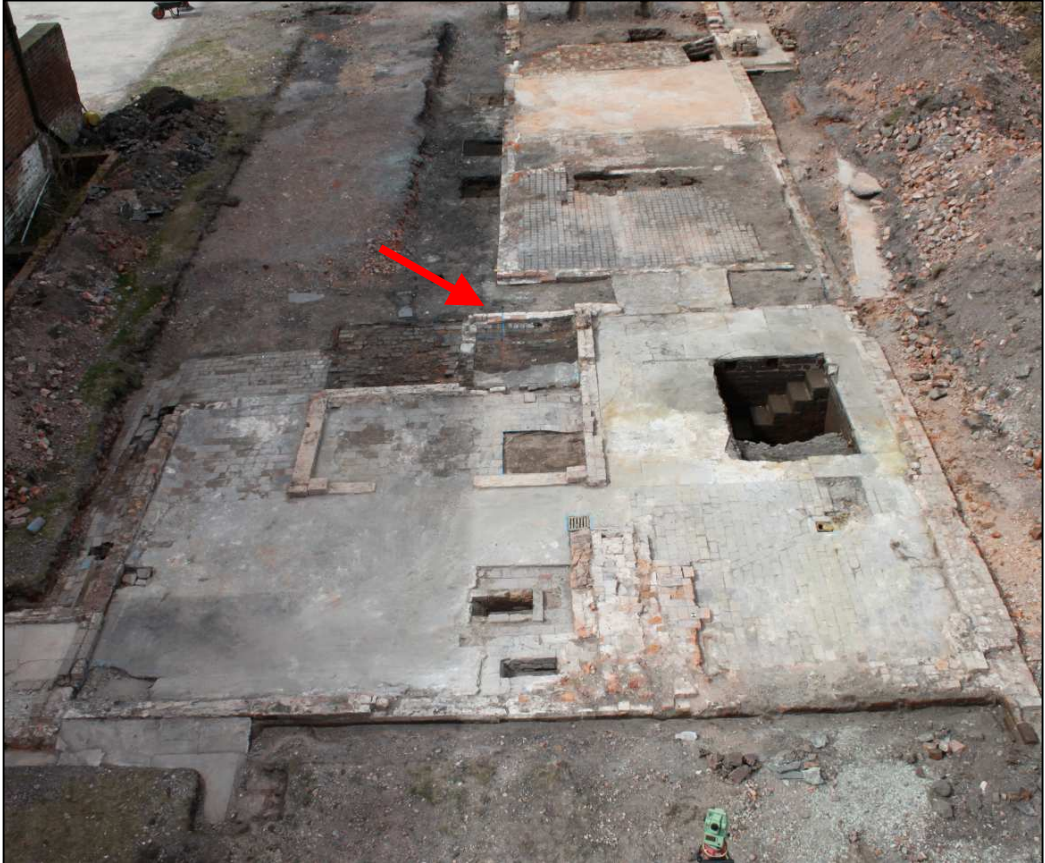
Plate 10: View looking north-west across the excavated area, with arrow marking the position of Room 5

- 4.3.13 **Room 5:** wall **2012** was an ‘L’ shaped brick wall that joined the west wall (**2002**) of Room 4 to the west wall (**2015**) of Room 2, utilising a corner of the Wash House and stable passageway to create a small square room (Room 5). Wall **2012** was not bonded to walls **2002** and **2015**, and there was no evidence of access into the Wash House from Room 5. Excavation of this area (Plate 10) exposed a layer of dark reddish-brown redeposited clay (**2051**).

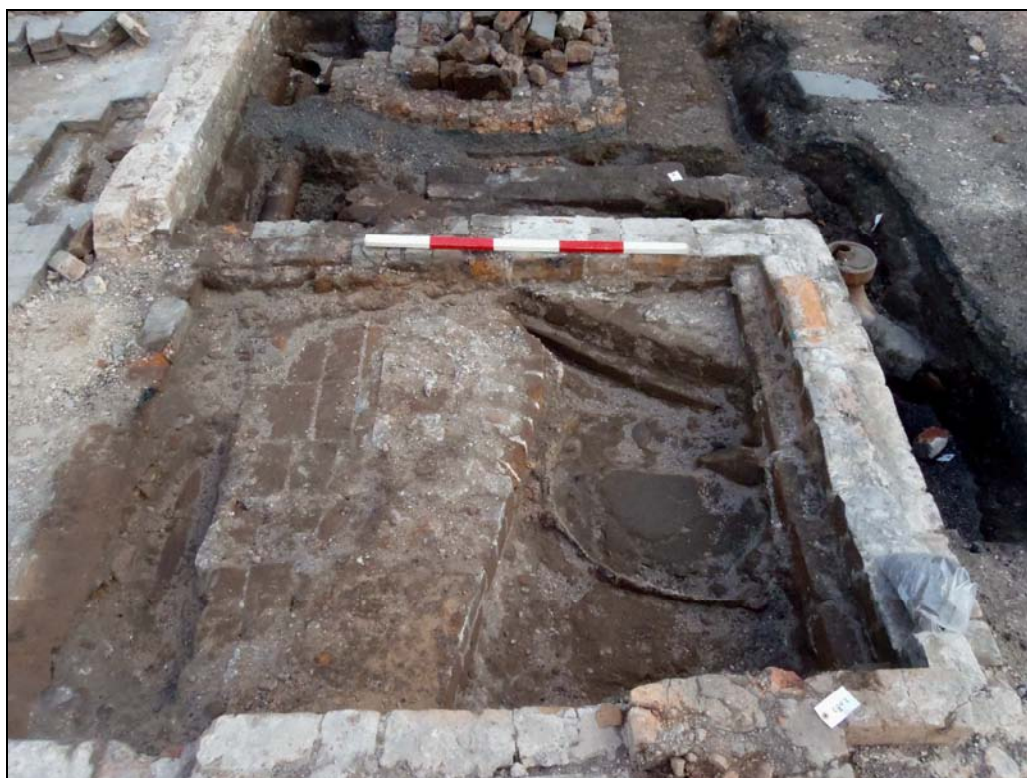
Plate 11: Brick platform 2049, iron ring 2050, and brick-lined drain 2054

- 4.3.14 Embedded in redeposited clay **2051** was a large iron hoop (**2050**) with a large piece of degraded slate (**2055**) within it (Plate 11). Above this and aligned north-west/south-east was drain **2054**, set on a bedding layer of light greyish-white mortar (**2093**). Drain **2055** was brick lined, and ran towards the east wall (**2015**) of Room 2. A brick platform (**2049**) was built up to the edge of drain **2054** on its north-east side.

- 4.3.15 Brick platform **2049** was set on a foundation of loosely packed brick backfill (**2091**) covered with a layer of mortar (**2073**) up to 0.11m thick. A brick wall (**2035**) abutted the south-east edge of drain **2054**. Wall **2035** was two bricks wide by two high with no foundations. Drain **2054** was truncated at its south-eastern end by a ceramic circular tile pipe drain (**2052**) that also truncated brick platform **2049**. Ceramic drain **2052** was aligned north/south, and served as a downpipe on wall **2015**, with the water being carried to the bath in Room 5.

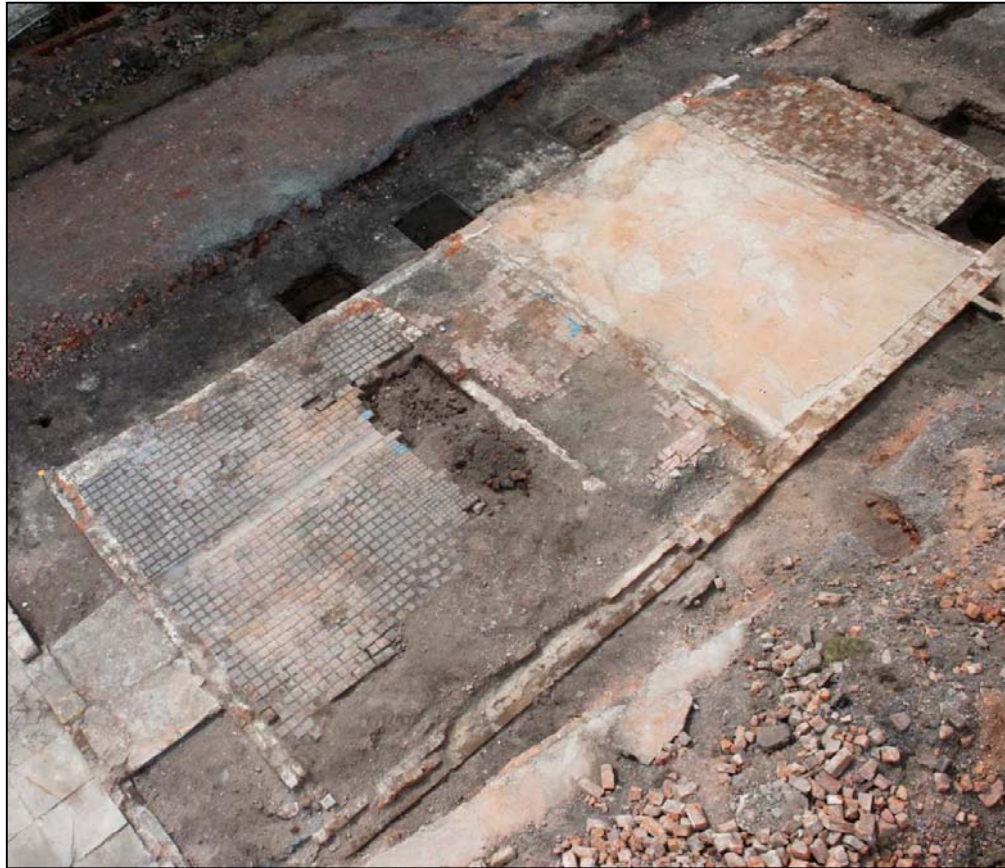
Plate 12: Remains of sett surface 1300 in the stables

- 4.5.5 The south wall (**1307**) of the stable was built over drain **1312**. Similarly, the east wall (**1306**) was built over and incorporated drain **2089** into its foundations. Wall **1307** abutted and was bonded to wall **1203**. The space between walls **1304/1309** and **1306** was filled with a dark greyish-black deposit of mainly ash and cinder (**1319**) that was the same as **2030**. This was topped with a bedding layer of mortar (**1320**) on which were dark blueish-grey brick setts (**1300**; Plate 12).

- 4.5.6 In brick sett surface **1300** was a square drain with a metal silt trap (**1308**). This drained north-east/south-west, and a segmented ceramic drainage pipe (**1321**) was uncovered set in deposit **1319**. Segmented ceramic drain pipe **1321** was connected to a square brick-lined drain (**1311**) aligned north-east/south-west. In brick sett floor surface **1300** a drainage channel (**1302**) comprised concave dark blueish-grey brick setts.

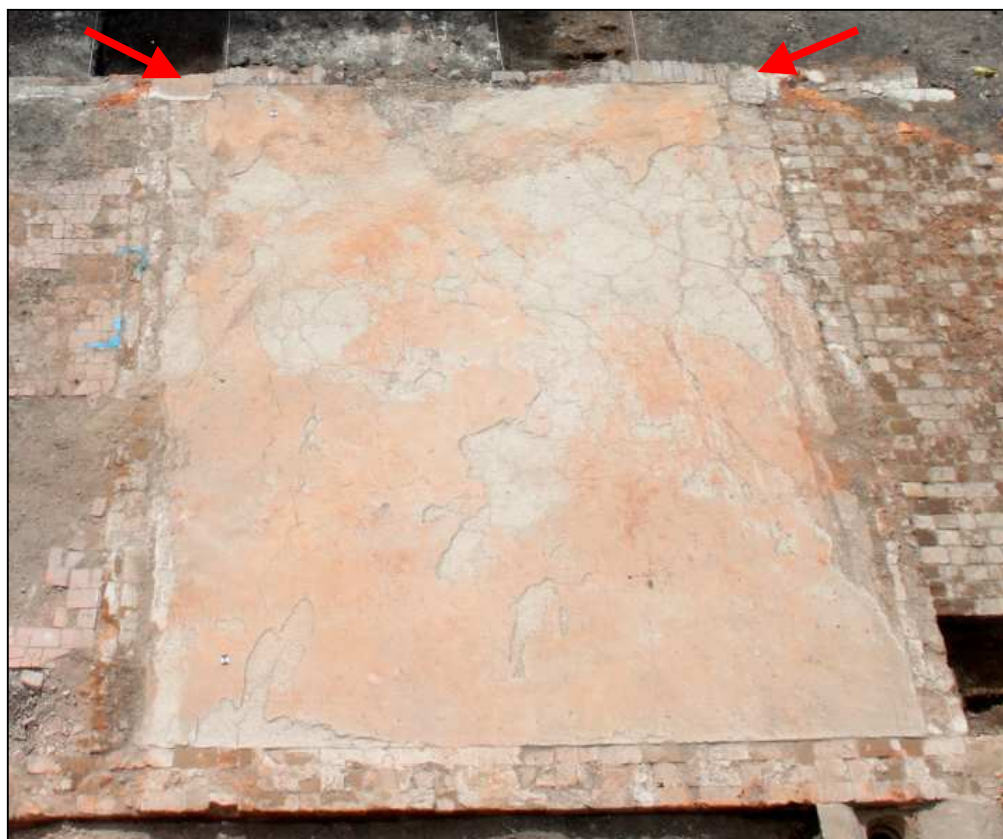
Plate 13: The excavated remains of the Cow House, with red arrows marking sandstone blocks 1205 and 1206

- 4.6.2 A brick wall (**1207**) 0.45m below the level of the Cow House floor (**1200**) was exposed to a depth of 0.40m. Wall **1207** was aligned approximately north/south and was marked on the 1849 mapping as the former west wall of a stable on this site. At the southern end of the Cow House was a large Grinsall sandstone block (**1206**) that was in line with wall **1207** and was a visible remnant of this wall (Fig 5). A similar Grinsall sandstone block (**1205**) lay at the end of brick wall **1203**, and was probably a visible remnant of a buried wall similar to **1207** (Plate 13).

- 5.5.1 The area designated the Cow House on the 1855 plan occupies the site of the former horse box in the 1849 building marked as Stable. The Cow House has north wall **1002** and two large Grinsall sandstone blocks (**1205** and **1206**) as remaining evidence of Phase 1. In addition, a probable section of foundation of the former east wall (**1207**) was exposed in a slot in the north-east corner of the Piggeries.

- 5.5.2 Phase 2 in the Cow House is represented by the east **1203**, south **1202** and west **1202** walls. Phase 3 is the distinctive concrete floor (**1200**). The two Grinshill sandstone blocks were distinctive by virtue of their presence in a brick building. Excavation revealed a section of the west wall of the former stable (**1207**) which was used as foundation for wall **1204**. Wall **1207** was exactly in line with sandstone block **1206** and marked the line of the former stable west wall. Excavation did not unearth a remaining section of the former east wall but as block **1206** is to wall **1204** so block **1205** is to wall **1203**.

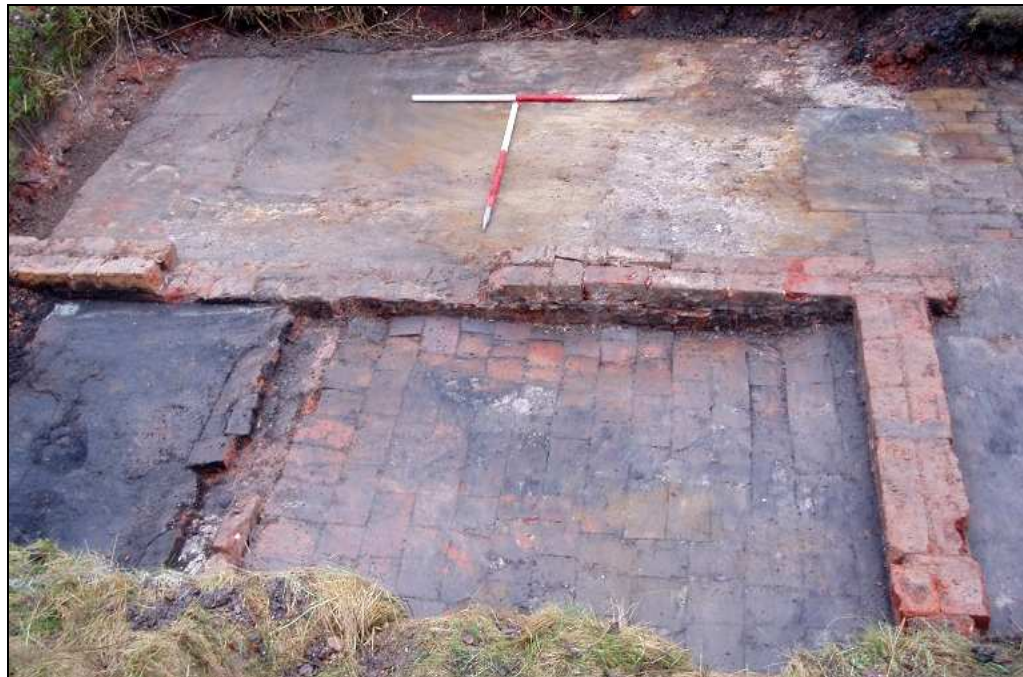
Plate 1: Remains of the wash house exposed in the evaluation trench in 2010

- 1.1.2 It is proposed that the community-led excavation should target a group of former outbuildings, including a stable and a wash house linked to a gas holder, that occupied the northern part of the flax mill site (Figs 1 and 2). These structures were targeted during an archaeological evaluation that was carried out in 2010, which revealed well-preserved structural remains at a depth of c 300mm below the modern ground surface (Plate 1).

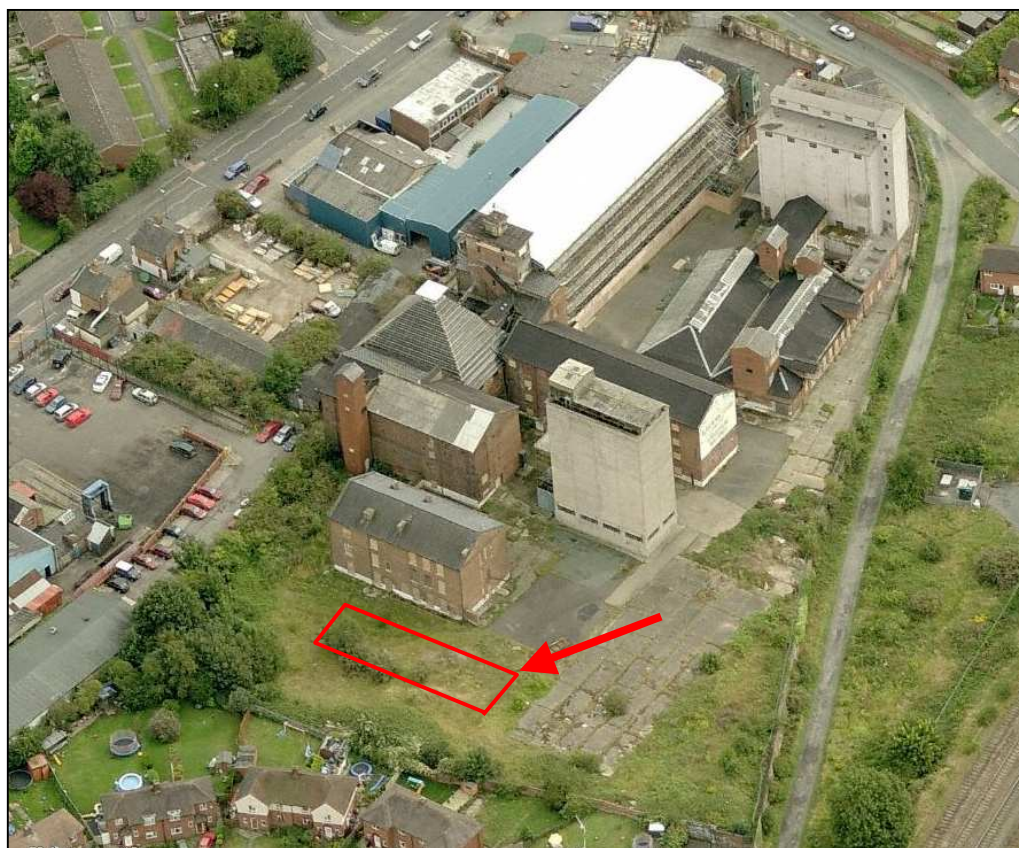
Plate 2: Arrow marking the proposed location of the excavation area, superimposed on a recent aerial view of the Ditherington Flax Mill Malting site

- 3.1.1 The programme of works will comprise the open-area excavation of a single targeted area (Figs 1 and 2), which will be placed across the open ground in the northern part of the site (Plate 2). The trench will measure *c* 25 x 12m, will incorporate the evaluation trench excavated in 2010, and will examine the footprint of the outbuildings shown on a plan dating to 1855 (Fig 2).

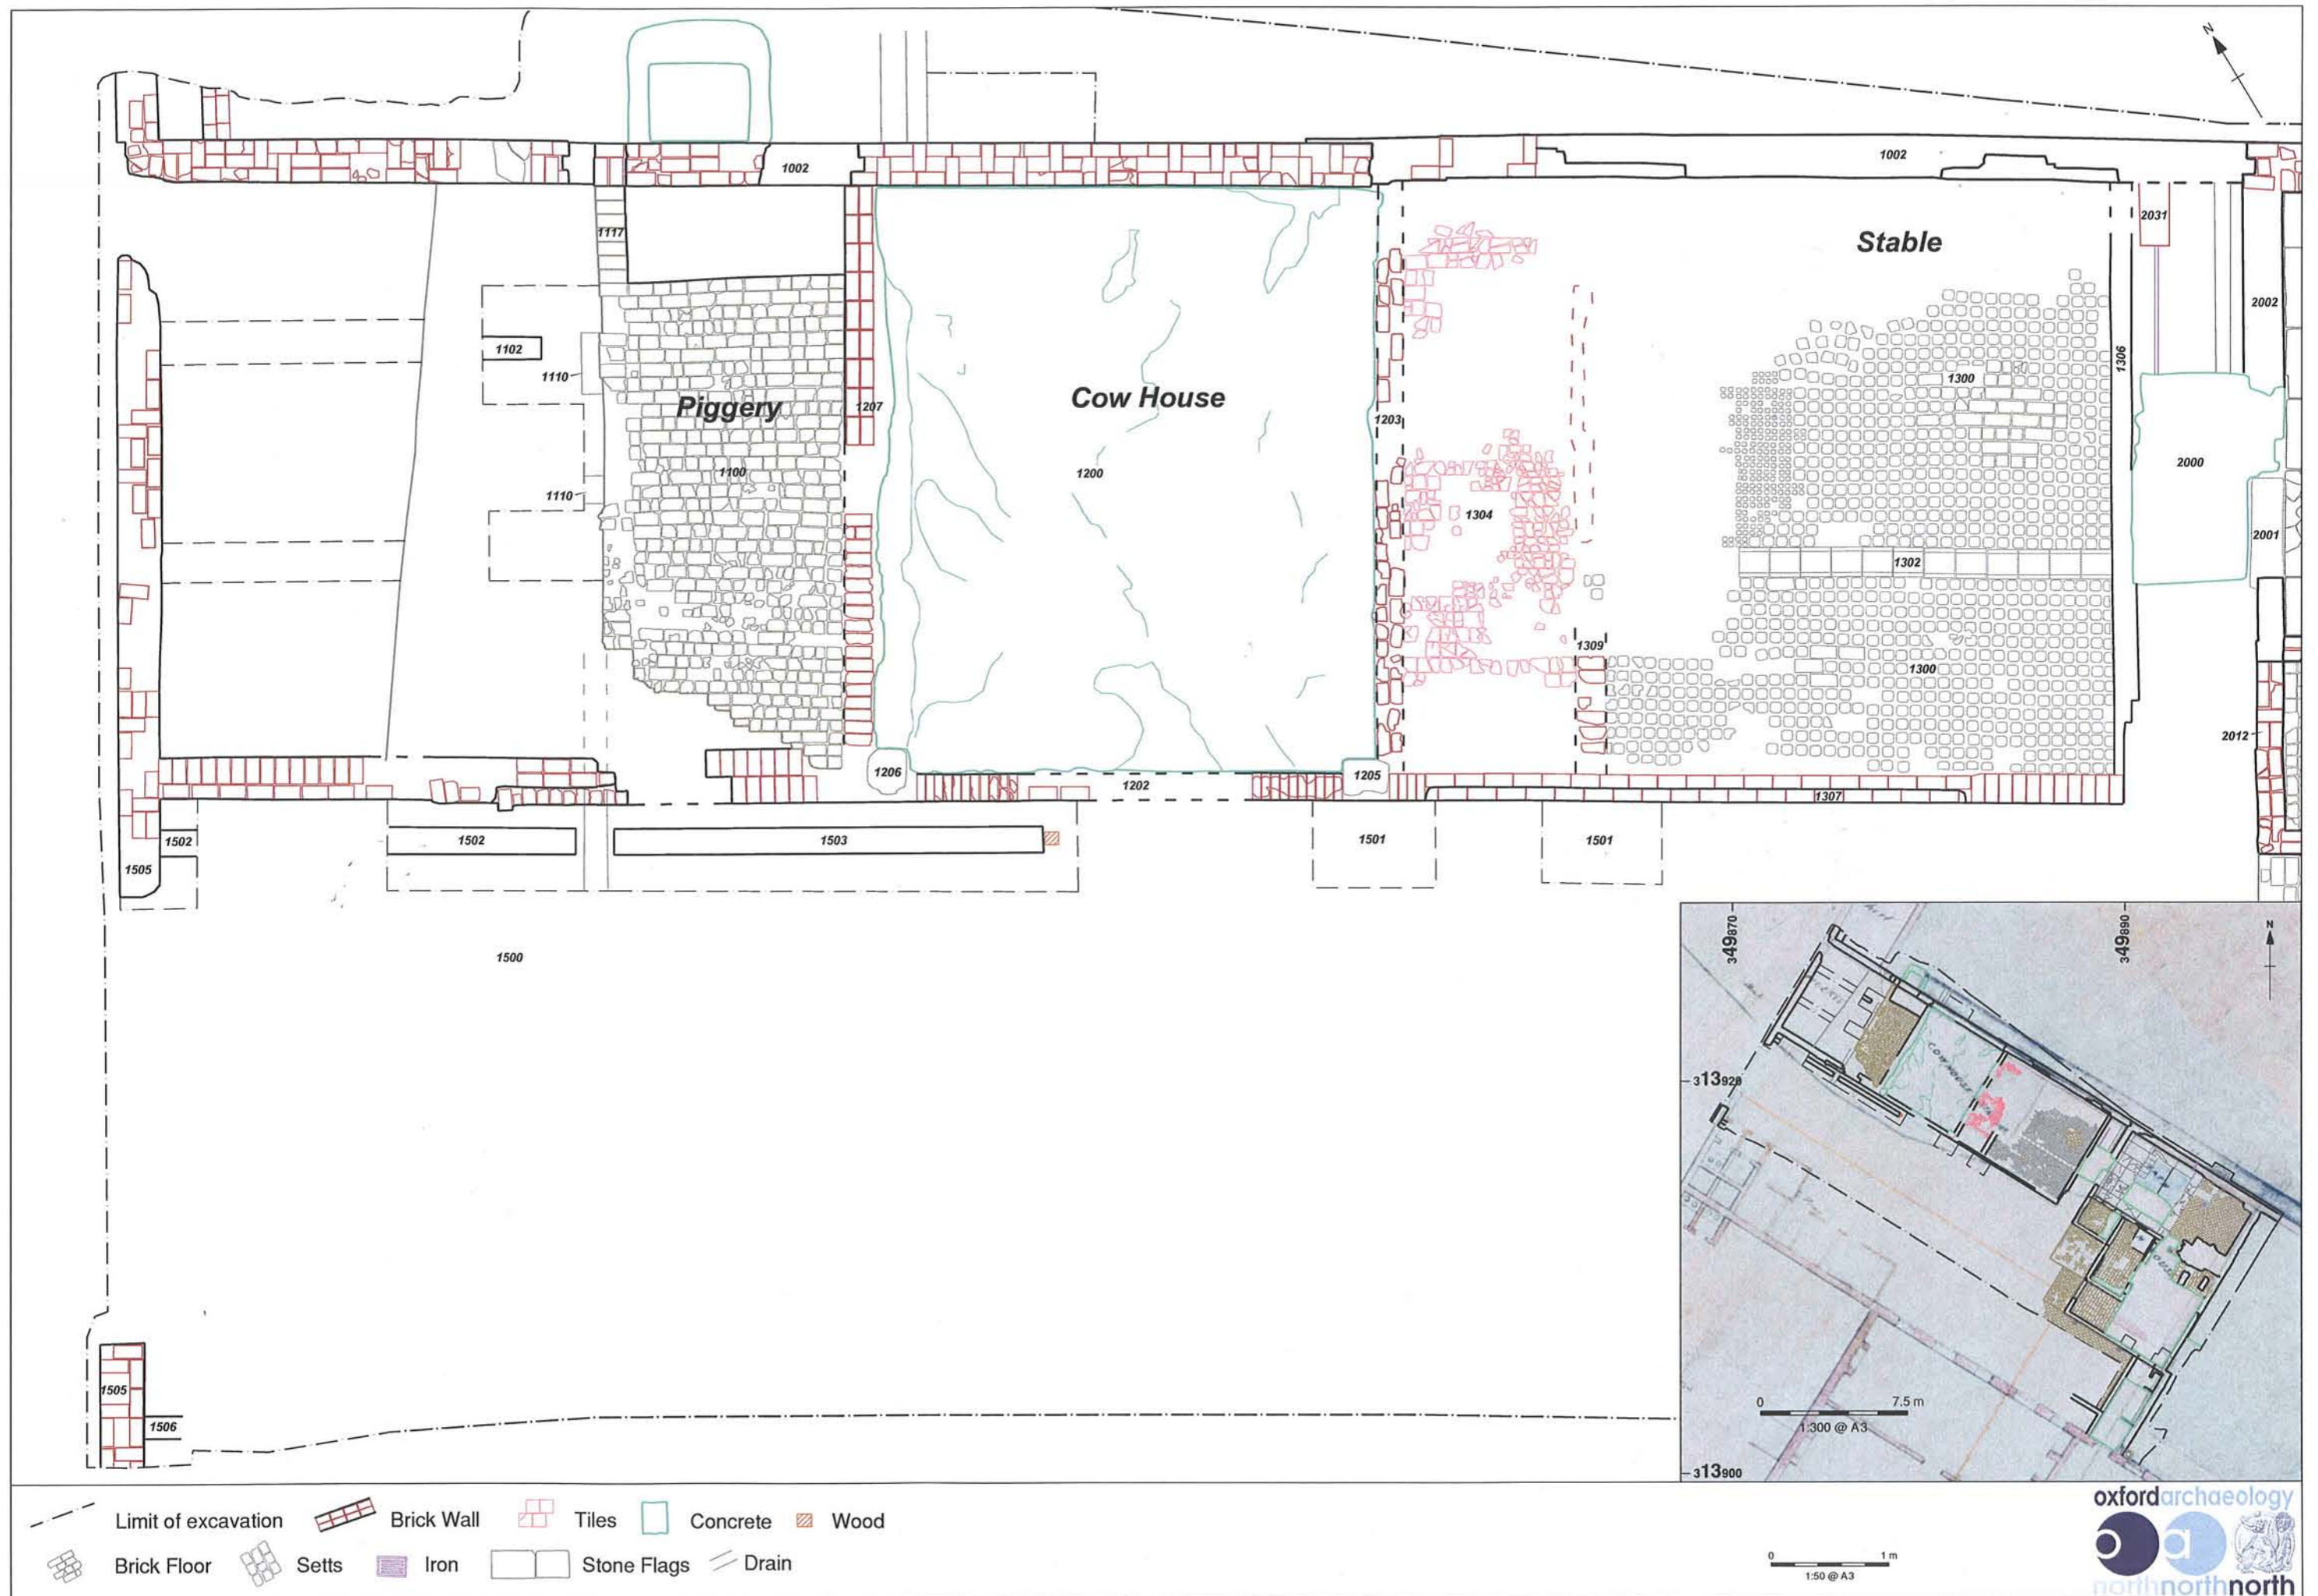
Figure 5: Detail of the remains exposed in the western part of the excavation area

- 4.3.10 On the passage side of doorway **2001** was a concrete slab (**2000**) that had been constructed in two pieces. There was no evidence of an entrance into the Stable, which was to the immediate west of concrete slab **2000** (Fig 5). To the north of concrete slab **2000** the space between the building foundations was filled with a dark greyish-black deposit of mainly ash and cinder (**2030**). Excavation of this fill revealed a segmented ceramic glazed pipe (**2029**), aligned north/south, that emptied into water channel **1403**. An iron water pipe, aligned north to south, with a stop tap (**2032**) housed in a small unbonded brick chamber (**2031**) was also exposed.
