Long Lane North, Chapel-En-Le- Frith,

Strip and Record and Evaluation Report

Oxford Archaeology North

March 2014

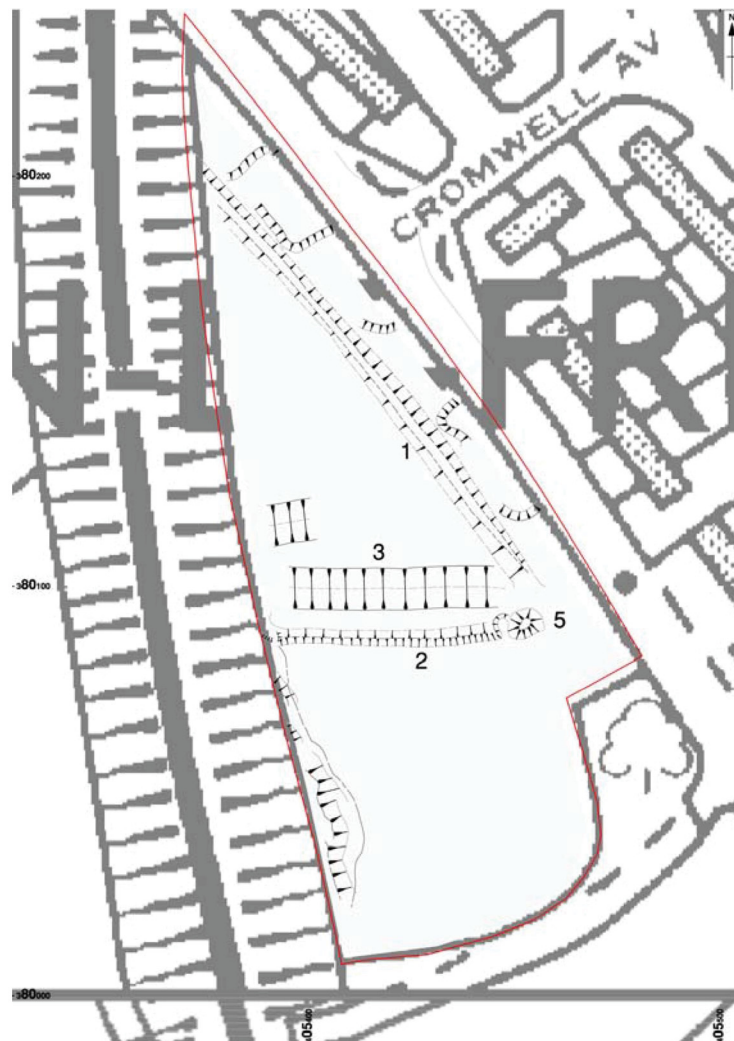
- 1.4.5 **Landscape Survey Results:** the landscape survey identified a number of features within the field adjacent to Long Lane, the most obvious being two linear earthworks (Plate 4). The HER entry (HER 3588) describes the features within the site as a ‘linear boundary running adjacent to Long Lane curving south-west and apparently cut by the railway’, implying that a single earthwork is present. The survey showed that the curving earthwork described in the HER, in fact, comprises two separate features (Sites 1 and 2) that may have been related (Plate 4). They both define edges of a raised, triangular-shaped, flat-topped platform, and have marked drops on their respective north-eastern and southern sides. On top of the platform are two subtle gullies, which were potentially agricultural features, such as lines of furrows.

Plate 4: Initial topographic survey of the study area (after OA North 2013a)

- 1.4.6 The area where the two earthworks may once have possibly intersected appeared to have been disturbed, as suggested by the presence of building rubble in this location. A circular mound (Site 5) at the eastern end of linear bank Site 2 may also have comprised rubble. The earthworks differed slightly in their appearance, with the earthwork parallel to Long Lane (Site 1) being flat-topped and slightly wider. Both of the earthworks were possibly overlain by the railway embankment, suggesting that they were both earlier features. Neither of these earthworks were visible in the geophysical survey data.

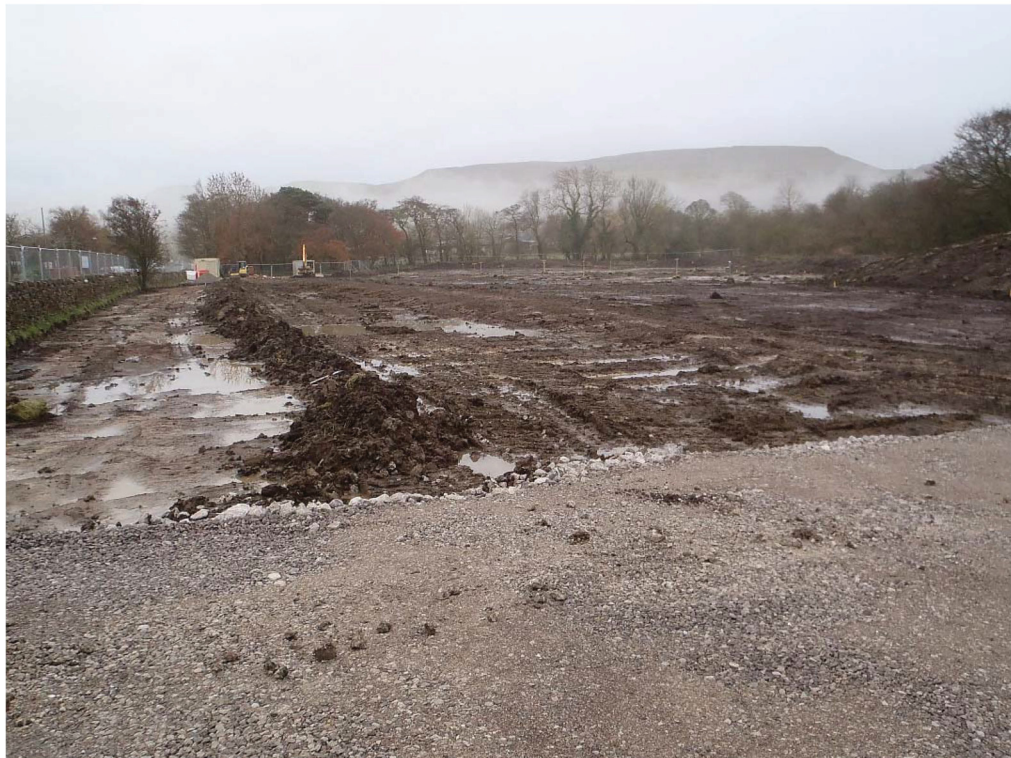
- 2.2.1 The topsoil on the area had been stripped by a D5 bulldozer down to natural deposits prior to OA North being called in to undertake the strip and record programme (Plate 5). The area was then cleaned by an 8 ton 360° excavator with a toothless ditching bucket under archaeological supervision (Plate 6). Two trenches were also dug through the north/ south bank (Site 1; Trench 1) and the east/west earthwork bank (Site 2; Trench 2), these trenches were excavated using the 8 ton excavator with a toothless ditching bucket, extending into the natural geology. A process of selective manual cleaning of any features revealed was undertaken to clarify their form and character.

Plate 5: General shot of the site looking south, following stripping but prior to cleaning

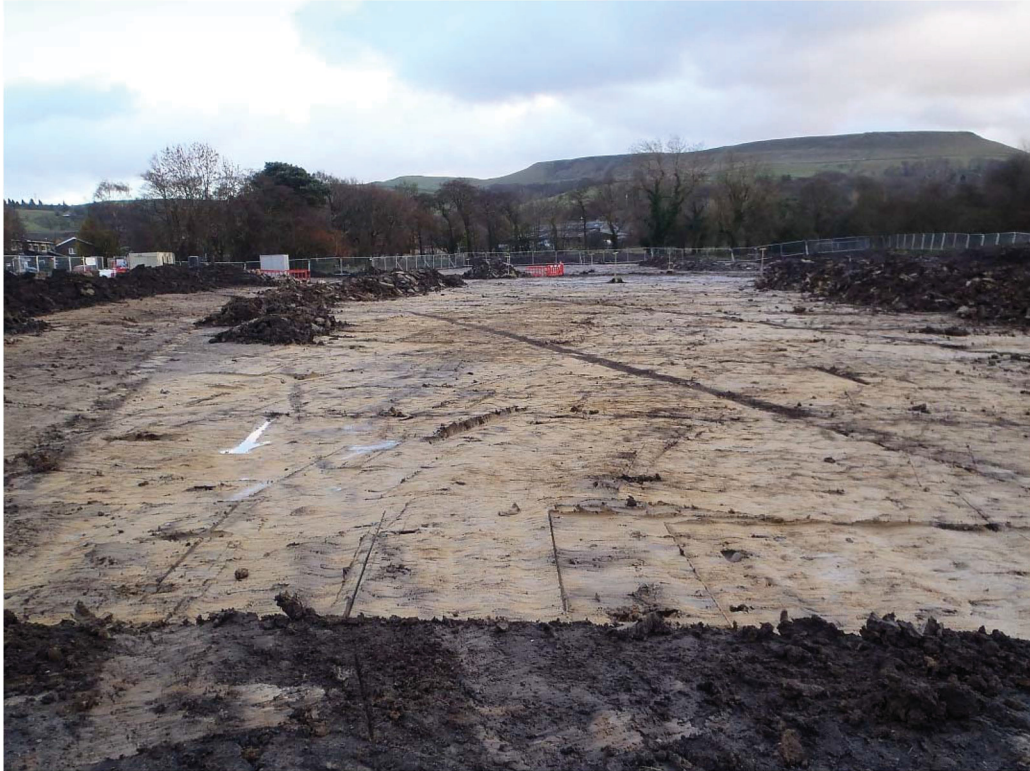
Plate 6: General shot of the site looking south once the cleaning was completed

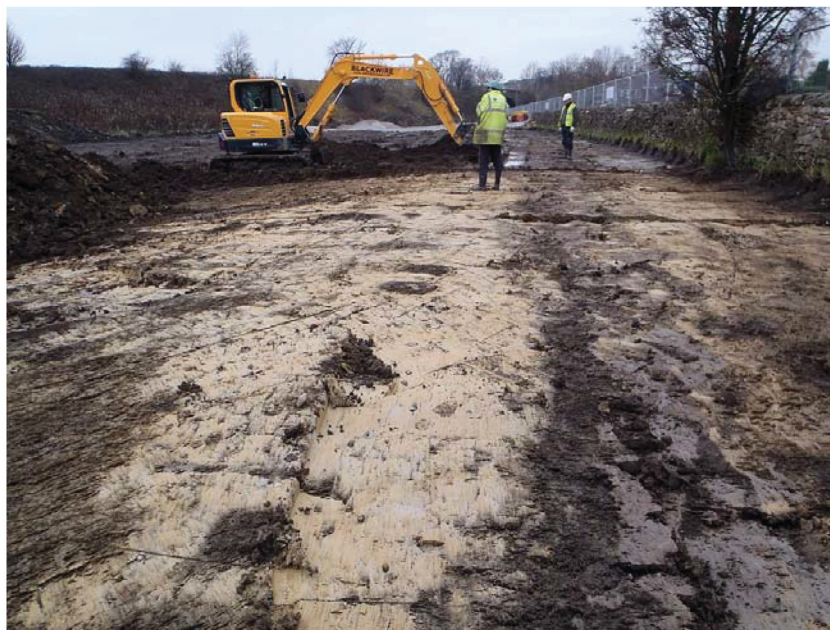
3.2.1 The natural geology, **103**, across the area was observed as a light-yellow, with patches of light grey, clay; this was overlain by 0.30m of topsoil (**101**) (Plate 6). The only features observed cutting the natural geology were seemingly modern and comprised three lines of postholes of regular sizes, approximately 0.40m in diameter and surviving to a depth of 0.10m (Fig 2; Plate 7). These were filled by topsoil and clay, and one, **115**, contained a fragment of clay tobacco pipe. The postholes were all approximately 1.50m to 2.00m apart, suggesting that these were for, relatively recent, post and rail fences. Six of these postholes were excavated and recorded, **109, 111, 113, 115, 117, 119**.

Plate 7: General shot looking north with postholes to the west of the water main

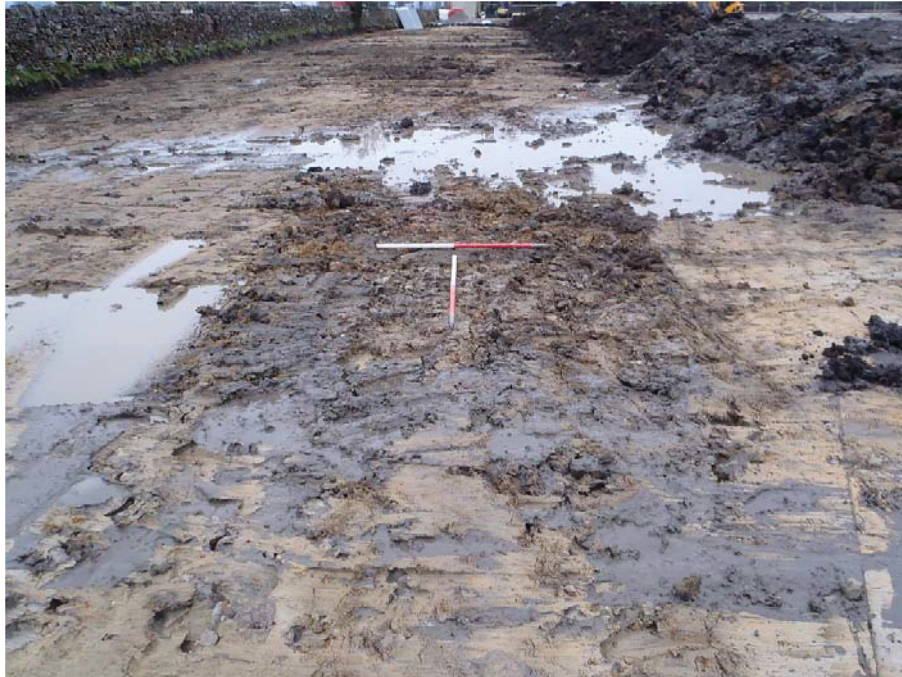
- 3.2.3 A trackway, **106**, was observed running north/south to the east of the north/south earthwork (Site 1; **104**; Plate 8). The trackway was made up of small cobbles and sandstone rubble, and is fairly irregular in shape, suggesting that it was a modern farm track that had been placed to fill in wheel ruts. The track was overlain by a thin subsoil deposit, **107**, which contained nineteenth and twentieth century pottery and clay tobacco pipe; clay pipe was also recovered from within the cleaning deposits of the track fabric.

Plate 8: Part of trackway **106** looking south

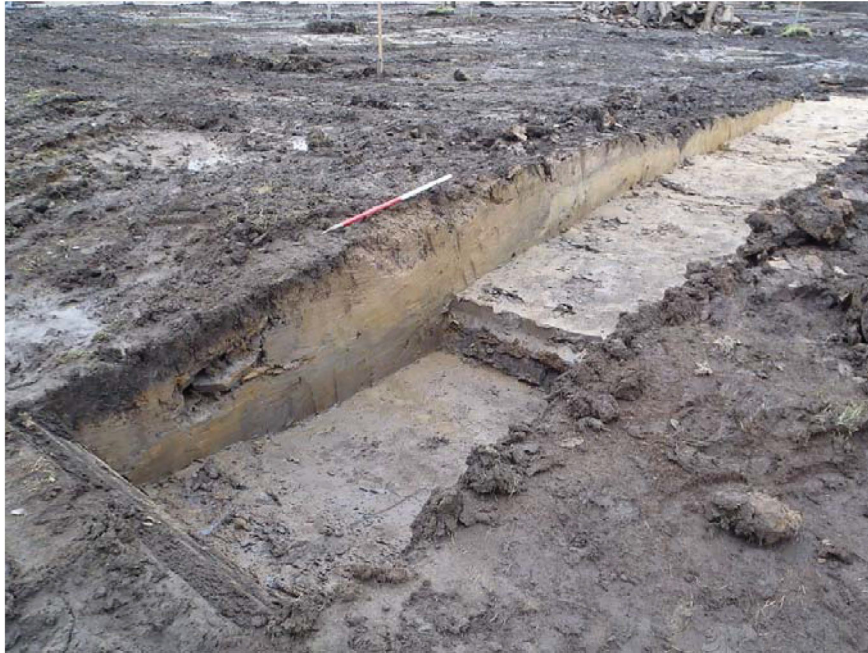
- 3.3.2 **Trench 1:** the excavation of Trench 1 revealed a ditch, **121**, orientated north-west/south-east (Figs 2 and 3; Plate 9). The ditch cuts the natural, **103**, and appears to have been filled shortly after its construction by fill **120** and was then overlain by the fabric of the north-west/south-east orientated bank, **104**. The ditch had steep sides, but a flat bottom, and survives to a depth of 0.40m; its fill, **120**, was uniform in character comprising redeposited natural, which was a yellow-grey firm clay with no inclusions.

- 3.3.3 The earthwork bank (Site 01; **104**) was 4.75m in width and extended to 0.28m above the upper level of the ditch, and had a gentle sloping, flat-topped profile; the bank extended only over the western part of the flat-bottomed ditch, and to the west it overlay the natural deposits, **103**. The bank was made from orangey-grey clay with no inclusions and contained fragments of nineteenth century pottery.

Plate 9: North-facing section of Trench 1 showing earthwork bank **104**, ditch **121**, and stone lined drain **105**

- 3.3.4 The north/south bank, **104**, and the ditch fill, **120**, were cut on their north-eastern sides by a stone-lined drain, **105**, running north-west/south-east, which was 0.49m wide and 0.35m deep, and which appeared to respect the orientation of the bank. The drain contained a fragment of nineteenth / twentieth century pottery. Above the bank, **104**, and the drain, **105**, was a shallow lens of topsoil, **101**, that had survived the top-soil strip operations.

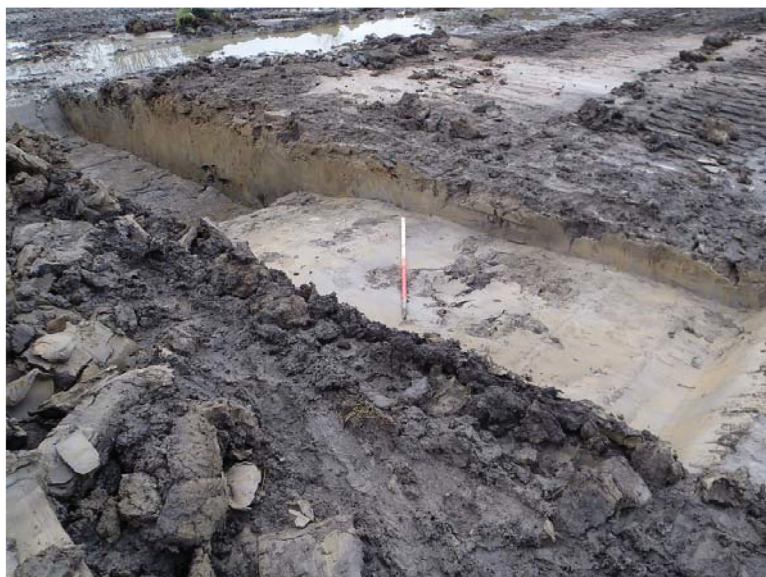
- 3.3.5 **Trench 2:** the excavation of Trench 2 revealed a ditch, **123**, orientated east/west (Figs 2 and 3; Plate 10). As with ditch **121**, ditch **123** cuts the natural, **103**, and appears to have been filled shortly after its construction by fill **122**. It was then overlain by the east/west orientated bank, **102** (Fig 3). The ditch had rounded sides and, where it was exposed, a curvilinear base, and survives to a depth of 0.70m; its fill, **122**, was uniform in character comprising redeposited natural, which was a yellow-grey firm clay with no inclusions.

- 3.3.6 The earthwork bank (Site 02; **102**) had been severely truncated during the initial top-soil strip, and its profile could not be determined with any precision; however, the surviving indications are that it was *c* 2.5m in width and extended to greater than 0.4m above the ditch (Fig 3). The bank extended over the southern part of flat bottomed ditch, **121**, and to the north the bank overlay the natural deposits, **103**. The bank was made up of an orangey-grey clay with no inclusions and contained fragments of nineteenth century pottery. Above the bank, **102**, was a shallow lens of topsoil, **101**, that had survived the top-soil strip operations.

Plate 10: East-facing section of Trench 2 showing earthwork bank **102** and ditch **123**

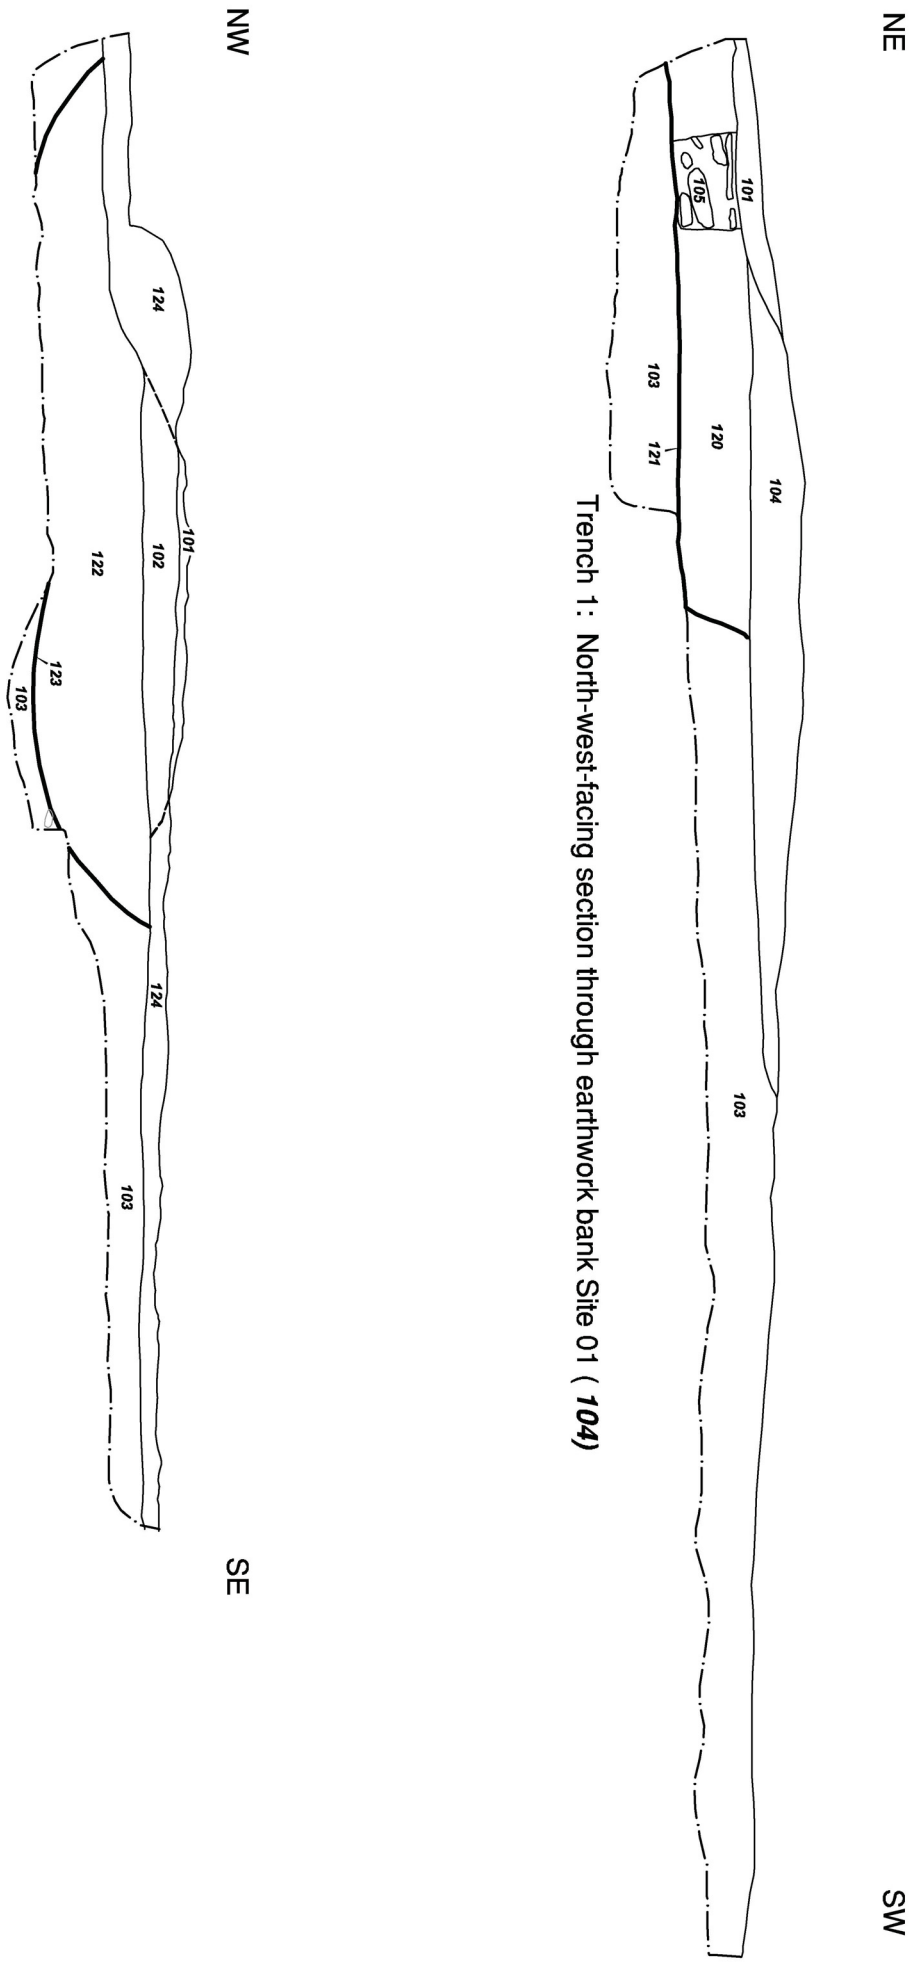
Trench 2: East-facing section through earthwork bank Site 02 (102)

Trench 1 : North-west-facing section through earthwork bank Site 01 (104)
