# 57-65 Dale Street, Liverpool, Merseyside

## Watching Brief Report

June 2012

**Document Type:** Watching Brief Report

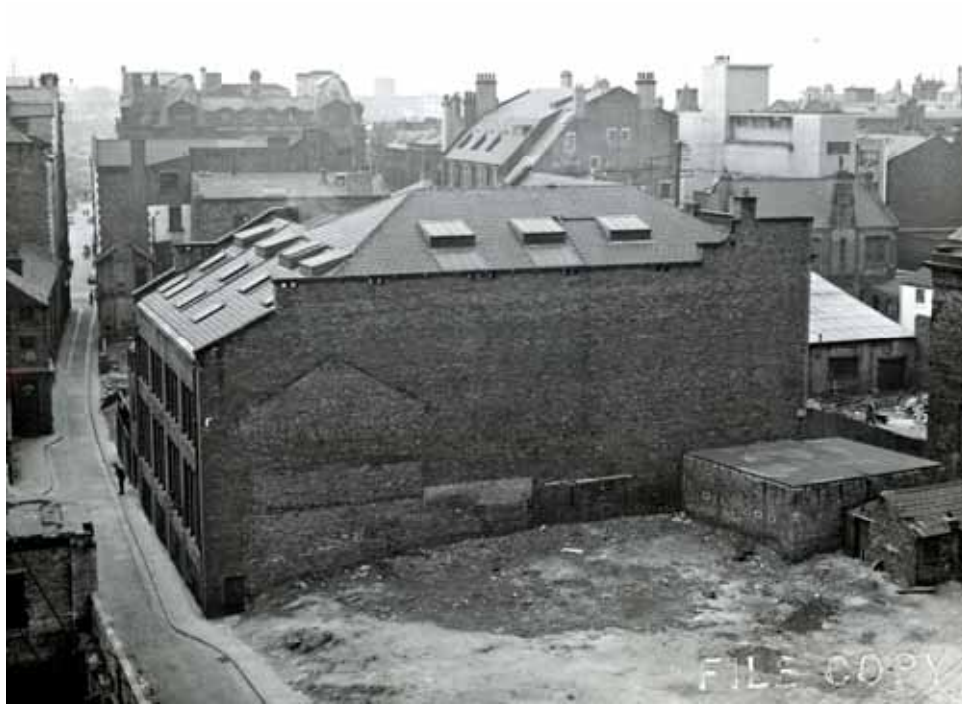
Plate 1: Historic image of the area to the rear of the Hale Street Warehouse showing warehousing and derelict buildings prior to the area being cleared (LRO CE 11 555)

- 5.1.6 Historic images, such as the view of Hale Street and Vernon Street from Cheapside (Plate 1), demonstrate the organic and cramped nature in which sheds, lean-to buildings and warehouses had developed within the study area along the northern side of Dale Street. It is likely that much of this earlier activity has been severely truncated and now only survives in ever decreasing pockets of ground between larger buildings and beneath earlier roadways and footpaths.

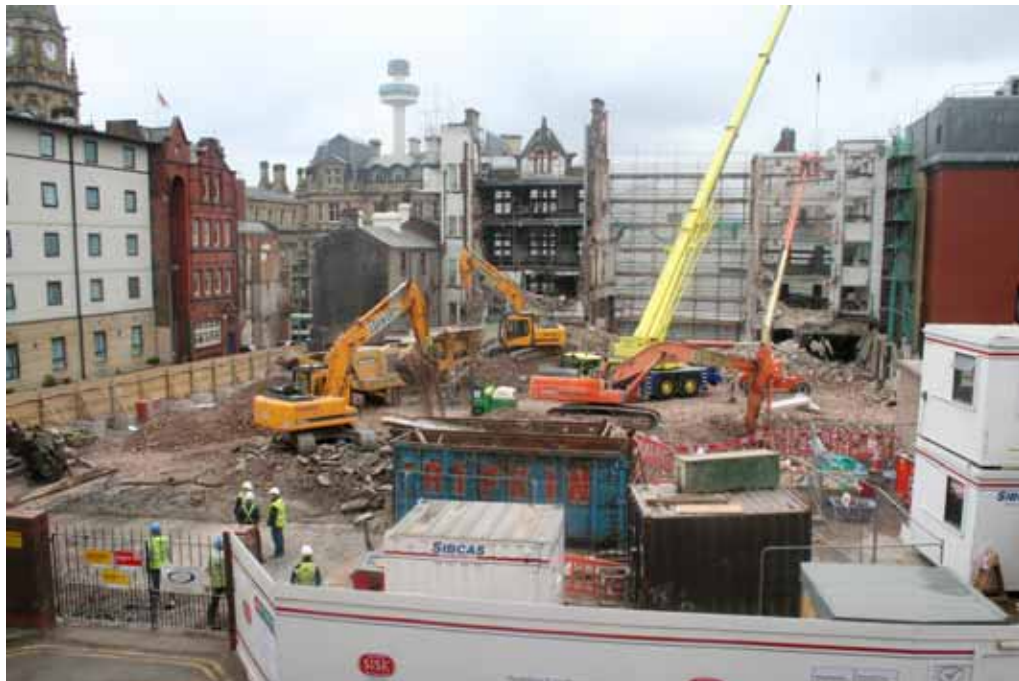
Plate 2: South facing view showing the excavation area in the foreground with ongoing demolition work of 57-65 Dale Street in the background

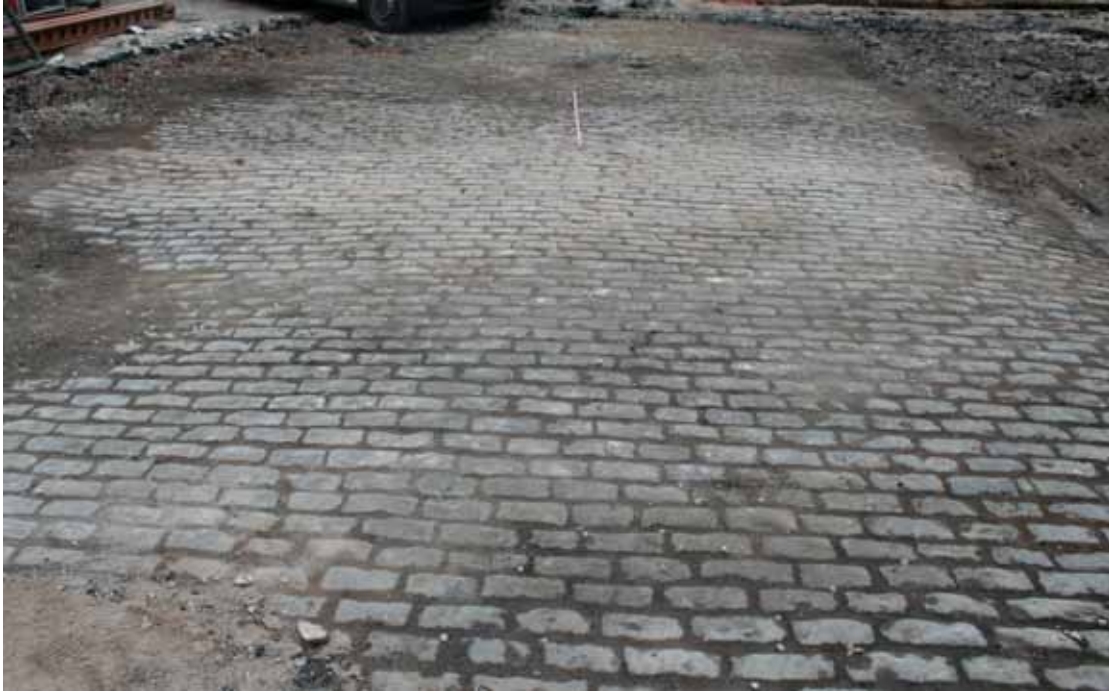
Plate 3: Areas 1 and 2, east-facing shot of cobble sett road (part of Hale Street) **002**

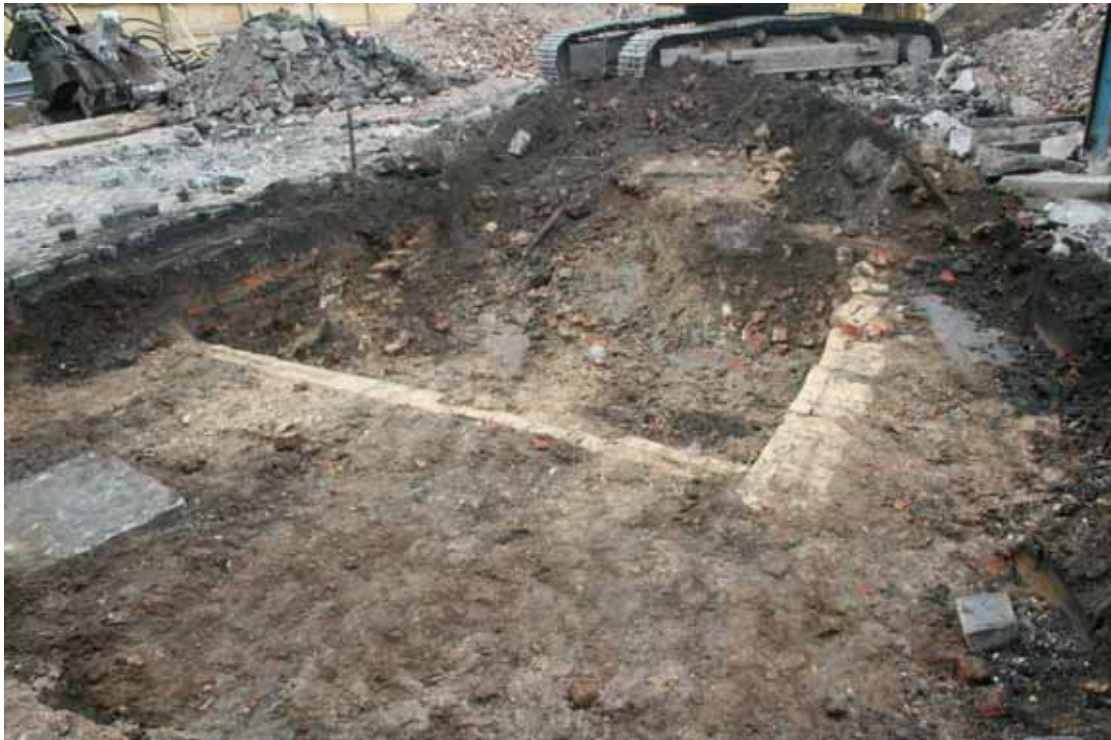
Plate 4: Area 1, south-facing shot of building foundations **006** and **008**

- 4.2.3 The foundations were constructed of handmade red-brick, bonded and crudely pointed using buff coloured sandy lime mortar (Plate 4); all the walls had been constructed in an English Garden Wall style bond. The western wall **008**, was orientated north-west/south-east and was the most substantial of the three walls. It was abutted by, rather than bonded to, wall **007**, suggesting that it was originally a gable wall for an pre-existing building; historic photographs of the area (Plate 1) indicate a somewhat organic evolution of sheds and outhouses within this area. This structure was three courses wide (0.35m), in excess of eight courses deep (0.68m) although the base of the wall was not identified during the watching brief because it extended beyond the formation level, and was in excess of twelve courses long (3.4m). Wall **007** (orientated north-east/south-west) and truncated wall **009** (orientated north-west/south-east and located parallel to wall **008**) were both less substantial structures, being only two courses wide and of a poorer quality construction, suggesting that they were added to the exterior of a more substantial building. Walls **007** and **009** were bonded indicating that their construction was contemporary. Located to the north-west of **008**, located just beneath cobbled surface **002** and associated clinker bedding layer **003**, was the remnants of a flagged stone yard or pathway **006**.

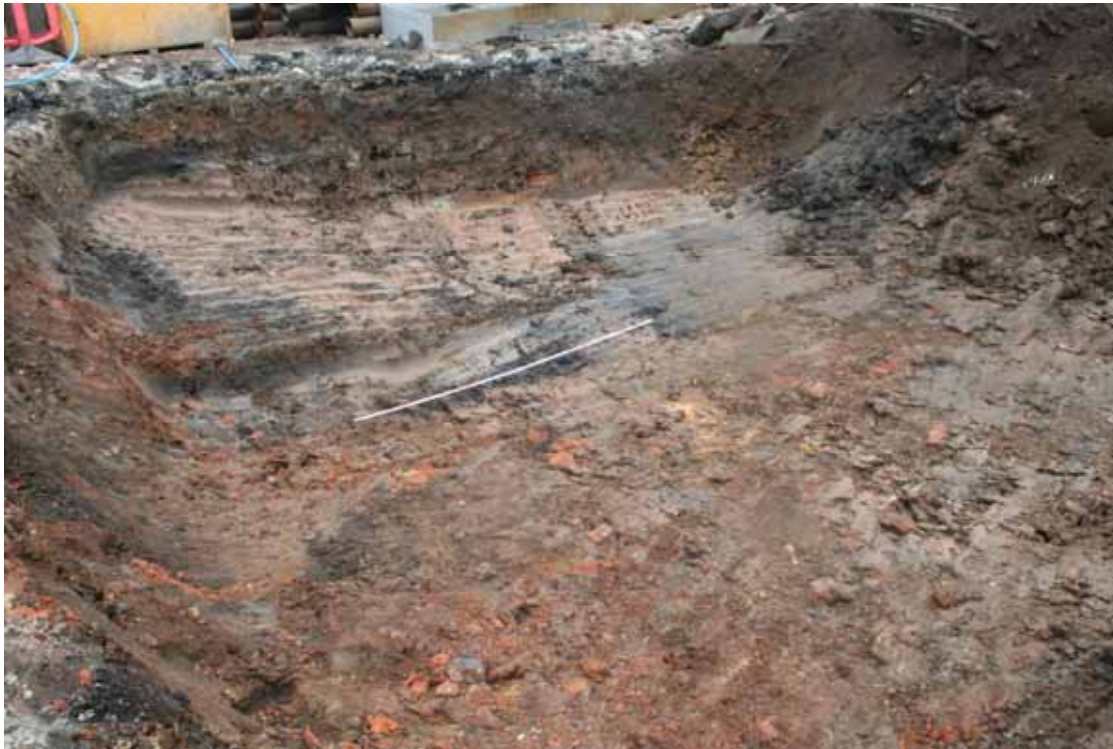
Plate 5: Area 2, natural clay cut by probable boundary or drainage ditch  
*013/014*

The earliest archaeological feature was a truncated curvilinear ditch **013**, in Area 2, which was found to contain a dark organic material **014**, and contained mid-eighteenth century pottery. The ditch was possibly a drainage or boundary and is all that remains of the early post-medieval landscape within this area of Dale Street as the rest of the development footprint had been truncated by extensive cellar construction undertaken after 1860.

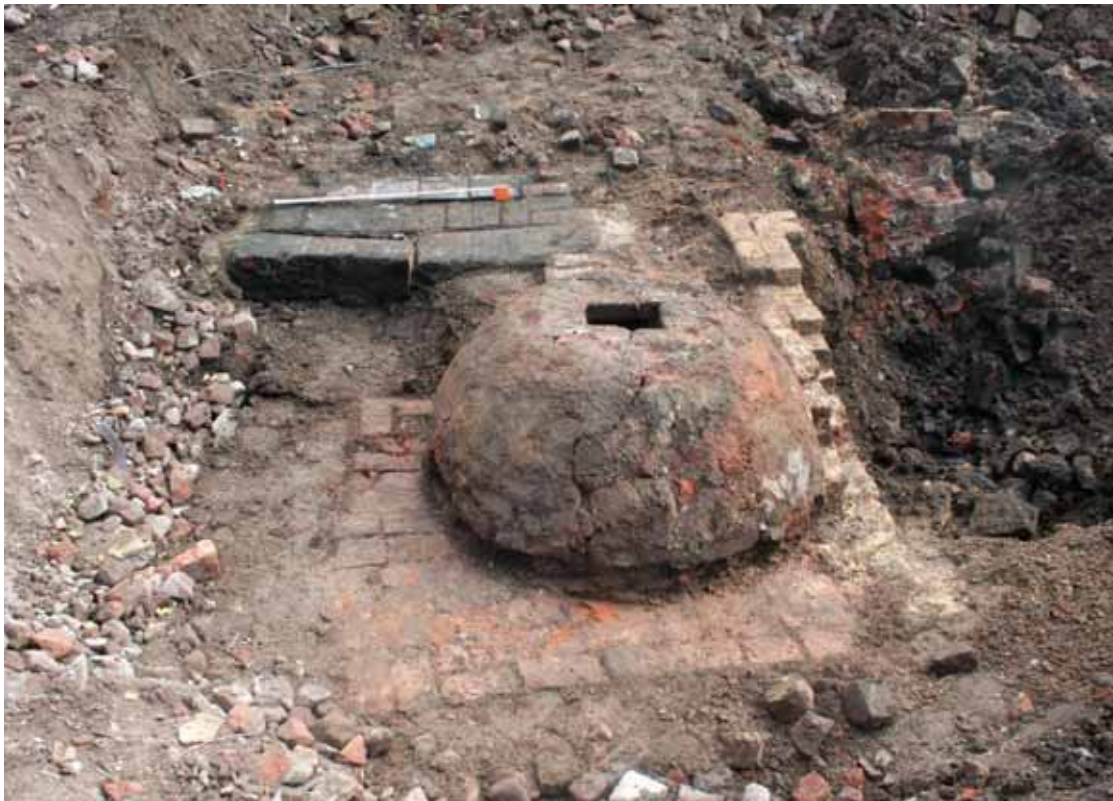
Plate 6: Area 3, capped well *015* and surrounding surfaces *018, 021, 022* and  
*023*

- 4.2.8 The well was originally identified capped with a domed brick structure **015** (Plate 6), which was also constructed of handmade red brick and measured 1.32m in diameter, standing to a height of 0.6m. Removal of the capping provided a clearer view of the brick lined well shaft and the surrounding plinth **018**. The well was constructed from carefully shaped red bricks, many of which had been formed to creating the internal curve of the well shaft. The bricks had been bonded with a patchy mortar, and given the sporadic application of the mortar this might suggest a repair rather than a part of the original construction process (Plate 8). The diameter of the well was approximately 0.8m.

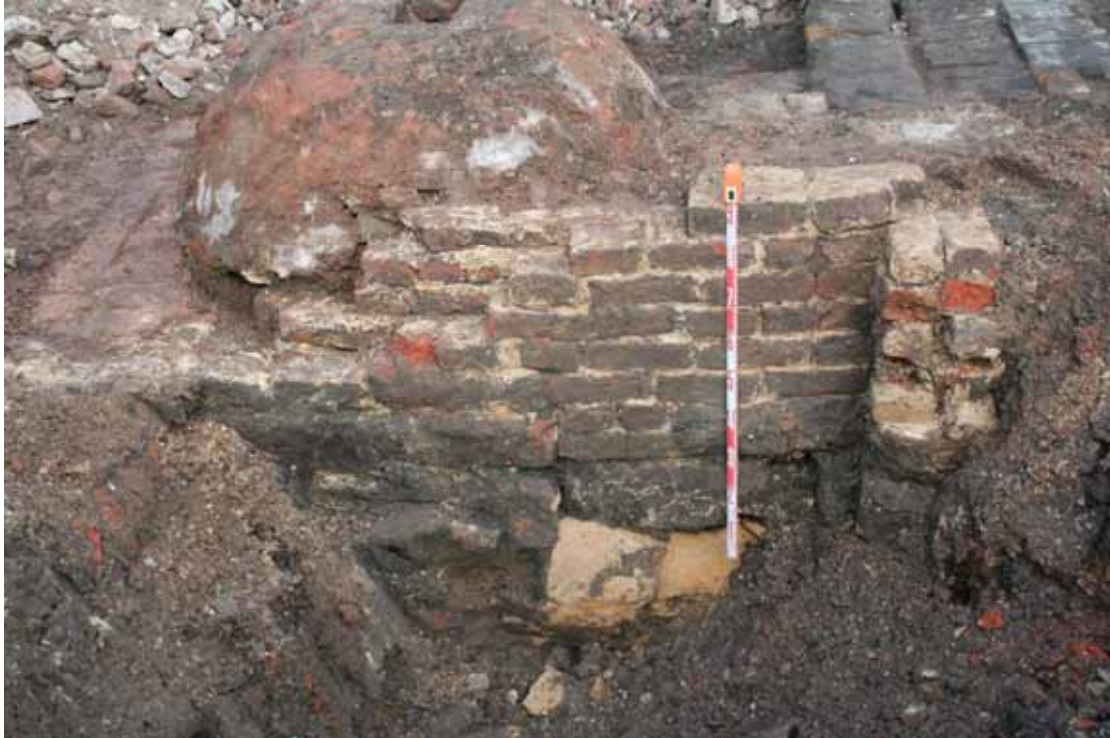
Plate 7: East-facing view of wall **020** to the west of well cap **015** showing earlier sandstone foundations **019**

- 4.2.10 To the west of well **016** was a yellow sandstone foundation wall **019** on top of which was constructed a later hand-made red brick wall (Plate 7). Yellow sandstone wall **019** was orientated north/south and was constructed of large roughly-hewn (or possibly rusticated) blocks of yellow sandstone three courses long (1.82m) and three courses deep (0.6m). Only the west-facing elevation of the wall was exposed with the east-facing elevation being obscured by the construction of the well shaft directly against it. Directly on top of this wall was a handmade red brick wall **020**, which was seven courses long, two courses wide and eight courses high and was constructed in an irregular style with a buff coloured sandy-lime mortar bond. There was evidence of a returning wall stub at the south-western limit of the structure. No surfaces or floor levels relating to these two walls were

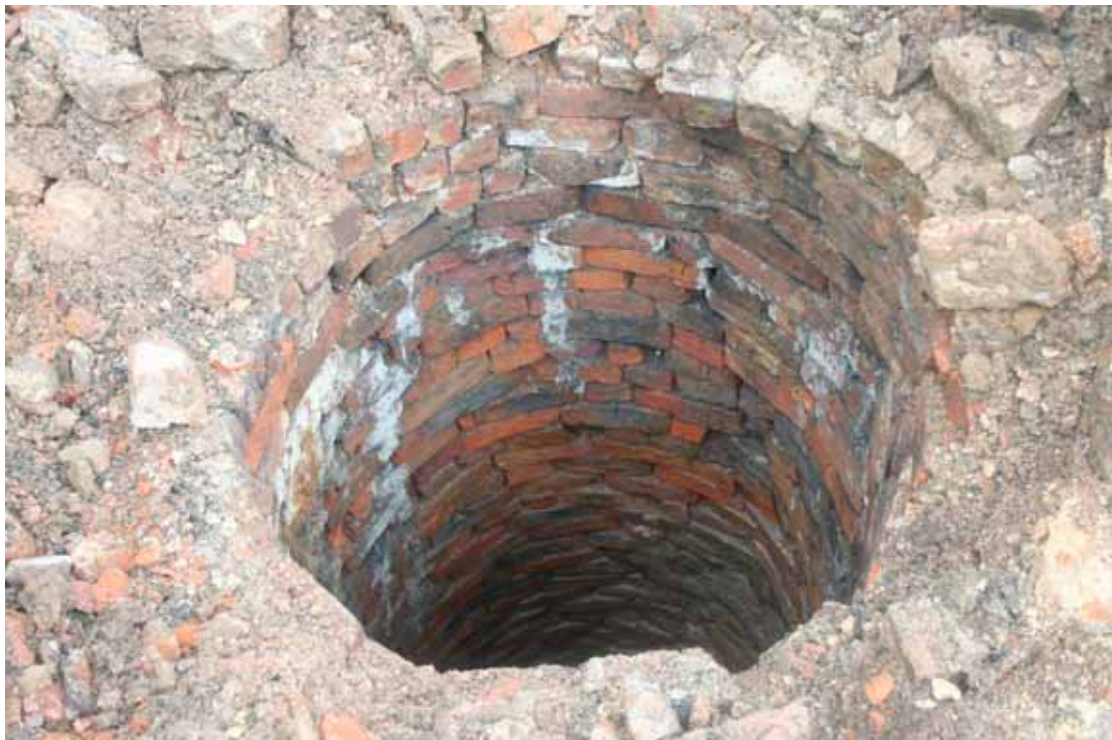
Plate 8: Brick-lined well shaft, **016**, following the removal of well cap **015**
