Rooms 10 and 15, Adjacent to the Two Lions Public House, Great Dockray, Penrith, Cumbria

Building Investigation

Oxford Archaeology North

October 2010

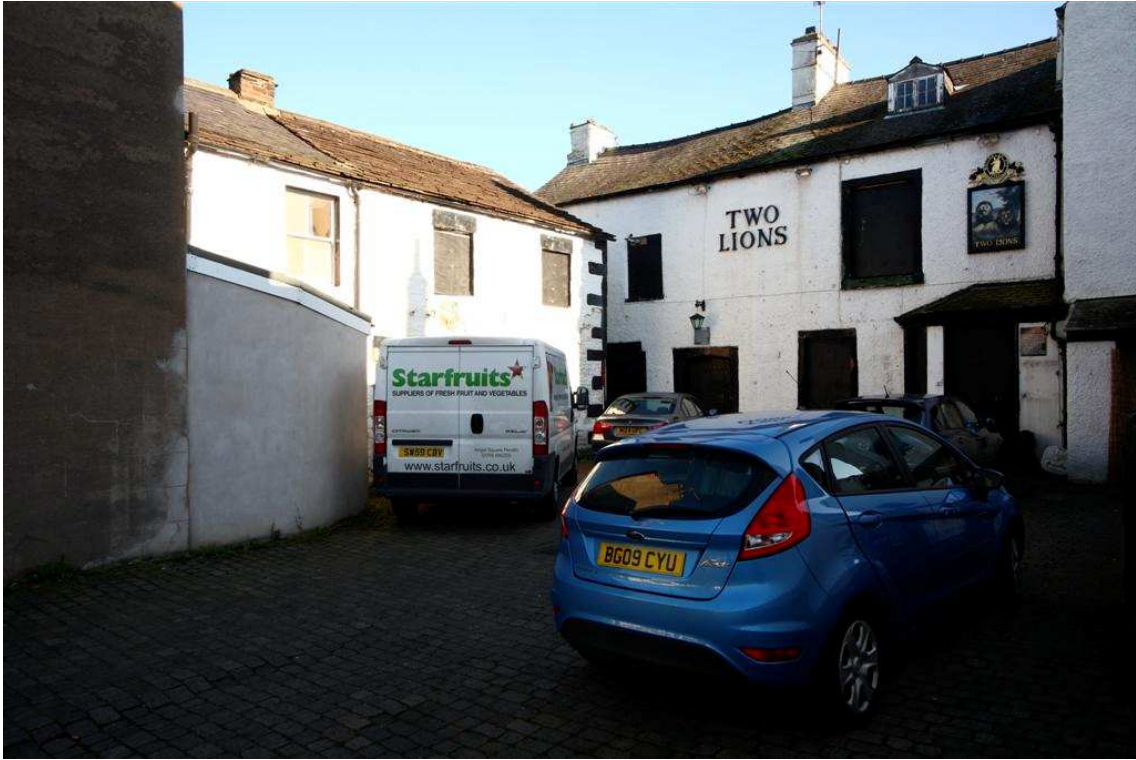
Plate 1: General view of the courtyard at the front of the Two Lions with the building surveyed at the left

- 1.2.1 The proposed development site lies to the south of the town centre of Penrith, The Two Lions is positioned at the rear of a courtyard which fronts onto the southern end of Great Dockray (NGR 51560 29970; Fig 1). The small building forming the subject of the supplementary building investigation lies on the east side of the small courtyard at the front of The Two Lions (Plate 1).

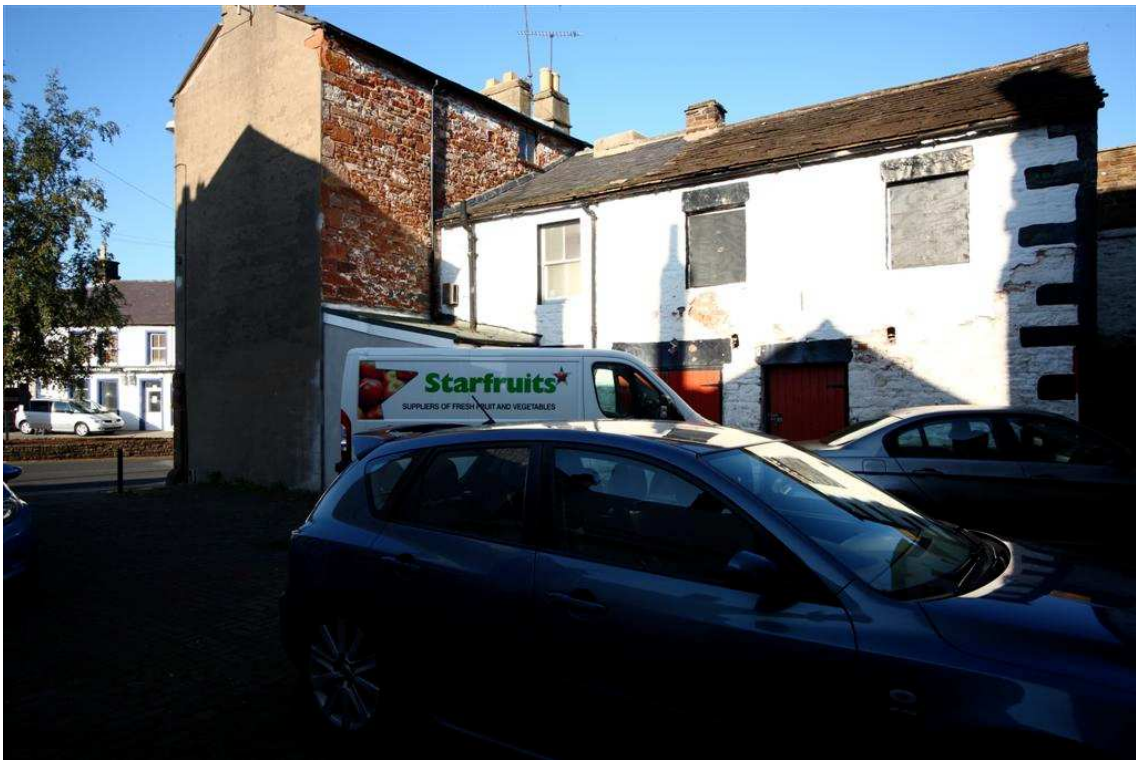
Plate 2: The relationship of Rooms 10 and 15 to Number 8 Great Dockray

3.2.1 Rooms 10 and 15 are contained within a small outbuilding which is physically attached to an extension at the rear of Number 8 Great Dockray (Figs 2 and 3, Plate 2). A vertical join is present between the two structures. The building is constructed of random sandstone rubble, typical of the area with long and short-work at the south-west corner. There are two doorways on the ground floor and two windows on the upper. A further doorway on the south elevation, accessed via a flight of stone steps allows access to the upper floor. The roof is of mono-pitch construction, the covering comprising sandstone flags with a sandstone ridge; the rain water goods are cast iron. The whole structure is painted white, the long and short-work and window and door lintels being painted black. Only the west- and south-facing elevations are visible.

3.2.2 The west-facing elevation houses the access into the ground floor consisting of two doorways of unequal dimensions. The north door is wide and has double doors, while the south entrance has a single door. Both are of plank and ledge construction. Each has a substantial sandstone lintel (the north doorway lintel is slightly larger) and the surrounds consist of large blocks. The main access into Room 10 is via the smaller of the two doorways. The upper part of the elevation houses two windows, both of which are boarded. They have similar lintels to the doorways and are without sills. The windows differ slightly from that contained in the extension to No 8 Great Dockray (Plate 2). The ground floor part of the south-west corner of the building is chamfered (Plate 3).

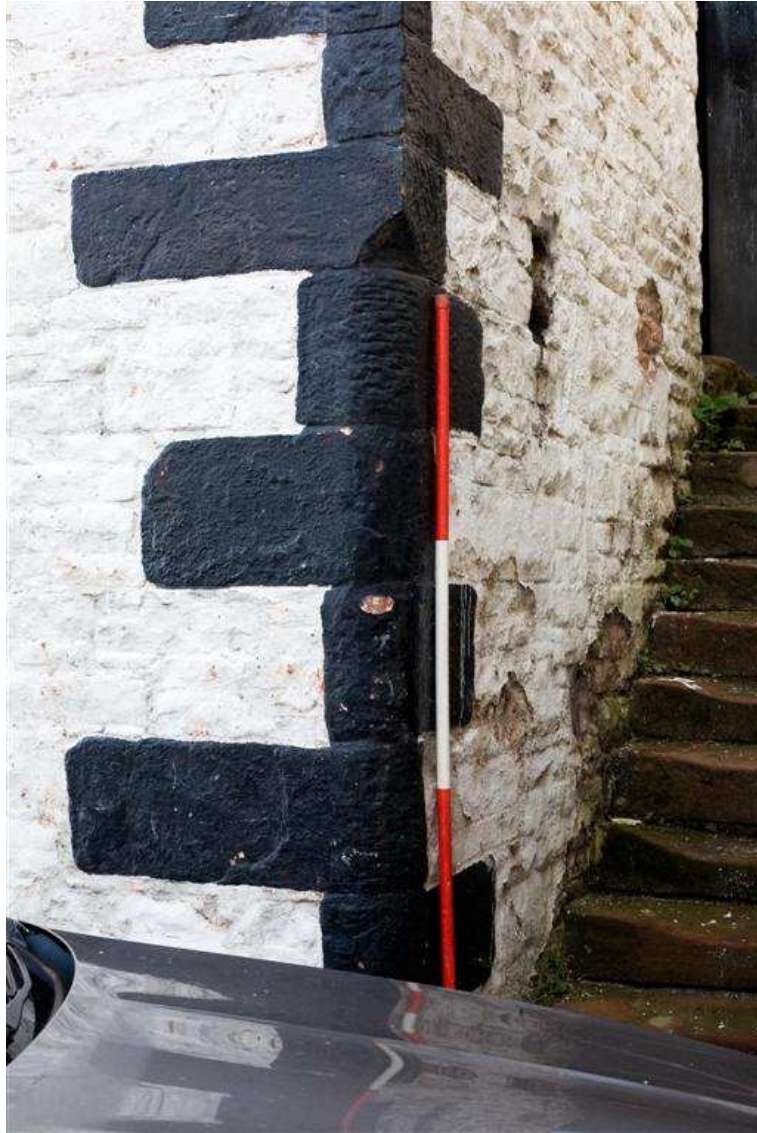
Plate 3: South-west corner of the building showing detail of chamfering.

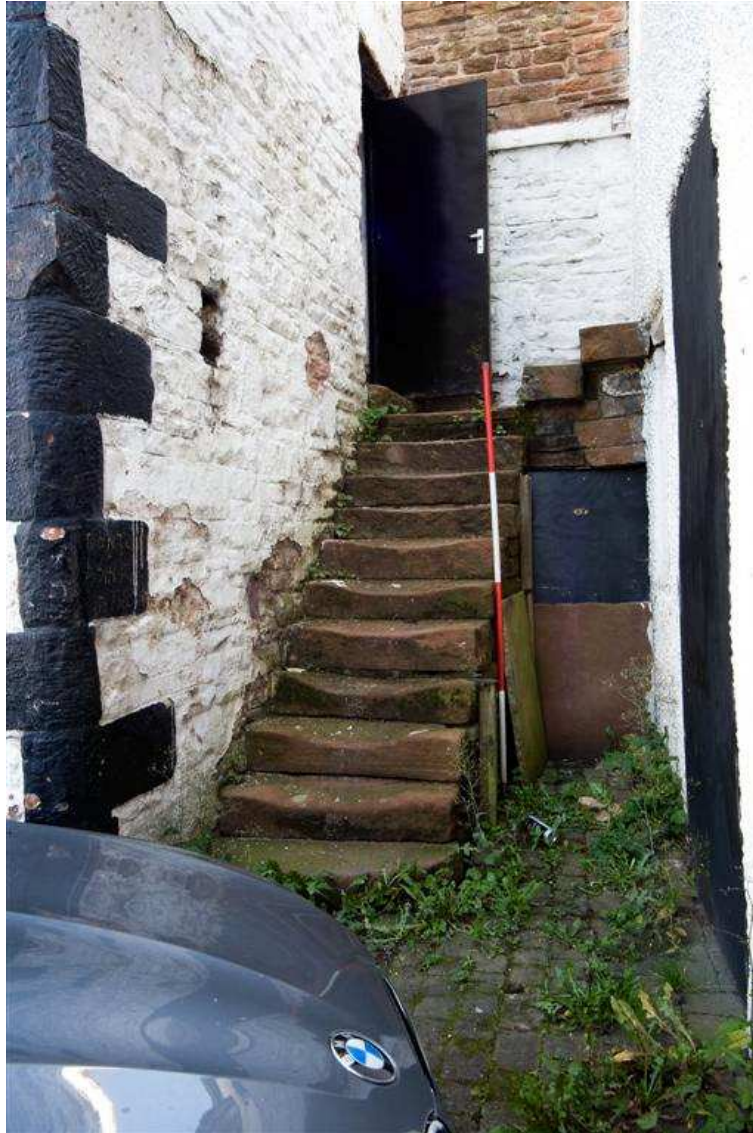
Plate 4: South elevation of the building showing the staircase

3.2.3 The south elevation is partly obscured by worn sandstone steps that allow access to the upper floor and Room 15, as well as the upper floor of the Two Lions (Plate 4). There is a small aperture visible within the south wall of Room 10 which matches a similar aperture inspected internally. The doorway into Room 15 is plain and without distinguishing features.

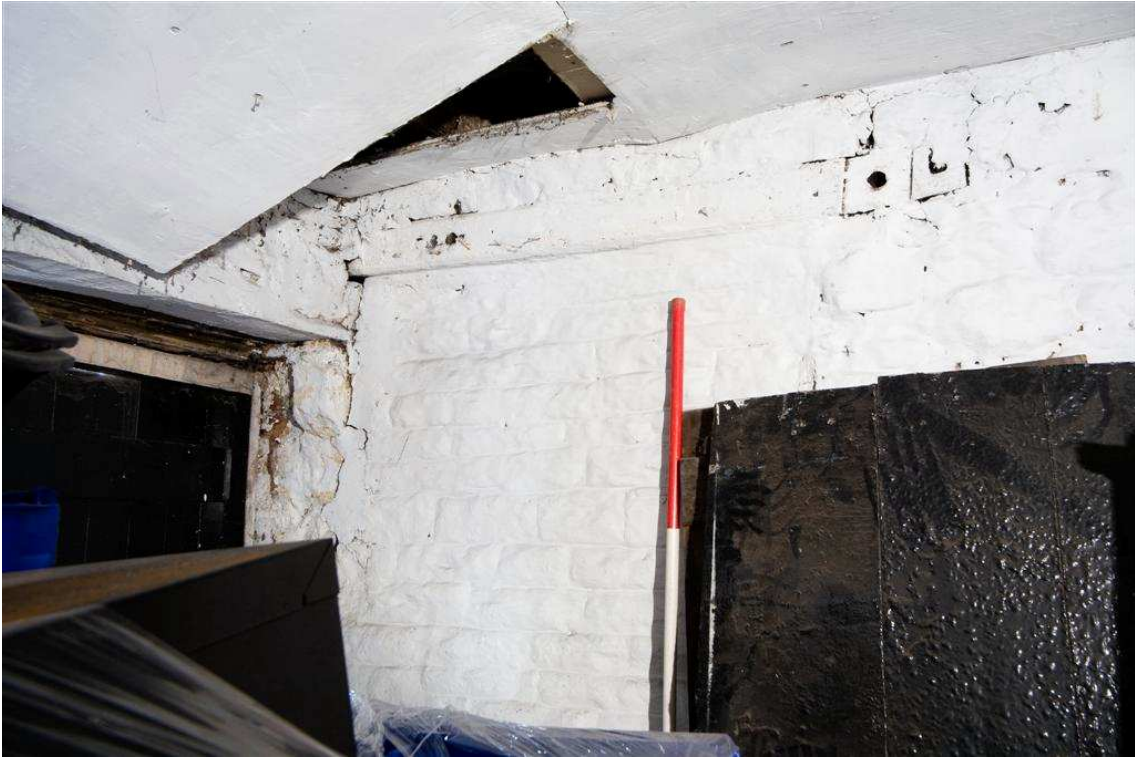
inspection difficult. Despite this, it appears that for the most part the room is plain. There is a blocked door at the north end of the room which once allowed access into the extension at the rear of No 8 Great Dockray (Plate 5). It has a timber lintel which appears to have been re-used. The two corbels present in the south wall are there to support the fireplace present directly above in Room 15 (*Section 3.2.4*).

Plate 5: Blocked door within the north wall of Room 10

4.2.1 Evidence suggests that Room 10 was linked to the extension at the rear of No 8 Great Dockray via the blocked door in the north wall. The roof of the extension is also visible from Room 15 and is part of the same construction, suggesting they were part of the same building. The dividing wall and vertical scar in the west external elevation suggests, however, that Rooms 10 and 15 and the extension are of different phases. Certainly, the extension has a slightly-differently-sized window, but this may have been altered later.

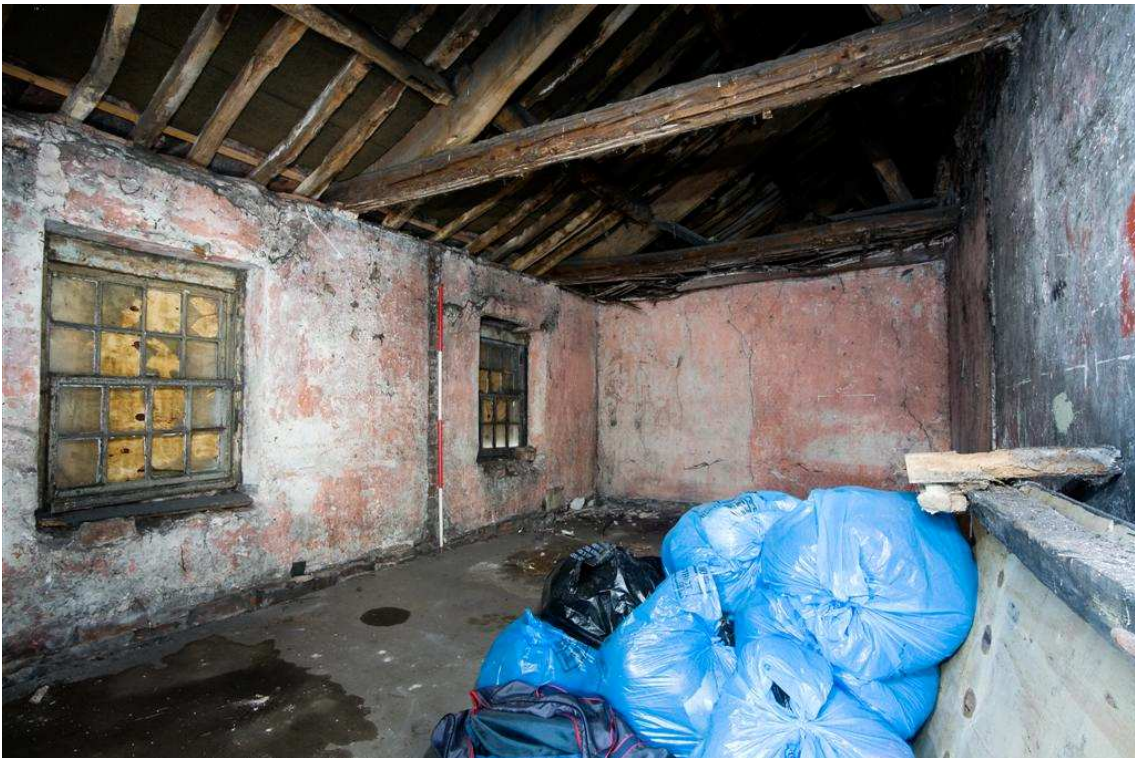
- 3.3.2 **Room 15:** this room is of similar dimensions to Room 10 and is only able to be accessed via the doorway in the south wall. The room is quite dilapidated and the north end of the floor was unsound. It appeared that the room was once used as a dwelling place, the walls being lime plastered, and evidence suggests it was once ceiled at truss height with a lath and plaster ceiling (Plate 6). There is evidence that the room was formerly divided as there are two vertical scars in the plaster on both of the east and west walls. There is also a five inch high scar running around the base of all the walls, suggestive of a removed skirting. The rear extension of No 8 Great Dockray is visible beyond the north wall.

Plate 6: General view of Room 15

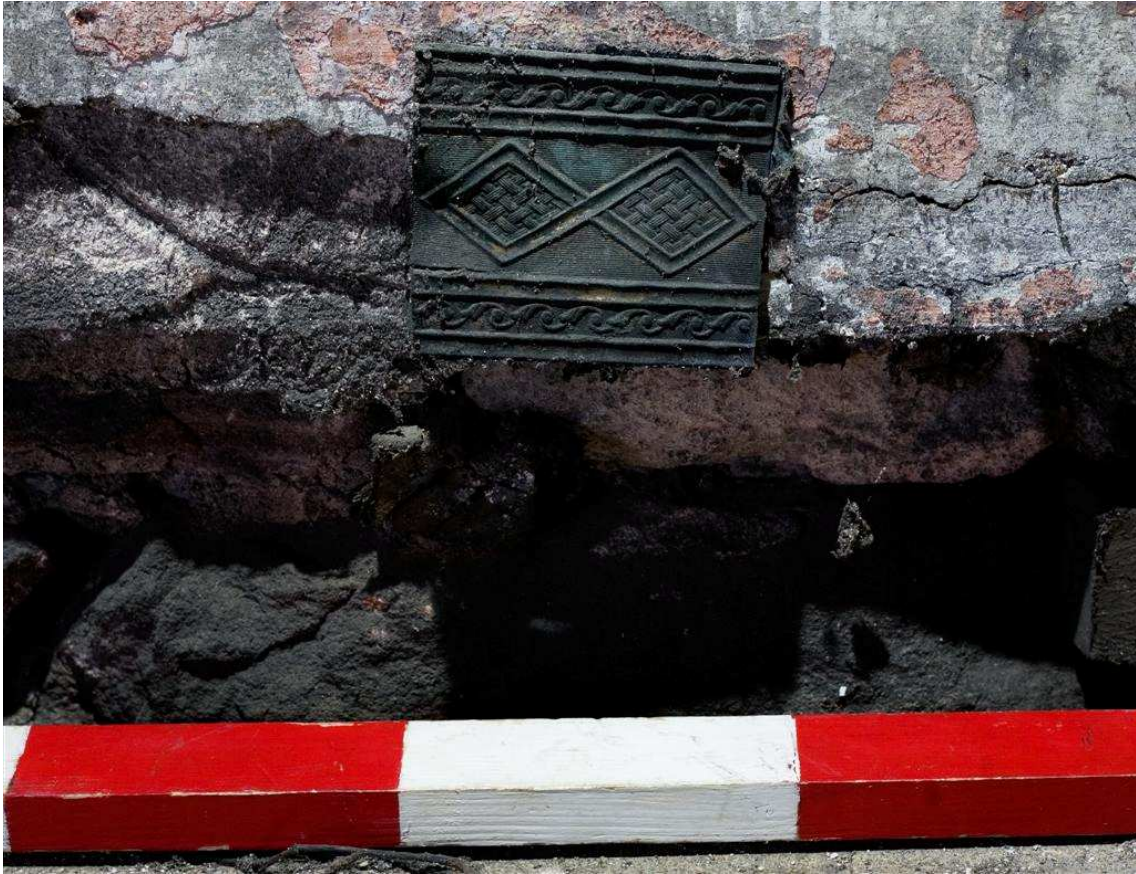
4.2.4 The small decorative copper ally panel attached to the wall in Room 15 is intriguing in that it serves no obvious function and is highly decorative. This may have been part of bigger fixture. It certainly needs further investigation

Plate 8: Decorative copper plate attached to the west wall of Room 15

- 4.4.1 Further investigation of the decorative copper alloy panel should be carried out, and it should be removed prior to commencement of any site work. The roof trusses may be suitable for dating, and this should be investigated further.

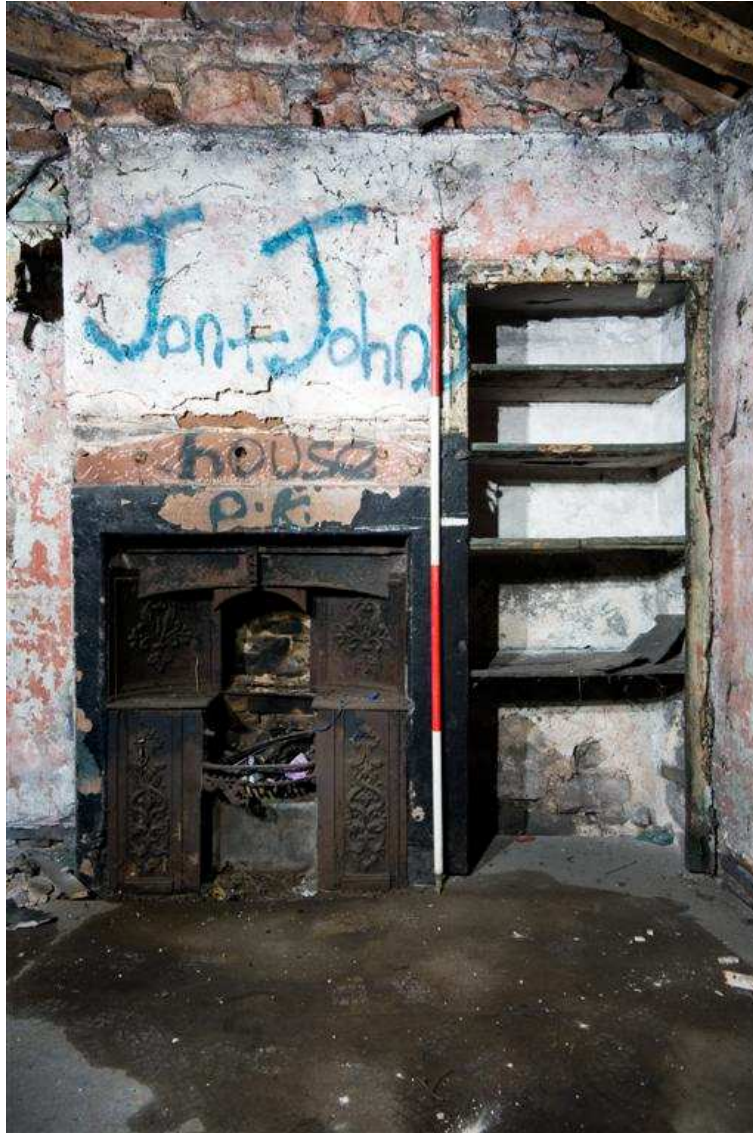
- 3.3.4 The south wall contains a chimney breast with wide opening within which is a hob grate fireplace (Plate 9). There is a sandstone surround with a further large saddleback sandstone lintel above. There may have been an earlier fireplace here as the opening has been slightly reduced in height to fit the current fireplace. The hearth appears to be of slate construction. The flue follows a diagonal course across the wall and is supported by a timber lintel above the doorway. There must have once been a chimney stack at the south end of the roof but this is no longer evident. To the right of the fireplace and built into the recess is a cupboard with four surviving shelves (Plate 9). This once probably had a door as a surviving catch testifies.

Plate 9: The fireplace and cupboard on the south wall of Room 15

4.2.3 The windows and the fireplace situated within Room 15 are suggestive of a late eighteenth or early nineteenth century date which correlates with the existence of the building on Wood's map. The sash boxes of the windows are visible and the multi-light frames are without horns. Visible sash boxes were phased out in the later eighteenth century due to fire regulations and horns only began to appear after the introduction of plate glass in the 1840s. The fireplace is a classic Georgian hob grate.
