# FORMER SUNLIGHT LAUNDRY PREMISES, PENRITH CUMBRIA

## Archaeological Desk- Based Assessment and Standing Building Assessment Report

**Document Title:** FORMER LAUNDRY BUILDINGS,  
PRINCES STREET, PENRITH, CUMBRIA

**Document Type:** Archaeological Desk-Based Assessment and Standing  
Building Assessment Report

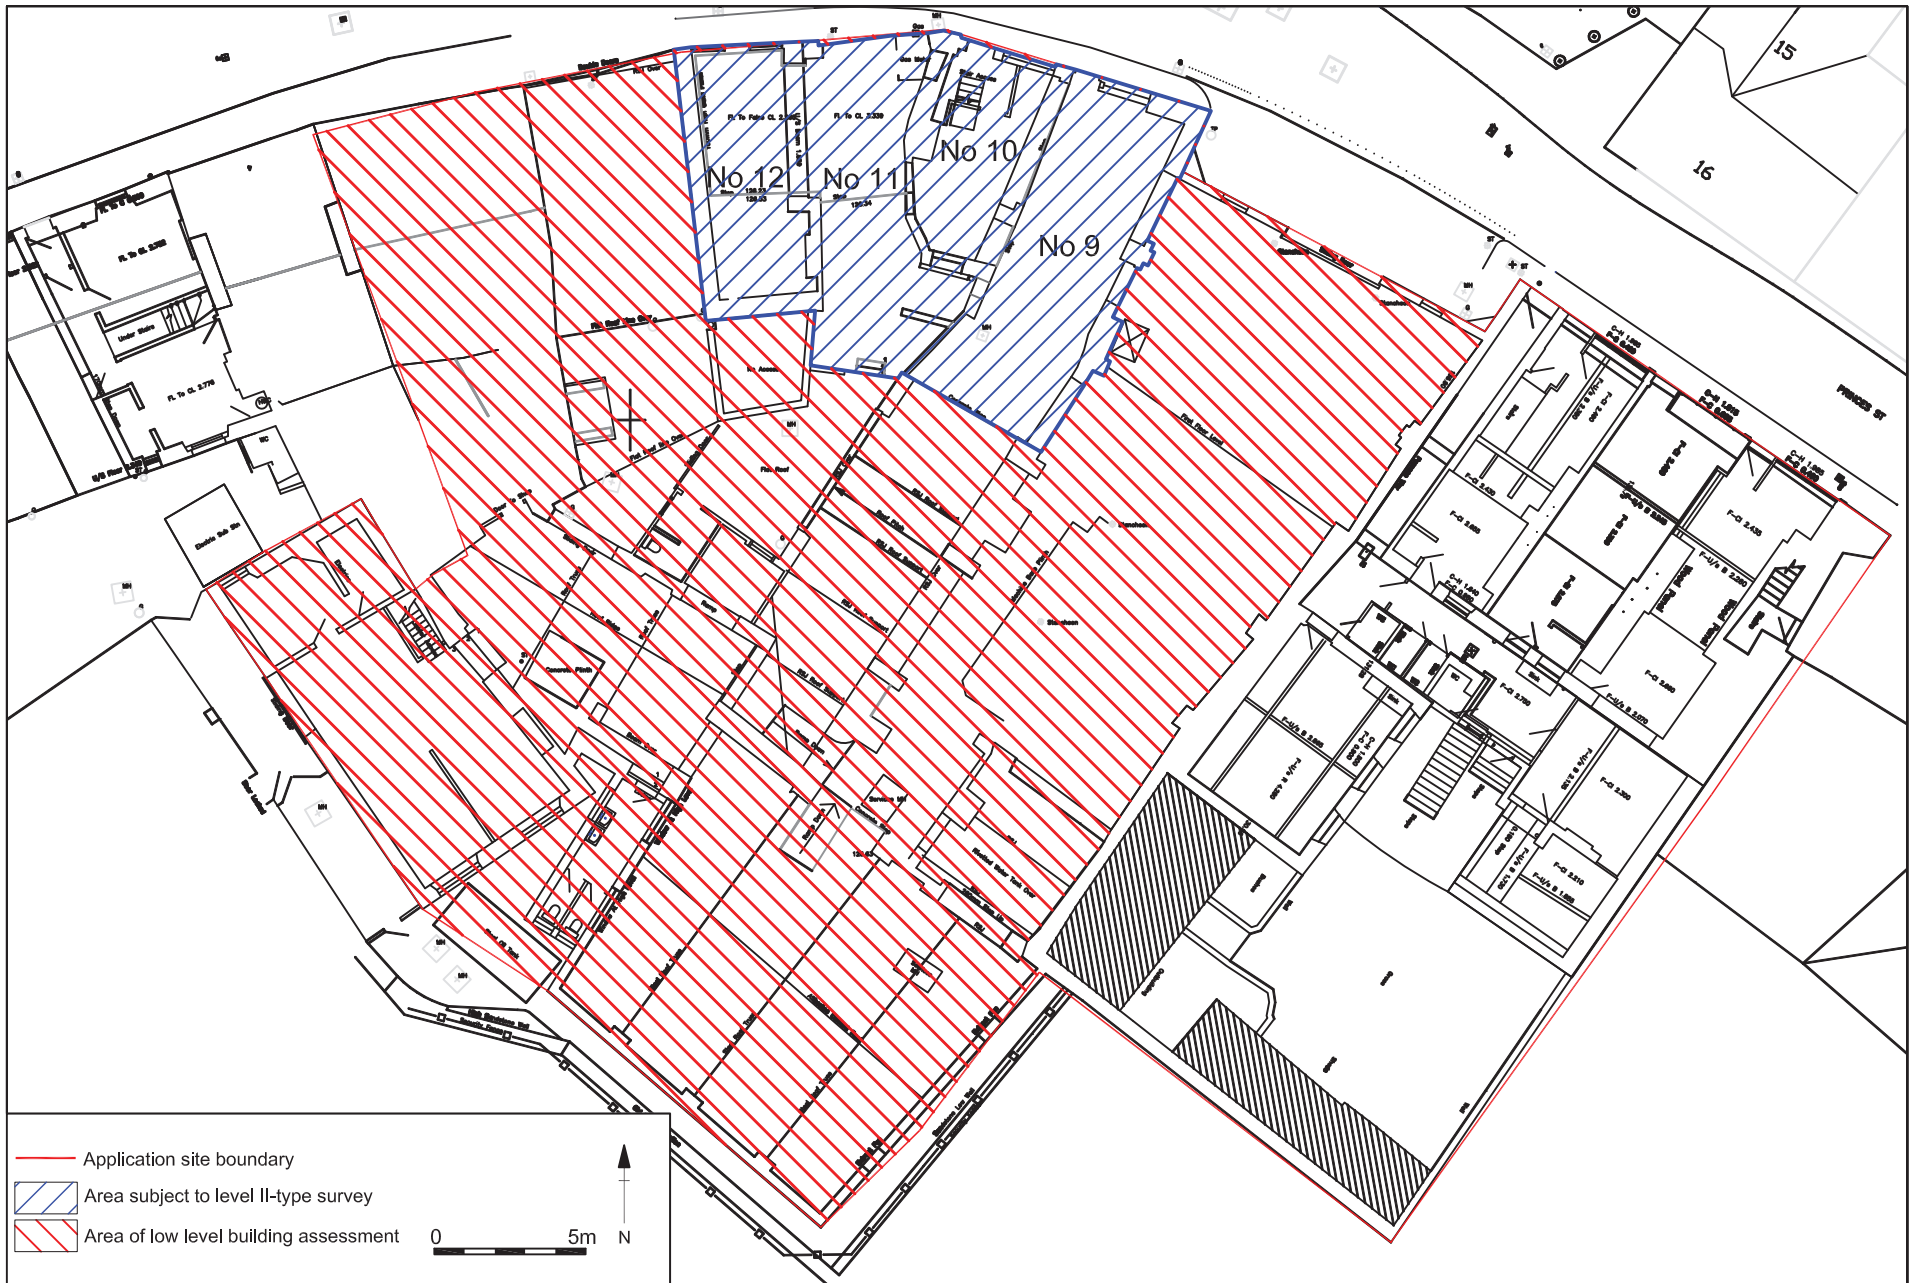
Figure 2: Plan Illustrating Buildings Investigated in Relation to Development Area

2.3.1 The main whitewashed or rendered laundry buildings (numbers 9-11 and number 12 Princes Street, highlighted on Fig 2) were investigated to a Level II-type standard survey (RCHME 1996) in line with the CCCHES brief (*Appendix 2*), which comprised a descriptive internal and external record combined with drawings and a detailed photographic record. The remainder of the laundry building complex to be affected by the proposed development was subject to a lower level of investigation, to approximately that of a Level I-type standard (a mainly visual record), and was carried out to provide a context for the main buildings.

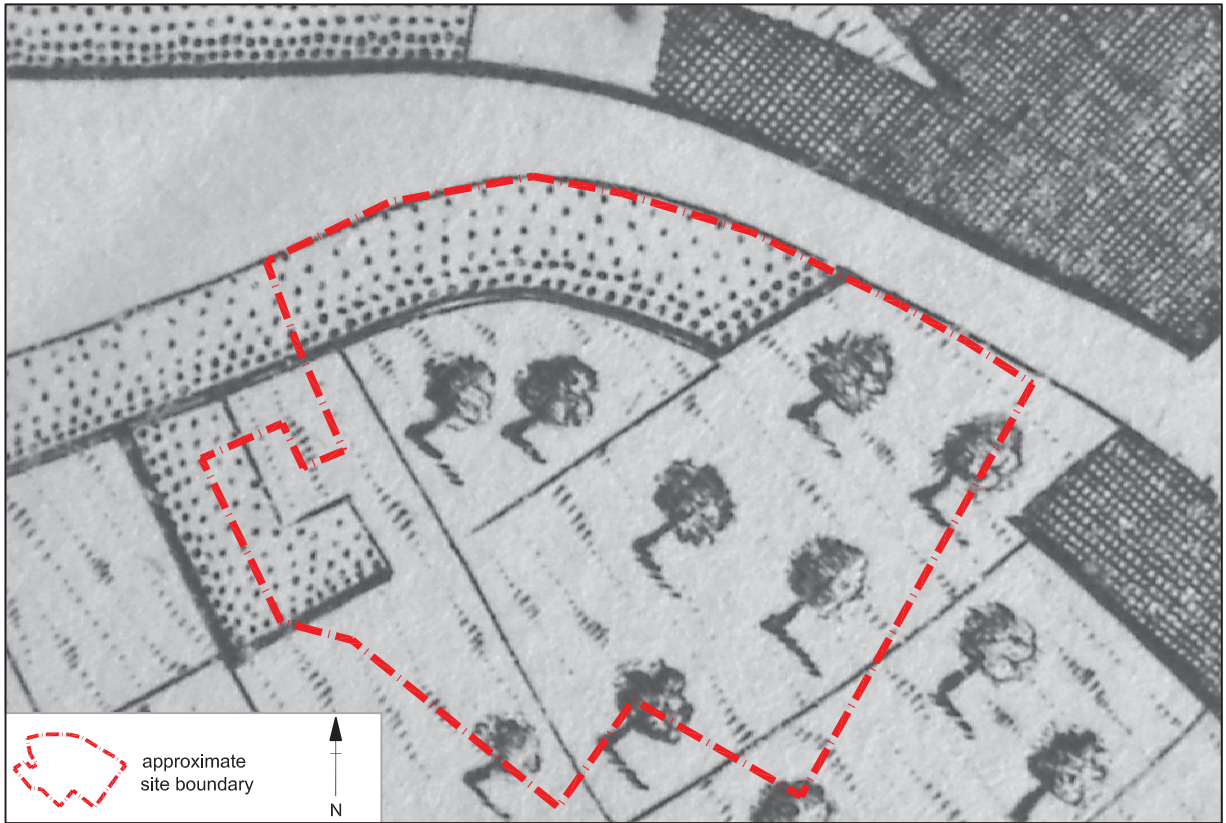
Figure 3: Extract from Clarke's map of 1787

- 3.3.1 **Clarke 1787** (Fig 3): within the west side of the study area is a row of buildings shown fronting what is now known as Princes Street. Within the east side is an open area depicted as an orchard. An L-shaped building is observed extending into the north-west corner of the study area. This is the earliest plan of the town and, albeit fairly simplistic, it seems reasonable to assume that the record represents the plan of the town in the late medieval period, with only minor changes (CCC 2002).

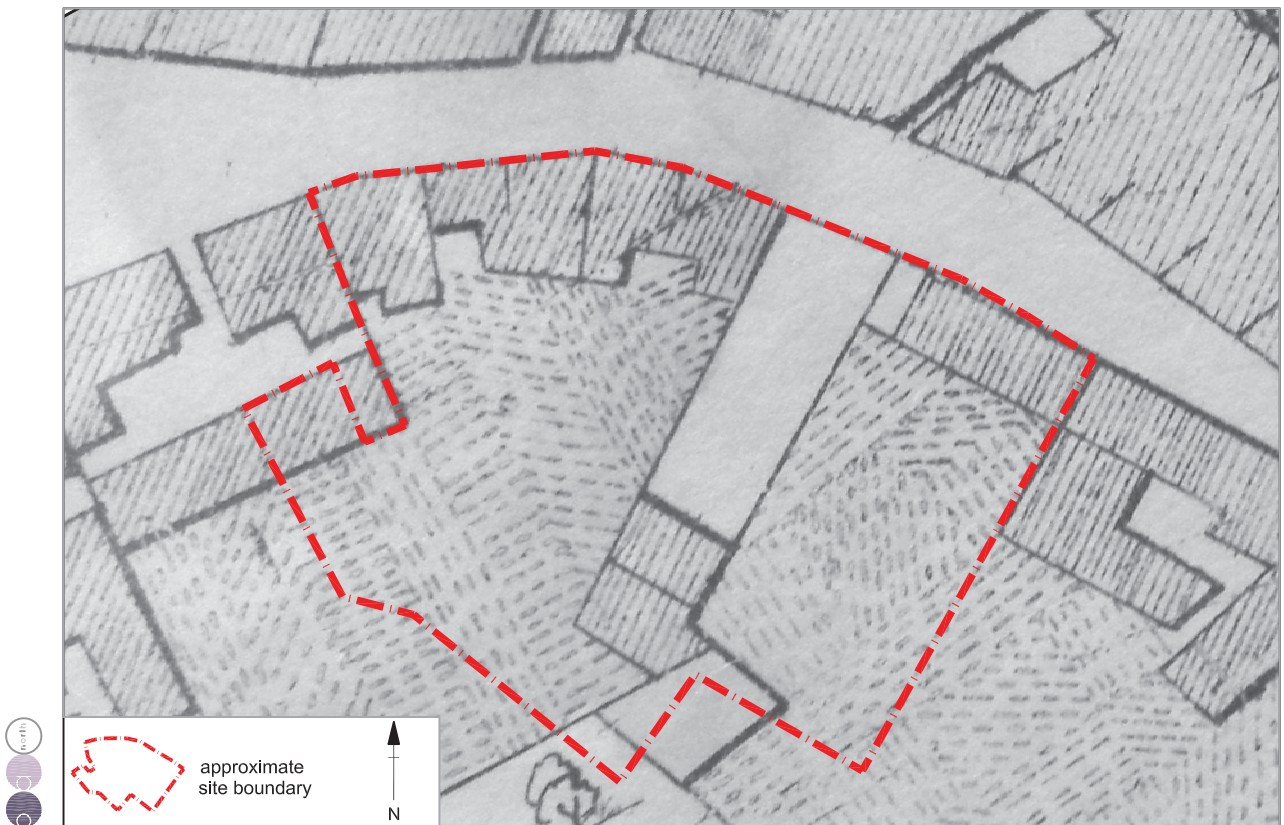
Figure 4: Extract from Wood's map of 1820

- 3.3.2 **Wood 1820** (Fig 4): this map is more detailed than Clarke's, with four buildings shown within the study area fronting Princes Street and gardens or yards behind. Two small 'notches' between two of these buildings may represent property divisions, and if so, these four properties probably represent numbers 9, 10, 11 and 12. A yard between numbers 9 and 8, which was previously shown as the orchard on Clarke's map, led to a building set well back from the street. The L-shaped building had also been removed by this time and replaced by a long building set back from Princes Street by a probable courtyard, the eastern half of which extends into the study area.

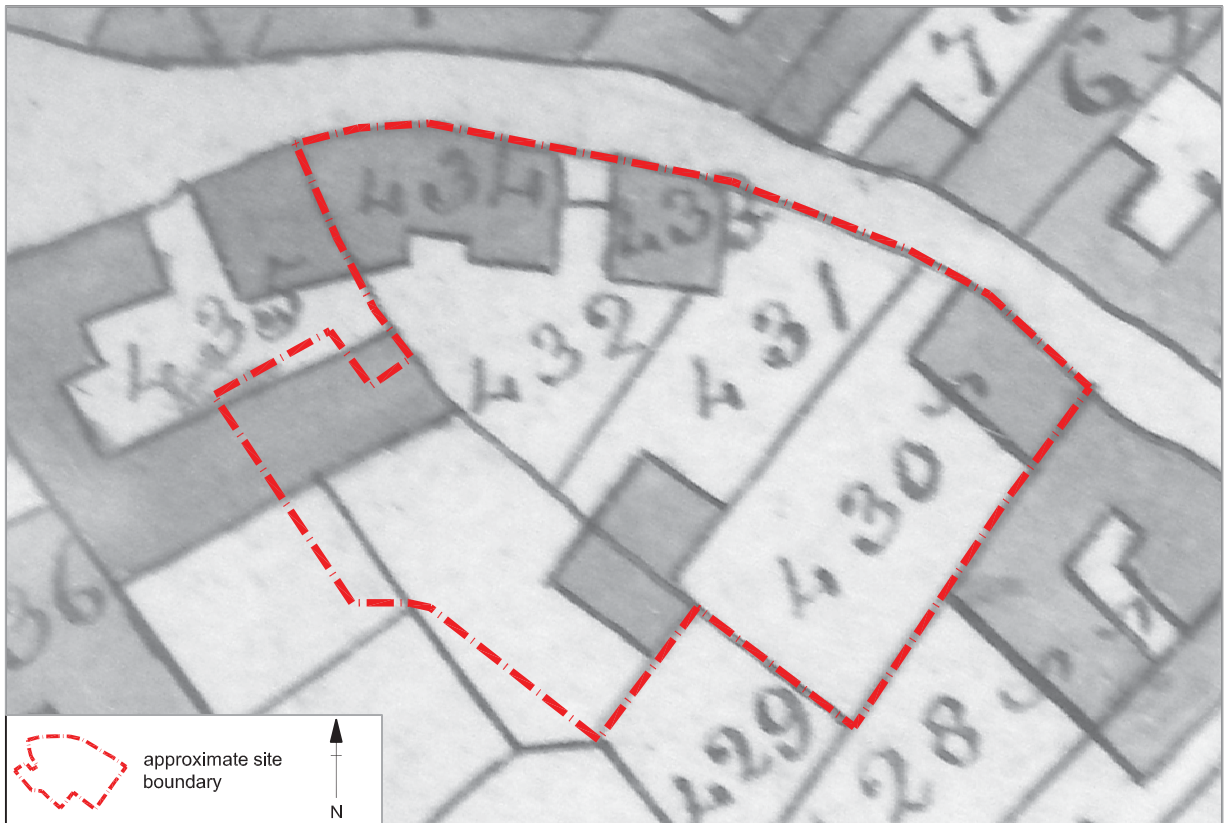
Figure 5: Extract from Penrith Parish tithe map of 1849

- 3.3.3 **Tithe Map 1849** (Fig 5): this map shows significant change in the study area, with numbers 9 and 10 set on a different alignment, and shows a gap or enclosure between numbers 10 and 11. Similarities between Wood's map of

1820 (Fig 4), and the Board of Health map of 1852 (Fig 6), however, suggests that the apparent changes were probably the result of inaccurate plotting by the tithe map surveyors. The apportionment makes no mention of the property or land in the study area, but does state that ‘35 acres of streets and sites of houses of various numbers’ were ‘not producing tithes’ (CRO(C) DRC/8/150).

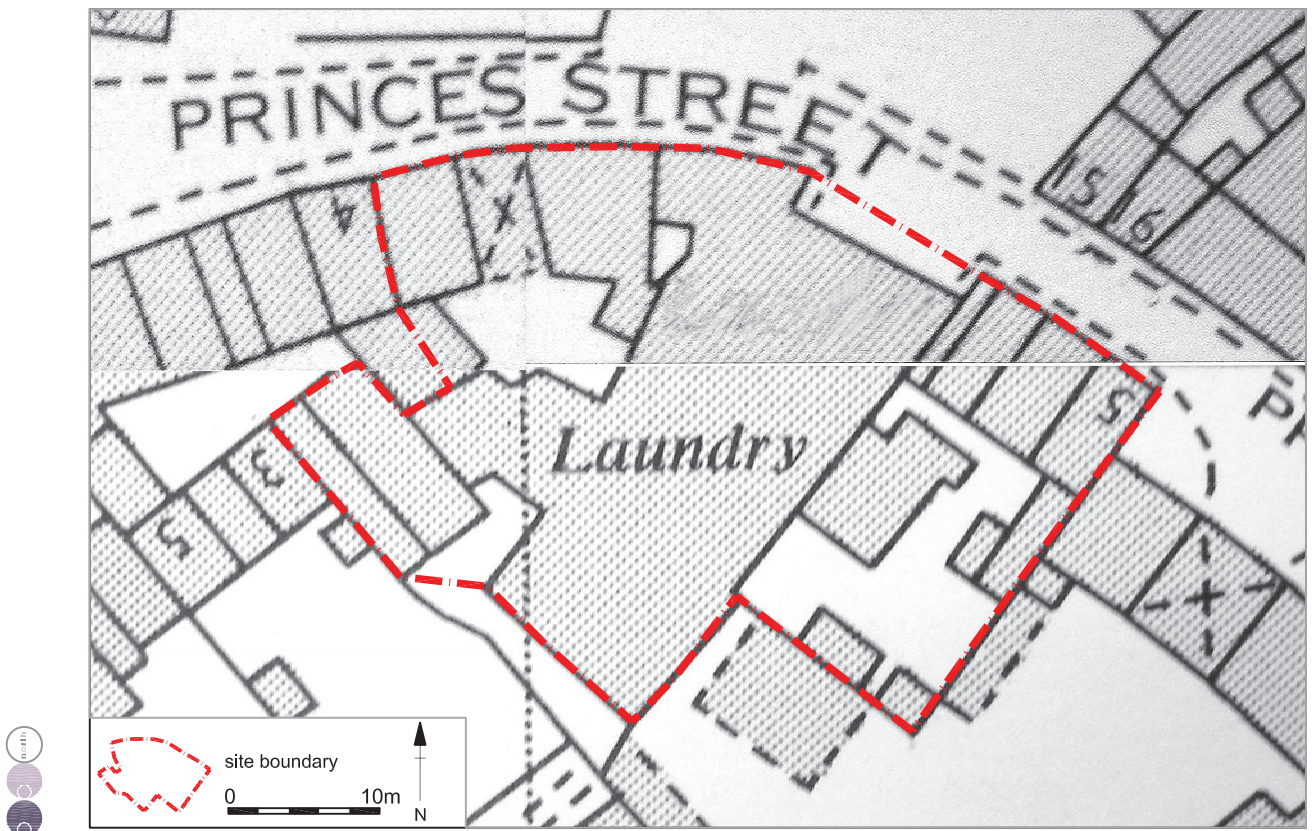
Figure 10: Extract from the 1:2500 Ordnance Survey map of 1967

- 3.3.11 **Ordnance Survey 1967-68 1:2500** (Fig 10): the word ‘Laundry’ is plotted and identifies the function of the buildings for the first time. The area previously

given over to an open area or gardens fronting Princes Street has now been infilled between numbers 8 and 9 for the purposes of the laundry. This open area was last identified in the mapping of 1938 and it is unfortunate that this area could not be seen in the available mapping of 1957 to provide a more accurate date for the construction of the new laundry building. Of the three main rendered buildings (numbers 9-12), the eastern buildings (number 9 and 10) can be seen joined to the laundry but are still a distinct property. The two remaining buildings (numbers 11-12) have been incorporated and amalgamated as one large building, as have many of the previously identified backland buildings. The western part of number 12 has been replaced by a 'new' building.

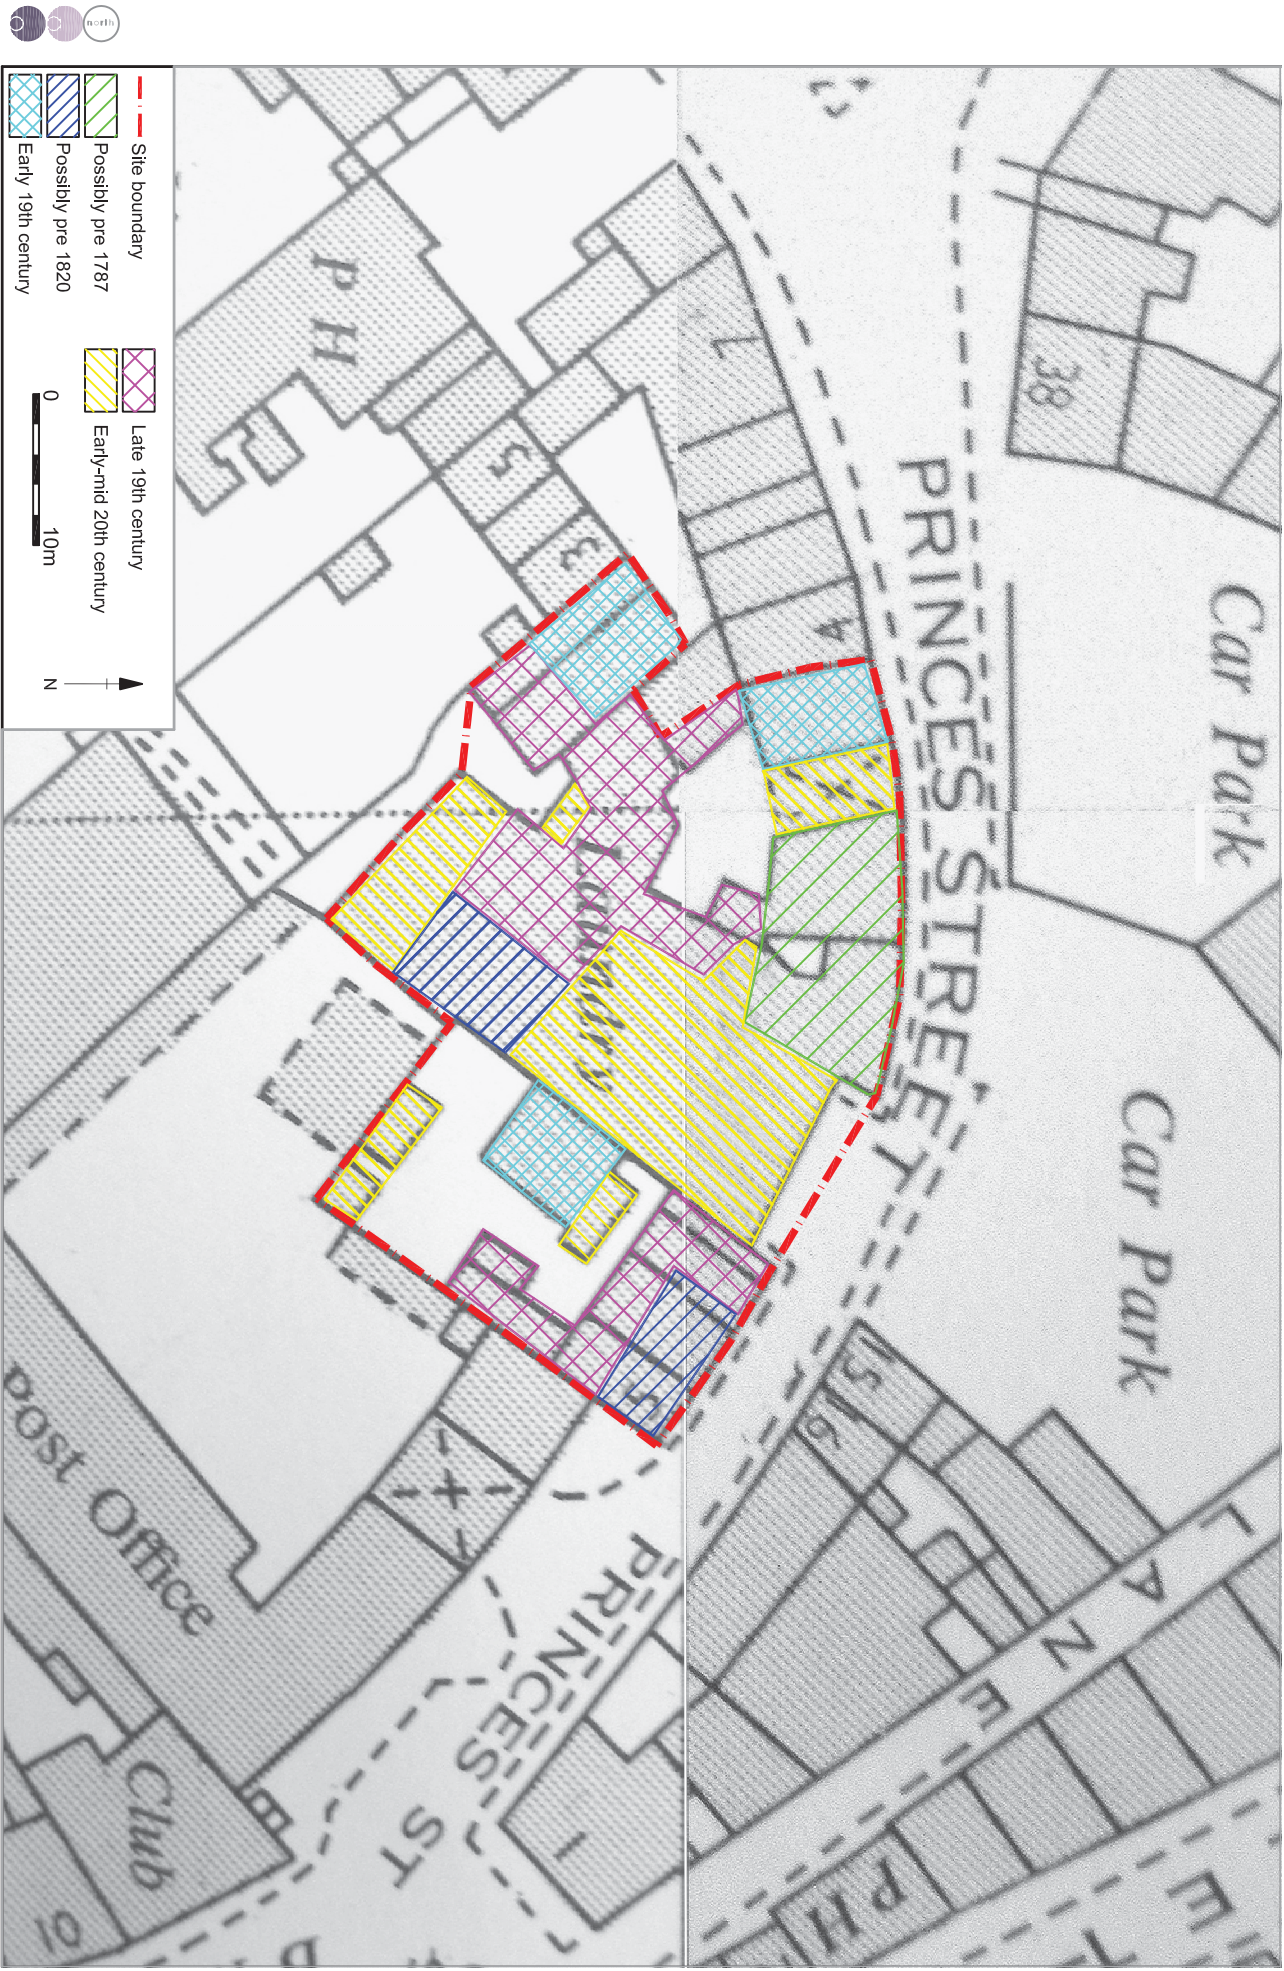
Figure 11: Plan showing the building phases extrapolated from cartographic evidence

- 5.1.4 The building investigation of numbers 9-12 Princes Street suggests that these are likely to be those identified from cartographic sources since 1787 (Figs 3 and 11). However, it is apparent that a great deal of modification and removal of early fabric has taken place, due in no small part to the commencement of laundry operations in the 1930s and its subsequent expansion as evident within the buildings. The removal of major sections of cross walls, replacement of floors and ceilings and insertion of rooms (**Rooms 5, 5a, 6 and 6a**) are indicative of these changes.

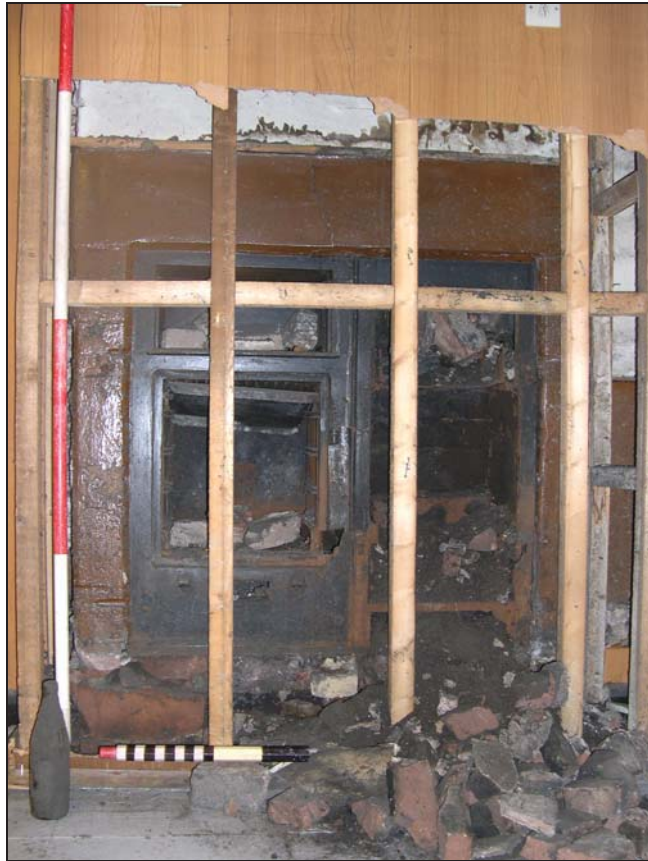
Plate 11: Kitchen Range in **Room 1**

- 4.5.3 At the rear of the room, located on the east wall is a wide panelled-over chimneybreast. Removal of some of the panelling revealed the presence of a cast iron kitchen range (Plate 11). It would appear that this has been inserted into a former fireplace and the lintel is clearly a later insertion. The surround is 1.21m wide and 1.21m high, chamfered and is painted brown. The range itself is 0.98m high by 0.97m wide, has four doors (all missing), together with a firebox and has a damper control with 'ON' 'OVEN' 'OFF' cast into a small plate screwed to the oven. There are no maker's marks but there is a number 'ST NO 23' stamped into the oven lining.
