# **Number 5 Dalton Square, Lancaster, Lancashire**

## **Archaeological Assessment, Building Investigation and Evaluation**

**Oxford Archaeology North**

March 2005

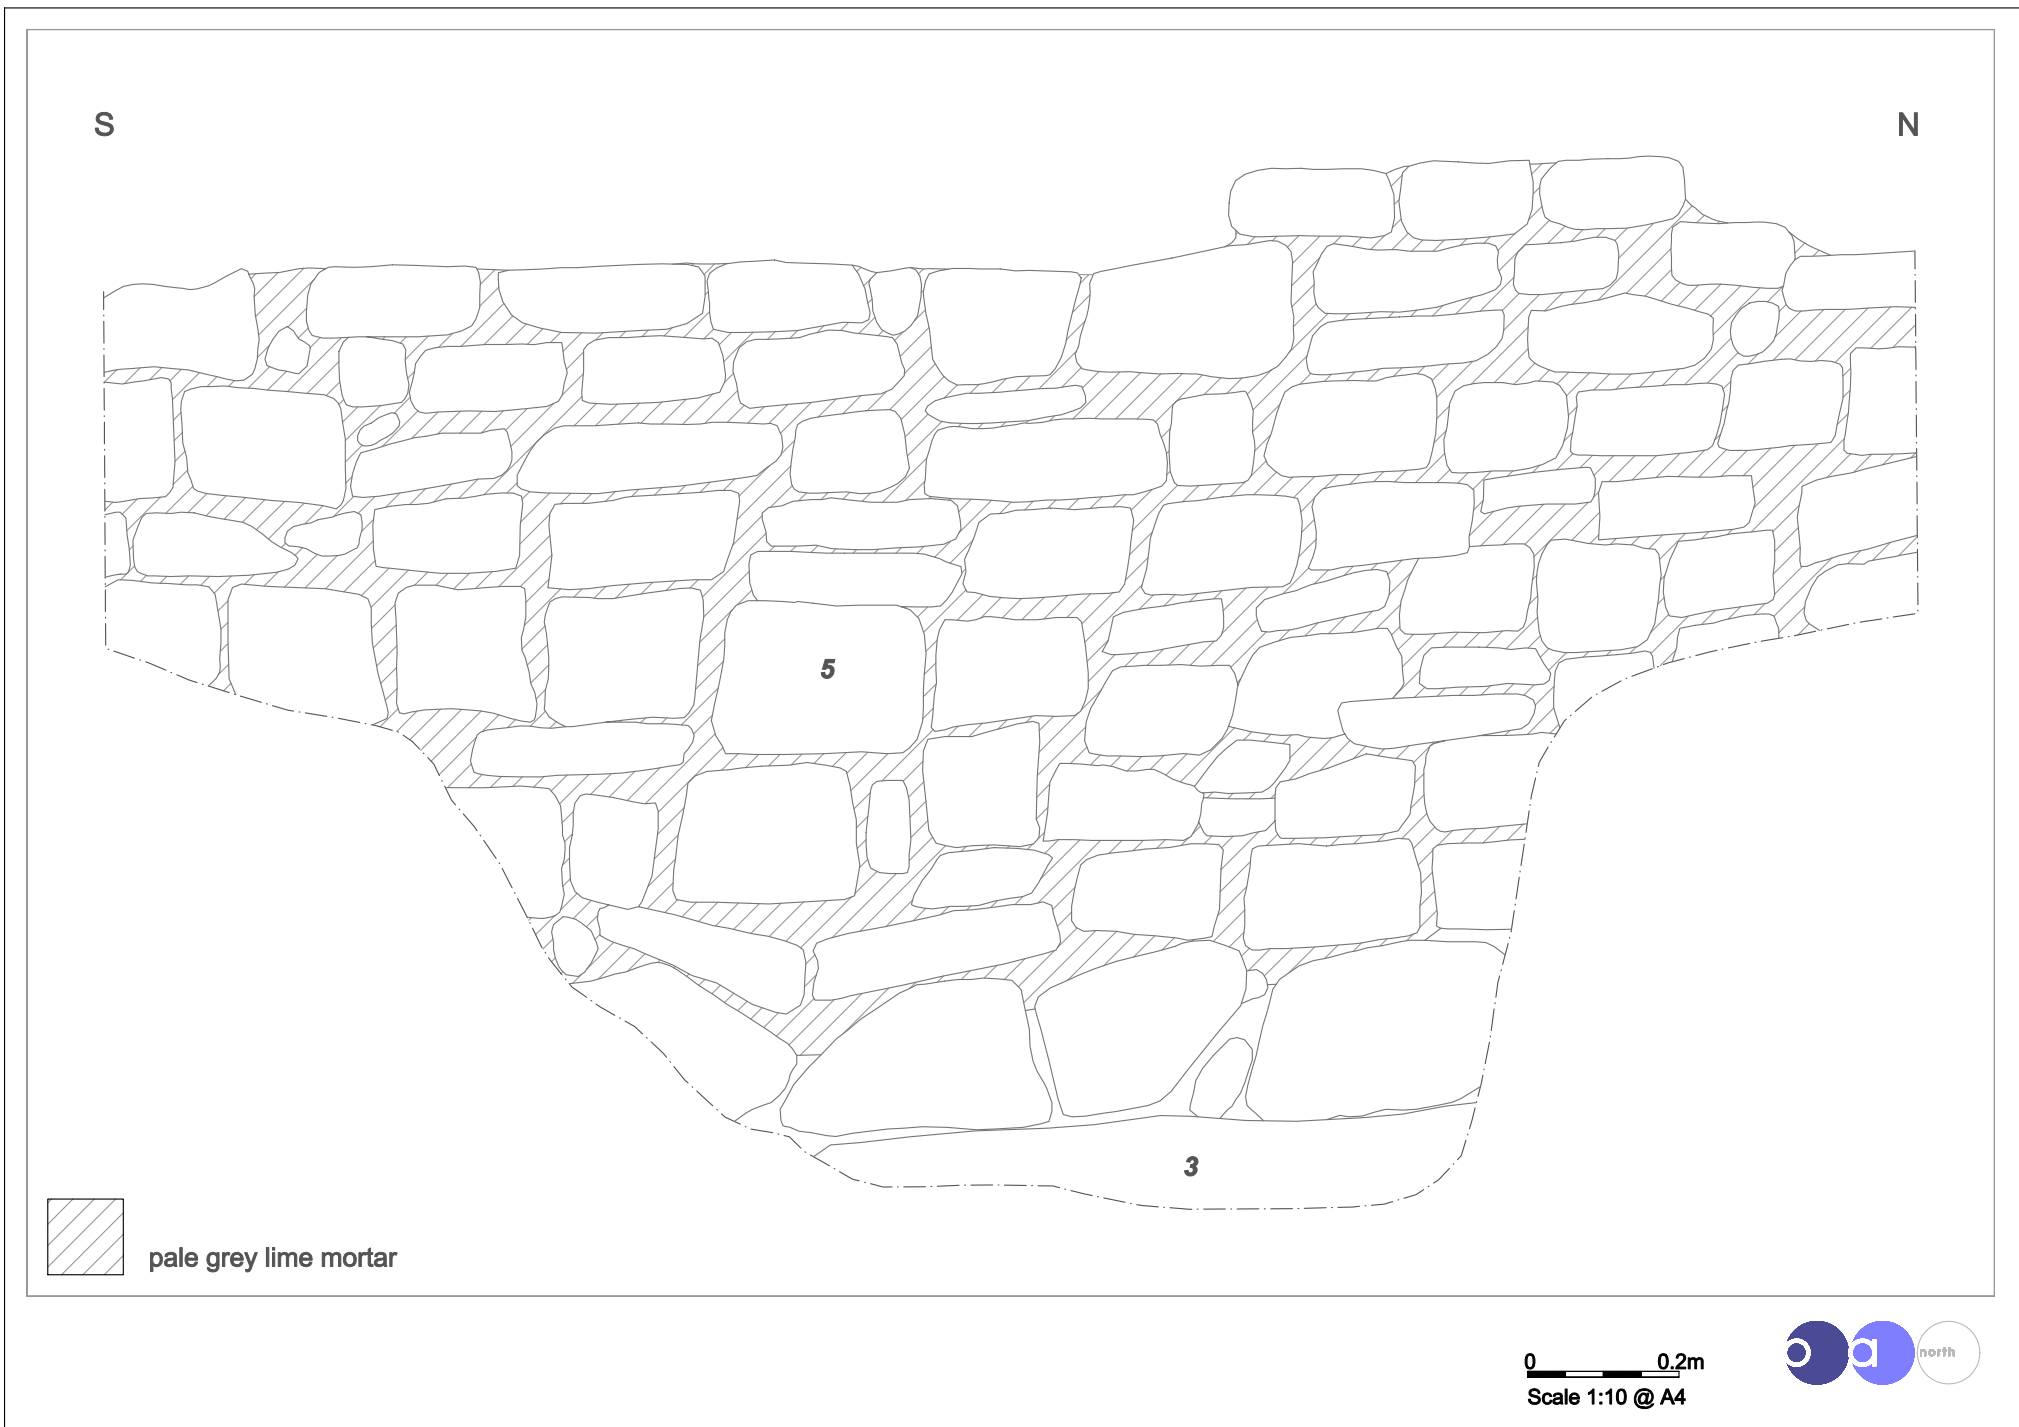
Figure 20: East-facing elevation wall 05

- 6.2.5 Excavation of the eastern sondage exposed the full elevation of the wall **05**, which was found to survive to approximately eight courses, and around 1.3m, in height (Fig 20). The wall had not been constructed within a foundation cut, but was evidently free-standing when it had been buried by the make-up deposits, as both sides of the wall were faced to the base of the wall, with no evidence of mortar bleeding out, which would have been expected had it been built within a narrow cut. The wall was constructed on a foundation course of large, crude sandstone blocks, which were partially set into the underlying deposit, a pinkish-grey friable silty-clay marl **03**. No dating evidence was derived from the wall. Excavation of the deposit of marl found it to contain rare charcoal flecks and sub-rounded stones, but no archaeological dating evidence, though it clearly marked a horizon between the eighteenth century activity and earlier, undated, activity. The deposit was excavated to 0.21m in depth.

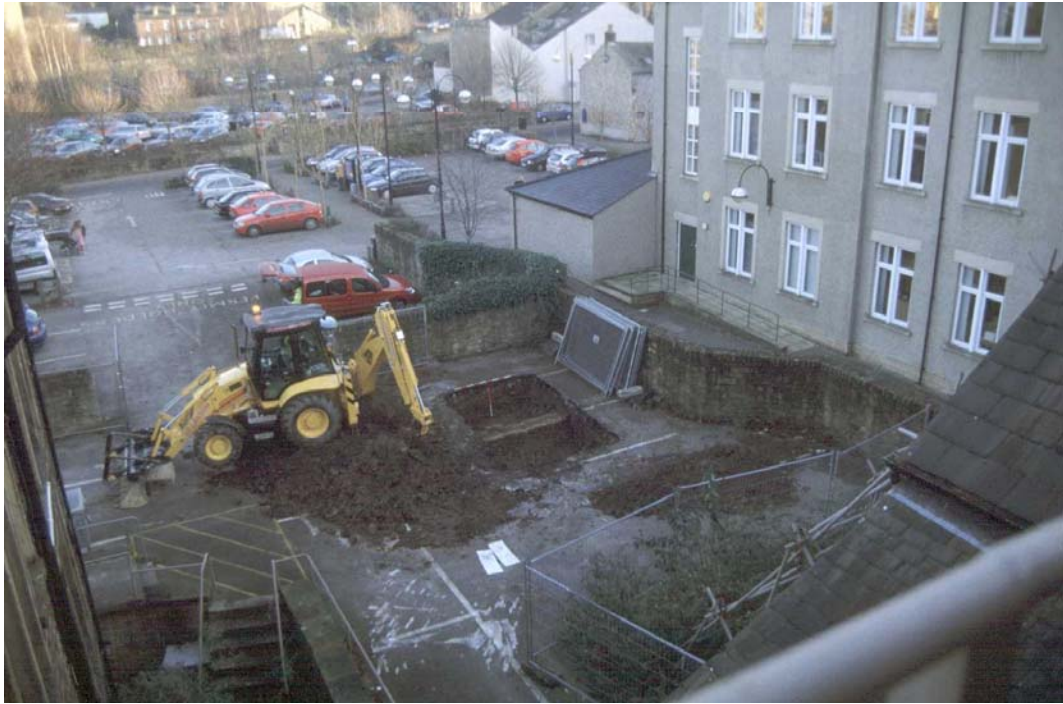
Plate 1: General shot of trench, facing east

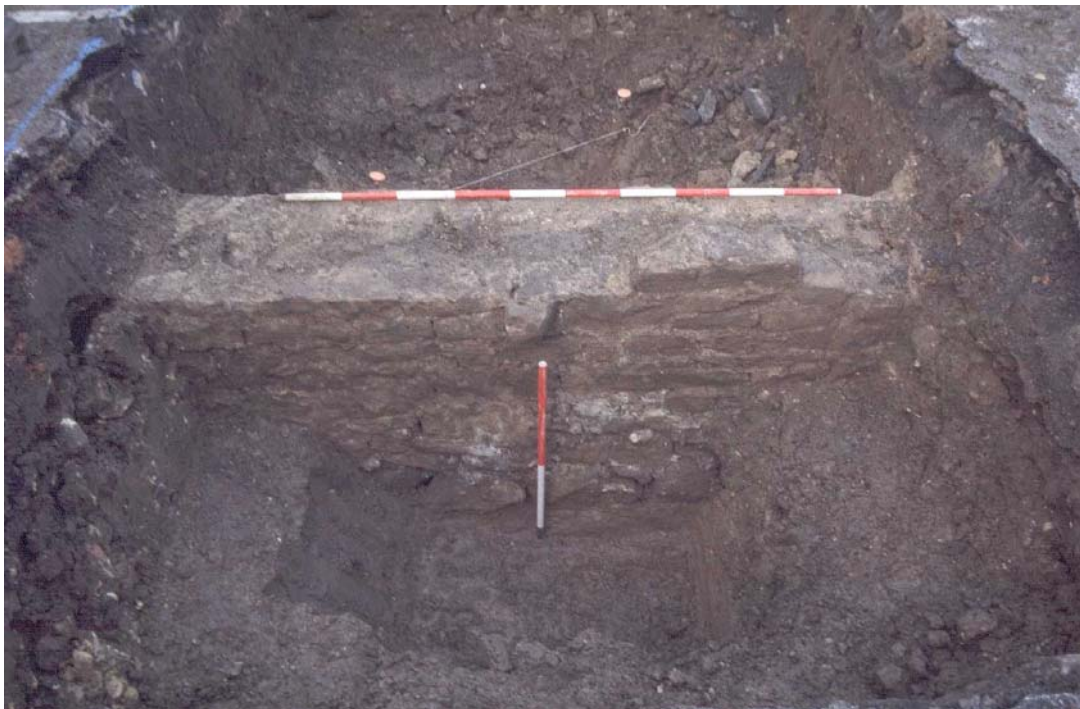
Plate 2: West-facing shot of wall and trench

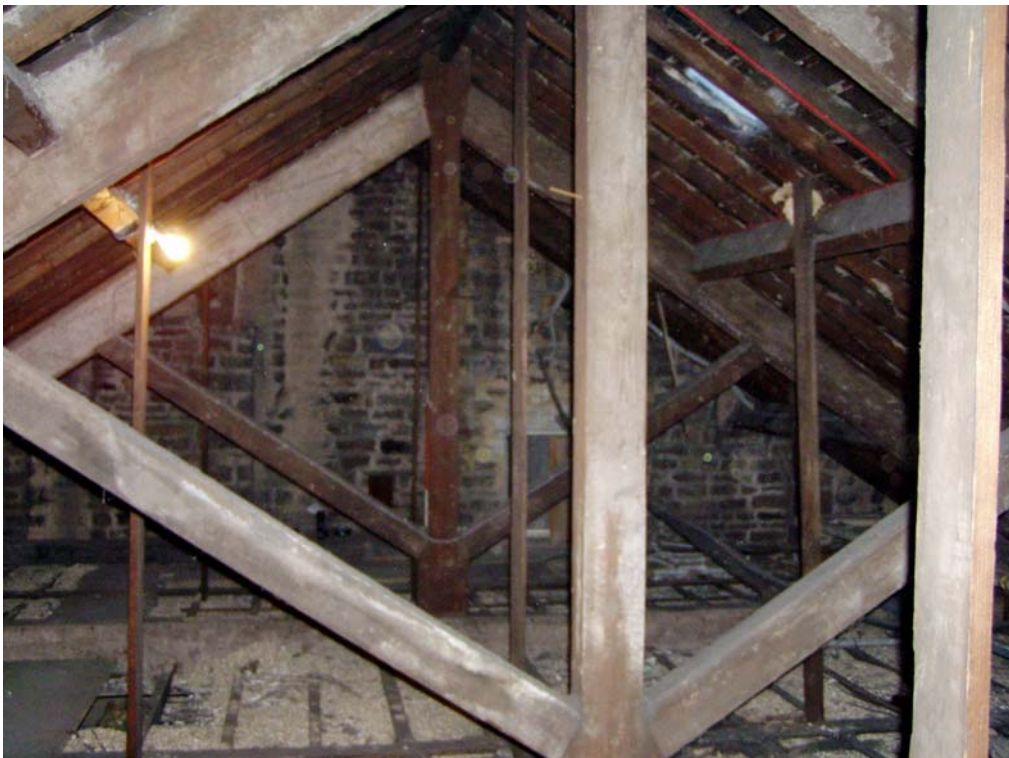
Plate 24: The roof trusses
