In December 2006, Oxford Archaeology North was commissioned by Ribble Valley Borough Council to undertake an archaeological evaluation at Clitheroe Castle, Lancashire (centred at SD 7424 4169). The site is a designated Scheduled Monument, which incorporates several structures, including Grade I and Grade II Listed Buildings. The archaeological evaluation was carried out in January 2007, and was required to inform and support the Listed Building and Scheduled Monument Consent applications for a proposed redevelopment of Clitheroe Castle Museum, and associated enhancement of the site. In particular, the proposed redevelopment of the museum allows for the erection of a new link building that will provide level access between the existing museum and adjacent outbuildings, but necessitating the localised excavation of foundations through archaeological deposits to the level of the solid geology. As part of a wider programme of enhancement of the site, it was proposed to erect floodlighting around the castle keep, install audio equipment, and remove sections of tarmac footpath.

The archaeological evaluation comprised the excavation of nine small trenches, which were placed around the ca

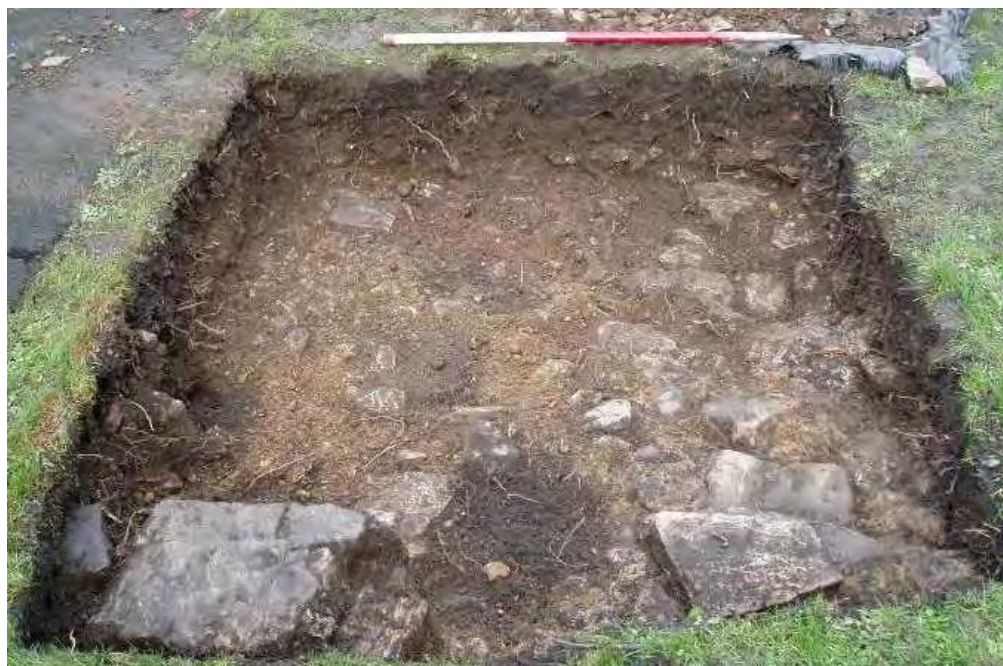
Plate 5: Trench 1, looking north-east, showing the exposed features

- 3.2.2 **Phase 1:** the bedrock was sealed by a layer of brownish-yellow silty-sand (**111**) that in places was up to 0.20m thick. This layer probably represented a deliberate levelling episode, and had been cut by several features and a wall foundation (Plate 5). Two of these features, posthole **113** and pit **112**, were selected for partial excavation in order to assess the date, character and nature of the archaeological resource.

- 3.2.4 Pit **112** was located in the eastern corner of the trench, and extended both south-east and north-east beyond the limits of excavation (Fig 3). It was cut through layer **111** and into the underlying solid geology. The pit was filled with loose grey-brown sandy-silt and stone rubble, **108**. Excavation of the pit yielded a single sherd of medieval pottery, probably of a thirteenth- or fourteenth-century date.

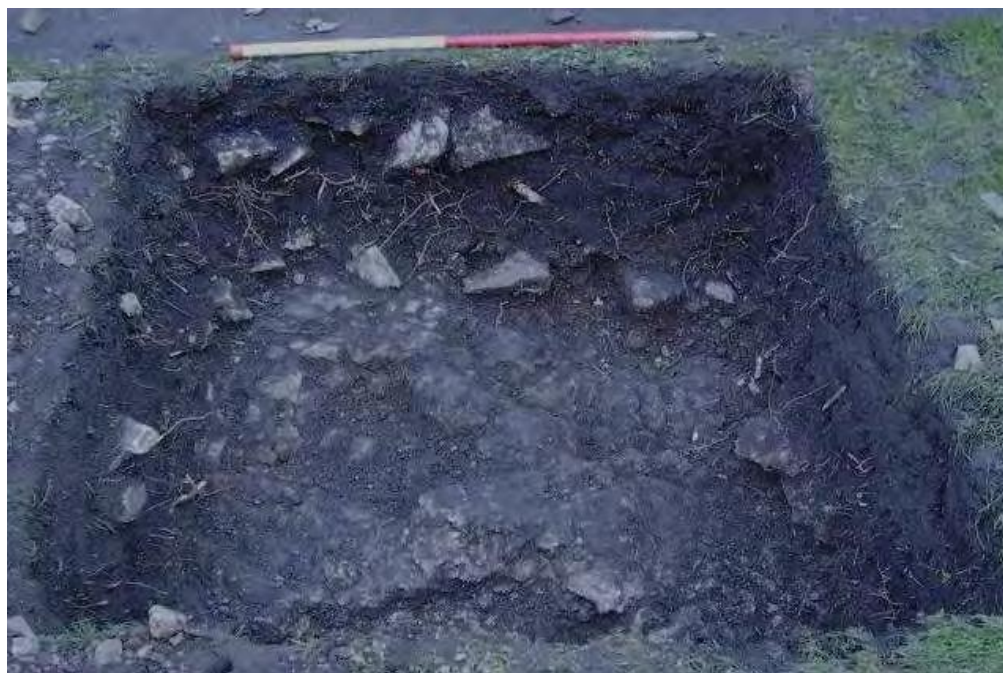
Plate 6: Trench 2, looking south-west, showing features cut into the bedrock

- 3.3.2 **Phase 1:** the solid geology in the trench had been cut by a posthole and a gully (Plate 6). The gully, **208**, was located along the north-eastern side of the trench and was irregular, sinuous and had a maximum depth of 0.20m (Fig 4). The fill (**205**) contained a few sherds of pottery of a thirteenth- to fourteenth-century date, together with a possible copper alloy brooch fragment, and fragments of animal bone. Toward the southern corner of the trench was a 0.27m deep posthole, **209**, which was filled with an homogeneous deposit (**206**) that contained fragments of animal bone (Fig 4).

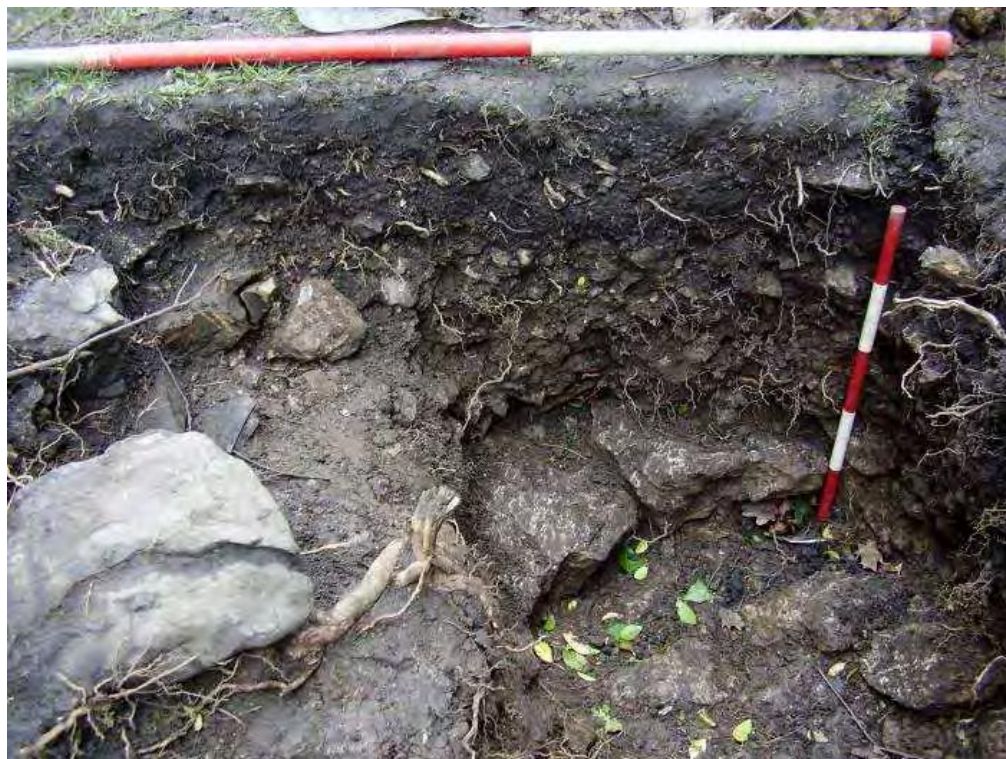
Plate 7: North-west-facing section of Trench 3

- 3.4.1 Trench 3 was located on the south-east side of the castle keep, but was of reduced dimensions (1m square) due to the space available and had a maximum depth of 0.60m (Fig 2). The modern ground level lies at a height of between 115.81m and 115.69m OD. The first significant archaeological deposit was encountered 0.10m below present ground level at a depth of 115.70m OD. The solid geology, **303**, was exposed at a depth of between 0.50m and 0.60m below the present ground level (Plate 7).

- 3.4.2 **Phase 1:** a fairly substantial deposit of silt and stone (**302**), which had a maximum depth of 0.45m and was seen to slope down to the south-east, overlaid the solid geology (Fig 5). It is likely that this deposit represented a deliberate levelling episode. The deposit produced fragments of animal bone and a single sherd of shell-tempered pottery. Such pottery was in use east of the Pennines for a considerable period, being found in Anglian York and into the thirteenth century. Here, given the date of the other pottery from the site and based on evidence from York itself, a twelfth- to thirteenth-century date would be applicable. The deposit also produced a bone disc, a stone needle sharpener/hone-stone, and a piece of antler, possibly representing working waste.

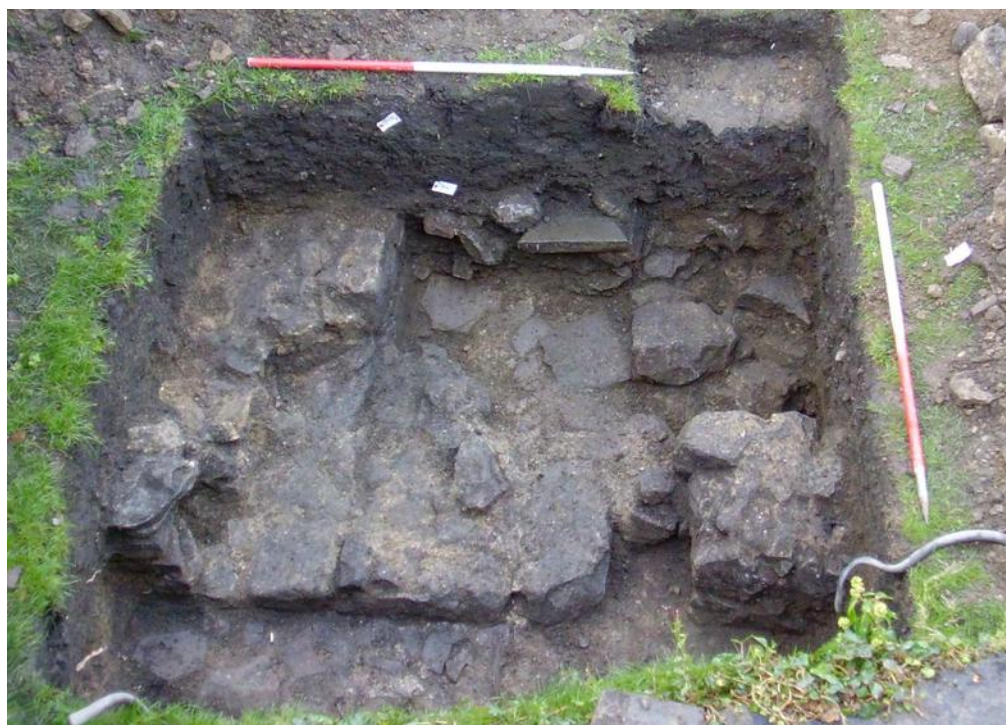
Plate 8: Looking south-west across Trench 5A

- 3.6.2 **Phase 1:** the earliest features within the trench were the remains of a substantial stone walls, **510/555/556** (Fig 7), the top of which were located at a height of 106.73m OD (0.42m below present ground level). The walls were composed of large, roughly-hewn and faced limestone blocks, some measuring 400mm by 300mm, and survived in some places to a height of four courses (Plate 8). The stones were bonded with creamy white mortar.

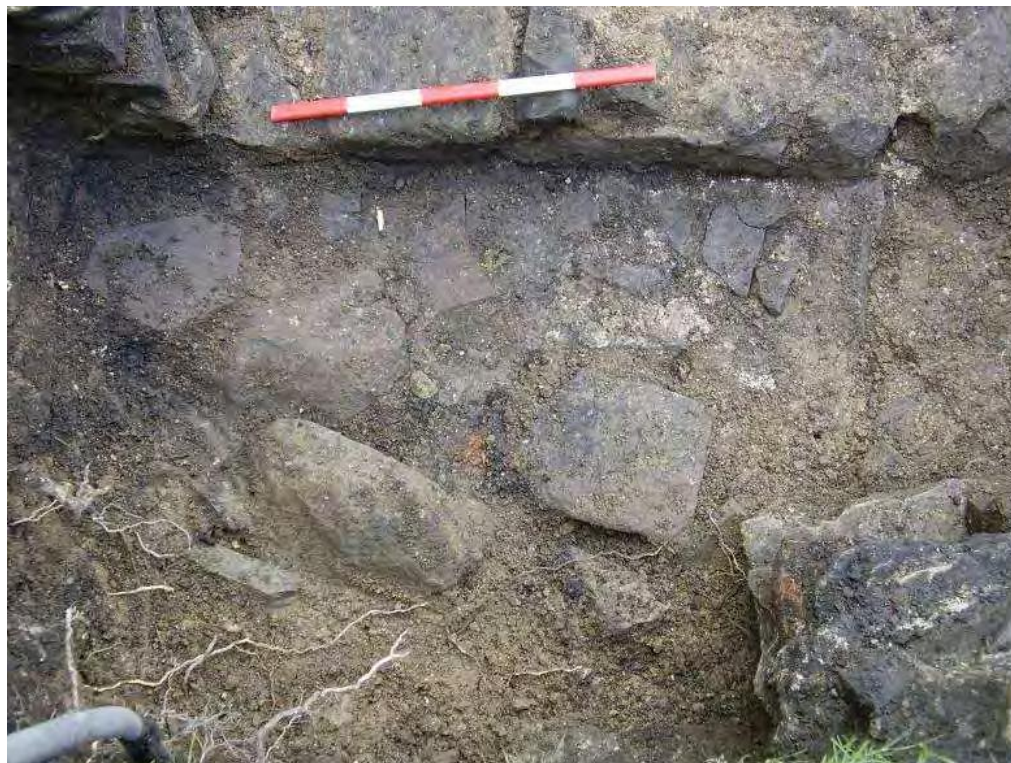
Plate 9: Trench 5a, showing the remains of fireplace **566**

- 3.6.4 Abutting wall **555/556** and **510** was a later fireplace (**566**) located on the north-eastern side of the wall (Plate 9). The feature survived as the hearth area only, and comprised a roughly rectangular structure extending 1.65m north-west from the edge of excavation and was 0.44m wide. Several re-used floor tiles were observed at the south-east end of the feature. These floor tiles, one of which exhibited splash glazing, were considered to be of a thirteenth-century date. A layer of charcoal-rich, slightly gritty sand (**565**) was contained within the fireplace/hearth.

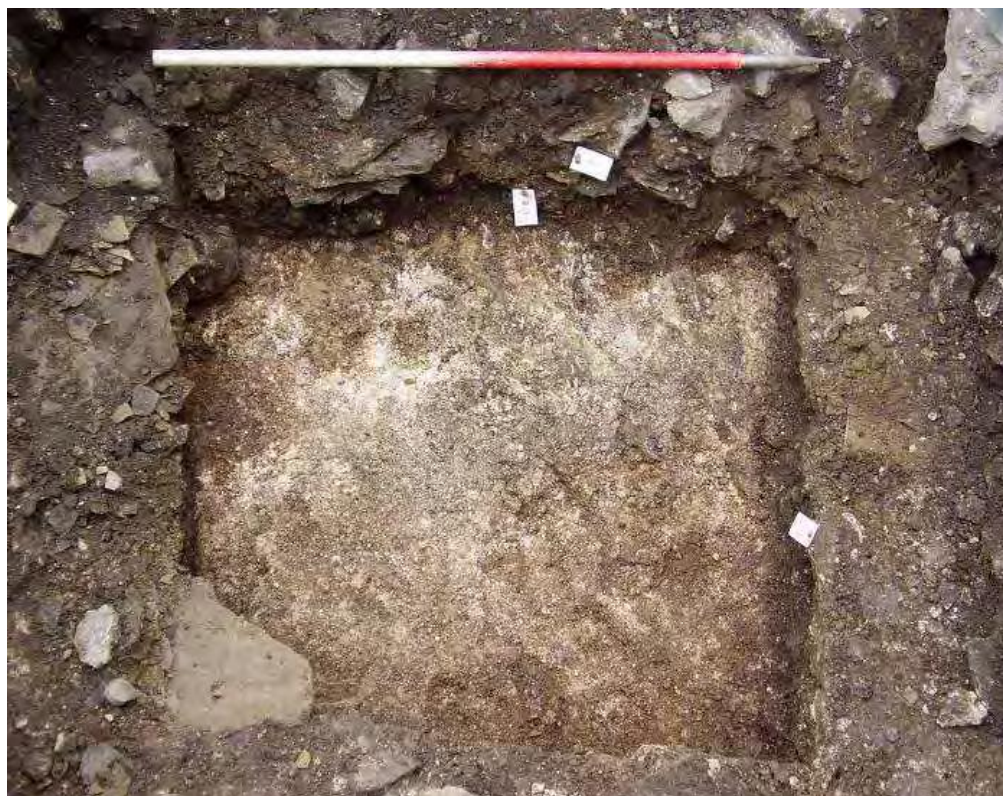
Plate 11: View north-west across Trench 6A, showing mortar deposit **658**

- 3.7.4 Overlying deposit 659 was a layer of creamy-white to light orangey-brown mortar, 658 (Plate 11). This deposit probably formed the foundation layer for a robbed floor. Cutting into this layer, and seen within the south-west-facing section of the excavated trench, was a V-shaped feature (661), possibly representing a posthole (Fig 10). This feature was backfilled with a deposit similar to the overlying layer (609), which had a maximum depth of 0.20m, and was composed of dark orangey-brown sandy-silt. This layer contained a relatively large group of animal bone fragments, probably representing food waste. The layer also yielded 13 sherds of medieval pottery, including six cooking pot fragments; a date no closer than between the twelfth and fourteenth century can be assigned to this pottery group. These finds, in addition to the organic nature of the deposit, suggest that part of the building had been abandoned and was used as a midden during the later medieval period.

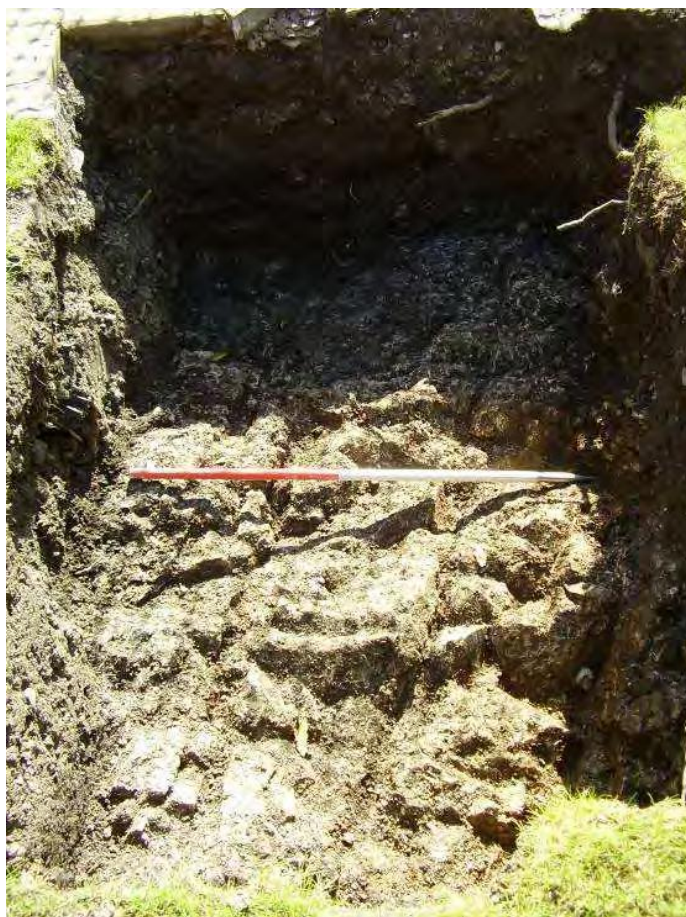
Plate 12: View across Trench 7A

3.8.2 **Phase 1:** lying above the solid geology was a layer reddish-brown clay-silt (754), lying within a possible rock-cut feature, 757. This was roughly L-shaped and aligned north-west/south-east by north-east/south-west and was 0.20m deep. It contained two sherds of medieval pottery.

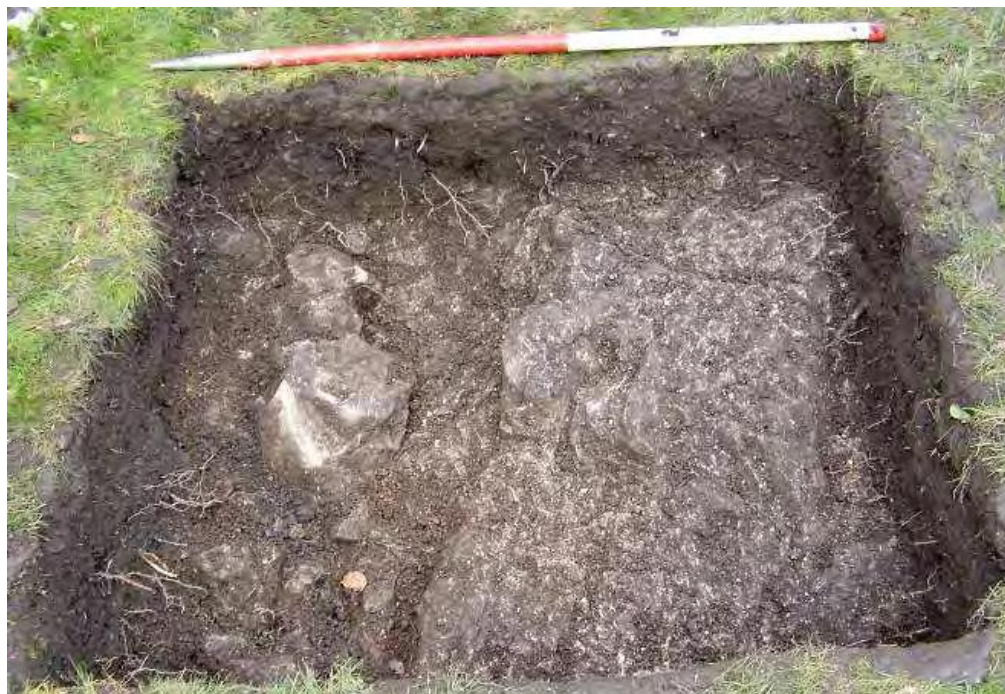
Plate 13: Looking north across Trench 8

- 3.9.2 A single feature was recorded within the trench (Fig 12). This comprised a north-west/south-east-aligned, shallow (0.11m) rock-cut linear feature (**804**), of which only the eastern edge and part of the base was visible within the excavated trench (Plate 13). The fill was composed of brownish-grey, clay-sand, and limestone rubble, **802/803**. This was probably either a robbed-out wall or a rock-cut gully, and whilst it was tempting to interpret **804** as a medieval structural feature, firm evidence was lacking.
- 3.9.3 **Phase 3:** the bedrock and feature **804** was sealed by a layer of garden soil (**801**). This layer yielded several sherds of pottery, to which nineteenth- and twentieth-century dates have been ascribed.

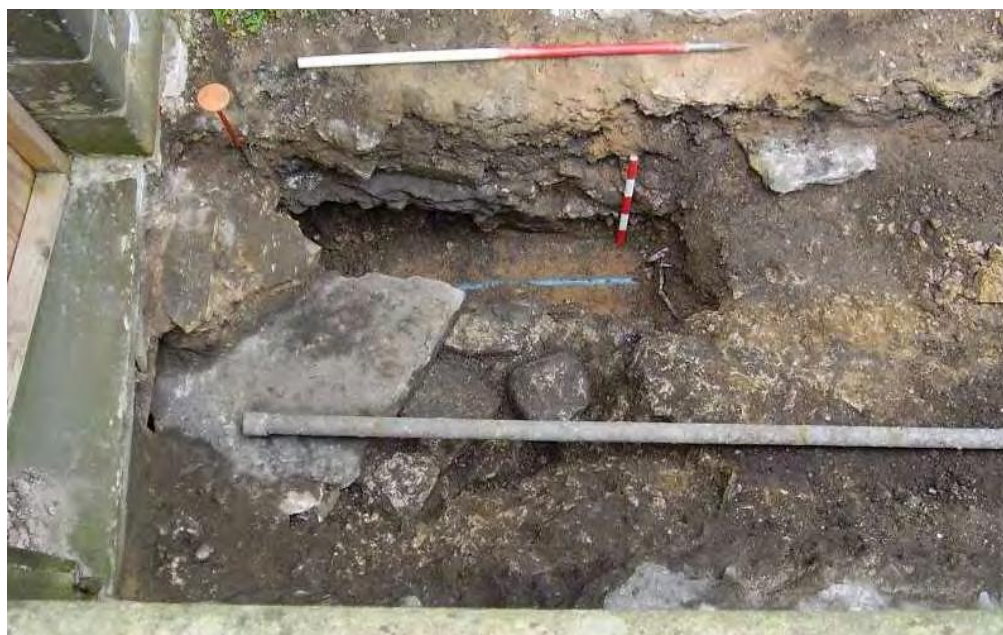
Plate 15: Culvert/conduit 1007 at the north-east end of the trench

- 3.11.3 **Phase 3:** a stone-built culvert or conduit (**1007**), 1.1m wide and 0.43m high, was exposed at the north-east end of the trench. This had been cut into the bedrock, and had stone walls with large slabs as capping (Plate 15); the culvert was still in use housing various more recent services. The trench was then sealed by a buried soil horizon, **1002**, which had a maximum depth of 0.15m.

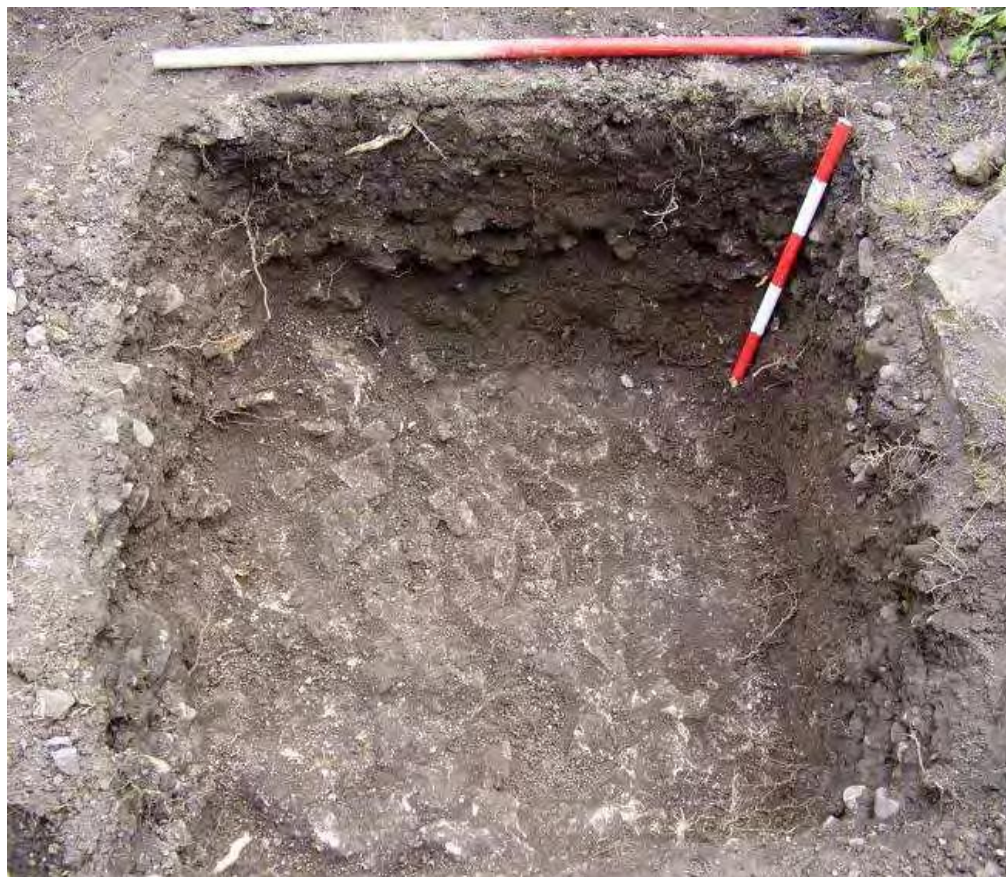
Plate 16: Trench 12, showing rock-cut feature 1207

3.13.2 **Phase 1:** a shallow-rock cut feature (*1207*) was noted running north-east/south-west across the trench (Plate 16). Although quite subtle in character, it extended in the same direction across Trench 14, where it was much more pronounced.

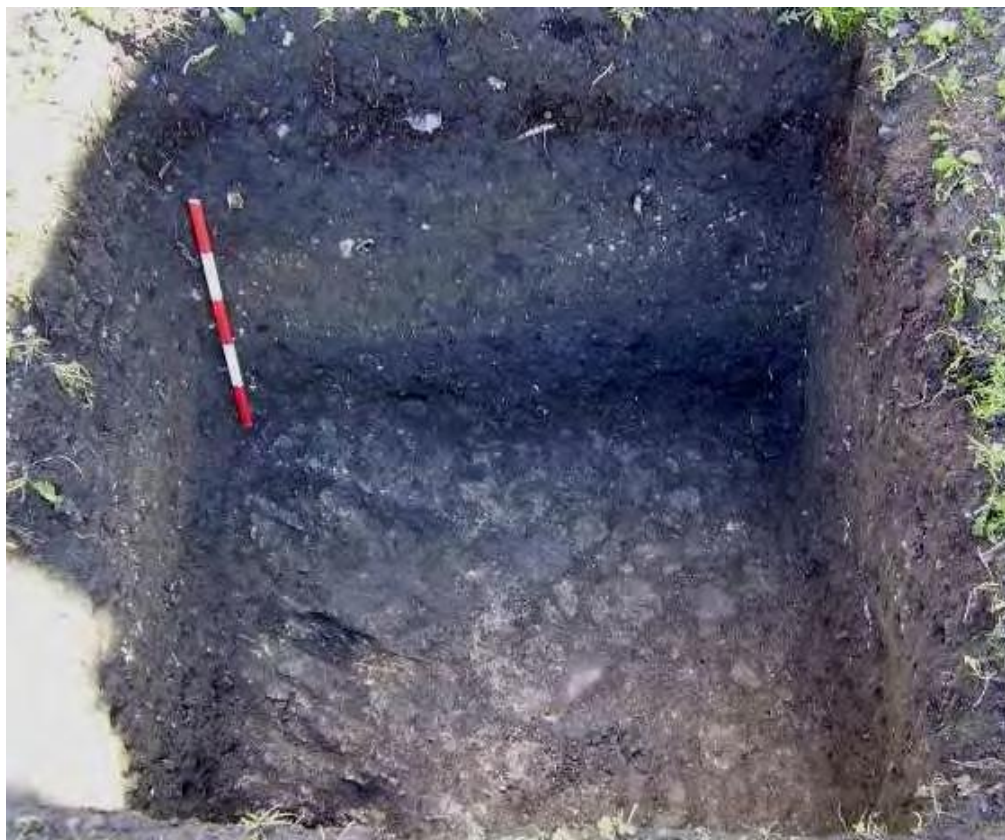
Plate 17: Trench 13, showing surface **1304**

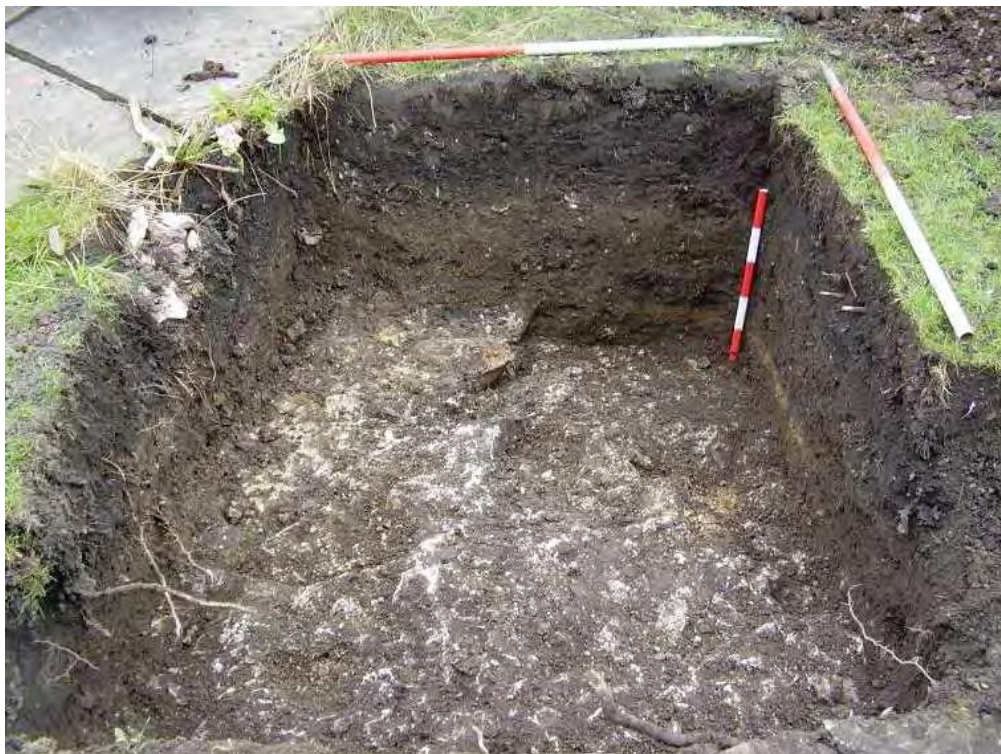
Plate 18: Trench 14, showing feature **1404** and mortar deposit **1406**

3.15.3 **Phase 2/3:** cutting into **1403** at the south-east end was another rock-cut feature (**1407**), which was aligned south-east/north-west (Fig 15). It was filled with a deposit of degraded mortar (**1406**). This was overlain by fill **1405**, and sealed by layer **1402** (Fig 15). None of these deposits yielded any finds, and it has not been possible to ascribe firmly a date to their origin. The uppermost deposit comprised topsoil **1401**.

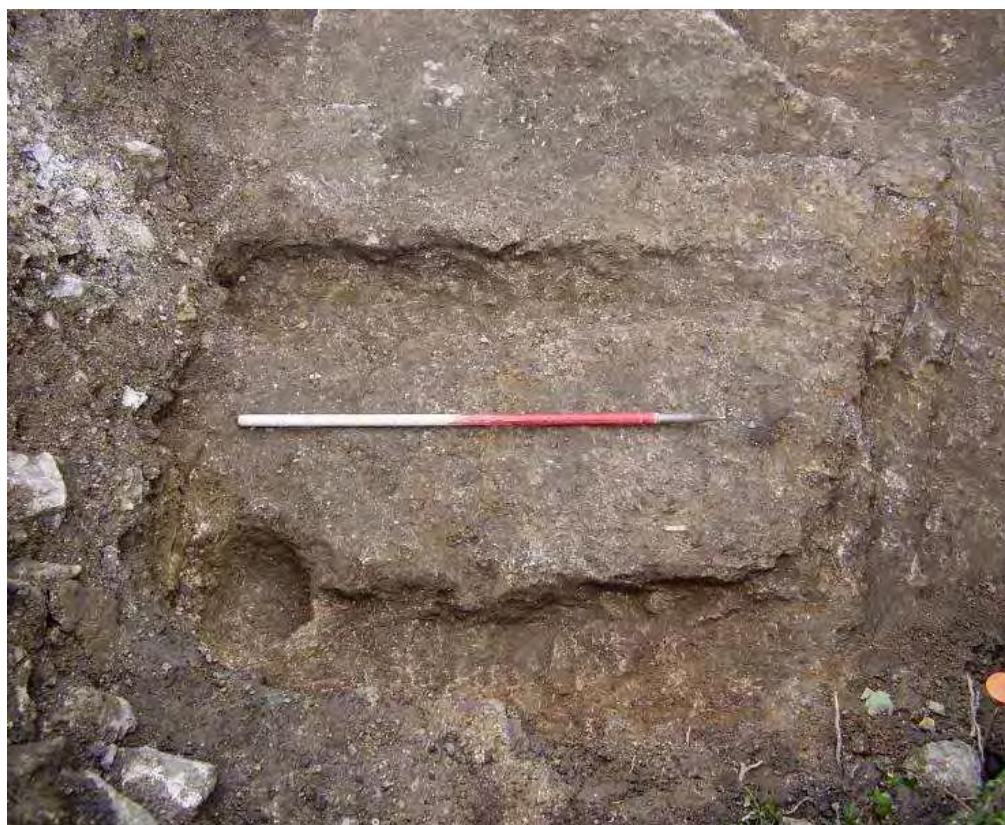
Plate 20: Beam slots **1510** and **1514**, and posthole **1512**

- 3.16.4 Located toward the south-west end of the trench and partially truncated by later activity, was a group of four north-west/south-east-aligned, shallow beam slots (Plate 20). The most south-westerly (**1510**) was 1.1m long and 0.25m wide, and incorporated a circular posthole (**1512**) at the north-west end (Fig 16). Beam-slot **1514** was somewhat longer, and spaced equidistant from **1510** and the adjacent beam slot to the north-east (**1524**). Beam slot **1524** was just over 1m long, and was only well defined on three sides. The last beam slot of the group (**1522**) extended beyond the limits of excavation (Fig 16). It was not clear whether the slots represented several different phases of activity, or whether the slots supported timber cill beams used for bearing walls and also for supporting floors.

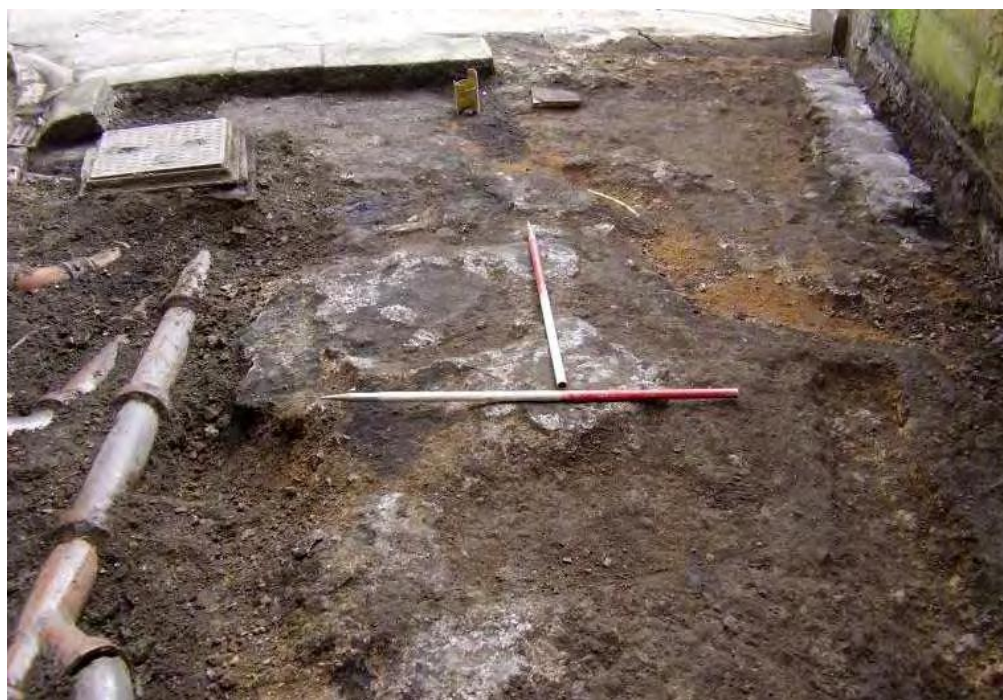
Plate 22: Looking east across Trench 18, showing beam slot **1815** to the right

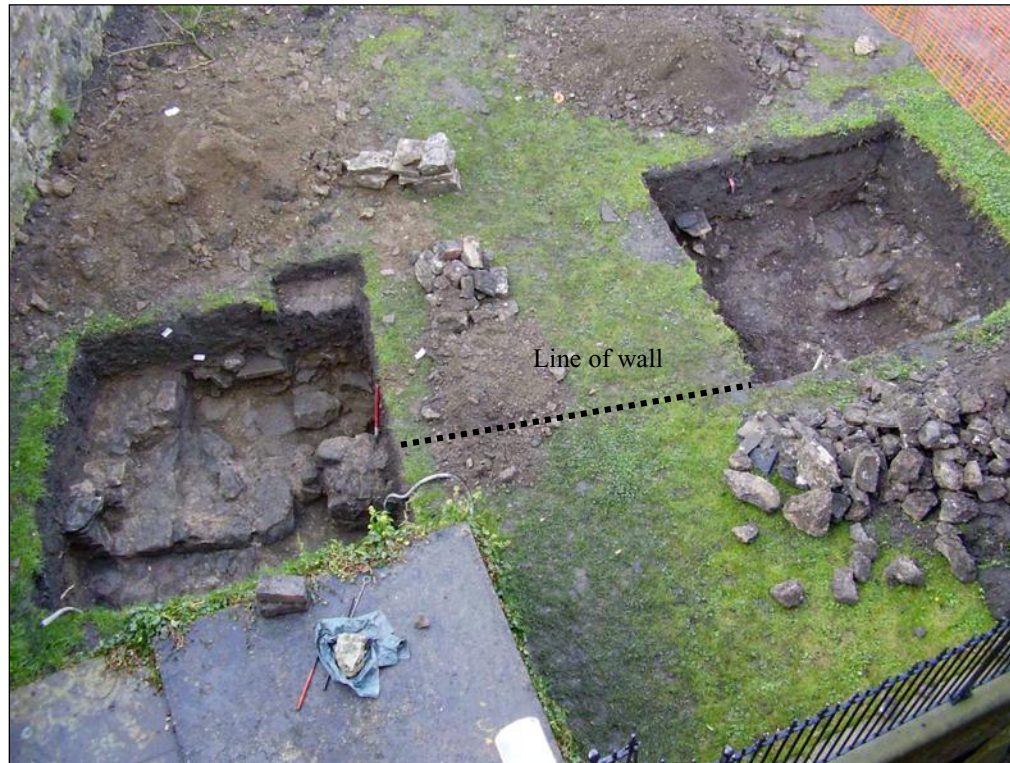
Plate 27: Trenches 5A and 6A during excavation, showing the projected line of the wall

stone walls, a floor surface and a later fireplace, which were all seemingly of a medieval date, and may correspond to the southern end of the building marked as the stewards house on the sketch plan of the castle dated to 1723 (Langshaw 1940). Well-stratified deposits and artefacts within Trench 6 demonstrated a sequence of occupation, abandonment and, based on dating provided by the excavated pottery, demolition in the early eighteenth century.
