# **SHARLSTON COLLIERY RECLAMATION SITE, NEW SHARLSTON, West Yorkshire**

## **Final Report**

February 2013

**UK Coal Mining Ltd**

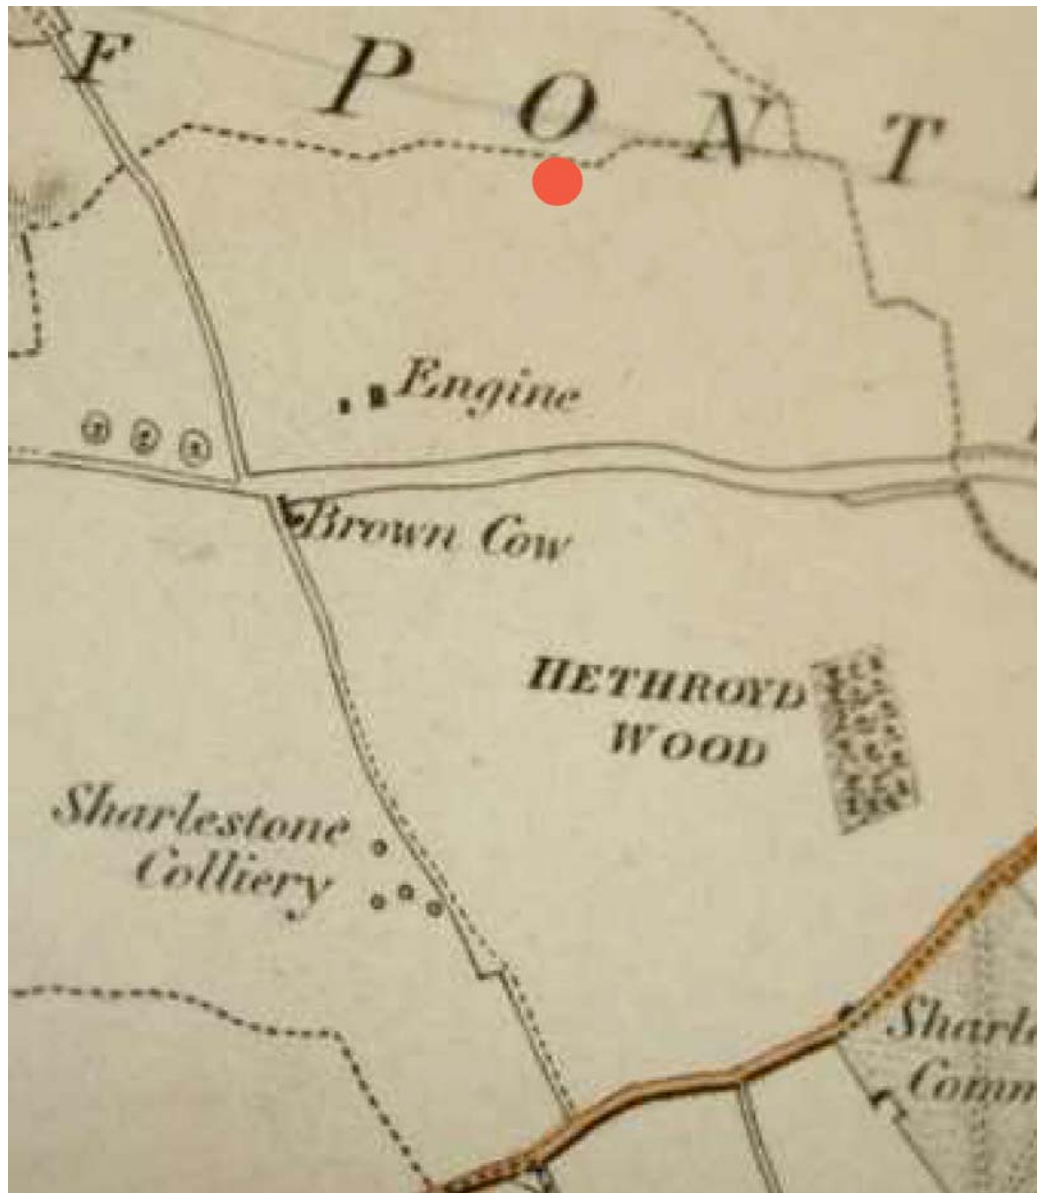
Plate 1: Extract from the 1823/4 Badsworth Hunt map (DAS DD/WN/A12/1), showing the Sharlston Colliery, the open-area excavation site being highlighted in red

- 2.3.8 Fortunately, the form and development of the workings during this period can be discerned, to some degree, from the early nineteenth-century cartographic sources. One of the earliest of the nineteenth-century maps is that showing the extent of the Badsworth Hunt, surveyed in 1823/4 (DAS DD/WN/A12/1), and this depicts ‘Sharlestone Colliery’, comprising four pit-shafts, which lay some distance south-west of the pit-head site examined by the archaeological excavation (Plate 1). To the north-east of ‘Sharlestone Colliery’, immediately to the north of a road which was later named High Street, the 1823/4 survey also plots the position of two pit-head buildings, one of which is denoted as ‘Engine’ (Plate 1). Moreover, it is possible, though by no means certain, that this was the engine documented in the latter part of the eighteenth century (*Section 2.3.5*). Significantly, this map does not depict the pit-shaft, or the associated buildings/structures, examined by the open-area excavation, which suggests that these features post-date 1823/4.

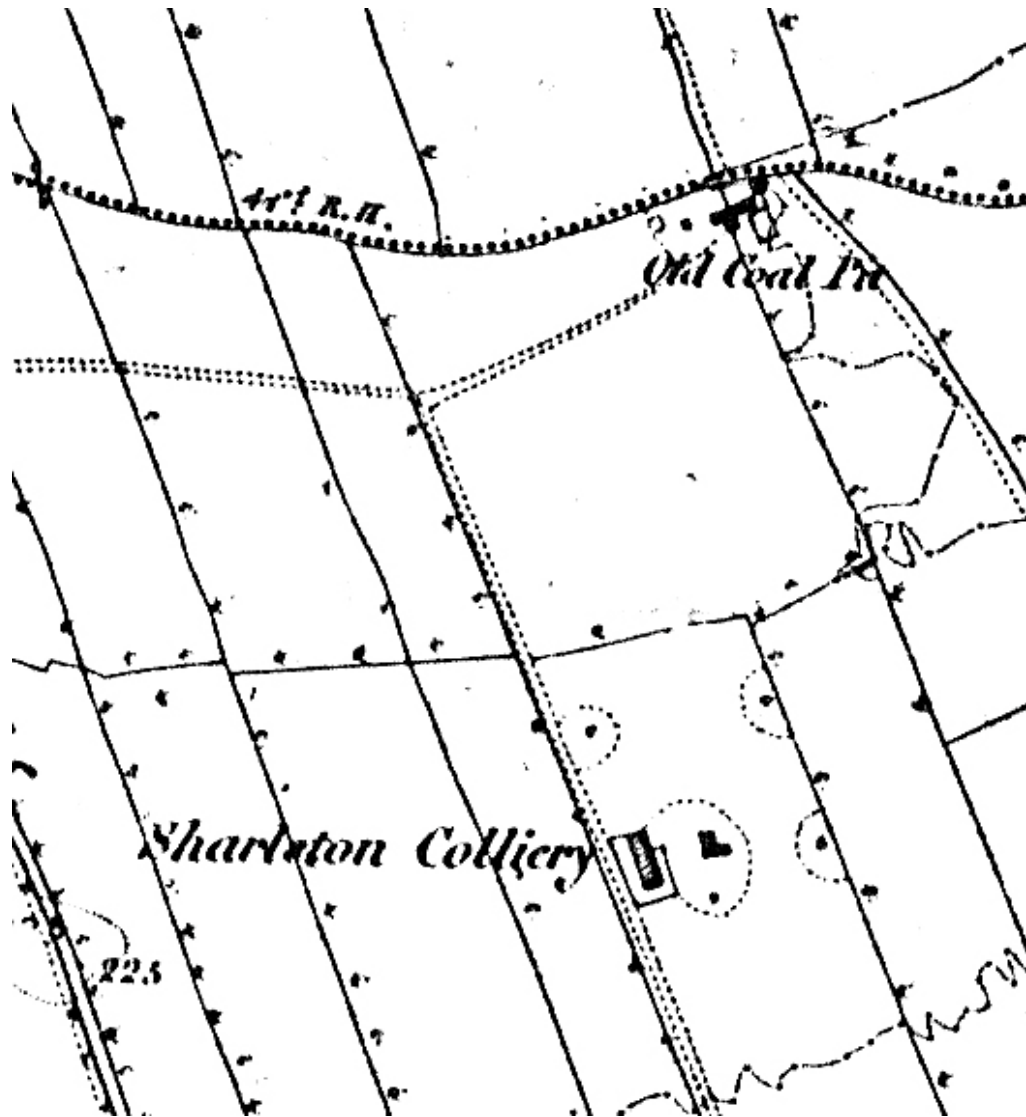
Plate 3: Extract from the 1849 OS 6 inch to 1 mile map, the open-area excavation site being denoted as 'Old Coal Pit'

2.3.10 Additional details of the early-mid-nineteenth-century workings at Sharlston can be discerned through reference to the OS First Edition 1849 6 inch to 1 mile map (Plate 3). This plots the position of 'Sharlston Colliery', which corresponds to the position of the 'Old Engine' plotted on the 1837 township plan. The 1849 map also denotes the site examined by the open-area excavation to the north-east. In contrast to the earlier, 1837, township plan, this site is denoted as 'Old Coal Pit' on the 1849 OS map, which also shows an L-shaped arrangement of buildings at this site, with a smaller building to the west, and a further building to the north-east.

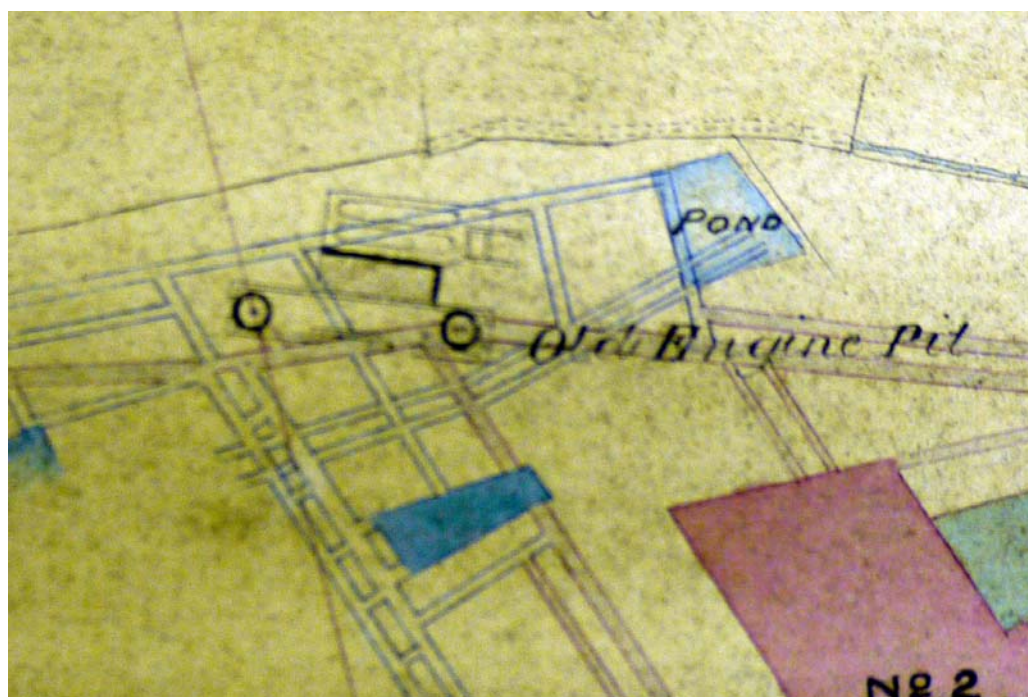
Plate 4: Extract from Greaves's 1861 plan, showing the above- and below-ground form of the open-area excavation site

2.3.13 Fortunately, an indication of the extent of the surface arrangement and below-ground workings of two of the more accessible Sharlston seams, during the 1860s, can be discerned from a set of plans which are now held in the John Goodchild Collection. These were originally produced by the mining engineer, J O Greaves, in 1861, though they contain details of the areas of coal won between 1859 and 1868. In terms of the surface arrangement of the colliery, these plans depict the area subjected to open-area excavation as containing two pits shafts, the more easterly of which is denoted as ‘Old Engine Pit’ (Plate 4). The shafts are contained within a rectangular structure that may represent a heapstead (pit-bank). Furthermore, this plan also plots the position of a rectangular structure immediately north of the pits, which probably formed an engine house, and, just beyond this, a boiler house, containing two boilers. Projecting from the eastern side of the boiler house, the plans also depict an additional compartment, whilst a separate small square building is plotted to the west.

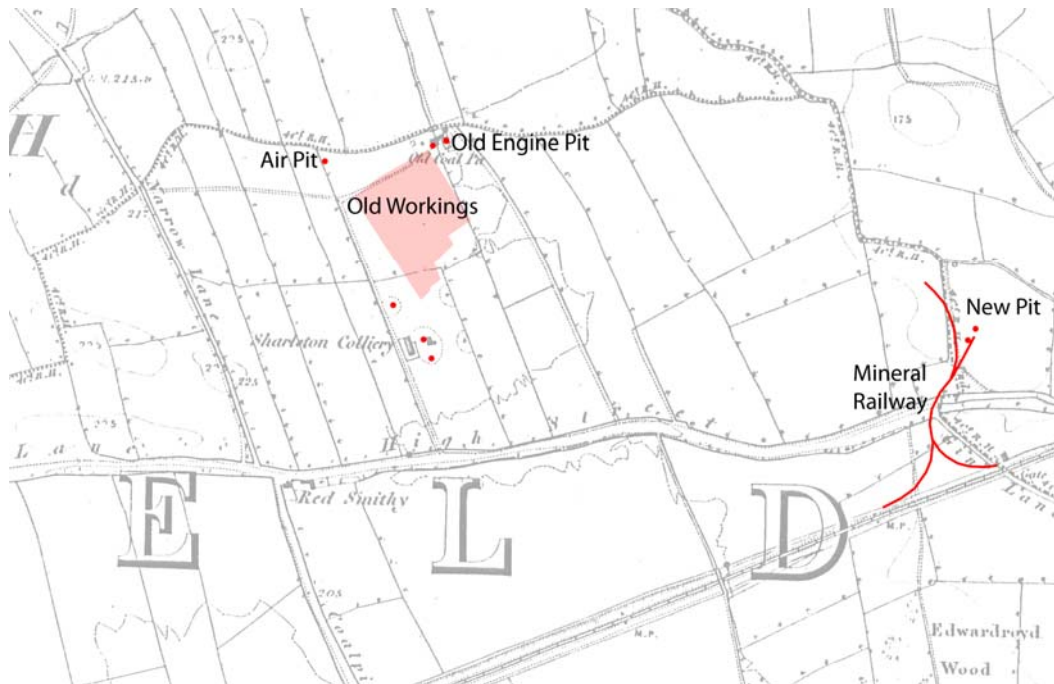
Plate 5: Extract from the 1849 OS 6 inch to 1 mile map, with the locations of the pit-shafts, mineral railway, and ‘old workings’ highlighted, as derived from Greaves’ 1861 plans of the Lower Bed (Sharlston Low Seam)

south-east, the plans plot the position of ‘New Pit’, which, at surface level, consisted of two pits, and an adjacent building comprising two probable engine houses, adjoining a boiler house, containing a single boiler. It is also clear that this ‘pit’ was served by a mineral railway, which joined with the Pontefract and Goole Railway. The Upper Bed plans also plot the position of an ‘Air Pit’ to the west of the ‘Old Engine Pit’ (Plate 5).

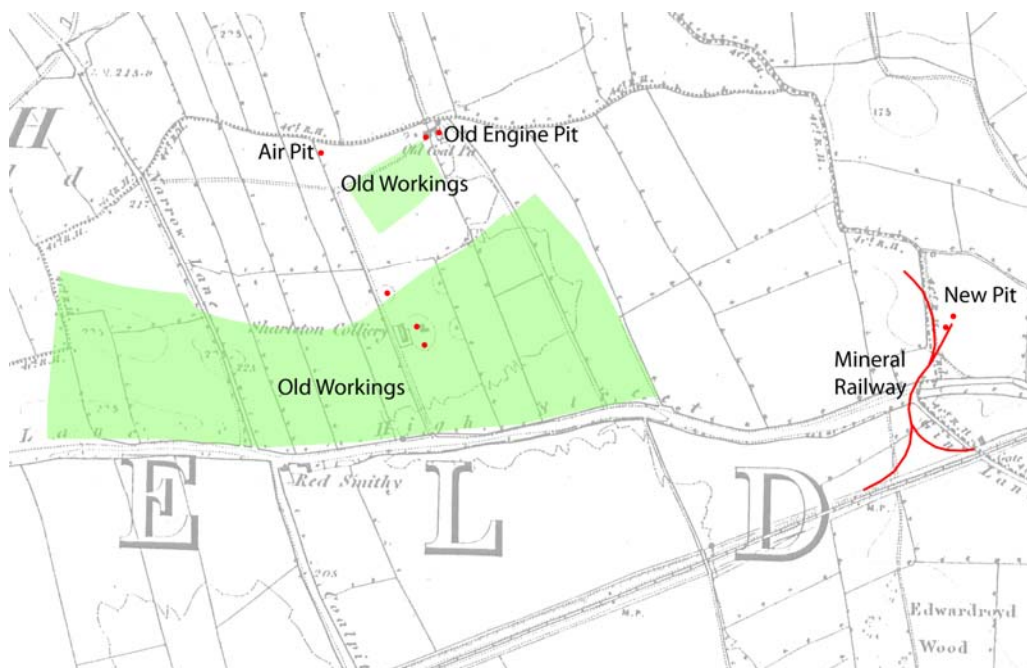
Plate 6: Extract from the 1849 OS 6 inch to 1 mile map, with the locations of the pit-shafts, mineral railway, and ‘old workings’ highlighted, as derived from Greaves’ 1861 plans of the Upper Bed (Sharlston Top Seam)

2.3.16 Significantly, Greaves’ 1861 plans plot the edges of several areas denoted as ‘old workings’, associated with both the Lower (Sharlston Low) and Upper (Sharlston Top) beds, and therefore provide some indication to the possible working areas exploited during the eighteenth and early nineteenth centuries. Those ‘old works’ associated with Sharlston Low seam were located in an area positioned immediately to the south-west of the ‘Old Engine Pit’ (Plate 5). Similarly, those associated with the Sharlston Top seam fell within a similar area, though they also include a large east/west-aligned swathe running across

the complete width of the area covered by the plans, which was accessed via the pit-shafts located within the area denoted as ‘Sharlston Colliery’ on the 1849 OS map (Plate 6).

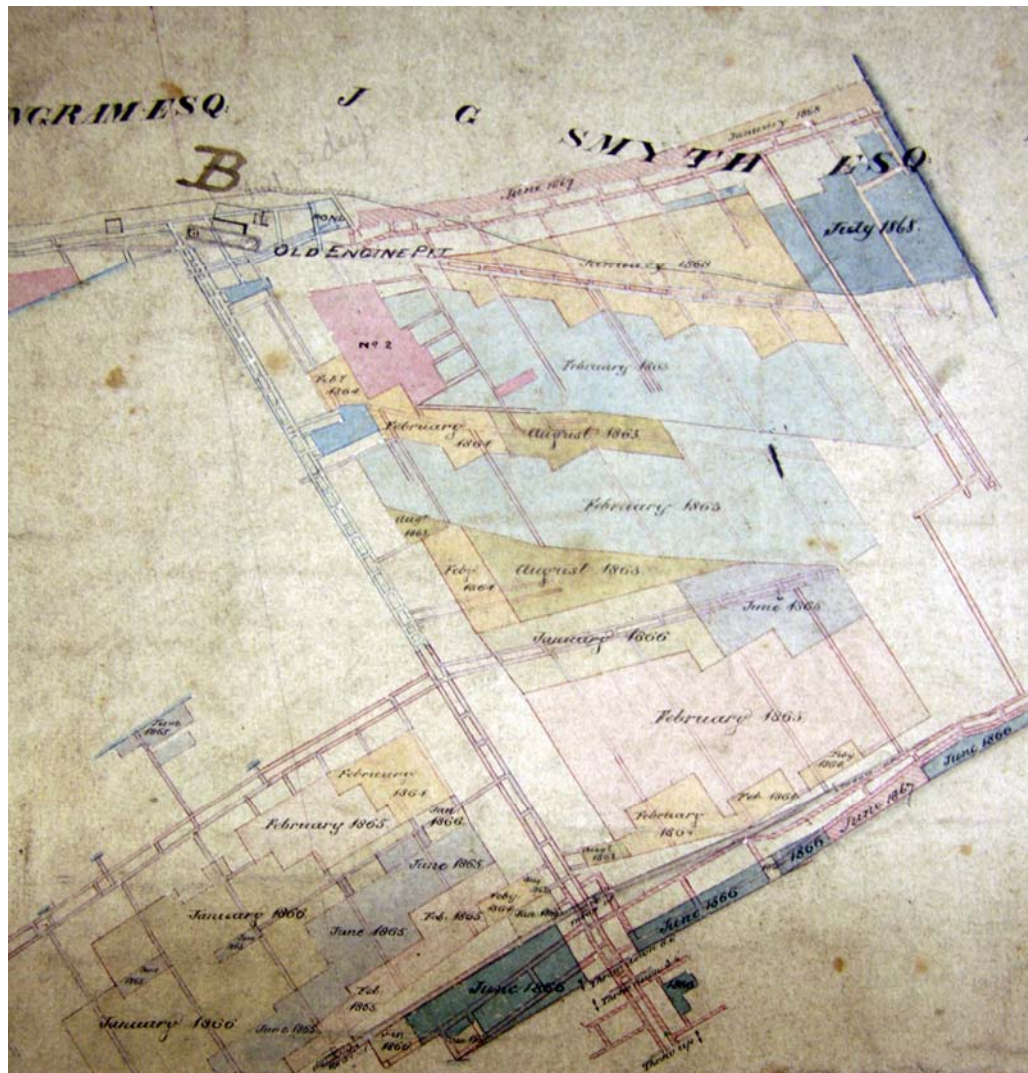
Plate 7: Extract from Greaves' 1861 plans of the Lower Bed, showing the arrangement of the below-ground workings in the vicinity of the 'Old Engine Pit'

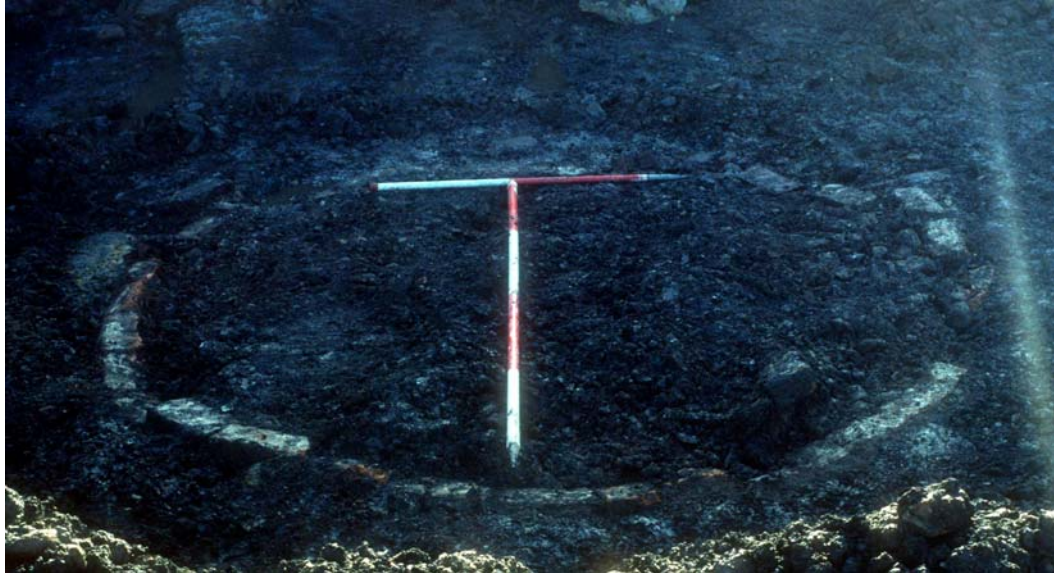
Plate 9: Pit-shaft 2, as exposed during the watching brief

- 3.2.9 **The Pit-Shafts:** the pit-shafts (1 and 2; Fig 2) were positioned on an east/west alignment and were spaced *c* 13.5m apart. Although both shafts had been capped by rectangular concrete at a later date, it is clear from the 1861 plan of the site (Plate 4) that originally they were circular in plan, and had similar-sized diameters. Moreover, this was confirmed by an archaeological watching brief undertaken during the removal of the concrete caps, as part of the opencast stripping of the site (*Section 3.3.1*). This stripping indicated that the shafts were

indeed circular with diameters in the region of 2.6m (*c* 8½ft), and were lined with brick (Plate 9). These comparatively small diameters are comparable to many of the pit-shafts dug in the Tyneside area in the early nineteenth century, which normally had diameters ranging between 8ft and 9ft (2.4m and 2.7m) and, as at Sharlston, were also dug in pairs (*cf* Galloway 1898, 389).

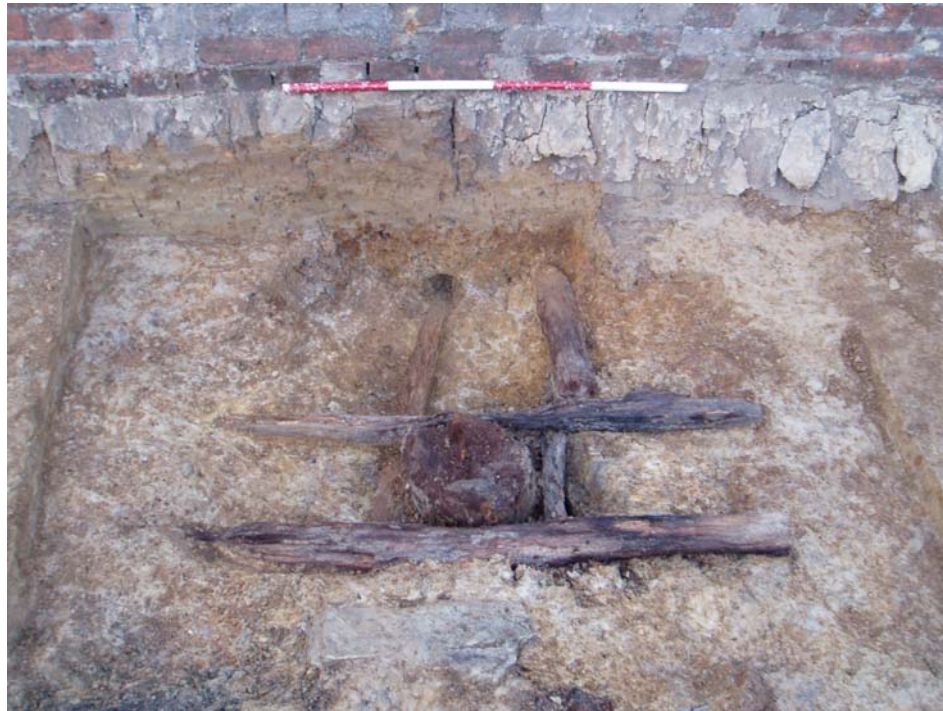
Plate 10: Post 251 and timber arrangement 220, looking north

3.2.10 *The Whim-Gin*: to the west of shaft 1, several *in situ* timbers and postholes were present, which might have formed the earliest structural remains at the pit-head, contemporary with the initial sinking of the shafts (Fig 2). These remains included an *in situ* upright circular post (251), with a diameter of *c* 0.3m, which was contained within a sub-circular postpit (245), with a diameter of *c* 0.9m and a depth of *c* 0.5m (Plate 10; Fig 3). This postpit also contained a large concentration of angular stones that had been packed around the buried base of the post. The post appeared to be largely unmodified, and was, in effect, an unconverted trunk, stripped of bark. The only modification noted was the removal of a large lateral branch (probably by sawing), and that the base of the trunk was flat (presumably also sawn, but too poorly preserved for this to be confirmed by the survival of toolmarks). Despite the poor condition of the wood, it was provisionally identified as elm (*Section 4.9*). Unfortunately, this timber was not suitable for tree-ring dating, due to its poor condition and also because the elm curve is limited and regionally variable (I Tyers *pers comm*).

3.2.11 Surrounding the upright post, four *in situ* cut timbers, probably representing reused pit props, were discovered (Plate 10). These timbers were probably oak, though, as with the central post, none was suitable for tree-ring dating. They measured *c* 0.1m wide, had been set in a cross-shaped arrangement (220), and were associated with a timber stake (219; not illustrated), which lay across the northern end of one of the props. This arrangement had the upright post (251) directly at its centre and measured *c* 1.6m north/south by 1.3m east/west. In addition to the cut timbers, a small posthole (238) and two stakeholes (255) lay immediately south of the timber upright. Evidence for two further timber uprights was also present *c* 2m east of the *in situ* timber upright (251), in the form of two postholes (152 and 154) both with diameters of *c* 0.6m. These features were spaced *c* 1.5m apart, were between 0.6-0.8m deep, and had been packed with stone.

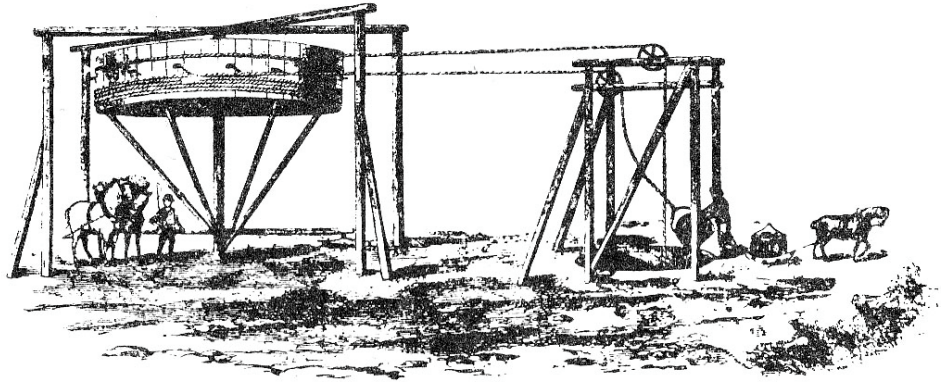
Plate 11: A whim-gin (reproduced from Galloway 1898, fig 6)

3.2.12 Although, as a discrete group, these features are difficult to interpret, it is quite possible that they formed elements of a whim-gin, which was perhaps employed to raise spoil/coal during the initial sinking of shaft 1. This type of horse-driven winder was utilised at many collieries from the seventeenth-century onwards and was set some distance back from the pit-shaft (Griffin 1971, 30; Galloway 1898, 178). These gins invariably consisted of a horizontal winding drum mounted on a vertical timber shaft, which was secured by a timber base and crossbeam, which itself was supported by vertical timber uprights (Plate 11). The vertical shaft and rope drum were driven by one or more horses attached to a timber horse arm, which was normally *c* 10m in length (Griffin 1971, 32). The construction of timber headgear, directly above the pit-shaft, was also essential to the working of the whim-gin, as this secured two pulleys, over which rope from the winding drum passed into the pit-shaft.

- 3.2.13 Given the known arrangement of these gins, one possibility is that the *in situ* timber upright (251) formed the eastern support for the crossbeam of the gin, with the winding drum lying to the west (cf Galloway 1898, fig 6; Plate 11). The upright for the crossbeam was, in turn, secured by the cross-shaped arrangement of timbers, and was perhaps given additional support from an angled timber post, the position of which was marked by posthole 238. If this was the case, the two postholes to the east (152 and 154) may well have formed elements of the timber headgear and perhaps secured two angled timbers, which provided additional support for those timber uprights positioned directly above shaft 1. Furthermore, these suspected timber uprights may well have been supported by two square brick piers (188 and 189) which were present on the western side of shaft 1.

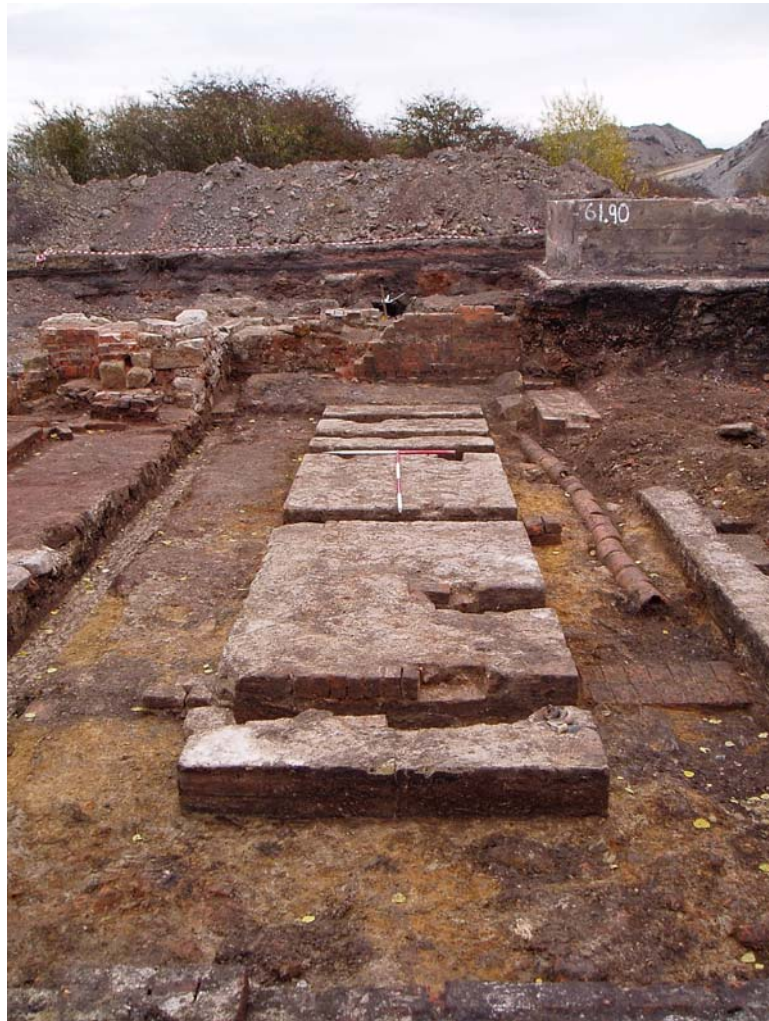
Plate 12: The engine setting within engine house 131, looking east

- 3.2.16 Within the interior of the engine house was the truncated setting for an engine, which drove a winding drum positioned to the south (Plate 12; Fig 2). The setting for the engine measured *c* 8.2 x 1.7m, was aligned east/west and survived as four *c* 0.4m-wide handmade brick plinths, which were two-courses (*c* 0.26m) high, and also two larger brick-and stone-built plinths, which were of comparable height. The larger of these features measured *c* 2.5 x 1.7m, and it

had a square socket on its southern side, whilst the smaller measured *c* 1.7m square, and lay at the centre of the building.

3.2.17 Given the form of the setting, it is likely that it represents the base of a beam engine. Furthermore, it is possible that the central plinth supported the engine's beam, though, given the relatively confined space within the engine room, this was perhaps supported by a north/south-aligned timber beam, which was tied into the walls of the engine house. Indeed, this arrangement, with the beam of the engine supported by a timber tie-beam, may have been a relatively common feature of early nineteenth-century winding engines, particularly as a comparable example is found adjacent to William pit, Whitehaven (*cf* Anderson 1967, 140-1). The relatively limited space within the engine room also implies that a flywheel was not present, but instead, the rod running down from the beam may well have been attached to a common crank, which directly rotated the adjacent winding drum. Given this arrangement, the engine's cylinder would then have been located at the eastern end of the plinth, and, given the width of the plinths, would have had a maximum diameter of 1.7m (66 inches). However, within the engine room, no evidence for a condenser was apparent, such as a condenser pit, and the only other feature identified was a ceramic drain. This drain ran parallel to the southern wall of the engine room for a

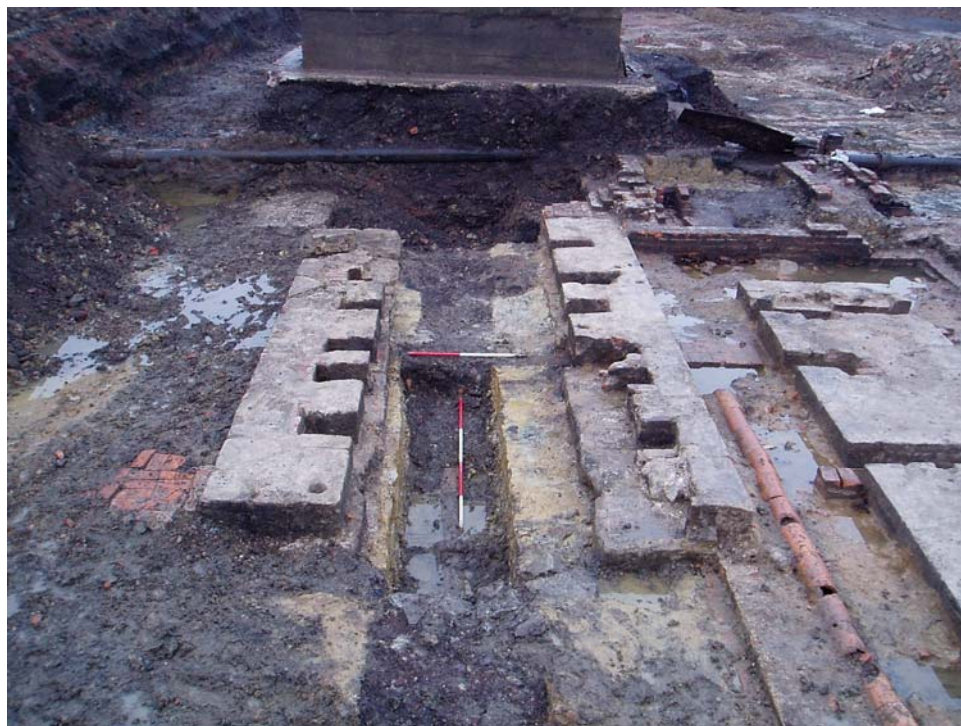
Plate 13: Structure **171**, looking west toward Pit-Shaft 1

- 3.2.19 The setting for a winding drum (Structure **171**), which was driven by the adjacent engine, was positioned immediately south of the engine house on the heapstead (Plate 13; Fig 2). The surviving remains included two parallel east/west-aligned walls (**200** and **202**), spaced *c* 1.7m apart, which would have supported the winding drum. Both walls measured *c* 7.4 x 1.1m and were constructed of a combination of stone and handmade bricks, measuring *c* 9 x 4¼ x 2½ inches (*c* 0.23 x 0.11 x 0.07m), bonded with lime mortar. In addition, two circular restraining bolt sockets were visible on the more northerly of the walls (**200**), whilst a single socket was evident on the southern wall (**202**). Positioned between the supporting walls for the winding drum was also a *c* 0.9m-wide infilled trench (**225**), which contained a ceramic drain.

- 3.2.20 Although the winding drum lay directly adjacent to shaft 1, it is likely that it was used to draw coal from shaft 2, as the headgear would need to have been positioned some distance from the drum, which in this instance was probably positioned directly above the shaft. Tentative evidence for this was provided by a fragment of walling (**118**), built against the western side of the pit-shaft, which may have partially supported the timber headgear. This east/west-aligned wall was constructed of handmade bricks, measuring *c* 9 x 4¼ x 2½ inches (*c* 0.23 x 0.11 x 0.07m), bonded with lime mortar, and measured *c* 2.1 x 0.6m.

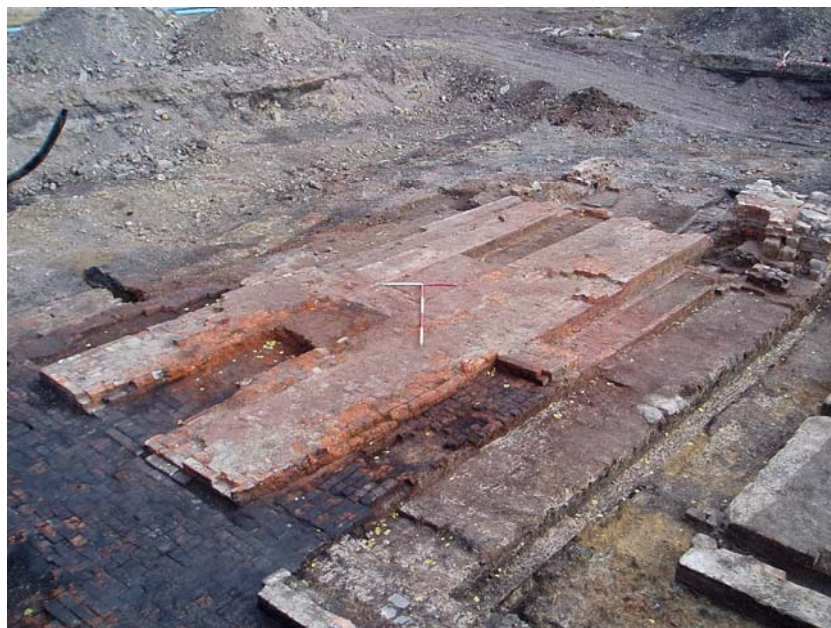
Plate 14: The remains of the boiler house, including platform **127**, surface **128**, and wall **150**, looking north-east

- 3.2.21 **The Boiler House:** the boiler house lay immediately north of the engine house and was undoubtedly of contemporaneous date (Plate 14; Fig 2). Its surviving remains included a platform (**127**), which formed the setting for the two adjacent east/west-aligned boilers depicted on the Greaves' 1861 plans (Plate 4). This platform was largely constructed of handmade bricks, which measured *c* 9 x 4¼ x 3 inches (*c* 0.23 x 0.11 x 0.08m), that were bonded with lime mortar, though its far southern side incorporated a *c* 1m-wide stone base. This base was composed of cut sandstone blocks, bonded with lime mortar, set above a silty-clay levelling layer (**177**; not illustrated). The platform measured *c* 12.4 x 6.9m, and two parallel brick-lined chambers (**158** and **159**) within its fabric denoted the positions of the two boilers. These chambers were set *c* 1.7m apart and both were aligned east/west, and measured *c* 1m wide. Both chambers were also subdivided by *c* 0.7m-wide handmade brick walls (**162** and **174**), which were identically positioned *c* 3.4m east of their eastern ends. The more northerly of the chambers (**158**) also contained a cast-iron plate (**166**), whilst, adjacent to the far-eastern end of the southern chamber, was an arcing section of wall (**150**). This wall, which appears to have supported the eastern end of the boiler, measured *c* 0.45m wide, stood to a height of *c* 1m, and was constructed of handmade bricks, measuring *c* 9 x 4¼ x 2½ inches (*c* 0.23 x 0.11 x 0.07m), bonded with lime mortar.

- 3.2.22 Immediately to the west of the platform (**127**) was a worn surface (**128**), heavily blackened with coal dust, which probably formed the stoking area for the boilers (Plate 14; Fig 2). This surface measured *c* 8.9 x 3.2 m, and was composed of handmade bricks measuring *c* 8½ x 4¼ x 2¾ inches (*c* 0.22 x 0.11 x 0.075m). A cast-iron plate, measuring 0.63m square, was also discovered, which had been set into this surface at its northern end, and it is possible that this feature acted as a pad for a timber or cast-iron upright support.

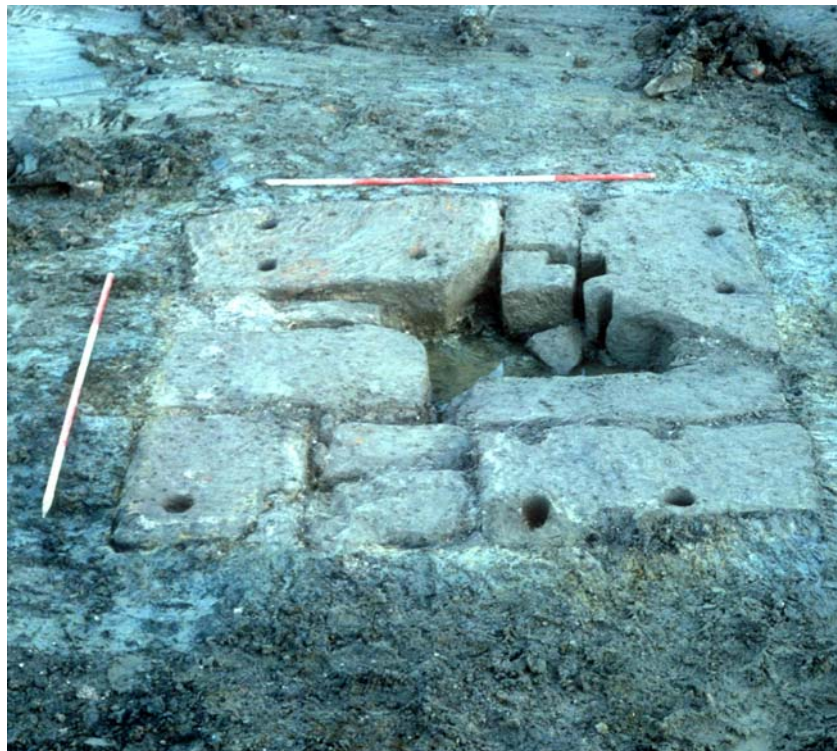
Plate 15: Setting **239**, looking north

- 3.2.23 **Additional Buildings and Structures:** in addition to the winding engine and boiler house, several contemporary structures/features were present relating to the surface arrangements at the pit-head. One of these was positioned directly within the open-ended room/compartments attached to the eastern side of the boiler house, which is plotted on Greaves' 1861 plans (Plate 4), and represented by a small setting (**239**), measuring *c* 1.75 x 1.75m (Plate 15; Fig 2). This square setting was constructed of *c* 0.25m-thick sandstone slabs that contained a series of sockets, arranged around its edge. Fourteen of these sockets were circular in form, all with diameters of *c* 0.08m, whilst a larger square-cut socket, measuring 0.14m square, was positioned close to the north-eastern corner of the base.

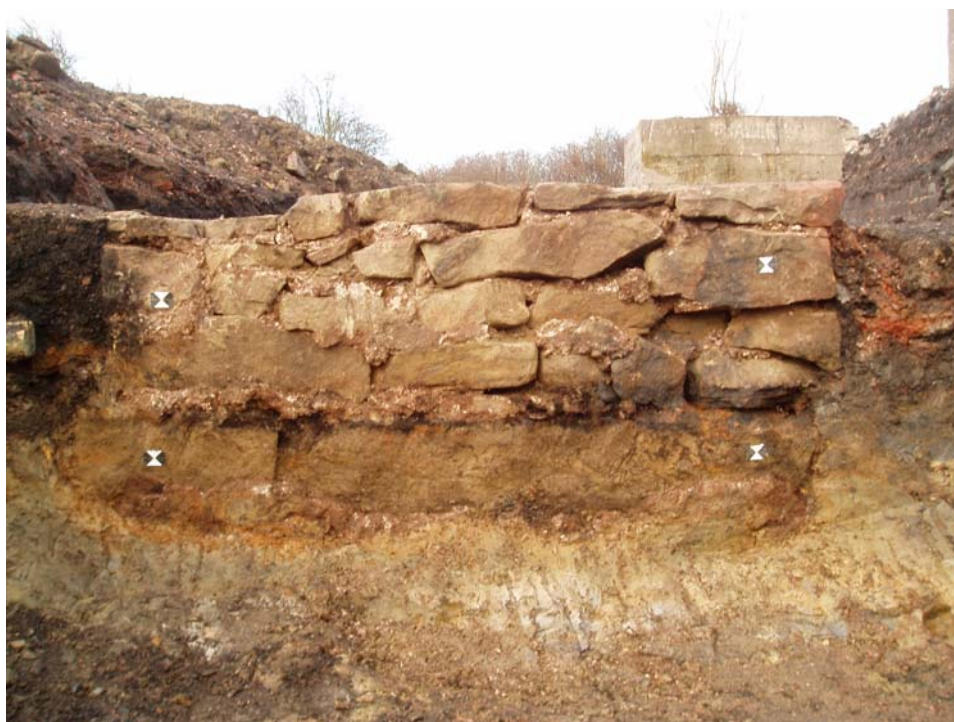
Plate 16: East-facing elevation of wall 132

- 3.2.24 A second structure (**146**) lay immediately east of shaft 2. This structure, although heavily disturbed, was defined by two east/west-aligned walls (**222** and **132**; Fig 2), spaced *c* 5.3m apart. The larger of these walls (**132**), was located to the south of Shaft 2 and measured *c* 1.9m wide, survived to a height of *c* 0.7m, and was constructed of roughly hewn sandstone blocks, which were bonded with a mid-red sand-based mortar (Plate 16). Similarly, the wall (**222**) to the north of the shaft was also constructed of mortar-bonded, roughly hewn,

sandstone blocks, though it was a narrower feature, measuring *c* 0.7m wide, which survived to a height of *c* 1.2m.

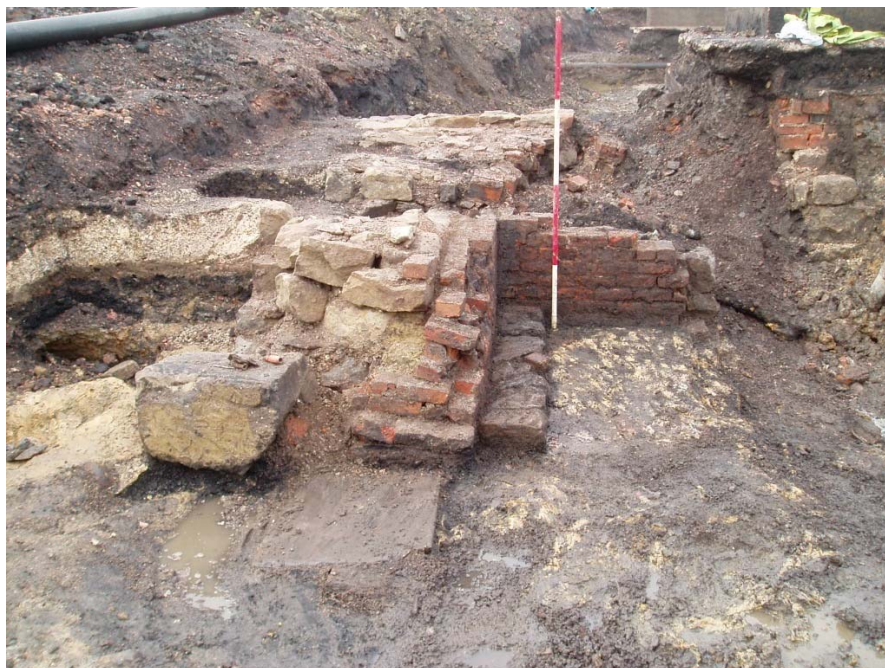
Plate 17: Wall 132, butted by wall 122 (right-hand side), looking west

3.2.25 In between walls 222 and 132, several additional walls were also present, forming further elements of the structure. These included a right-angled length of stone walling (226/223) linked to the southern side of wall 222, which measured *c* 0.7m wide and survived to a height of *c* 0.6m. This wall, in turn, was abutted by a north-south-aligned wall (122), which measured 1.7m wide and was composed of handmade bricks, measuring *c* 9¼ x 4¼ x 2½ inches (*c* 0.24 x 0.11 x 0.07m), bonded with lime mortar. This wall also butted wall 132 (Plate 17), and, immediately to its east, the remains of a possible flagstone floor were uncovered, whilst a 0.45m-wide culvert (221) led from the eastern side of the structure. This culvert was lined with handmade bricks, measuring *c* 9 x 4 x 2½ inches (*c* 0.23 x 0.1 x 0.07m), and had been capped with sandstone slabs. With regard to the function of this structure, it is likely that it at least defined the area of the heapstead where coal, once raised from shaft 2 in corves (baskets), was tipped ready for loading into carts, which could then be transported to the screens for grading. However, the presence of fairly substantial stone walls might indicate that these directly supported the cast-iron grading screens. If this was the case, perhaps, at Sharlston, coal was raised from shaft 2 and then tipped directly over the screens, separated into different sizes, and placed into separate carts. Further support for this suggestion is given by a discrete deposit of coal ash (257), which lay at the southern end of wall 132. This deposit may well represent fine coal or ‘duff’, which was an unsaleable by-product of the coal-screening process (Galloway 1898, 458-9).

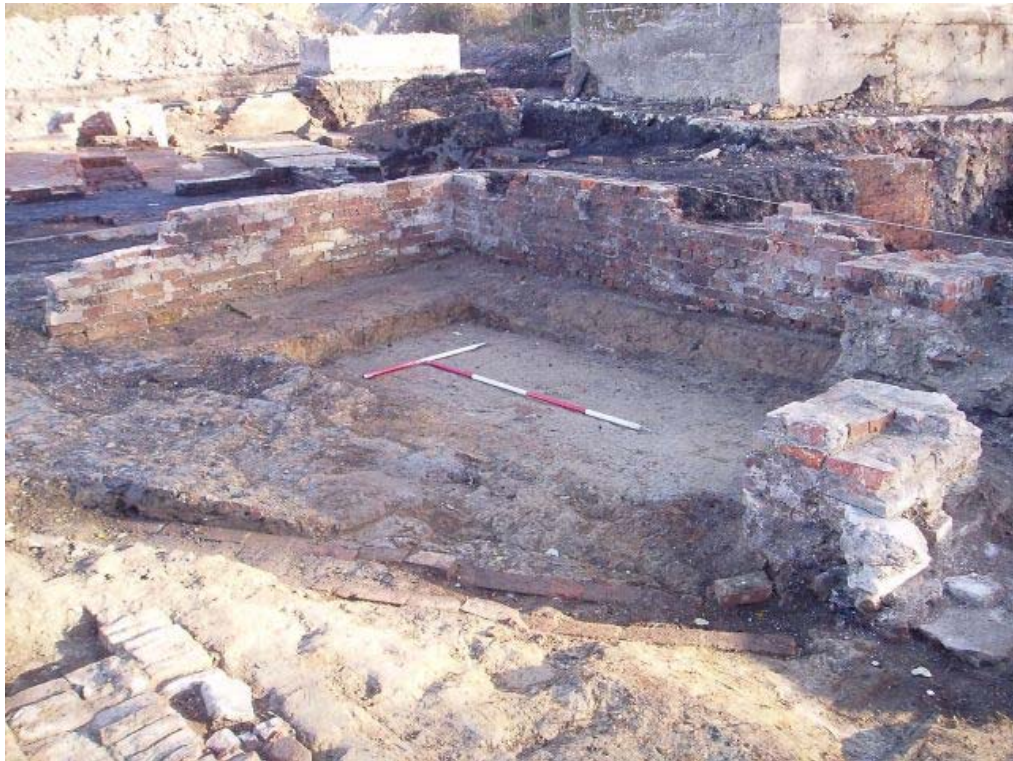
Plate 18: Building 140, looking south-east

3.2.26 Another pit-head structure exposed by the excavation was a building (140) to the north-west of the shaft 1, which may have acted as either a drying room, store, or small workshop (Plate 18; Fig 2). Its positioning suggest that it was constructed following the dismantling of the timber whim-gin (Section 3.2.10), and it represents the small building depicted on the 1849 OS map and on Greaves' 1861 plans to the west of the pit-shafts, albeit being positioned by Greaves slightly erroneously. The building had a rectangular plan, measuring  $c$  9.3 x 5.2m, and was defined by an external two course-thick brick-built wall. This wall was composed of handmade bricks measuring  $c$   $8\frac{1}{2} \times 4\frac{1}{4} \times 2\frac{1}{2}$  inches ( $c$  0.22 x 0.11 x 0.07m), laid in an English garden-wall bond, at a ratio of one course of headers to four stretcher-courses, and had been set on four course-thick brick footings that were visible on the northern side of the building. The eastern wall was afforded additional support by a small handmade brick buttress (250). Within the interior of this building, close to its centre, a handmade brick pier (247) was discovered, measuring  $c$  0.7 x 0.8m, which had been set on a sandstone slab, and it is possible that this supported an upper storey. Extending north-east from this feature was also a 0.35m-wide brick-lined drain (252). Following the demolition of this building, two rectangular handmade brick-built piers (248 and 249), measuring  $c$  1.3 x 0.9m, were then constructed, one of which (249) lay directly over the demolished wall line of the building. Two similar piers (188 and 189) also lay to the south-east, which were positioned on the western side of shaft 1. However, as a group, the function of these structures is not particularly clear.

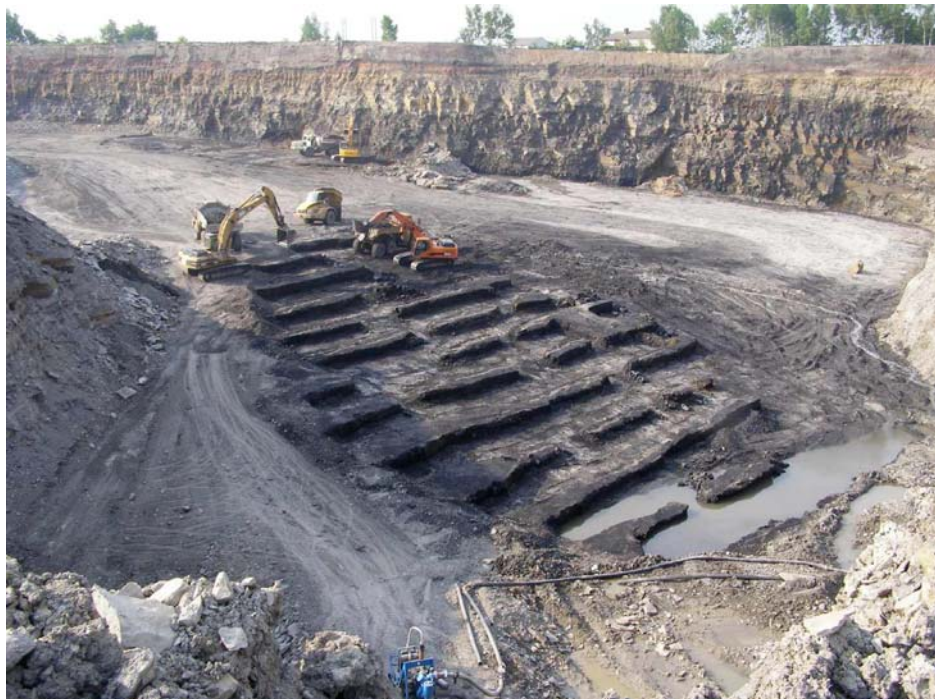
Plate 19: Bord-and-pillar workings uncovered in Area C1

3.3.3 The largest and most coherent area of the historical workings was located in the western half of Area C, covering an area of *c* 190 x 175m (Area C1; Plate 19). In this area, the positions of two single roadways (headways) and one double roadway, were visible (Fig 4: a, b, and c), though these did not appear to traverse the complete length of the historical workings. These were aligned north-west/south-east, following the rise of the coal seam (rising in south-easterly direction), and were generally laid out in a straight course. The double roadway formed the most westerly of the headways (Fig 4: a) and it appeared to converge at its mid-point and then proceeded northwards as a single roadway. These headways, along which the extracted coal was transported, were spaced approximately 64m (70 yards) apart and ranged between *c* 3.9m (4 yards) and *c* 1.9m (2 yards) wide.

- 3.3.4 In between, and set at right-angles to, the headways were the bords. The bords, from where the coal was originally extracted, followed the level of the coal seam and their width showed some slight variation, being between *c* 3.8m and 4.6m (4-5 yards) wide. Within the areas between the headways, the bords were defined and separated by pillars of coal, which supported the roof. Gaps between the pillars also allowed communication between the adjacent bords and presumably also aided ventilation (cross-holing), though it is possible that these cuttings represent ‘jenkins’ that were cut by the miners in order to rob the coal from the pillars (Griffin 1971, 47).

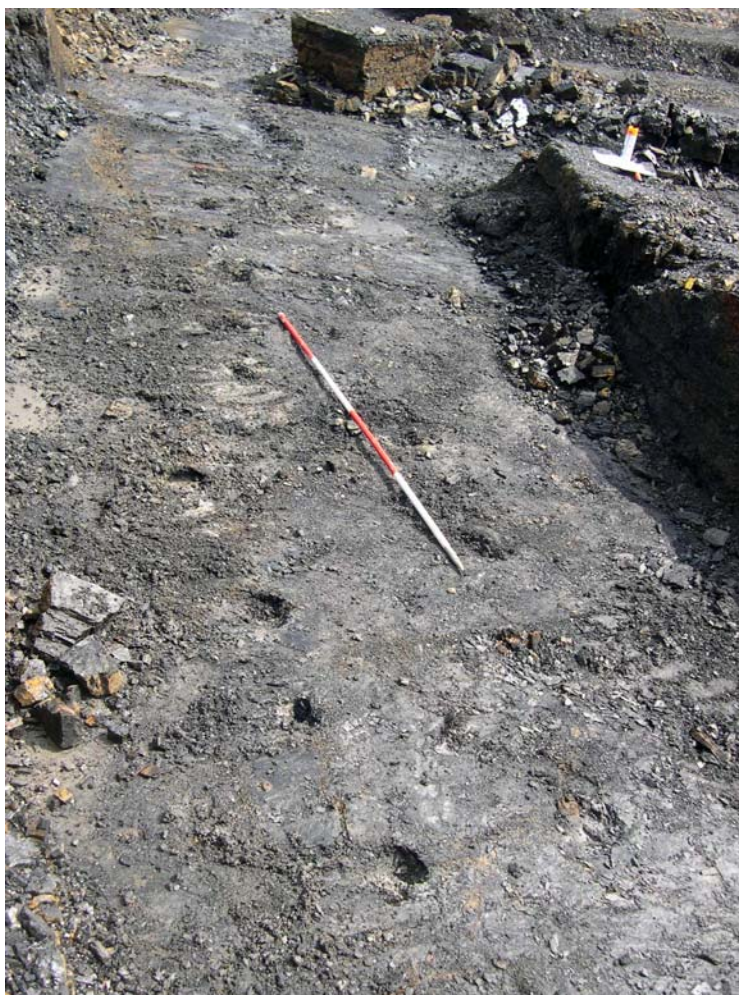
*Plate 20: Line of depressions in Area C1 marking the position of pit props*

were suitable for tree-ring dating. In addition, circular depressions in the floor of the mine also denoted the positions of the former props (Plate 20). The locations of the props indicated that they were positioned within the bords partially to support the roof of the mine, with the main weight carried on the adjacent pillars. Indeed, it is possible that these props were required as a result of cutting ‘jenkins’ through the pillars (*Section 3.3.4*).

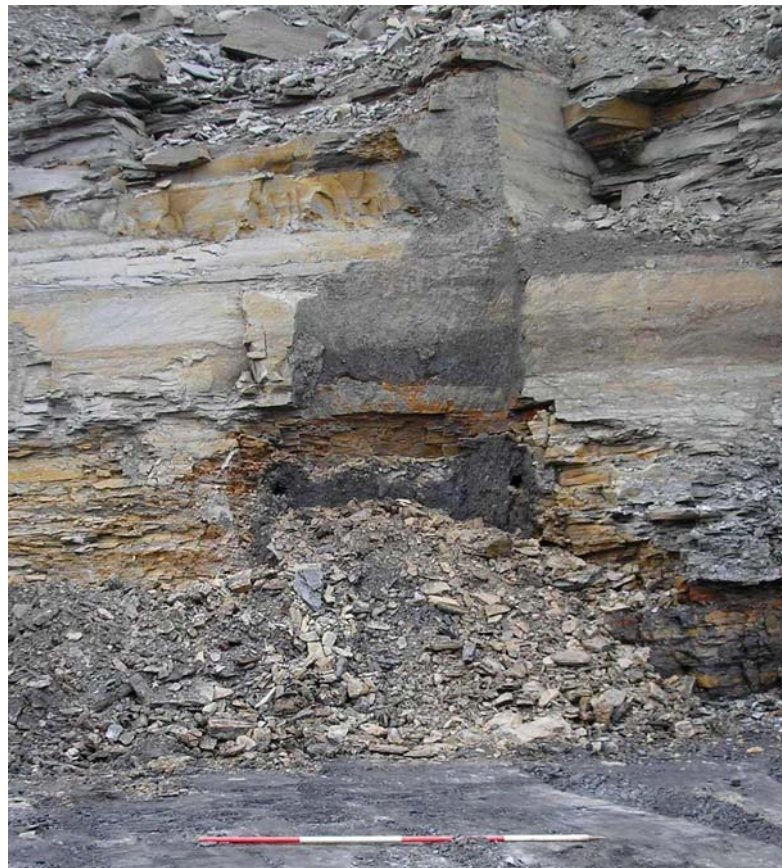
*Plate 21: Unlined ventilation shaft uncovered in Area C*

3.3.10 **Other mining features:** in addition to the bord-and-pillar workings, UK Coal Mining Ltd also surveyed the positions of 11 shafts within Area C (Fig 4). In the majority of cases, it was not particularly clear whether these shafts related to the bord-and-pillar workings recorded this area, or represented shafts dug at a later date to lower seams. One unlined shaft was, however, exposed, which appeared to provide ventilation to the Sharlston Low seam (Plate 21). One other feature recorded during the watching brief in Area C was a brick-lined tunnel, perhaps functioning as a sough, which appeared to be associated with the Sharlston Top workings (Fig 4).

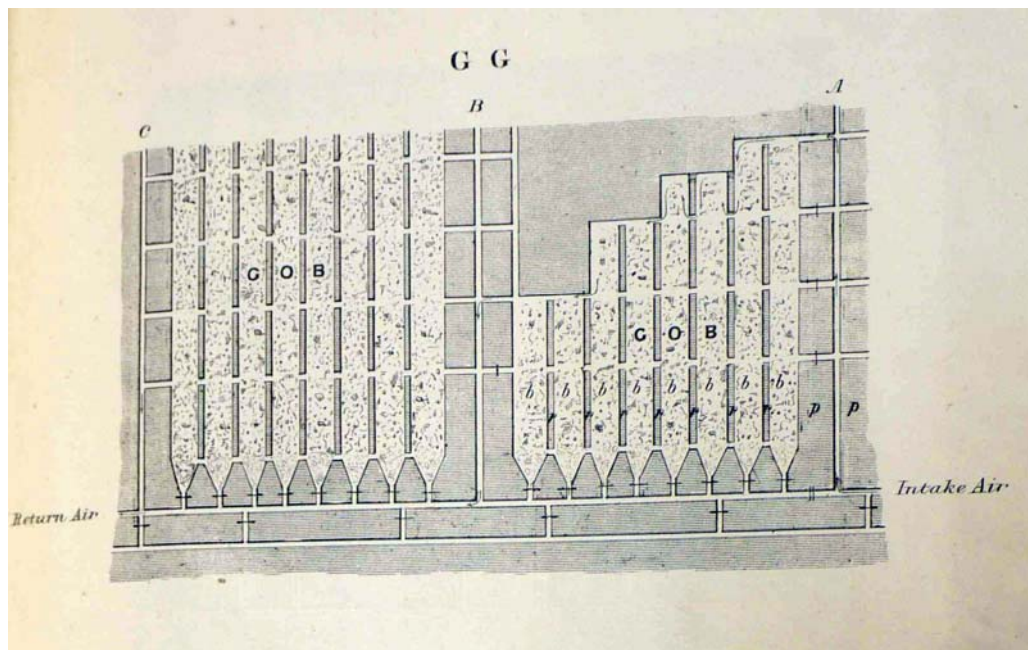
Plate 22: The Yorkshire ‘narrow-work’ system (reproduced from Phillips 1850)

5.4 Significantly, in terms of the known early-mid-nineteenth-century coal working practices in Yorkshire (*cf* Phillips 1850, 42-4), this style of working, particularly in one portion of the bord-and-pillar workings (C1; Fig 5), shows some similarity to the ‘narrow-work’ system, and it is possible that, within Yorkshire, ‘narrow work’ was a later derivative of the type of working identified at Sharlston (Plate 22). ‘Narrow work’ is known to have been utilised in the collieries around Wentworth and was described in 1850 as ‘perhaps the oldest underground working in Yorkshire’ (*op cit*, 43). The layout of this system involved the digging of a headway, following the rise of the seam, from which parallel roadways (bord gates) were set at right-angles. These bord gates were supported by solid ribs of coal, and between these lay eight or ten working bords. The bord gates therefore compartmentalised the working areas and, in turn, minimised the risk of the complete collapse of the roof during the subsequent removal of the pillars, or indeed by natural processes of collapse. At Sharlston, in Area C1, whilst there is clear evidence for the headways, it is difficult to identify any bord gates, suggesting that either the roof of the mine was considered to be sound, a more high-risk strategy of extraction was practised, or that, more probably, it was never intended to remove the pillars of coal during a subsequent phase of working (working in the broken). If this was the case, that area (C5) immediately to the east of Area C1, where no evidence for bord-and-pillar working was present, may well represent an area where the roof of the mine had naturally collapsed due to the weight of the overlying strata.

5.5 At Sharlston, the width of the bords (4-5 yards (3.6-4.5m) wide) might suggest that each was worked by two men, though, if a proportion of the works are of eighteenth-century date, the general practice during this period was to have one man per bord (JC 1708, 42). The length of the recovered pit props indicates that working head-height within the bords was *c* 1m. This suggests that the miners knelt within the bords, though, if the seam was extracted by undercutting
