# **SHARLSTON COLLIERY RECLAMATION SITE, NEW SHARLSTON, West Yorkshire**

## **Final Report**

February 2013

**UK Coal Mining Ltd**

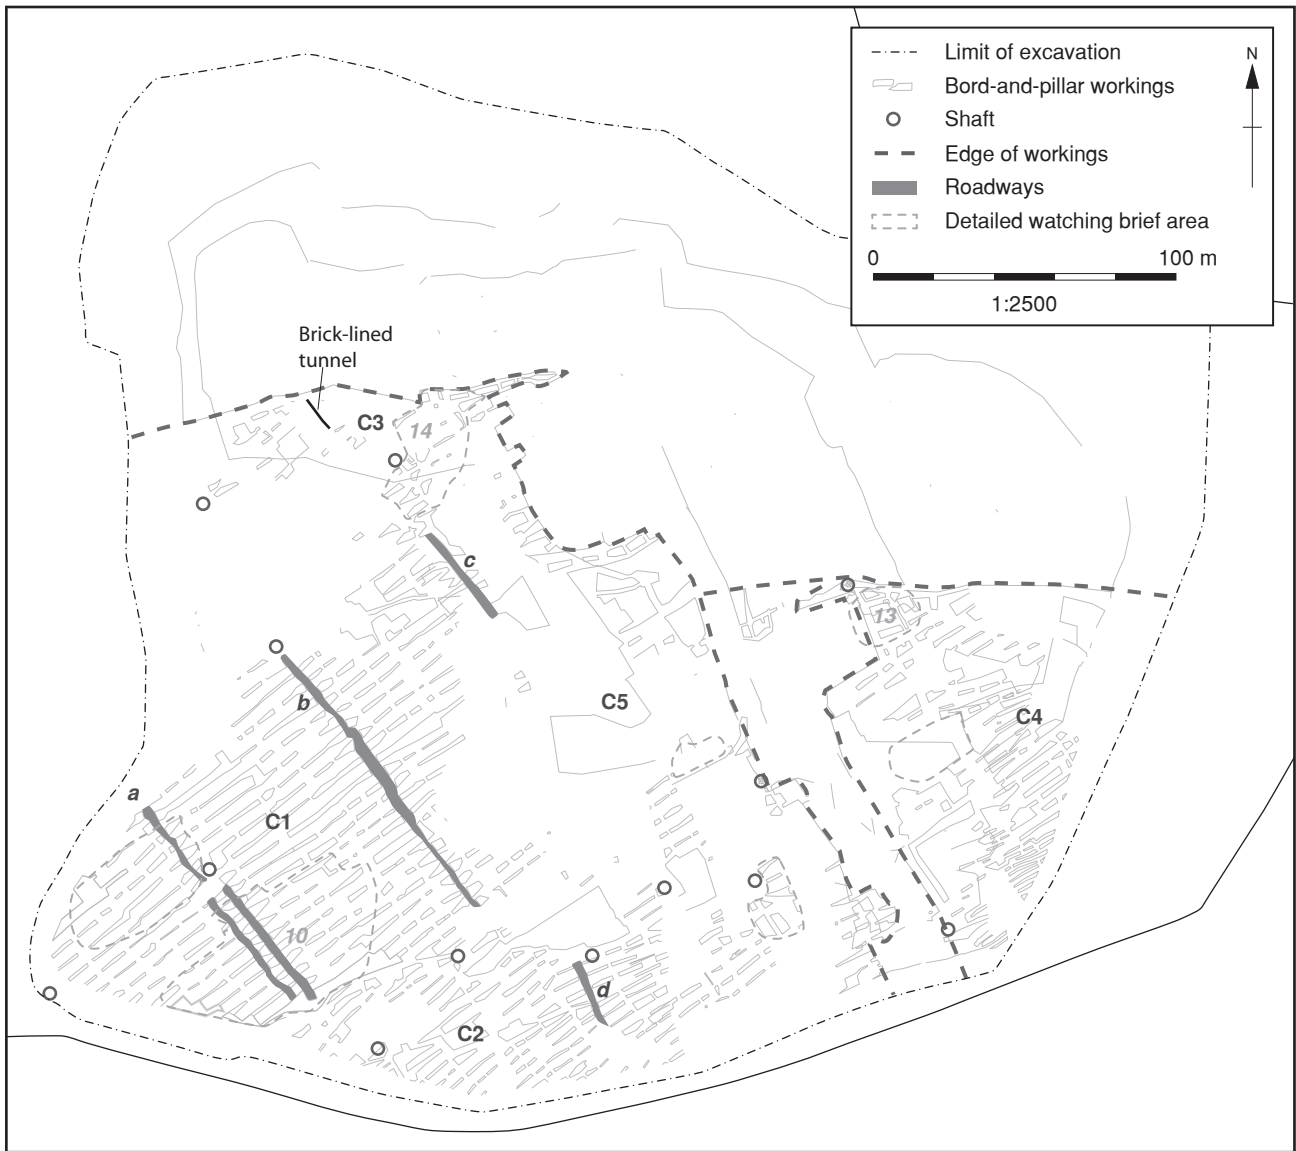
Figure 4: Bord-and-pillar workings within Area C

- 3.3.7 Other discrete areas of bord and pillar lay to the north and east (Fig 4: C3 and C4). However, these covered smaller areas, and, although the bords and pillars were spaced and aligned (north-east/south-west) in a similar manner to those found in the western half of Area C, no headways could be identified. Generally, the pillars in these areas were of similar size to those found in the western half of Area C, but several sizable pillars were also present, suggesting that the roof of the mine was less sound at these locations. In between the areas of bord and pillar, a large, irregular-shaped ‘blank’ area was also present (Fig 4: C5), with an apparent absence of bord-and-pillar working. It is possible that this represents a goaf (abandoned working), where the pillars of coal had either been removed, at some stage, as part of a scheme of ‘working in the broken’, or had naturally disintegrated, due to a process known as ‘thrust’ by nineteenth-century mining engineers (*cf* Dunn 1852, 81-2). This process effected weak and thin pillars, which were crushed and then ground into small pieces of coal following a fracture of the roof of the mine (*op cit*, 82).

3.3.10 **Other mining features:** in addition to the bord-and-pillar workings, UK Coal Mining Ltd also surveyed the positions of 11 shafts within Area C (Fig 4). In the majority of cases, it was not particularly clear whether these shafts related to the bord-and-pillar workings recorded this area, or represented shafts dug at a later date to lower seams. One unlined shaft was, however, exposed, which appeared to provide ventilation to the Sharlston Low seam (Plate 21). One other feature recorded during the watching brief in Area C was a brick-lined tunnel, perhaps functioning as a sough, which appeared to be associated with the Sharlston Top workings (Fig 4).

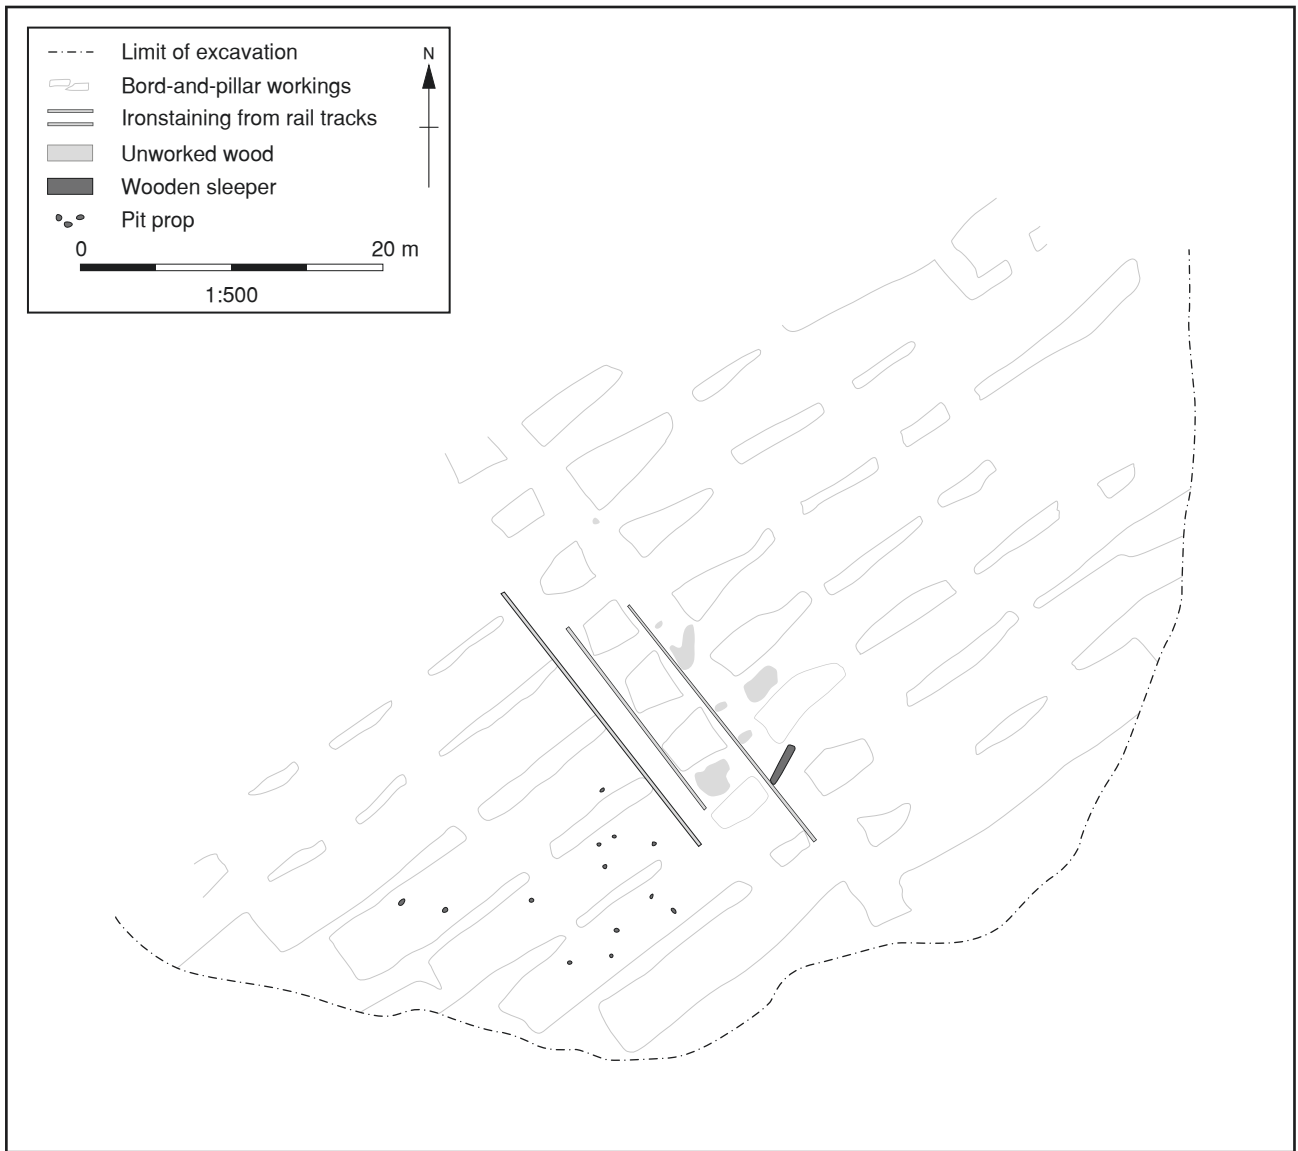
Figure 5: Bord-and-pillar workings in Area C1.10

3.3.9 oning of the props varied, and presumably these differences accorded with the perceived condition of the mine’s roof. For instance, in one area (Area C1.10; Fig 5), where it was possible to examine the positions of the props in some detail, their close spacing (*c* 0.5m apart) within the bords suggested that there was a high risk of roof collapse in this section of the workings. Significantly, during the examination of this area, several features were discovered, which provide some indication of the transport of extracted coal, and also the possible date of the bord-and-pillar workings. These features included a timber railway sleeper (*Section 4.8.4*) and two parallel lengths of ferrous staining, suggesting that haulage of the coal along the double headway was via wheeled trams travelling on cast-iron railways. Beneath and adjacent to these tramways, several layers of unworked wood were also recorded. In terms of date, this type of below-ground haulage, along light cast-iron railways, was introduced in *c* 1790 by John Curr of Sheffield, and it replaced an earlier form of haulage along

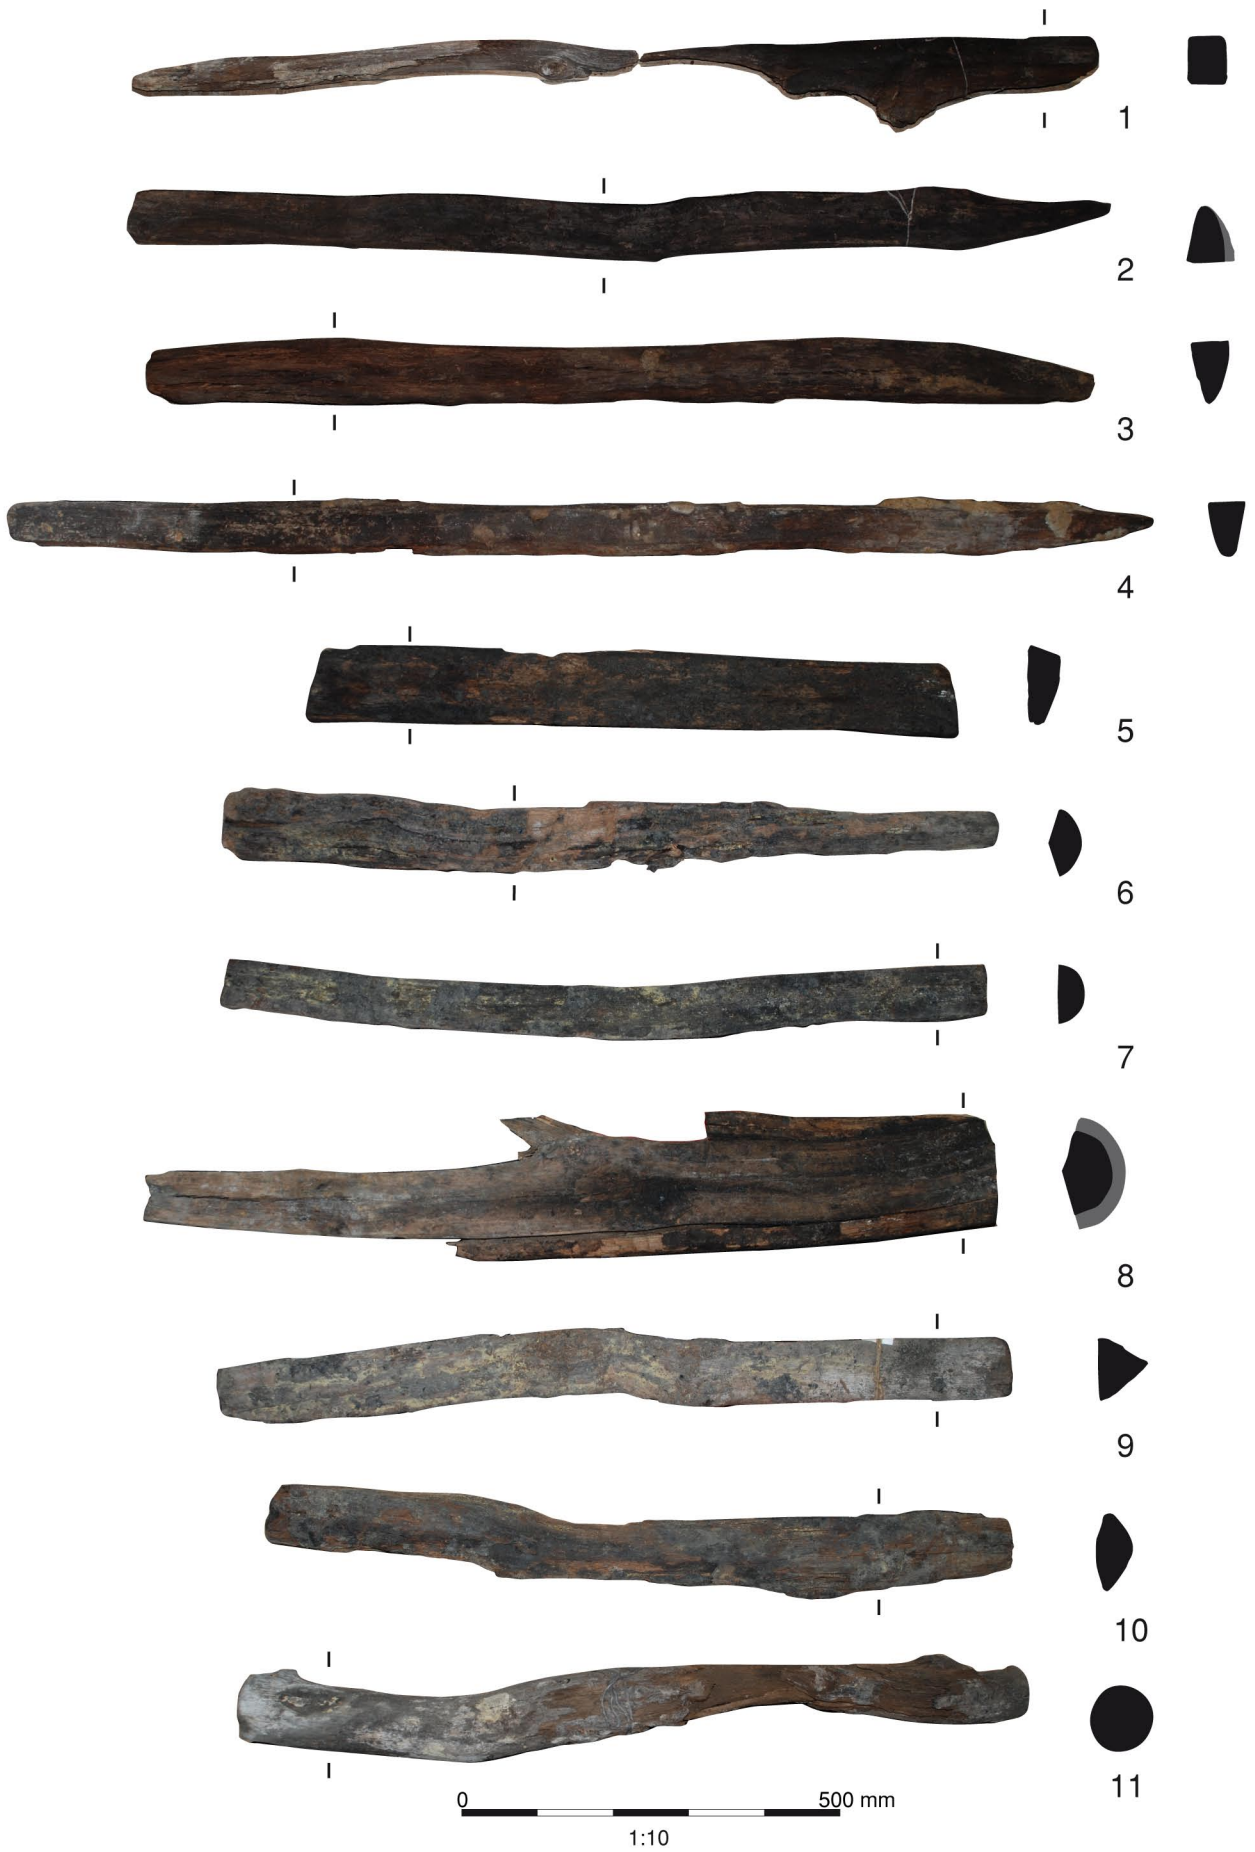
Figure 6: The wooden pit props recovered during the open-area excavations and watching brief

Area C: Unstratified (Fig 6.10)	Minimally shaped pit prop derived from a halved tree trunk. Bark preserved on one side of prop. No tapered points visible at ends	L: 1m; W: 0.06m; T: 0.03m	cf Oak
Area C: Unstratified (Fig 6.11)	Minimally shaped pit prop, with square-cut ends	L: 1.1m; W: 0.06m; T: 0.06m	cf Oak
Area C1.10 (Sharlston Top Seam)	Railway sleeper with square-cut ends	L: 1.85m; W: 0.25m; T: 0.05m	cf Oak
Area C1.10 (Sharlston Top Seam)	Possible track, with bevelled point, in very poor condition	L: 0.64m; W: 0.03m; T: 0.03m	cf Oak
