THE SILL PROJECT, ONCE BREWED, NORTHUMBERLAND

Interim Desk-based Assessment and Field Survey

July 2013

Issue No: 2013-14/1420
OA North Job No: L10627
NGR: NY 75248 66892

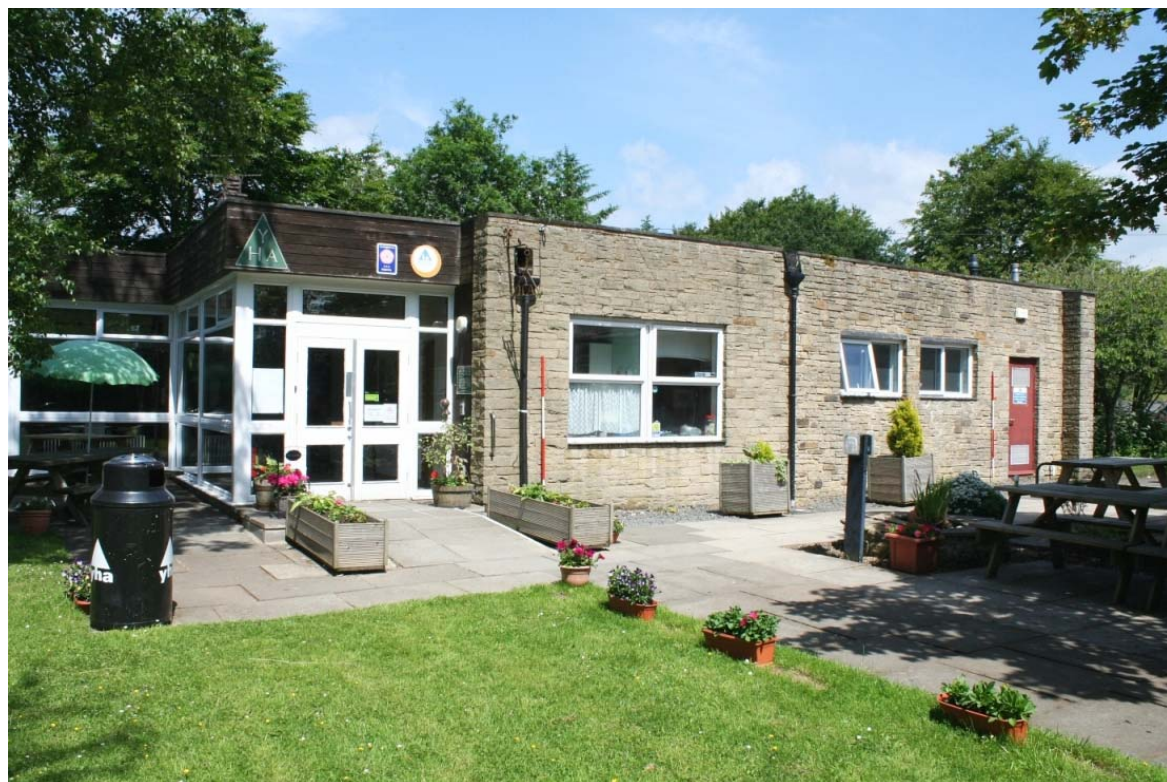
Plate 5: Once Brewed Youth Hostel entrance viewed from the south

5.2.2 The main entrance to the building is on the south-facing elevation (Plate 5) and consists of a double wood-framed door set on the front of an L-shaped corridor of uPVC replacement windows, with wood cladding above, that leads west to the dormitory. Pertinent details include metal signage next to the door and a metal YHA sign above it (Plates 6 and 7).

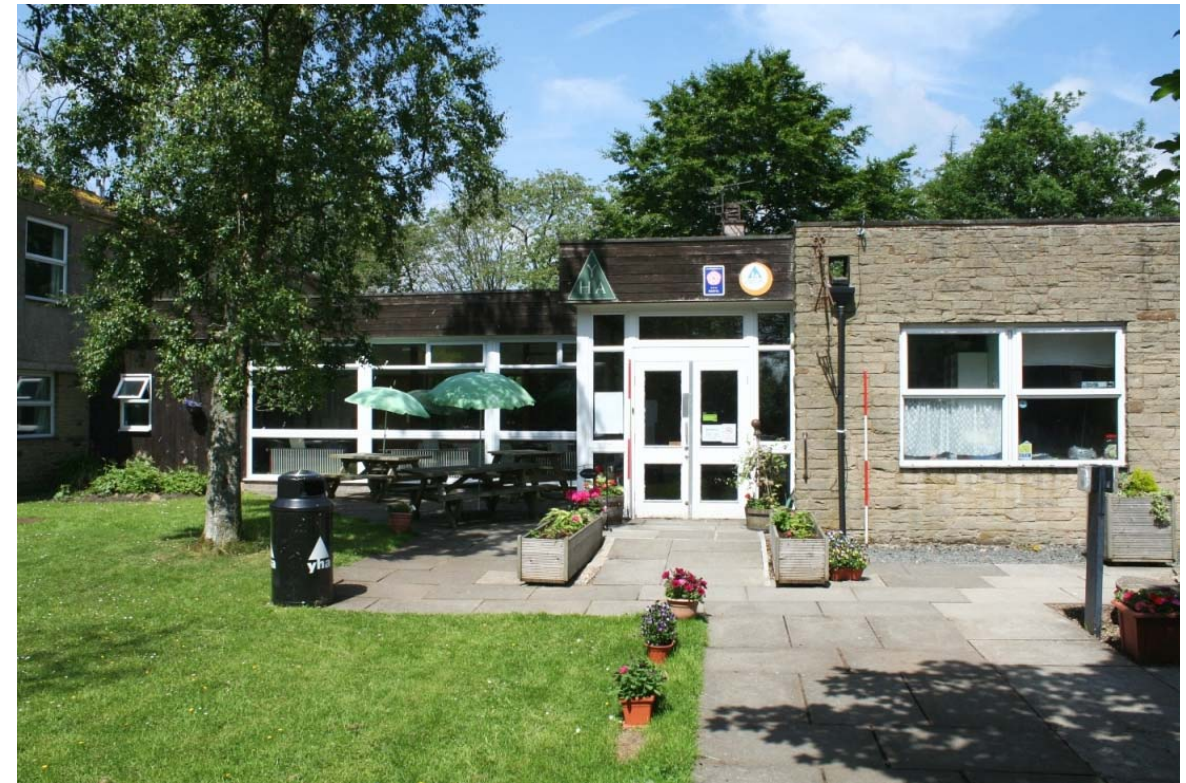
Plate 8: Main south-facing entrance and adjoining externally wood-clad corridor in the communal part of the 1960s YHA building

5.2.3 The communal eastern wing forms a J-shape behind the entrance corridor. It is single-storey and flat-roofed and probably contains offices/reception immediately east of the main entrance, and probably kitchens to the east of that (Plate 8). The south-facing wall elevation has three uPVC replacement windows with concrete lintels and ceramic slate-effect tiled sills, and a wooden door. The south-east corner of the building has a protruding wall stub which is in alignment with the same on the north-west corner of the NNPA Visitor Centre, this alignment mirrors a removed north/south-aligned plot boundary (Site 37). The long east/west-orientated part of the east wing has at least one large hall or school room with a series of five narrow metal-framed sliding privacy windows near roof level on the north-facing wall elevation (Plate 9). The east-facing elevation contains a wooden door, possibly leading into the kitchens, and there is a row of four wood-framed windows and a door set back in a slight rebate, with vertical clad wooden pillars and surrounds (Plate 10). External to this wall elevation are (from north to south) a wire-fenced enclosure containing three LPG tanks, a wooden garage with doorway on the east side and a small wooden shed with a door on the west side.

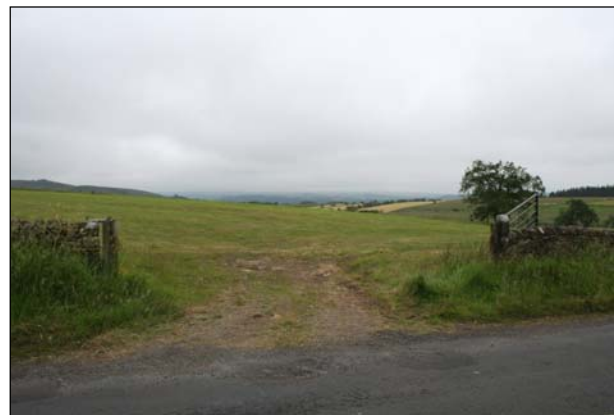
Site Number 2
Site Type Quarry
NMR No. 1408114
NGR NY 75333 66939
Period Post-medieval
Photograph(s) 6875.jpg , 6878.jpg and 6885.jpg
Description A sub-rectangular area of shallow quarrying located adjacent to the crossroads that has disturbed the western end of the vallum bank (3). The east side of the quarry scoop is defined by a small stub of earthen bank that was identified by the NMP aerial photographic interpretation. Overall the site measures approximately 35m by 18m.

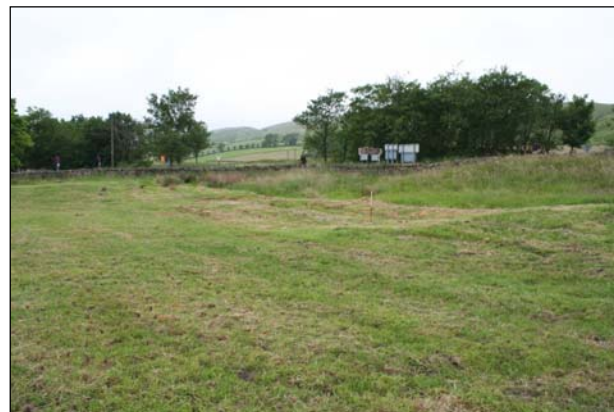
Site Number 3
Site Type Vallum Earthworks, East of Crossroads
SM No. 26061
NMR No. 1408072
HER No. 6545
NGR NY 75398 66963
Period Roman
Photograph(s) 6886.jpg – 6893.jpg and 6904.jpg – 6906.jpg
Description The vallum between the road to Steel Rigg car park and the road in Caw Gap in wall miles 39, 40 and 41. The earthwork was defined by the NMP aerial photographic interpretation. The earthwork survives within the development area up to 6m wide by over 1.5m in height. The western end is disturbed at the crossroads by a quarry (2), the eastern end has been cut through by the route of a post-medieval trackway (35), adjacent to a field boundary bank (5).

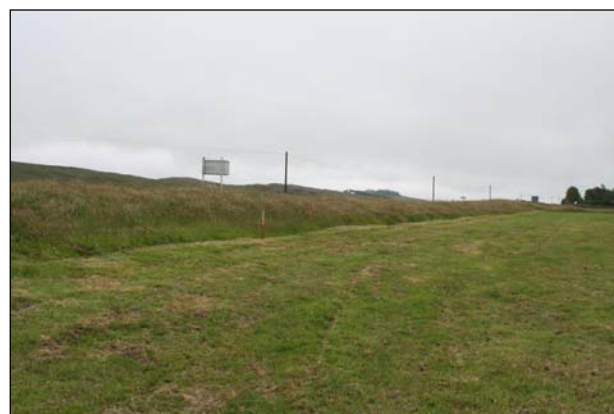
Site Number 4
Site Type Broad Ridge and Furrow Cultivation
NGR NY 75,92 66952
Period Medieval to Post-medieval
Photograph(s) 6893.jpg and 6899.jpg-6902.jpg
Description A small sub-rectangular area of broad ridge and furrow cultivation in the northern end of the eastern development field. It measures approximately 0.08 hectares, is located abutting the south side of the vallum bank (3), is of a north/south orientation and survives as shallow 7m wide ridges. The edge of the cultivation was picked out as a wavy line on the edge of the vallum earthwork by the NMP aerial photographic interpretation.

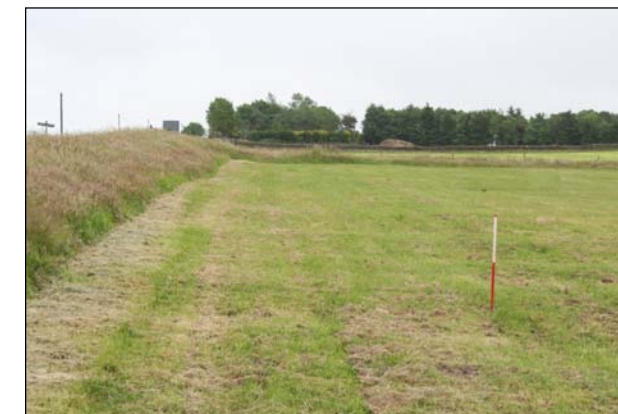
Site Number 5
Site Type Boundary Bank
NMR No. 1408114
NGR NY 75469 66,930
Period Post-medieval
Photograph(s) 6914.jpg, 6919.jpg , 6924.jpg and 6932.jpg
Description A linear section of field boundary bank orientated roughly NNW/SSE on the eastern edge of the eastern development field. It was identified by the NMP aerial photographic interpretation. The boundary is separated from the boundary surrounding the field to the east (6) by a deep ditch.

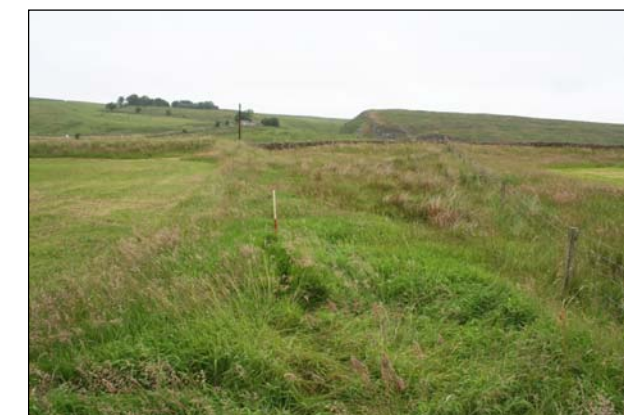
Site Number 6
Site Type Boundary Bank
NMR No. 1408114
NGR NY 75488 66754
Period Post-medieval
Photograph(s) 6940.jpg – 6941.jpg
Description A linear section of field boundary bank orientated roughly N/S on the south-eastern corner of the eastern development field. It was identified by the NMP aerial photographic interpretation. The boundary is separated (outside of the development area) from the boundary surrounding the field to the west (5) by a deep ditch.

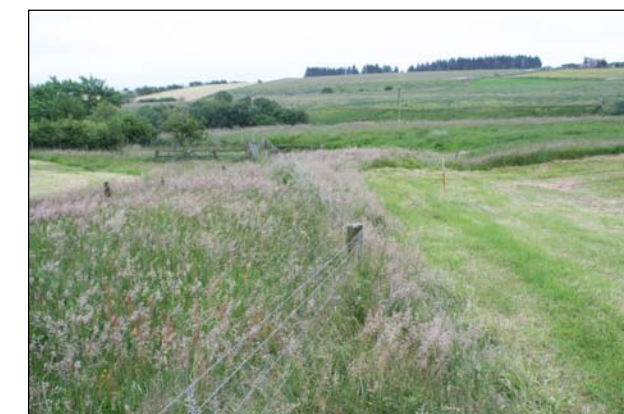
Site Number 7
Site Type Hollow Way/ Trackway
NGR NY 75347 66719
Period Post-medieval
Photograph(s) 6950.jpg – 6952.jpg
Description A short section of NNE/SSW orientated hollow way located on the south-west corner of the eastern development field. It survives in the development area as a very shallow ploughed-out linear feature. In the field to the south it is a well-defined feature that can be observed on aerial photographs (but was not recorded in the NMP aerial photographic interpretation).

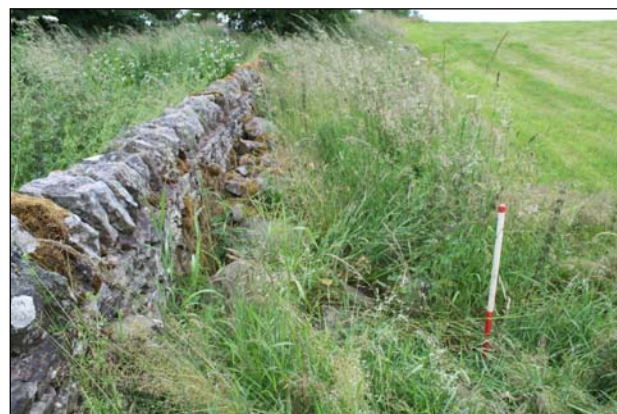
Site Number 11
Site Type Boundary Bank
NMR No. 1408114
NGR NY 75220 66808
Period Post-medieval
Photograph(s) 7046.jpg – 7047.jpg
Description A linear section of field boundary bank orientated roughly NW/SE on the west side of the western development field. It was identified by the NMP aerial photographic interpretation. The boundary defines the west edge of an area of narrow ridge and furrow cultivation (10).

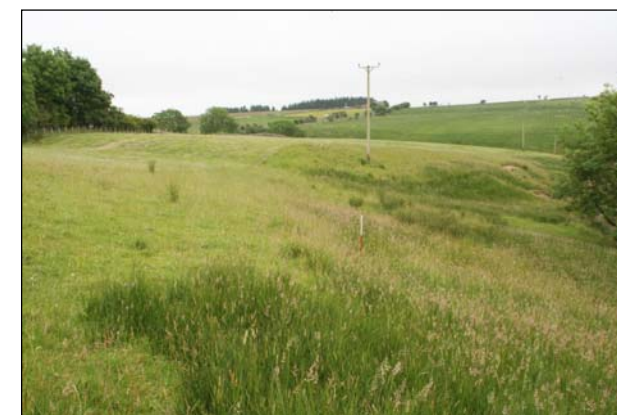
Site Number 9
Site Type Boundary Bank
NGR NY 75301 66841
Period Post-medieval
Photograph(s) 6957.jpg – 6958.jpg
Description A linear section of field boundary bank orientated roughly N/S on the west side of the eastern development field. The boundary consists of a 0.5m-0.75m deep lynchet falling away to the modern field wall on the west side. There are several mature trees on top of this boundary. The feature may be a continuation to the sunken lane (31) located further to the south.

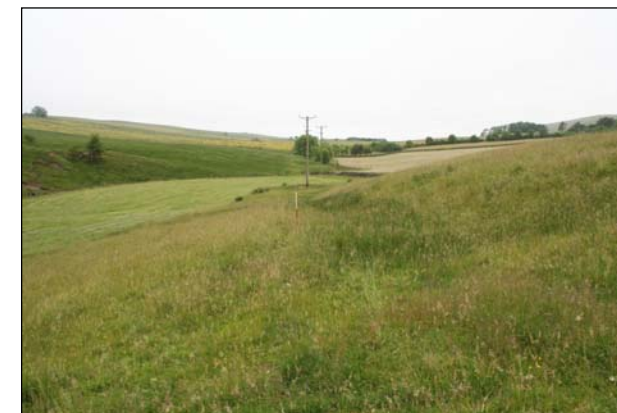
Site Number 14
Site Type Quarry
NGR NY 75294 66734
Period Post-medieval
Photograph(s) 7001.jpg – 7002.jpg
Description A shallow D-shaped quarry scoop or relict field entrance located on the eastern field boundary of the western development field. It measures approximately 5m by 4m and up to 0.5m deep.

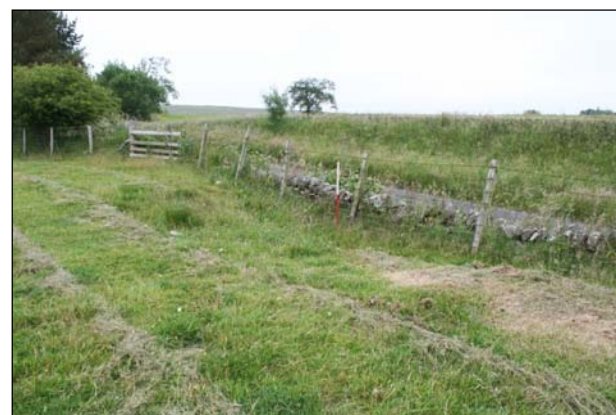
Site Number 18
Site Type Water Smoot
NGR NY 75209 66713
Period Post-medieval
Photograph(s) 7039.jpg – 7041.jpg
Description An arched stone water smoot set into the N/S orientated walled field boundary crossing the beck on the western edge of the western development field.

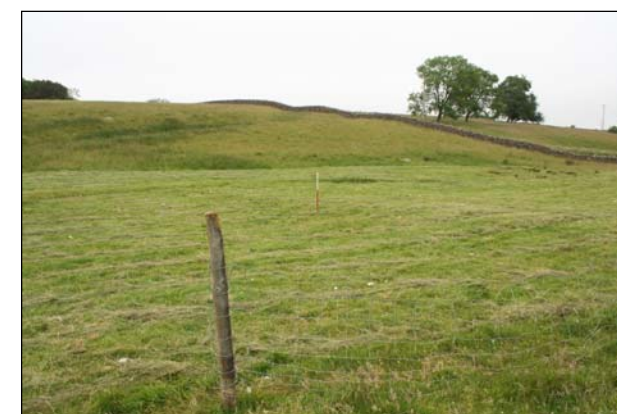
Site Number 21
Site Type Disturbed Ground
NGR NY 75315 66624
Period Modern
Photograph(s) 7015.jpg – 7016.jpg
Description A sub-rectangular slightly sunken area of disturbed ground located in the south-east corner of the western development field. It measures approximately 20m by 9m. The site was not depicted on the NMP aerial photographic interpretation but a modern rectangular structure is possibly depicted on the aerial photography.

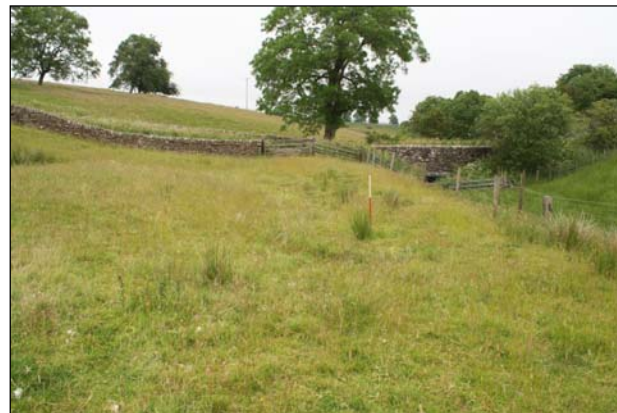
Site Number 24
Site Type Boundary Stone
NGR NY 75214 66775
Period Post-Medieval
Photograph(s) 7044.jpg – 7045.jpg
Description A small unscribed rectangular boundary stone located near the east bank of the stream in the western development field.

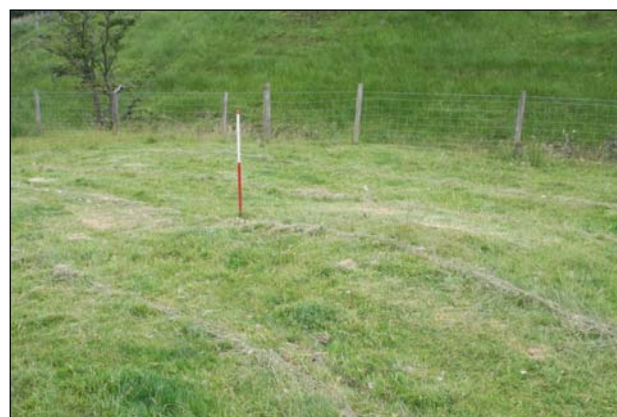
Site Number 25
Site Type Spoil Mound
NGR NY 75,234 66865
Period Modern?
Photograph(s) 7048.jpg – 7049.jpg
Description A large sub-oval spoil mound located in a small wooded area immediately to the south of the Youth Hostel and adjacent to the Visitor Centre car park. The site is probably spoil cleared in construction of the buildings or car park but the present vegetation cover precluded more detailed investigation. A nearby sign indicated that the woodland was planted in 1992.

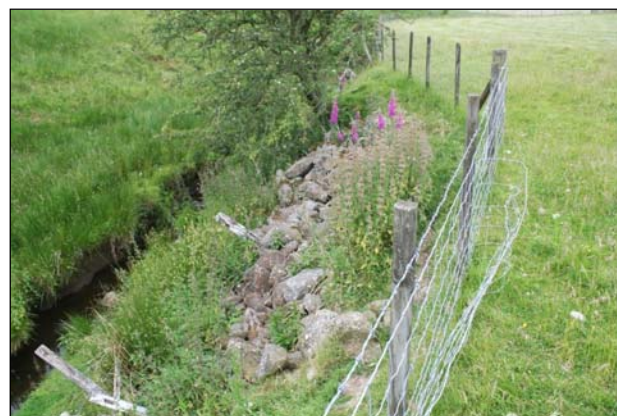
Site Number 26
Site Type Vallum Earthworks, West of Crossroads
SM No. 26063
HER No. 6677
NGR NY 75398 66963
Period Roman
Photograph(s) 7051.jpg – 7078.jpg
Description The vallum between the road to Steel Rigg car park and the road in Caw Gap in wall miles 39, 40 and 41. The earthwork was not defined by the NMP aerial photographic interpretation as it lay within woodland in the Scheduled Monument area on the north side of the Youth Hostel. The earthwork survives within the development area up to 6m wide by over 1.5m in height. The western end of the vallum bank is truncated near to the car park of the Twice Brewed Inn (cleared away by the farmer in the 1950s – Twice Brewed owner, *pers comm*) but continues to the east into the curtilage of the Youth Hostel. The earthwork on the north side of the Youth Hostel tapers slightly and becomes narrower as it runs further to the east and peters out as a visible earthwork feature next to the Youth Hostel car park. This end will have been cleared during the construction of the original 1934-dated Youth Hostel (41).

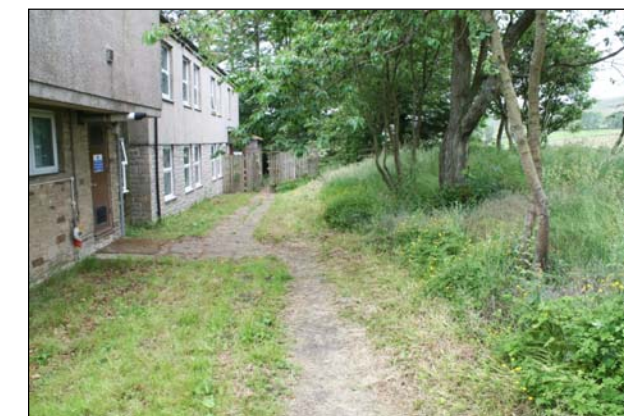
Site Number 27
Site Type Garden/Pinfold
NGR NY 75322 66967
Period Post-medieval
Photograph(s) 7086.jpg – 7087.jpg, 7092.jpg, 7099.jpg – 7101.jpg, 7104.jpg and 7109.jpg-7110.jpg
Description An extant rectangular garden or pinfold enclosure located on the north-west corner of the crossroads to the north of the development. The drystone walled structure was shown on the OS 1859-62 mapping and was probably associated with the demolished Lane End house (43) on the opposite side of the road. It has a narrow gateway on the south side (28) and contains extant Vallum earthworks beneath scrubby woodland (29).

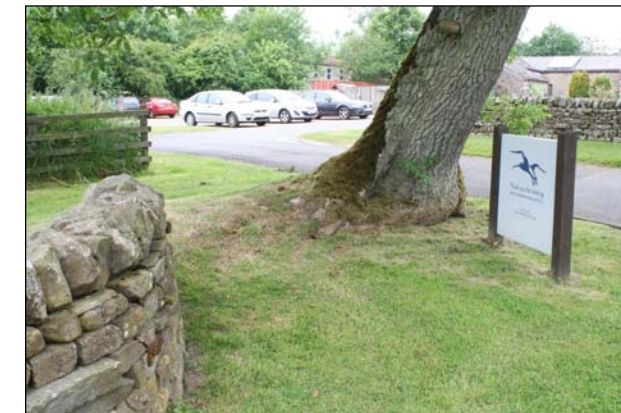
Site Number 28
Site Type Gate stoup
NGR NY 75300 66952
Period Post-medieval
Photograph(s) 7105.jpg-7107.jpg
Description A narrow gateway giving access to the south side of a garden/pinfold enclosure (27). It consists of a pair of small quarried stone stoups.

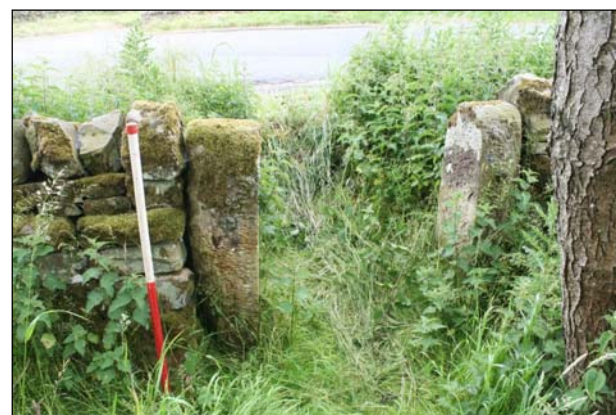
Site Number 31
Site Type Lane / Hollow Way
NGR NY 75304 66728
Period Medieval to Post-medieval
Photograph(s) 7141.jpg – 7148.jpg , 7150.jpg and 7155.jpg
Description A curvilinear lane orientated roughly N/S and bisecting the two development area fields. The southern end of the feature is cut into the ground as a large and wide sunken hollow way over 2m deep as it descends the hillside towards a bridged crossing point of Brackies Burn.

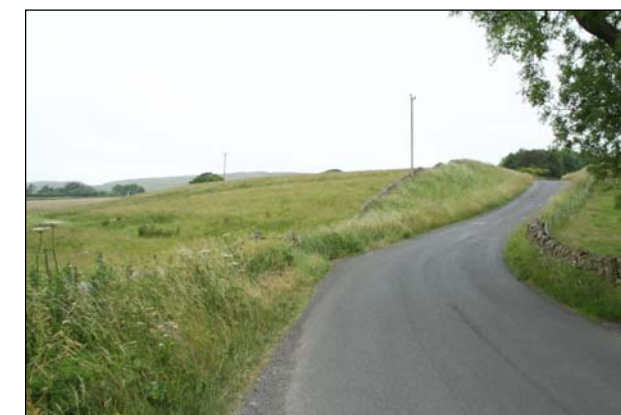
Site Number 29
Site Type Vallum Earthworks, West of Crossroads
SM No. 26063
HER No. 6677
NGR NY 75309 66965
Period Roman
Photograph(s) 7104.jpg and 7109.jpg
Description The Vallum between the road to Steel Rigg car park and the road in Caw Gap in wall miles 39, 40 and 41. The extant earthworks of the vallum ditch and northern bank found within the pinfold enclosure (27) on the north side of the crossroads on the Military Road. The bank survives up to 6m wide by 1.5m high with a slight flat berm separating it with the boggy ditched area that abuts and follows the southern wall of the enclosure.

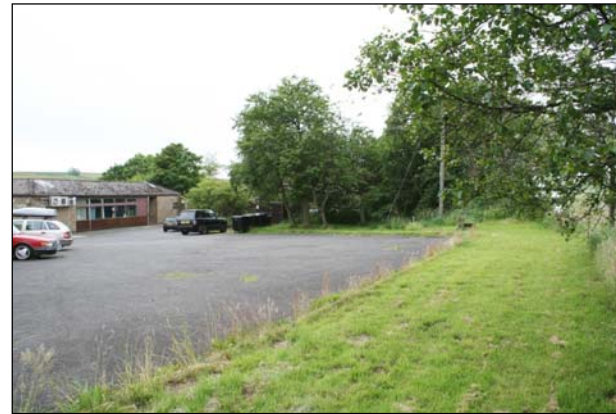
Site Number 42
Site Type Site of Building
NGR NY 75,315 66862
Period Post-medieval
Photograph(s) N/A
Description The site of a demolished farm building, possibly a barn/byre located on the west side of the eastern development field. The site was depicted as an un-named rectangular roofed building on the 1859-62 OS mapping. The structure was demolished before later editions of the historic mapping.
