LONG LANE, CHAPEL-EN-LE- FRITH, DERBYSHIRE

PHASE 2

Archaeological Evaluation Report

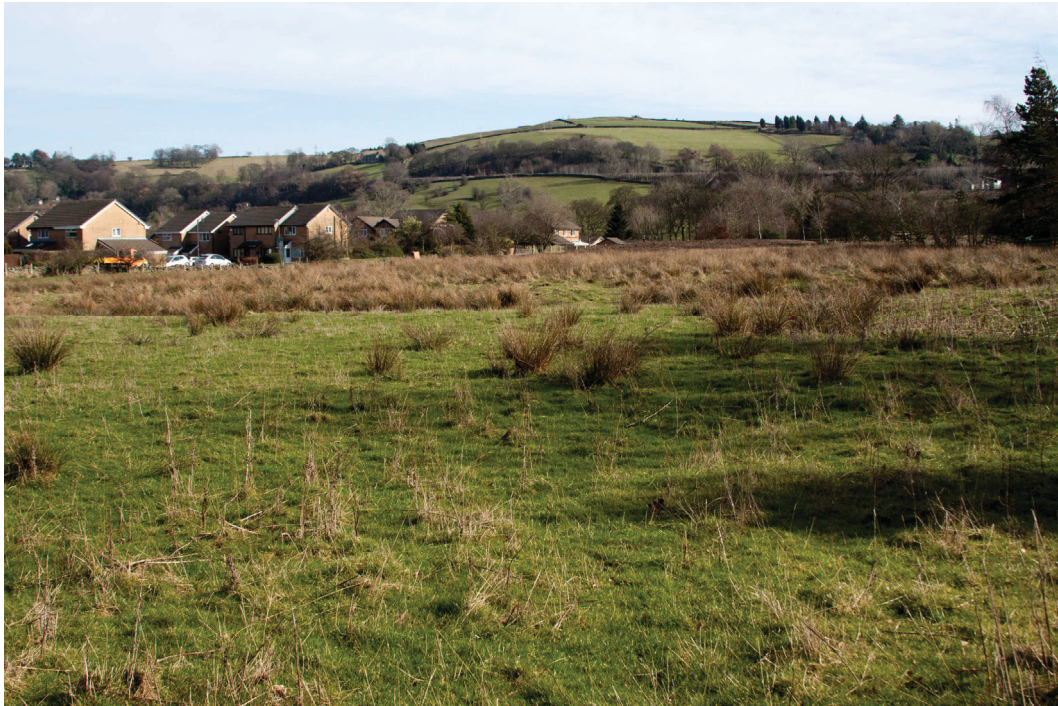
- 1.2.2 The survey area was mostly level and laid down to rough pasture (Plate 1); clear ridge and furrow plough scars were evident in the southern field. The northern field was saturated and boggy and its northernmost corner had been mechanically

Plate 1: The general rough pasture terrain of the northern field

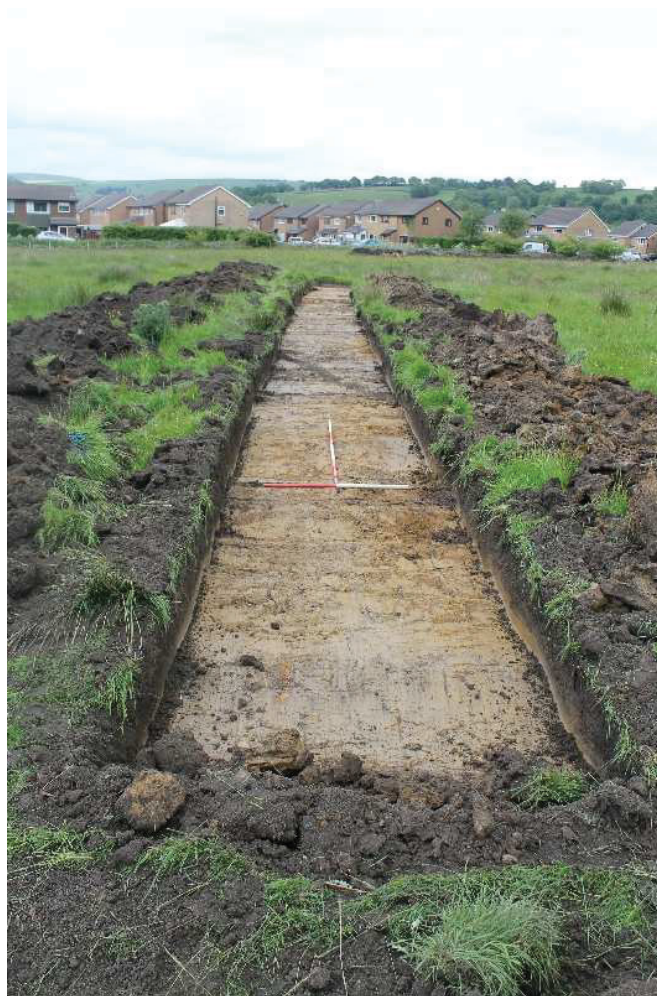
- 3.3.1 Trench 1 was located at the western end of Field 3 (Fig 2) and was aligned broadly east/west. Natural deposits, **101**, were encountered at a depth of 0.30m below the present ground surface and were covered by a light-grey-brown silt subsoil, **102**, which was 0.15m thick with very occasional, sub-angular stones up to 20mm in size (Plate 4). A single narrow linear feature, **103**, on a north-east/south-west alignment, was identified towards the western end of the trench and which cut the subsoil. It was filled with a light-grey-brown silt, **104**, with occasional lumps of re-deposited natural clay; its excavation revealed it to be just 0.24m wide and 0.13m deep with a convex 'V'-shaped profile that was consistent with that left by a plough share. A layer of topsoil, **105**, lay above the subsoil to a depth of 0.15m.

Plate 4: Trench 1, facing east

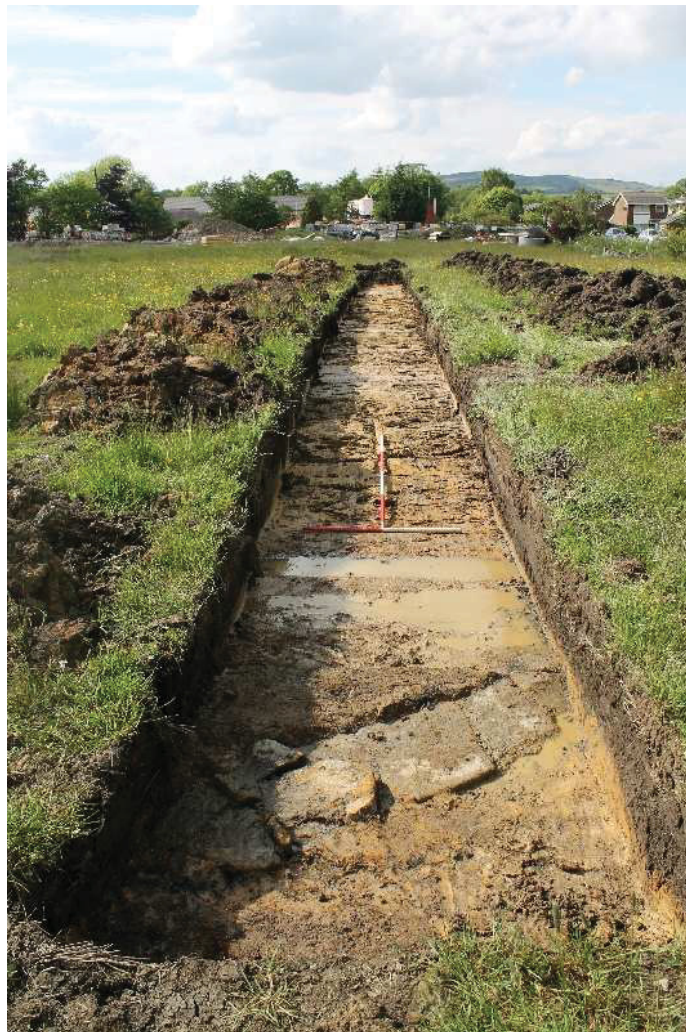
3.4.1 Trench 2 (Fig 3) lay near the eastern boundary of Field 1, with which it shared its north-west/south-east alignment. Its excavation revealed natural clay deposits, **203**, at a depth of 0.39m below the present ground surface (Plate 5). A sondage, excavated at the north-western end of the trench, demonstrated the continuation of this deposit to a depth of at least 0.72m without change. A layer of subsoil, **204**, covered the base of the trench to a depth of 0.09m and a drain, **201**, had been cut through it at the south-western end of trench (Plate 6). The drain was 0.91m wide, 0.23m deep and extended across the width of the trench on a north-east/south-west alignment. It had moderately- sloping concave sides and a flat base that was covered with overlapping flat stones (Fig 4). The drain had been filled with a mixed orangey-brown silt clay, **202**. Topsoil **205** covered the trench to an average depth of 0.30m below the present ground surface.

Plate 5: Trench 2, facing north-west

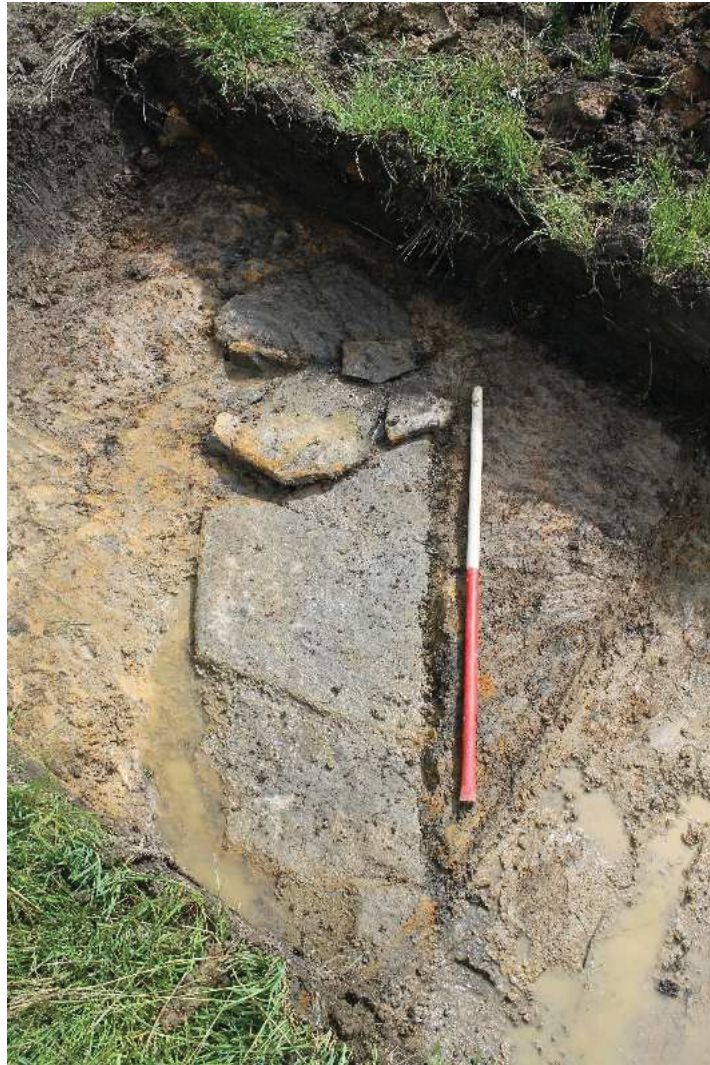
Plate 6: Stone-lined drain **201** at the south-eastern end of the trench, 1m scale

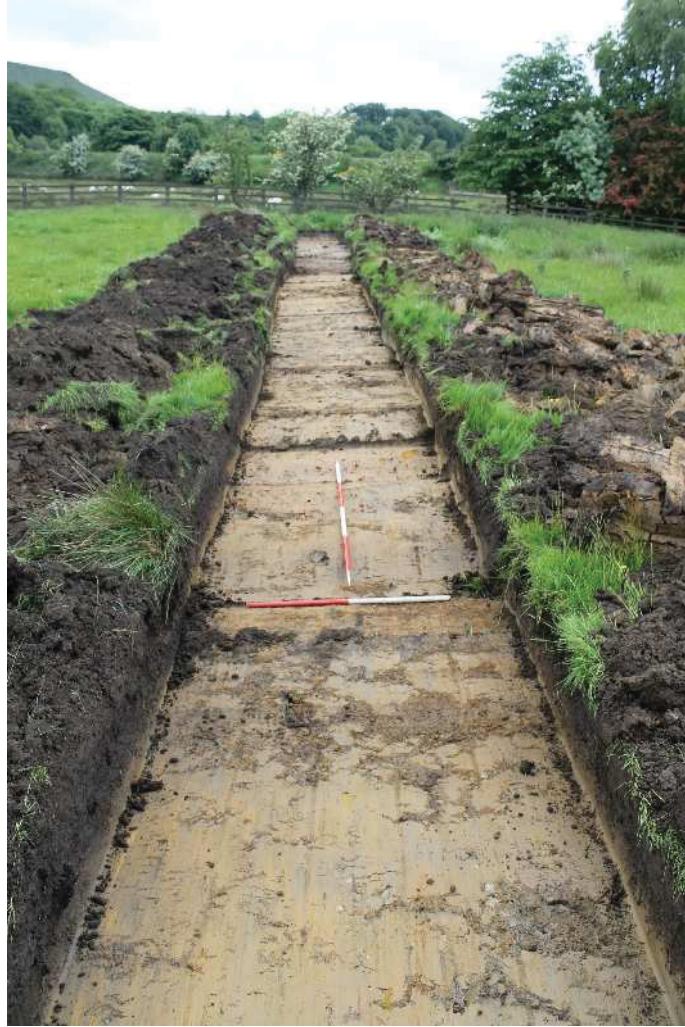
Plate 7: Trench 3, facing south-west

- 3.5.1 The original position and alignment of Trench 3 was adjusted slightly in order to avoid an area of boggy ground. It lay towards the western boundary of Field 1 and was excavated upon a north-east/south-west alignment. Natural clay, **301**, was encountered at a depth of 0.34m below the surface and lay beneath a layer of subsoil, **302**, that was 0.16m thick (Plate 7). Topsoil **303** covered the trench to a depth of 0.18m below the ground surface. The trench contained no archaeological features.

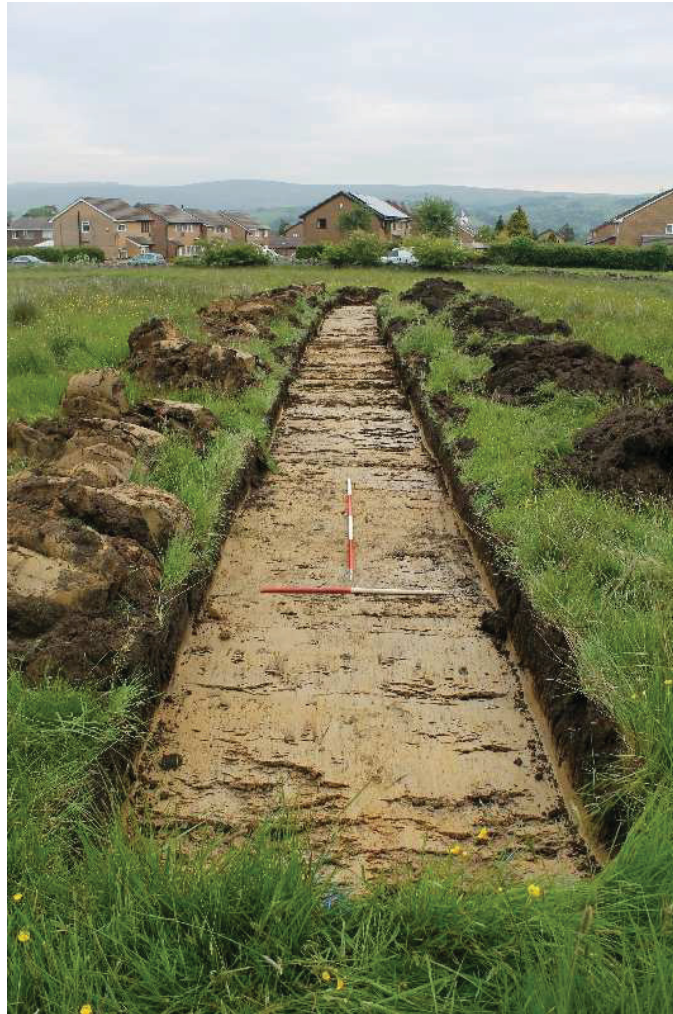
Plate 8: Trench 4, facing north-east

- 3.6.1 Trench 4 was located towards the centre of Field 1 upon a north-east/south-west alignment. Natural clay deposits, **401**, were encountered at just 0.23m below the present ground surface and were covered by a thin layer of intermittent subsoil, **402**, to a maximum thickness of 0.09m (Plate 8). Topsoil **403** covered the trench to a maximum depth of 0.14m. The trench contained no archaeological features.

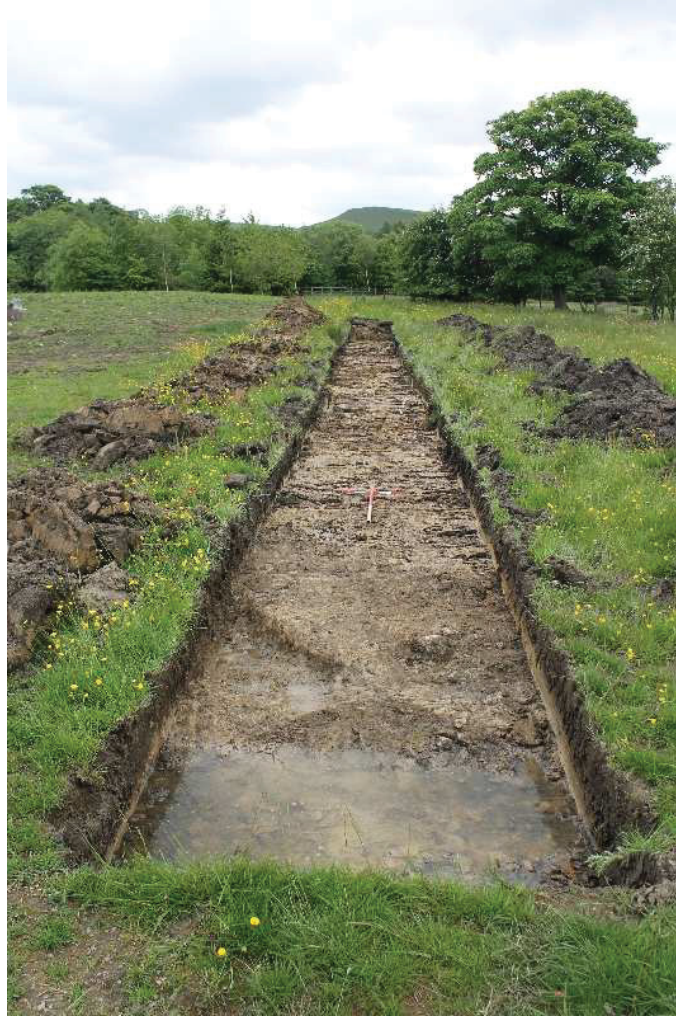
- 3.7.1 Trench 5 lay at the south-eastern end of Field 1 and was aligned north-west/south-east. Natural sub-soils, **503**, were reached at depth of 0.28m beneath the ground surface, and a sondage was excavated at the south-eastern end of the trench demonstrating its continuation for at least another 0.52m (Fig 3; Plate 9). At the opposite end of the trench, a linear feature, **501**, was identified on an east/west alignment and which cut the natural clay (Fig 4; Plate 10). Its excavation revealed it to have a width of 0.80m and a depth of 0.18m, with gently sloping sides of about 30 degrees and a flat base. It was filled with a mid-brown silty clay, **502**, with frequent stone inclusions but which contained no dating evidence. A layer of topsoil, **504**, covered the trench to a maximum depth of 0.28m.

Plate 9: Trench 5, facing south-east

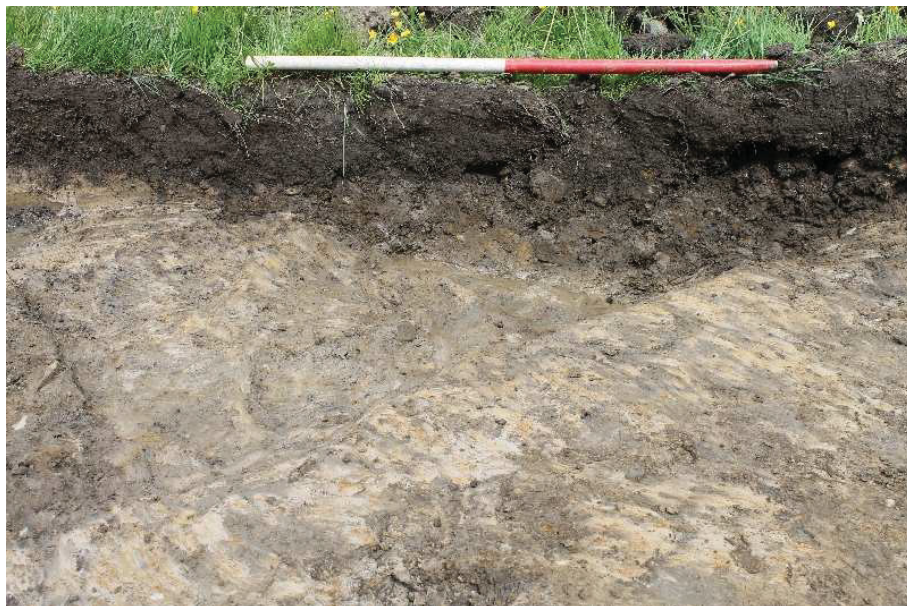
Plate 10: The south-west-facing section of ditch **501**, 1m scale

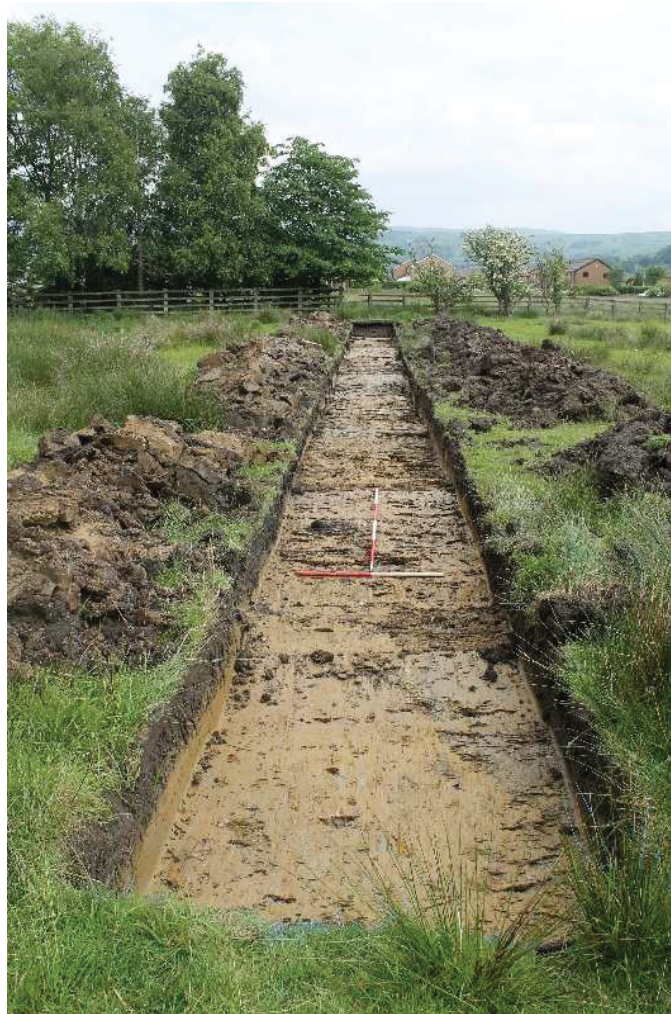
Plate 11: Trench 6, facing north-east

- 3.8.1 Trench 6 lay at the northern corner of Field 2 and was aligned north-east/south-west. Its excavation revealed a natural clay, **601**, at a depth of 0.29m below the present ground surface overlain by a deposit of subsoil, **602**, which was 0.10m thick (Plate 11). A field drain crossed the centre of the trench from north to south with another, on an identical alignment, at the southern end of the trench. A third field drain, with a north-west/south-east alignment, crossed the north-eastern end of the trench. All three drains had a width of 0.30m, and were back filled with a re-deposited clay natural and they could be seen to cut the subsoil. A layer of topsoil, **603**, which was 0.19m thick, sealed all the deposits beneath. The trench contained no archaeological features.

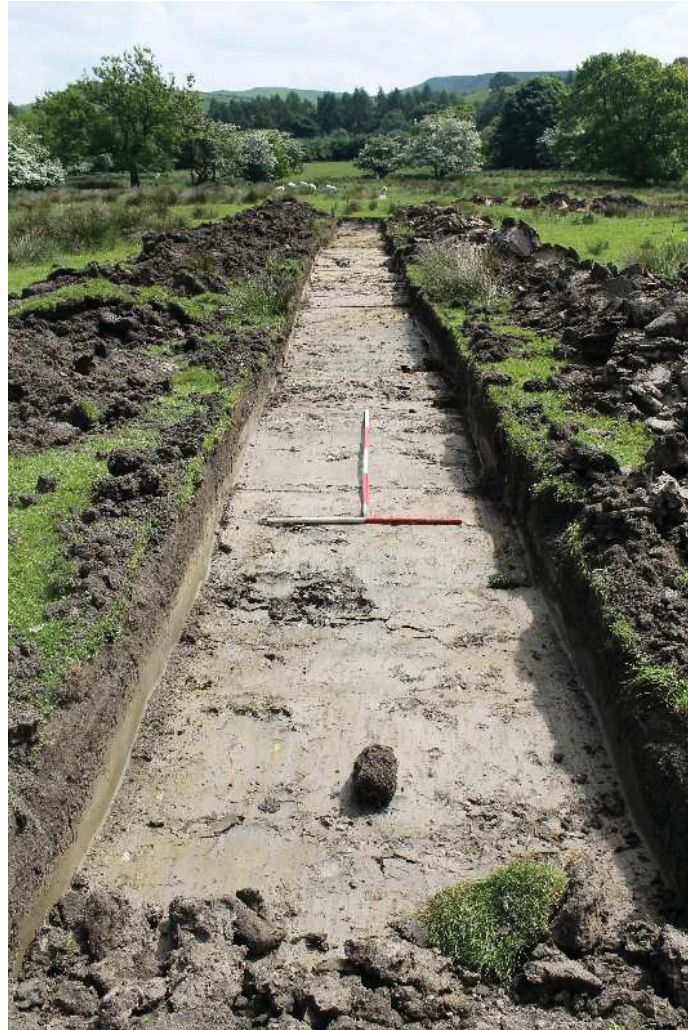
- 3.9.1 Trench 7 (Fig 3) was located at the centre of the northern half of Field 2 on a north-west/south-east alignment. Deposits of undisturbed natural clay, **703**, were encountered at a depth of 0.29m below the present ground surface with a layer of subsoil, **704**, that was 0.14m thick, lying above it (Plate 12). A ditch, **701**, which was 0.50m wide, extended across the width of the trench on a north-east/south-west

Plate 12: Trench 7, facing south-east

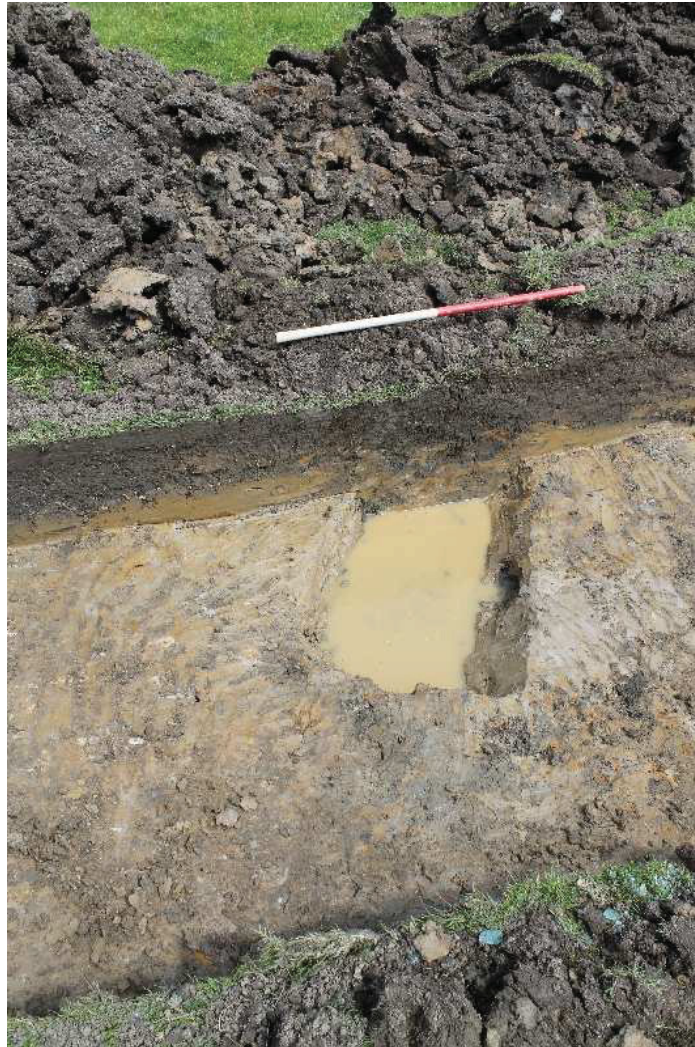
alignment and was recorded at the south-eastern end of the trench (Plate 13). Upon excavation the ditch was found to cut the subsoil and was filled with a mixed mid-grey clay silt with lumps of redeposited natural clay, **702** (Fig 3). It had moderate-sloping, slightly convex, sides but the base was not investigated due to the height of the water table. A narrow field drain was identified at the northern end of the trench, on a north-west/south-east alignment. A layer of topsoil, **705**, was 0.15m thick and sealed all deposits beneath.

Plate 13: West-facing section of ditch **701**, 1m scale

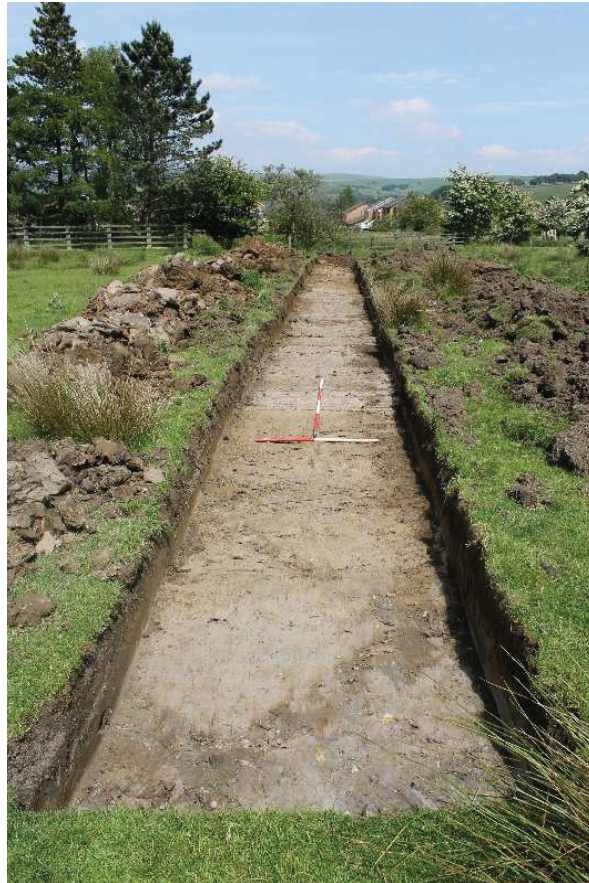
Plate 14: Trench 8, facing north-east

3.10.1 Trench 8 was positioned in the eastern corner of Field 2 and had a north-west to south-east alignment. Its excavation revealed undisturbed natural clays, **801**, at a depth of 0.27m beneath the present ground surface, and was covered by a layer of subsoil, **802**, that was up to 0.12m thick (Plate 14). This subsoil layer was itself overlain by a deposit of topsoil, **803**, typically 0.15m thick. A narrow field drain was revealed at the south-western end of the trench on a north-west/south-east alignment with a second and third drain towards the centre and at the north-eastern end. The latter two drains shared a north-west/south-east alignment but were otherwise identical to the first and all three were cut through the subsoil. The trench contained no archaeological features.

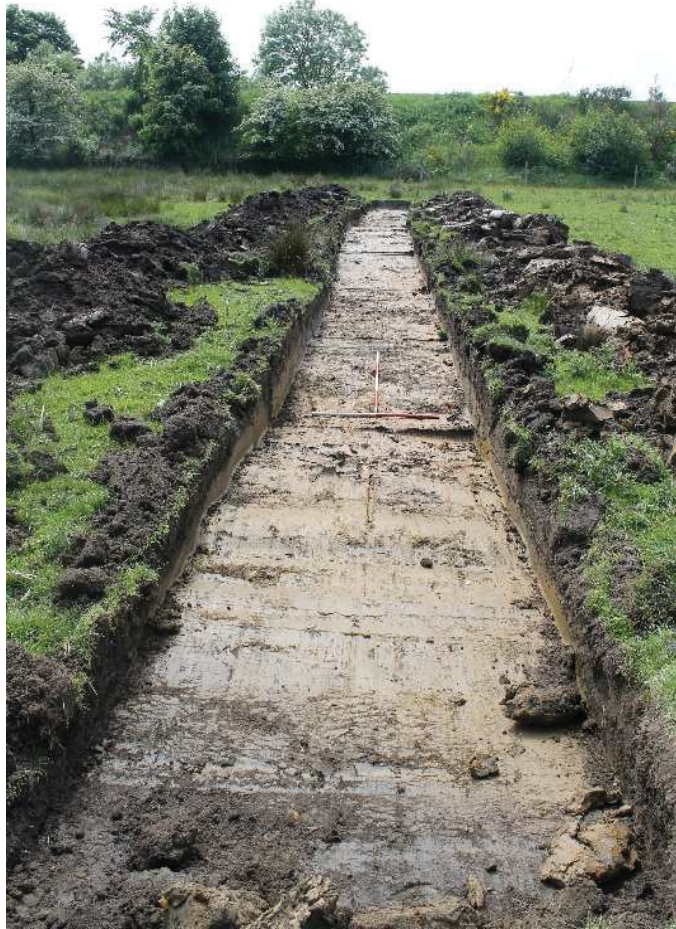
Plate 15: Trench 9, facing west

3.11.1 Trench 9 lay at the western side of Field 2, extending north-eastwards from the western boundary. Natural clays, **901**, were encountered at 0.32m below the present ground surface and were overlain by a deposit of subsoil, **902**, that was 0.16m thick (Plate 15). This in turn was sealed by a layer of topsoil, **903**, that was 0.16m thick. Two narrow field drains were recorded, one at the south-western end of the trench and another towards the centre, both on a broadly north/south alignment. The trench contained no archaeological features.

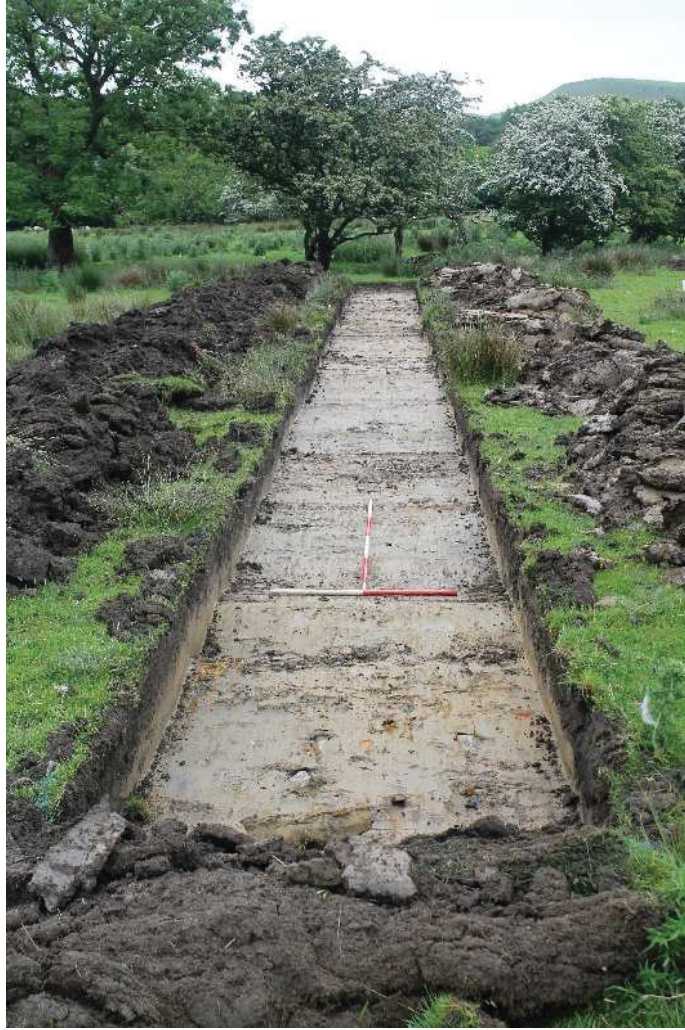
Plate 16: Trench 10, facing south-east

3.12.1 Trench 10 was located upon a north-west/south-east alignment near the eastern boundary of Field 2. Excavation revealed natural clay deposits, **1001**, at a depth of 0.30m below the present ground surface (Plate 16). This layer was covered by a layer of subsoil, **1002**, which was 0.10m thick and which was in turn sealed by a layer of topsoil, **1003**, that was 0.20m thick. Two field drains were noted at the north-western end of the trench with a north-east/south-west alignment and a third was recorded at the opposite end of the trench on the same alignment. The trench contained no archaeological features.

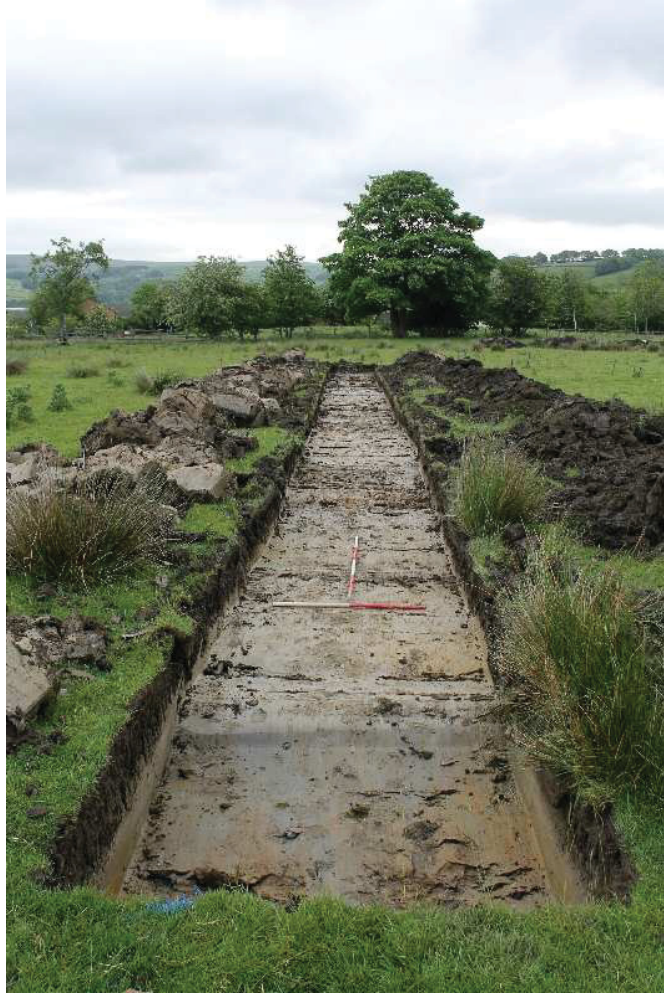
Plate 17: Trench 11, facing east

3.13.1 Trench 11 lay near the northern corner of Field 3 and was aligned north-east to south-west. Natural clays **1101** were recorded at a depth of 0.33m beneath the present ground surface and were covered by a deposit of subsoil, **1102**, which was 0.12m thick (Plate 17). A layer of topsoil, **1103**, was 0.21m thick and covered the subsoil deposit. A field drain on a broadly north/south alignment lay at the south-western end of the trench with another on the same alignment towards the north-eastern end of the trench. A third, on a north-west/south-east alignment, was noted near the centre of the trench. No archaeological features were recorded.

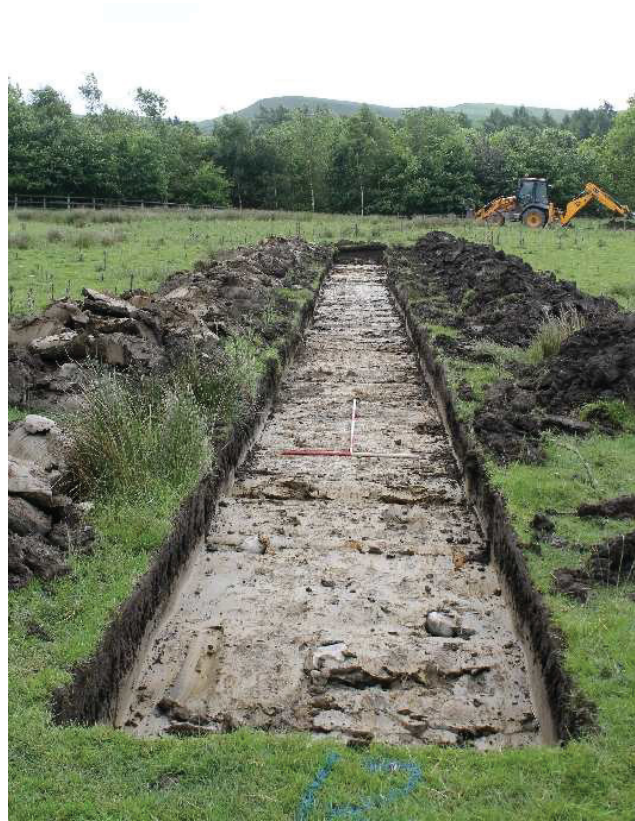
Plate 18: Trench 12, facing south

- 3.14.1 Trench 12 was aligned north-west to south-east and was located near the northern boundary of Field 3. Its excavation revealed natural clays, **1201**, at a depth of 0.29m below the present ground surface, and was overlain by subsoil **1202**, to a depth of 0.10m (Plate 18). Topsoil, **1203**, was 0.19m thick and sealed the subsoil beneath. The trench contained no archaeological features but a field drain was recorded at each end on a north-east/south-west alignment.

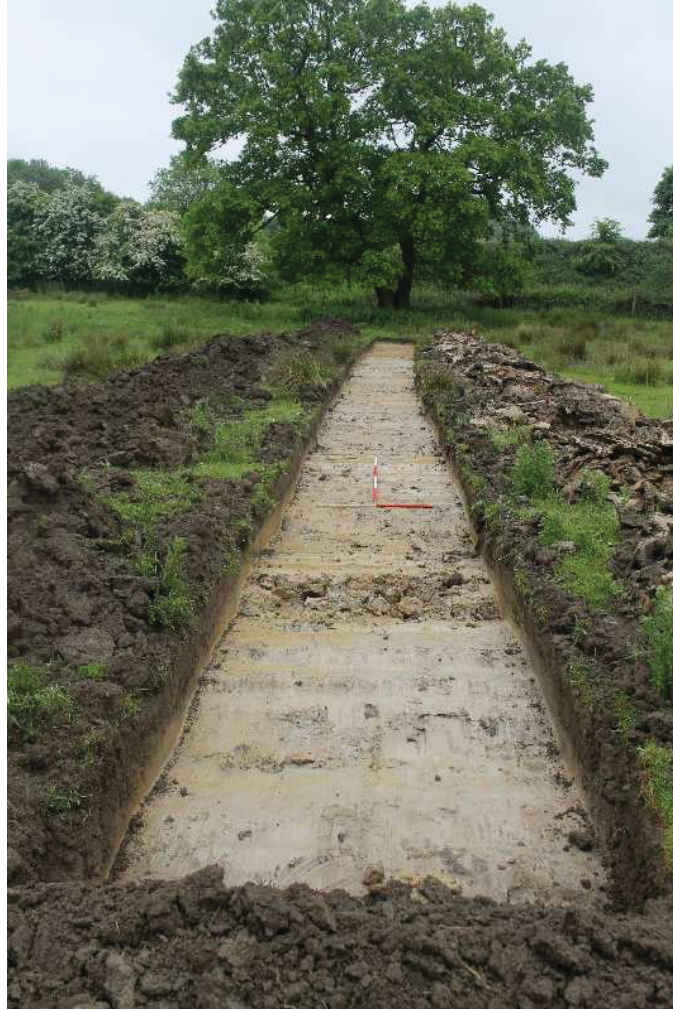
Plate 19: Trench 13, facing west

3.15.1 Trench 13 lay towards the centre of Field 2 upon a south-west to north-east alignment, but was shifted slightly further to the east from its originally intended location to avoid tree roots. Natural clay deposits, **1301**, were recorded 0.30m below the present ground surface and were sealed by a thin layer of subsoil, **1302**, which was 0.08m thick (Plate 19). A layer of topsoil, **1303**, was 0.22m thick and covered the subsoil deposit. Field drains, upon a broadly north/south alignment, lay at the north-eastern and south-western ends of the trench. No archaeological features were recorded.

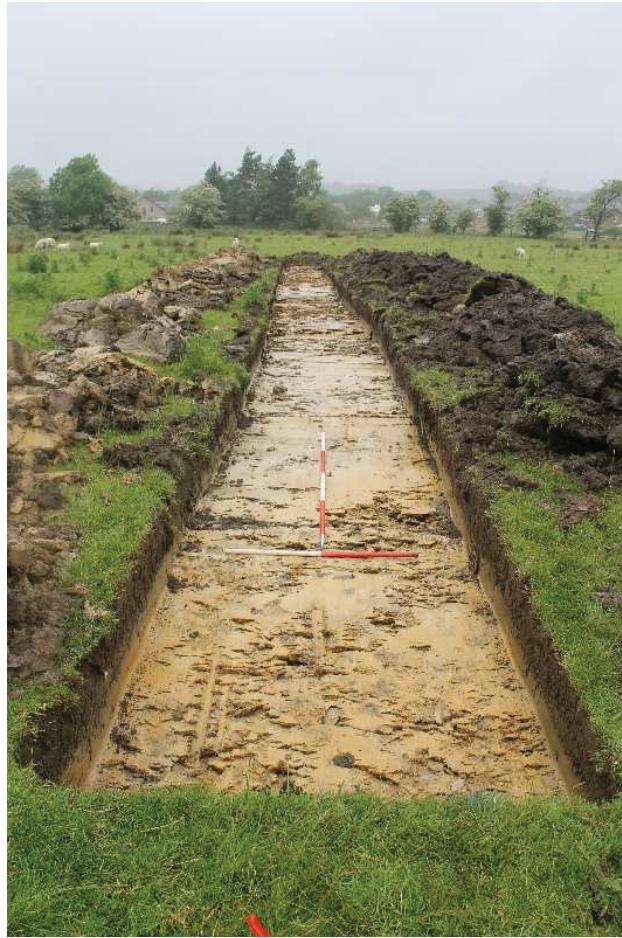
Plate 20: Trench 14, facing north

- 3.16.1 Trench 14 was located towards the southern end of Field 3 and was aligned north-west/south-east. Natural clays, **1401**, were recorded at a depth of 0.34m below the present ground surface and were sealed by a layer of subsoil, **1402**, that was 0.10m thick (Plate 20). The subsoil was covered by a layer of topsoil, **1403**, which was 0.14m thick. No archaeological features were revealed but there was a field drain at the south-western end of the trench and another towards the opposite end, both were on a broadly north/south alignment.

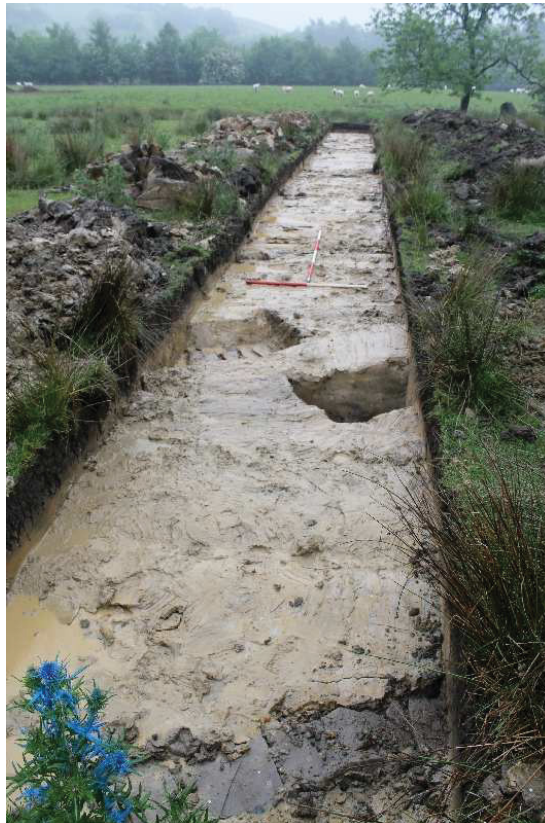
3.17.1 Trench 15 (Fig 3) lay in the southern corner of Field 2 on a north-west to south-east alignment. Its excavation revealed natural clays, **1509**, at a depth of 0.30m beneath the present ground surface and was overlain by a layer of subsoil, **1508**, that was 0.11m thick (Fig 3; Plate 21). Two ditches were encountered towards the north-western end, less than half a metre apart and both were aligned north/south.

Plate 21: Trench 15, facing south-east

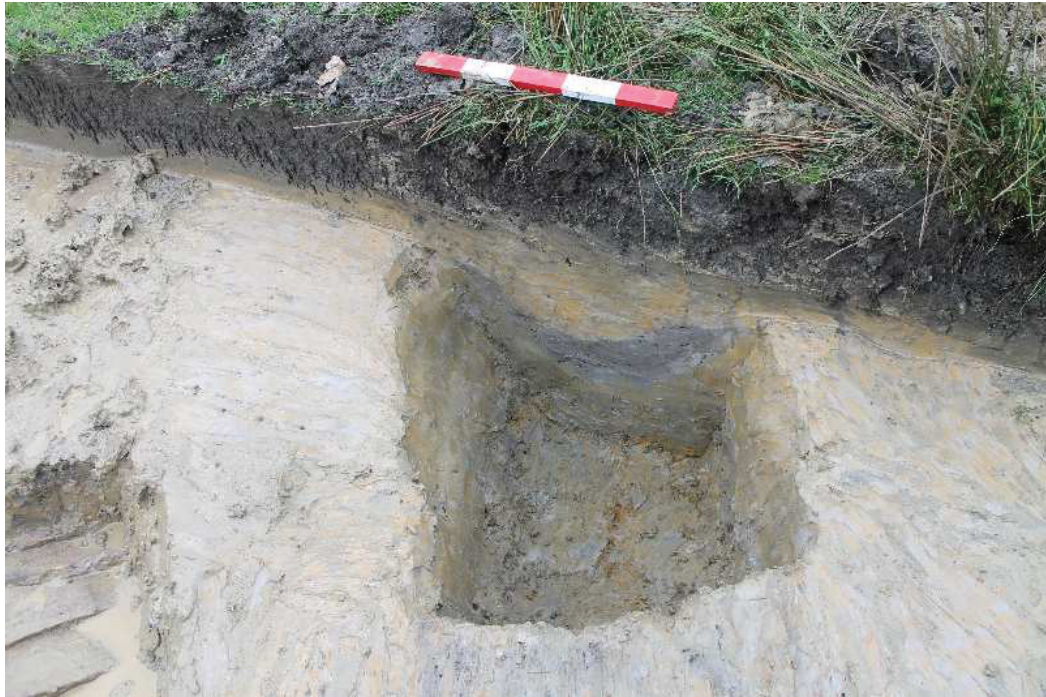
3.17.2 The first ditch, **1501**, clearly cut through the subsoil, had steep concave sides, a flat base and reached a maximum depth of 0.59m (Plate 22; Fig 4). It extended beyond the limits of excavation to both the north and south and had a width of 0.88m. Its lower third was filled with a mid-grey silt clay with patches of orange clay throughout, **1504**, indicative of redeposited natural and was up to 0.25m thick (Plate 23). Above this lay a greyish-blue silty clay, **1503**, that was up to 0.15m thick. This in turn lay beneath a mottled orange and brown clay **1502**, which was 0.28m thick, and which filled the upper third of the ditch. None of the fills included any dating material.

Plate 22: The north-facing section of ditch **1501**, 0.5m scale

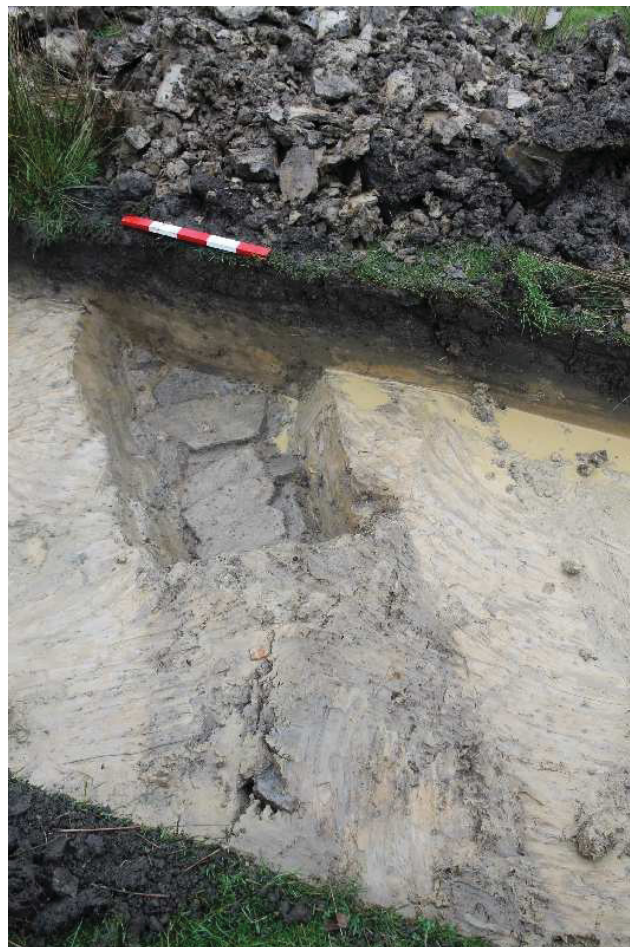
3.17.3 The second ditch, **1505**, also cut through the subsoil but had a moderate, slightly concave sloping sides and a flat base (Fig 4); it had a width of 1.08m and a maximum depth of 0.33m. At the base of the cut was a series of overlapping flat stones, of roughly rectangular shape, and these had been covered by a redeposited

mid-brown-orange natural clay backfill, mixed with patches of grey-brown clay silt, **1506**. This deposit filled the entirety of the ditch and contained two fragments of pottery.

Plate 23: The south-facing section of ditch **1505**, 0.5m scale

- 3.20.2 Three joining fragments from ditch **1505** (fill **1506**) are from a hand-thrown Staffordshire-type slip-decorated dish; although it was most probably of earlier eighteenth-century date, it could date to the late seventeenth-century. Eighteenth-century press-moulded pottery was recovered during an early phase of the works (OA North 2014), giving the impression of some, albeit disparate, activity at this time.

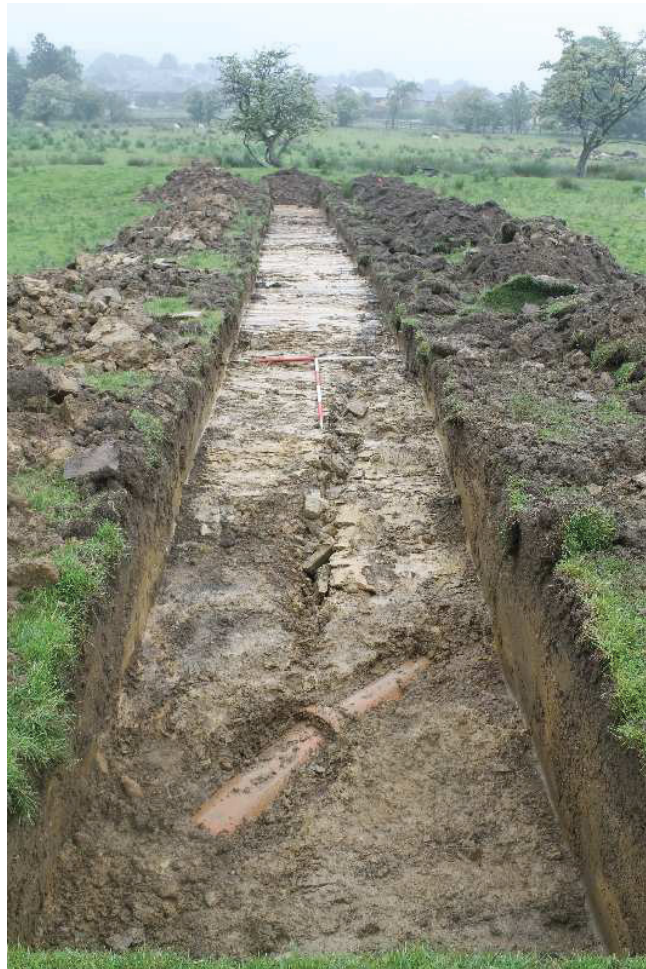
Plate 24: Trench 16, facing north

3.18.1 Trench 16 lay in the south-eastern corner of Field 2 and was excavated along a north/south alignment. Natural clay, **1601**, was encountered at a depth of 0.28m below the ground surface and was covered by a layer of subsoil, **1602**, which was 0.10m thick (Plate 24). Two field drains had been cut through the subsoil, one at the northern end of the trench on an east/west alignment and another to the south, extending north-eastwards from the southern end of the trench. The latter had been truncated at its southern end by the cut of a 0.25m ceramic water pipe which crossed the trench north-east/south-west at its southern end. A layer of topsoil, **1603**, 0.14m thick, sealed the drains and the subsoil beneath it. No archaeological features were recorded.

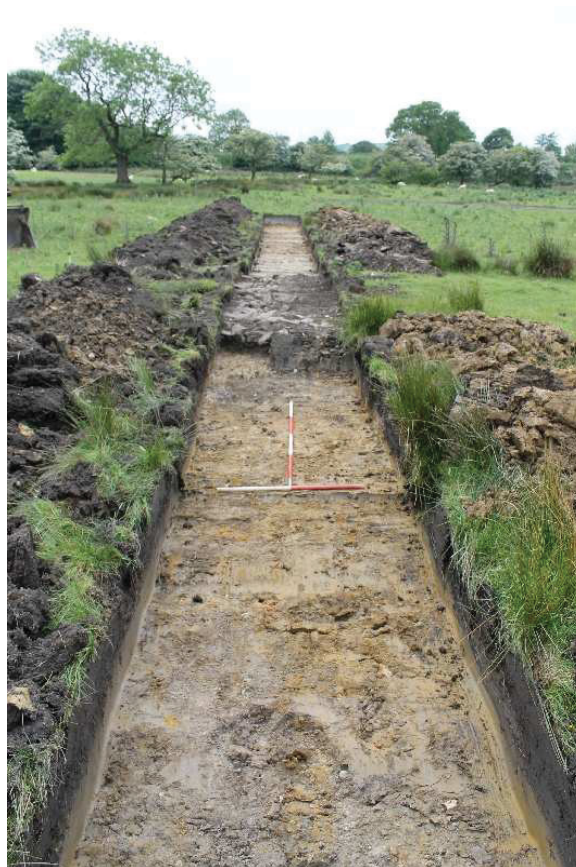
3.19.1 Trench 17 (Fig 3) lay at the eastern end of Field 3 and was shifted slightly to the west to avoid an area of marsh that would have flooded the trench. It was laid out on a north-east/south-west alignment and incorporated a raised linear bank at its north-eastern end which was visible above ground as an earthwork. Its excavation revealed natural clay deposits, **1705**, at a depth of 0.36m beneath the present ground surface, and was overlain by a mixed mid-grey-brown natural subsoil interface

deposit, **1704** (Plate 25). At the centre of the north-eastern half of the trench, this subsoil interface deposit had been cut away down to natural by a construction cut, **1707**, which was 6.60m in width and had a length that extended beyond the full width of the trench. Within this cut had been placed a layer of firm mid-yellow-brown silt clay, **1706**, which formed a base, that was 0.10m thick, upon which was constructed a raised track, **1701** (Plate 26; Fig 5). The raised track comprised a series of rectangular stone sets within a dark to mid-brown clay silt matrix, **1701**, that was 0.18m thick, 6.60m wide and had a gentle camber at each edge. Both **1706** and **1701** extended beyond the width of the trench on a north/south alignment. Two parallel lines of crushed, and sunken, stones ran along the length of the track, indicative of wheel ruts and which were consistent with heavy or extended use.

Plate 25: Trench 17, facing south-west

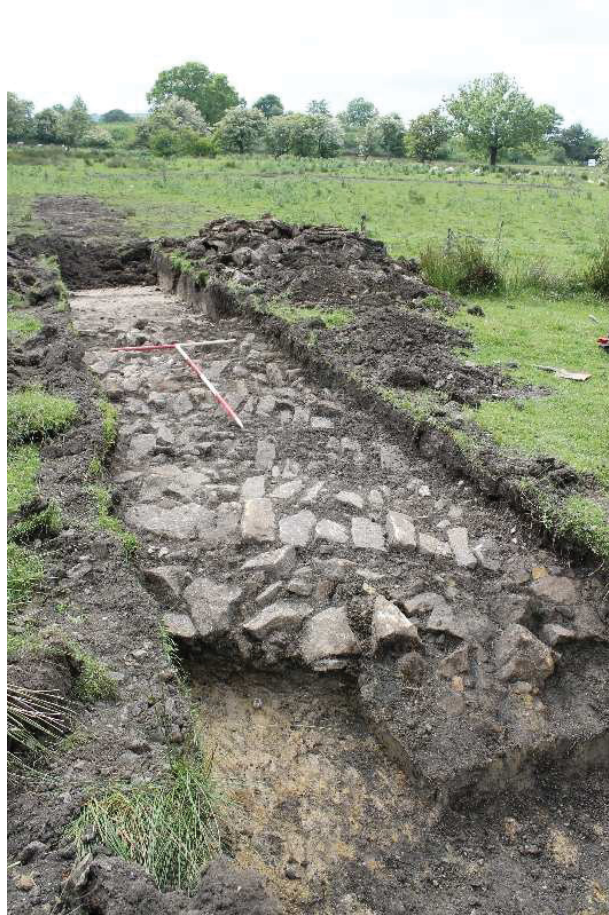
Plate 26: Raised track, **1701**, facing west, 2m scale and 1m scale

- 4.1.2 **Significance:** the roadway is of local interest because of its putative relationship with the railway, and it can be suggested that it is of Local Borough significance. It has now been recorded by the geophysical survey, the LiDAR earthwork survey, and a section through it has been obtained as a result of the archaeological evaluation, and which has generated finds sufficient to provide outline dating. The ridge and furrow is of low local interest for its contribution to our understanding of the development of agricultural practice in the area. Further excavation is unlikely to return significant additional information.

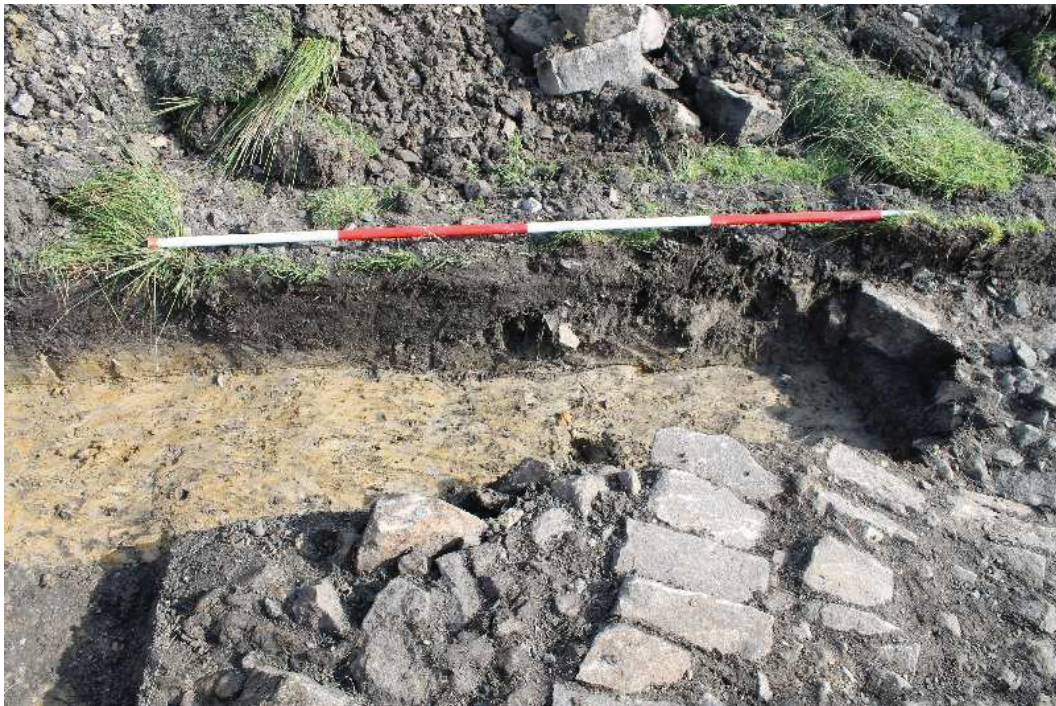
- 3.19.2 A sondage 0.80m wide was excavated into the easternmost edge of the track, revealing its construction and a fragment of calcinated bone was retrieved from deposit **1701** (Plate 27). Immediately above track **1701** lay a dark-brown silt subsoil, **1703**, which had a maximum thickness of 0.29m. This deposit extended across the full width of the trench, with the exception of the raised centre of the track, and its excavation yielded several fragments of eighteenth to nineteenth century pottery and clay pipe.

Plate 27: The north-facing section of sondage through track **1701**

- 3.20.3 Elsewhere, metalled trackway **1701** produced a single small fragment of calcined bone, which cannot clarify the dating of this particular feature. Layer **1703**, above this, produced one small fragment of clay tobacco pipe stem, and three of eighteenth and nineteenth-century pottery, providing a probable *terminus post quem* for the construction of the trackway around the mid-nineteenth century. The narrow bore of the tobacco pipe stem might also point towards a late date for the finds from this context.
