# **HELMSHORE MILLS TEXTILE MUSEUM, HELMSHORE, LANCASHIRE**

## **Archaeological Evaluation**

**Oxford Archaeology North**

August 2006

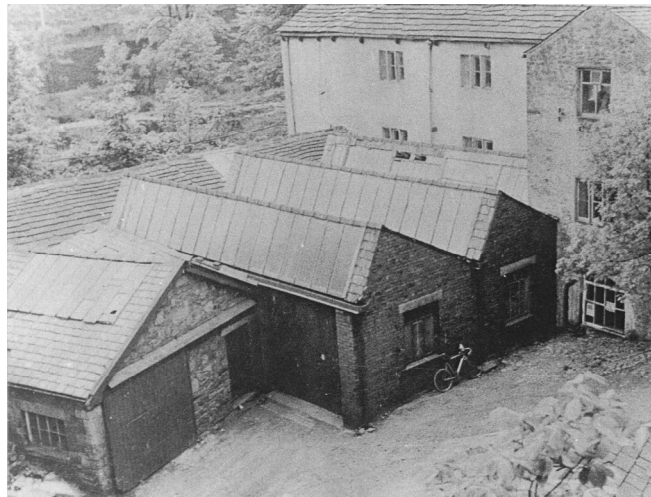
Plate 2: The boiler house (on the left) prior to demolition

- 3.2.8 It is uncertain precisely when the boiler house that forms the focus of the present investigation was erected, although it was probably contemporary with a single-storey extension linking the two mills (Plate 2). A recent survey concluded that this was possibly constructed sometime during the late nineteenth century, and was further extended in the 1980s, following the demolition of the boiler house (UMAU 2005). During its operational life, the boiler house contained a single Cornish-type boiler, which is thought to have been installed after the end of the First World War (I Gibson pers comm). Boilers of this type typically measured 16ft by 6ft. This boiler, however, was not connected with the mill's steam-power plant, but was intended to generate the steam for heating the working floors in the mill.

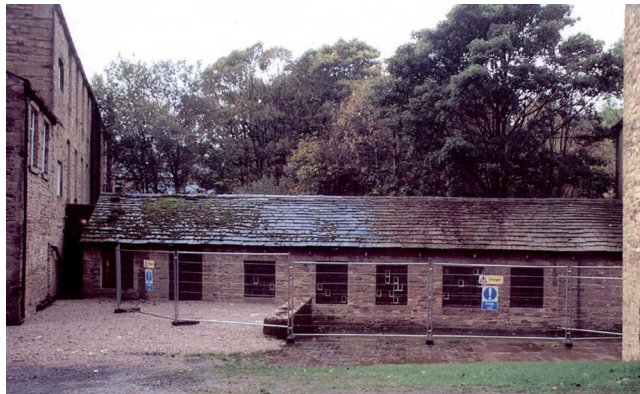
Plate 3: Looking west across site of boiler house

4.2.1 At the time of investigation, the footprint of the former boiler house was overlain with loose gravel, which had been deposited in recent years (Plate 3). This sealed a single-course flagstone surface, which butted the north wall of a single-storey stone-building extension connecting the two mills. A north/south-aligned wall (09) of a comparable date, extended north from a set of steps in front of the building. The part of the site investigated by TP 2 comprised a small yard, surfaced with sandstone flags, which lies some 0.5m below the ground level to the north. This part of the site was occupied by a single-storey structure (Plate 2), which has since been demolished. The site of the boiler house and the small flagstone yard are bounded to the north by an unsurfaced track, which provides an access route to domestic properties (Helmshore Cottages) to the west of the mill complex.

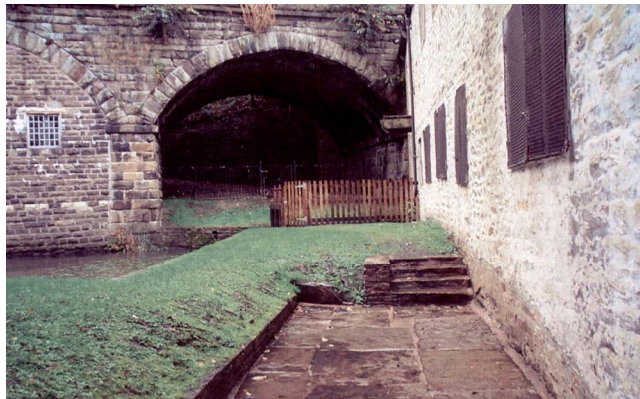
Plate 10: North elevation of Higher Mill

- 6.2.5 **The original headrace:** the point at which the headrace from the millpond to the original waterwheel entered Higher Mill is marked in the northern elevation of the mill by a blocked arched aperture, the crown of which is presently visible above ground level. A path currently exists between the north elevation of the mill and the millpond (Plate 10), which provides visitor access to the extant headrace. An element of the proposed development allows for the improvement of the visitor paths in this area of the site, which may result in a slight lowering of the present path level. Whilst this is unlikely to have a negative impact on any buried remains, it may expose the edges of the original headrace, which would require an accurate archaeological survey.

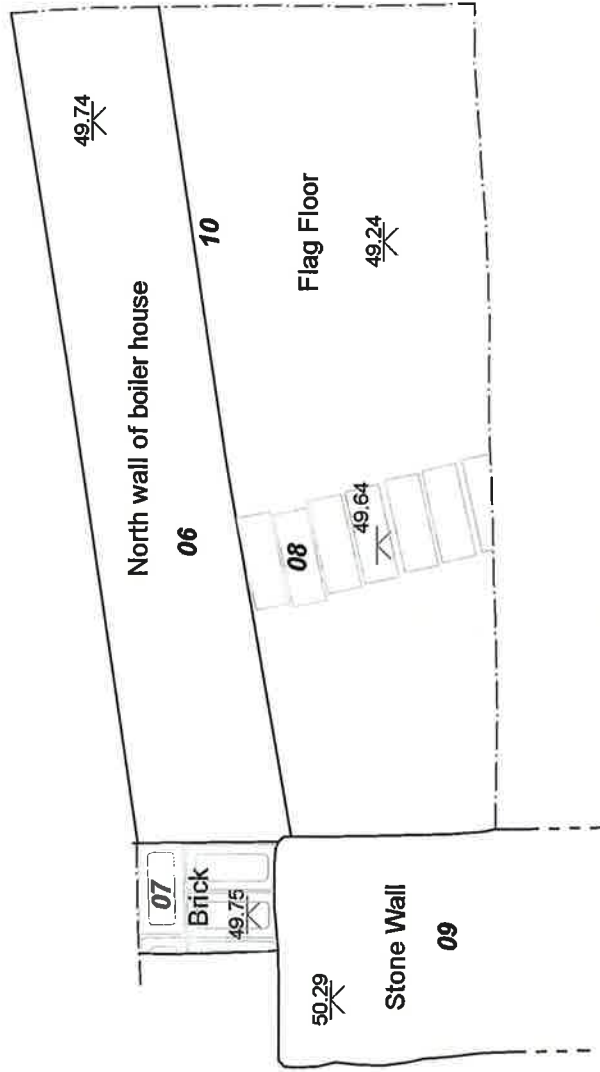
Figure 4: Plan of Test Pit 1

- 4.3.11 The earliest remains exposed in the test pit comprised a 0.40m-wide stone wall (**06**), exposed immediately below the modern gravel surface at a height of 49.74m aOD, and a floor (**10**), represented by a single flagstone. Wall **06** was aligned north-east/south-west, and was exposed to a depth of 0.40m. It comprised two courses of irregularly-sized stones, varying between square blocks measuring 100mm<sup>2</sup>, and thin slabs measuring 100mm by 50mm, that were bonded with compacted ash-rich grey mortar. The wall undoubtedly represented the north wall of the boiler house.

- 4.3.12 Wall **06** was abutted by a large, worn flagstone (**10**), which appeared to be of the same phase of construction as the wall. It was exposed at the same level as floor **03** in Trench A, and almost certainly represented part of the original floor within the boiler house.

- 4.3.13 Wall **08** was located in the centre of the test pit, aligned north/south, and placed on top of the boiler house floor. The wall comprised three courses of machine-pressed, frogged bricks, which had been crudely laid without the use of any bonding material. The rationale of wall **09** remains uncertain, although it may have formed the foundation for a partition within the boiler house, representing a modification to the original build.

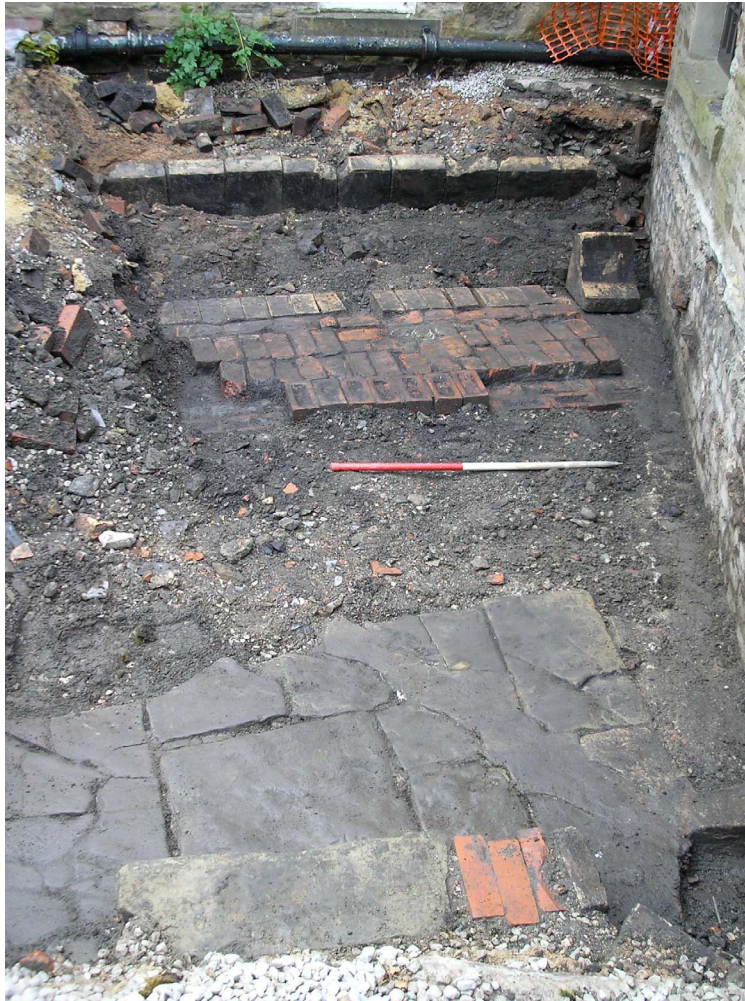
Plate 4: View of Trench A, looking south

- 4.3.1 **Trench A:** an east/west-aligned trench, measuring 5m by 3.4m (Plate 4), was placed along the north elevation of the single-storey building linking the two mills (Fig 2). The loose, uppermost deposits within the trench, comprising gravel and rubble mixed with sand, were battered to a safe angle of repose, reducing the investigated area to 4.4m by 2.2m. The trench was excavated to an overall maximum depth of 0.85m.

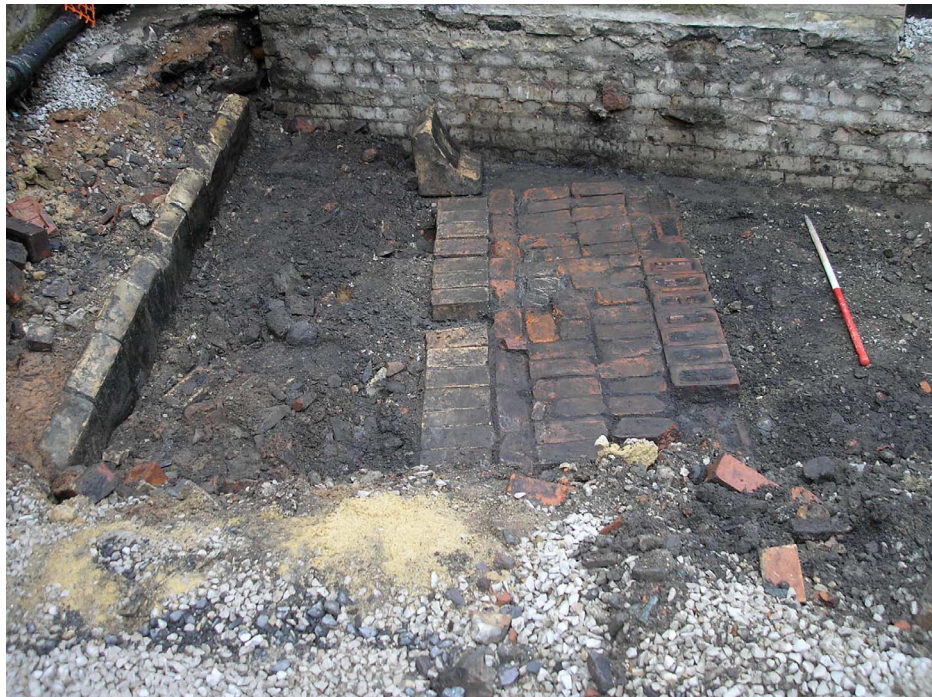
Plate 5: Boiler mounting blocks and seating wall within Trench A

- 4.3.4 The upper surface of the boiler seating wall (**02**) was exposed some 1.3m to the south of floor **03**, at a height of 49.27m aOD (Plate 5). This low wall measured 1m wide, extending north/south across the trench, and was exposed at a depth of 0.73m below the modern ground surface. It comprised a single skin of refractory brick headers (each measuring 220mm x 110mm x 90mm) along the eastern edge, bonded to three strings of hand-made bricks (200mm x 100mm by 80mm) set in lime-based mortar. A row of hard-fired Accrington bricks, set in an ash-rich mortar, lined the western edge of the seating wall. The rationale for the inclusion of Accrington bricks is uncertain; they may have been intended purely for decorative purposes, although they may perhaps denote a later addition to the structure. A single concave boiler mounting block was exposed *in-situ* on top of the wall, representing the sole survivor of what would have been a series of such blocks. However, a line of nine *in situ* boiler mounting blocks (**01**) was exposed 0.9m to the east, representing the position of the second boiler seating wall.

- 4.3.5 The row of boiler mounts (**01**) was orientated north/south along the eastern edge of the trench (Plate 5); the southern edge of the row had seemingly been removed during the construction of the single-storey washroom during the 1980s. Each mount measured 0.30m wide and 0.33m high, and comprised a flat-based refractory block with a chamfered edge along the top sloping, which

will have provided the point of contact with the boiler. The paucity of boiler mounts on the western seating wall suggest that the boiler was dragged rather than lifted away from its original position during removal.

- 4.3.6 The 0.90m-wide space between the boiler mounting blocks (**01**) and seating wall **02** was filled by brick rubble and fuel waste. This presumably overlay a reduced-level floor beneath the boiler, although this was not exposed during the evaluation.

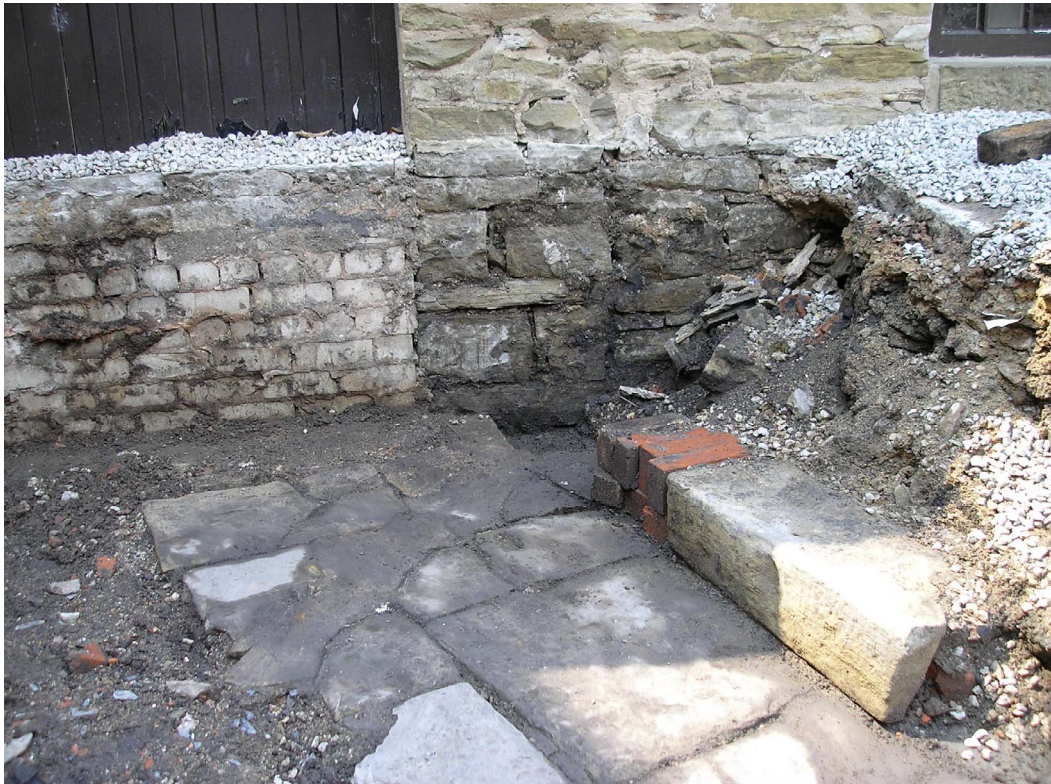
Plate 6: Boiler house floor, Trench A, with east wall of 1980s extension to the rear

- 4.3.8 A layer of concrete infill (**04**), observed butting the southern edge of floor **03** and boiler seating wall **02**, formed part of the north wall of the extension to the washroom, which was built during the 1980s. This appeared to be associated with an area of brick repair, situated below the doorway for a distance of 3.40m and at height of 1m above the concrete infill. It comprised eight courses of glazed bricks married with cement mortar, which was also possibly installed during the extension work to the washroom building in the 1980s (Plate 6).

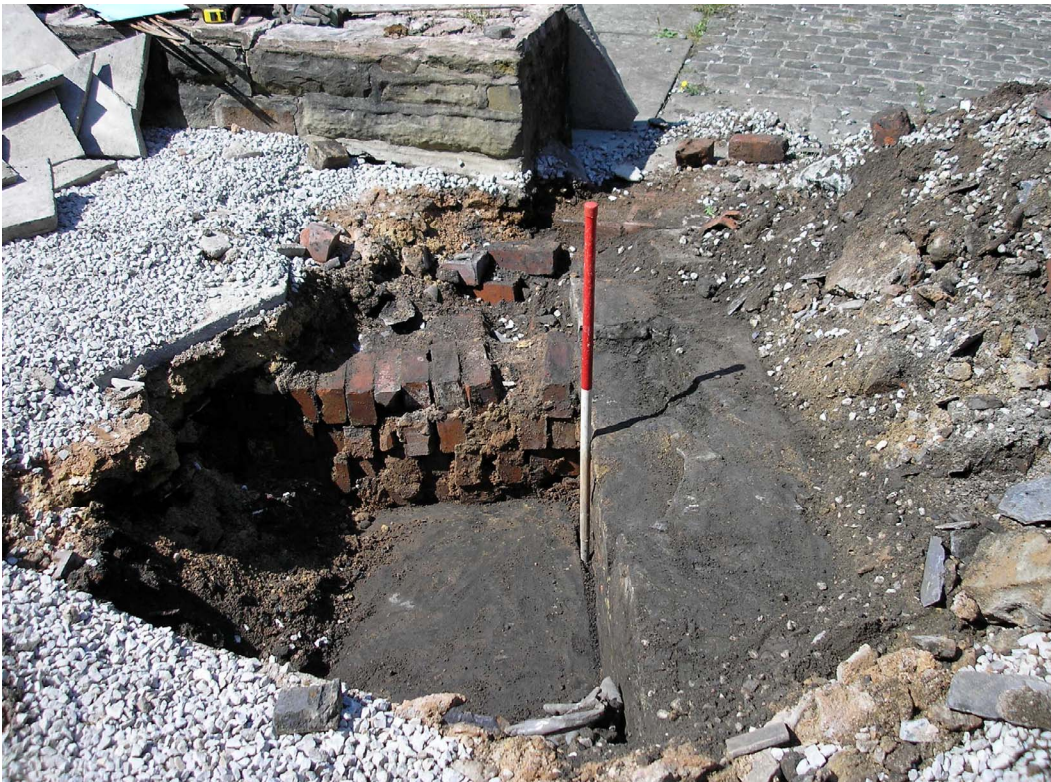
Plate 7: View of Test Pit 1, looking north

- 4.3.10 **Test Pit 1:** this east/west-aligned test pit measured 2.20m by 1.2m, and was placed across the north-western corner of the former boiler house (Plate 7). It was excavated to a maximum depth of 0.40m onto the top of a stone-flagged floor (**10**), which was exposed at a depth of 49.64m aOD (Fig 4). Other *in situ* remains encountered included the north wall (**06**) of the boiler house, part of the original floor (**10**), and a small brick wall (**08**) of uncertain function that overlay the floor. The structural remains were backfilled with loose soil and debris, including rubble and plastics, indicative of recent deposition.

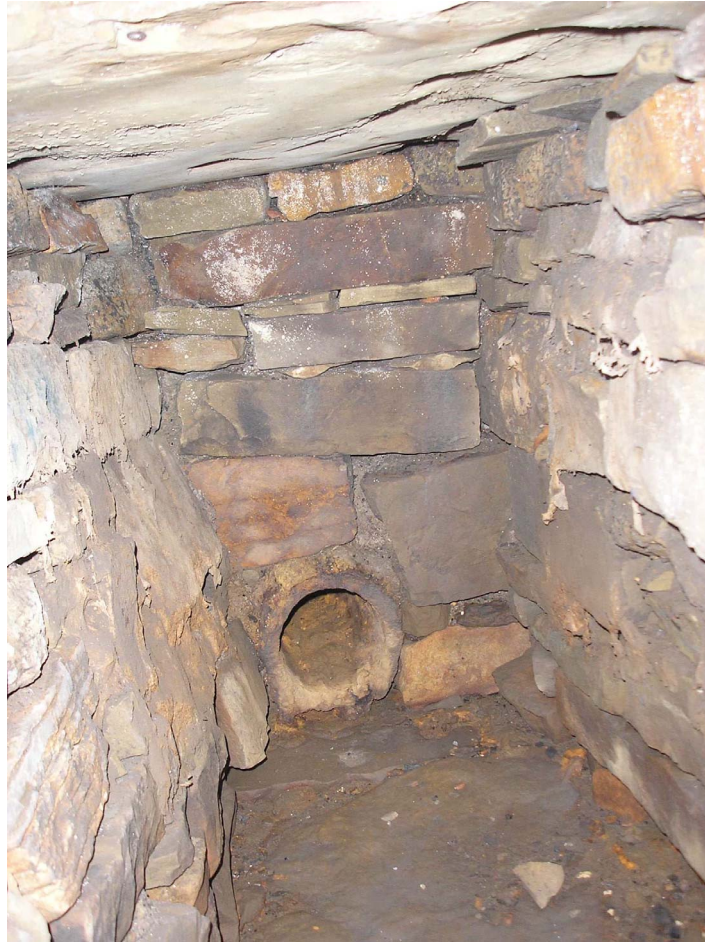
Plate 8: Culvert in Test Pit 2

- 4.3.15 A north/south-aligned culvert (**II**) was encountered immediately below the flagstone at a depth of 1.20m below the yard surface (Plate 8). The culvert was observed running into a damaged section of the tailrace roof, which was observed at a depth of 0.30m below the base of the culvert. A 90mm-diameter iron pipe had been installed at the entrance into the culvert, which appeared to run in the direction of the new washroom building. However, the pipe was seemingly no longer in use as a drain.

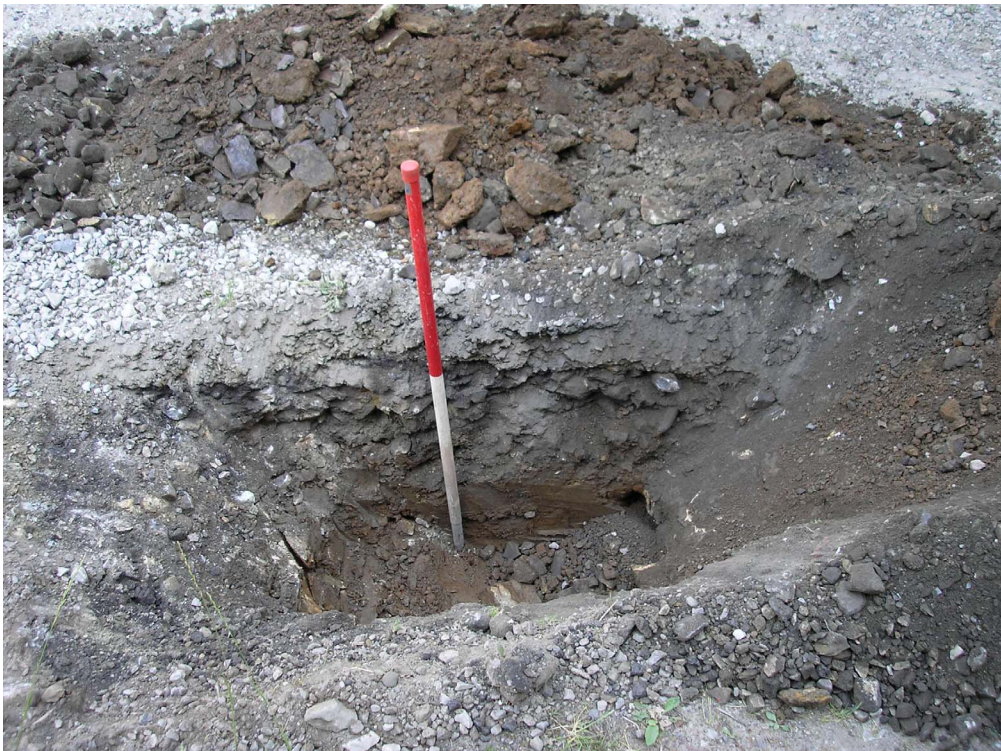
Plate 9: View of Test Pit 3

- 4.3.16 **Test Pit 3**: the test pit was placed adjacent to the access track that passes along the eastern edge of the mill complex (Fig 2). It measured 0.50m<sup>2</sup>, and was excavated to a depth of 1m. No *in situ* archaeological features were observed in the pit (Plate 9).

- 4.3.17 The exposed deposits comprised a 0.40m-thick layer of red silty-clay at the base of the test pit, which was sealed by 0.15m-thick layer of loose subsoil. This was overlaid by 0.35m-thick deposit of stone overburden that was associated with levelling for the access track.

- 6.2.4 **The access track:** the excavation of Test Pit 3 has confirmed an absence of buried structural remains along the western edge of the access track to Helmshore Cottages. The proposed installation of new surface drainage infrastructure will not therefore have a negative impact on the sub-surface archaeological resource. Indeed, improved surface drainage may even be seen as a positive direct impact, as it will remove a potential cause of erosion to the extant remains.
