# **ST SAVIOUR'S CE CHURCH, STYDD, Lancashire**

## **Archaeological Watching Brief**

May 2006

**IWA Architects/ St Wilfrid's  
and St Saviour's Parochial  
Church Council**

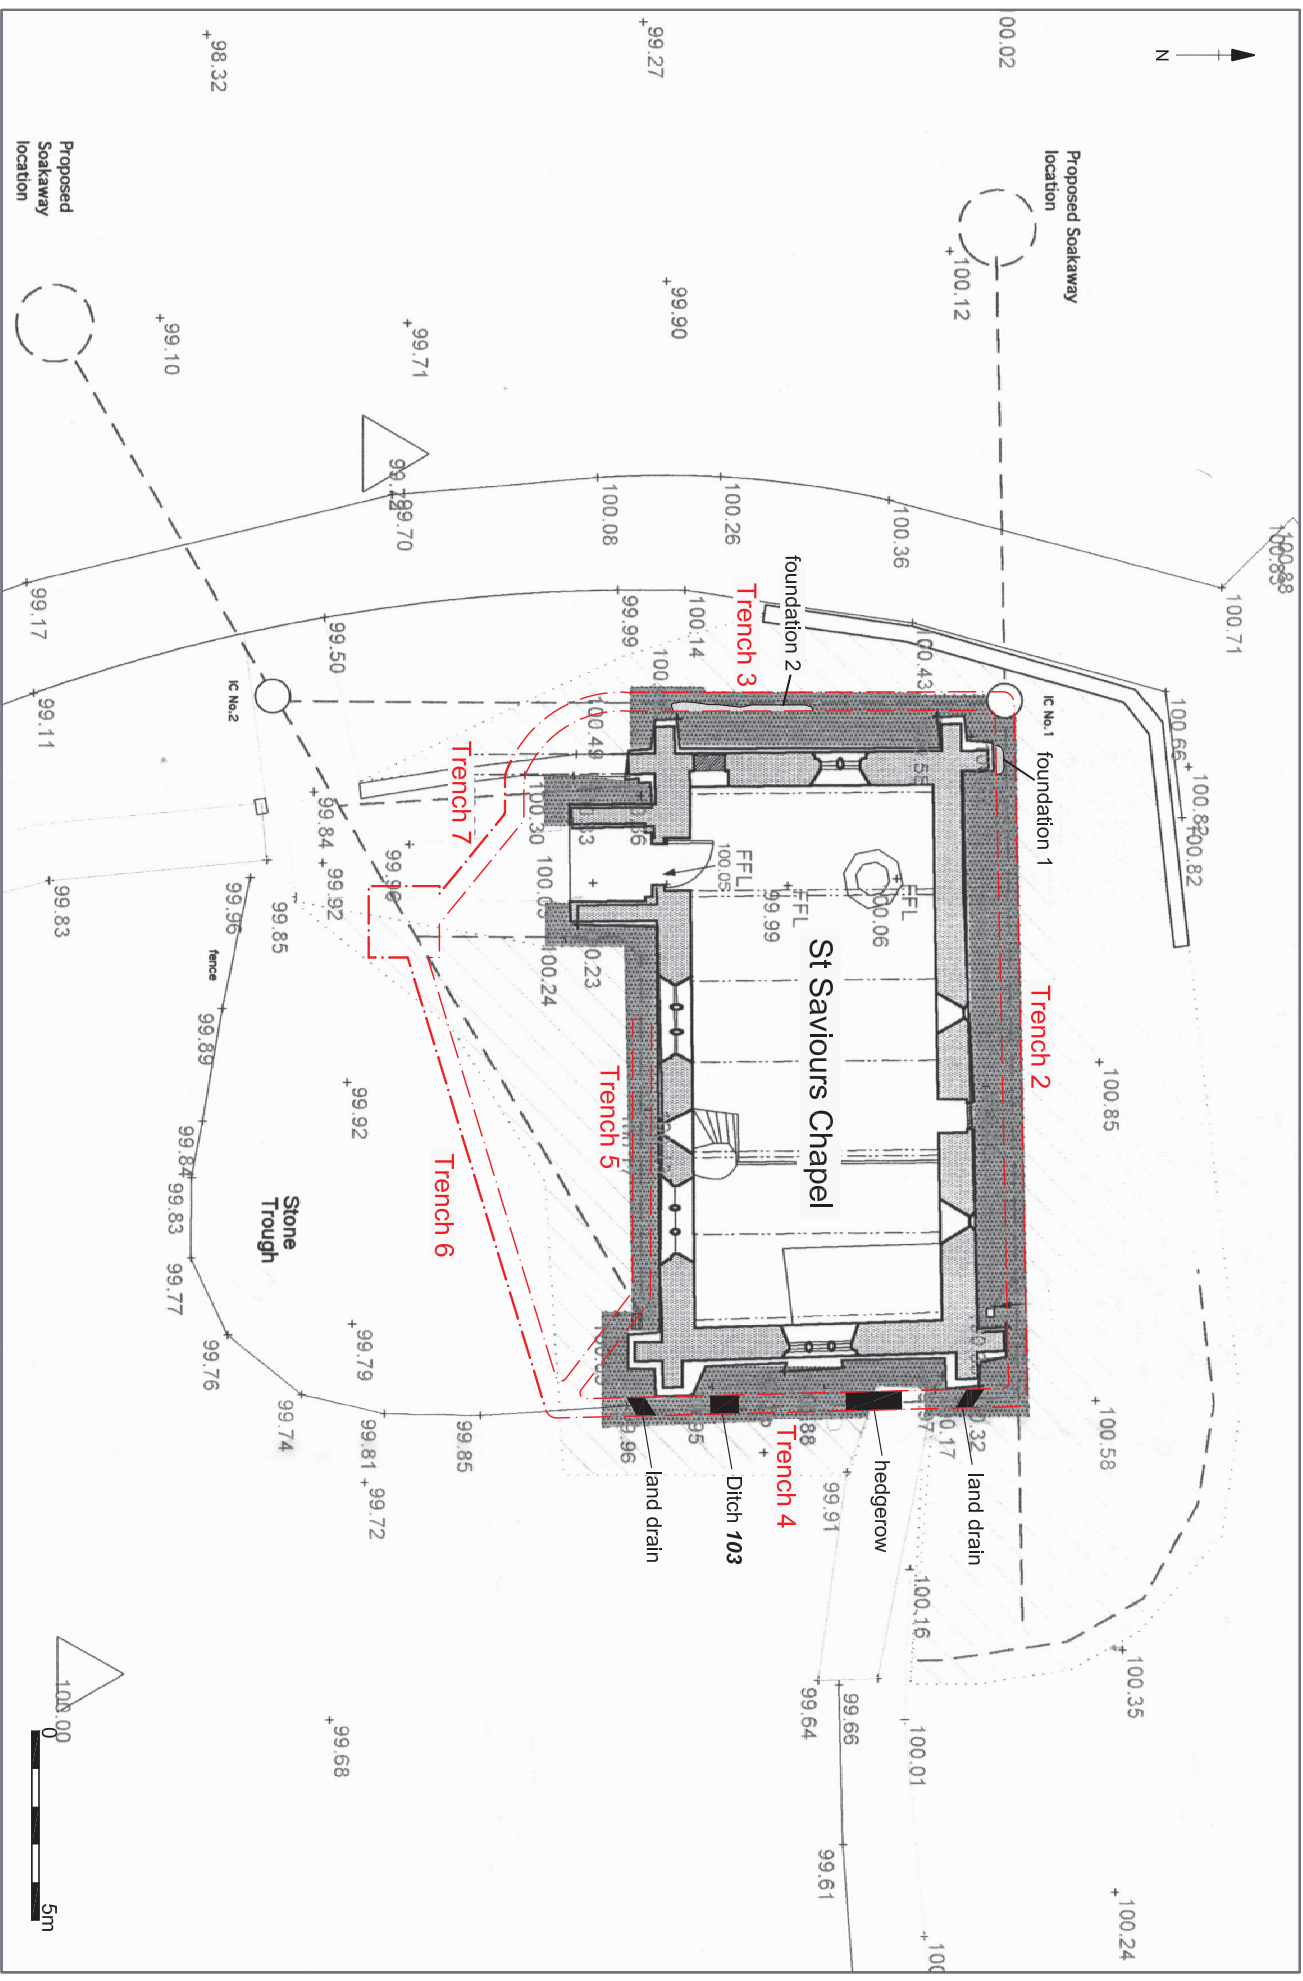
Figure 2: Trench Location Plan

- 4.1.1 **Introduction:** the groundworks were effected over a three day period and in total, seven trenches and one sump were opened (Fig 2). For all the trenches, the ground was graded to a reduced level equivalent to 0.15m below the present internal floor of the church.

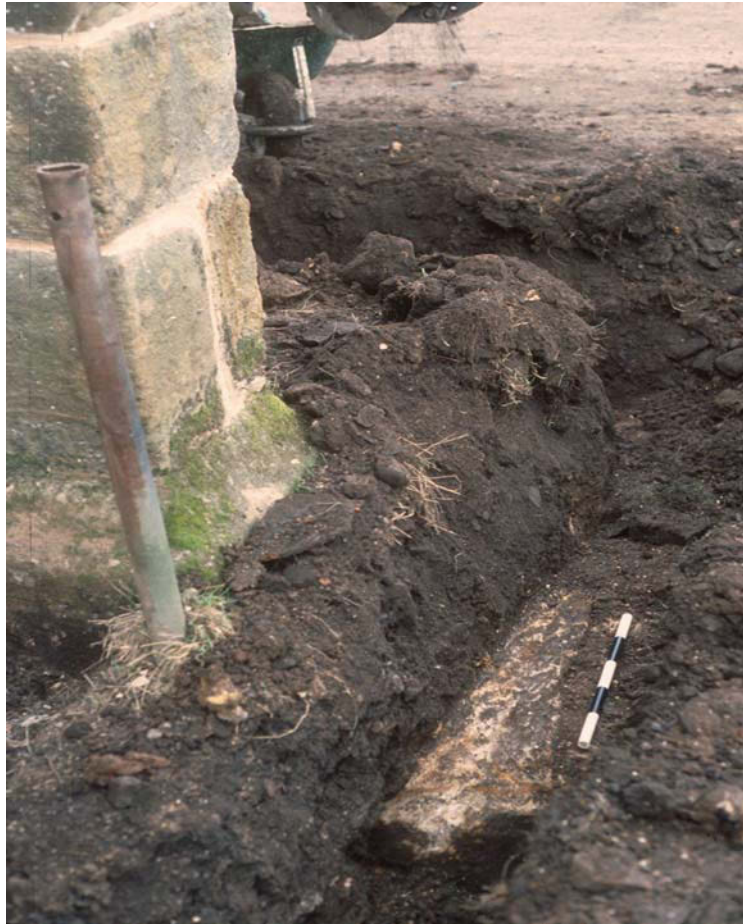
- 4.1.3 **Trench 2:** oriented east/west along the northern wall of the church, this measured c 18.0m x 0.6m x 1.0m (maximum). The stratigraphy comprised 0.3m dark brown sandy-clay topsoil with sandstone fragments and a moderate amount of fragments of stone roof tile over mid-greyish brown sandy, stony-clay silt subsoil with some stones. The foundation stone for the western buttress was observed within the trench (Fig 2; Plate 1) at a depth of 0.5m below ground surface. It was 0.8m long, at least 0.25m wide and over 0.25m in depth. Finds of pottery were also recovered from the trench (*Section 4.2*).

Plate 1: Butters foundation in Trench 2 – facing south-west

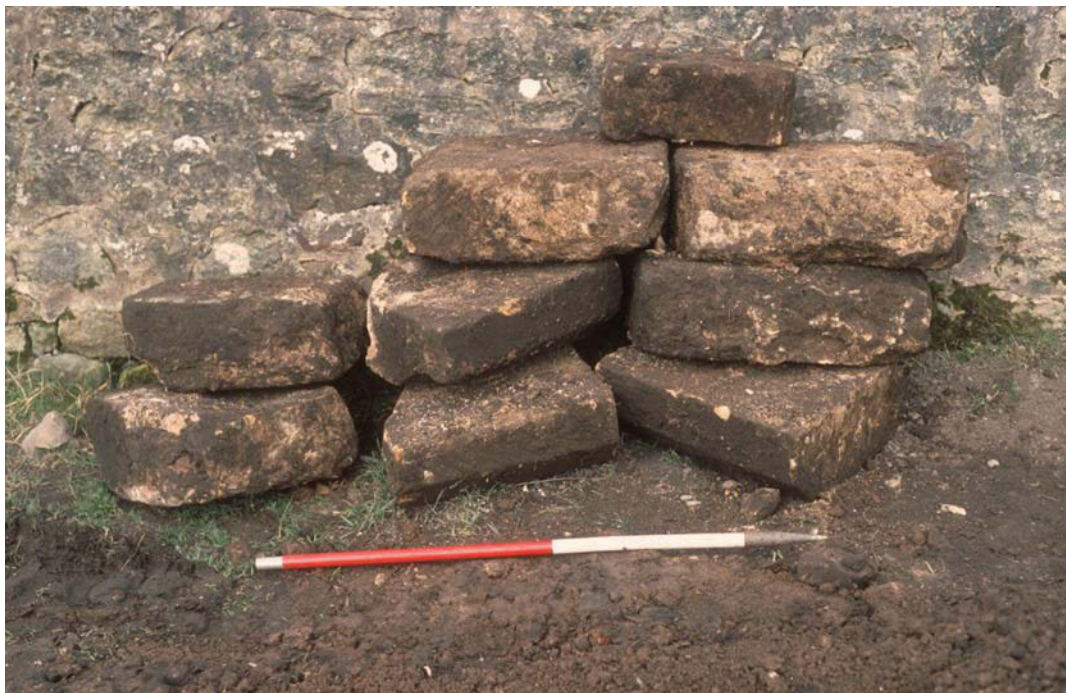
- 4.1.4 **Trench 3:** oriented north/south along the west wall of the church, this measured c; 14.0m x 0.6m x 0.9m. The stratigraphy entirely comprised 0.4m dark brown sandy-clay topsoil over 0.5m brown silty-clay subsoil. Nine large, worked pieces of stone were recovered from along its length (Plate 2), all with a chamfered edge and typically measuring 570mm x 330mm x 200mm. A foundation was encountered 3.16m north of the west buttress comprising un-worked sandstone blocks of between 340mm x 140mm and 170mm x 80mm. They were bonded by buff sandy mortar and bedded on the brown sandy-clay-silt subsoil. The maximum depth of the foundation, at its southernmost extent, was 0.6m below present ground surface.

Plate 2: Worked masonry from Trench 3

- 5.1.3 Following the Dissolution of the Monasteries, the manor and church were seized by the Crown and the hospice, which would originally have comprised a suite of buildings, was destroyed. The chamfered blocks of stone found within Trench 2 (Plate 2) could be taken as evidence of this destruction. It is quite possible that they were the remains of another building which may well have adjoined the church to the west, the remains of which will now lie beneath the present access road to the farm.

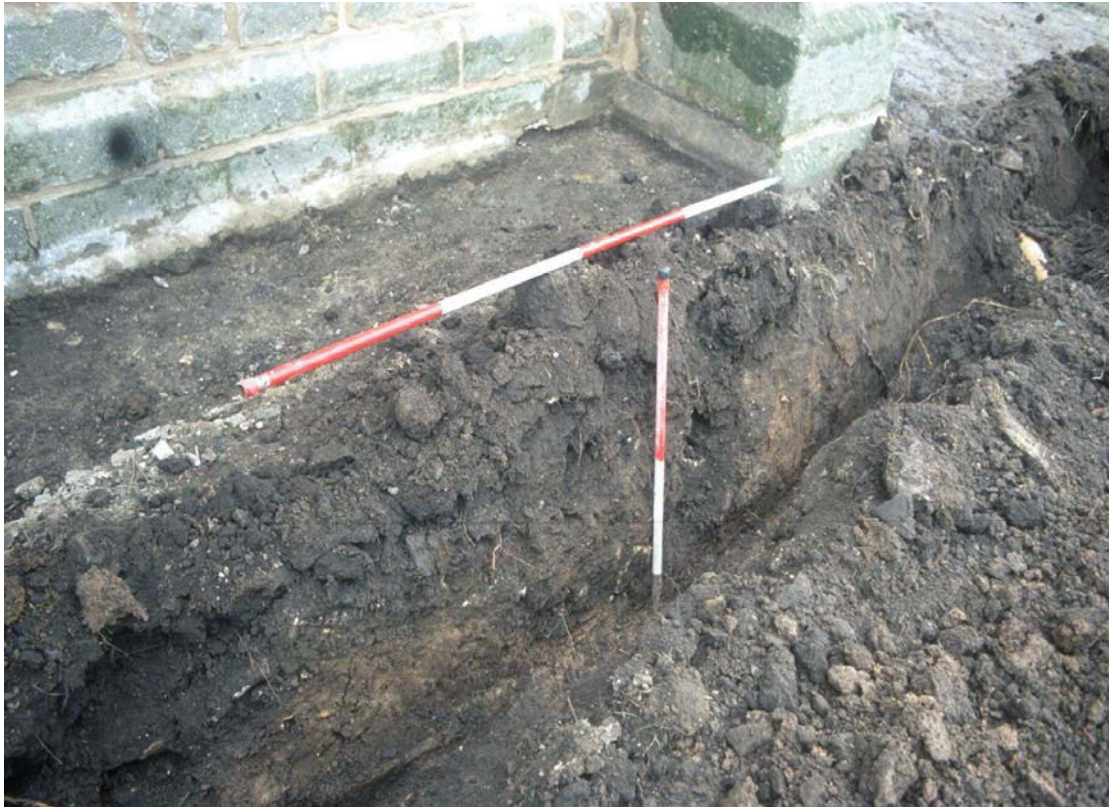
- 4.1.5 **Trench 4:** oriented north/south along the eastern wall of the church, this measured c 10m x 0.6m x 0.65m and the stratigraphy comprised 0.1m topsoil (**100**) over 0.13m sub-soil (**101**) over clay natural (**104**). An east/west aligned linear feature (**103**, Fig 3) was observed 1.5m north of the southern terminus of the trench (Plate 3). Its fill (**102**) contained some redeposited yellow sandstone masonry with evidence of mortar bond but there were no diagnostic finds.

Plate 3: Ditch in north-east-facing section of Trench 4

- 5.1.1 The single linear feature in Trench 4 seemingly extended beneath the present building and, therefore, must predate its construction, although no diagnostic finds were recovered to corroborate this. Its function remains unclear and it was not evident from the section whether the ditch had silted-up naturally or had been deliberately backfilled. The presence of mortar bonded sandstone fragments within its fill does nevertheless suggest that it was open possibly during the construction of the church. If it immediately pre-dated or was contemporary with the building of the church, it is certainly of local importance given the relative paucity of medieval sites, features and finds within Lancashire as a whole.

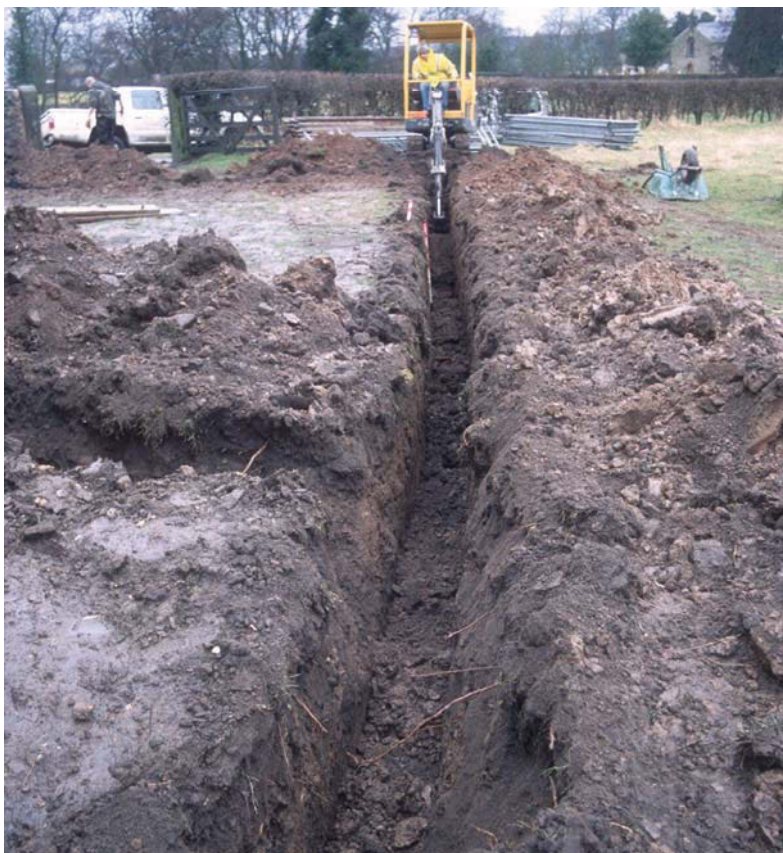
- 4.1.7 **Trench 6:** oriented south-west/north-east between the sump (*Section 4.1.8*) and *Trench 4*, this measured *c* 14.0m x 0.6m x 0.7m (Plate 4). The trench was entirely excavated through firm, light-brown to buff gravelly clay natural with some sand and inclusions sandstone fragments. There were no archaeological horizons observed and no finds recovered.

Plate 4: Plan of Trench 6 facing south-west

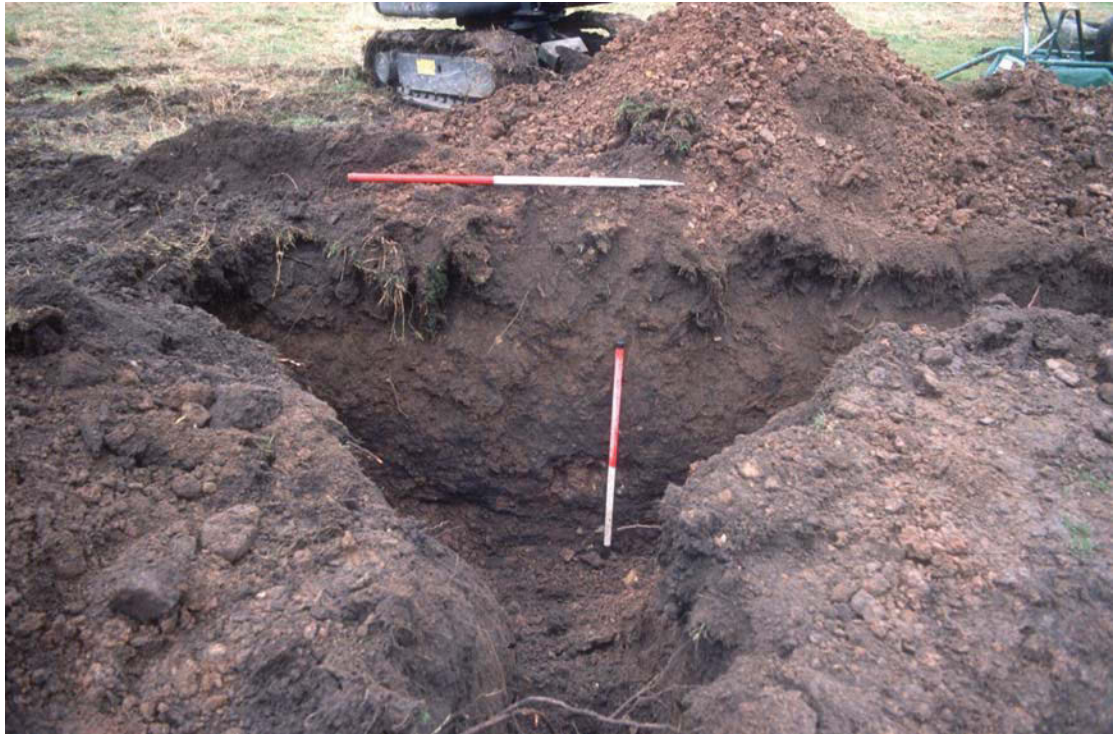
- 4.1.9 **Sump:** the soakaway measured 2.0m x 2.0m x 1.2m (Plate 5) and was entirely excavated through firm, light-brown to buff gravelly clay natural with some sand and inclusions of sandstone fragments. There were no archaeological horizons observed and no finds recovered.

Plate 5: General view of sump facing south-east
