**Lower Mill,
Mill Lane,
Cheadle,
Cheshire**

**Archaeological
Investigation**

Interim Report

Oxford Archaeology North

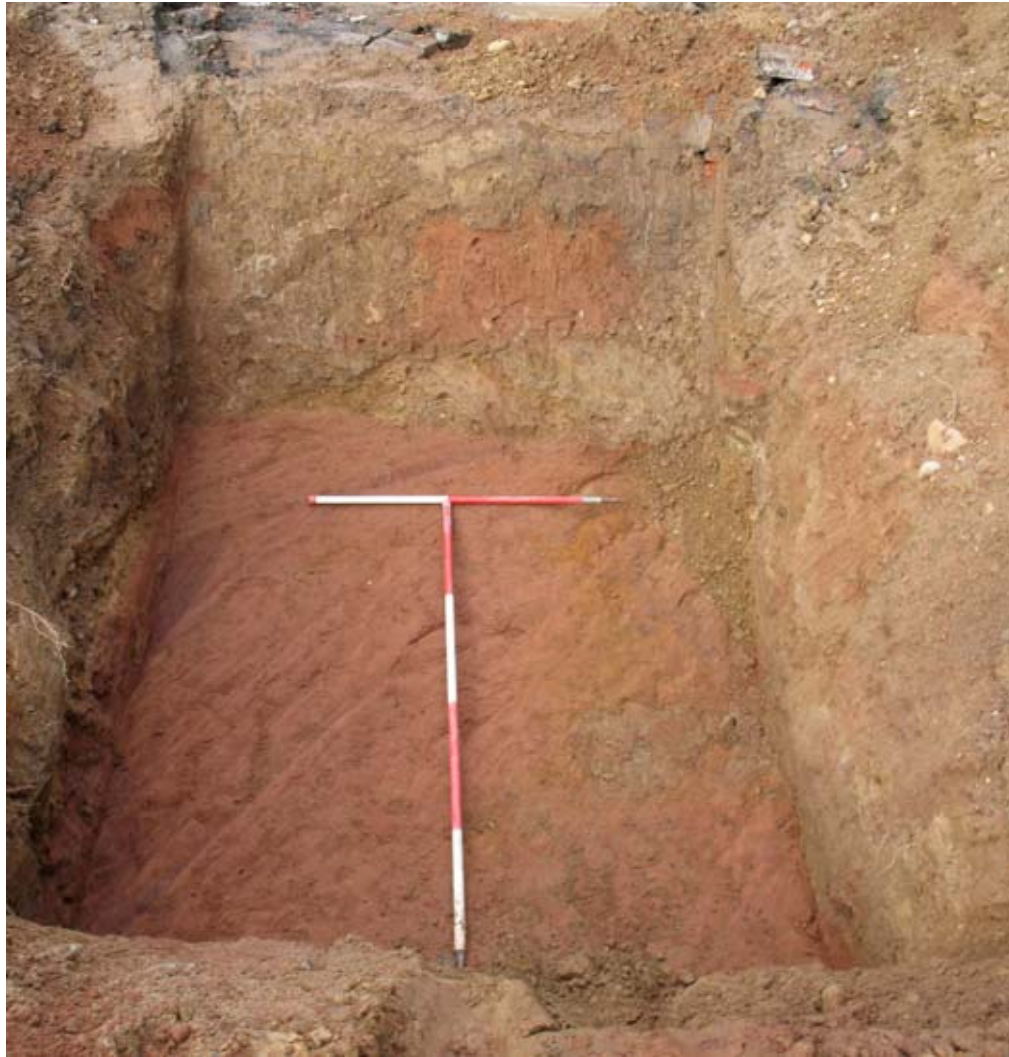
Plate 28: Looking north-east across Trench 2

- 5.2.5 **Trench 2:** this small trench was placed a short distance to the south-west of Trench 1, measured 2m long was excavated to a maximum depth of 1.05m (Fig 11). No deposits or features of archaeological interest were encountered.
- 5.2.6 The solid geology, comprising red sandstone, was exposed at the base of the excavated trench (Plate 28). This was overlain by a deposit of pale yellow sandy gravel, which had an average depth of 0.19m, and a deposit of grey clayey-sand (Plate 29).

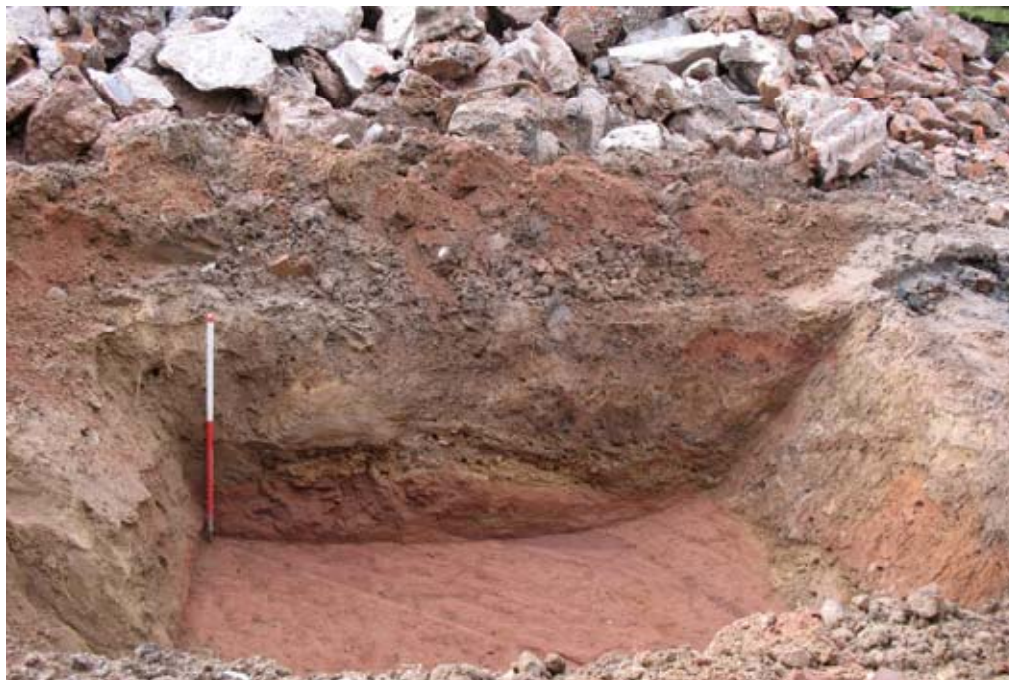
Plate 29: Looking north-west across Trench 2

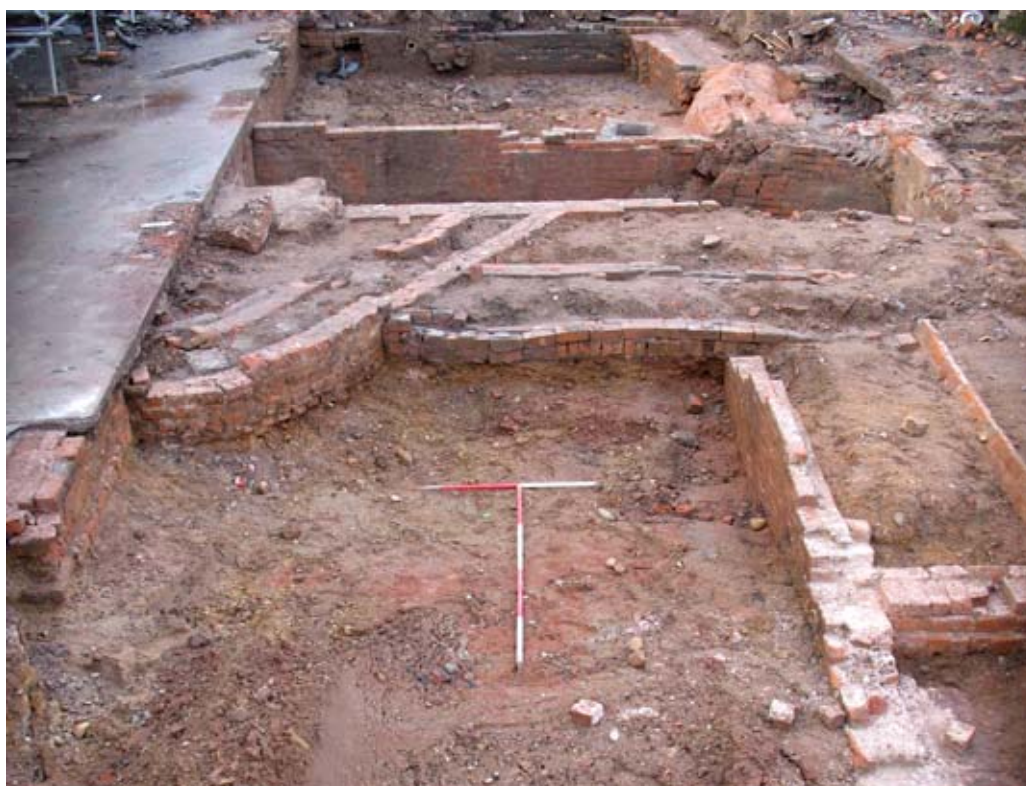
Plate 30: View looking west across Area 1

- 5.3.1 Area 1 comprised an area measuring 20.1 x 8.0m, and was located along the southern edge of the site, across the footprint of the former Hanging Stove room of the bleach works (Fig 11). The exposed remains were dominated by a series of structures pertaining to the bleach works (Plate 30), which were sealed beneath a modern concrete floor associated with the 20th-century use of the site as a chemical works (Building 22; 4.2.40 above).

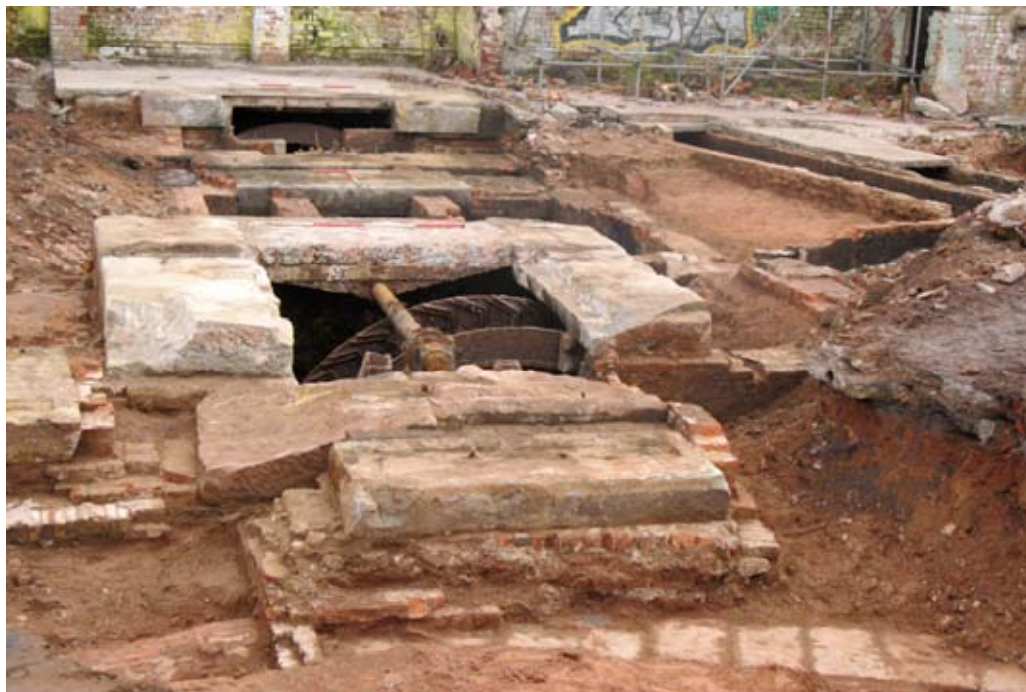
Plate 33: General view looking east across Area 2

5.4.3 The southern part of the excavated area, however, contained structural remains pertaining to the post-medieval corn mill, and later adaptations for the bleach works. Of particular interest were two waterwheels and associated fittings, which probably represented the final capital investment in the corn mill before it was converted to a bleach works (Plate 33). The remains of the mill were entirely of a late 18th- or 19th-century date, with no evidence for any earlier (Phase 1) structures or activity. However, it seems likely that the documented medieval corn mill will have occupied a similar position within the site.

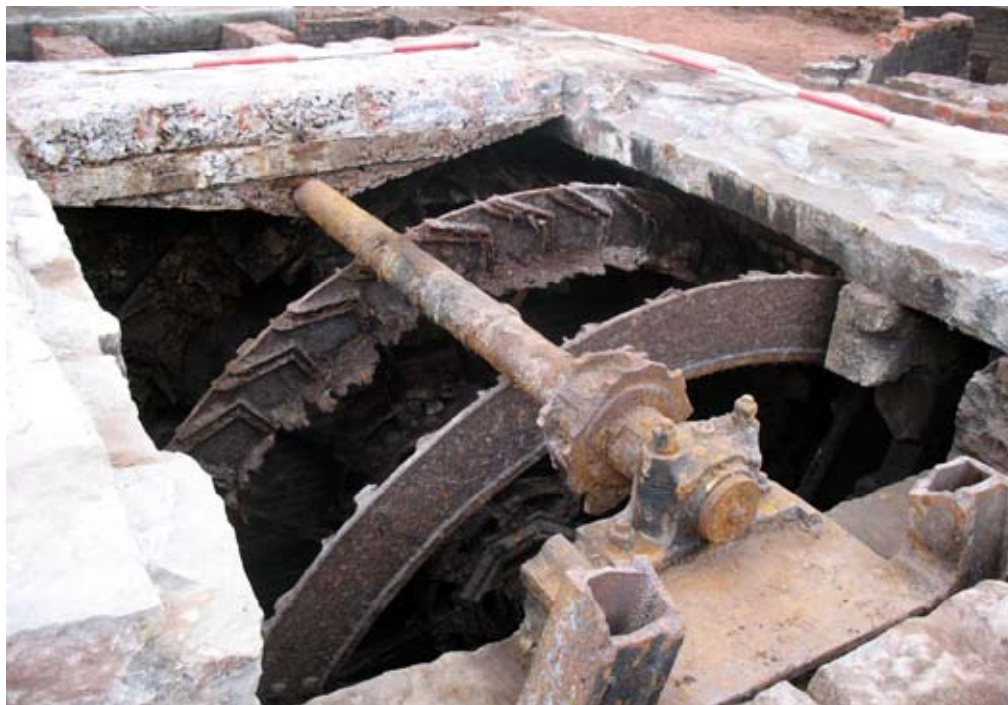
Plate 34: Waterwheel 27 and driveshaft 29 across the top

- 5.4.6 The west waterwheel (**27**) survives in fair condition (Plate 34). It is a high-breast wheel, 14ft (4.26m) diameter by 7ft 8in (2.33m) wide; the diameter is as stated in an inventory of machinery at the site, but confirmation awaits safe access to the waterwheel pits. It has three sets of cast-iron hubs and shrouds, but wooden arms (eight per ring). All 40 wooden buckets and the sole boards are missing. The shaft is square in section and, as the eyes of the hubs are octagonal, there are castings keyed onto the shaft to secure the wheel. The shaft also carries a cast-iron spur pit wheel, cast in two parts, of c 12ft (3.65m) diameter. This gear is massively constructed with a pitch of 3in (0.07m), consistent with a date of construction between 1830-60.

- 5.4.8 An iron shaft (**29**) across the top of the waterwheel, slightly north of centre, appears to have been geared to the pit wheel, although it is now cut short. At its outer end this shaft carried a gear or pulley, broken off at the hubs. The shaft is likely to have been associated with a heavy square stone machine bed (**51**), situated to the west of waterwheel **27**. This comprised three limestone blocks, which were possibly the mounting for a steam engine, known to have been installed in the mid-19th century. Two of the blocks were aligned north/south, and were mortared together to make a bed measuring 3.76m by 1.40m by 0.49m. This contained three iron rods, each 25mm in diameter with a thread gauge of 2mm, set 0.60m apart. This was extended to the west by the addition of a third block, which measured 2.47m by 0.97m by 0.34m, divided by bricks. This had two machine ties 0.65m apart with the same dimensions as those the east. The entire surface measured 3.76m by 3.23m. Machine bed **51** was situated adjacent to the remains of a massive stanchion, whilst the foundations to the west of this may mark the site of the engine house.

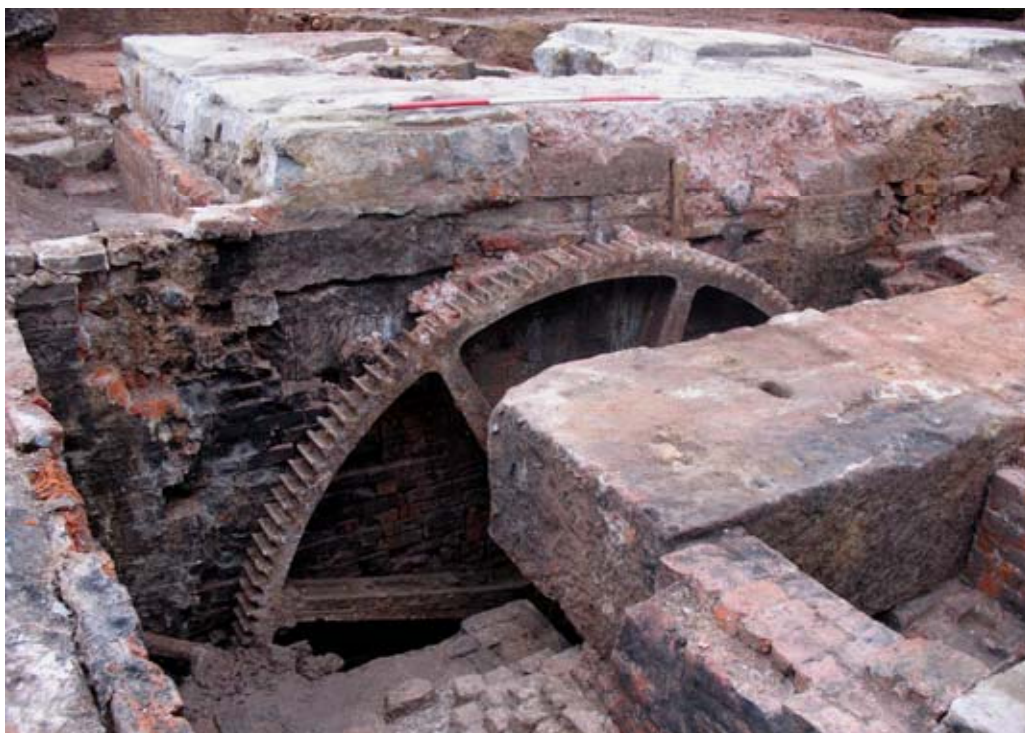
Plate 35: Pit wheel 30, connected to waterwheel 27

5.4.7 Waterwheel 27 and its associated pit wheel (30) are situated towards the projected position of the northern wall (35) of the mill, suggesting that the pit wheel drove a lineshaft along the southern wall (36). It is difficult to be certain of the exact position of this, as the ground level of the bleach works was just above the top of the pit wheel, whereas the ground floor of the corn mill was possibly anything up to 2m lower. Massive cross walls with enormous stone blocks were added to reinforce the floor of the bleach works.

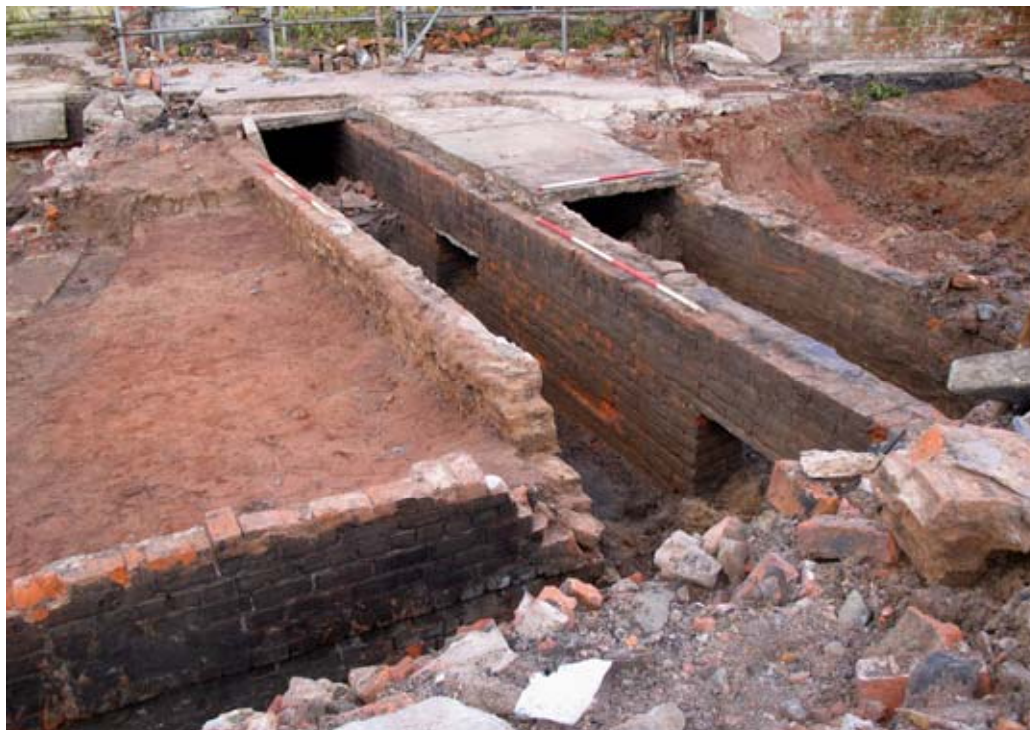
Plate 36: Head races **46** and **45**, looking south-east

- 5.4.18 Other structures dating to Phase 3 included the surviving head races (**45** and **46**), which provided the waterwheels with a supply of water (Plate 36), and flagstone floor **01**. The head race structures had been designed to be capped by the overlying flagstone floor, suggesting that these elements resulted from a single phase of remodelling.

- 5.4.19 The square-section head race connected with the Micker Brook to the south, entering the site beneath Mill Lane, and had been cut into the solid geology. The head race splits into two channels at some point within the site, thus being able to supply the two waterwheels; head race **45** supplied the eastern waterwheel (**56**), and head race **46** was connected to the western waterwheel (**27**). Both of the head races had been divided longitudinally by a central brick partition, which incorporated a series of apertures to allow the free flow of water between the two channels. There is no technical rationale for the insertion of the longitudinal partition, as this would not have improved the flow performance of the water, and it was perhaps intended solely as extra support for the overlying flagstone floor in the 'Making Up and Calendar Room'. Each of the flagstones that functioned as a capping over the head race measured approximately 1.30m by 1.20m by 0.10m, and were slightly larger than the other flagstones that formed floor **01**.

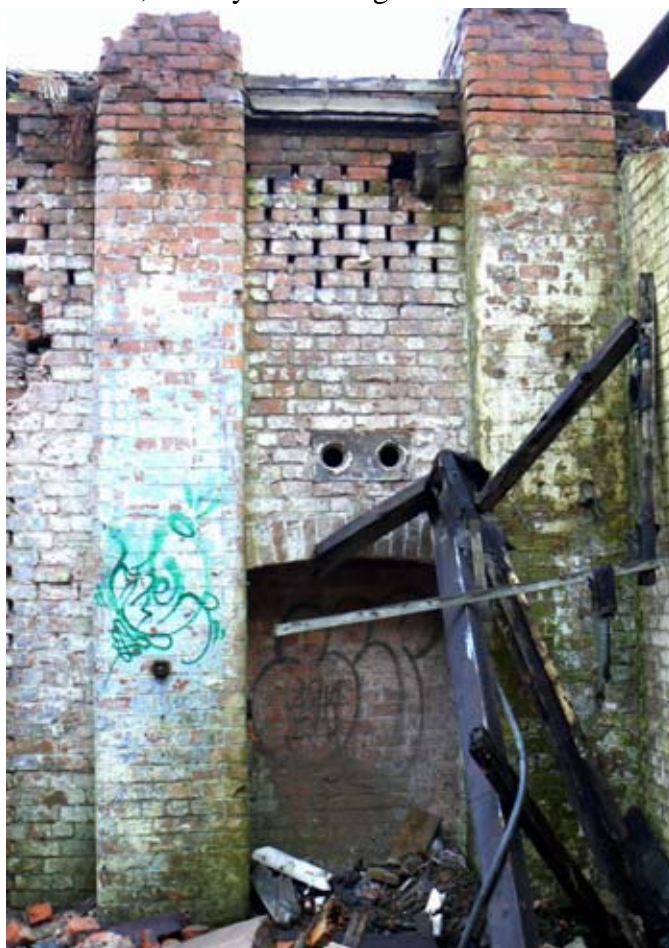
Plate 37: Porcelain eyes in the east wall of the Singe House

respectively, whilst various ancillary buildings provided support roles, such as the Pattern Office (10), maintenance (5) and the staff facilities (6). Additional buildings to the north east of the site, mainly consisting of storerooms and a greenhouse since demolished, were also built. As the expansion was deliberate and planned, there would appear to have been no further work required at the complex, until the turn of the 20th century. Few of the surviving internal fixtures and fittings recorded during the building survey could be attributed firmly to the bleaching process, although a single pair of porcelain eyes that had guided the cloth between the various rooms did remain *in-situ* (Plate 37). These were identified in the partition between the Singe House (Building 17) and the Bleach Croft (Building 13), situated above a blocked doorway (4.2.36 above).
