# CHESTER NORTHGATE REDEVELOPMENT: AREAS B, C AND D

## Archaeological Evaluation

Issue No: 2016-2017/1752  
OA North Job No: L10959  
NGR: SJ 4039 6638

**Document Type:** Archaeological Evaluation

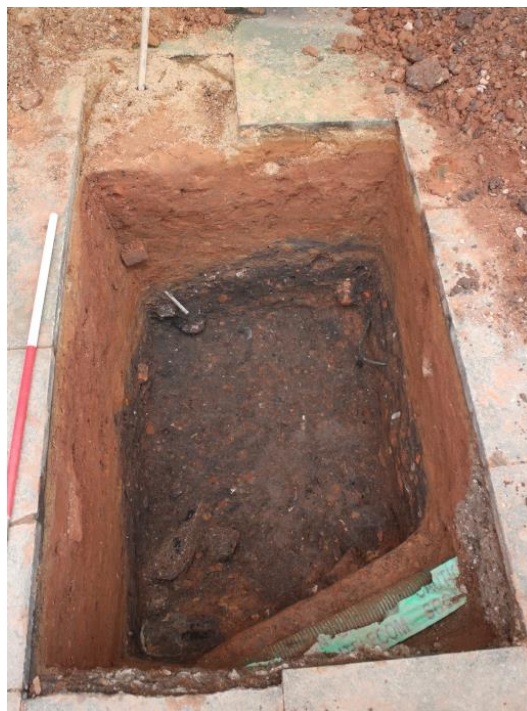
- 3.2.2 Trench 1 was hand-dug from ground level (22.69m aOD) to excavation base level at 21.49m aOD. Below the modern flagstones, and 0.5m of 'crushed red sandstone' (**101**), and a 0.18m compact levelling layer of sand, there was a recently disturbed and levelled post-medieval deposit (**102**) to a depth of 1.2m (Fig 3; Plate 1), containing clay pipe and ceramic fragments. A service cable, on a north-west to south-east alignment, was noted on the east side of the trench at c 22.19m aOD.

Plate 1: Trench 1, facing east, showing a section through 'made ground' associated with the Crowne Plaza Hotel complex

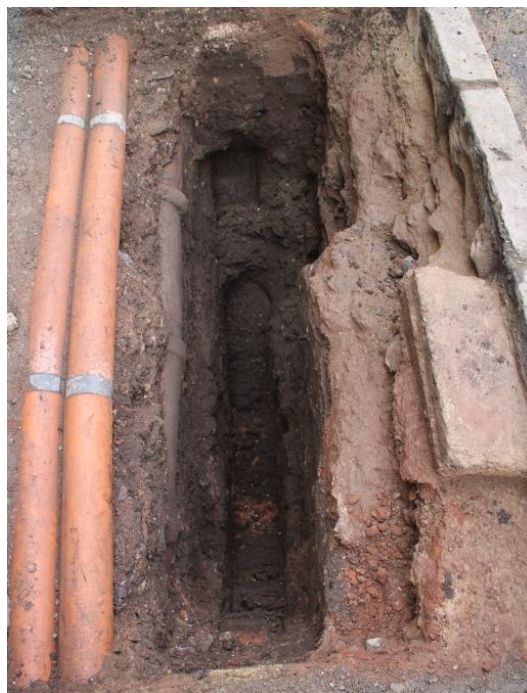
- 3.3.3 Post-medieval made ground was recorded at 0.18m (Fig 4; Plate 2), extending to at least 1.7m below the modern surface (c 25.18m aOD to 23.66m aOD). However (as more tentatively recognised in the deeper part of the sondage), this post-medieval made ground (**201**) appears to have extended to the base of the trench (at 2.15m depth, 23.21m aOD). Above this, there was sand and gravel to 0.18m and the concrete raft for the road was exposed in the north section. There were also linear cuts for modern services to a depth of 1m, with the uppermost and clearly modern services at 25.02m aOD.

Plate 2: Trench 2, facing west, with large cuts for service pipes, and the concrete raft which extends beneath the road

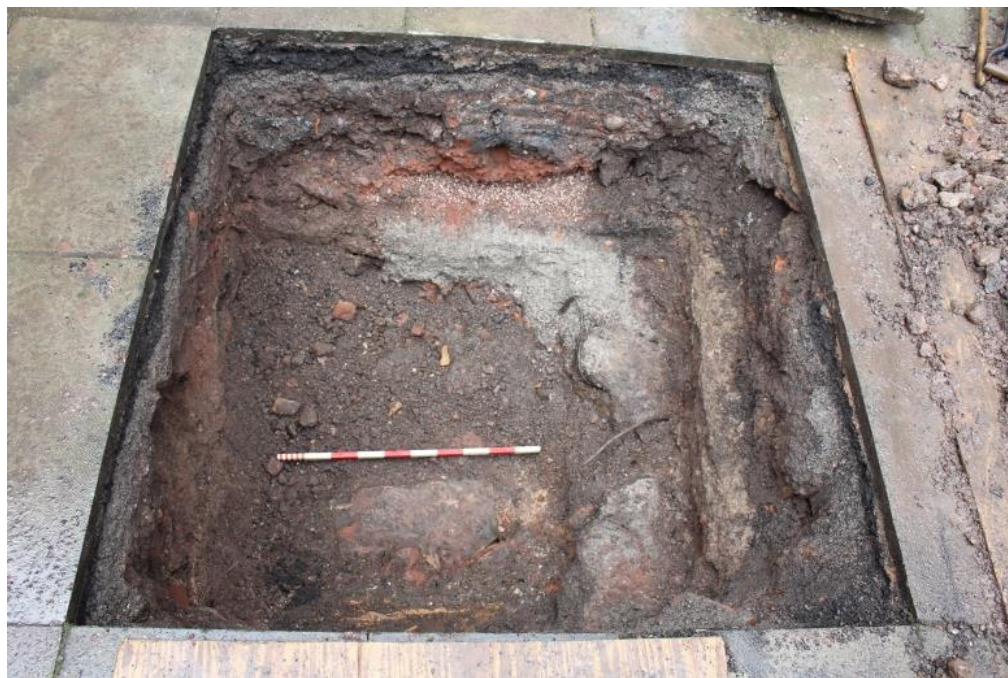
- 3.3.5 A gravel levelling layer was observed to 0.1m (Fig 5; Plate 3), and at a depth of 1.5m, a ceramic service pipe (c 26.48m aOD). A concrete raft extending 0.5m from the west section (**302**) was at 1m below the modern ground surface (c 26.98m aOD). Extending 0.9m from beneath the concrete raft, at a depth at 1.3m, there were post-medieval wall footings (at 26.78m aOD; **303**). Backfilled soil and rubble were encountered to a depth of 1.8m (**301**). The features and deposits identified in this trench were all either apparently recent or post-medieval.

Plate 3: Trench 3, facing north, illustrating the concrete raft (at 1m deep) and post-medieval wall footings (26.78m aOD), which include post-medieval brick

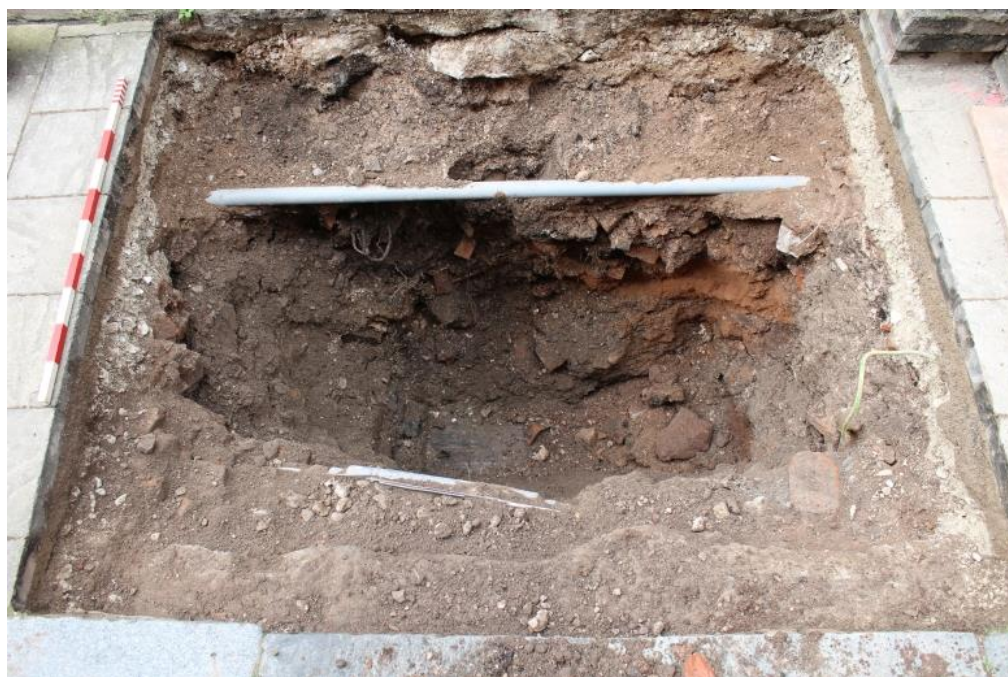
- 3.3.6 **Trench 4:** Trench 4 was 2.1 x 1.7m, and was situated in the pavement on the west side of Crook Street (Fig 2), just to the east of Hamilton House. This trench (like Trench 3) is within *Insula XIII* of the Roman legionary fortress.
- 3.3.7 Gravel levelling was observed to 0.15-0.2m (Fig 6; Plate 4), below which, on the east side, there were concrete footings for the kerb. Services were seen on the east and west sides, at 0.3m (c 26.73m aOD). Most notably, there was a (nineteenth- to twentieth-century) tiled floor (**402**) at a depth of 1.72m. A layer of soil and rubble (**401**), to a depth of 2.06m (24.97m a OD), may possibly relate to a backfilled cellar.

*Plate 4: Trench 4, facing north, with services on both sides of the trench and four tiles of a post-medieval floor in situ at the base*

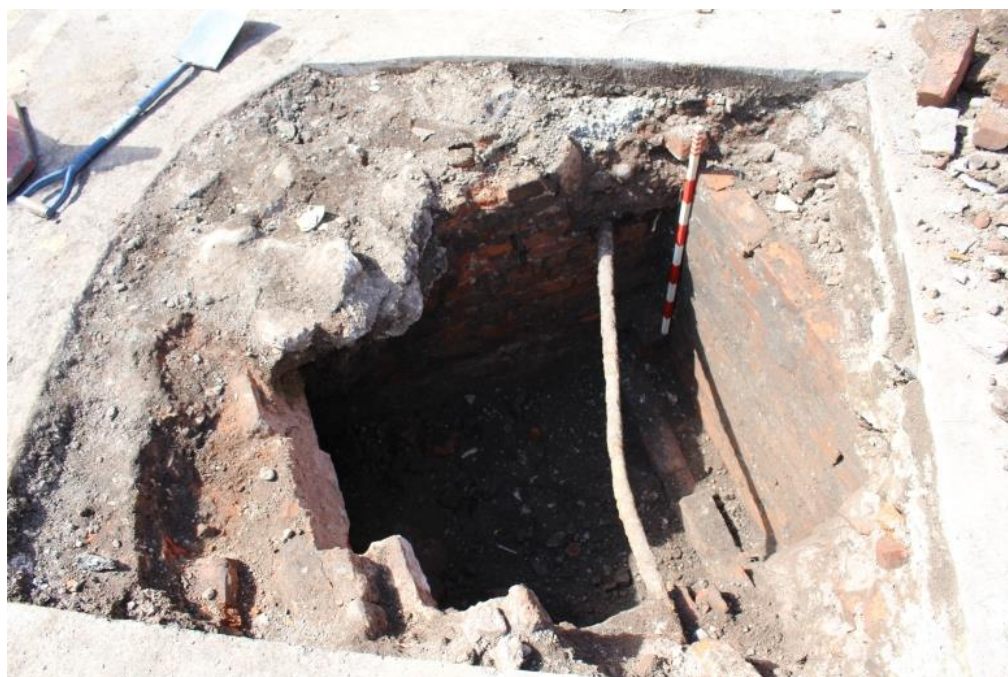
- 3.3.9 Tarmac and gravel levelling were recorded at 0.15m in depth (*c* 27.47m aOD; Fig 7; Plate 5). The top of a brick-vaulted cistern (**601**) was revealed at 27.42m aOD, and the same feature extended beyond the maximum excavated depth of 1.86m (25.71m aOD).

Plate 5: Trench 6, facing west, showing the brick-built cistern, which had a vaulted roof and had been backfilled with demolition rubble

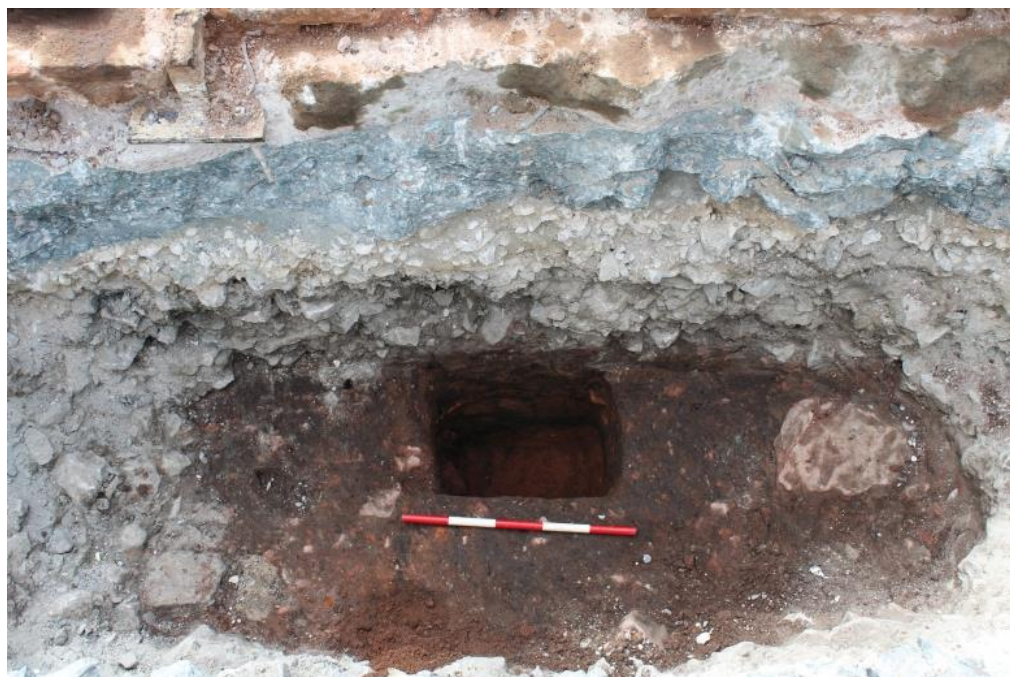
- 3.4.3 A considerable depth (0.6m) of surviving Roman stratigraphy and structural remains was uncovered in this trench (Fig 8). A Roman soil horizon (**701**) was revealed at 27.87m aOD, comprising a firm dark brown sediment with charcoal

flecks, Roman ceramic building material, including fragments of Roman tile (or *tegula*), pottery fragments and animal bone. At the north end of the trench, there was a dressed sandstone block (at 27.98m aOD), set horizontally within Roman sediments and aligned approximately north-north-west to south-south-east (Plate 6). The block (703), measuring *c* 300 x 200mm, was apparently in association with another such sandstone block, although this was largely under the north section. Although it is dangerous to speculate from a small trench such as this, this appears to be some kind of structure, possibly an approximately north to south wall and (given the alignment and what is known of the archaeology of the immediate area) it is potentially part of the large Roman building that has been identified to the north of the Elliptical Building complex (in *Insula XXI*).

Plate 6: Trench 7, facing west, showing the position of the sondage and Roman dressed sandstone block(s)

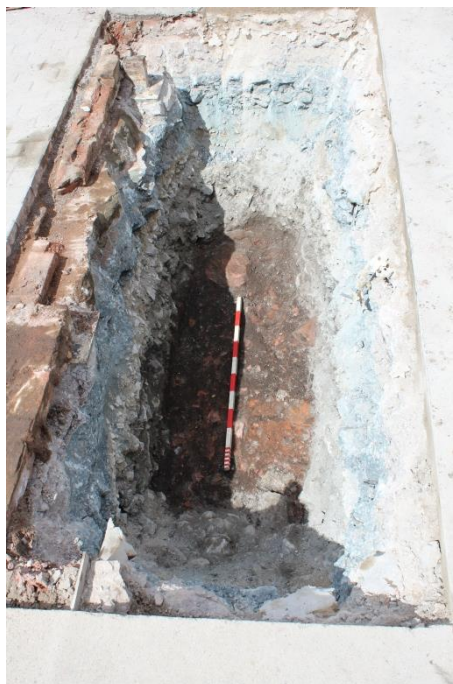
- 3.4.4 A twentieth-century (*c* 1982) feature was the 1m-thick concrete, tarmac and hardcore overlying the Roman archaeology (Plate 7). The concrete was 0.45-0.5m in depth and included a 0.25m-thick, heavily reinforced layer. The concrete overlay a further 0.5m of limestone aggregate, which in turn overlay the Roman deposits.

Plate 7: Trench 7, facing approximately northwards, showing the depth of concrete (including reinforced concrete) which overlies the surviving Roman archaeology

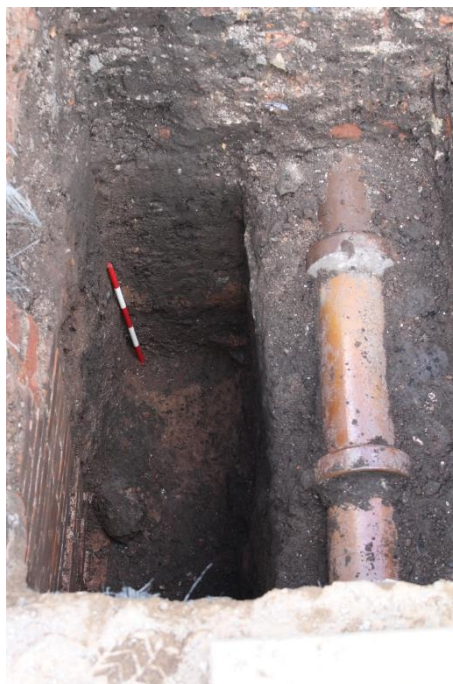
- 3.4.6 A Roman soil horizon (c 26.88m aOD) was revealed at a depth of 1.4m (Fig 9; Plate 8), extending to a recorded depth of 1.87m (the base of excavation was recorded at 26.50m aOD). The Roman sequence comprised at least two deposits (**802** and **803**), both with inclusions of Roman ceramic building material, pottery and bone. Layer **802** was a medium yellow/brown, firm sandy clay, 180mm in depth, and **803** was a dark brown friable silty sand, 200mm deep, which in turn overlay **804**, a yellow-brown firm sandy clay. It is worthy of note that Roman walls, which probably relate to a barrack block within *Insula XXII*, were recorded to the south-west of this trench on the west side of the Masonic Hall (Earthworks 2006a). The present work demonstrates that such survival should also be expected to the east of the Bowling Green area, now the pocket park.

Plate 8: Trench 8, facing north, showing a post-medieval brick wall (west) and service pipes

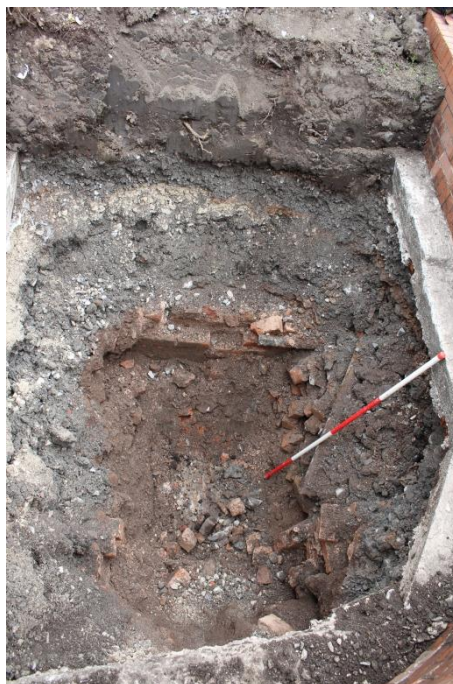
- 3.4.9 The surface level in the flower bed was 29.41m aOD. A depth of 0.4m of garden soil overlay limestone aggregate, which was recorded to a depth of 1.2m. Post-medieval walls were recorded on the north (an east to west wall) and east sides (a north-south wall) of the trench (Fig 10; Plate 9), and a concrete surface (**902**) was revealed at a depth of 2.15m (27.36m aOD). These post-medieval walls appear to relate to an area of housing located to the west of the present library, and on the east side of the original (more easterly) ‘Hunter’s Walk’. These buildings were demolished by the early 1980s to make way for the bus station (Strickland 1982).

*Plate 9: Trench 9, facing north, showing limestone aggregate to 1.2m, post-medieval walls on the north and east sides, and demolition rubble overlying a concrete floor at a depth of 2.05m*

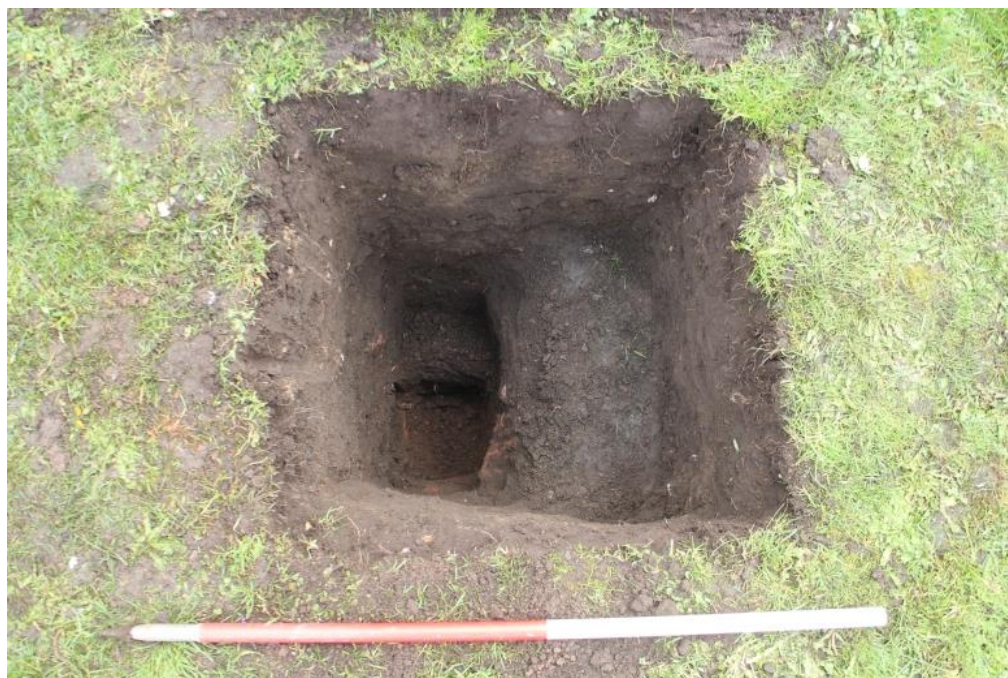
*Plate 10: Borehole 7, on the east edge of bus station, to the rear of the library*

3.5.1 Borehole 7 was dug to the rear of the library on the east side of the bus station (Fig 2). The substrate recorded (Plate 10) was topsoil to a depth of over 1.2m. The test pit demonstrated that made ground extended to a depth of 1.7m, where sandstone bedrock was encountered.

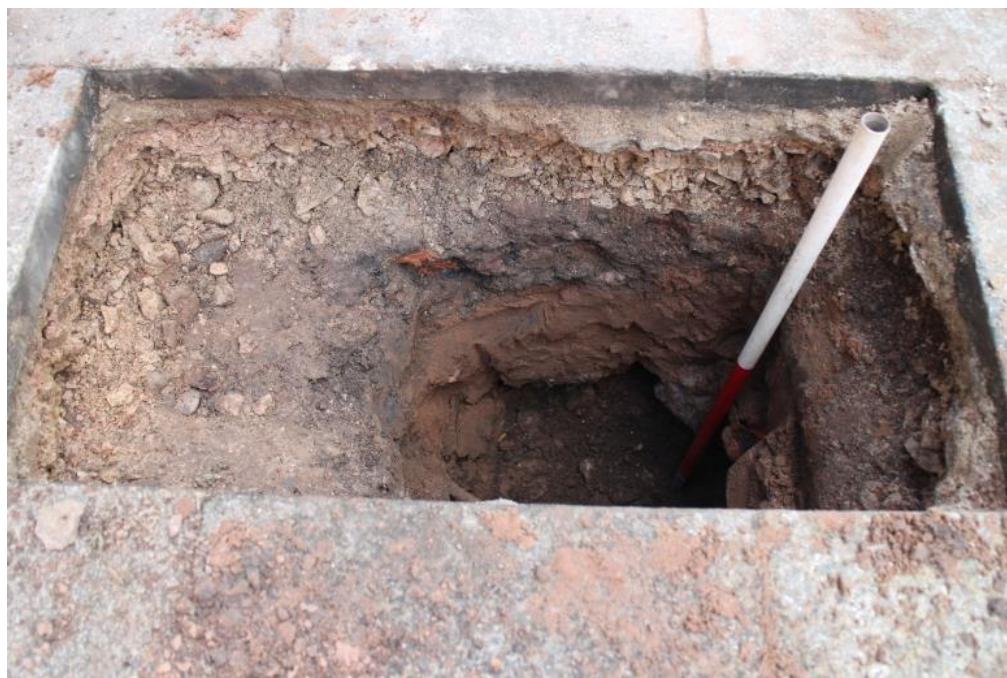
*Plate 11: Borehole 10, on the Corner of Trinity Street and the north side of Hamilton Place*

3.5.2 Borehole 10 was placed at the corner of Trinity Street and Hamilton Place at the west end of the Market Hall (Fig 2). No archaeology was recorded

within the start hole (Plate 11), as it did not exceed the limits of the modern overburden used in the construction of the current pavement/road. The overburden consisted of building sand, gravel and concrete rubble. Drilling began at a depth of 1.2m and hit solid-rock geology at a depth of 3.5m. A potential archaeological horizon was observed at c 1.2m, but, due to the size of the borehole, whether this was ‘made ground’ or intact archaeology remains unclear. Thus Borehole 10 was important in establishing that there is a depth of 1.2m of modern deposits to the immediate south of the present Market Hall, which overlies any potential archaeology (OA North 2016b, 37).

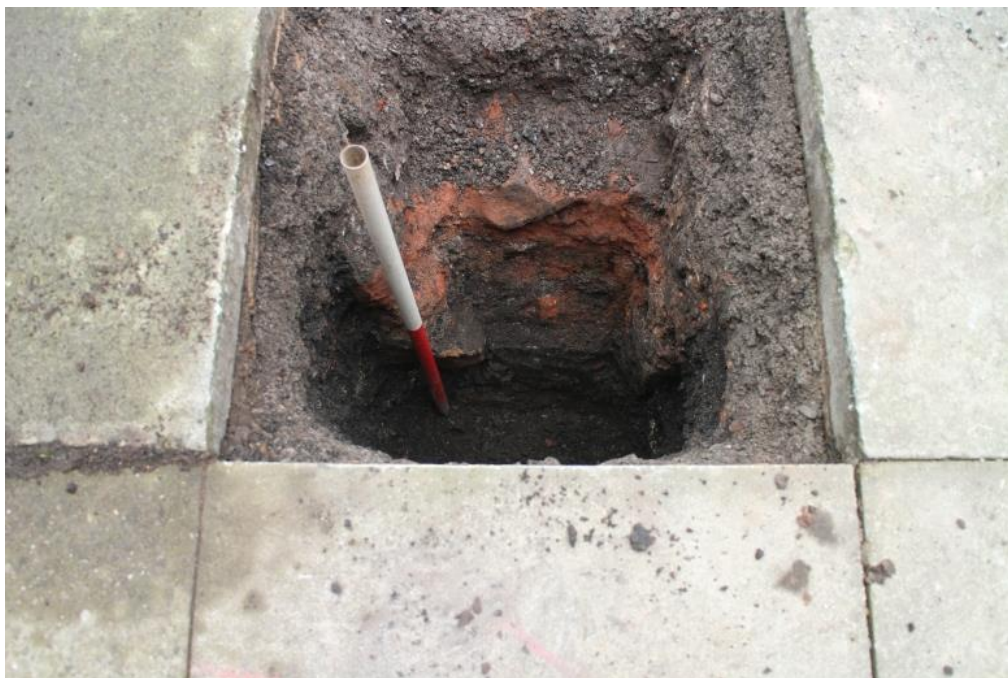
*Plate 12: Borehole 15, adjacent to the south-east corner of Hamilton Place and Crook Street*

3.5.3 Borehole 15 was situated on the south side of Hamilton Place, to the north of Merchant’s House (Fig 2). A brick-lined drain was observed within the start hole (Plate 12) at a depth of 0.45m, the backfill of which contained clay pipe stem and modern building rubble. The overburden appeared to be similar to that observed in Borehole 10. Drilling began at a depth of 1.2m and hit bedrock at 2.5m. A potential archaeological horizon was observed at c 1.3m, although the deposits, given the very restricted exposure, could not be adequately characterised. Thus, the observations of Borehole 15 appear to suggest modern and disturbed deposits to a depth of 1.2m.

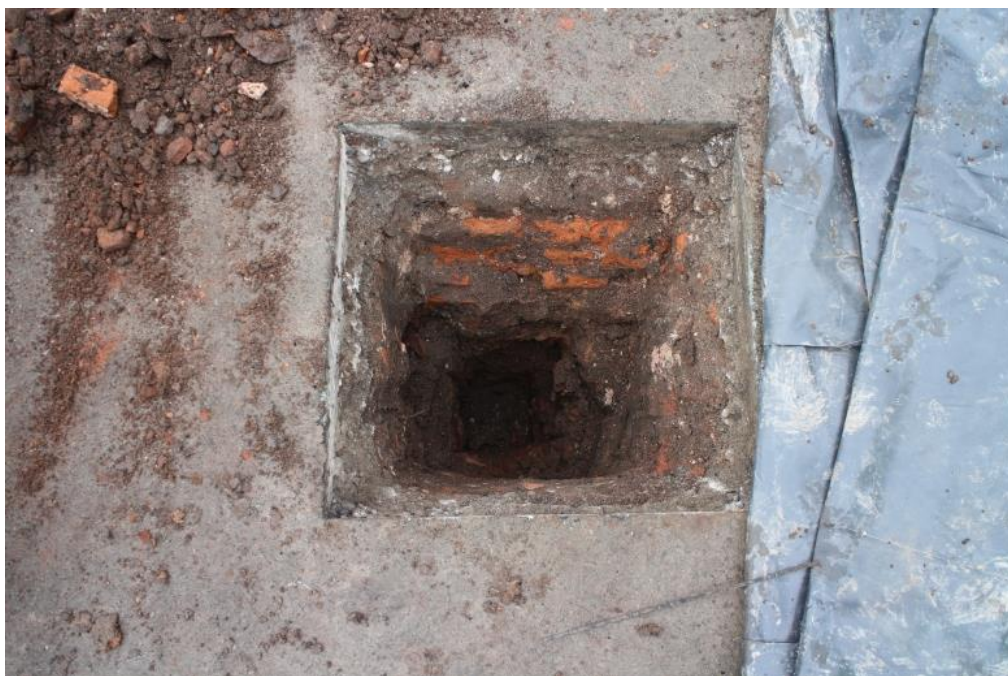
*Plate 13: Borehole 18, on the east side of Goss Street, adjacent to the bike park*

- 3.5.4 Borehole 18 was located on the east side of Goss Street, adjacent to the bike park (Fig 2). A tarmac and gravel surface (0-0.3m in depth) overlay post-medieval deposits (Plate 13), including what appeared to be ‘made ground’, apparently comprising demolition rubble. There was also a possible post-medieval structure on the east side of the trench. Bedrock was recorded at a depth of 3m.

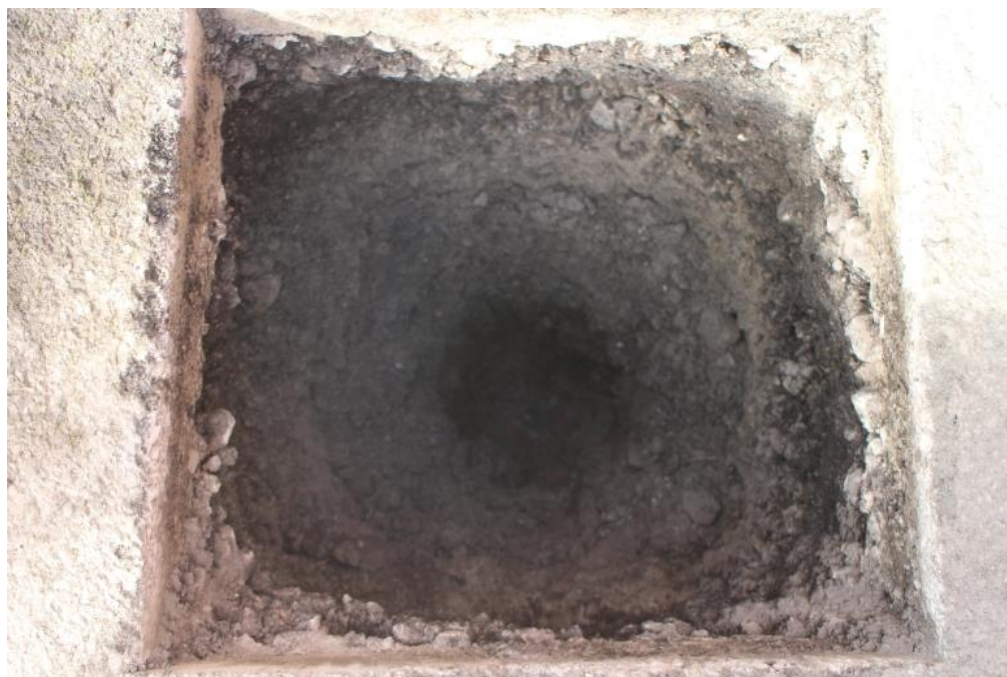
Plate 14: Borehole 19, Crook Street, to the rear of Goldsmith House, adjacent to the pavement

- 3.5.5 Borehole 19 was excavated on Crook Street, adjacent to the pavement on the south side of the Goldsmith House car park (Fig 2). A tarmac and gravel surface at 0-0.3m overlay further gravel and levelling rubble to 0.3-0.7m (Plate 14), and appears to be modern levelling. A post-medieval deposit was recorded at 0.7-

1.2m prior to drilling, which was interpreted as relating to modern disturbance. Bedrock was recorded at 3.5m.
