Northgate Redevelopment Phase 1, Chester Archaeological Watching Brief Report

November 2019

Client: Cheshire West and Chester Council

Archaeological Watching Brief Report

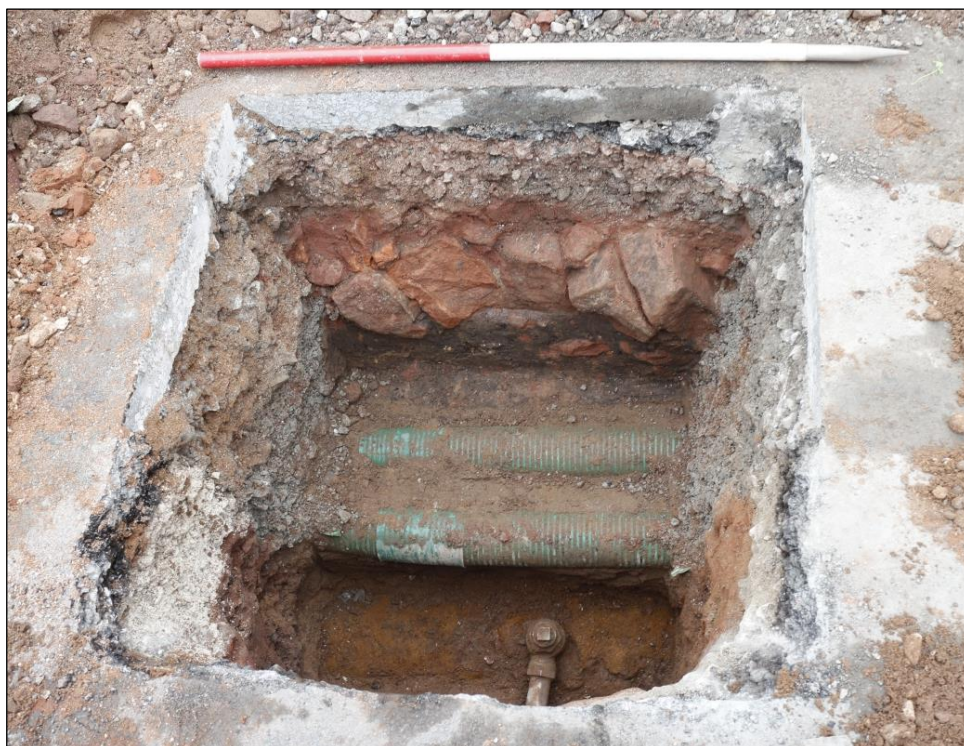
3.2.1 Test-pit 3 was situated on the northern side of Hunter Street, towards the western end (Fig 2) and was excavated to a maximum depth of 1.1m. The earliest deposit, identified along the northern edge of the test-pit, was levelling layer **302**, consisting of dark grey-brown firm silty sand, with regular inclusions of red sandstone. This appears to have been deposited prior to the construction of a seemingly east/west-aligned feature composed of sandstone blocks and fragments (**301**; Fig 3; Pl 1), perhaps the remains of a Roman wall (though it remains undated), the top of which lay at an approximate depth of 0.25m. The likely continuation of **301** was identified in the northern section of Test-pit 5 (**501**; *Section 3.3.1*). Possible wall **301** was cut to the south by modern service trenches extending east to west, which were subsequently overlain by the modern Hunter Street road surface.

Plate 1: Test-pit 3, looking north, showing possible sandstone wall 301 (scale 1m)

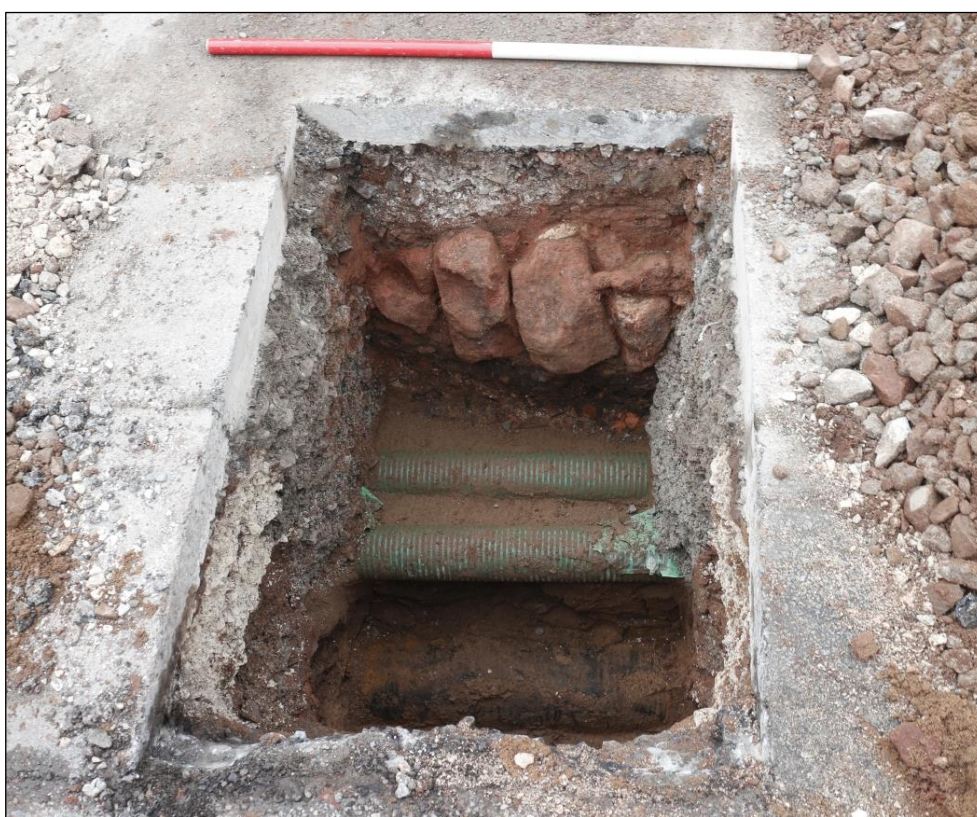
3.3.1 Test-pit 5 was opened on the northern side of Hunter Street, to the west of Test-pit 3 (Fig 2), and was excavated to a maximum depth of 1.05m. The earliest deposit identified along the northern edge of the test-pit was levelling layer **502**, consisting of dark grey-brown firm silty sand, with regular inclusions of red sandstone. This appears to have been deposited prior to the construction of a seemingly east/west-aligned feature composed of sandstone blocks and fragments (**501**; Fig 4; Pl 2), perhaps the remains of a Roman wall (though it remains undated), the top of which lay at an approximate depth of 0.24m. The likely continuation of **501** was identified in the northern section of Test-pit 3 (**301**; Section 3.2.1). Possible wall **501** was cut to the south by modern service trenches extending east to west, which were subsequently overlain by the modern Hunter Street road surface.

Plate 2: Test-pit 5, looking north, showing possible sandstone wall **501** (scale 1m)

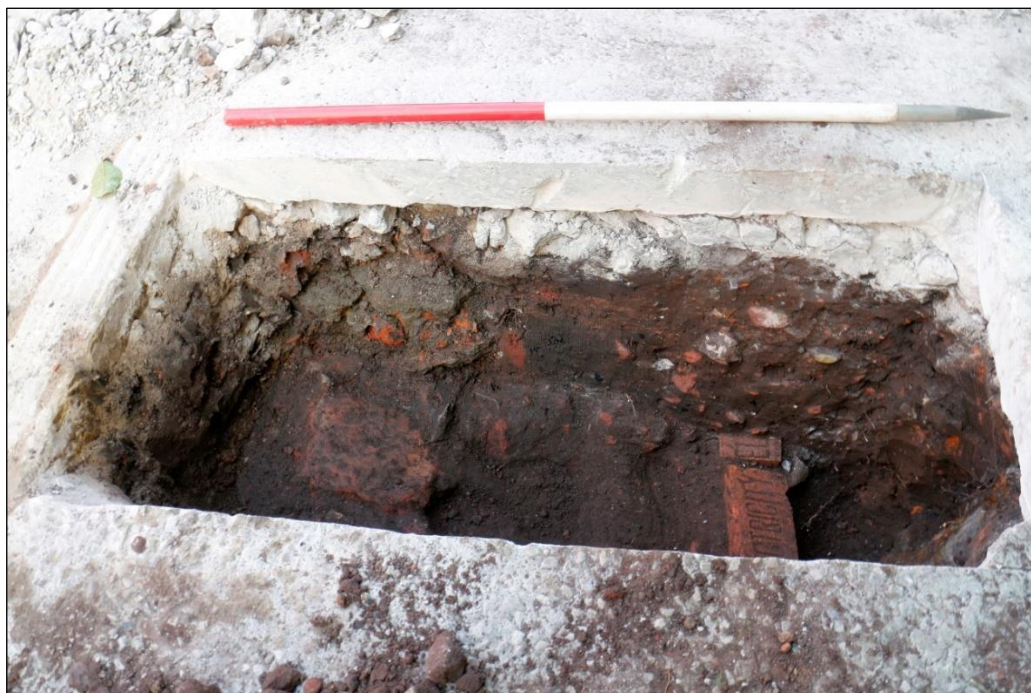
3.4.1 Test-pit 6 was opened on the southern side of Hunter Street, to the south of Test-pit 5 (Fig 2), and was excavated to a maximum depth of 0.69m. The earliest deposit identified, in the centre of the test-pit, was levelling layer **603** (Pl 3), consisting of dark grey-brown firm silty sand, with regular inclusions of red sandstone. Layer **603** was consistent with the levelling layers identified in Test-pit 3 (**302**; Section 3.2.1) and Test-pit 5 (**502**; Section 3.3.1). The top of this deposit was identified at a depth of 0.22m, but was cut by a modern intervention, **602**, in the north-eastern corner of the test-pit, and further truncated to the south by modern service trenches extending east to west,

Plate 3: West-facing section of Test-pit 6, showing levelling deposit 603 (scale 1m)

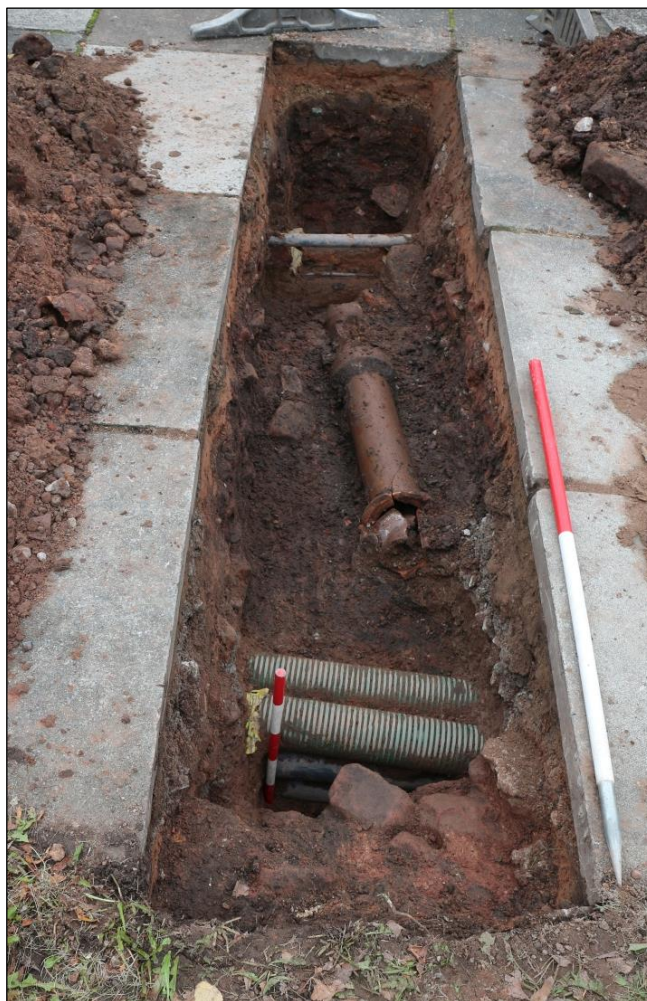
3.5.1 Test-pit 14 was opened midway along the eastern footpath of St Martin's Way (Fig 2) and was excavated to a maximum depth of 0.85m (PI 4). The earliest deposit identified was **1412**, consisting of mid-grey-brown silty clay, containing yellow and white flecks. Deposit **1412** was overlain by **1411** (Fig 5), which was identified as a concentration of sandstone rubble within mid-grey-brown silty clay, containing yellow and white flecks (PI 5). The sandstone rubble within **1411** appeared to have been disturbed by modern services, suggesting that it may have been tumble from nearby structures. These deposits were identified at a depth of 0.2m and were truncated by modern service trenches extending north to south, which were subsequently overlain by the modern footpath of St Martin's Way.

Plate 4: Test-pit 14, looking west, showing deposits **1411** and **1412** (scales 0.5m and 1m)

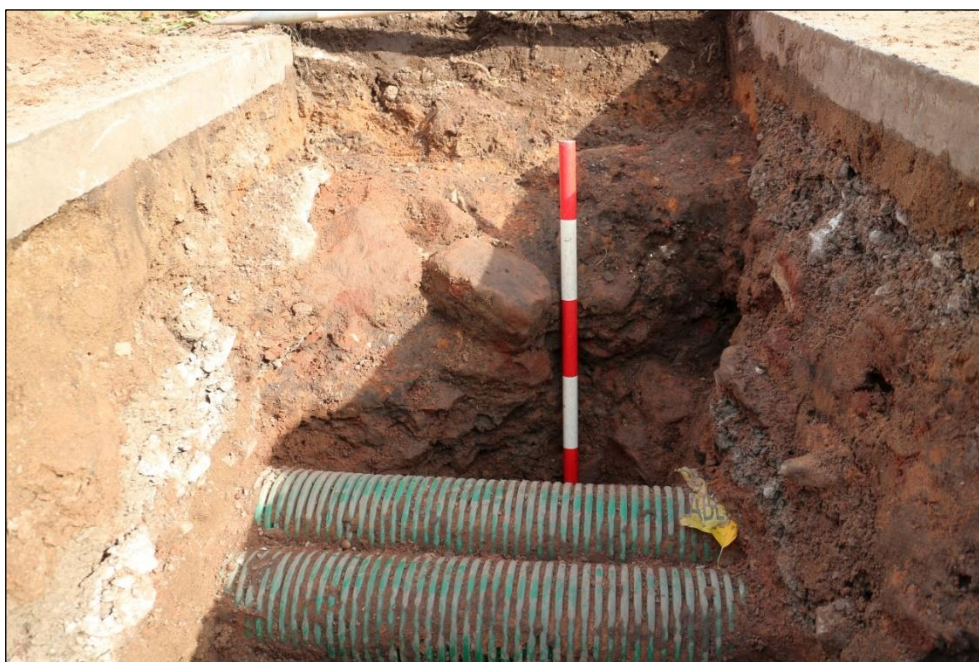
Plate 5: West-facing section of Test-pit 14, showing deposits **1411** and **1412** (scale 0.5m)

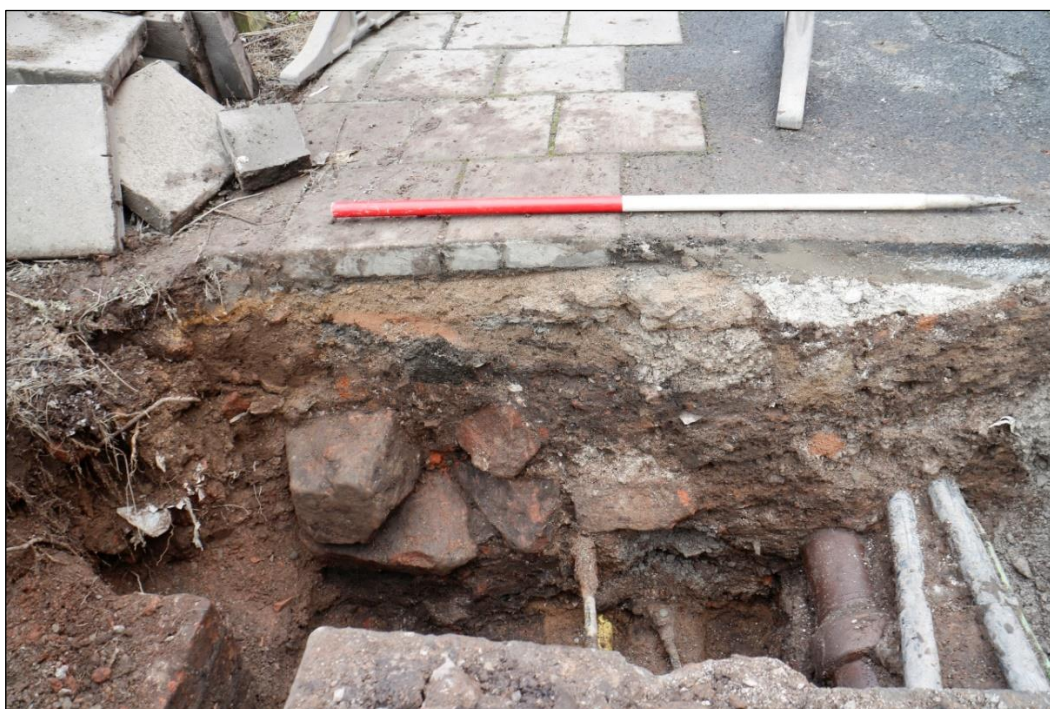
3.6.1 Test-pit 15 was situated towards the western end of Princess Street on its northern footpath (Fig 2) and was excavated to a maximum depth of 0.93m. The earliest surviving deposit was **1517** (Fig 6; Pl 6), identified as a levelling layer, consisting of dark grey-brown firm silty sand, with regular inclusions of red sandstone, similar to levelling deposits **302**, **502** and **603**, identified in the test-pits on Hunter Street. This layer appears to have been deposited prior to the construction of a seemingly east/west-aligned feature composed of sandstone blocks and fragments (**1514**), perhaps the remains of a Roman wall (though it remains undated), the top of which lay at an approximate depth of 0.37m. Possible wall **1514** was cut to the south by modern service trenches extending east to west, which were subsequently overlain by the modern Princess Street footpath.

*Plate 6: West-facing section of Test-pit 15, showing possible sandstone wall **1514** (scale 1m)*

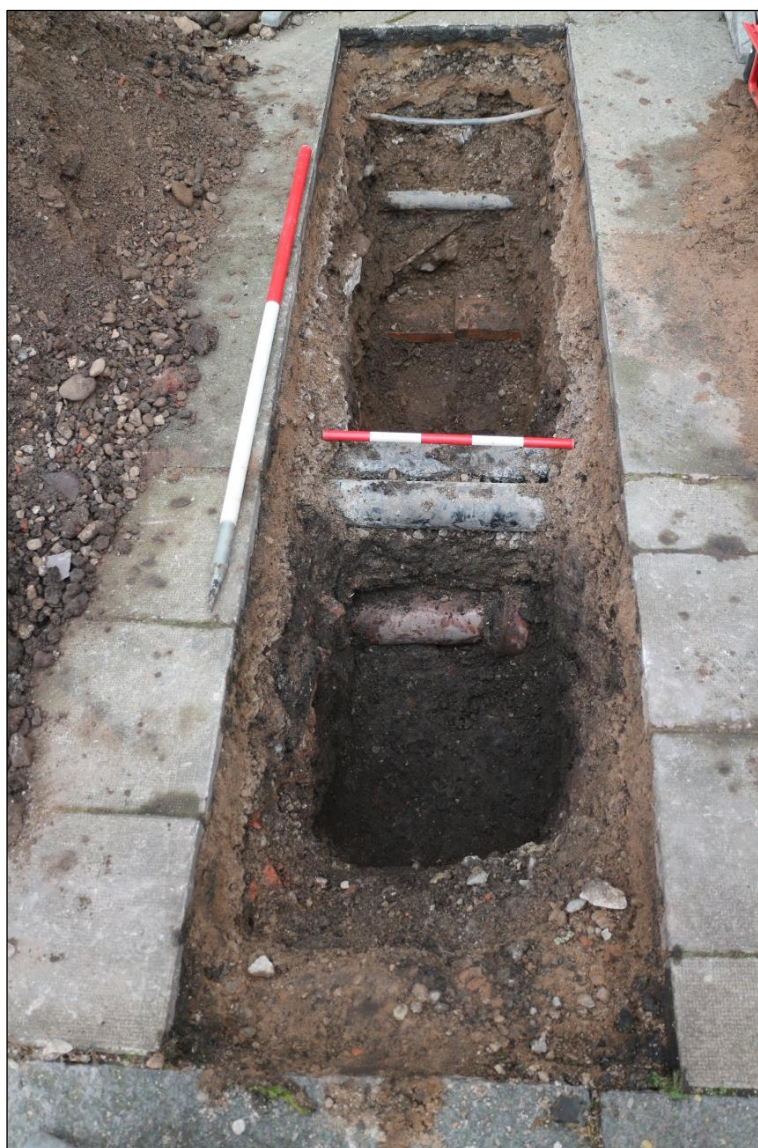
3.7.1 Test-pit 16 was placed to the east of Test-pit 15, on the southern pavement of Princess Street (Fig 2), and was excavated to a maximum depth of 0.85m. The earliest surviving deposit identified was **1611** (PI 7), consisting of dark grey silty sand with regular red sandstone inclusions, which was probably a relict soil horizon. Deposit **1611** contained fragments of Roman tile, amongst other ceramic building material, suggesting that this may be the top of significant archaeological remains. This was identified at a depth of 0.5m, but had been removed to the south by modern service trenches extending east to west, which were subsequently overlain by the modern Princess Street pavement. A trench excavated during the 2018 archaeological evaluation (OA North 2018b), west of Test-pit 16, contained evidence of Roman demolition at a depth of 0.6m, which may relate to relict soil **1611**.

*Plate 7: Test-pit 16, looking south, showing relict soil horizon **1611** in the base of the test-pit (scales 0.5m and 1m)*

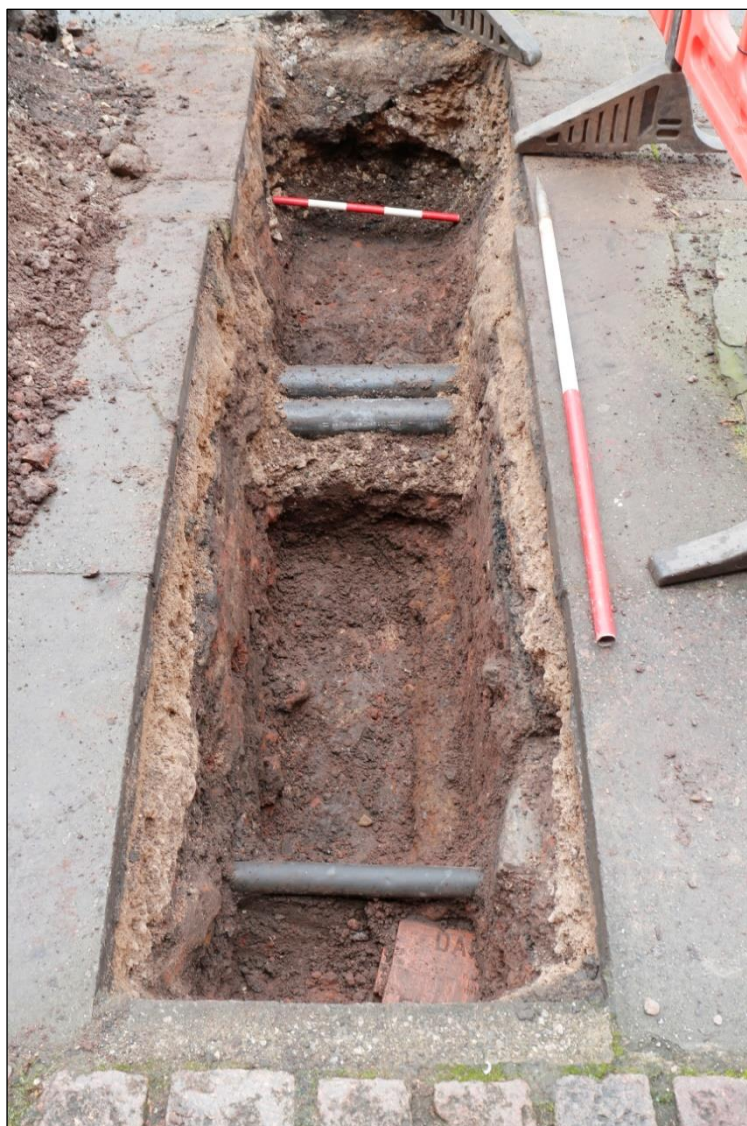
3.8.1 Test-pit 17 was directly to the east of Test-pit 16, on the southern pavement of Princess Street (Fig 2), and was excavated to a maximum depth of 0.62m. The earliest surviving deposit identified was **1709** (PI 8), consisting of dark grey silty sand with regular red sandstone inclusions, which was probably a relict soil horizon. Deposit **1709** contained fragments of Roman tile and samian pottery, suggesting that it may be the top of the significant archaeological remains. This was identified at a depth of 0.5m, but had been destroyed to the south by modern service trenches extending east to west, which were subsequently overlain by the modern Princess Street pavement.

*Plate 8: Test-pit 17, looking north, showing relict soil horizon **1709** in the base of the test-pit (scales 0.5m and 1m)*

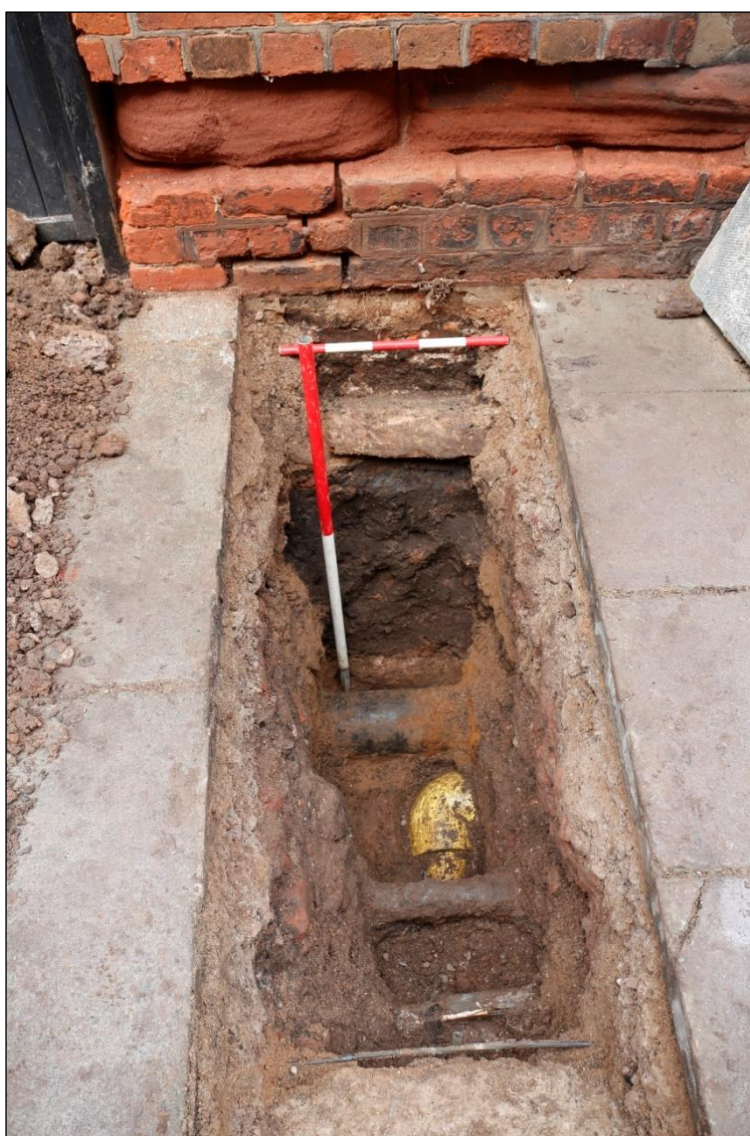
3.9.1 Test-pit 21 was opened towards the eastern end of Princess Street on its northern pavement, immediately to the south of the Coach House Inn (Fig 2), and was excavated to a maximum depth of 1.05m. The earliest deposit identified was compacted clay **2114** (Fig 7; Pl 9), comprising a light reddish-yellow-brown hard clay, identified at a depth of 0.9m, which was potentially a floor. Potential floor **2114** was overlain by relict soil horizon **2112**, comprising mid- to dark grey silty clay, up to 0.6m thick.

*Plate 9: Test-pit 21, looking north, showing possible floor **2114** and relict soil **2112** (scales 0.5m and 1m)*

3.9.2 The significant archaeological remains had been truncated in the north of the test-pit by the red sandstone foundations of the Coach House Inn (**2113**). Throughout the

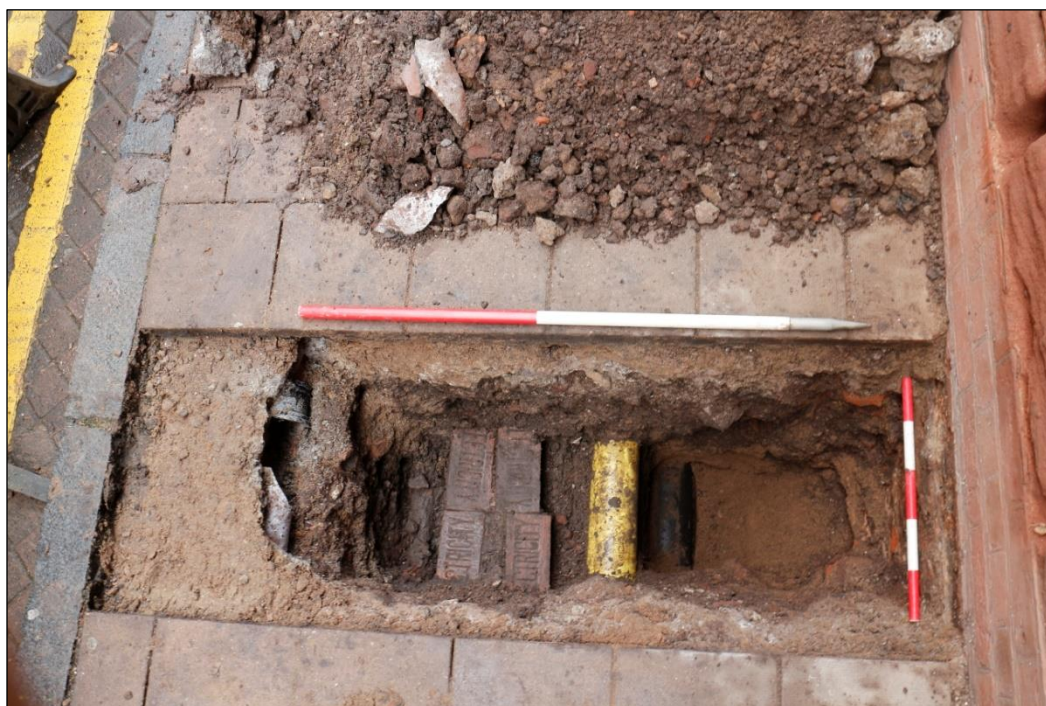
3.10.1 Test-pit 22 was placed at the eastern end of Princess Street, east of Test-pit 21, again on the northern pavement, immediately to the south of the Coach House Inn (Fig 2), and was excavated to a maximum depth of 1.09m. The earliest deposit identified was relict soil horizon **2213** (Pl 10), comprising mid- to dark grey silty clay, up to 0.6m thick.

Plate 10: Test-pit 22, looking west (scales 0.5m and 1m)

3.10.2 The relict soil had been truncated by the foundations for the Coach House Inn to the north, and by several modern services to the south. The modern services were subsequently overlain by the modern pavement of Princess Street.

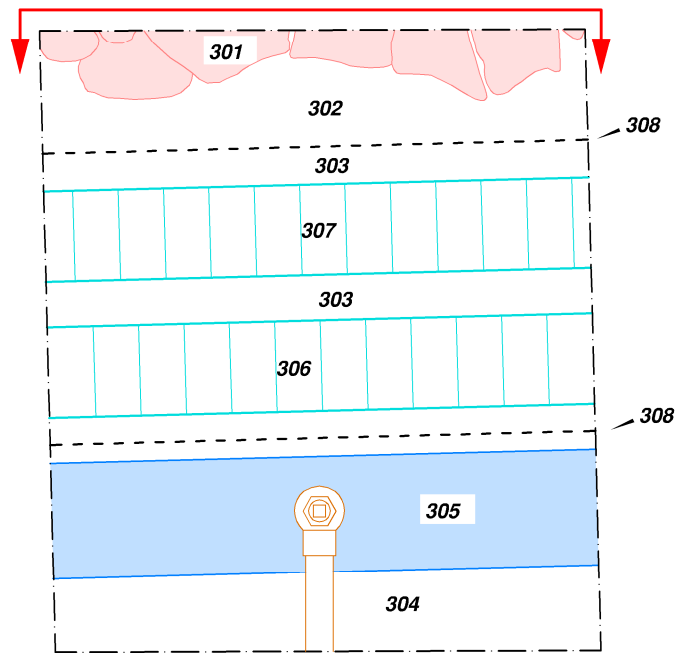
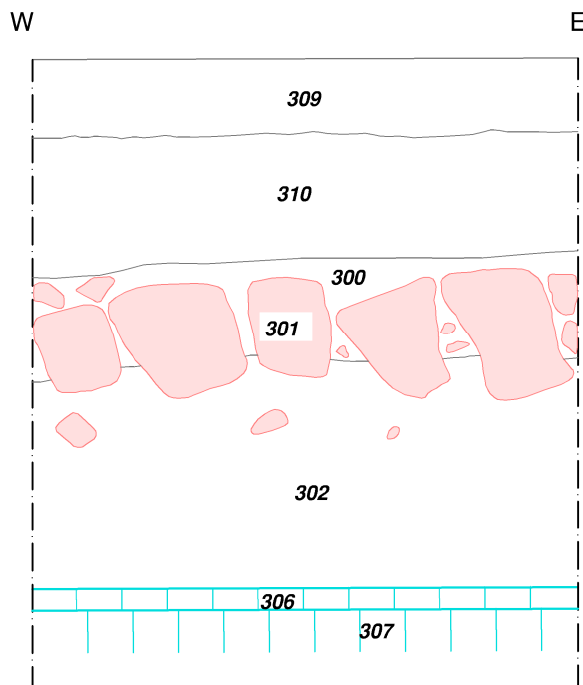
Figure 3: Plan and cross-section of Test-pit 3

Plan of Test-pit 3

South-facing cross-section of Test-pit 3

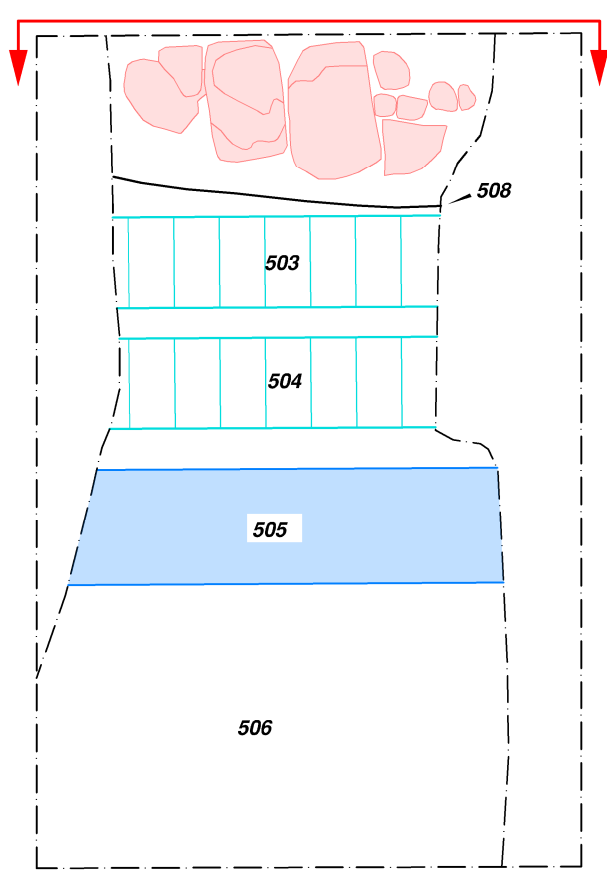
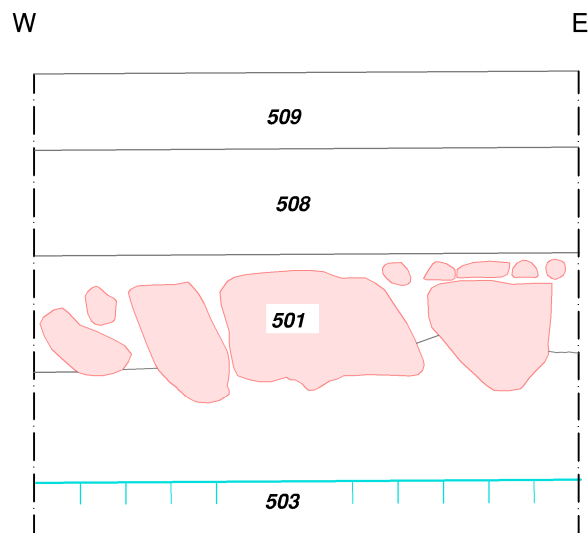
Figure 4: Plan and cross-section of Test-pit 5

Plan of Test-pit 5

South-facing cross-section of Test-pit 5

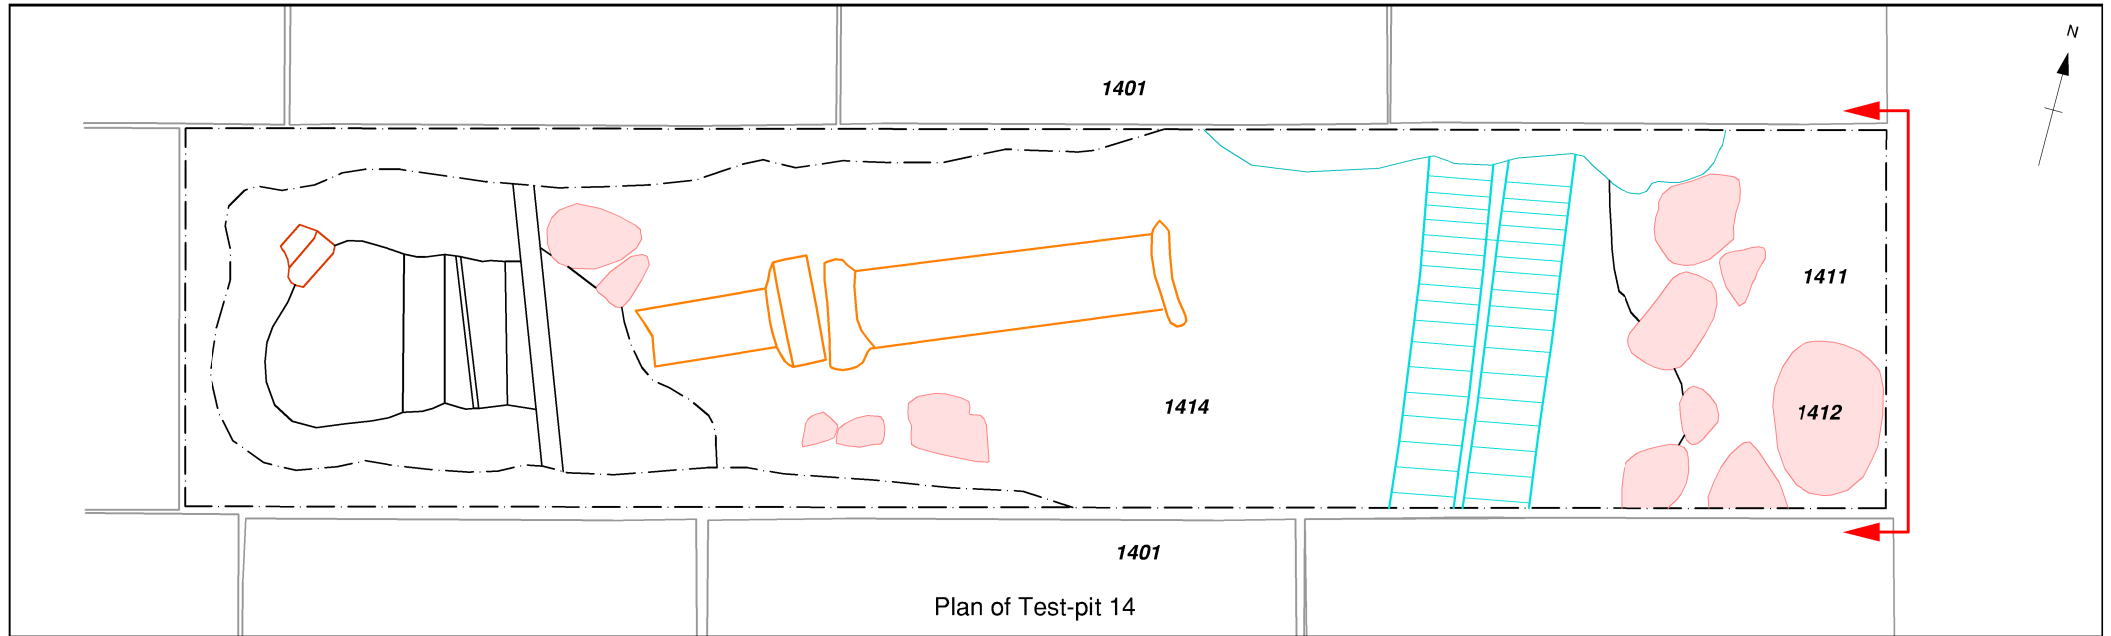
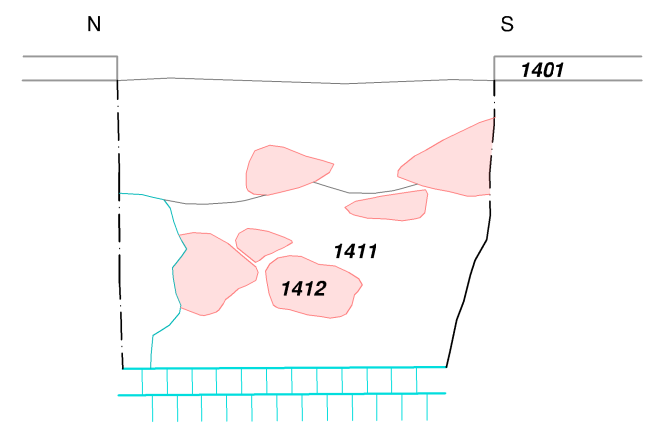
Figure 5: Plan and cross-section of Test-pit 14

Plan of Test-pit 14

West-facing cross-section of Test-pit 14

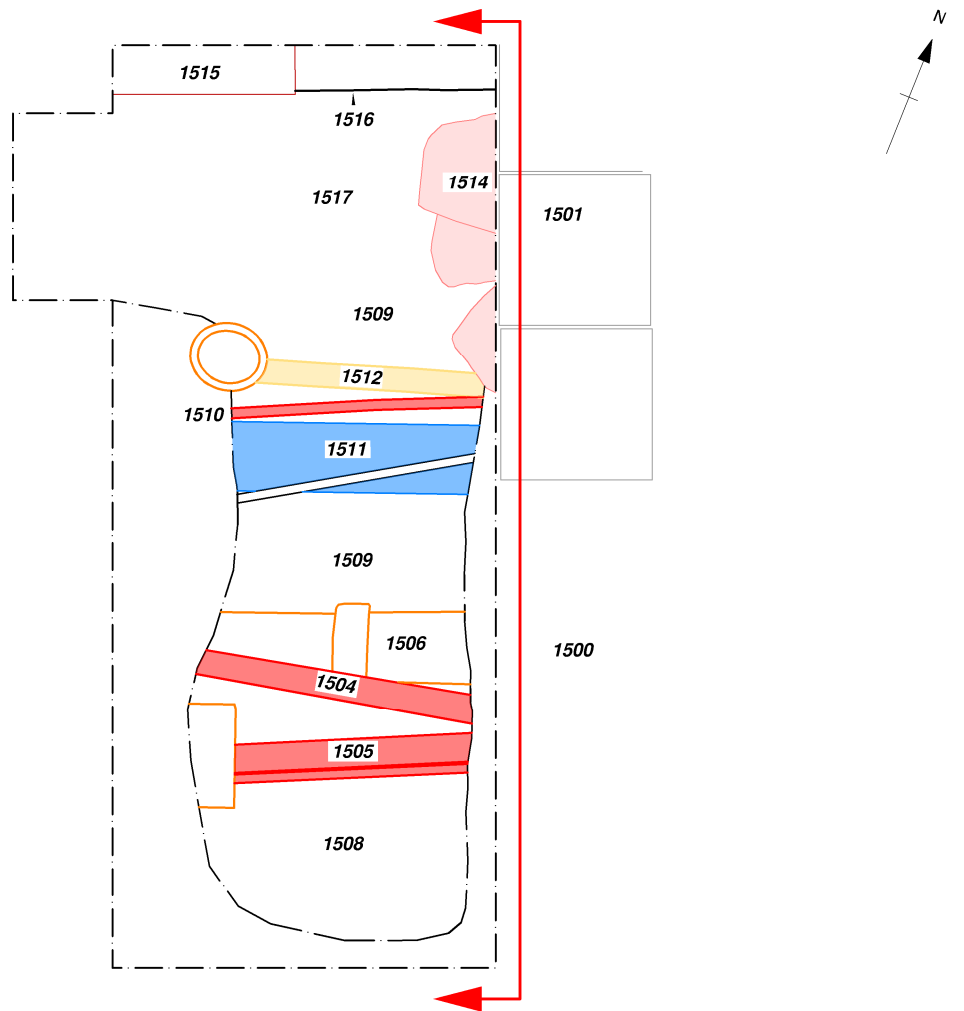
Figure 6: Plan and cross-section of Test-pit 15

Plan of Test-pit 15

West-facing cross-section of Test-pit 15

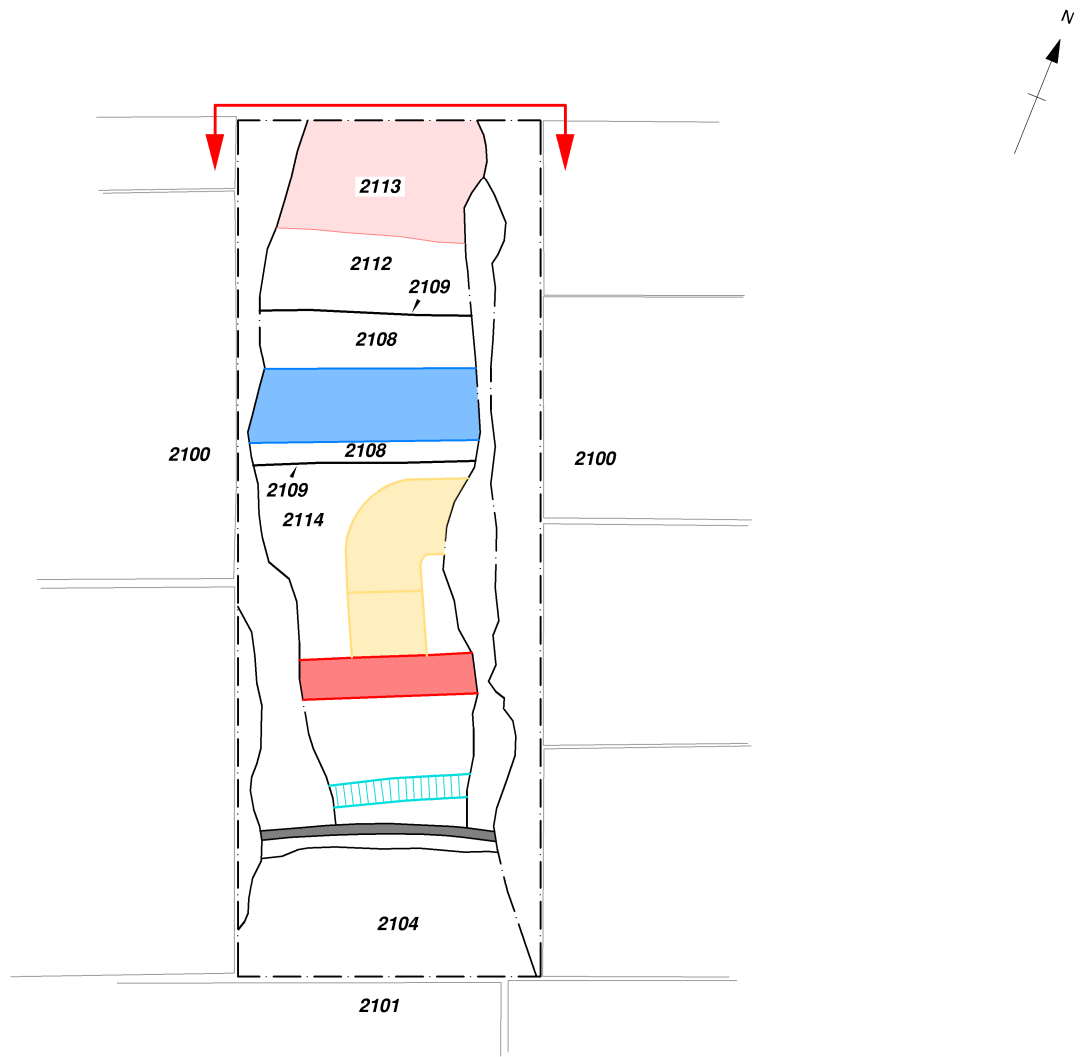
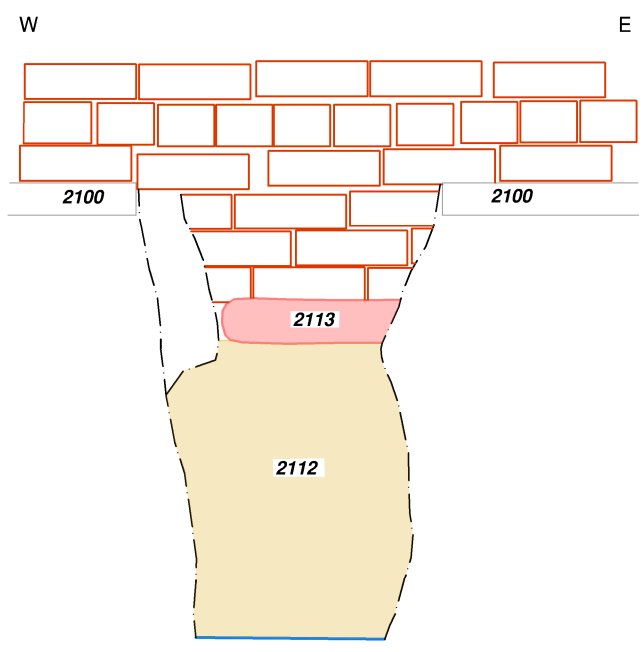
Figure 7: Plan and cross-section of Test-pit 21

Plan of Test-pit 21

South-facing cross-section of Test-pit 21
