# Land off Aldcliffe Road, Lancaster, Lancashire

## Archaeological Evaluation and Expanded Works Report

October 2019

**Client: Orion Heritage**

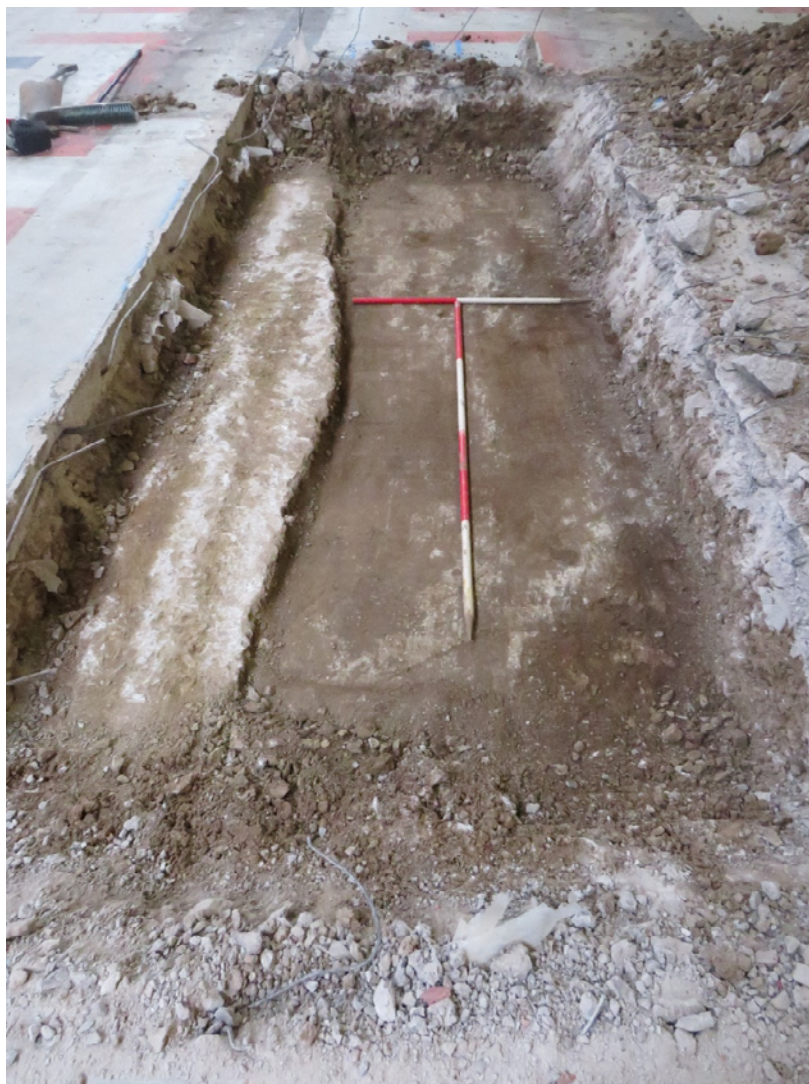
- 3.3.2 Context **304** was removed first, comprising 0.2m of modern reinforced concrete and the modern linoleum flooring of the warehouse. Beneath this lay levelling deposit **303**, a mixture of medium brown sand and assorted rubble, measuring 0.3m thick. Beneath the modern overburden, were two separate concrete rafts, contexts **301** and **302**, believed to be earlier than the modern material, and likely relating to a later phase of the mill's internal structure (Plate 1). Surface **302** partially overlay the earlier **301** and covered the southern half of the trench with a width of 0.7m and thickness of 0.1m. Surface **301** lay within the base of the trench covering its entirety. Both surfaces were composed of plain grey concrete.

**Plate 1:** Surfaces **301** and **302**. Viewed facing west.

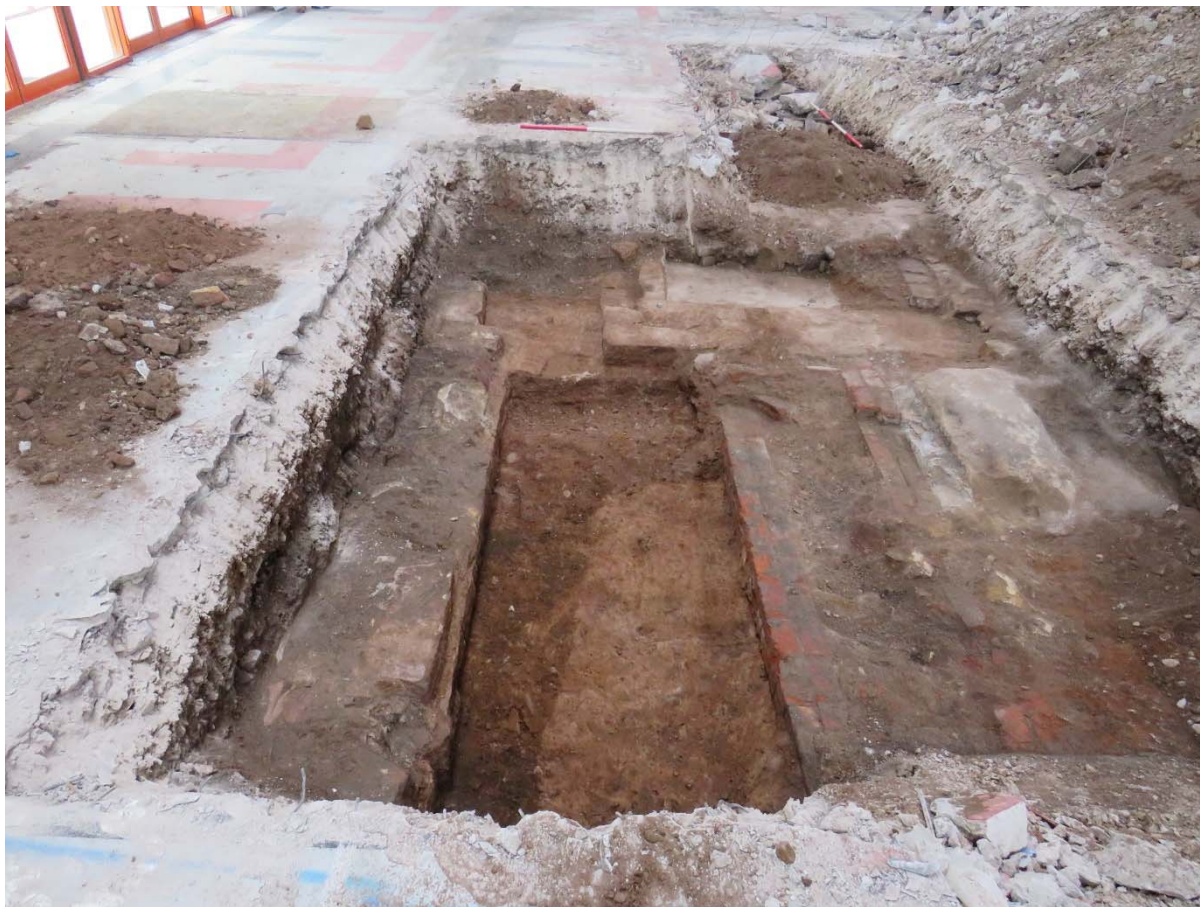
- 3.4.7 The remains identified in Trench 4 and 4b seemingly relate to two or more phases of the Queen's Mill history, with the structures towards the western end of the trench relating to the later western expansion, while those to the east relate to the earlier building.

**Plate 2:** Trench 4 and its extension. Viewed facing west.

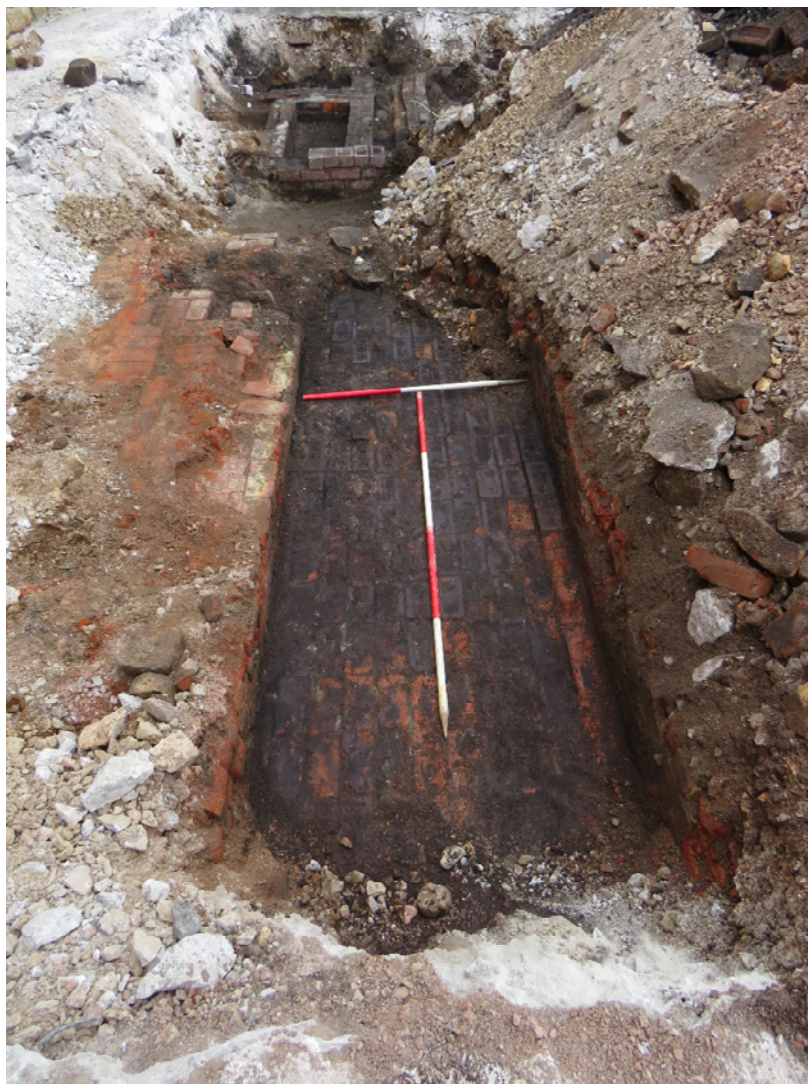
- 3.5.8 Collectively these features appear to represent the remains of the boiler house powering at least one phase of the mill, with evidence for a potential recessed boiler bed and associated flue systems extending to the east and potentially further to the north where the power mechanisms would have entered the main space of the former building. Unfortunately, insufficient details were revealed within the constraints of the trench and the expanded area, which would identify the precise form of the power mechanism, and, given the mixture of building materials used in various aspects of the construction, the phasing of the structures is also unclear. The presence of factory frogged brick and grey cement bonding may indicate a later addition, although the possibility of repairs to existing fabric cannot be ruled out.

**Plate 3:** Suspected Boiler Bed in Trench 5 (Contexts **509**, **510** and **511**)

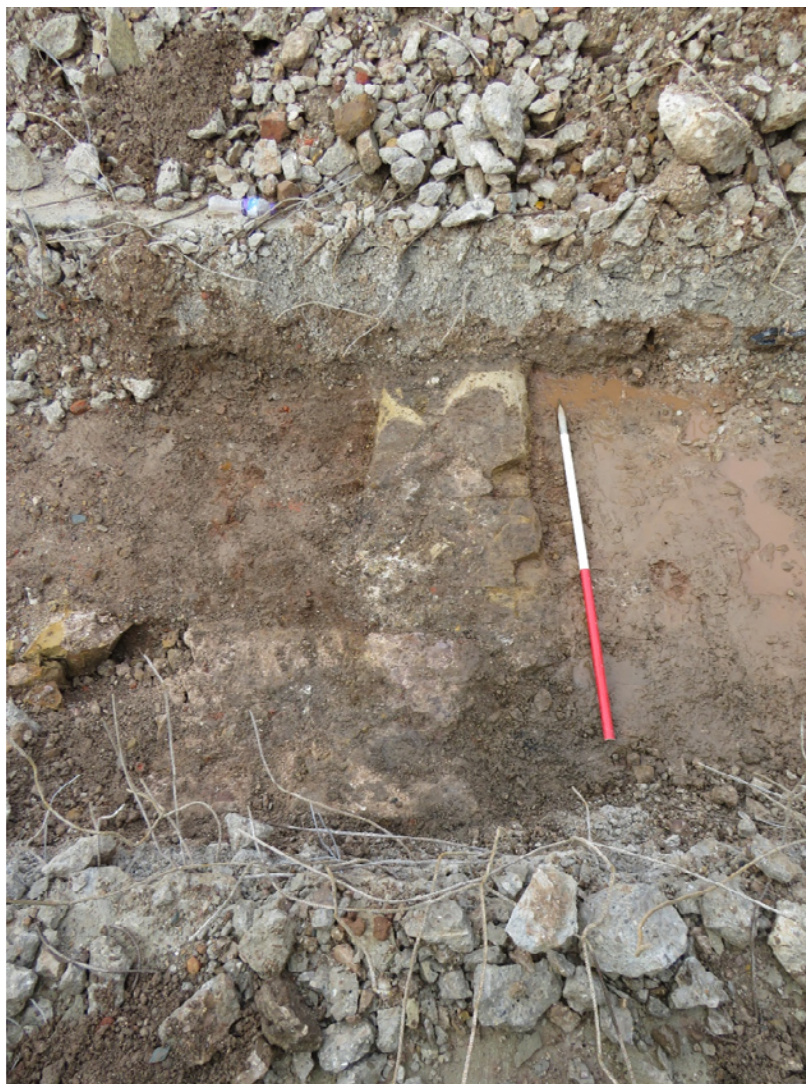
- 3.7.2 Three overburden deposits were removed, **700**, **701** and **702**. Context **700** was a 0.15m thick layer of reinforced concrete, overlying hardcore layer **701** and a grey/brown clay deposit **702**, both of which measured 0.2m thick. Removal of the overburden revealed three wall footings **703**, **704**, and **705**. Wall **703** crossed the trench on an east/west axis located 4m from its northern end. It comprised several roughly-shaped sandstone blocks and measured 0.3m wide and 0.2m high, no bonding material was observed. Approximately 2m to the south, walls **704** and **705** formed a right-angle (Plate 4), with **704** crossing the trench east to west and **705** heading south of the eastern end. The southern end of **705** was truncated by a substantial modern drain cut that dominated the southern end of the trench. These two wall footings were constructed from the same sandstone blocks, irregularly shaped, but faced on their outer edges to form a double skin that was infilled with rubble, traces of a light pink mortar were evident along the top edge of some of the stones. Both walls were slightly larger than **703** with a width of 0.5m and they potentially correlate with the north-eastern corner of an outbuilding evident on the historical map (Figures 8 and 9).

Plate 4: Walls **704** and **705** within Trench 7

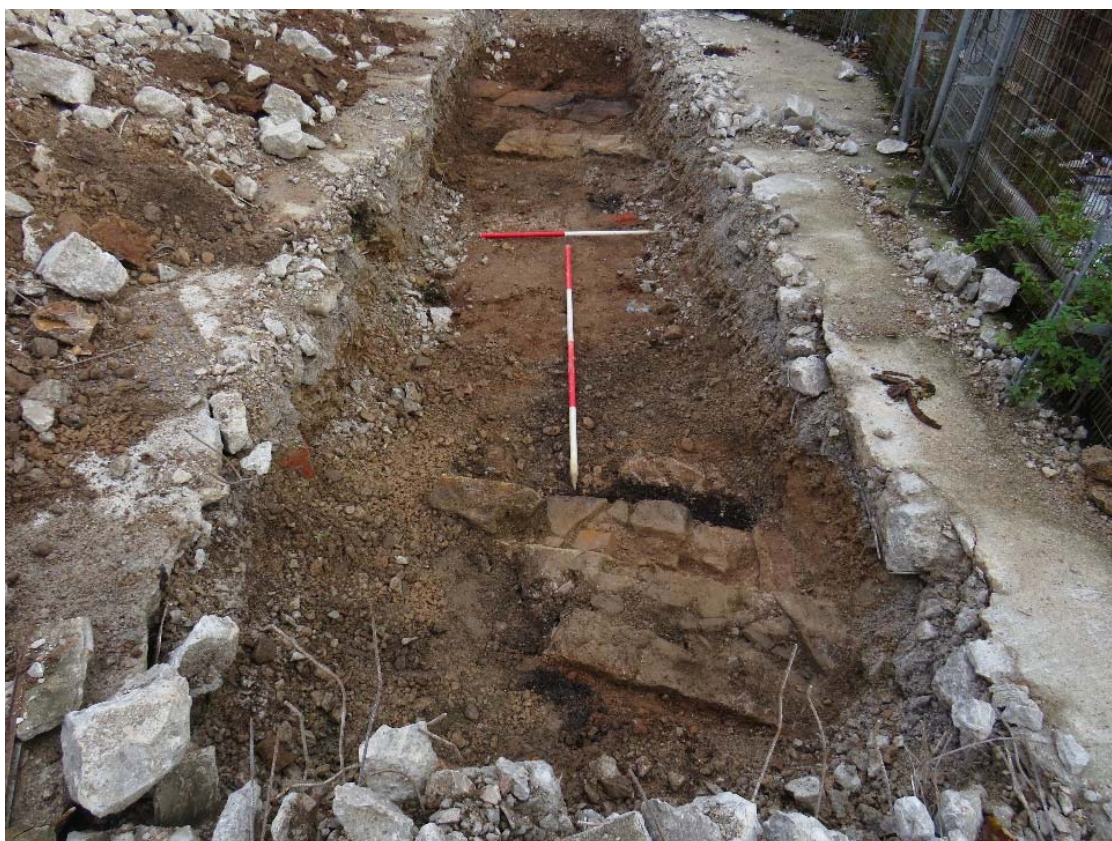
- 3.8.3 At the southern end of Trench 8 were a further two wall foundations, truncated at the western end by a modern drain cut. These walls butted against each other with **805** being an apparent later addition to **806** (Plate 5). Wall **806** was seemingly the original foundation, approximately 0.5m in length with a width of 0.4m, it comprised a double skin of sandstone blocks, faced on their outer edges with a rubble infill. Wall **805** butted against the northern edge of **806** and comprised a single skin of irregular sandstone blocks and a rubble infill that lay between that and the northern face of wall **806**. It measured 0.45m in width effectively doubling the thickness of the foundation and may have been a later addition in order to strengthen or repair the original wall.

**Plate 5:** General Shot of Trench 8. Viewed facing north-east.

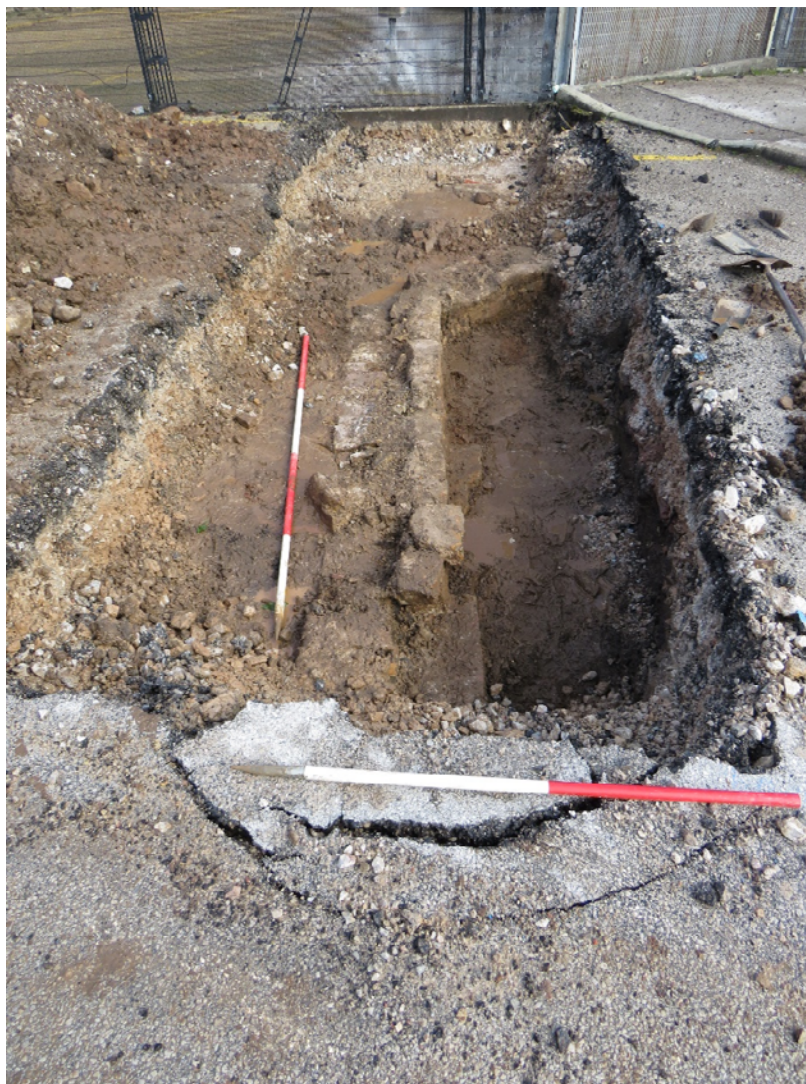
height of 0.3m. Its construction comprised a double skin of square and rectangular dressed sandstone blocks with a rubble infill, bonded with lime mortar. At the northern end of wall **9001**, wall **9002** continued on a slightly different alignment, to the north/east, forming a 45-degree angle. It was keyed into the fabric of wall **9001** and constructed in an identical fashion. This footing directly correlates to the shape of a building on the 1892 OS map (Fig 9), although no internal features such as flooring were preserved.

**Plate 6:** Foundations in the southern half of Trench 9

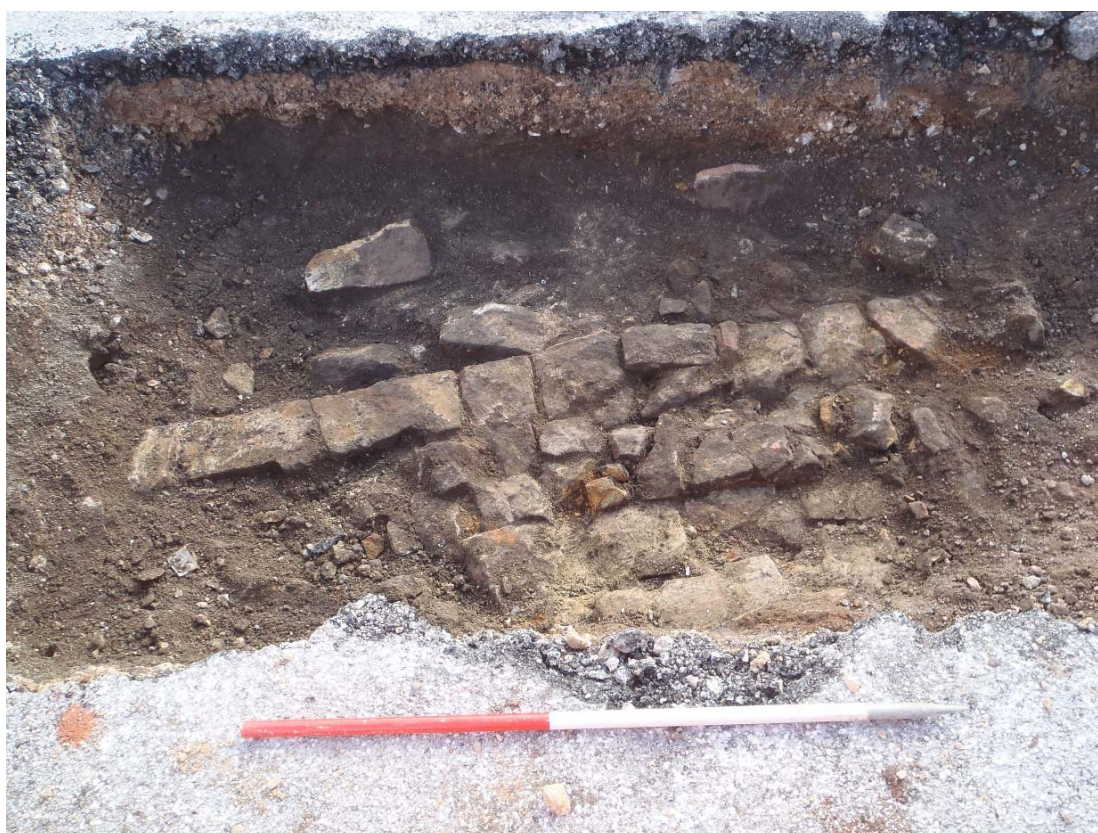
and **1105** may indicate that, despite a shared alignment and position, they represent separate phases of construction or modification to a single wall, truncated to the centre of the trench. Butting the southern face of wall **1105** was a slightly larger foundation, wall **1103**. This wall measured 2.5m in length with a width of 0.45m, the composition of the wall was similar to its neighbour, with a double skin of well-dressed rectangular sandstone blocks infilled with a rubble core.

**Plate 7:** Foundations Within Trench 11

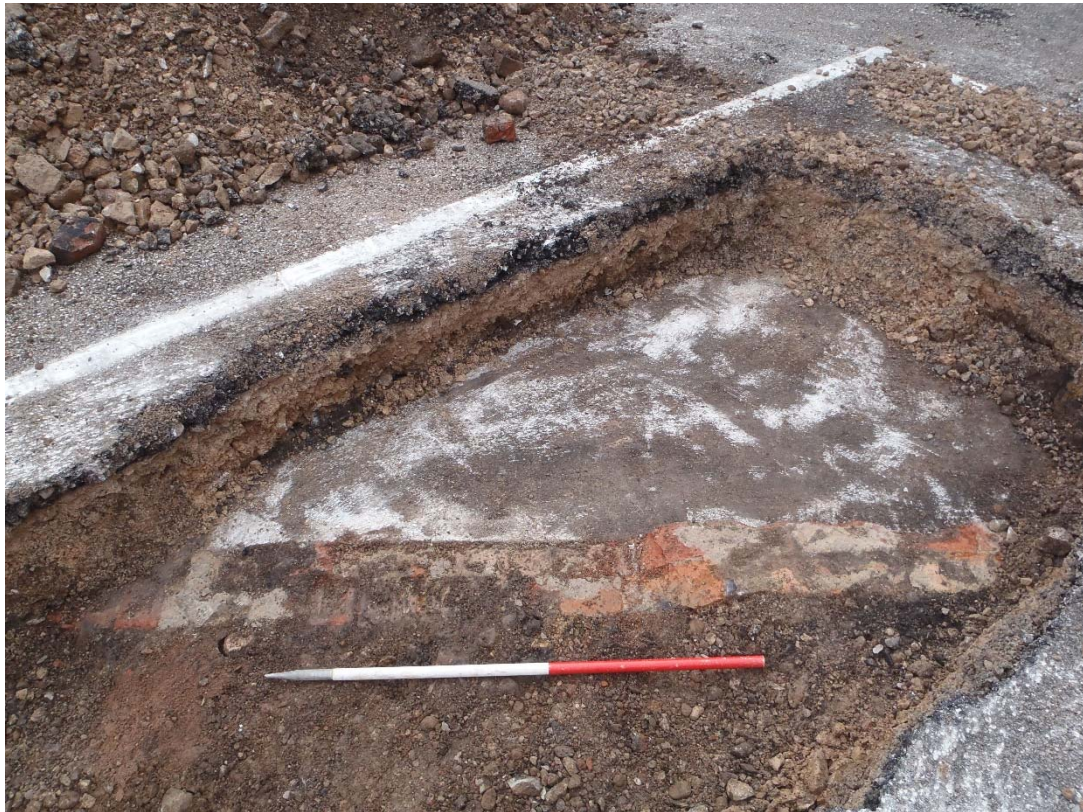
the trench on a north-east/south-west alignment and comprised a double skin of frogged brick laid as stretchers. Only a single course survived for most of its length. These bricks were bonded with a grey cement mortar. The wall foundation was butted against by concrete surface **1405**, which lay to the south. These remains were almost certainly twentieth-century in origin and may pertain to a substation marked on the OS map of 1971 (see Orion Heritage 2018, Fig 9).

**Plate 8:** Suspected twentieth-century remains in Trench 14
