Chester Northgate Redevelopment Archaeological Evaluation Report

April 2018

Client: Cheshire West and Chester Council

Archaeological Evaluation Report

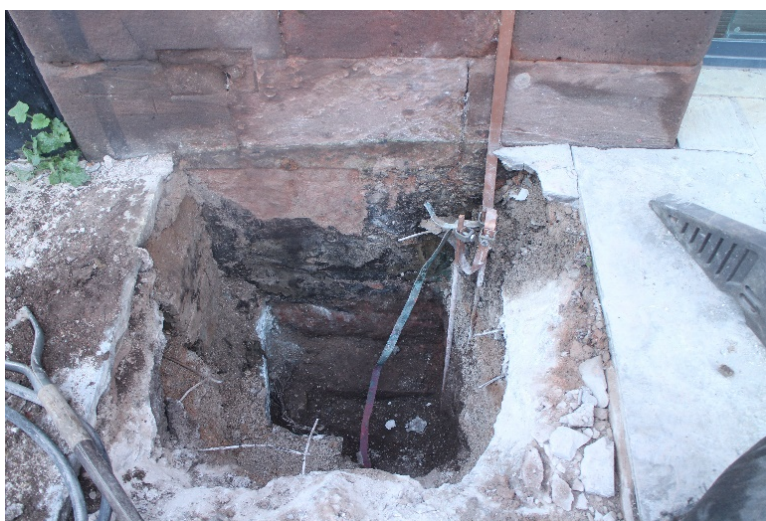
3.3.1 **Test pit 1 (TP 1)**: this was excavated on Northgate Street, in the access ramp immediately outside the visitor centre (Fig 2). Although excavated to a depth of 1.2m (c 28.10m aOD), no significant archaeological remains were found. All recorded deposits were clearly of recent date (PI 1), probably of the 1960s or later, largely comprising deposits of sandstone rubble (tipping steeply from east to west, towards the building), containing a few factory-made bricks and cut by modern services.

Plate 1: TP 1, looking west

- 4.1.4 **Northgate Street:** at 1.2m, TP 1, on Northgate Street (Fig 2), was the deepest of all the test pits investigated, but despite this, only layers of modern sandstone and brick rubble were revealed beneath the present surfacing and make-up deposits (Section 3.3.1). Perhaps significantly, the rubble exhibited tip lines extending from east to west, suggesting that it had been thrown back into a large cut. The edges of this putative feature were not seen within the test pit itself, so its character and significance remain unclear.

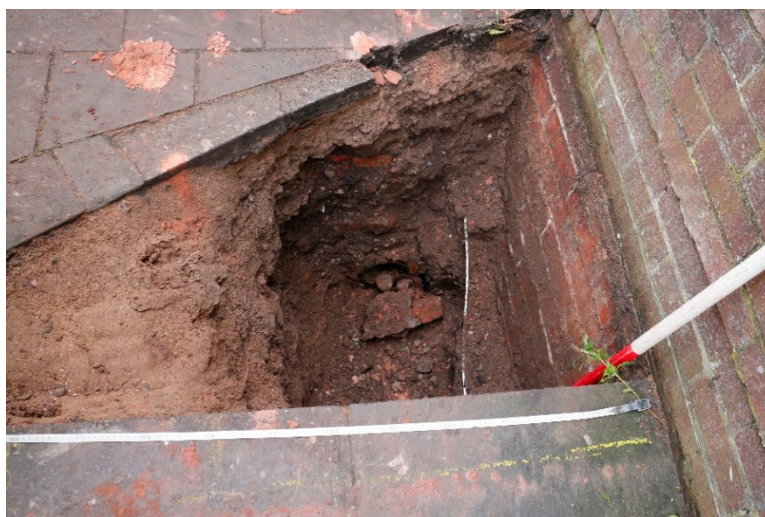
3.3.2 **Test pit 2 (TP 2):** TP 2 was placed in the pavement on the south side of Princess Street, adjacent to the base of the ramp giving access to the Market Hall (Fig 2). Removal of the modern flagstone surface and underlying sand bedding layer revealed a reinforced concrete slab, 0.15m thick, above 0.6m of brown sandy soil containing brick and concrete rubble (PI 2); a ceramic drainpipe was recorded towards the base of this. Excavation was halted at a depth of 0.9m (28.10m aOD) due to discovery of a tile-capped electricity cable. No significant archaeological remains were recorded above this.

Plate 2: TP 2, looking east

- 4.1.5 **Princess Street:** TP 2, on the south side of Princess Street (Fig 2), may have been sited within a construction overcut outside the north wall of the Market Hall. There, immediately adjacent to the base of the wall, modern surfaces and a concrete slab were found to overlie a mixed deposit of earth, brick and concrete rubble to at least

0.9m (*Section 3.3.2*), though deeper excavation was impossible due to the presence of a live electricity cable. As in TP 1, the edge of the putative overcut itself was not seen, since the test pit, which was only c 0.8m wide, north to south, probably lay wholly within its fill. However, a test pit excavated nearby in 2002 revealed the well-defined outer (northern) edge of a trench that was interpreted as the construction overcut for the Market Hall (Earthworks Archaeology 2002, 4). The top of this lay 0.65m below the surface, and its lip was c 3m from the modern retaining wall, though it had a battered profile, sloping from north to south (*op cit*, 12, fig 3). Since this feature was excavated to only 0.5m, its depth is unknown. Significantly, however, it was dug through the remains of a post-medieval cellar that in turn cut a sequence of earlier archaeological strata, north of (*ie* outside) the modern cut (*op cit*, 5), the base of which (as represented by the natural boulder clay) lay 1.75m below the surface (26.21m aOD).

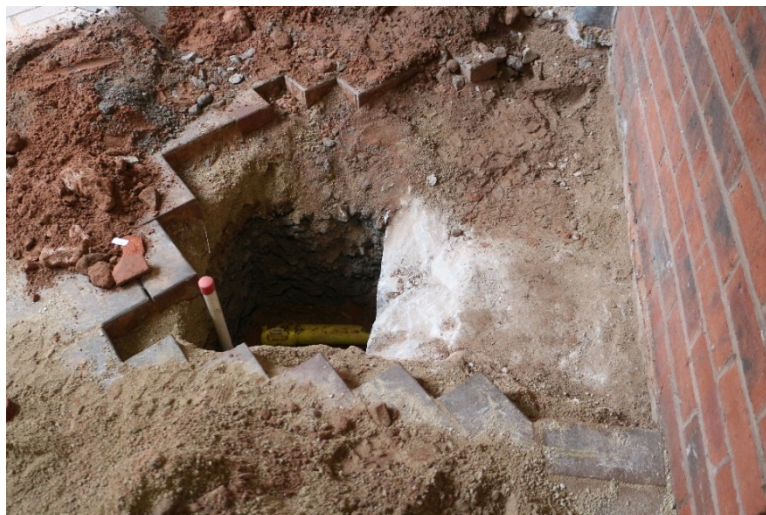
- 3.3.3 **Test pit 3 (TP 3):** TP 3 was excavated on the north side of Hamilton Place, in the north-west corner of the access yard for the current B&M Bargains store (Fig 2). This area is one of particular archaeological sensitivity, since it is adjacent to the position of the Elliptical Building, a structure, unique in the Roman world, which stood within the central range of the Roman legionary fortress (Mason 2000). Although what remained of the Elliptical Building itself was destroyed in the 1960s, during construction of the Forum shopping centre, the south-west corner of the associated precinct, representing all that now remains of its complex, extends into the B&M Bargains site.

- 3.3.4 Investigation of TP 3 revealed no surviving archaeology (PI 3). Instead, a series of disturbed modern deposits was recorded to 1.15m (c 26.38m aOD) below the present yard surface (at which depth excavation was terminated), presumably backfill of the overcut for the Forum shopping centre. A north to south gas pipe crossed the west side of the pit at a depth of 0.66m. In the northern half of the pit, a concrete slab was found at a depth of 0.17-0.78m, extending 0.6m south from the modern brick wall delineating the north side of the access yard. Parts of a brick retaining wall associated with the construction of the concrete slab were also recorded.

Plate 3: TP 3, looking south-west

- 4.1.7 **B&M Bargains, Hamilton Place:** TP 3, located up against the modern wall delineating the north side of the service yard on the west side of the B&M Bargains store (Fig 2; *Sections 3.3.3-4*), was opened to investigate further levels of archaeological preservation in what has long been highlighted as the most archaeologically sensitive part of the development site (OA North 2016c, 12, 39), due to the fact that it encompasses the only surviving part of the complex associated with the Roman Elliptical Building (*Section 3.3.3*), though Roman barrack blocks also extend into the area, separated from the Elliptical Building complex by an east/west road (Mason 2000). Although the pit was excavated to a depth of 1.15m, only disturbed modern deposits were encountered, with no *in situ* archaeological remains present. If this was the overcut for the wall, it was at least 1m wide (as measured from the wall face to the back (south) face of the test pit, though no cut was observed. Possibly, therefore, the pit lay wholly within the fill, although broadly similar levels of disturbance were recorded elsewhere within the service yard during the excavation of two earlier test pits (Earthworks Archaeology 2007, 6-7). Whilst the evidence might, therefore, point to fairly extensive modern disturbance over much of this area, it cannot be assumed that all significant archaeological remains have been destroyed, since a possible Roman layer was observed at the base of one of the earlier pits, c 1.3m below the surface (*ie* below the level to which TP 3 was excavated) and intact stratigraphy was recorded, at or about 1.15m, in a third test pit further to the east, on the north side of Hamilton Place (*ibid*).

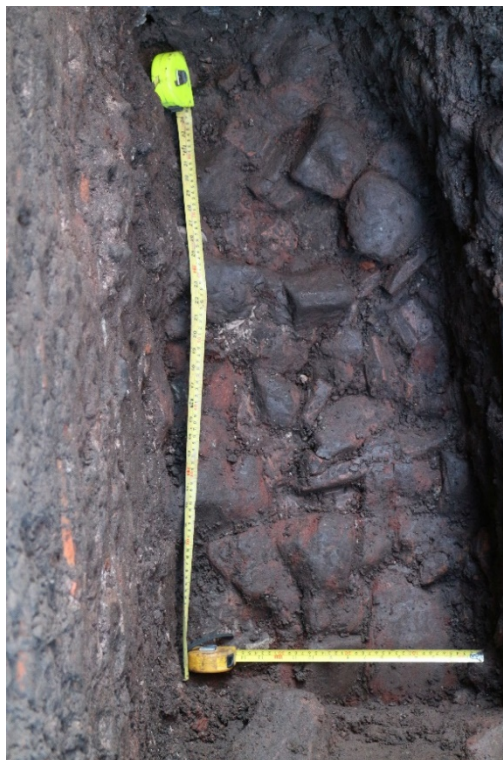
3.3.5 **Test pit 4 (TP 4):** the fourth test pit, excavated to a depth of 1.05m (base at c 21.93m aOD), was situated towards the south-west corner of the development site, between the Guildhall, on the west, and No 68 Watergate Street, to the east (Fig 2). Significant archaeological remains were revealed at a depth of 0.95-1m beneath the modern surface (c 21.98-22.03m aOD), comprising a compacted layer of sandstone, Roman brick/tile fragments and a few waterworn cobbles (421; Fig 3; Pl 4). This was recorded in a narrow strip, c 0.4m wide and 1.1m in length, adjacent to the upstanding brick wall of 68 Watergate Street, which formed the east boundary of the test pit. These stones may have been part of a Roman road surface, another part of which was seen nearby in 2007 (Earthworks Archaeology 2007; *Section 4.1.1*). In TP 4, it was overlain by c 0.45-0.5m of dark earth (Fig 3), comprising a brownish-grey silty clay loam (420), overlain by a dark grey silty loam (419). The top of this (at c 22.48-22.53m aOD), which can, perhaps, be regarded as the uppermost significant archaeological horizon, was cut by the construction trench for the west wall of 68 Watergate Street (418), the edge of which was only 50-70mm beyond the outer face of the wall itself. This was overlain by a narrow strip of crushed red sandstone (416), which was in turn overlain by deposits associated with the surfacing of the modern lane. On the west side of the pit, most earlier deposits had been removed by a modern pipe trench, located immediately beneath the surface of the lane, though the putative Roman road surface appeared to extend at least partly beneath this.

Plate 4: TP 4: Probable Roman metalled surface 421, looking north

- 4.1.1 **Trinity Street:** of the six test pits investigated (TPs 1-6), *in-situ* deposits of archaeological significance were recorded only in TP 4, towards the south end of Trinity Street (Fig 2), adjacent to the west side of No 68 Watergate Street, a townhouse with brick-vaulted cellars, built in 1729 for Alderman Henry Bennett (National Heritage List for England, No 1376448). Within this pit, a layer of compacted sandstone, Roman brick/tile fragments (retained *in situ*) and cobbles (421; Section 3.3.5), 0.95-1m below the modern surface (Fig 3; Pl 4), can be equated with a seemingly identical deposit recorded in 2007, c 21m to the north (Earthworks Archaeology 2007, 3), where it was at a depth of c 0.6m. This was exposed in a very limited area at both locales, but its character suggests a Roman date, whilst its position within the legionary fortress, a few metres inside (*ie* east of) the projected line of the west rampart, would be consistent with its identification as part of the intervallum road (*via sagularis*), which extended around the entire defensive perimeter, facilitating rapid access to the ramparts (Mason 2012; Johnson 1983, 30).

- 4.1.2 Directly overlying the putative road surface was a build-up of dark soils (420 beneath 419; Section 3.3.5), up to 0.5m thick. This was cut by the construction trench for the west wall of 68 Watergate Street, above which were deposits of later post-medieval and modern date. The dating of these soils, and their significance, is uncertain, but the lack of post-Roman artefacts (the only datable item is a large Roman roof tile (tegula) fragment, from 420 (Appendix B)), and in particular the absence of post-medieval material, is suggestive of a potentially early date for its accumulation, possibly during the later medieval period and/or earlier. Indeed, in 2007, two medieval potsherds were recovered from a soil, c 0.1m above the metallised surface (*op cit*, 4).

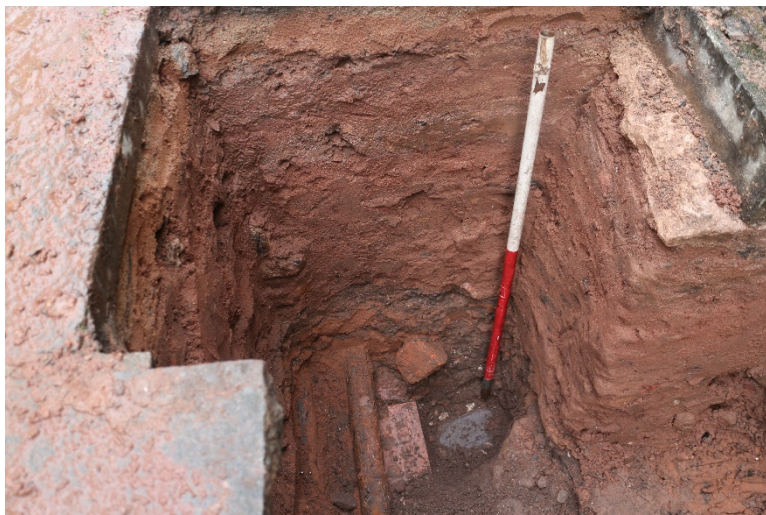
3.3.6 **Test pit 5 (TP 5):** the fifth test pit was the easternmost of two trenches (the other being TP 6; *Section 3.3.7*) situated in the narrow lane extending between Trinity Street and St Martin's Way, immediately south of the Crowne Plaza Hotel (Fig 2), adjacent to the Guildhall (or Trinity Church) on Watergate Street. Removal of the modern paving slabs and a series of modern deposits associated with the formation of a ramp from St Martin's Way to Trinity Street revealed several cable runs extending broadly east to west beneath the lane (PI 5), c 1.05-1.1m beneath the modern surface (c 22.25-22.30m aOD). and between 0.7-1m to the north of the brick wall on the Guildhall side. These post-dated a layer of loose, medium grey, sand and mortar, containing brick and slate fragments, which extended down to a depth of at least 1.25m below the surface (22.05m aOD), at which point the excavation was terminated. This was certainly a post-medieval deposit, though its precise date is unclear. No significant archaeological remains were recorded in this test pit.

Plate 5: TP 5, looking north-east

- 4.1.6 **The Crowne Plaza Hotel:** TPs 5 and 6, in the modern passageway on the south side of the Crowne Plaza Hotel complex adjacent to the Guildhall (Fig 2; *Sections 3.3.6-7*), also revealed only modern remains, to depths of 1.25m and 1.1m respectively. Much of the disturbance was clearly due to the insertion of service runs beneath the lane, but the nature of the earliest deposit revealed, a layer of grey-brown soil containing brick rubble, mortar and slate fragments, is unclear. However, it was certainly of relatively recent date and was only loosely compacted, suggesting either that it was associated with the construction of the hotel itself, or with the construction/demolition of late post-medieval/modern buildings that the hotel had replaced.

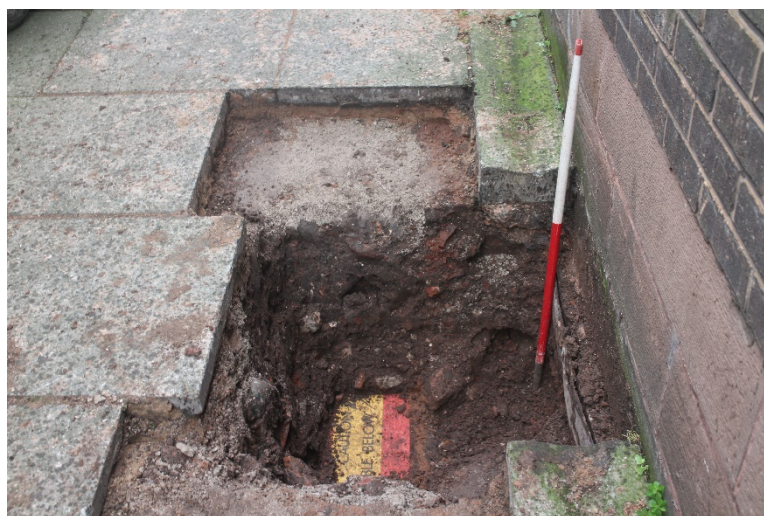
3.3.7 **Test pit 6 (TP 6):** TP 6 was located a short distance west of TP 5 (Section 3.3.6), in the narrow lane on the south side of the Crowne Plaza Hotel complex, extending west from Trinity Street to St Martin's Way (Fig 2). Removal of the modern flagged surface and the underlying sand bedding layer revealed a service trench (PI 6), 0.45m wide and over 0.6m deep (it was not bottomed), which had been cut through a modern layer of grey-brown soil and brick rubble, in excess of 0.95m thick, which extended beyond the base of the excavation (at 20.90m aOD). Consequently, no significant archaeological remains were recorded in this test pit.

Plate 6: TP 6, looking east

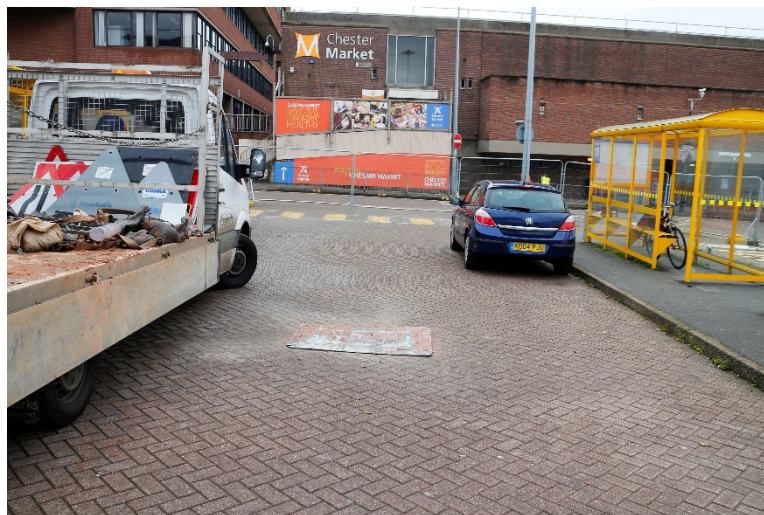
3.4.1 **Borehole 5 (BH 5):** this was situated towards the centre of the former bus exchange on the north side of Princess Street (Fig 2; PI 7). Breaking out and removal of the bus exchange surface and other modern deposits (including a concrete slab), to a depth of 0.82m, revealed a layer of dark sandy loam, at least 0.18m thick (507), the top of which lay at 27.50m aOD. This extended below the base of the hand-dug start hole, which was 1m deep (27.32m aOD), and yielded 15 small fragments of ceramic building material, of possible Roman date, with no later material present. Consequently, it was

judged to represent the uppermost significant archaeological horizon. It can probably be equated with a Roman soil layer that was recorded in a test-pit, excavated in 2016, little more than 2m to the east (OA North 2016b, 19-20), the top of which lay at 27.87m aOD. The borehole log for BH 5 records that ‘made ground’, potentially including stratified archaeological deposits, extended to c 3-3.5m below the modern surface (c 24.82-25.32m aOD).

Plate 7: Location of BH 5, looking south

- 4.2.8 **Former bus exchange:** in the former bus exchange north of Princess Street, BHs 5 and 6 (Fig 2) yielded similar results to BH 20 on Northgate Street (*Section 3.4.8*), with a probably significant archaeological horizon, represented by a dark soil (respectively 507, 605), revealed in the start holes, 0.82-0.84m below the surface (*Sections 3.4.1-2*). Drilling below this revealed 'made ground', perhaps representing *in-situ* archaeological strata, to a depth of up to 3.5m in both boreholes, and also in BH 11, nearby (Fig 2; *Section 3.4.4*), suggesting the possible existence of intact stratigraphy, up to 2.68m thick, in this part of the development site. This is broadly consistent with the results of an earlier phase of test-pitting on the Northgate site, which revealed archaeological deposits to a depth of at least 1.87m (the base of these strata was not reached) in a pit located elsewhere within the bus exchange (OA North 2016b, 21).

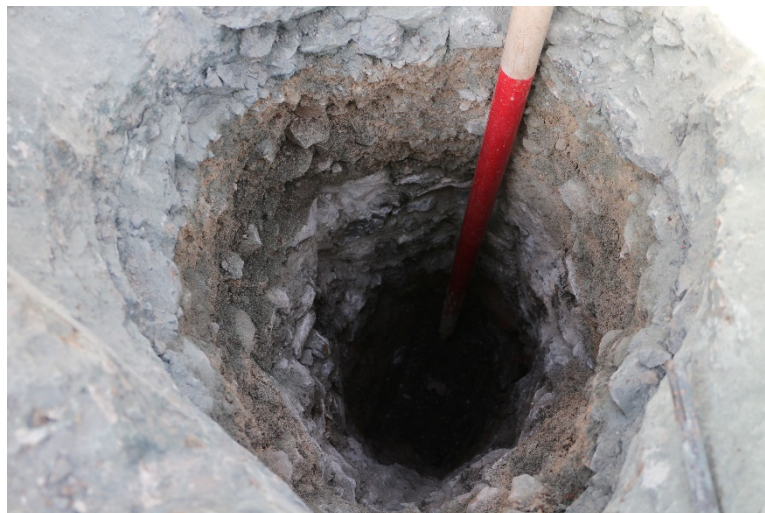
3.4.2 Borehole 6 (BH 6): BH 6 was situated towards the north-east corner of the former bus exchange (Fig 2), and the sequence recorded was very similar to that seen in BH 5, to the south-west (Section 3.4.1). Removal of the surface and underlying modern deposits (including a concrete slab; PI 8) revealed a layer of dark grey sandy loam (605), at least 0.16m thick (hand-excavation of the start hole terminated at 28.46m aOD, 1m below the surface), at a depth of 0.84m, the top of which (at 28.64m aOD) represents the uppermost significant archaeological horizon. This deposit yielded a single sherd from a Roman-period flagon (Appendix B) and, as with the similar soil in BH 5 (507; Section 3.4.1), can probably be equated with a Roman soil horizon recorded nearby in 2016 (OA North 2016b, 19-20), the top of which lay at 27.87m aOD. The borehole log records a ‘zone of assumed core loss’ from 1-3.2m below the surface, but indicates the existence of ‘made ground’, possibly representing intact archaeological strata, from 3.2-3.5m (26.44m aOD to 26.14m aOD), overlying the bedrock.

Plate 8: BH 6, looking north

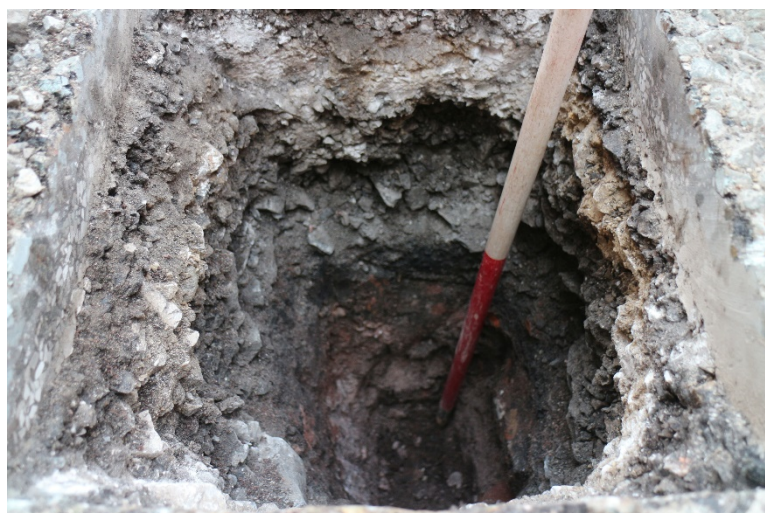
3.4.3 **Borehole 8 (BH 8):** BH 8 was situated on the west side of Trinity Street, close to the junction with Princess Street and 4.3m east of the east wall of the Crowne Plaza Hotel (Fig 2). On the west side of the start hole, removal of the modern tarmac surface revealed a layer of concrete overlying hardcore and brick rubble to a depth of c 1m beneath the surface (23.40m aOD; PI 9). On the east, similar modern deposits were recorded to a depth of 0.73m (23.67m aOD), below which was a layer of sandy loam containing some large sandstone fragments. This is undated, but is, perhaps, most likely to represent debris associated with the construction of either the hotel, on the west, or the Forum shopping centre, to the east (a similar deposit containing some relatively modern, machine-made bricks, was observed in the extension trench to BH 101, to the north-east (*Section 3.4.10*)). From 1m to 3.46m (20.94 aOD), the borehole log records a zone of ‘assumed core loss’, with ‘made ground’ containing ‘limestone, sandstone and brick’, possibly representing *in-situ* archaeological remains, from 3.46m to 3.76m (20.64 aOD), directly above the bedrock.

Plate 9: BH 8, looking north

- 4.2.1 **Trinity Street/Princess Street:** excavation of the start hole for BH 8, on the west side of Trinity Street, close to the junction with Princess Street and c 4.3m east of the east wall of the Crowne Plaza Hotel (Fig 2), revealed a mixed deposit of earth and sandstone rubble, 0.73m below the surface (*Section 3.4.3*). A similar deposit, comprising a seemingly extensive spread of modern sandstone/brick rubble, sand and earth, was also found directly beneath modern surfaces and service runs a short distance to the north-east, in the extension trench associated with BH 101, at the west end of Princess Street (Fig 2; *Section 3.4.10*). Whilst the precise significance of these deposits is unclear, it seems likely that those in the extension trench relate to the construction of the Forum shopping centre, and/or to the demolition and levelling of earlier buildings immediately prior to the Forum's construction, whilst the deposit observed in BH 8 could be associated with the construction of the Crowne Plaza Hotel. At neither locale was there any conclusive evidence that the rubble filled a construction overcut associated with either the Forum or the hotel, though the existence of an overcut outside the Forum retaining walls has been demonstrated elsewhere, for example, further to the east on Princess Street (Earthworks Archaeology 2002) and on Trinity Street, to the west (OA North 2015), where the lip of the cut was found to lie c 2-3m outside the walls (no such overcut has, as yet, been proven to exist for the walls of the hotel). However, it is likely that the debris recorded in the BH 101 extension trench masked the top of such a cut, and this might also have been the case in BH 8. Taken together, the evidence from these interventions suggests that an extensive area at the junction of Trinity Street and Princess Street may have been 'dug out', or otherwise disturbed, during construction of the Forum and/or the hotel. This disturbance clearly extends to at least 1-1.2m below the present surface, but exactly how deep it is remains unclear.

- 4.2.2 Beneath the rubble in BH 8, there is no record of the strata until a zone of 'made ground' was reached by drilling at 3.46-3.76m below the surface, directly above the bedrock. From this level, fragments of limestone and 'brick' were seemingly recovered, suggesting that these deep deposits may have been of anthropogenic origin, perhaps representing early Roman remains. In BH 101 too, the existence of potentially *in-situ* archaeological strata at a considerable depth below the modern surface was suggested by the recording of another zone of 'made ground', c 3.7-4m down (*Section 3.4.9*).

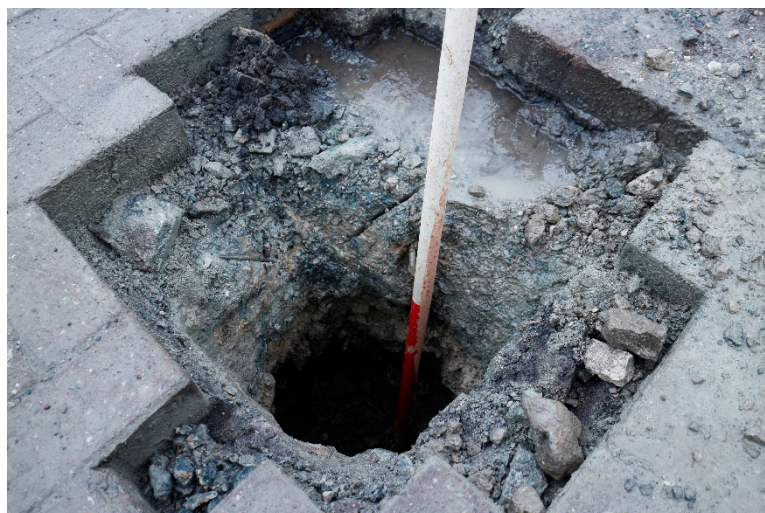
3.4.4 **Borehole 11 (BH 11):** this borehole was drilled on the south-east side of the former bus exchange to the north of Princess Street (Fig 2). Within the start hole, all recorded deposits, to a depth of 1m below the surface (27.78m a OD) were modern, comprising

layers of reinforced concrete and hardcore (PI 10). However, it should be noted that Roman archaeological remains were recorded in 2016 in a test pit excavated elsewhere in the bus exchange, the top of which lay at 27.98m aOD (OA North 2016b, 20). From 1m to 3.02m (25.76m aOD), the borehole log records a zone of 'assumed core loss', beneath which was 0.48m of 'made ground' from which fragments of limestone, sandstone and 'brick' were seemingly recovered. As in BH 8, it is possible that this horizon, which was directly above bedrock, at 25.28m aOD, 3.5m below the surface, represents intact archaeological strata, though this cannot be proven from the existing evidence.

Plate 10: BH 11, looking north-west

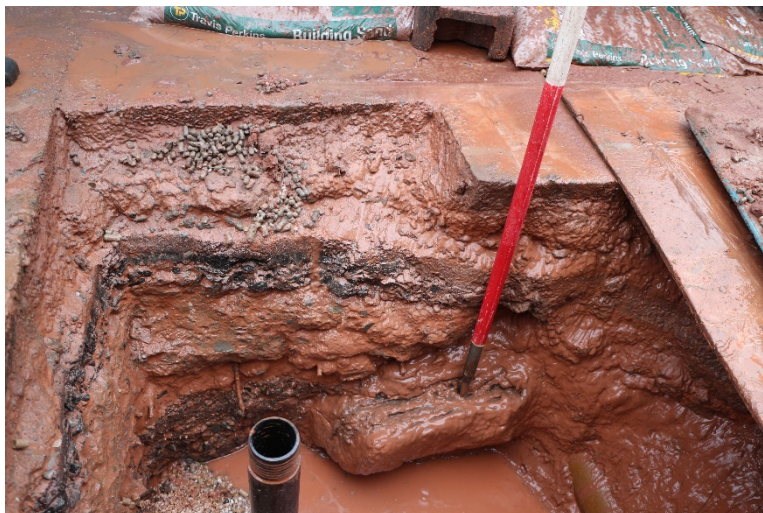
3.4.5 **Borehole 12 (BH 12)**: this was situated in Northgate Street, in the pavement directly in front of the Town Hall (Fig 2). Removal of the modern surface and make-up deposits revealed the top of possible significant archaeological horizons at 0.45-0.5m below the surface (28.55-28.60m aOD), represented by a large sandstone block in the east side of the pit (PI 11) seemingly within a dark grey silty-clay loam (1205). Although the drilling operatives thought that sandstone bedrock was reached c 1m below the surface (27.37m aOD), the recovery, from the drilling spoil, of small fragments of ceramic building material (presumably of Roman date), at depths of c 2.5-2.75m below the surface (c 26.30-26.55m aOD), suggested that *in-situ* archaeological remains extend to at least this depth. It is possible, therefore, that the supposed 'bedrock' was, in fact, *in-situ* sandstone masonry (or a large stone block), though this is uncertain.

Plate 11: Start hole for BH 12, looking east, showing sandstone block in deposit 1205

- 4.2.5 Also on Northgate Street, the possible existence of significant archaeology at a relatively shallow depth, c 0.5-1m below the surface, was indicated by the results of the start hole excavations for BHs 12 and 13 (Fig 2; *Sections 3.4.5-6*). Whilst the remains at these locales could not be characterised, they may incorporate large sandstone blocks, either in the form of *in-situ* masonry (?walls), spreads of rubble or large, 'stray' fragments. In terms of the topography of the Roman legionary fortress, both boreholes were located within the interior of an extremely large, rectangular building located within the central range, in *Insula XVI* (Mason 2012, 56, fig 20b). The function of this structure is unclear, though its size and position, immediately north of the headquarters building (*principia*) and east of the Elliptical Building, a structure unique in the Roman world (Mason 2000), suggests that it was of considerable importance. As in BH 20, the possible existence of deep archaeological strata at these locales was suggested by the recovery of small brick/tile fragments from zones of 'made ground' at depths of c 2-3m below the surface.

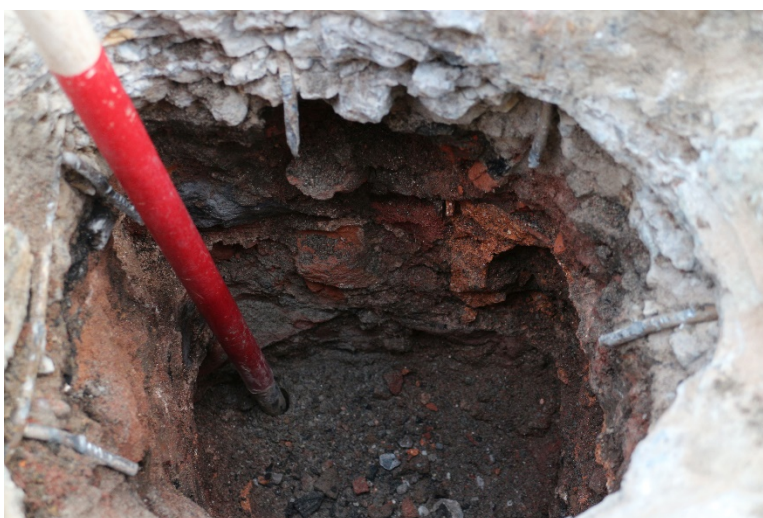
3.4.6 **Borehole 13 (BH 13):** BH 13 was situated on Northgate Street, on the south side of the market square, north of the Dublin Packet public house (Fig 2). Modern deposits, extending to 0.5m below the present surface (PI 12), were found to overlie the loose earth fill of a modern service trench, which extended to a depth of c 1m below the surface (c 27.37m aOD). At this level, a layer of paler soil (1308) containing Roman ceramic building material (*Appendix B*) was recorded, which may represent the uppermost significant archaeological level. As in BH 12 (*Section 3.4.5*), it was initially thought that the natural bedrock lay at a depth of approximately 1m, but in this borehole too, this is more likely to have been a stone block or the remains of sandstone masonry, since fragments of ceramic building material, presumably of Roman date, were recovered from 1.97-2.87m below the surface (c 25.50-26.40m aOD), suggesting the survival of archaeological strata to at least this depth.

Plate 12: BH 13, looking east

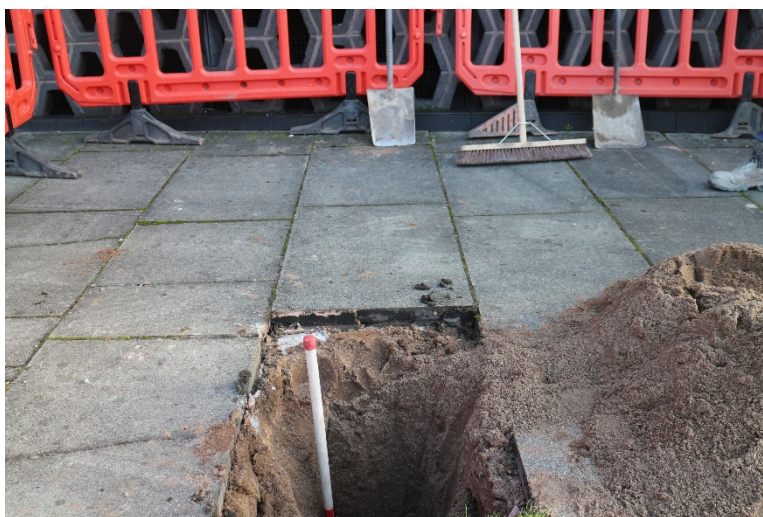
3.4.7 **Borehole 16 (BH 16):** this was situated in the pavement between St Martin's Way and the electricity substation at the south end of the Crowne Plaza Hotel car park (Fig 2). Removal of the modern concrete flags revealed a homogeneous deposit of pale red-brown sand (PI 13), to a depth of at least 1m (20.56m aOD). This is thought to represent the fill for the overcut associated with the construction of the hotel complex,

though the edge of the cut was not observed, the start hole presumably lying entirely within it. If this is correct, the overcut must have been at least 3m wide at this locale (as measured from the western edge of the borehole start hole to the outer face of the retaining wall of the hotel complex), though it is conceivable that the sand filled some other, unrelated, feature, such as a service run. At a depth of 1.1m (20.46m aOD), a layer of concrete and a membrane were encountered, at which point the borehole was abandoned, since these indicated the possible presence of live electricity cables associated with the nearby substation.

Plate 13: BH 16, looking east

- 4.2.6 **The Crowne Plaza Hotel:** the single borehole in the vicinity of the hotel (BH 16) was sited in the pavement towards the south-west corner of the hotel complex (Fig 2). Although no archaeological remains were recorded, excavation of the borehole being abandoned at a depth of only 1.1m (*Section 3.4.7*), the discovery of a homogeneous deposit of pure sand, at least 0.95m thick, suggested that it may have been sited within an overcut associated with the construction of the hotel. If this is correct, this is the first occasion, during the various phases of archaeological investigation and other SI works undertaken in respect of the Northgate scheme, where the existence of a potentially large construction overcut for the hotel has been recorded. It would also provide an indication that the overcut is at least 3m wide at this locale (as measured from the start hole for BH 16 to the outer face of the hotel wall), though, on a cautionary note, it is possible that the sand represents the fill of an entirely unrelated feature, for example a service run. If the modern deposits recorded in BH 8, towards the northern end of Trinity Street, also relate to the construction of the hotel (*Sections 4.2.1-3*), then below-ground disturbance may extend for a distance of at least 4.3m east of the hotel, though this remains uncertain.

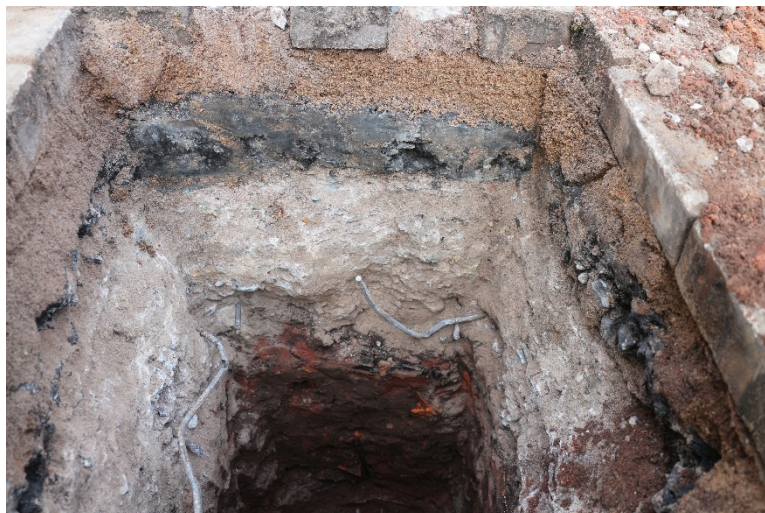
- 3.4.8 **Borehole 20 (BH 20)**: BH 20 was situated on Northgate Street, towards the junction with Hunter Street (Fig 2). Removal of modern deposits to a depth of 0.57m beneath the surface (c 29.12m aOD) revealed a layer of reddish-grey-brown sandy loam (2006), up to 0.43m thick (Fig 4; Pl 14), containing Roman pottery, ceramic building material and butchered animal bones. This very probably represents the uppermost significant archaeological horizon encountered in BH 20. At 0.9m beneath the surface (c 28.58m aOD), this overlay a pale red sand deposit (2007), c 0.1m thick, lying above what was initially interpreted as sandstone bedrock, c 1m down (c 28.68m aOD). However, the recovery, from the borehole, of ceramic building material and limestone fragments, at a depth of up to 2.8m (26.89m aOD), as recorded in the borehole log, suggests that *in-situ* archaeological remains may extend down to at least this level, the supposed 'bedrock' possibly being sandstone masonry (see also BHs 12 and 13; Sections 3.4.5-3.4.6).

Plate 14: BH 20, looking north

- 4.2.4 **Northgate Street:** from an archaeological perspective, BH 20, drilled on Northgate Street, towards the north-east corner of the development site (Fig 2; *Section 3.4.8*), was by far the most informative of the ten boreholes investigated. There, a soil (2006) revealed in the start hole, at a depth of only 0.57m below the surface, yielded exclusively Roman finds, including 16 potsherds and 42 small brick/tile fragments, the latter undiagnostic but, given the dating of the associated pottery, almost certainly Roman. Drilling beneath this level seemingly brought up fragments of ceramic building material from a depth of up to 2.8m, which, if correct, would indicate the existence of Roman strata at least 2.23m thick at this locale.

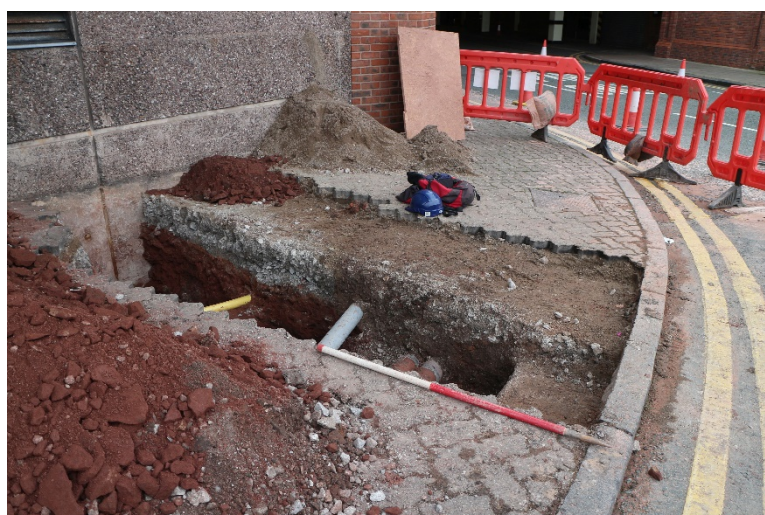
3.4.9 **Borehole 101 (BH 101) and extension trench:** BH 101 was situated on the south side of Princess Street, east of the junction with Trinity Street (Fig 2). The extension trench was excavated, on a south-east to north-west alignment, for c 3.7m, extending south-east from the start hole for the borehole up to the retaining wall for the car park of the Forum shopping centre (PI 15). Within the start hole itself, modern layers of tarmac, bedding deposits and brick rubble (PI 16) were removed to a depth of 0.56m (24.09m aOD). Beneath this was a layer of dark grey/black, mortar-rich sandy soil, at least 0.44m thick (base at 23.65m aOD), which extended below the base of the 1m-deep, hand-excavated start hole. This was clearly a post-medieval deposit, and was possibly quite recent, though it could not be closely dated. From 1-3.69m, the borehole log records an 'assumed zone of core loss', with 'made ground', possibly representing intact archaeological deposits, from 3.69-4m. Another zone of core loss was recorded from 4-4.28m (base at 20.37 aOD).

Plate 15: Extension trench for BH 101, looking south-west, showing utilities

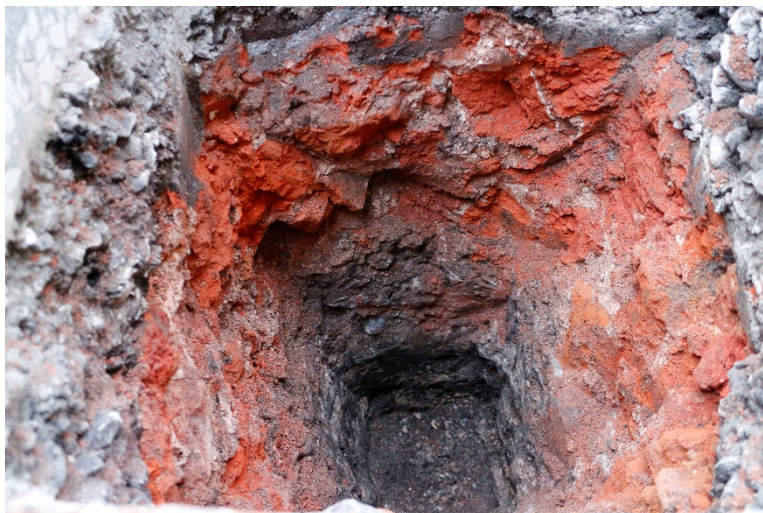
Plate 16: BH 101, looking north

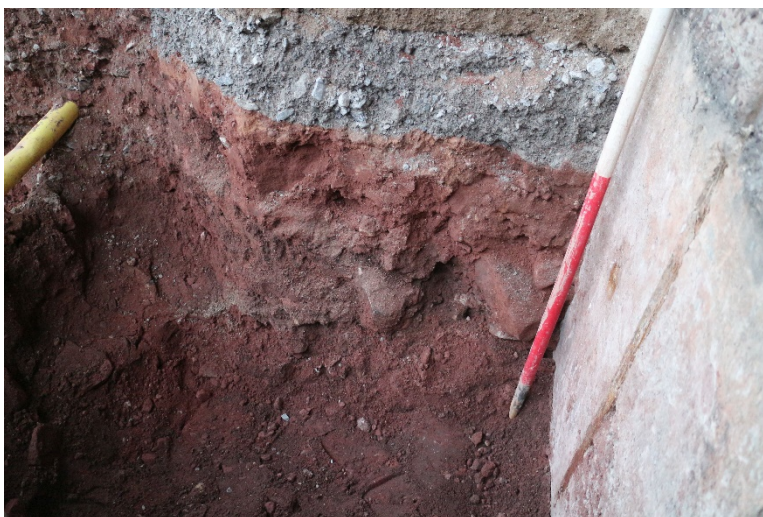
3.4.10 The extension trench contained a similar depth of modern surfacing and bedding layers, beneath which was a deposit of coarse sandstone rubble and sandy soil containing some modern, factory-made bricks (PI 17). This was at least 0.75m deep (top at c 24.21m aOD), but continued down beneath the base of the trench, which was dug to a depth of 1.2m (c 23.76m aOD). It was cut through by several modern service runs, all located close to the modern surface (PI 15). Tip lines were clearly visible within this material (PI 18), tipping from north to south, towards the retaining wall for the Forum basement car park, suggesting that it may have filled a wide construction overcut, at least 3.7m wide, though, if this was the case, the edge of the cut was not seen.

Plate 17: Extension trench to BH 101, looking north-east, showing sandstone rubble adjacent to the outer face of the basement retaining wall of the Forum shopping centre

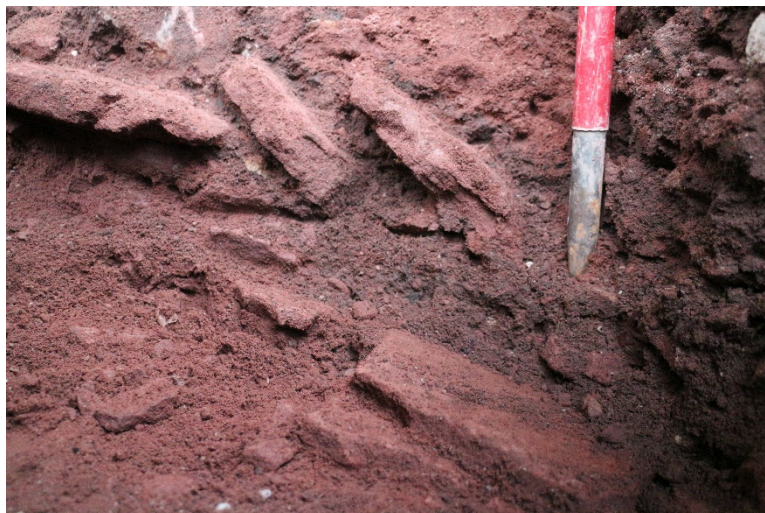
Plate 18: Extension trench for BH 101, looking south-west, showing tip lines in sandstone rubble adjacent to the basement retaining wall of the Forum shopping centre

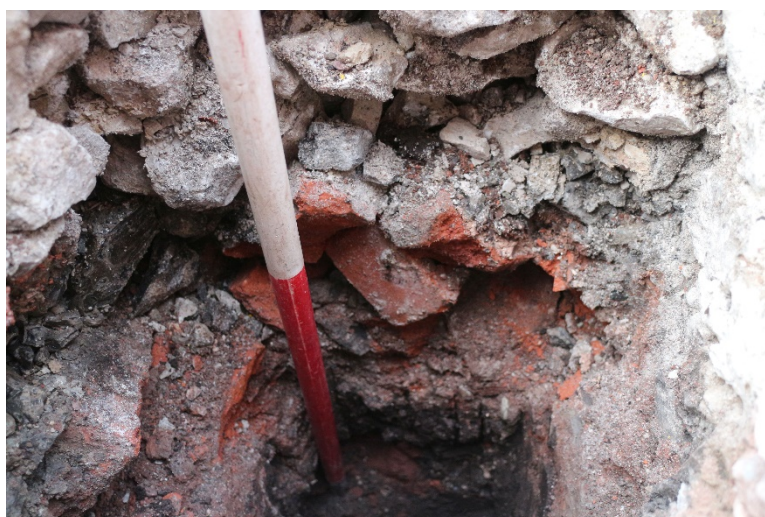
3.4.11 **Borehole 103 (BH 103)**: BH 103 was situated on the south side of Hamilton Place, near to its junction with Trinity Street, in the roadway just north of the entrance to Hamilton House (Fig 2). The modern road surface overlay brick rubble to a depth of 0.65m (24.51m aOD), beneath which was a layer of dark grey silty loam, at least 0.42m thick; this extended below the base of the hand-dug start hole (24.09m aOD), which was excavated to a depth of 1.07m (PI 19). This was judged to be a possible post-medieval deposit, though it yielded no artefacts and remains undated. The borehole itself was not drilled below the level of the start hole, since this would have had a severe impact on traffic flow.

Plate 19: BH 103, looking north

- 4.2.7 **Hamilton Place:** the single borehole in Hamilton Place (BH 103; Fig 2) was not drilled below the base of the hand-dug start hole, which was 1.07m deep (*Section 3.4.11*). Consequently, no significant archaeological remains were observed, the stratigraphically earliest material recorded being a probable post-medieval soil. However, the fact that this deposit remained *in situ* suggests that intact archaeological

strata may well survive at a greater depth, protected, as it were, by the post-medieval soil build-up.

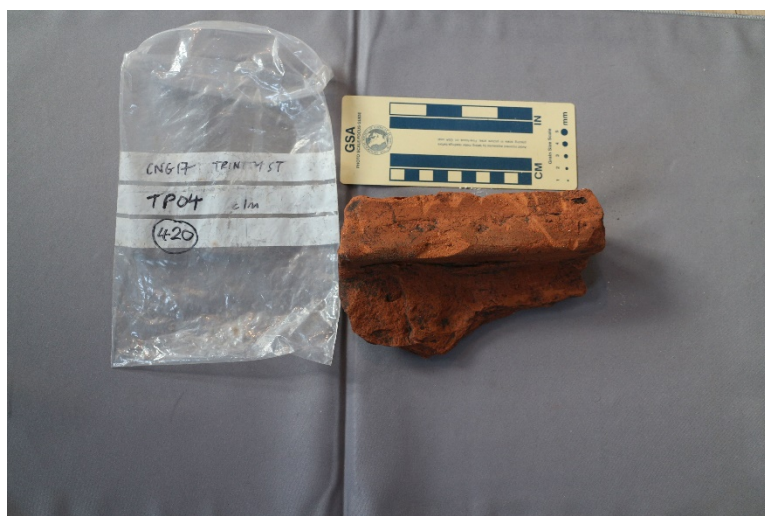
3.5.1 In all, 288 artefacts and ecofacts (principally animal-bone fragments) were recovered from the investigations; a catalogue is presented in *Appendix B*. Most of the test pits and boreholes yielded some evidence for Roman activity (Table 1), though in many cases this was sparse, often being limited to a few fragments of ceramic building material, much of which was residual in demonstrably post-Roman deposits, or was unstratified. The larger, more diagnostic fragments include several unabraded pieces

of tegulae (Pl 20) and imbrices (roof tiles), and box tiles. There is, in addition, a small assemblage of Roman pottery, including Black-burnished Ware Fabric 1 (BB1), a Wilderspool mortarium, and possibly fragments from an imported Gauloise 1 wine amphora (Tyers 1996), much of which came from BH 20 (*Section 3.4.8*). The bulk of this material appears to be broadly datable to the second century AD, though, in view of the small size of most of the fragments, this cannot be confirmed.

Plate 20: Roman tegula (roof tile) fragment from deposit 420 in TP 4
