1 CABLE STREET, LANCASTER, LANCASHIRE

Archaeological Building Investigation

Cable Street Developments

Issue No.: 2002-2003/072

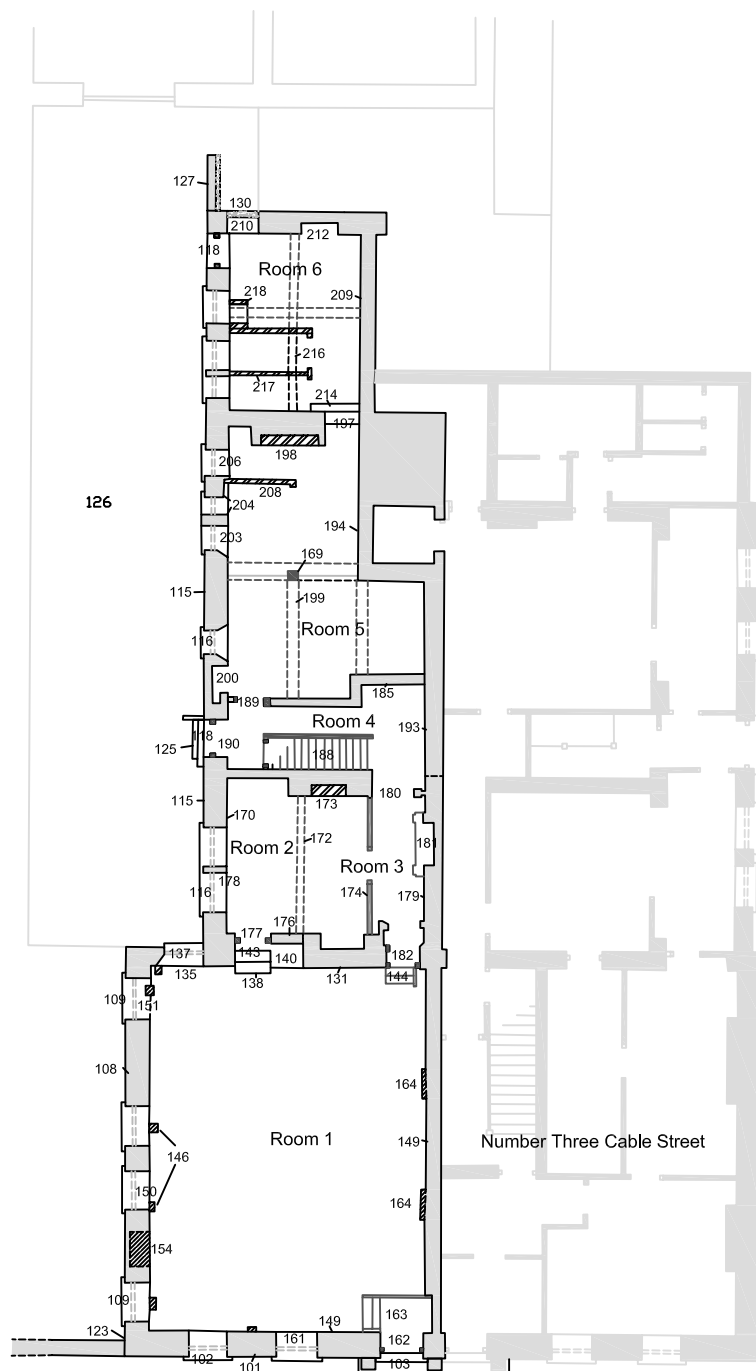
Figure 2 : Ground floor and cellar plan

- 4.1.1 **Introduction:** for the purposes of the survey the building was divided into 12 rooms, six on the ground floor (Fig 2), four on the first (Fig 3), and two in the cellar (Fig 2). The front (south) end of the building consists of a roughly square block, now consisting of 1½ storeys, but originally of three and forming part of a block with number 3. The back (north) of the building is long and narrow, orientated north/south, running away from Cable Street, and is of two storeys.

4.1.22 **Internal Detail, Room 11:** this is the northern room of the cellar, lying beneath Rooms 4 and 5 (Fig 2 and 7). The build is the same throughout, comprising rough stone courses finished with decayed plaster and the walls continue into the low vaulted ceiling (262). The floor (263) consists of stone flags, some of which have recently been removed and holes excavated below. There are small, machine cut timber battens (264) nailed to the north and east elevations, some with the remains of metal pipe clips still attached. Iron water pipes (265) are attached to the ceiling, cutting through it in places. Within the west elevation there is a small cellar light (266), 0.7m wide and 0.8m tall, which is blocked with brick on the outside (280). The staircase (267) is on the south side of the room, against the south elevation, and consists of a series of neatly tooled sandstone steps, each 0.25m tall, and 0.25m deep, with a handrail along the north side.

4.1.23 **Internal Detail, Room 12:** this is the southern room of the cellar, lying beneath Room 2 (Figs 2 and 7). The build is very similar to that of Room 11, with a low vaulted ceiling and walls made of rough stone courses (268). The floor (269) is also stone flags, again with the occasional one removed. Again there are small timber battens (270) fixed to the east and south walls, with electrical cables attached, and there are water pipes (271) attached to all parts of the room, coming to a lead water tank on the north side. There is a small patch of concrete render repair within the north elevation (278). In the south elevation there is a narrow doorway (275), only 0.7m wide, with a chamfered left jamb, which has been blocked with brick (276). To the right of this a fuse box and other electrical fittings (277) are attached to the wall. Within the west elevation there is a large aperture (272), the majority of which is only 0.25m deep. Within this there is a low stone seat or shelf consisting of a stone slab on a brick plinth (274), and on the right side there is a deeper recess, presumably forming a window, now blocked with brick (273).

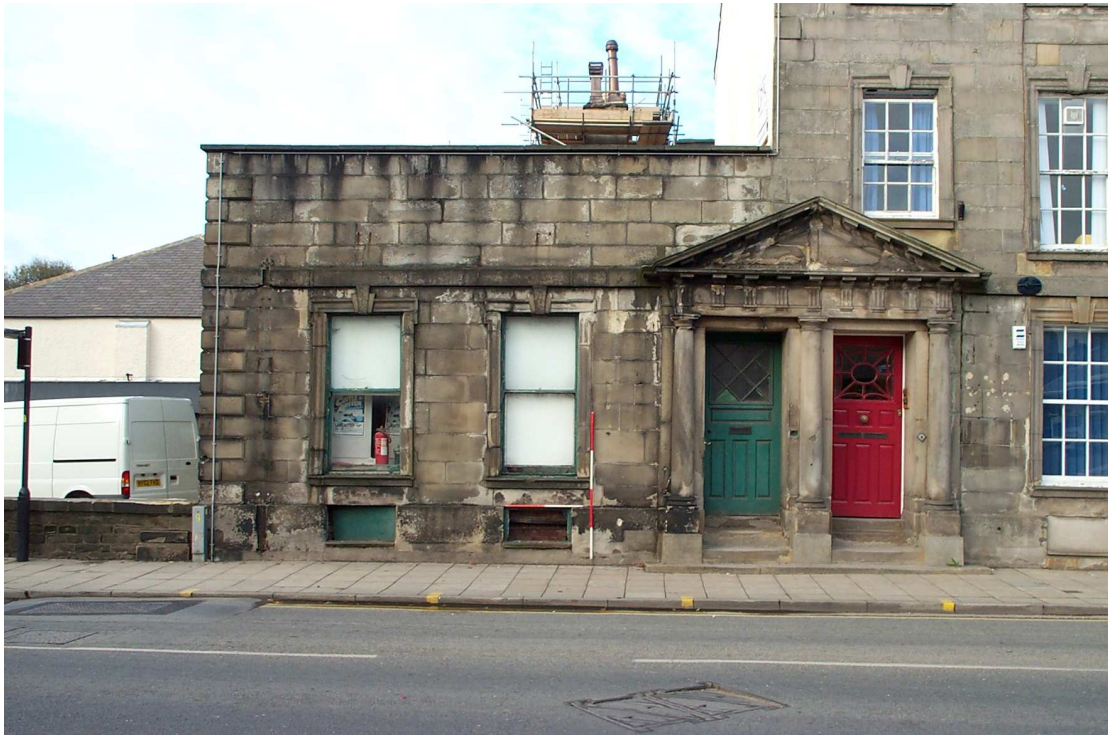
Plate 1: Front (south) external elevation

- 4.1.3 **External Elevation, South:** this forms the front of the building (Plate 1) It is now effectively 1½ storeys tall, reduced from three, originally forming the left side of a larger, roughly symmetrical block (Fig 4). The build consists of large ashlar sandstone blocks (**101**), incorporating a narrow, square, sill band, with chamfered rusticated quoins and a tall, square, projecting plinth course. There are two windows on the ground floor with two corresponding cellar windows below (**102**). Each of the upper windows has moulded architraves, with triple key stones and a 2-light sliding sash frame, while the cellar windows are very plain, with heavy stone lintels, the right one being blocked by brick (**105**). The doorway on the right side, **103**, is part of an ornate double entrance, below a Doric pediment with an entablature decorated with fluted pilasters, supported by three engaged Doric columns. On the left hand side the sill course and plinth have been cut to fit a downpipe, **106**, the scars of which are visible on the stonework. Along the base of the wall is a skim of rerendering, on average 0.1m tall (**107**). Although only apparent externally because of the slight irregularity in block sizes, the top of the wall, above the sill band, has been entirely rebuilt in the same ashlar sandstone as the rest of the wall, which corresponds to the rebuilding (**148**) seen internally. This is capped with a row of thin concrete slabs acting as coping (**104**).

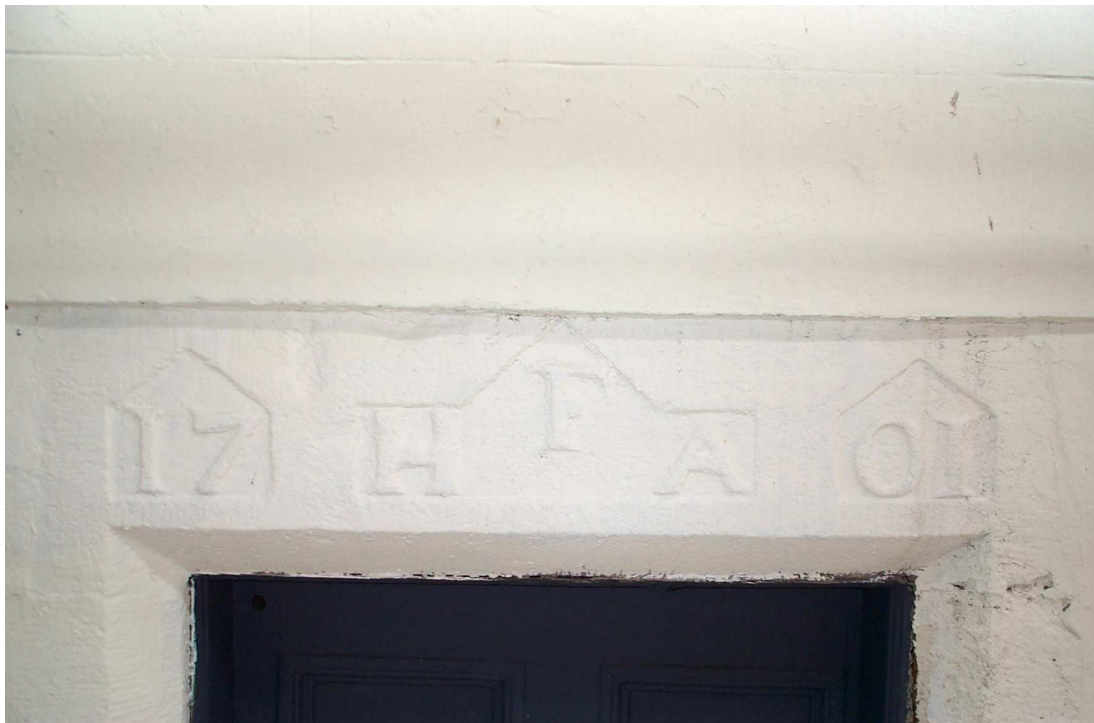
Plate 2: Datestone in west external elevation

- 5.2.1 The datestone (Fig 5; Plate 2) gives some vital evidence about the development of Number One Cable Street. The year 1701 is considerably earlier than the supposed date of construction of the building, c1759, (White 2000, 41). However, the initials H and A F would appear to fit with the name of Captain Henry Fell for whom part of the house was built (*ibid*). It seems entirely plausible, therefore, that the HF of 1701 was an ancestor of the Captain Henry Fell of c1759 (A White pers comm). Captain Henry Fell was a port commissioner and possibly a relative of Richard Gillow (*Appendix 1*), who built the house and made use of the experience when constructing the new Custom House in 1762 (White 2000, 8). This datestone fits well with the evidence from the building itself, in that the northern part (incorporating the datestone) is earlier than the southern part. Investigations (Garnett 1999, 100) has not been able to trace the potential ancestor, and has suggested that the date may have been recut from 1761, but considers the earlier date more likely. It would seem therefore that the building date of c1759 refers to the front of the building and that this was built onto an existing structure.

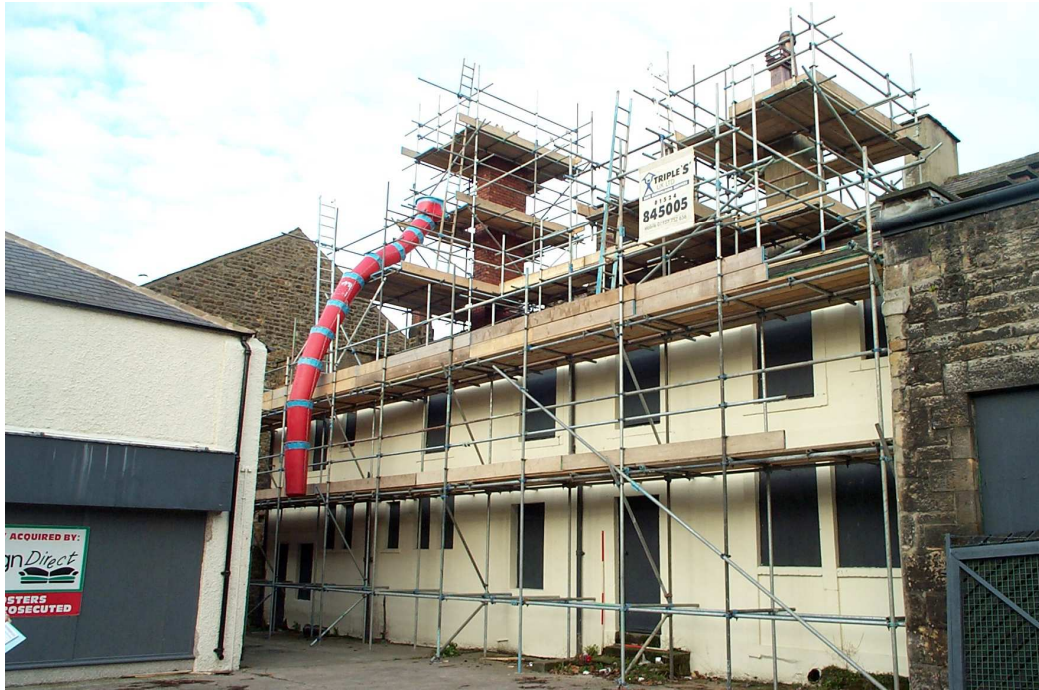
Plate 3: West external elevation

- 4.1.4 **External Elevation, West:** the right hand side is, like the front, only 1½ storeys high (Fig 5), and consists of courses of much smaller sandstone blocks, only roughly finished (**108**) (Plate 3). There are four tall windows on the ground floor (**109**), each with quoined jambs, thick lintels and projecting sills. Below the two left-hand windows are smaller cellar windows, both of which have been blocked with a mix of concrete and brick (**111**), although the left hand example evidently extended into a larger aperture at one point, before being blocked with stone (**110**), reducing the height of the window. Attached to the wall top is a modern gutter (**117**), and on the left side the gable top is finished with further concrete coping (**112**). On the lower right hand side the rusticated quoins have been cut flat and there is an area of repointing associated with an iron gate hook (**123**). The wall returns to the east on the left

4.1.5 The remainder of the west elevation, left of the projecting right side, is very different in character. It is entirely painted pale yellow/off-white, and finished with a render covering scored to look like ashlar blocks (**115**). There are several windows within it, in a variety of sizes and shapes (**116**), the majority of which are tall, with thick, square stone surrounds. Some of the others are in the same style but consist of a single large aperture divided by a central square mullion, while the rest are small and plain, with no surround and only a narrow projecting sill. The extensive wall finish makes it impossible to tell whether any of these are later additions, although the varying styles might suggest this. The two large windows divided by square mullions have both apparently been blocked with brick (**119**), and the right hand example has a sill made out of bull-nosed bricks rather than stone. There are two doors within this elevation (**118**), both of which have square stone surrounds and lintels. The left-hand door has a date of 1701 carved into the lintel, with the initials H and A, F, and has chamfered jambs (Fig 5). This doorway, and the window to its right, is within a slightly recessed area within the render, although this does not appear to be a structural detail. The more central doorway has a short flight of steps leading up to it (**125**), constructed from a mix of brick and stone. There are three cast iron downpipes attached to the wall, with another short water pipe projecting through it to a drain (**124**). The slate roof (**120**) includes five chimneystacks, the south examples being predominantly brick (**122**), while the northern ones are mostly stone (**123**), making a total of eight pots. The base of the wall is met by a concrete floor forming a yard or parking space to the west (**126**), and the far north end there is a low outshoot wall butting the north elevation, constructed of concrete blocks with a randomly coursed sandstone facing (**127**).

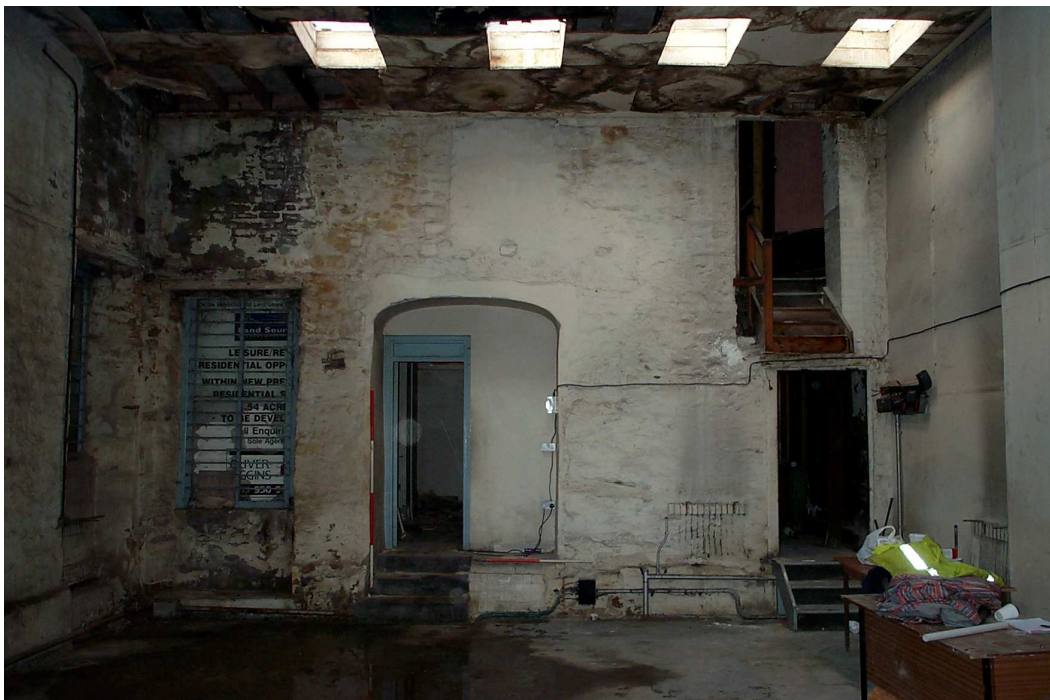
Plate 4: North elevation, Room 1

4.1.7 **Internal Detail, Room 1:** this is a large open room, of 1½ floors open to the ceiling and with no internal divisions. It has evidently been heavily altered, and therefore consists of several building materials (Fig 2). The north elevation principally consists of sandstone in coursed, roughly finished blocks, which is almost entirely finished with off white paint (**131**) (Plate 4). The upper left corner has been rebuilt in brick, visible through a dark grey render (**132**). There is a tall 4-light window on the left side (**137**, part of **109**), covered by horizontal iron bars, the left jamb of which has been rebuilt in brick (**133**), the lower part of the right jamb is also rebuilt in brick (**136**), and below which has possibly been rebuilt in stone (**134**). There is also a low concrete ‘step’ in the base of this window (**135**). In the centre of the elevation

there is a tall, roughly round-headed, arched doorway (**139**), which is partially blocked to form a smaller doorway (**143**). Three concrete steps, **138**, lead up into the smaller entrance and onto a larger concrete platform within **139** built out of brick (**140**). Above the arched entrance is a blocked window (**145**), to the right of which is a doorway (**142**) with no surround but the remains of a set of timber stairs coming down into the room below. The right jamb of this doorway has been entirely rebuilt in brick (**141**). On the ground floor, below this doorway is another, **144**, with a set of timber steps down to the ground proper. Electrical service cables are attached to the wall (**147**), and water pipes run around the room on low brick pillars (**146**).

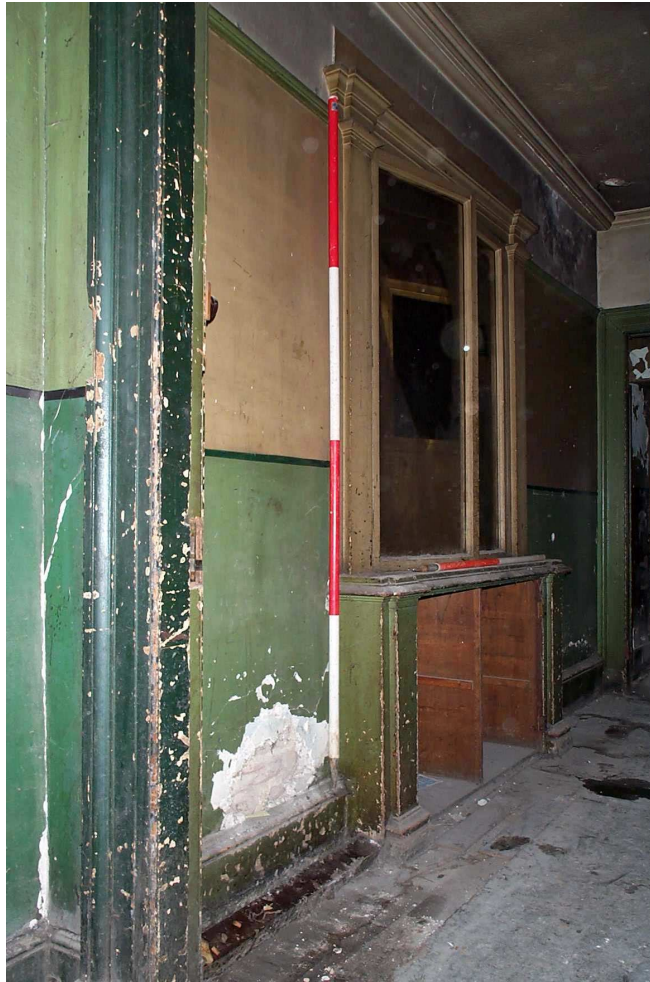
Plate 5: Cupboard in Room 3, looking south-east

4.1.10 **Internal Detail, Room 3:** this is a short corridor linking Rooms 1, 2 and 4. The floor (**184**) is the same as **171**, consisting of timber boards covered by vinyl sheets, while the ceiling (**183**) is the same as in Room 2 (**172**), and the same cornice is present in both rooms, continuing above the panel wall **174**. The north elevation essentially consists of just a doorway (**180**) into Room 4, with only a slight wall on the left side. The east elevation (**179**) is of sandstone build, finished with plaster and paint, with a dado rail, cornice and moulded skirting board. There is a built-in cupboard within this wall (**181**), consisting of a lower level of deep open shelves, below narrower shelves with glass fronted double doors, flanked by timber pilasters (Plate 5). The south elevation, like the north essentially consists of a doorway into Room 1 (**182**), incorporating **144**, forming a 'porch' with a lower, panelled ceiling, returns for a second door and heavy iron gate hooks for the outer door. The west elevation essentially consists of the timber partition wall (**174**), although the south end is incorporated into **182**.

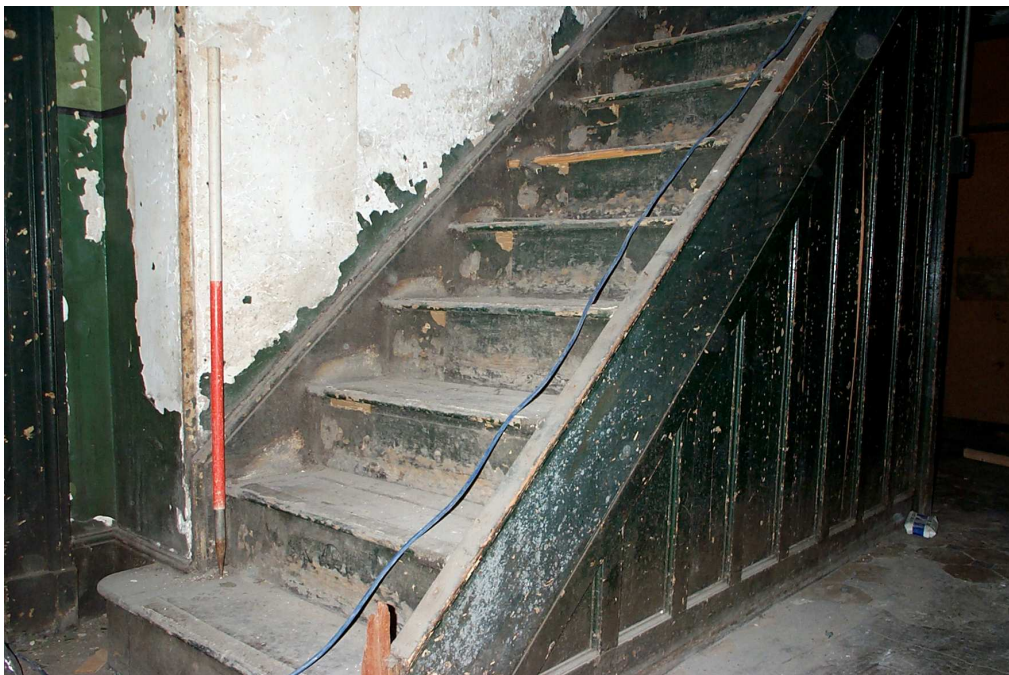
Plate 6: Staircase in Room 4, looking west

4.1.11 **Internal Detail, Room 4:** this comprises a dog-leg corridor connecting the ground floor to the first floor and cellar, and Room 3 to Room 5. The ceiling (**186**) is lathe and plaster, rising up on the west side, following the stairs, while the floor (**187**) is concrete, finished with brown and black tiles. The staircase (**188**), in the south-west corner, is timber, with a panelled north side, the partial remains of a turned newel post and banister, and a doorway into the cellar in the west end (Plate 6). The walls (**185**) are typically finished with plaster, and painted two shades of dark green with a painted dado strip. The north elevation is recessed on the right side, returning to the left, with a door at the left end (**189**), and there are modern electric cables in aluminium housing (**191**) attached across the wall. The east elevation is unremarkable except that there is a timber board attached to it, below the ceiling, with brass fittings screwed on, forming the remains of a row of service bells (**192**). Within this wall there is also evidence for some sort of blocked aperture of unknown function (**193**), recognisable as a mark in the plaster. The staircase mostly obscures the south elevation, with a doorway (**180**) leading into Room 3 to the left and a rail of coat hooks to the right. The west elevation is unremarkable, except for a doorway leading outside (**190**, same as **118**) with splayed and beaded jambs.

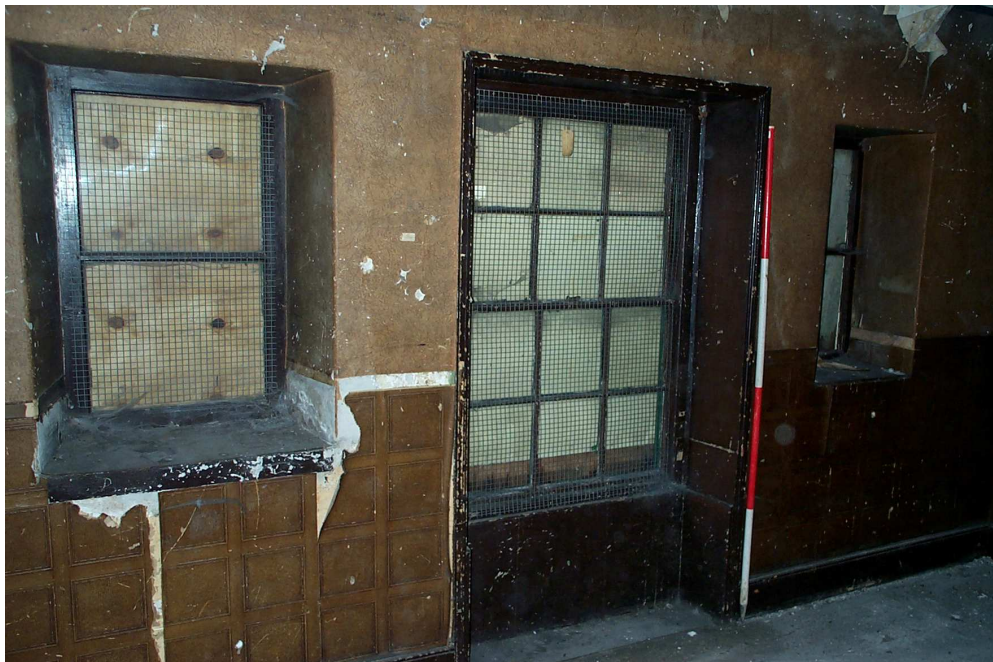
Plate 8: Windows in Room 10, looking south-west

4.1.21 **Internal Detail, Room 10:** this lies at the far north end of the first floor. The lathe and plaster ceiling (257) curves up from the wall tops, while the floor (256) consists of uncovered timber boards each around 0.21m wide. The walls (258) are all finished with wall paper over plaster, the lower part being 'timber panel' effect, the upper a more rusticated wood effect, with a dado strip near the top and painted above, and a skirting board along the ground. There are three windows in the west elevation (259), in almost a Palladian style arrangement (Plate 8). The central one comprises a 12-light sliding sash,

covered by a metal mesh, with splayed jambs to the ground with narrow moulding, and some plain panelling. The two flanking are much smaller, with plain surrounds, 2-lights, and only slightly splayed. In the south elevation there is a small fireplace (260), now surrounded by mid-twentieth century tiles, and with a small opening. Attached to the north elevation, and cut through the floor, is a collection of copper water pipes (261), evidently once attached to a radiator.
