2 Lancaster Road, Overton, Lancaster, Lancashire

Archaeological Building Investigation

June 2009

Issue No: 2009-10/944

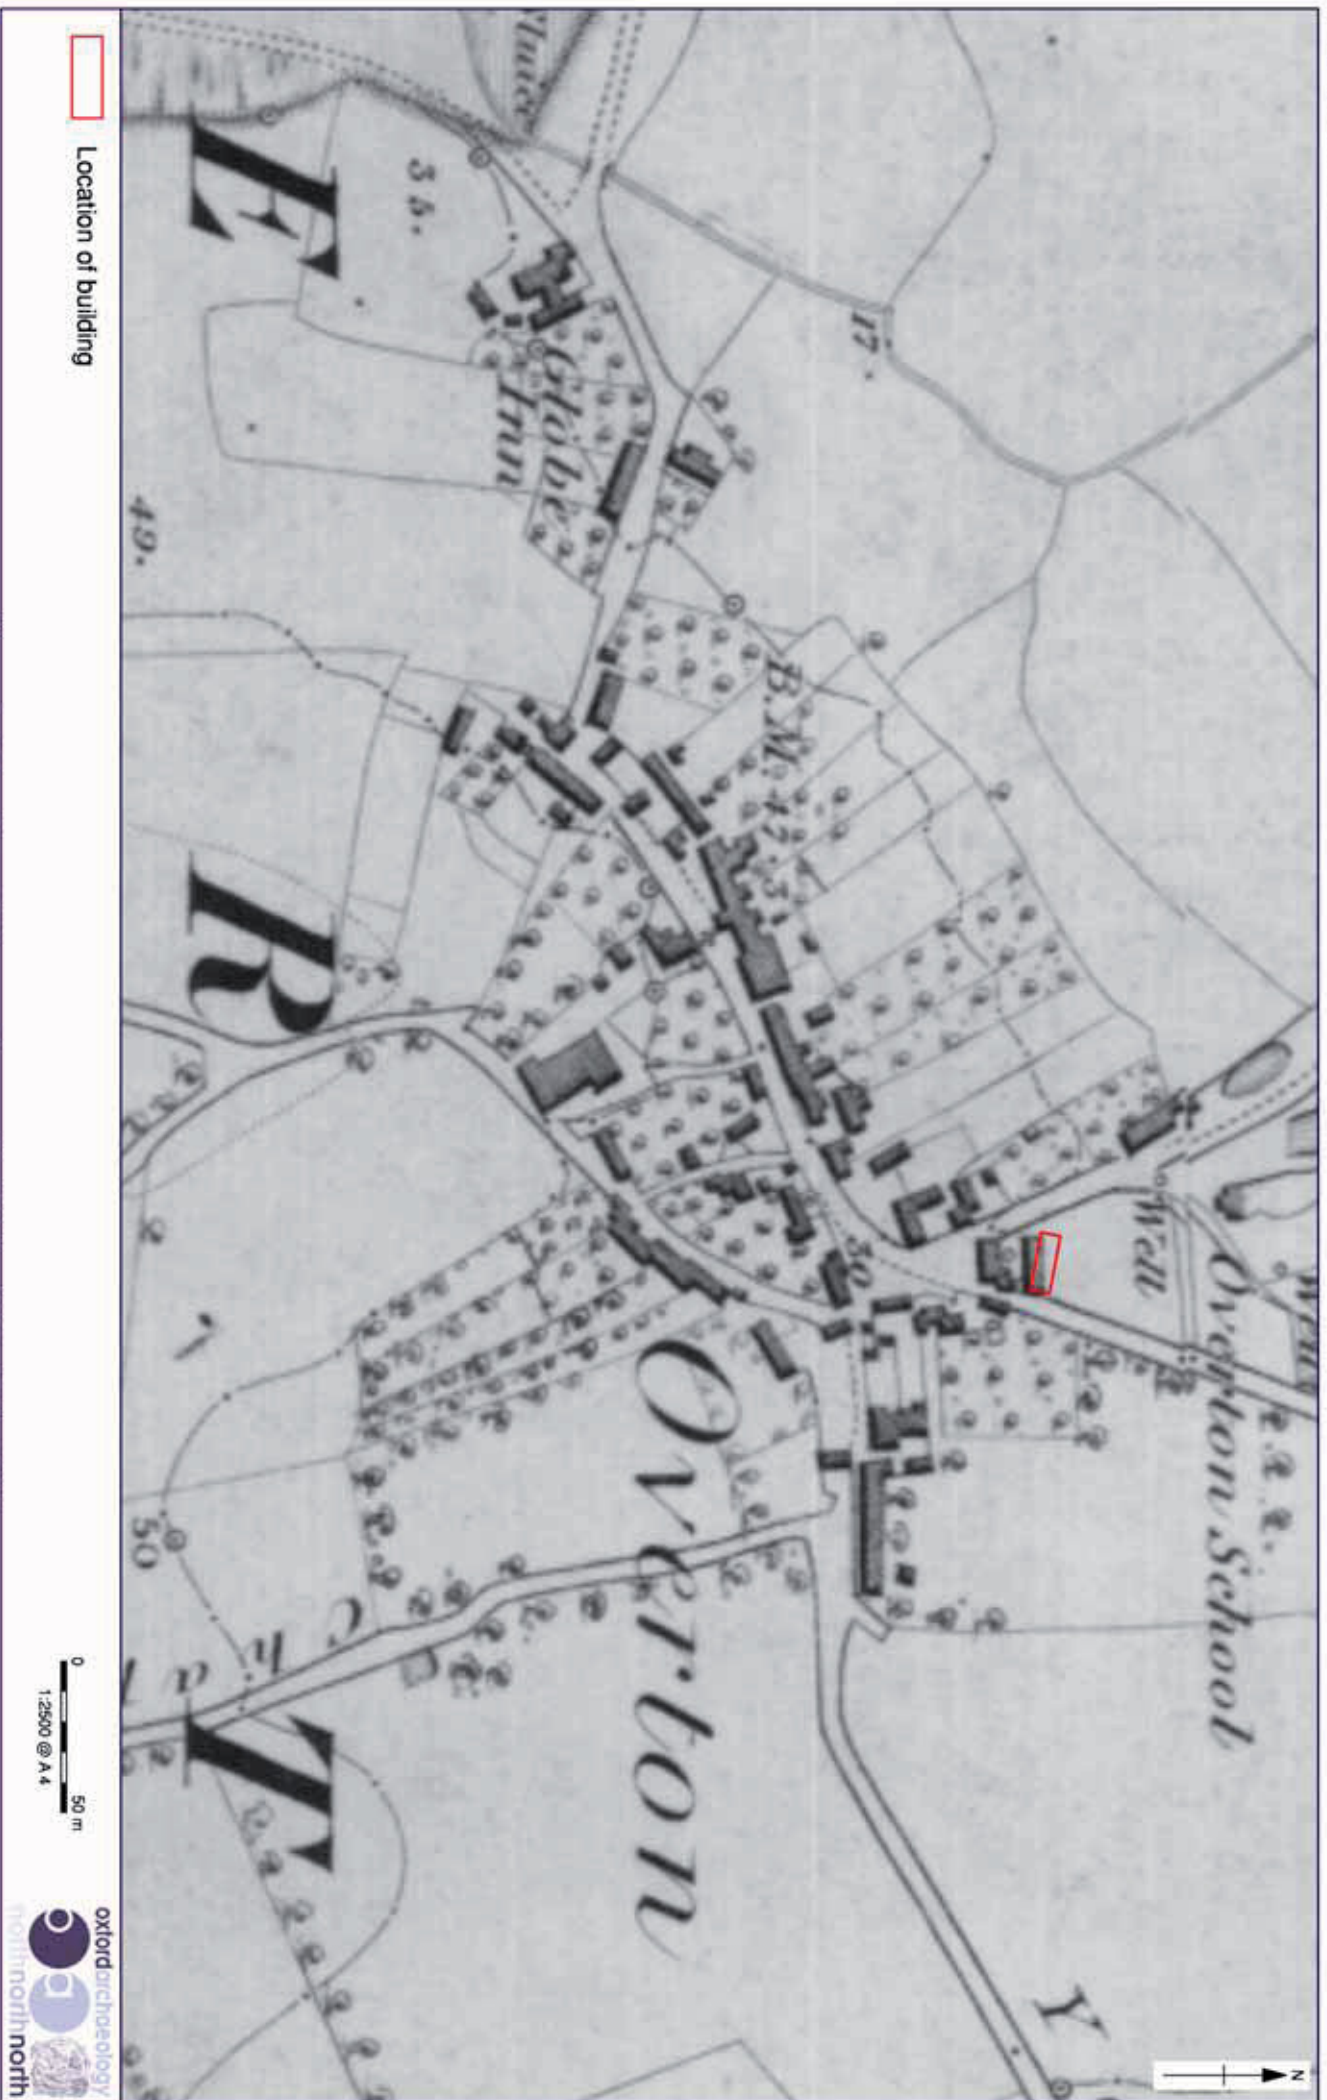
Figure 2: Extract from Ordnance Survey First Edition 6" to 1 Mile 1848

3.2.3 *Ordnance Survey First Edition 6" to 1 mile, 1848 (Fig 2)*: this is the first map to illustrate buildings in the location of the current structure being directly north of the fork of Lancaster Road and Middleton Road. There are two parallel east/west aligned rectangular buildings shown, with a collection of smaller structures between the two, at the east end, thus forming an enclosed 'yard'. Within the yard there is a feature which is possibly a tree. The southernmost of the two rectangular buildings is the smaller of the two, and is situated on the edge of the road junction.

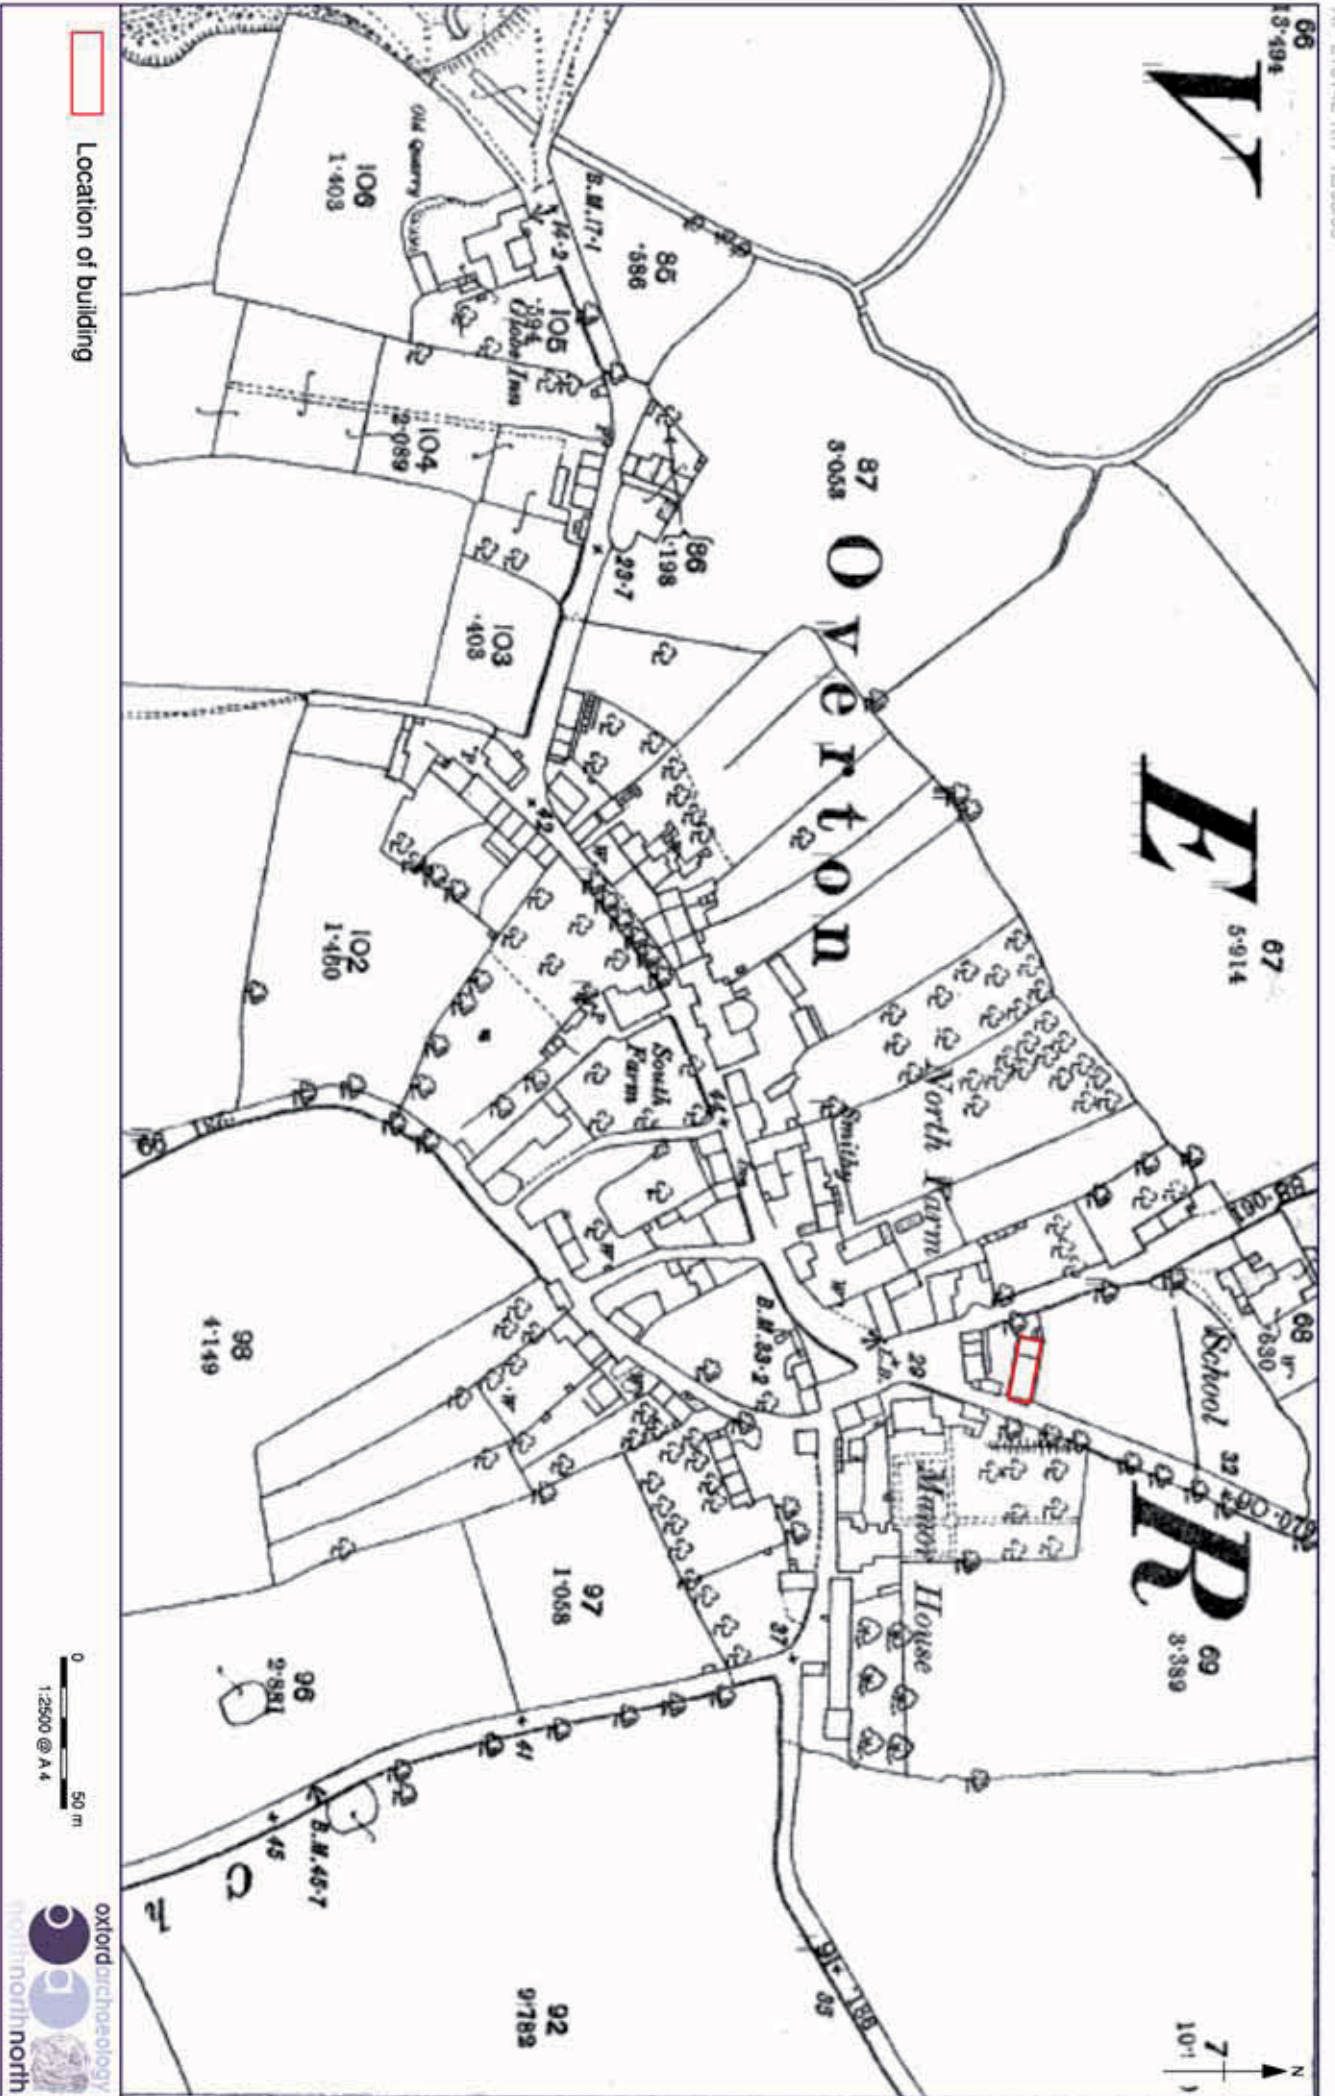
Figure 3: Extract from Ordnance Survey First Edition 1:2500 1891

3.2.4 *Ordnance Survey First Edition 1:2500, 1891 (Fig 3)*: this map is more detailed than the previous 6" map and clearly shows the nature of the buildings. The two buildings illustrated on the 1849 map are shown as not parallel to each other on this map, and the southern-most structure or range is divided into three, together with a long narrow structure along its north elevation. There is a further single structure to the east, which follows the line of Lancaster Road. The attached barn is clearly divided into two and there are small structures attached to its east elevation and the west end of the north elevation. A short boundary wall or fence protrudes from the west side. The layout of the buildings forms a 'C-shape' and encloses a small yard accessed from Middleton Road.

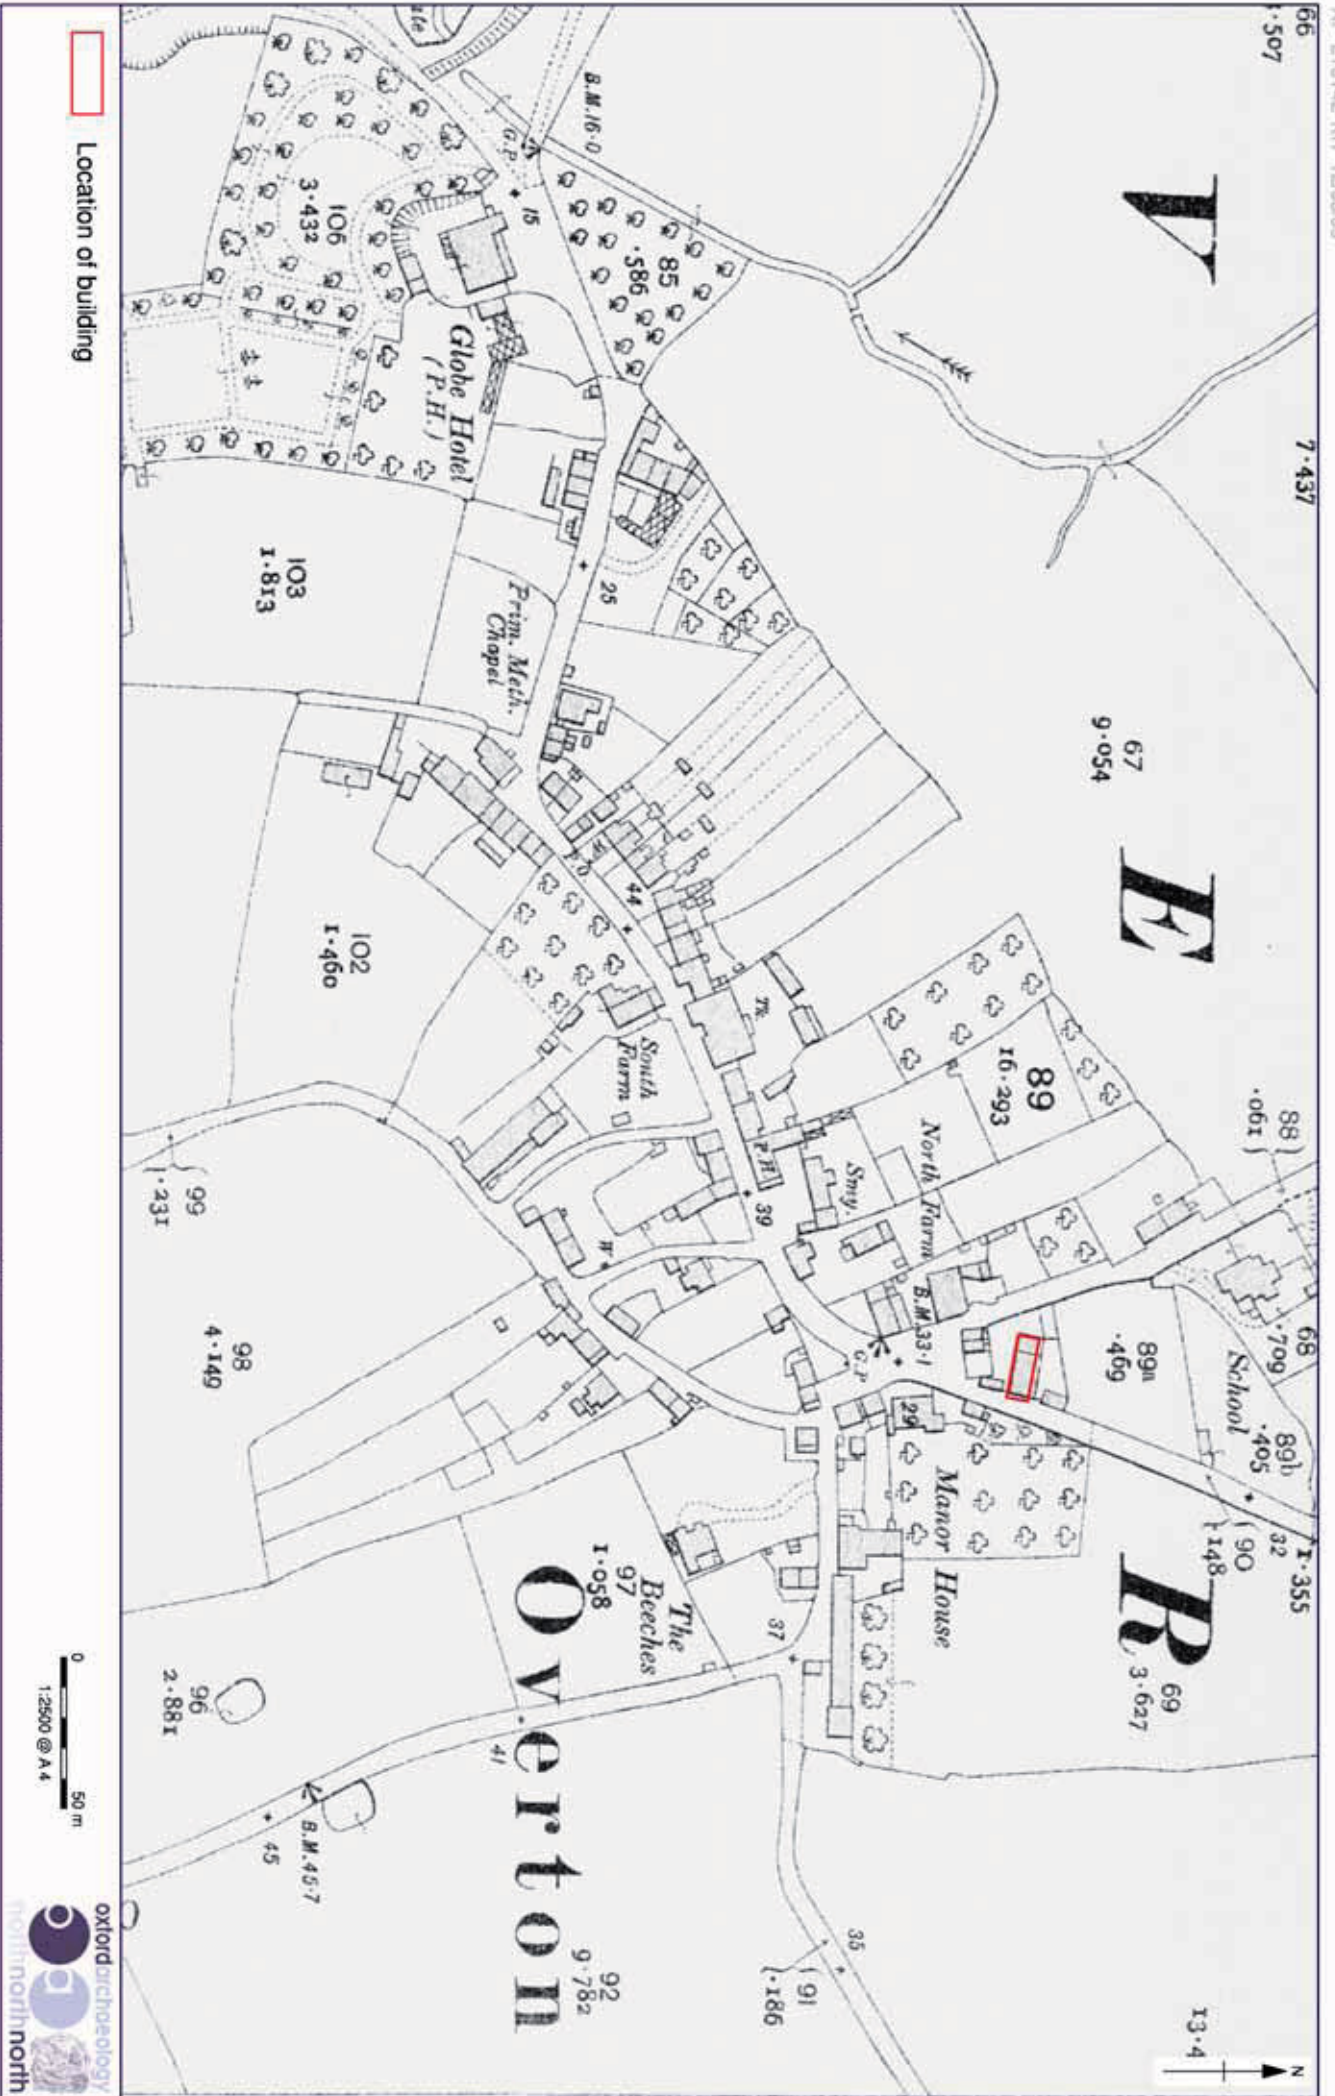
Figure 4: Extract from Ordnance Survey Second Edition 1:2500 1913

3.2.5 *Ordnance Survey Second Edition 1:2500, 1913 (Fig 4)*: the layout of the site illustrated on this map is very similar to that shown on the previous map. There are notable differences though, including the illustration of the eastern third part of the southern range, which now appears to be a fenced or walled off enclosure and not a building. The other two buildings are identical and appear to have small enclosures on the north side. An additional building is now located just to the north-east of the site, adjacent to Lancaster Road. Three field boundaries are located at the north side of the site. The small structures attached to the east and north sides of the attached barn, are not illustrated.

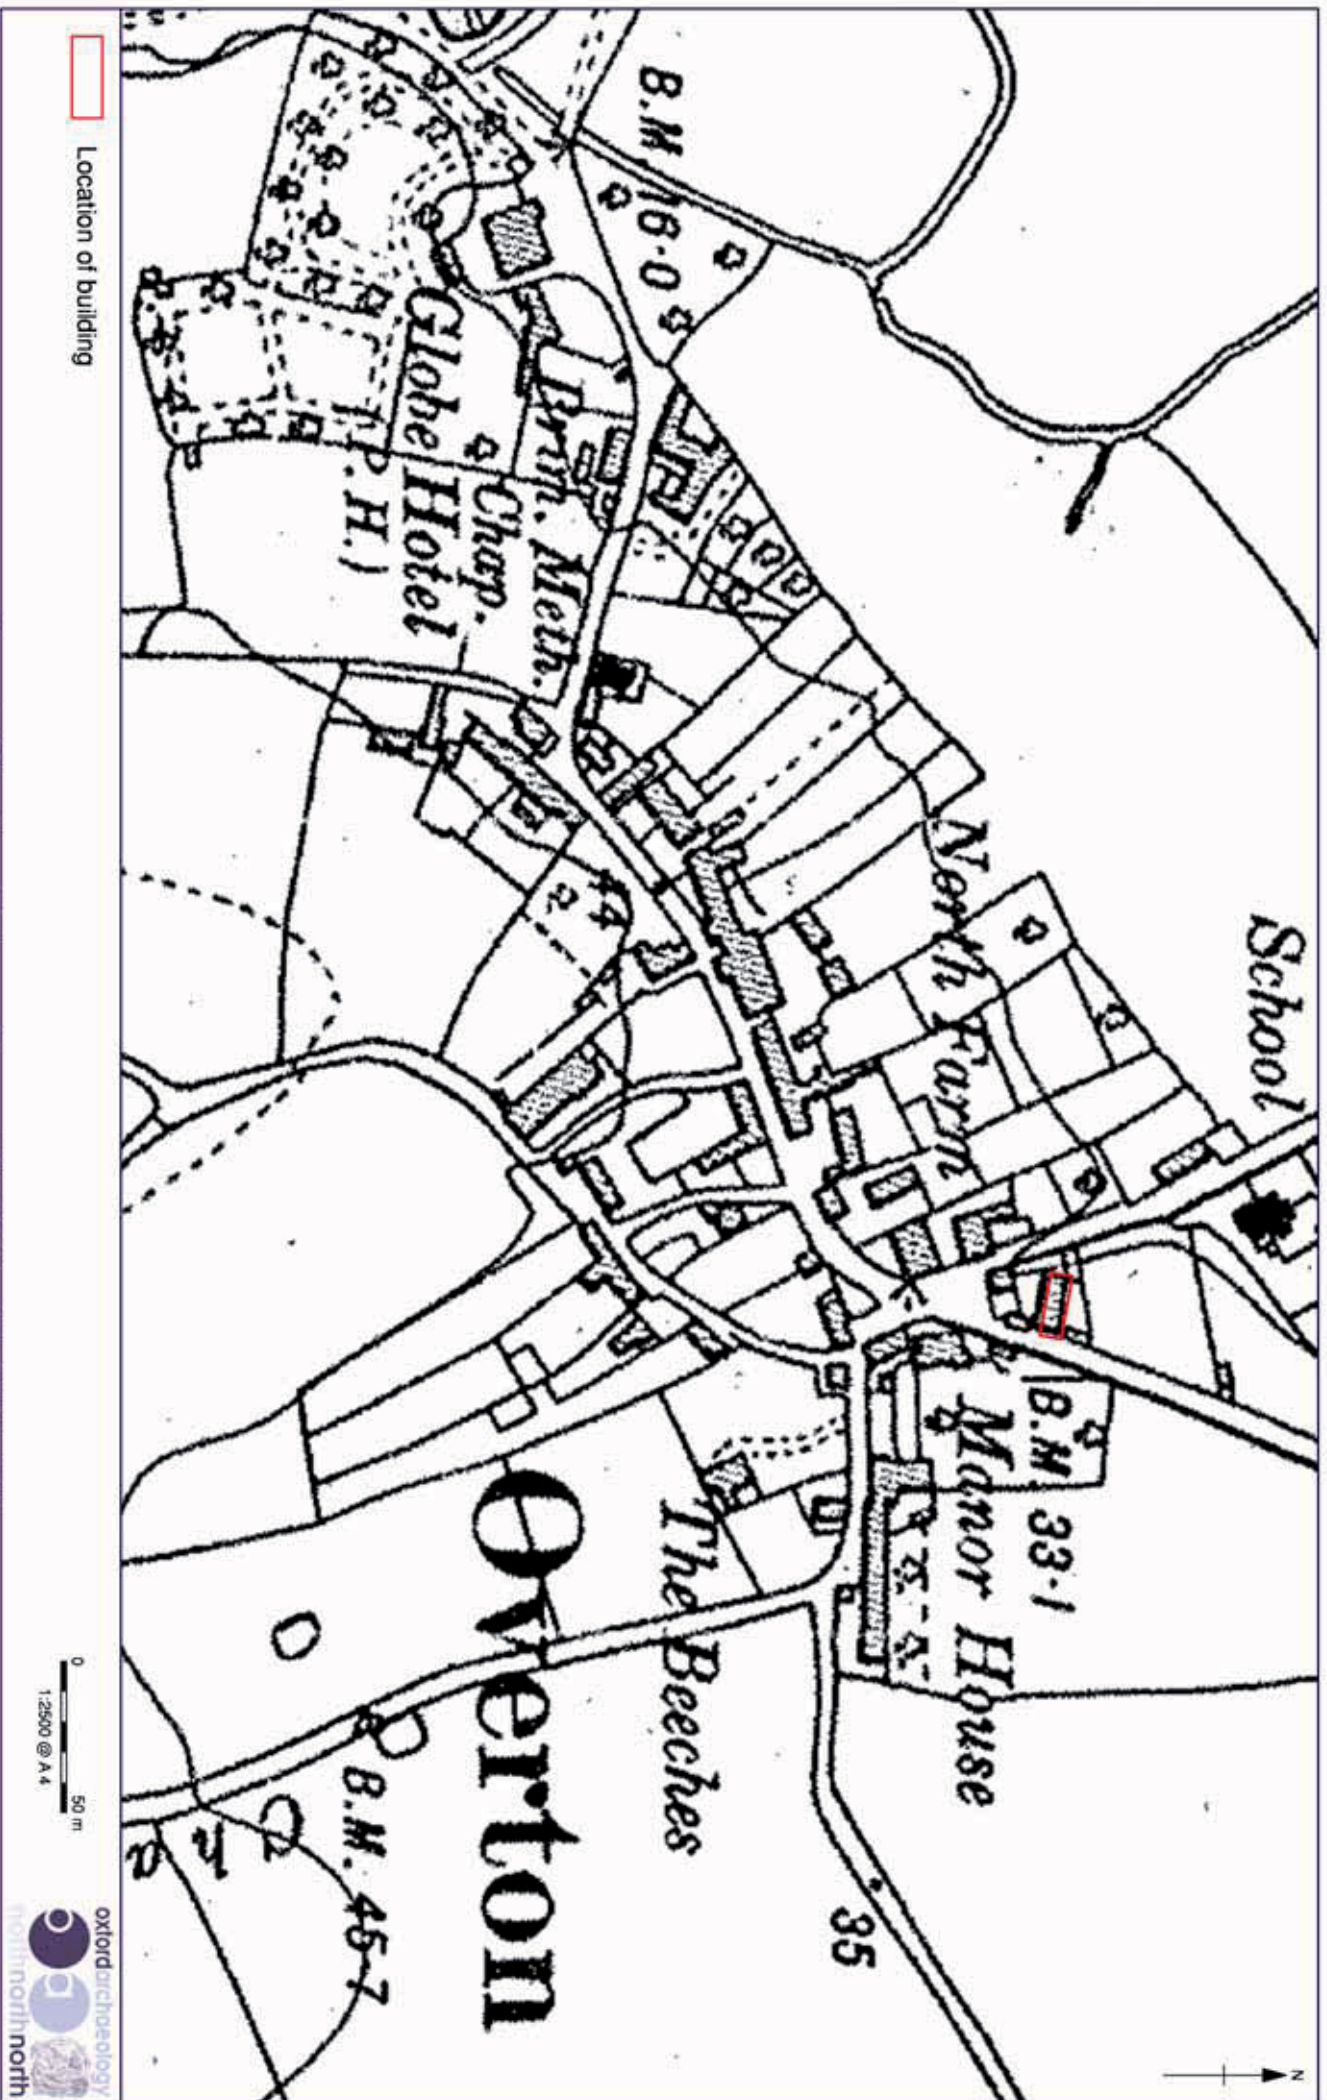
Figure 5: Extract from Ordnance Survey Third Edition 6" to 1 Mile 1916

- 3.2.6 **Ordnance Survey Third Edition 6" to 1 Mile, 1916 (Fig 5):** the 6" maps are not as detailed as the 1:2500 but nevertheless some changes appear to have taken place since 1913, notably with the sub-division of a field to the north of the site and the addition of a boundary to the west of the buildings.

5.2.5 Evidence suggests that most of the changes took place in the late twentieth century, which included the removal of much of the internal fabric, including the stalls in Room 3 and the creation of the current loft. The barn door was partially blocked and a garage door was inserted. The date of demolition of the remaining structures is unknown but must have occurred after 1916, as they are still illustrated on the Ordnance Survey map of this date (Fig 5).

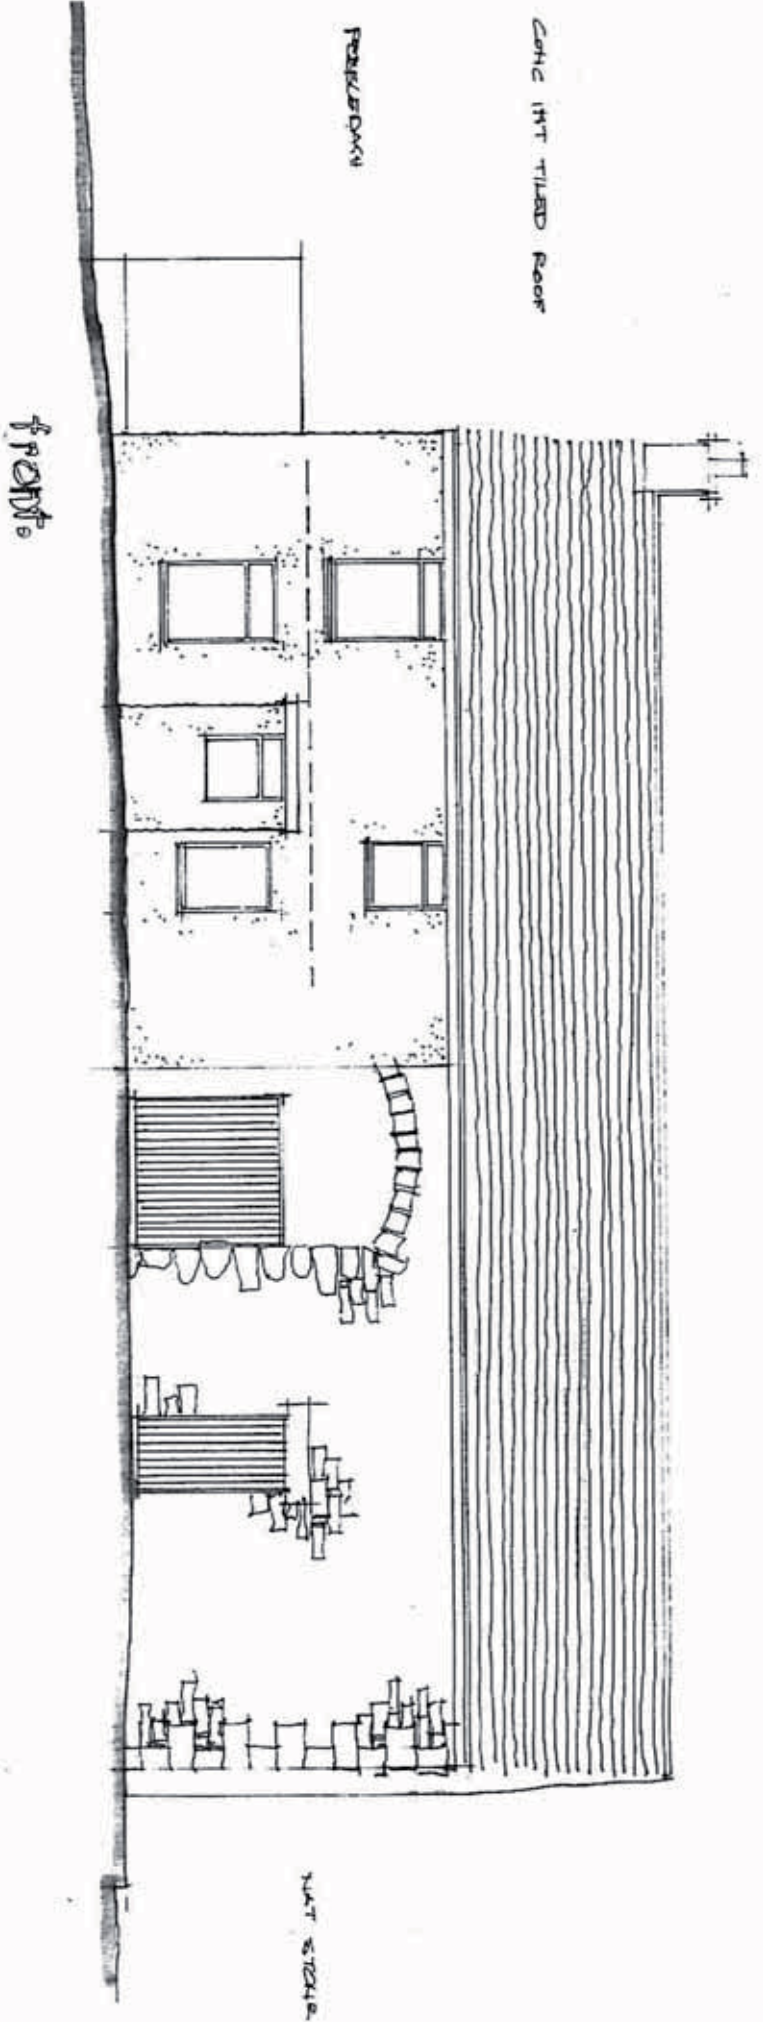
Figure 8: Existing South Elevation

- 4.2.2 ***The south elevation (Fig 8):*** this houses the main entrance, which is currently an 'up and over' late twentieth century garage door. This is set within a larger barn doorway which has a segmental arch and quoins and has been partially blocked with concrete or 'breeze' blocks (Plate 5). Internally, there is a timber lintel. This door allows access to the main internal space (Room 1, *Section 4.3.1*). To the right of this is a further, smaller doorway, that provides access to Room 2 (*Section 4.3.5*). This has a substantial stone long-and-short work surround with large stone lintel and a later twentieth century door. There are no windows, neither is there any evidence for any blocked or removed windows.

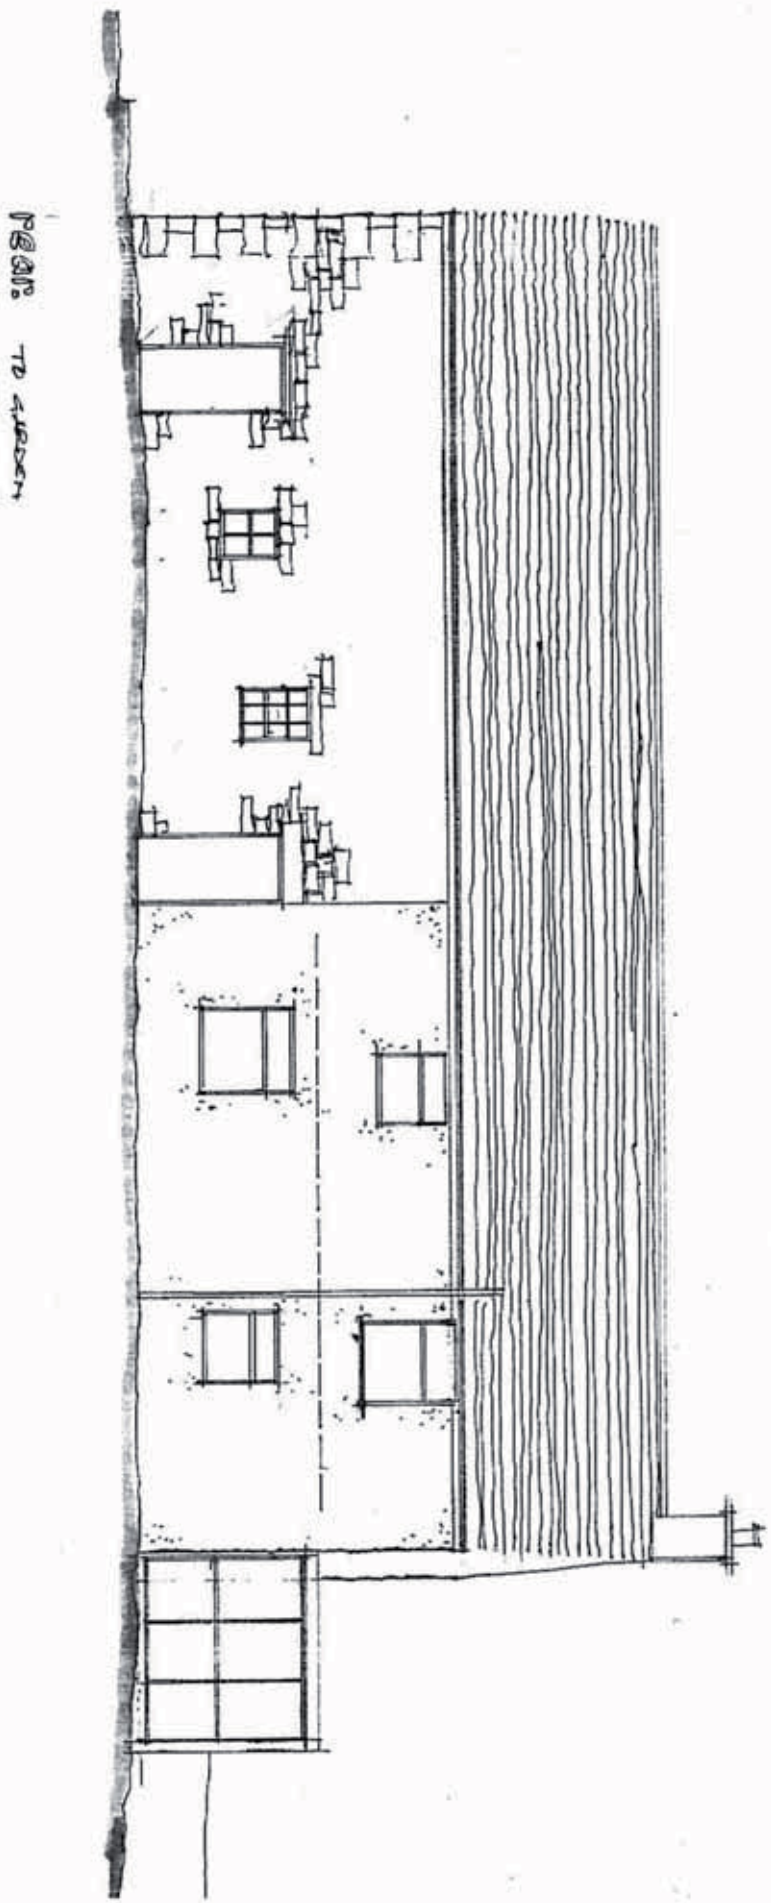
Figure 9: Existing North Elevation

- 4.2.3 ***The north elevation (Fig 9):*** this is identical in construction to the south elevation and contains two doorways and two windows (Plate 3). The door on the right side of the elevation provides access into Room 1 and is of similar appearance to the smaller doorway already described. This also has a modern door. The doorway on the left side of the elevation allows access into Room 3

(Section 4.3.6) and appears to have been inserted or is a converted former window. The lower part of the jambs appear to have been cut out in order to create the opening (Plate 6). There is no stone surround and there is a simple timber lintel. The fenestration consists of two windows, that on the right being a nine-light timber-framed example with a timber lintel. The other is a four-light casement with a large stone lintel. Both window apertures appear to be part of the original fabric, although the frames may have been replaced.

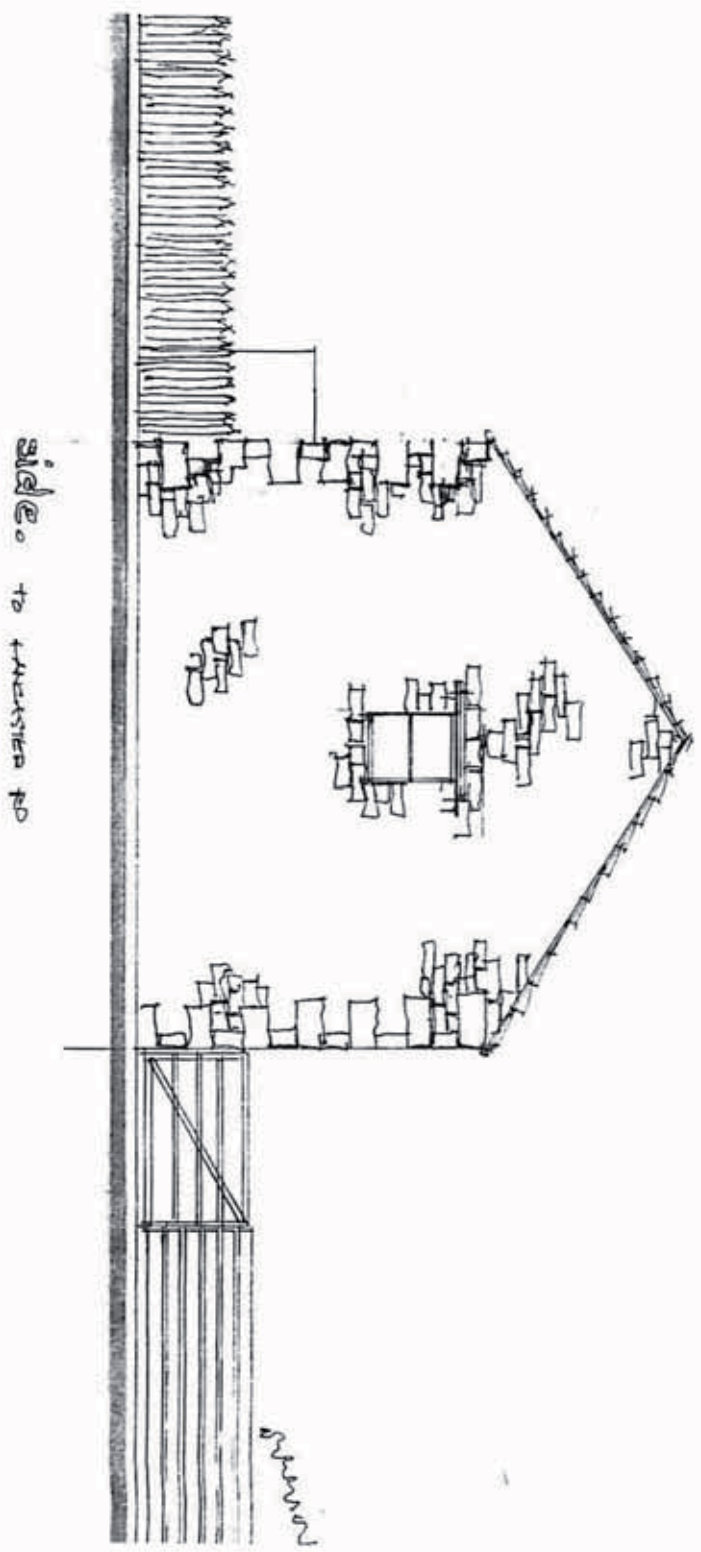
Figure 10: Existing East Elevation

4.2.4 **East Elevation (Fig 10):** this east-facing gable elevation faces directly onto Lancaster Road (Plate 4). Again, it is of identical construction to the other elevations but all the mortar has been removed. There is a blocked ground floor door at the north side which once allowed access to Room 3. This has been blocked externally with the same fabric as the main elevation but internally it is blocked with concrete or 'breeze' block. There is a single small window centrally placed on the upper floor, which has been blocked internally (Room 4) with concrete blocks. Externally, the former frame remains *in situ* which is of casement type. Above the window is a small square 'owl hole'

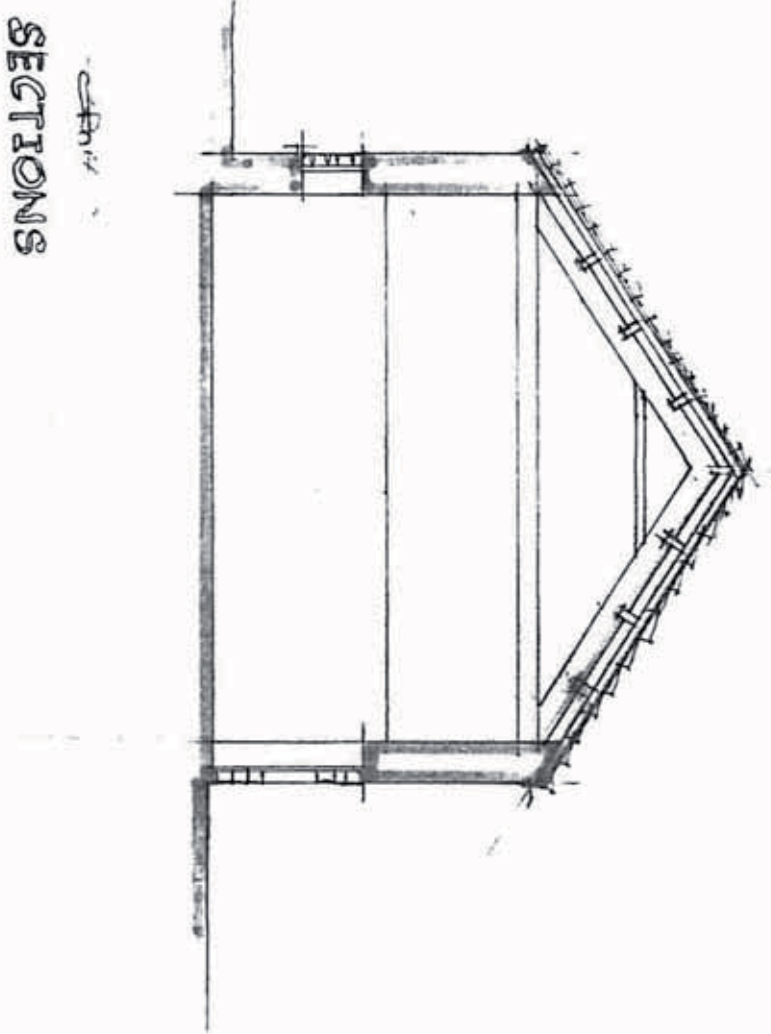
Figure 11: Existing Cross-section Facing West

- 4.3.9 There are two trusses visible, both of which are of 'A-frame' construction each having a collar (Fig 11, Plate 12). There are no bolts or pegs visible. The trapezoidal nature of the building is clearly reflected in the trusses which lie at an obvious angle. Each truss exhibits carpenters marks at both heels, the apex and the collar joints. These are simple chisel marks denoting the truss number (Plate 13). The west truss is marked III and the east truss is IIII, the other part of the building probably contains trusses I and II. The purlins are trenched into the principal rafters and exhibit some rudimentary chamfering.

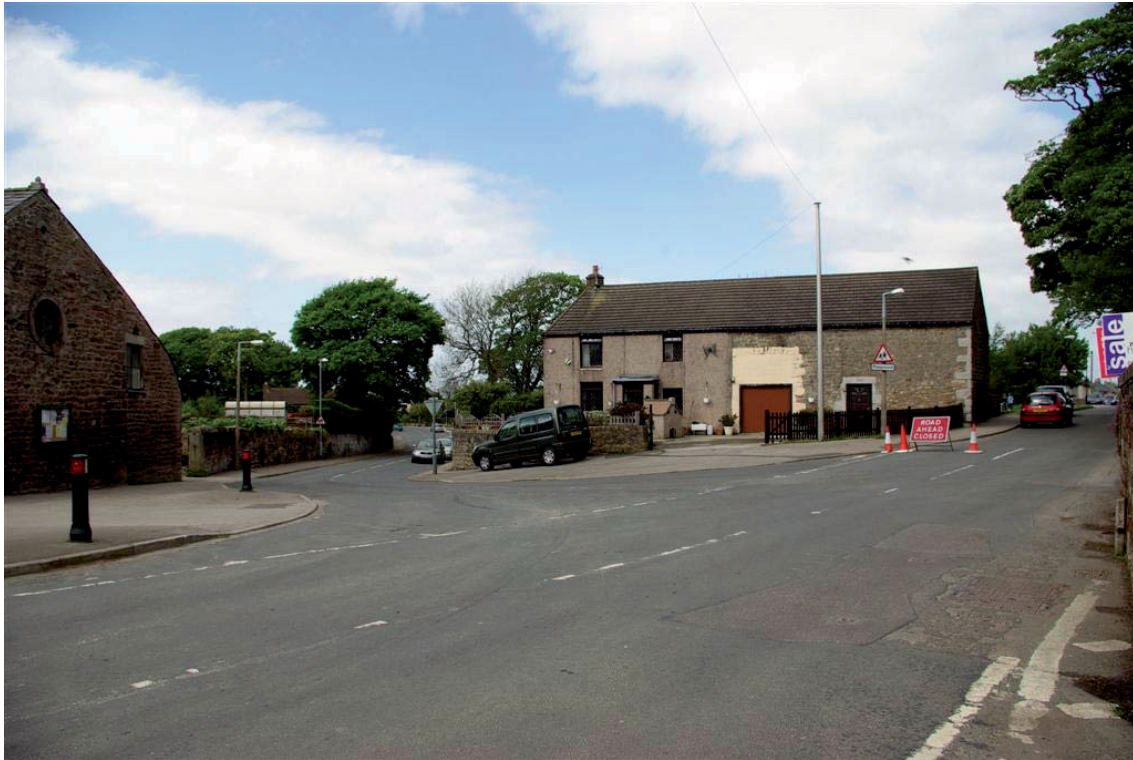
- 4.1.2 The house and barn are situated in the centre of the village of Overton (Fig 2) in the fork created by Lancaster Road and Middleton Road (Plate 1). They appear to be part of the same building, the western part of which has obviously been modernised. The building is trapezoidal in plan; surrounded by gardens and is set back somewhat from the main road. Current access is via a concrete drive at the south side of the building.

Plate 1: General view of the barn in the fork of Lancaster Road and Middleton Road

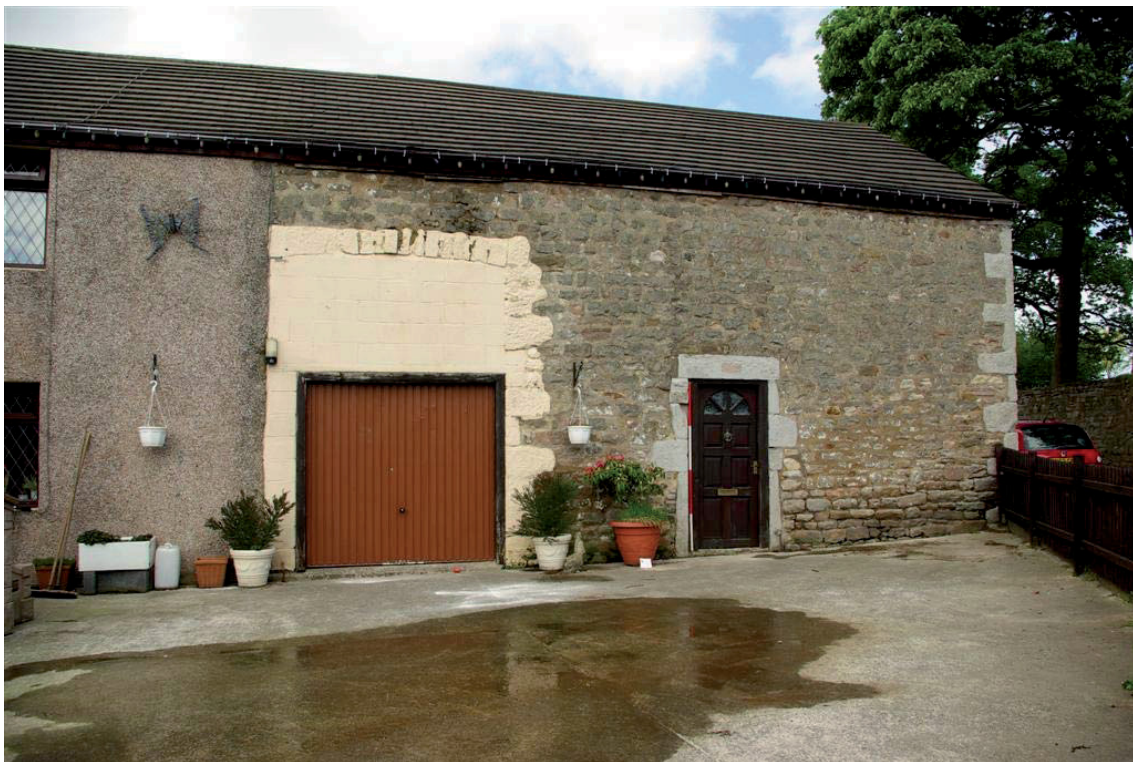
Plate 2: The south elevation of the barn

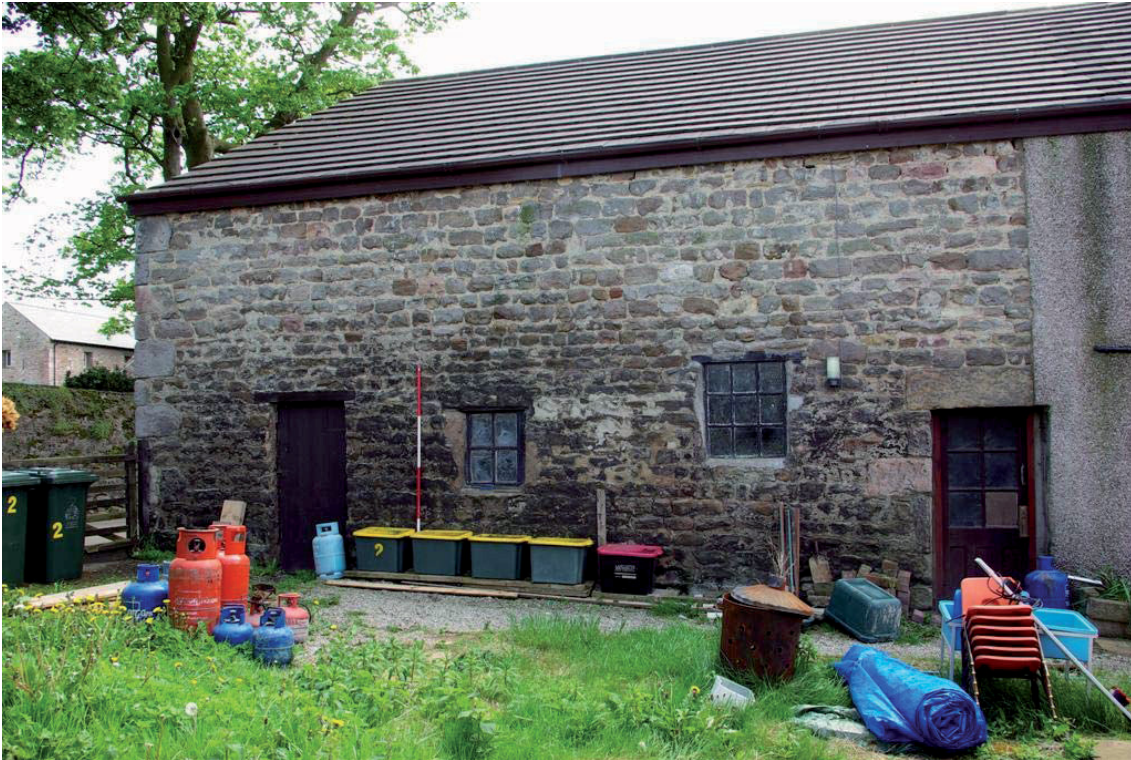
Plate 3: The north elevation of the barn

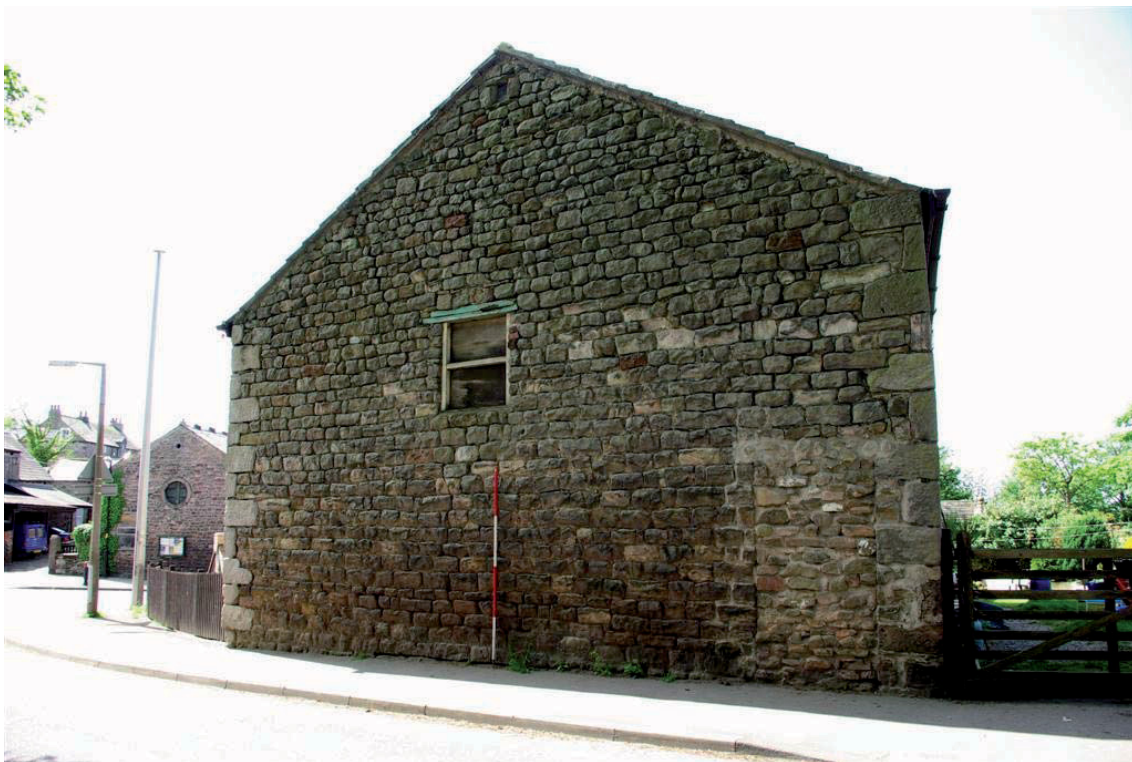
Plate 4: The east gable elevation of the barn

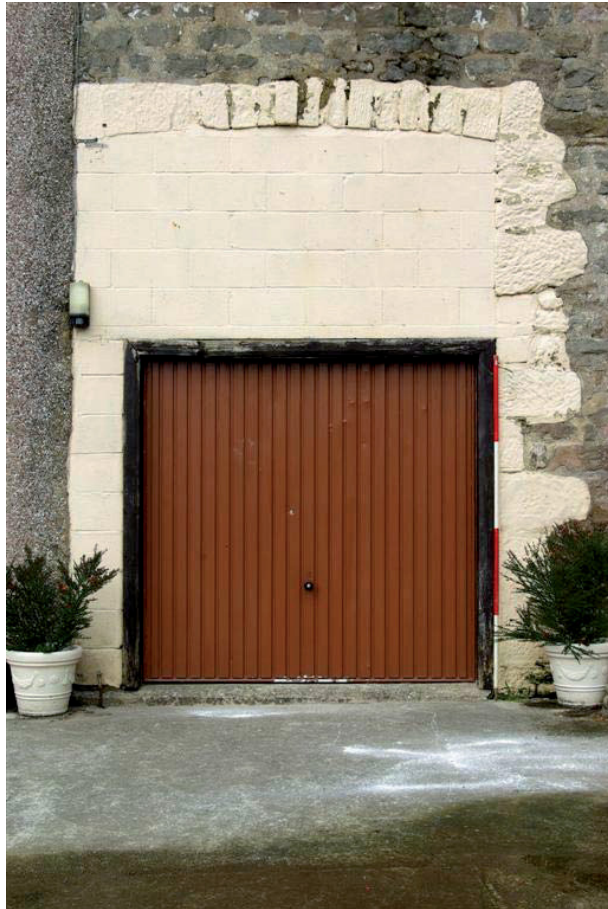
Plate 5: The main barn door on the south elevation

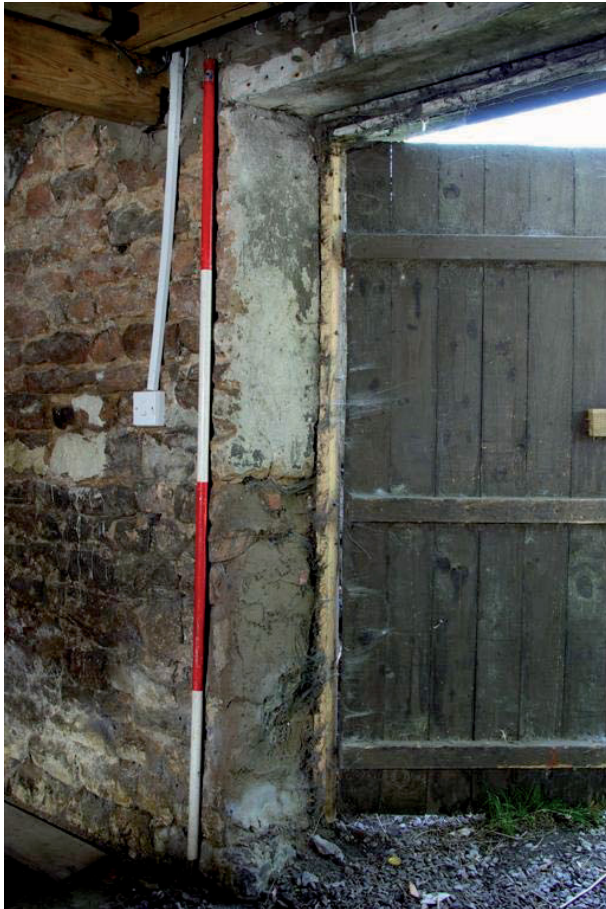
Plate 6: Doorway into Room 3 showing modified lower jambs
