2 Lancaster Road, Overton, Lancaster, Lancashire

Archaeological Building Investigation

June 2009

Issue No: 2009-10/944

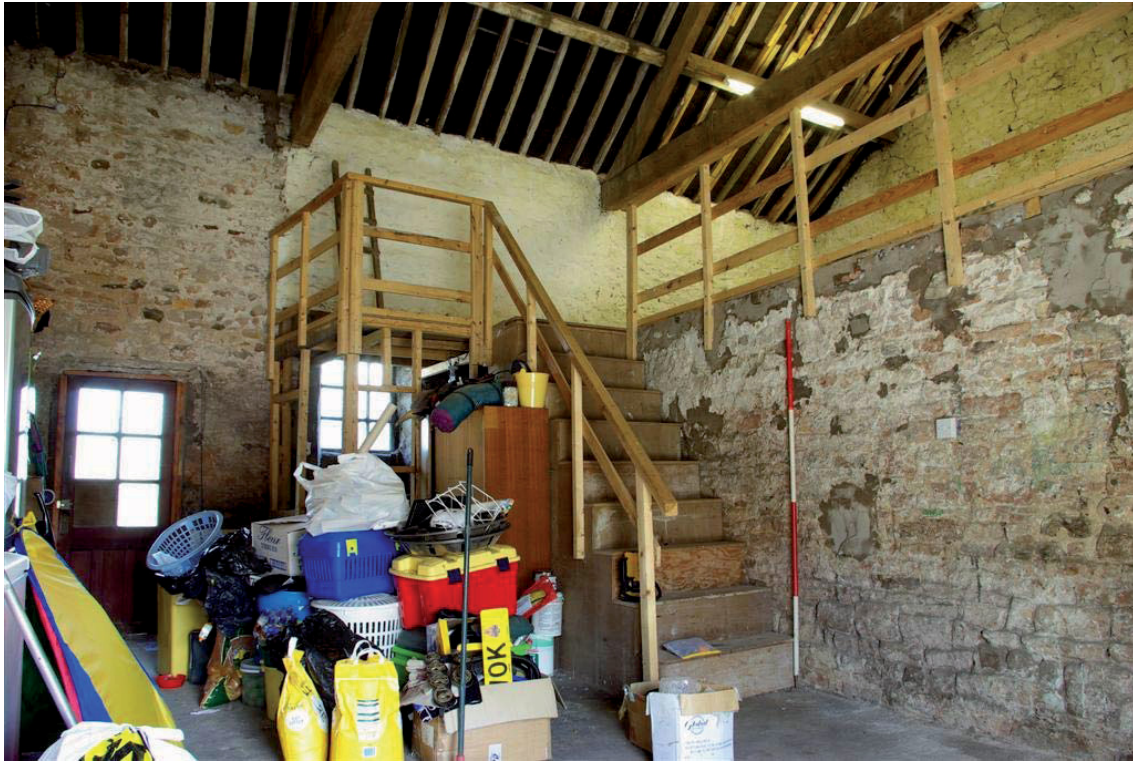
4.3.2 **Room 1 (Fig 6):** as has already been mentioned, this is the largest room in the building and is open, from ground floor, right up in to the roof space (Plate 7). The room was being used for storage at the time of the survey, and although some boxes obscured the view, most of these were placed against the west wall, which was of concrete block construction and was not included in the conversion plans. This wall divided the already converted house from the barn. Most of the internal walls have been whitewashed and lime mortar is visible. The floor is laid down to concrete.

Plate 7: View of Room 1, facing north-west

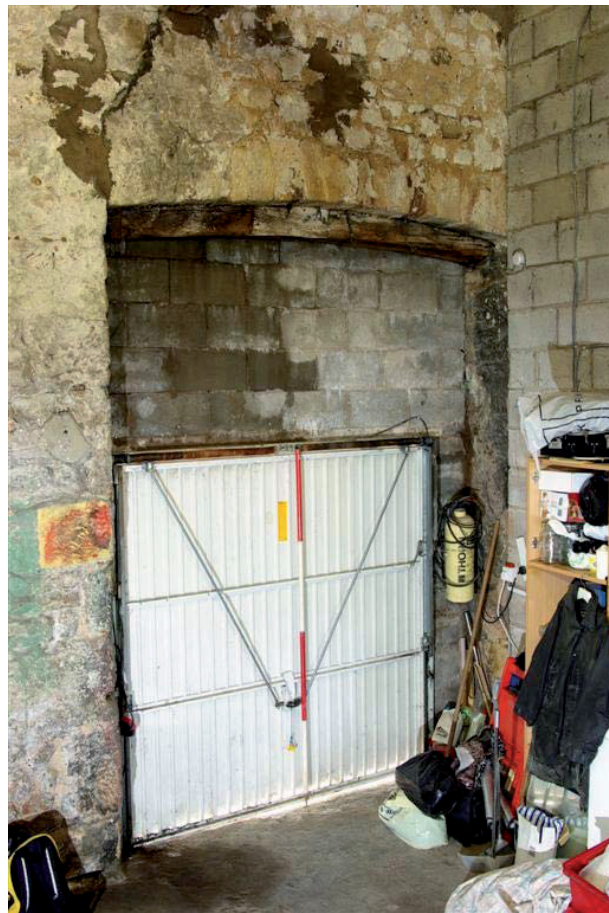
4.3.3 Upon entering the room, the nature of the construction of the original opening of the barn door is visible (Plate 8). This has a segmental arch augmented by a substantial timber lintel, which was probably inserted due to structural weakness as evidenced by a large crack above the doorway.

Plate 8: The internal aspect of the barn door

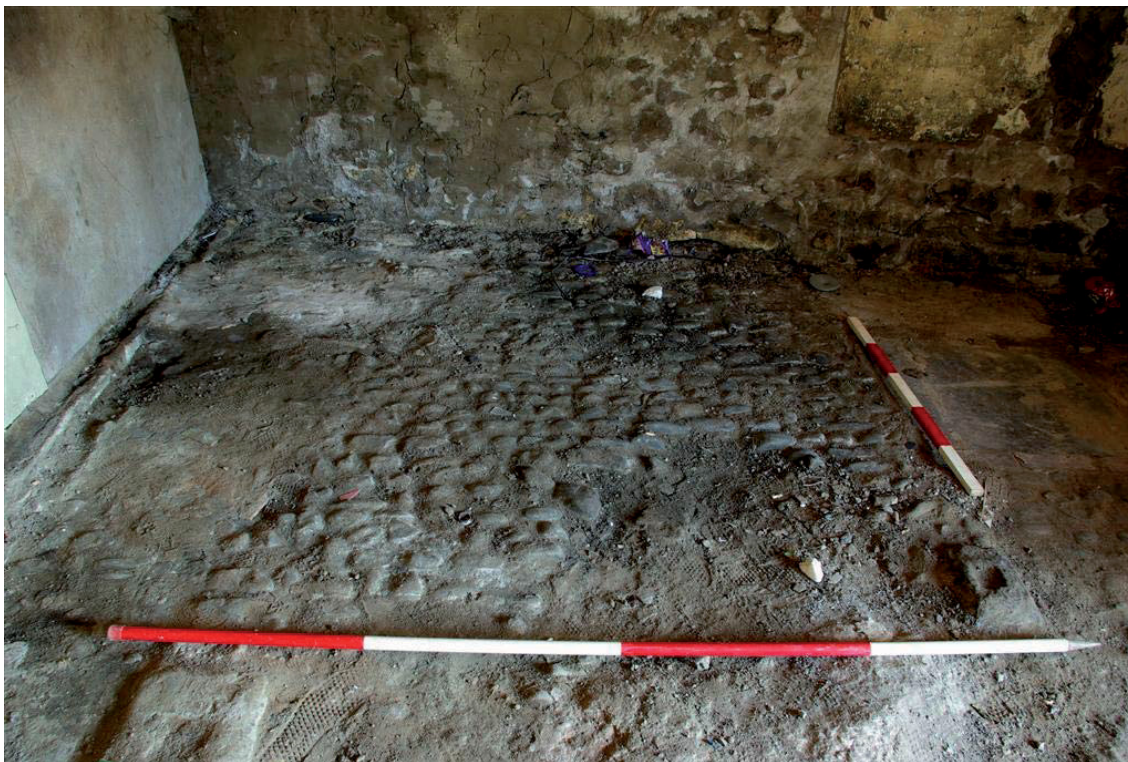
(*Section 4.2.2*). It is a small room and is divided from Room 3 by a makeshift plywood partition wall. The external walls were originally whitewashed but extensive smeared repointing has been undertaken. The most interesting feature within this room is the cobble floor, which may have been part of the original fabric, or at least part of an early phase. There is evidence in the floor, in the form of post holes, for the previous existence of animal stalls (Plate 9). Further evidence for this exists in the layout of the cobbles, which follow a rectangular pattern. There are two flagstones at the south-east side of the room. Partly obscured by the partition wall is a sandstone gully which consists of individual 'U-shaped' stones set within the floor (Plate 10). The ceiling is of modern construction.

Plate 9: The cobble floor in Room 2, with a post-hole visible on the right.

5.2.3 The interior of the building, particularly Room 2 (*Section 4.3.5*), provides clues as to its former use. Evidence that animal stalls once existed is present, over which a previous loft may have been in place. The remaining roof structure is of straight-forward 'A-frame' trusses, which are commonly found, and, although difficult to date exactly, is probably of early nineteenth century origin.

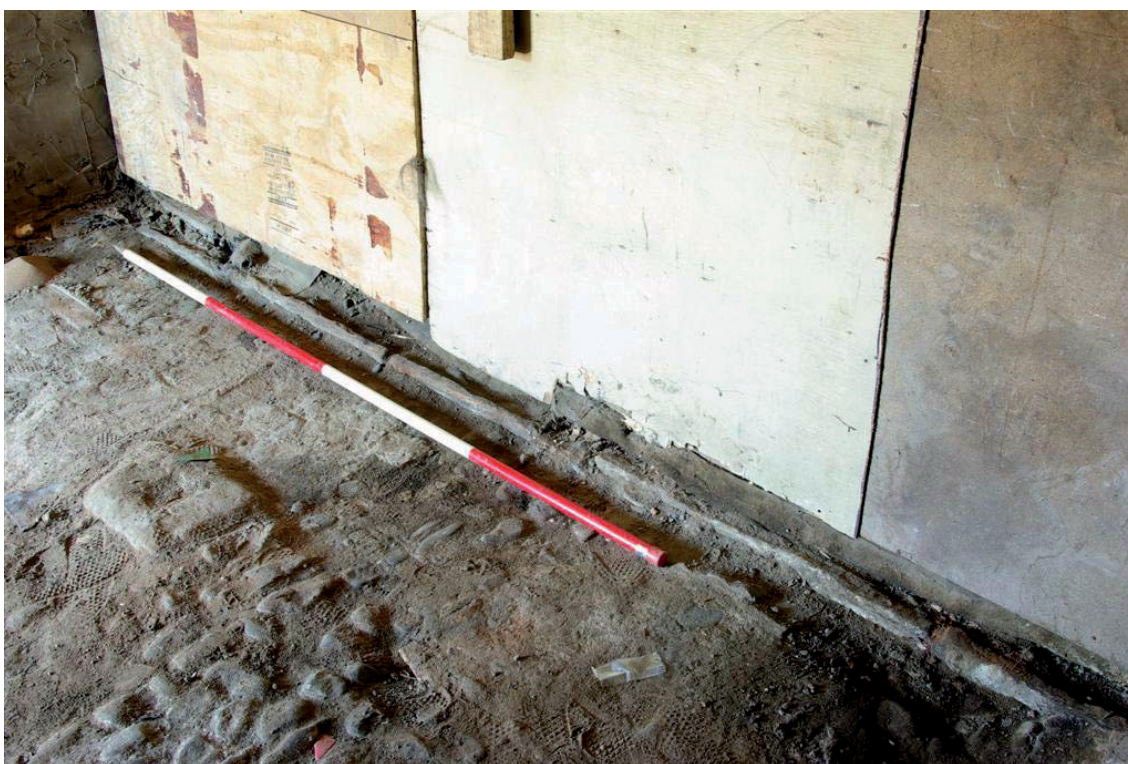
Plate 10: The stone gully in Room 2

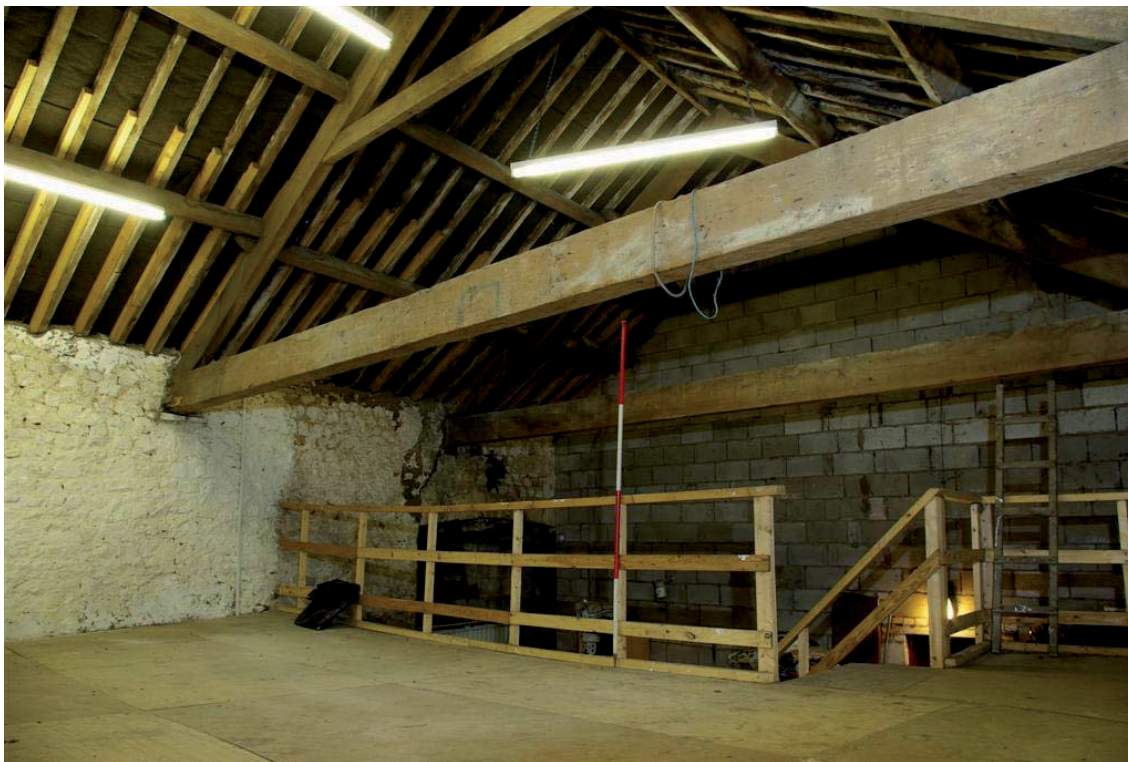
- 4.3.8 **The Roof:** the interior of the roof is visible from both Rooms 1 and 4 (Plates 7 and 11). As already described in *Section 4.2.1* the roof has been replaced and the bitumen felt is visible internally (Plate 12). There are no battens present and some of the common rafters have been replaced. For the most part though, the roof structure appears to be fairly intact, and most of the original timbers appear to have survived.

Plate 11: View of Room 4 facing west towards Room 1

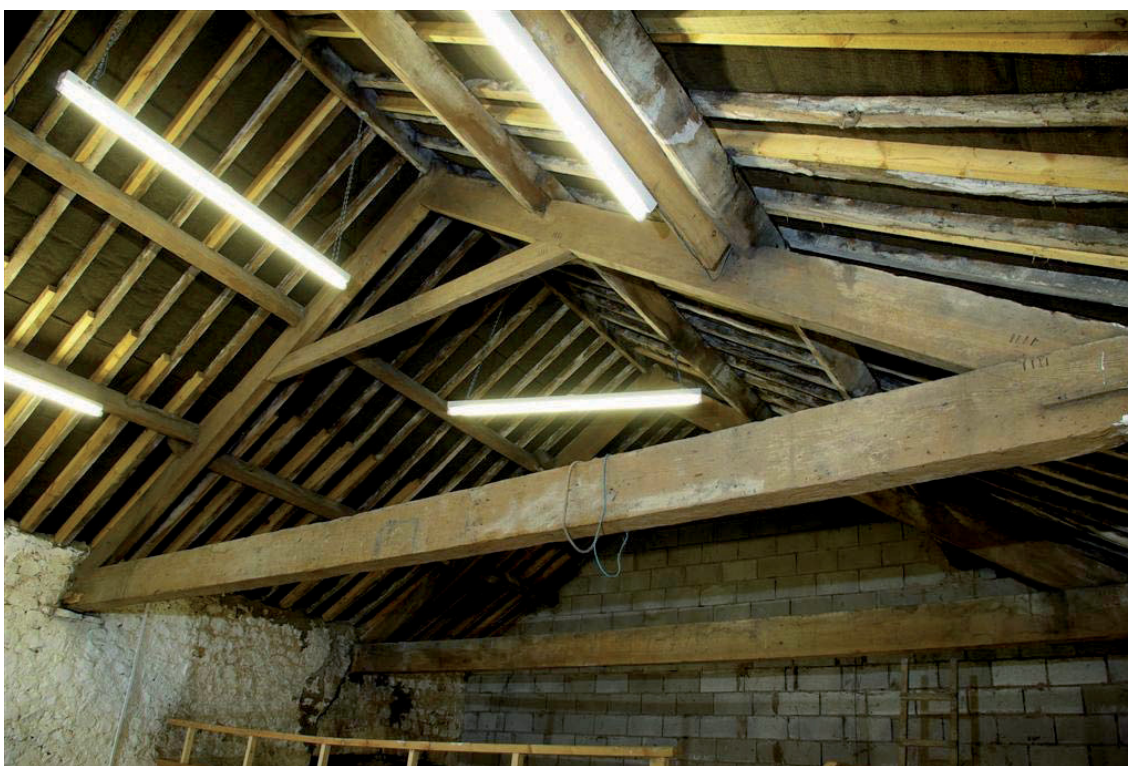
- 4.3.9 There are two trusses visible, both of which are of 'A-frame' construction each having a collar (Fig 11, Plate 12). There are no bolts or pegs visible. The trapezoidal nature of the building is clearly reflected in the trusses which lie at an obvious angle. Each truss exhibits carpenters marks at both heels, the apex and the collar joints. These are simple chisel marks denoting the truss number (Plate 13). The west truss is marked III and the east truss is IIII, the other part of the building probably contains trusses I and II. The purlins are trenched into the principal rafters and exhibit some rudimentary chamfering.

Plate 12: The roof as viewed from Room 4

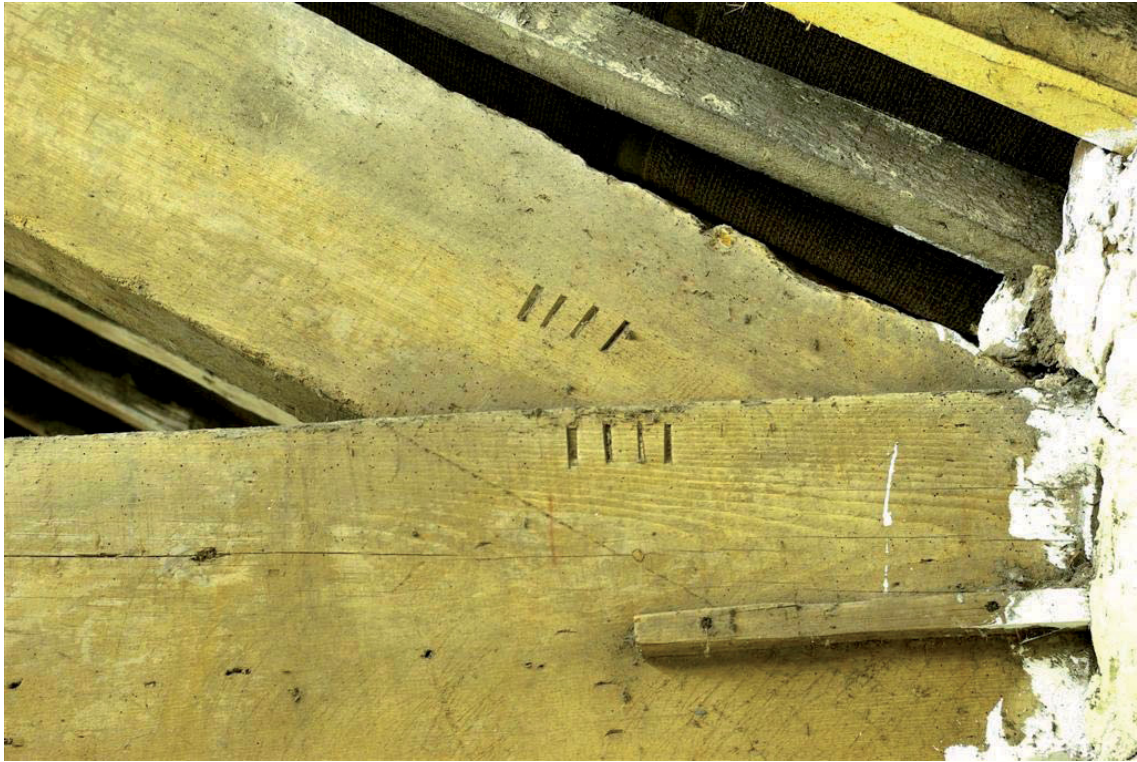
Plate 13: Example of the carpenter's marks
