ST PAUL'S SQUARE, LIVERPOOL

Archaeological Watching Brief

Oxford Archaeology North

January 2010

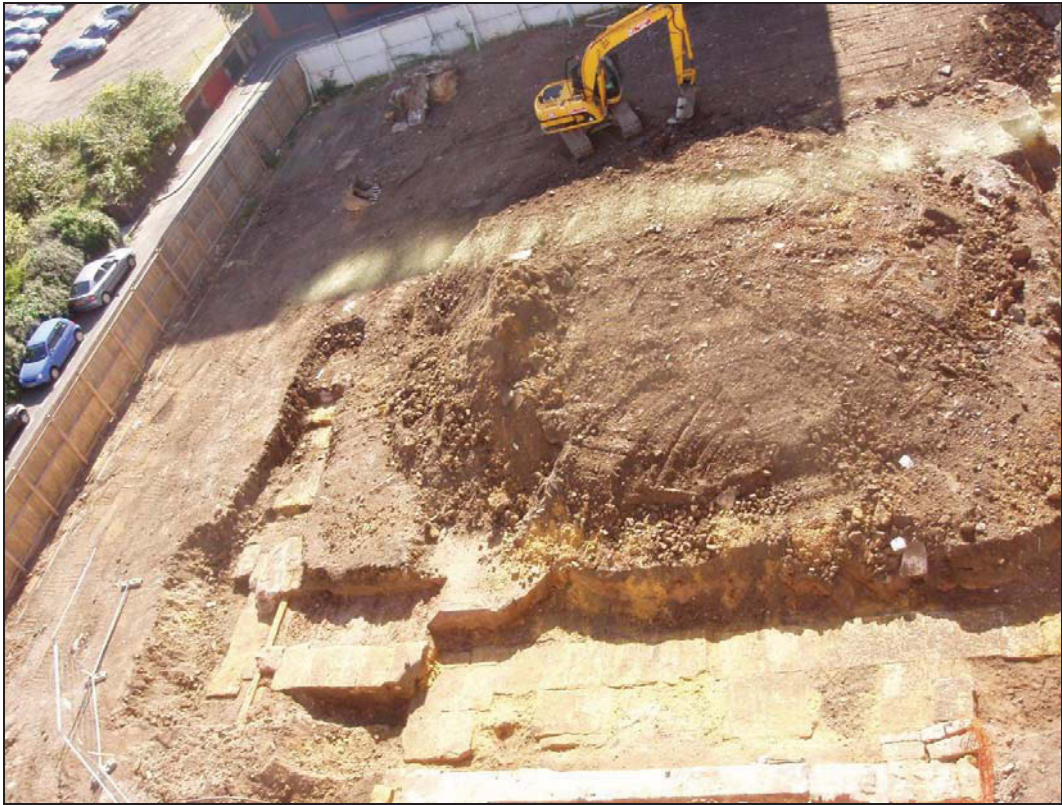
Plate 12: Foundations for the north-east corner of St Paul's Church

3.2.2 The north-west and south-east walls were abutted externally by four bases for portico columns, which were, in turn, surrounded by the stepped-out footings for the stairs that would have led up to the porticoes (Plates 12-15). These stepped-out footings, wall **312** to the north-west (Figure 3; Plate 13), and fragmentary walls **301/302** to the south-east (Plate 14), comprised a mixture of sandstone sections interspersed with supporting vaulted brick archwork. Although the poorly preserved north-east end lacked column bases, it retained stepped-out foundation wall **703/704/705** (Plate 12), analogous to the stair base foundations on the other facades. The church's cruciform plan was completed by the south-west portico, which was clearly both more complex and extensive than those of the ancillary entrances, but also harder to trace due to a combination of truncation and only partial exposure. Surviving components included very fragmentary wall footing **50/205/209/311** (Plates 14 and 15), which was of the same depth as the stair bases for the ancillary porticoes. Beyond that footing, several further small fragmentary sections of sandstone walls/plinths, **61** and **102**, may have helped support the portico and columns. Two further wall stubs, one of brick to the south-east, **49**, and one of sandstone to the north-west, **323**, are possibly the only surviving evidence for the outer wall which would have supported the steps on the outer edge of the portico.

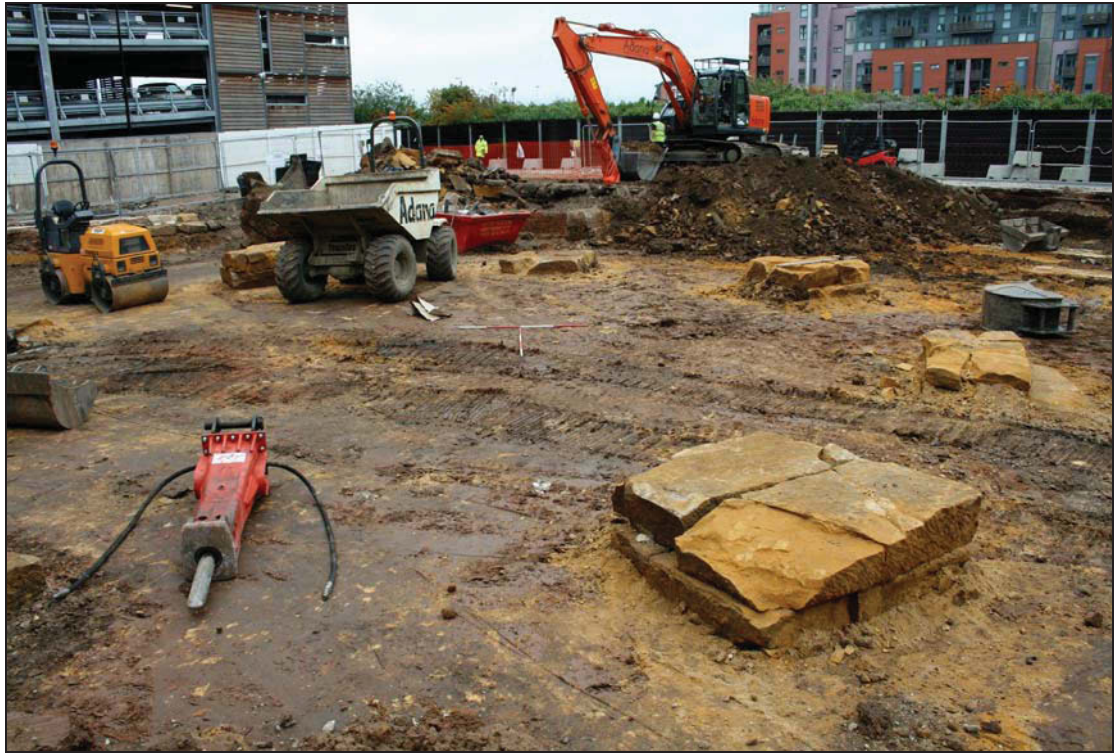
Plate 16: Supporting plinths 307 for the dome of St Paul's Church

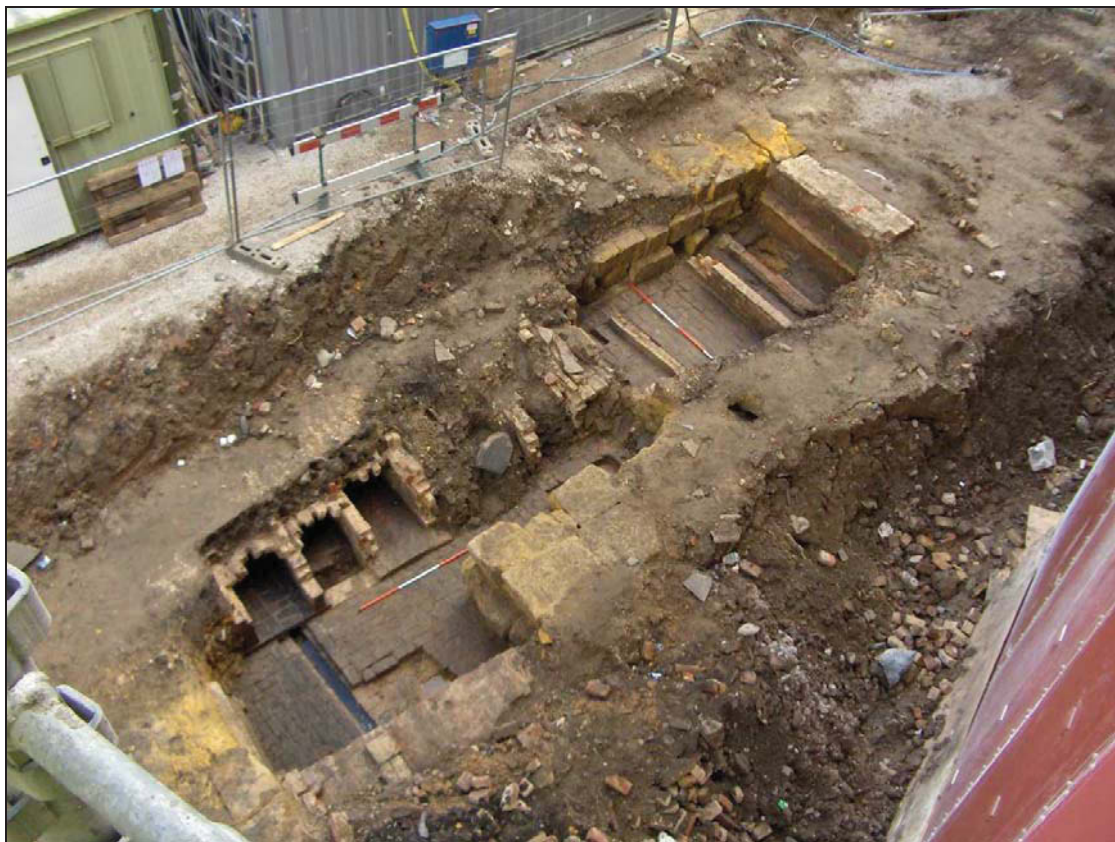
- 3.3.1 Removal of demolition rubble **69** exposed part of a crypt within the foundations of the main entrance portico (*Section 3.2.2*; Figs 3 and 4; Plates 17 and 18). The north-eastern edge of the crypt appeared to be defined by wall **311**, although any corresponding feature to the south-west must have lain beyond the limit of excavation. The crypt consisted of a series of north-east/south-west-aligned subterranean brick-vaulted bays (VB), 23 of which were recorded and are summarised in Table 1 and fully described in *Appendix 2*. The majority of the observed bays, surviving in places up to two tiers high, were located beneath the central part of the south-west portico and arranged flanking perpendicular corridor **70**. A second, smaller, group was located at the north-west end of the portico. This comprised upper-tier VB19 and 20 and, built against sandstone foundation wall **311**, short sections of dividing walls and vaulted roofs that were all that remained of highly fragmentary VB21-23.

Plate 17: Brick-vaulted crypt complex as seen from Building 4

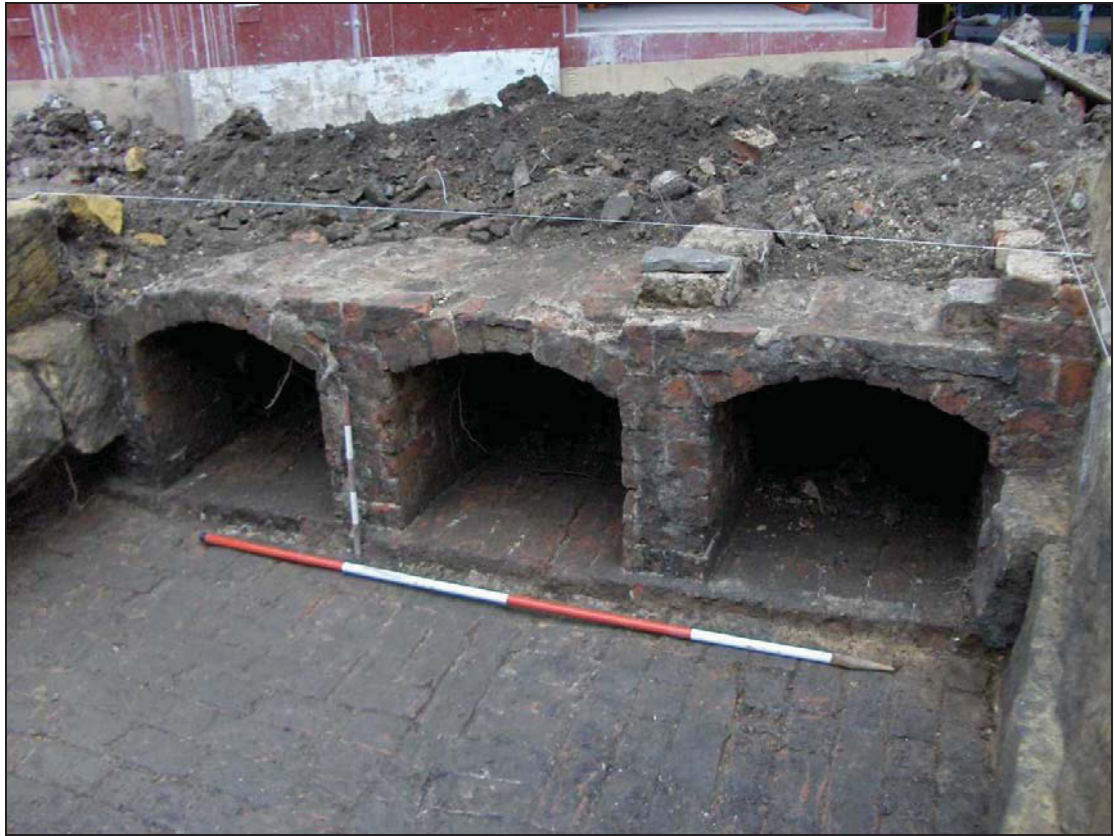
Plate 18: VB 15-18, bounded by the church foundations to the north and south

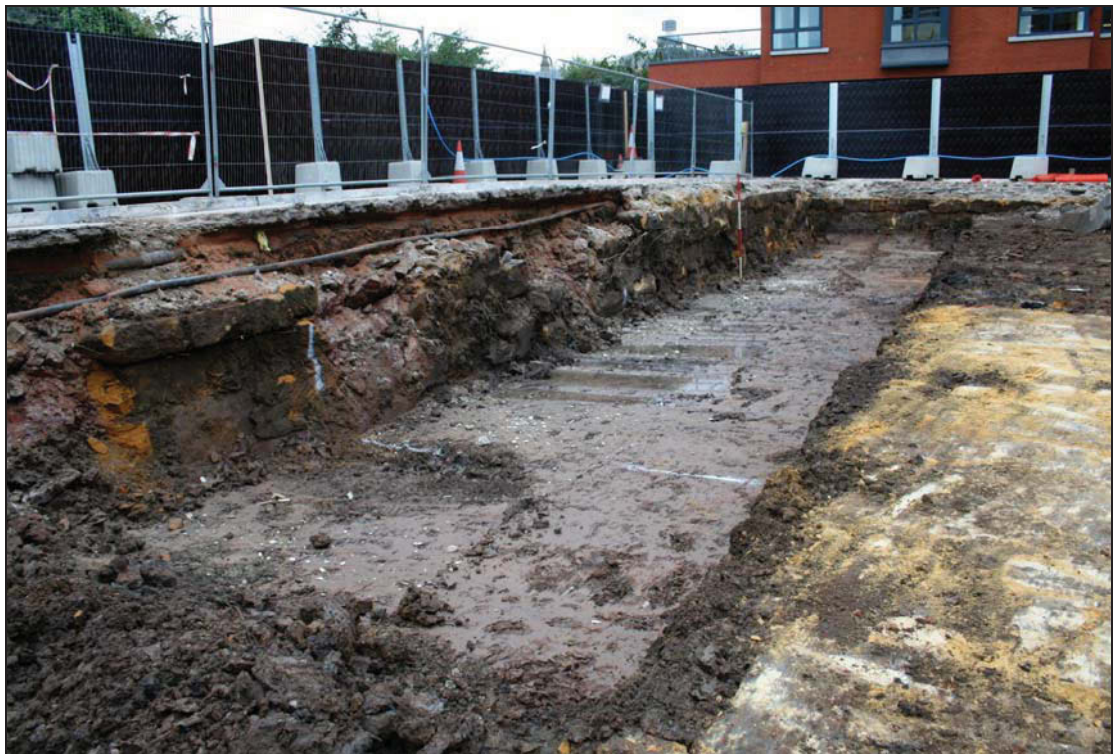
3.4.1 Evidence for the boundary wall of the graveyard was found in two places and collectively measured over 69.7m in length by 0.55m wide, surviving in parts to at least 1.5m high in section (wall **324**). On the south-western edge of the watching brief area for Building 4, the boundary was recorded as the unfaced foundations of north-west/south-east-aligned wall **7**, observed running along what would have been the frontage onto Earle Street (Fig 3). Wall **7** was best preserved towards its centre, where it was composed of large yellow sandstone blocks 0.4m in width, but otherwise survived intermittently as traces of sandstone and occasional blocks. A further L-shaped section of the boundary wall, **324**, was exposed on the eastern corner of the watching brief area for Building 5 (Fig 3; Plate 19), where a continuous length of dressed ashlar masonry foundations survived.

Plate 19: South-east end of graveyard perimeter wall 324

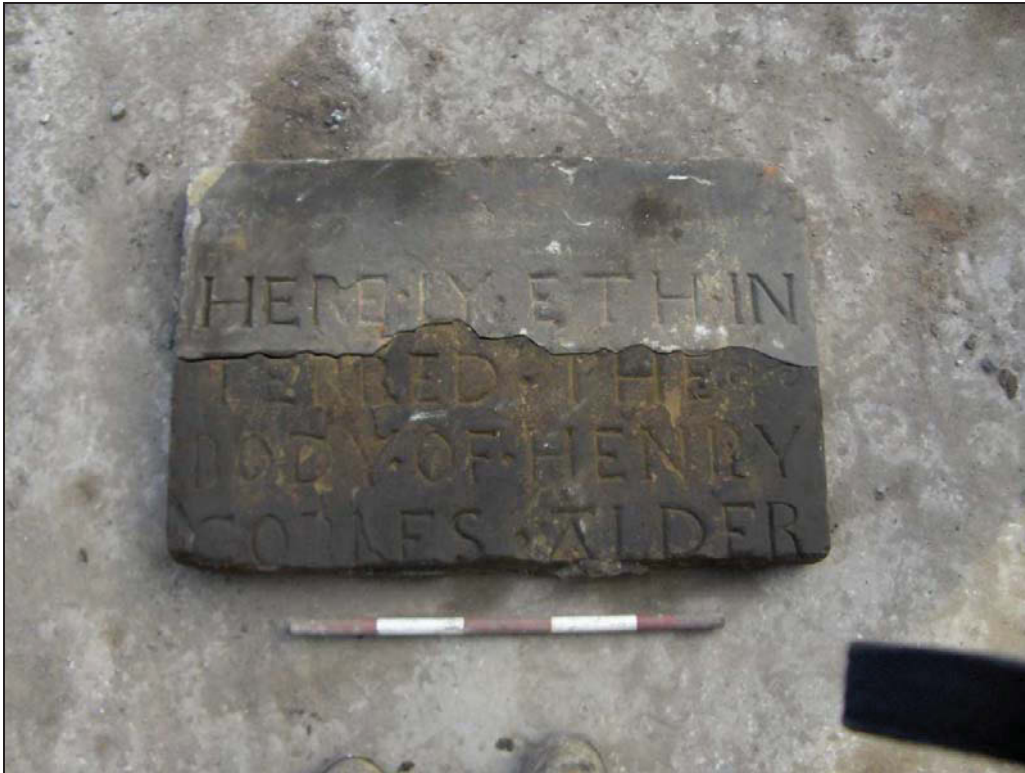
- 3.7.3 Two refitting fragments (ORN 77 and 94; Plate 24) were found within backfill 83 of VB9. Given the comparatively thin (only 50mm) nature of this flat rectangular stone, it is likely that this was a grave slab designed to lie horizontally across the top of the grave. The slab was inscribed, in a somewhat irregular and naïve style, perhaps indicative of an early date, with the words “*Here ly.eth interred the body of Henry Corles Alder*”. In addition, there are decorative sworls incised in places where a clear error in judgement was made in the spacing of the text, suggesting again that there was no template for the text. The font is incised *sans serif* but the “B” of body and the “A” in Alder are particularly irregular. The “A” appears to have been carved as a letter “E” and then corrected, perhaps indicating that the person carving the stone was not a mason. The lower portion of the stone was not recovered. The name Henry Corles Alder is not recorded in any of the online burial registers for St Paul’s Church (Online Parish Clerks). Consequently, he could have been buried in the period between 1822-1857 (and might thus be found on the undigitised burial registers held by the MRO (283 PAU)) or, more likely, his name has been truncated and his death pre-dates 1822. Alternatively, Henry Corles may have been an alderman of the city; however, no records of the surname Corles were recorded in either the parish records or Gore’s directory (1766).

Plate 24: Gravestone of Henry Corles Alder(?man)
"HERE.LY.ETH.INTERRED.THE.BODY.OF.HENRY.CORLES.ALDER"
 Refitted ORN 77 and 94
