Ormonde Offshore Windfarm Project:

Archaeological Watching Brief Along Route of Onshore Cable Connection at Heysham

October 2010

Document Type: Archaeological Watching Brief Report

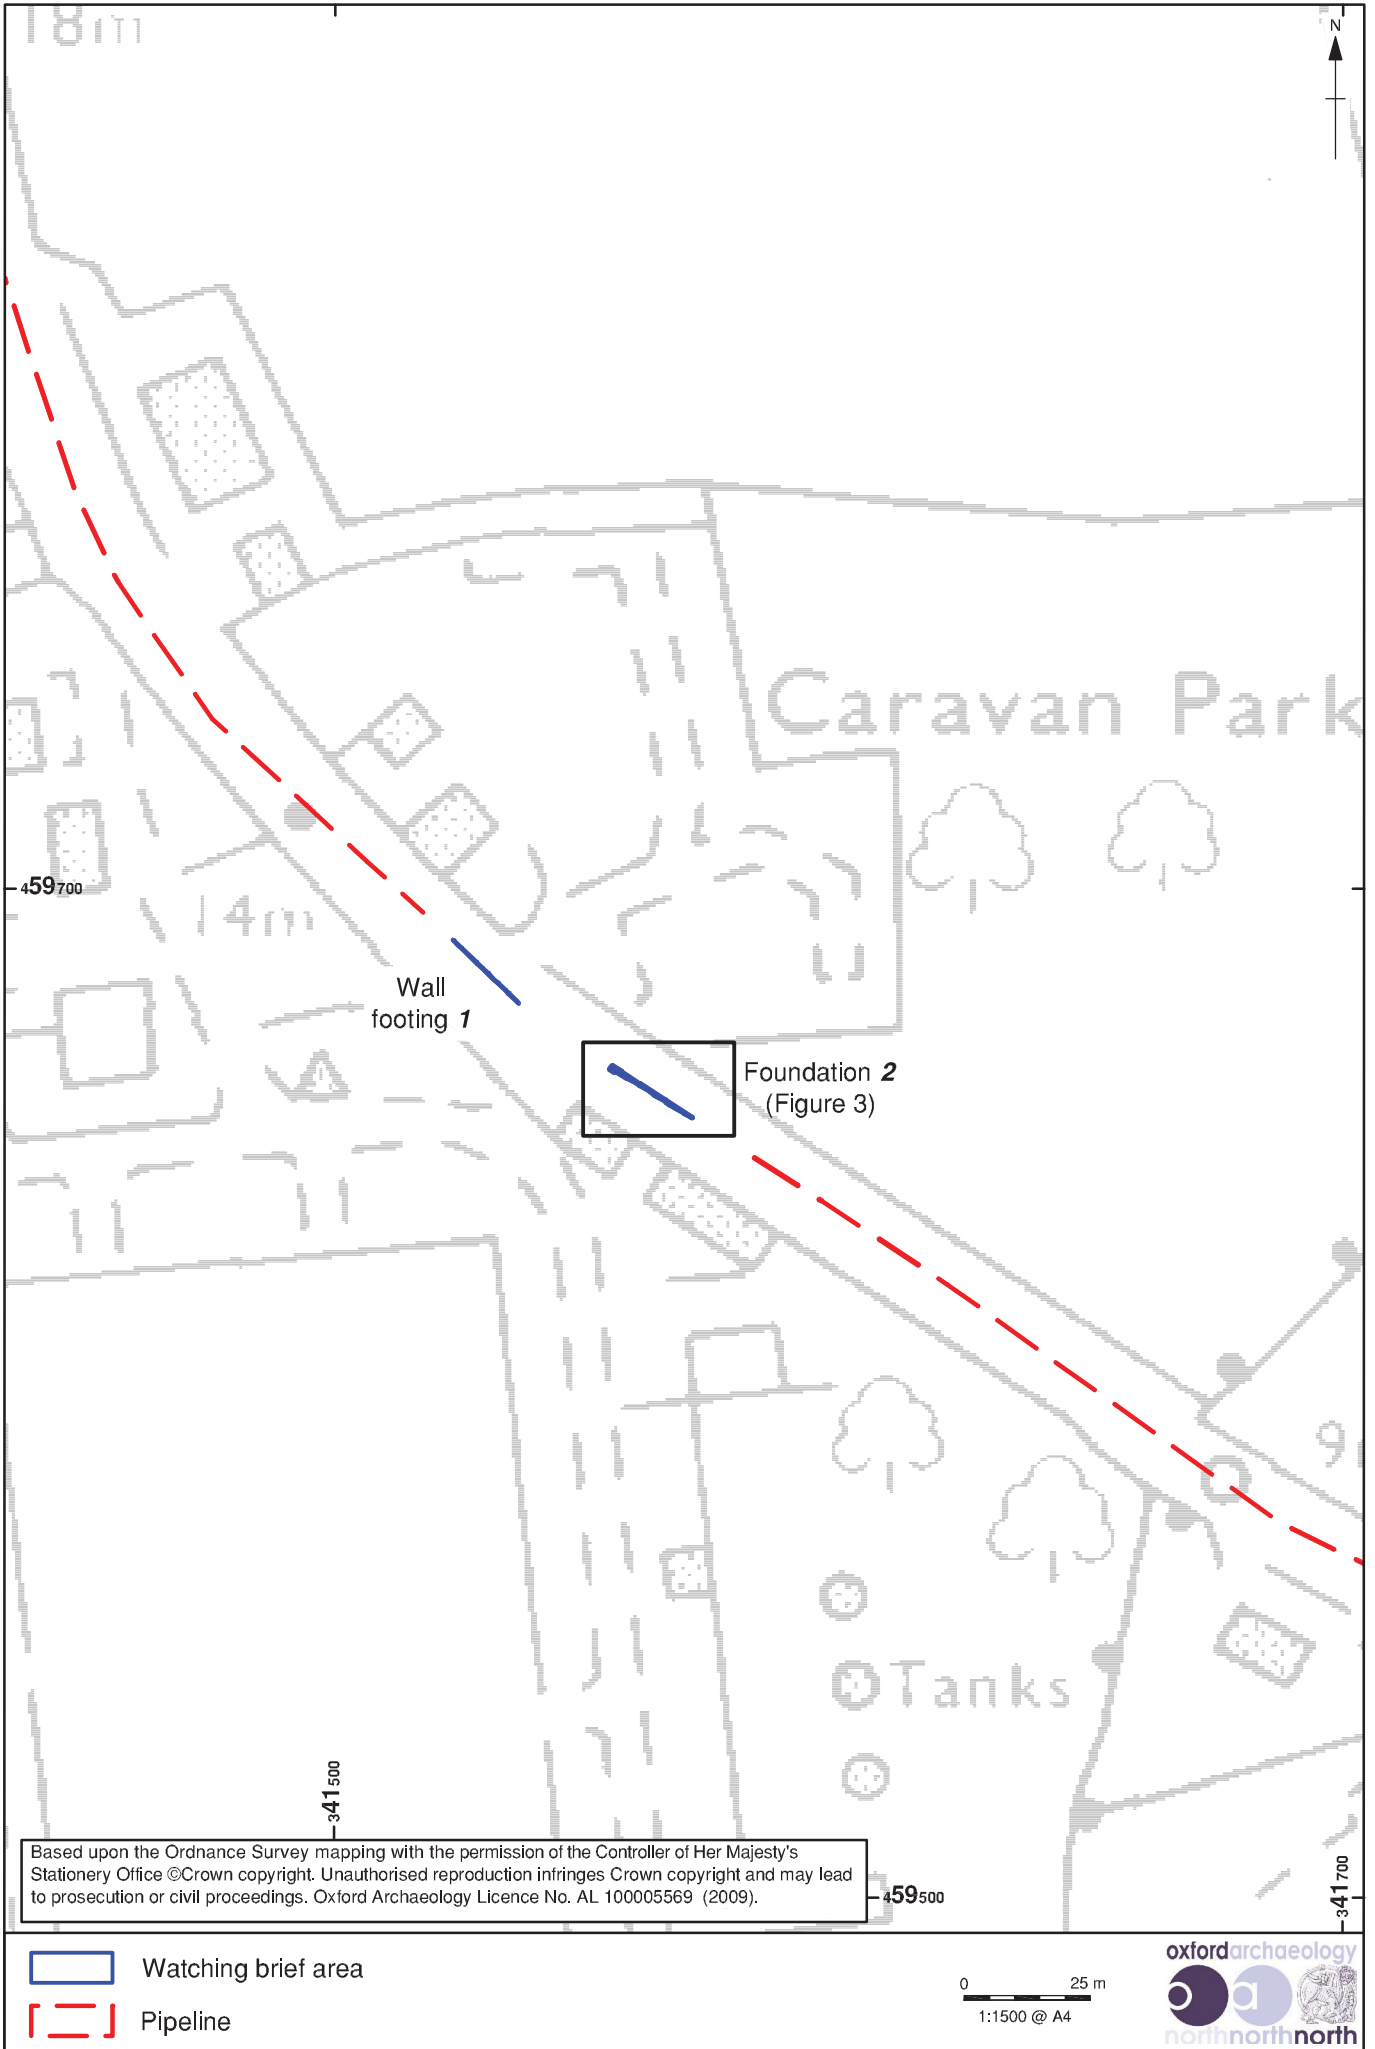
Figure 2 : Location plan of wall footing 1 and foundation 2

3.2.2 In the north-western half of the watching brief area, at a depth of 0.40m and surrounded by the hardcore of the current road's makeup, was a red brick footing, **1**, on a north-west/south-east orientation (Fig 1: Plate 1). It comprised late 19th or early 20th century brick, stamped with the lettering 'Claughton Manor Brick Co Caton'. The footing was only one brick wide and two courses high, and interpreted as the remains of a structure such as a boundary wall. It is most likely associated with the former property marked on the 1913 OS map, located on the north-eastern side of Middleton Road.

3.2.3 At the south-eastern end of the watching brief area a sandstone foundation, **2**, was recorded (Fig's 1 and 2 and Plate 2). It measured at least 0.70m wide, and comprised three courses of roughly hewn stone, on a north-east/south-west orientation. Its construction cut, **6**, truncated the remnants of a buried soil horizon, **5**, which overlay glacial till, **8**. The glacial till was located at a depth of 0.95m below the modern road. Two surfaces of the former Middleton Road, prior to its current form, located to the east of the foundation comprised the areas of cobbles, **4**, covered by tarmac, **3**. Foundation **2** matches the position of the southern wall of a structure marked in the 1895 OS map. This structure is absent from the 1913 OS map.

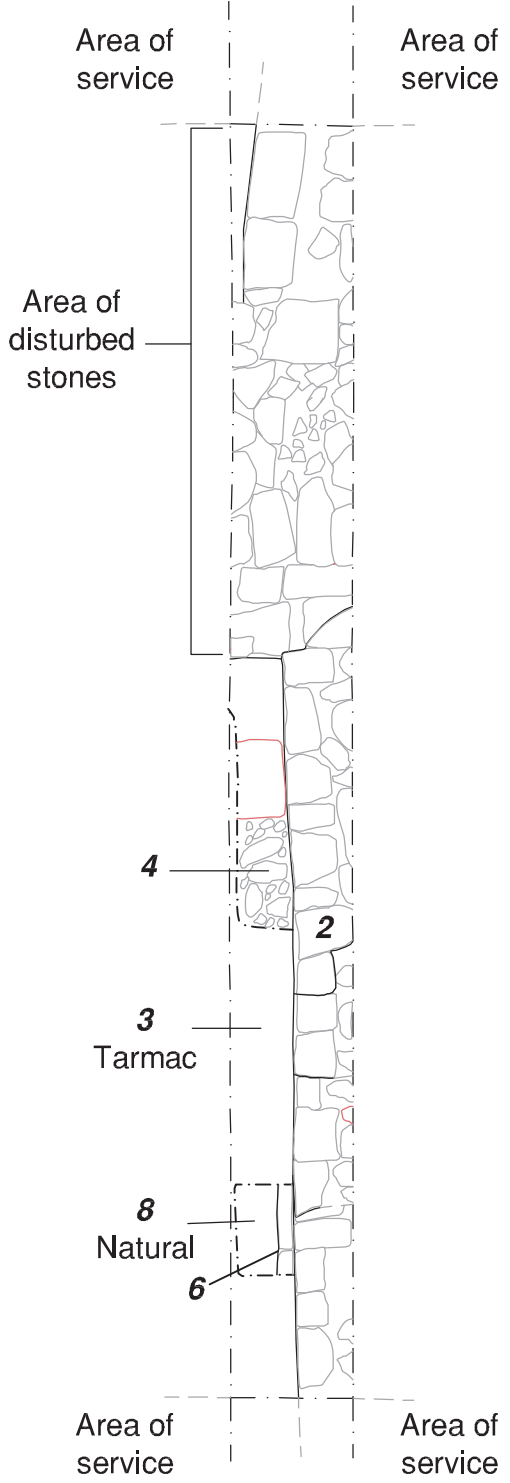
Figure 3: Plan and section of foundation 2

Section of foundation 2

- 4.1.3 In the southern stretch of this road a sandstone foundation, *2*, was located. The position of this foundation is a good match for a structure marked on the 1895 OS map of the area, but which is absent by the time of the 1913 edition.

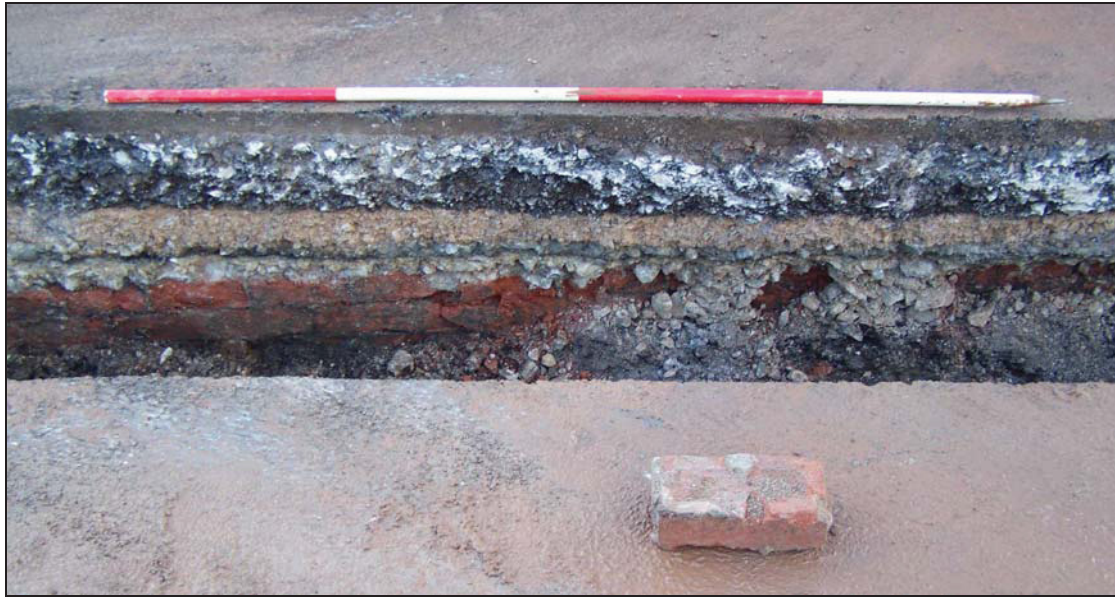
Plate 1: Footing, *1*, looking south-west, surrounded by the hardcore of Middleton Road

- 4.1.2 Excavations along Middleton Road were observed in November and December of 2009. A late 19th century to early 20th century red brick footing, *1*, was located in the northern part of this stretch of road. It most likely relates to a the boundary wall of property formerly located on the north-eastern side of Middleton Road, and visible on the 1913 OS map of the area.

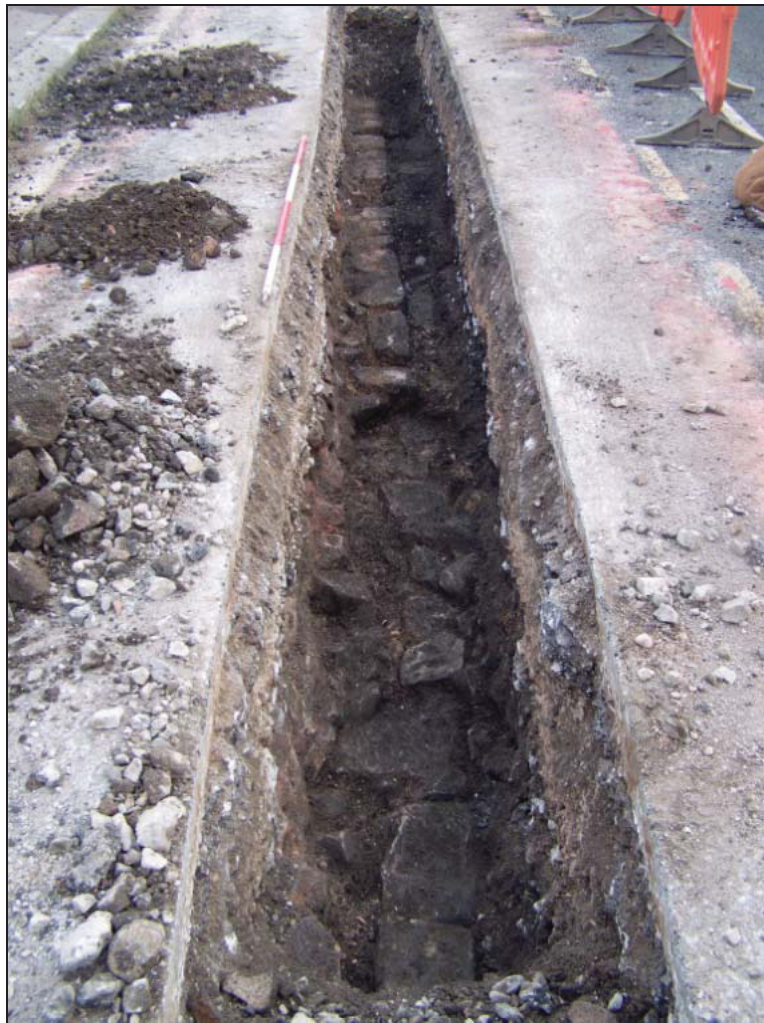
Plate 2: Foundation 2, looking south-west

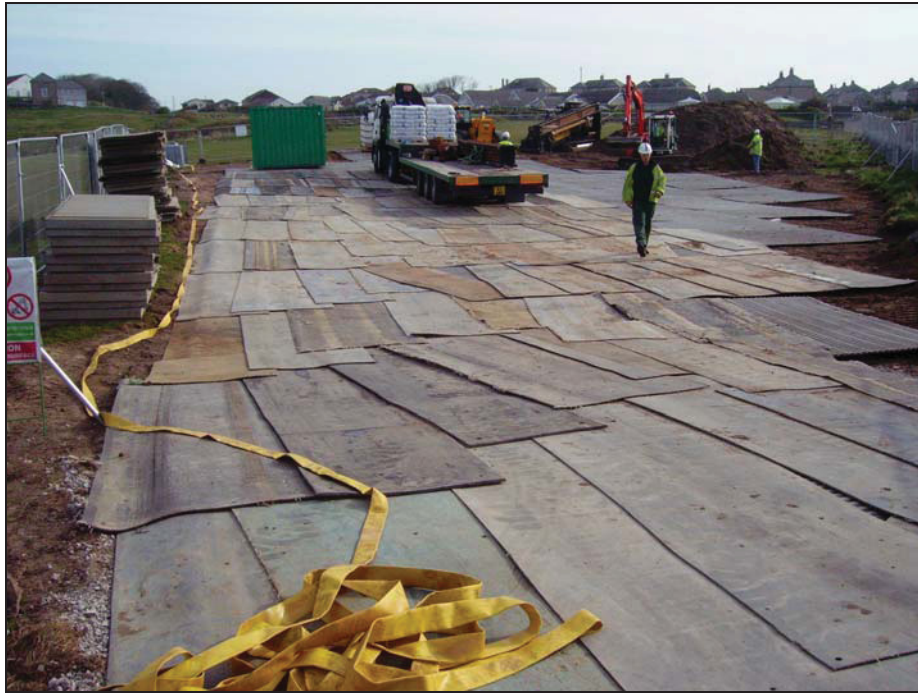
3.2.5 Prior to the next visit two areas had been topsoil stripped, with a maximum of 0.3m of soil removed. The larger of these, adjacent to Old Smithy Lane, was a triangular area measuring 76m in length and a maximum of 47m wide (Plate

Plate 3: Area of topsoil strip adjacent to Old Smithy Lane, looking north-west

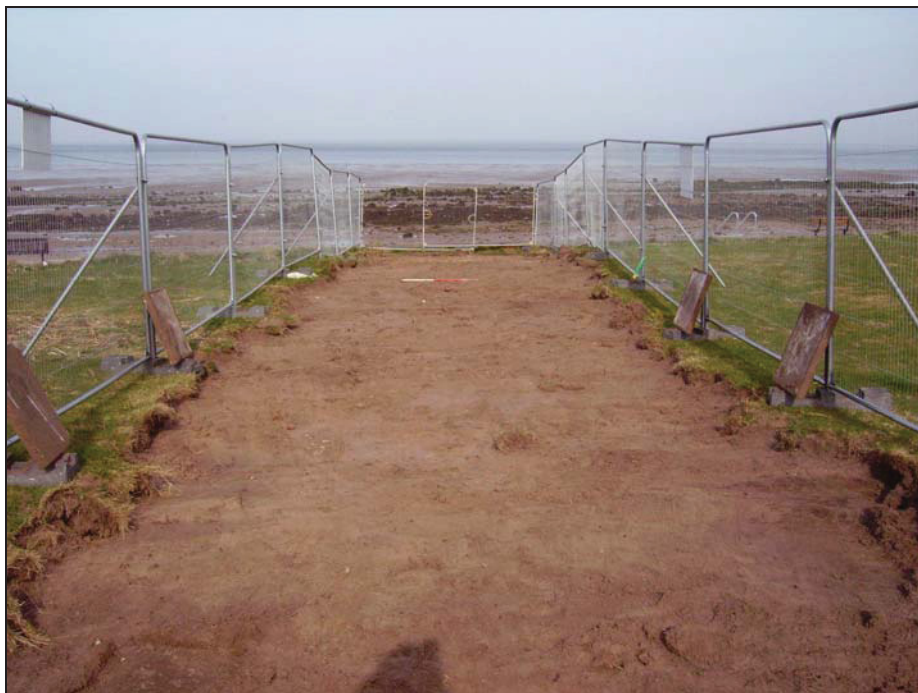
- 3). The second area measured 0.32m in length and 0.40m wide, located perpendicular to the sea wall, intended to form an access track (Plate 4). The first area was predominantly covered with matting, and could not be inspected. No archaeologically significant deposits were visible in the area adjacent to the sea wall.

Plate 4: Area of topsoil strip perpendicular to sea wall, looking north-east

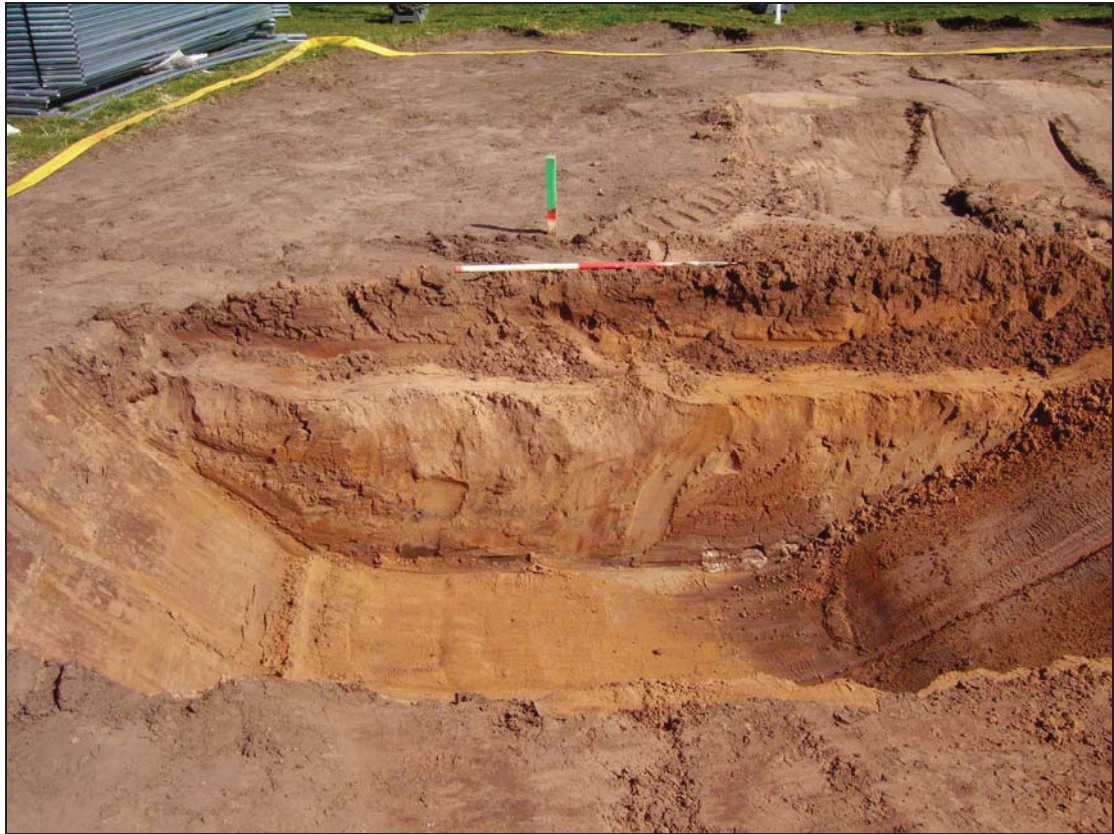
- 3.2.6 A pit for the drilling rig was excavated in the northern corner of the larger area. It measured 4.4m in length and 2.50m wide and reached a maximum depth of 1.20m, aligned on an east-west orientation (Plate 5). Excavation proceeded through 0.20m of sandy subsoil, and 1.0m of mid-yellowish orange and dark grey beach sands, at which point the water table was reached. No archaeologically significant deposits were encountered.

Plate 5: Pit for drilling rig, looking north

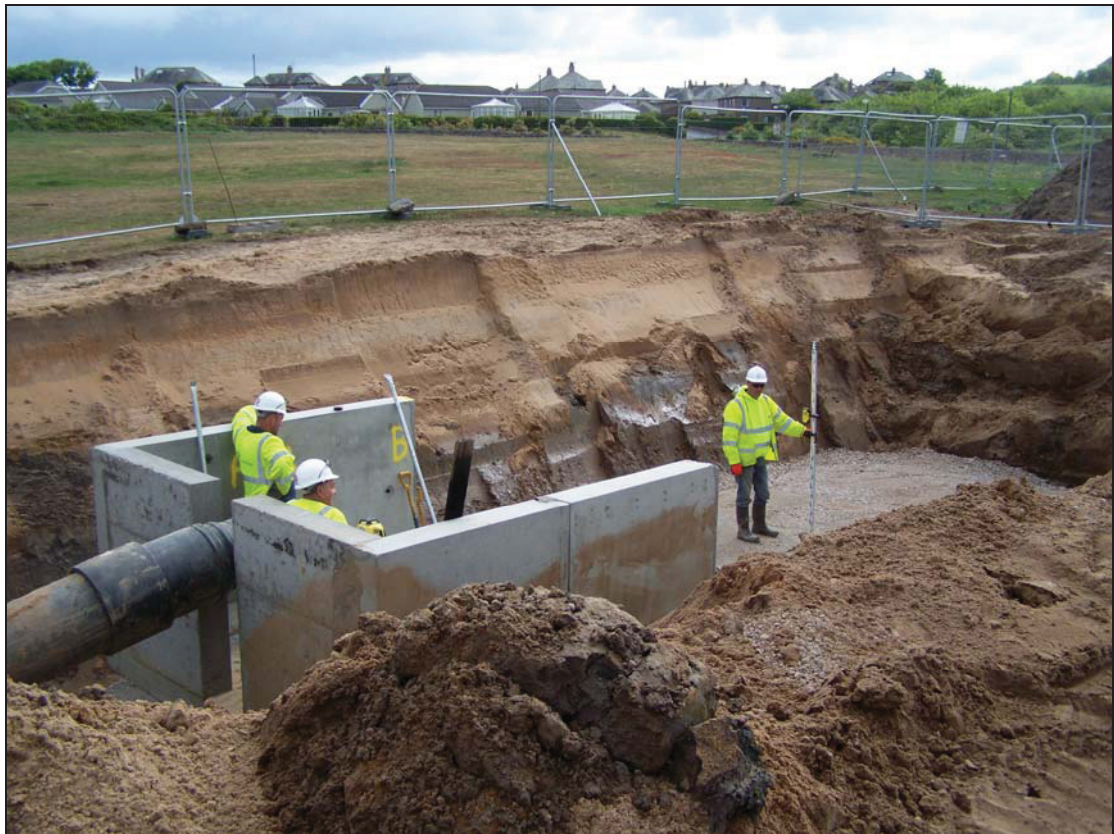
- 3.2.7 Prior to the next site visit the pit originally excavated for the drilling rig had been extended 17.40m to the east, and widened to 9.40m, reaching a depth of 3.50m. Within this pit a wall supporting the cable landed from the sea had been built (Plate 6). The excavated area was not entered for health and safety reasons. In section the beach sand deposits previously described were visible, for *c* 2m of the section. Below this a blue grey, possibly marine, clay was visible.

Plate 6: Extension to pit for drilling rig, looking north-west

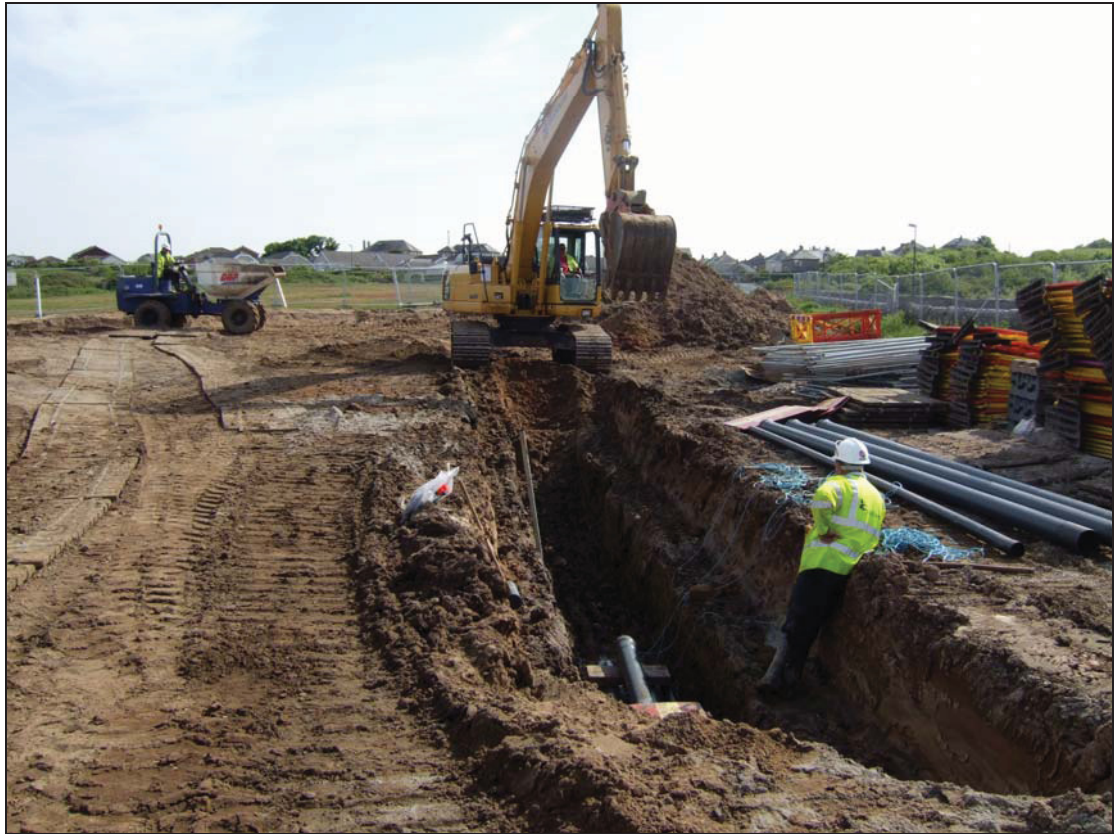
- 3.2.8 A trench measuring 29m in length and 0.60m wide, reaching a maximum depth of 1.6m, was excavated between Old Smithy Lane and the above described pit. Excavation proceeded through 0.20m of modern hardcore, recently laid by the developer, 0.80m of mid-yellow beach sand, 0.1m of dark grey sand, and 0.50m of mid-brown grey sandy clay (Plate 7). No archaeologically significant deposits were encountered. A further *c* 6m remains to link this excavated trench to the cable currently supported by the aforementioned wall. All but *c* 20m of this will be excavated through the backfill of the large 17.40m by 9.40m pit.

- 3.2.9 Within this trench, at a depth of 0.9m, was encountered a thin layer (0.1m thick) of dark grey silty sand which has been interpreted as buried turf or topsoil, **10**. This, in turn, was sealed by 0.85m of light yellow, highly stratified sand, **9**, apparently the result of sand dune formation or spreading. No finds were recovered from the buried topsoil to indicate the date at which it was sealed beneath wind-blown sands. Within the field north of Smithy Lane, parallel to the modern foreshore and promenade, is an observable raised linear (surveying to approximately 0.2m in height) likely to represent the remnants of the coastal dune.

Plate 7: Excavation of trench for cable duct in land adjacent to Old Smithy Lane, looking north-west

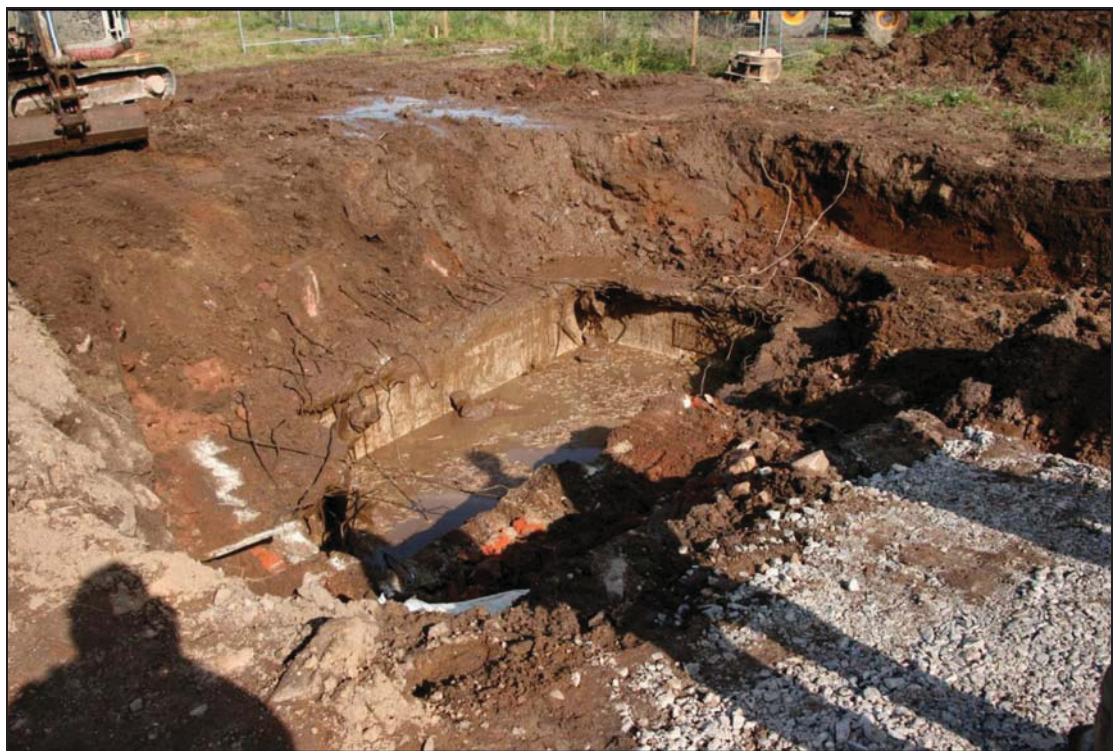
- 3.2.13 At the time of the two archaeological site visits (23rd and 28th September 2010) the structure was filled with a mixture of Bentonite and water (apparently in the region of 25,000 gallons), to facilitate drilling, which was also being undertaken at that time (Plate 12). Photographs were furnished of the structure as exposed prior to the demolition and infilling with the mixture (Plates 8-11). Of particular note were the (then) surviving extents of the side walls of the structure (Plates 8 and 10), and in particular the store cupboard/toilet on the west end wall elevation (Plate 11) and the shuttered ventilation shaft on the east wall elevation (Plate 9).

Plate 8: Exposed surface of Heysham ROC Monitoring Post, looking north-east (© Duncan Davis)

- 4.2.3 The Royal Observer Corps Monitoring Post identified on Heysham Golf Course was recorded in its present damaged condition. Given the number of surviving sites of this type in the country it is of low individual archaeological importance and no further archaeological work is recommended.

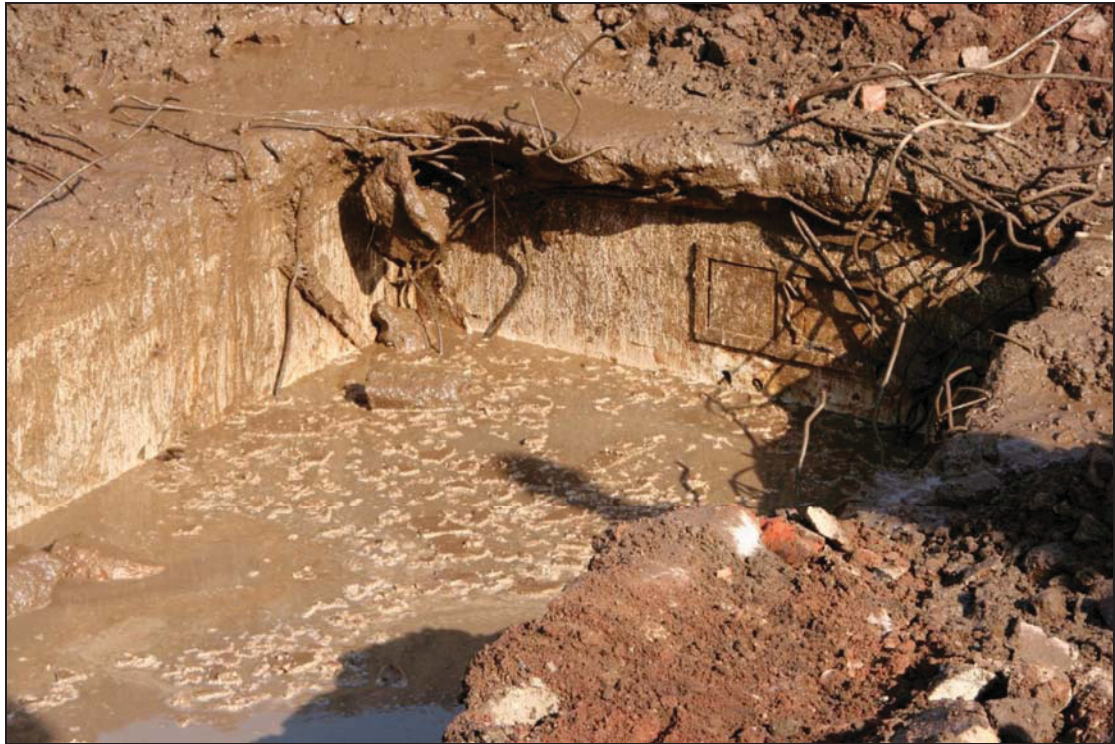
Plate 9: Detail of the exposed metal hatch covering access to the ventilation shaft (© Duncan Davis)

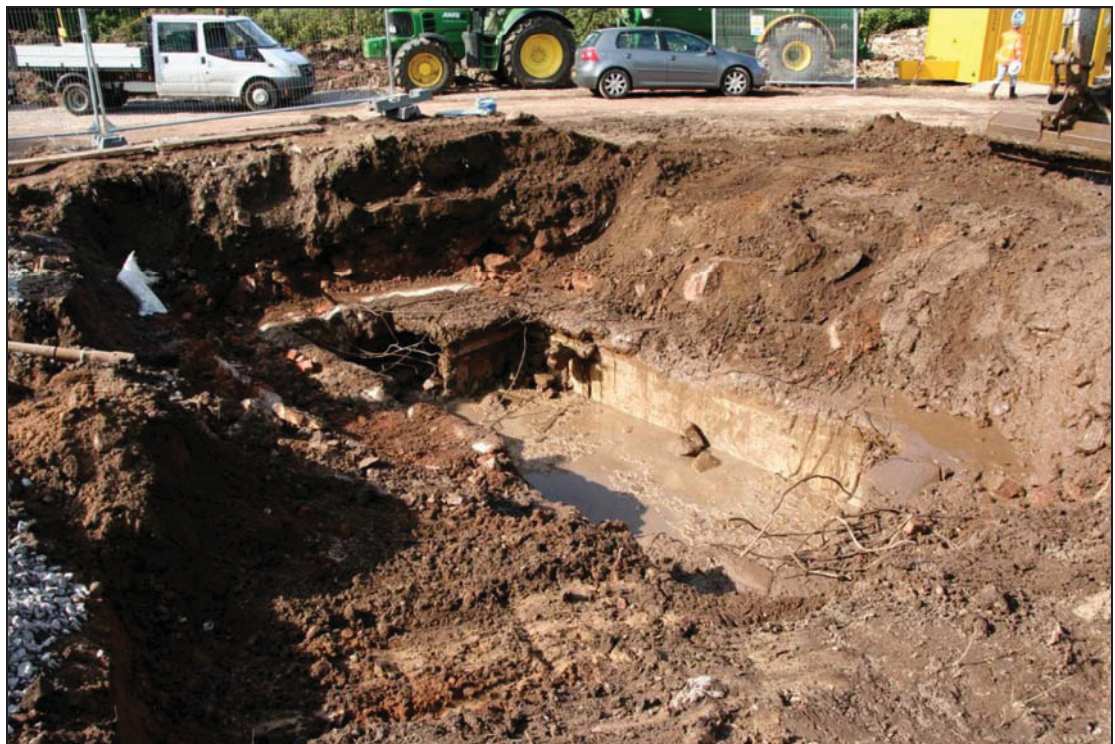
Plate 10: Exposed surface of Heysham ROC Monitoring Post, looking north-west (© Duncan Davis)

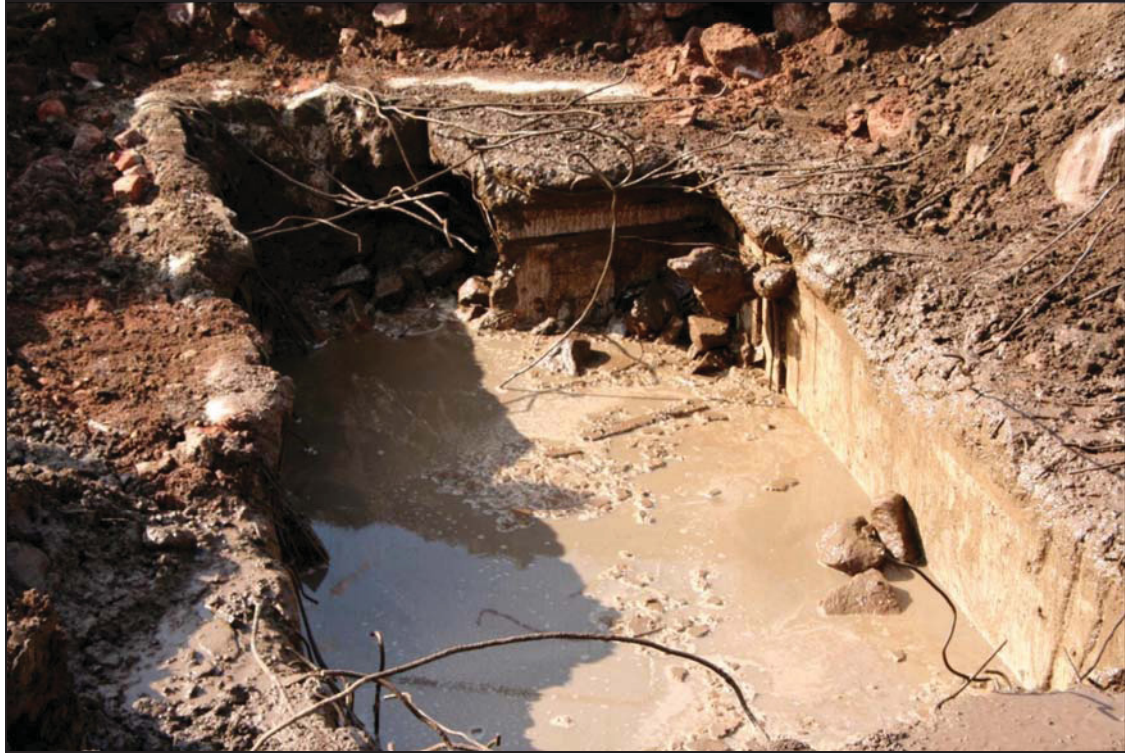
Plate 11: Detail of the exposed toilet and entrance chamber (© Duncan Davis)

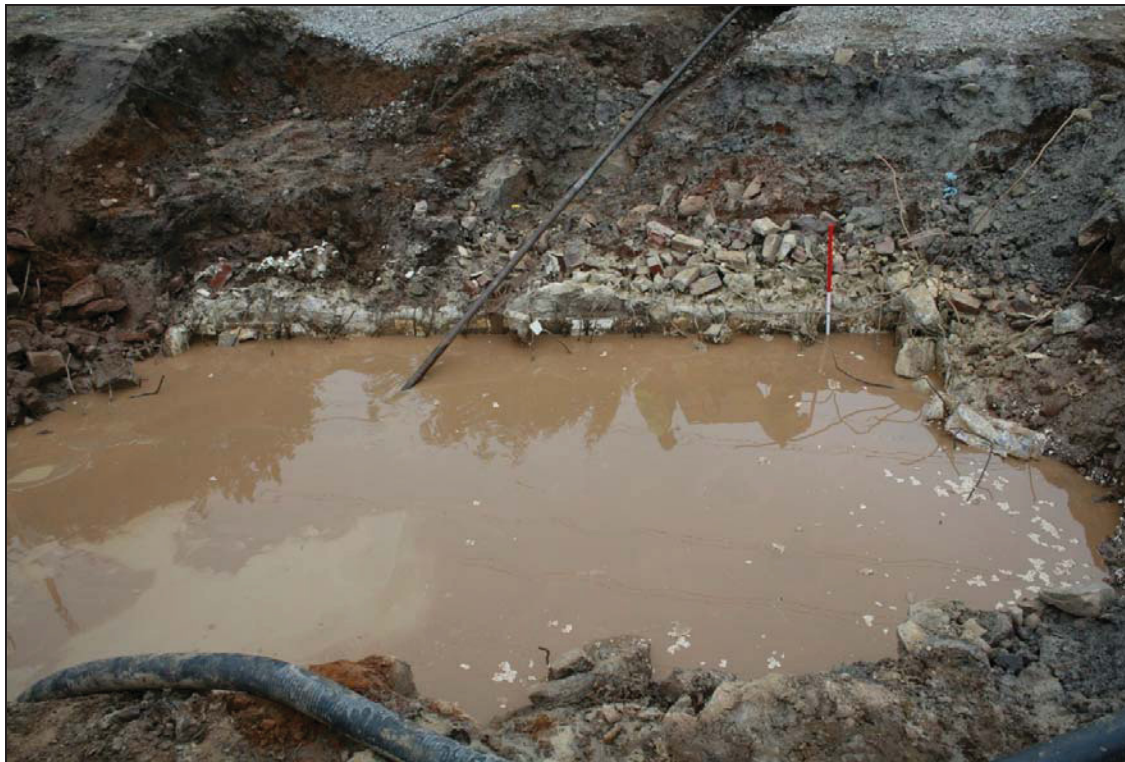
- 3.2.14 During the archaeological site visits it was ascertained that the monitoring post structure *II* had, after its initial exposure and without archaeological monitoring, subsequently been further reduced in height on all but the south

Plate 12: State of preservation upon archaeological investigation after further reduction of walls, looking south

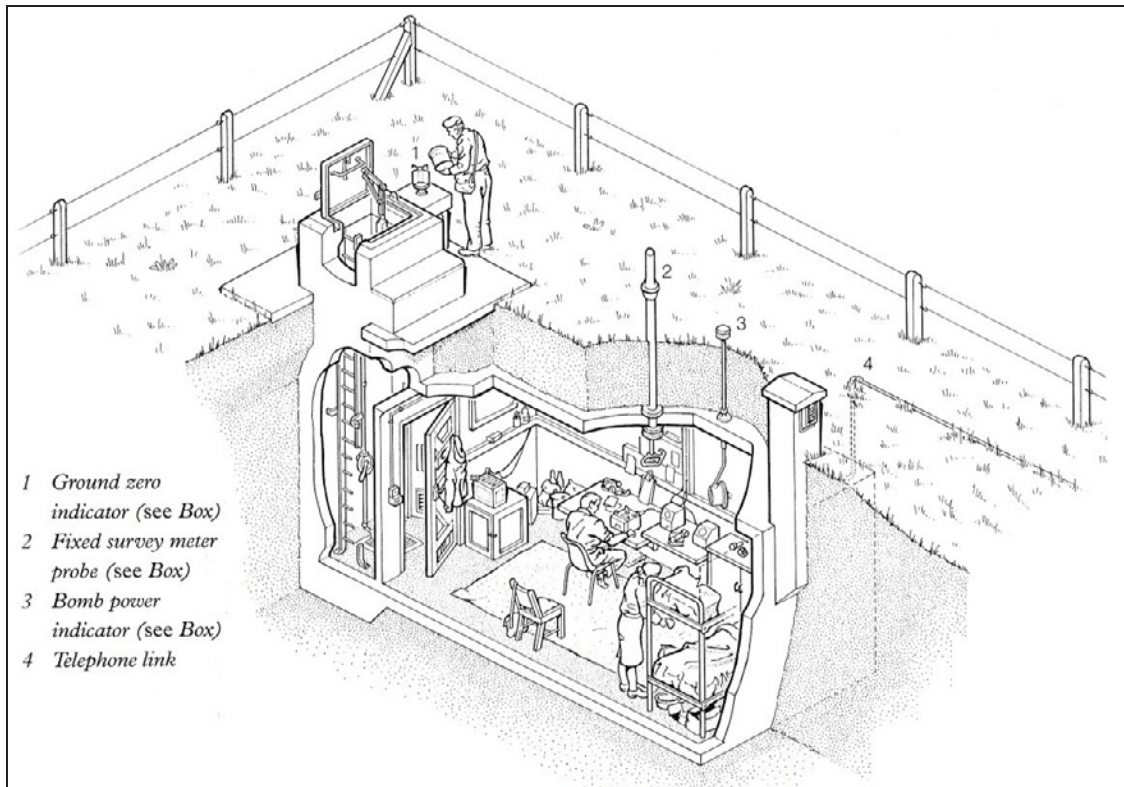
Plate 15: Cutaway view of a 1960s Royal Observer Corps Nuclear Monitoring Post (Cocroft and Thomas 2004)

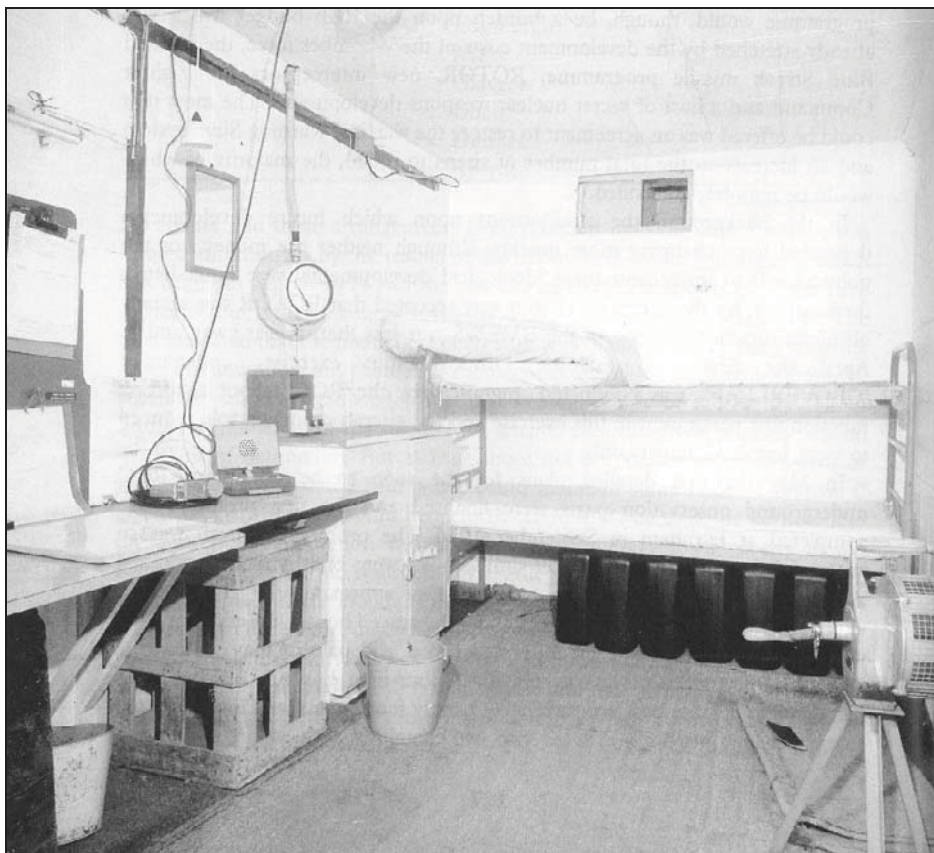
Plate 16: Internal view of a typical fully-fitted Royal Observer Corps Nuclear Monitoring Post (McCamley 2007)
