**NO. 1, COTTESFORD PLACE, JAMES STREET, LINCOLN**

**ARCHAEOLOGICAL MONITORING AND RECORDING  
OF TEST PITS**

NGR:	SK 97733 72036
CLC planning ref.:	2019/0291/HOU
Scheduled Monument	
Consent:	S00222739
PCAS Job No.:	2224
Site code:	CJLE 19
Archive acc. code:	2019.135
OASIS ref.:	preconst3-371201

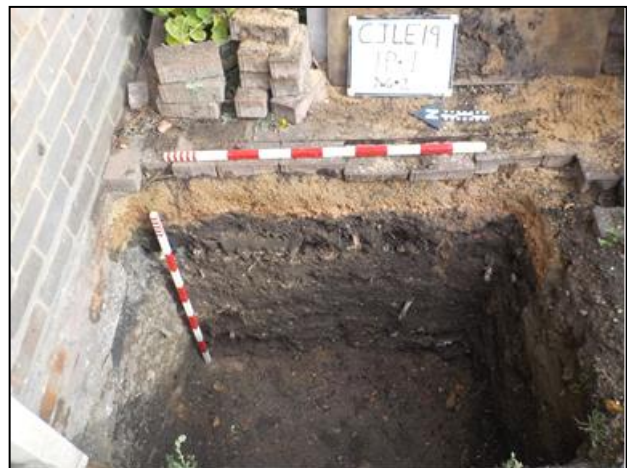
Plate 1: Test Pit 1, looking east.

Test Pit 1 was located within the southwest of 1 Cottesford Place and measured 1.1 x 0.95m<sup>2</sup>, it reached a depth of 1.2m. Under the modern bedding material (101) and garden soil (102) a 0.8m deep mid grey brown silty sand (103) was observed. This material was identified within Test Pits 2, 3 and 4 and is a made ground derived from existing buried soils, but disturbed and mixed during the construction of the current structure.

Oyster and Ceramic Building Material (CBM) was recovered from Test Pit 1, but no archaeological features or horizons survived within its footprint.

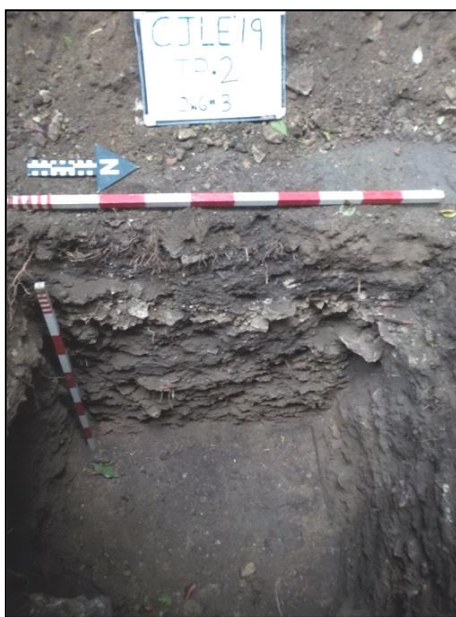
Plate 2: Test Pit 2, looking west.

Test Pit 2 was located within the Northwest of 1 Cottesford Place and measured 1.1 x 0.9m<sup>2</sup> and reached a depth of 1.2m. This test pit comprised of a garden topsoil (201), and two layers of made ground (202) and (203), the latter appears to be the same as (103). This sealed a further made ground layer (204) at a depth of 0.75m. Layer (204) was a lighter orange brown silty sand and contained mixed material from different periods and may also have derived from disturbed buried soils.

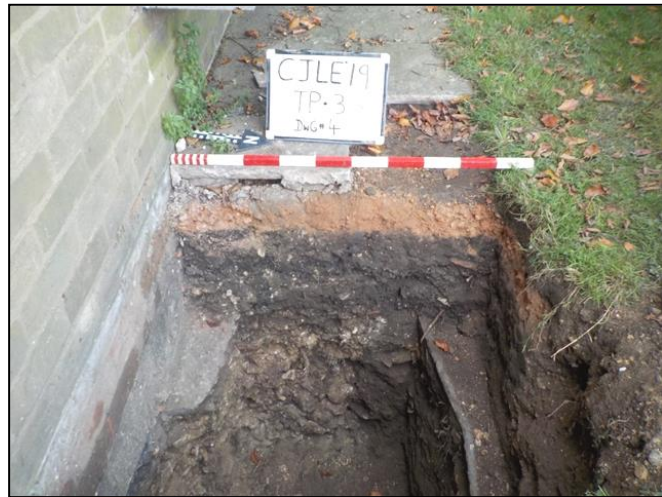
Plate 3: Test Pit 3, looking west.

Within this trench the uppermost layer was that of (301), a modern bedding material, this sealed a garden soil (302), which in turn sealed the common sandy silt disturbed layer seen within test pits 1, 2 and 4, (303). This sealed a compacted light grey and white limestone deposit (304), which appeared to be the fill of an almost vertical cut, whose other side and base were not seen: this seems most likely to be the fill of the 1950s evaluation trench, either at its edge or within a feature that had already been excavated. This possible feature was cut into a brown grey silty sand mixed material (305). The foundation of the house wall appeared to rest on fill (304).

The material recovered from this trench was of mixed Roman to Post medieval/modern date and suggests that the construction of the house and modern activity within the site has disturbed the surrounding ground to a depth of 1.2m+.

A cable service trench cuts deposits (302), (303) and the upper portion of (305).

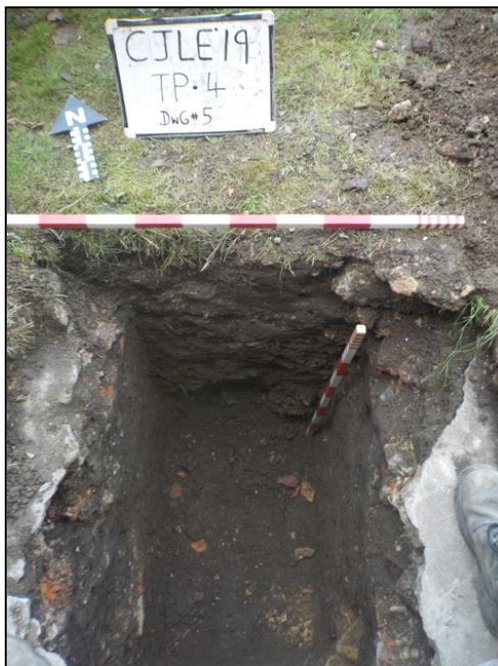
Plate 5: Test Pit 4, looking north.

Test Pit 4 was located along the eastern wall of 1 Cottesford Place and measured 0.7 x 1.1m<sup>2</sup> and reached a depth of 1.2m. Under the garden soil (401) a mid brown silty sand backfilled material was identified, this appears to be the backfilled material for a drain which was identified within the base of the test pit. The finds recovered from this test pit, like the others was mixed Roman and modern pottery. No archaeological features or horizons were identified due to truncation by the drain.

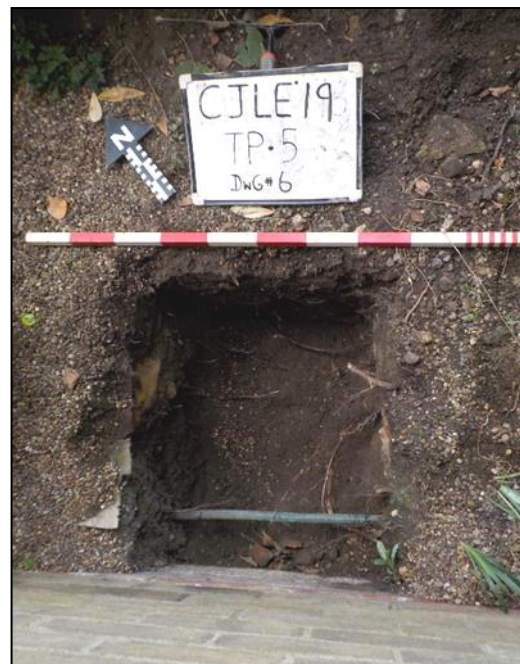
Plate 4: Test Pit 5, looking north-east

Test pit 5 was located along the southeast of 1 Cottesford Place and measured 0.6 x 0.65 x 0.56m. After initial top/ garden soil excavation this test pit was abandoned due to the presence of a service cable. Mixed pottery and CBM were recovered but represent residual finds and no archaeological horizons were identified.

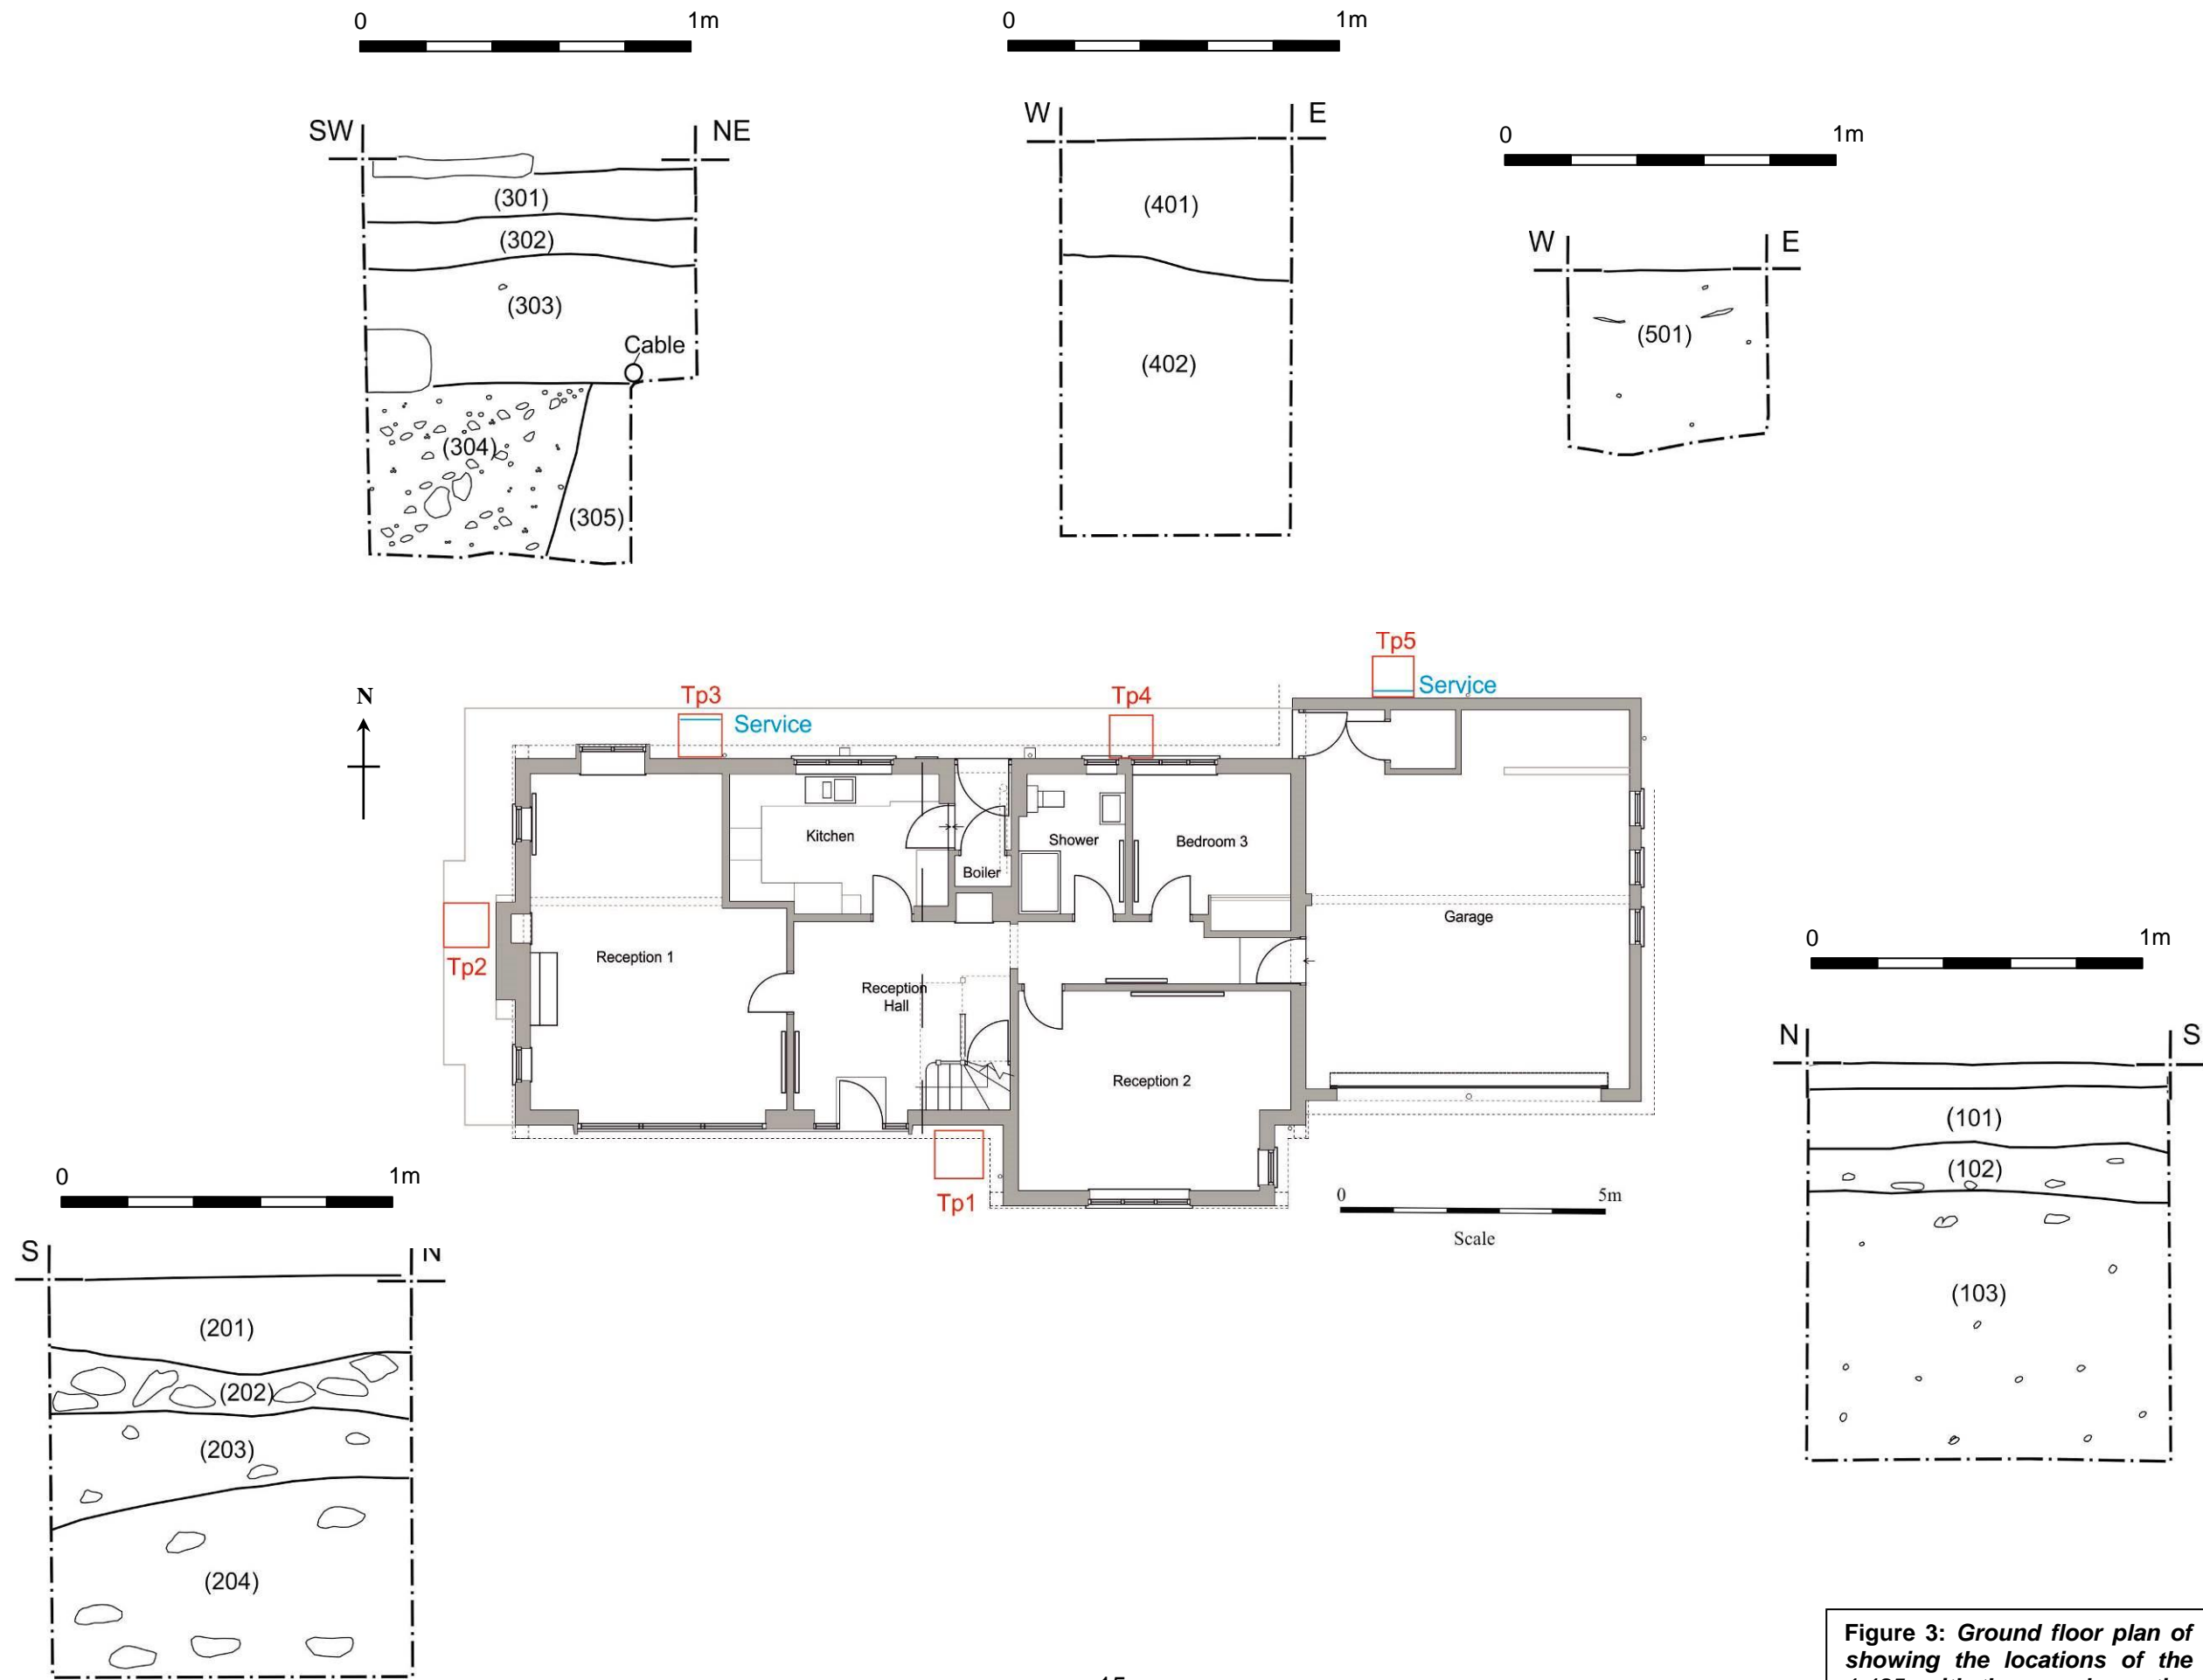
Figure 3: Ground floor plan of 1 Cottesford Place, showing the locations of the test pits, at scale 1:125, with the sample sections of the test pits at scale 1:20. Base plan supplied by developer.

The test pits were located along the external walls of Cottesford Place, positioned as shown in Figure 3, to investigate the existing foundations and ground floor slab proposals. They were excavated up to 1.20m in depth and measured no more than 1m<sup>2</sup> in plan as per the construction requirements. Scheduled Monument Consent was granted on the 1<sup>st</sup> August 2019 before any groundworks commenced.
