**HAXEY VILLAGE DRAINAGE IMPROVEMENT SCHEME,
HAXEY, NORTH LINCOLNSHIRE**

**SCHEME OF ARCHAEOLOGICAL OBSERVATION, ASSESSMENT
AND RECORDING**

Report prepared for
Lindsey Marsh Drainage Board

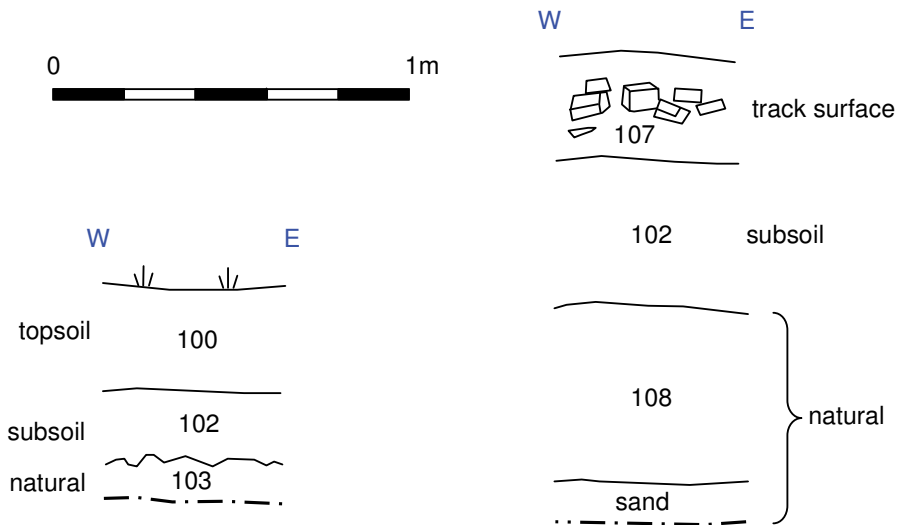
Figure 4: Sample section of the Zone 1 pipe trench in the paddock area, at scale 1:20; section located on figure 3.

Figure 5: Sample section of the Zone 1 pipe trench at the boundary between the paddock and the arable field, at scale 1:20; located on figure 3.

Topsoil 101 in Zone 1 was up to 0.40m deep, and overlay a sandy silt subsoil, 102. Datable finds retrieved from the subsoil ranged from the 18th to the 20th centuries (appendix 3). Subsoil 102 overlay a variety of natural sand and clay deposits (figs. 4 and 5).

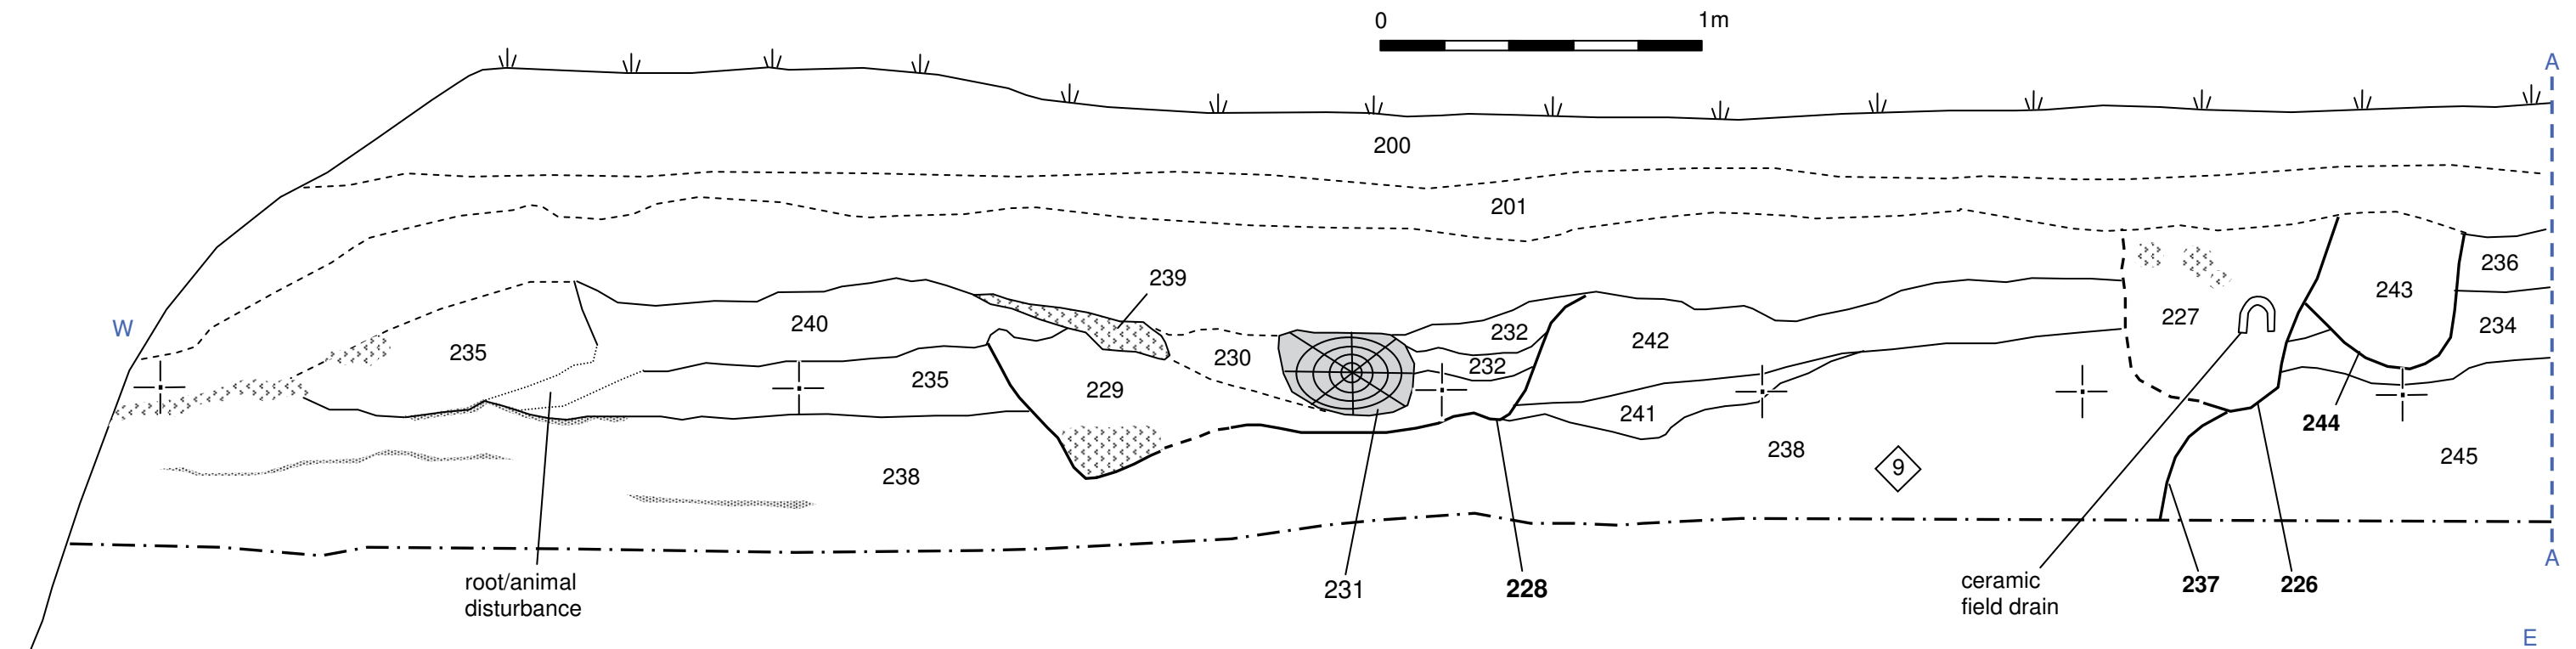
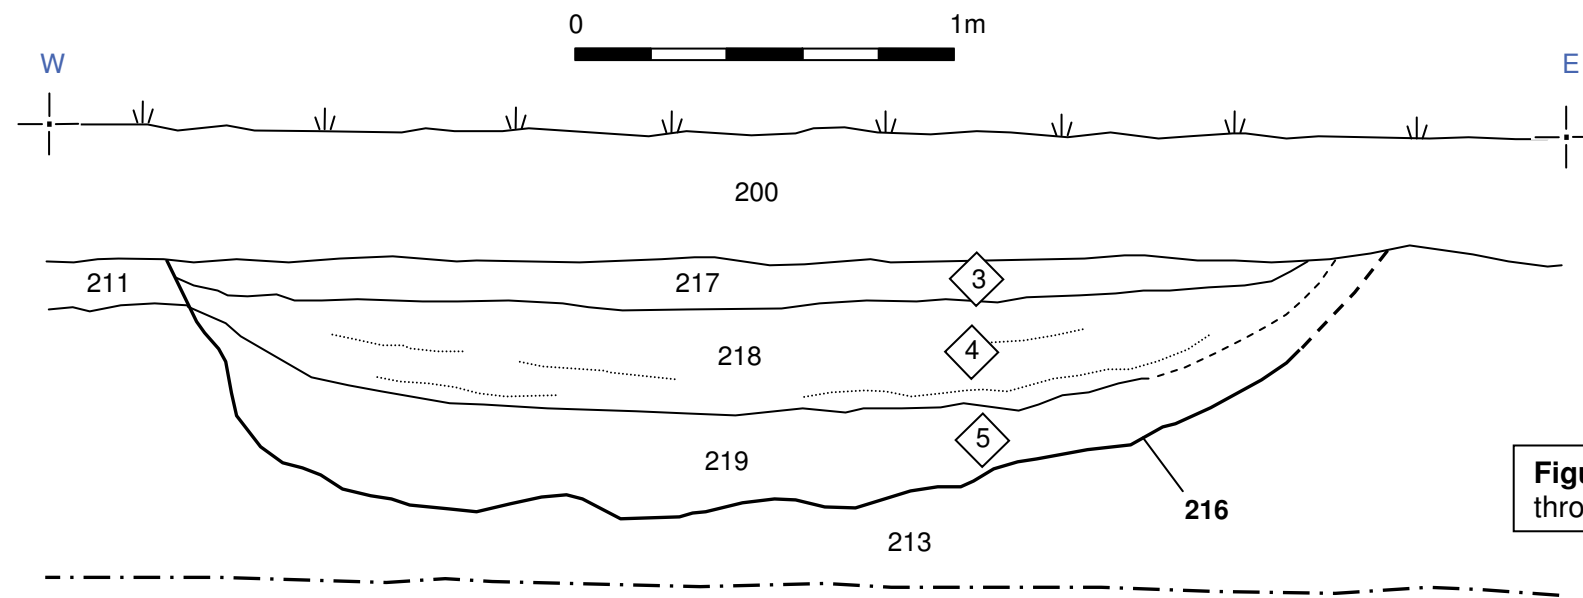
Figure 10: Section through ditch 216

Figures 10-12: Sections through features encountered in the sections of the Zone 2 drain, at scale 1:20, showing the location of environmental samples. The drawings are located on Figure 3.

The other two linear features, 216 and 220, both ran approximately perpendicular to the cut, and can tentatively be associated with two of the small, irregular cropmarks, whose northern ends lie close to or cross the line of the trench (fig. 2). Both features were 3m wide and relatively shallow, 216 being 0.66m and 220 0.60m deep. Ditch 216 contained three fills: the lowest, 219, consisted of silty peat, while the upper fills, 217 and 218, were silty clays and sands (fig. 10a). An environmental sample was taken from each of the fills: samples 3 and 4, from the upper fills, were uninformative, but sample 5, from peat fill 219, contained abundant remains of hemp and flax. The highly decomposed nature of the remains, and the indications that young rather than mature flax plants were represented, suggest that these remains represent waste from the processing of the plants for textile fibres (appendix 5). Ditch 220 contained a more complex sequence of five fills, 221-225, and their appearance in section suggests that the ditch may have been periodically cleaned or recut (fig. 10b). The three lowest fills, silty sands 223, 224 and 225, were all sampled, but no archaeobotanical remains of any significance were retrieved (appendix 5).

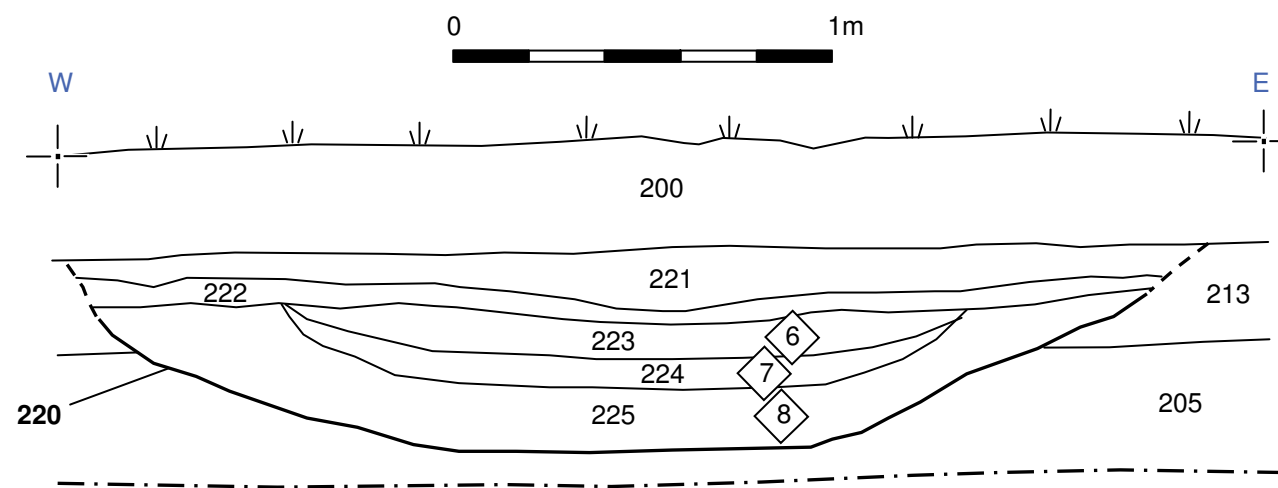
Figure 11: Section through ditch 220

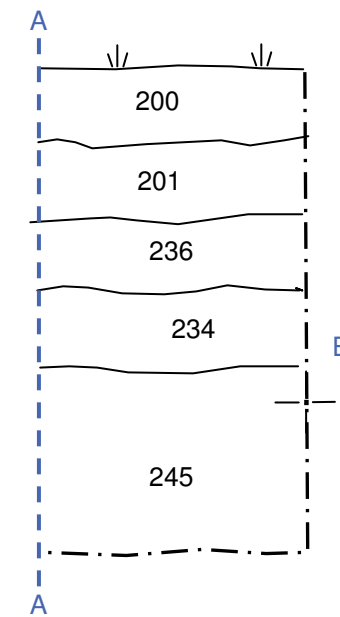
Figure 12: South-facing section of the new drain cut, showing features 237 and 228.

A group of intercutting features was exposed at the west end of the east-west running section of the new drain cut (fig. 10c). The earliest of these features, 237, which cut a sequence of natural deposits 236, 234 and 245, measured at least 6m east to west: its western end was not identified. It was initially interpreted as a very large pit, but was probably part of a linear feature following roughly the same alignment as the new drain cut: the 1st edition 25" Ordnance Survey map of 1886 shows the Lound Rates Drain as extending much further westwards than it did at the

The two upper fills of feature 237 were cut by a shallow pit, 228 (fig. 10c). This contained a rather confused melange of small fills and a piece of horizontal timber, whose disturbance by the machining probably accounted for the condition of the other fills. Timber 231, which could not be retrieved, did not appear to be worked. No dating evidence was retrieved, but the feature can be assigned by stratigraphy to the late post-medieval or modern periods. At its eastern end, feature 237 was also cut by a small linear feature, 244, which appeared to be a field drain, and which was in turn cut by field drain 226.

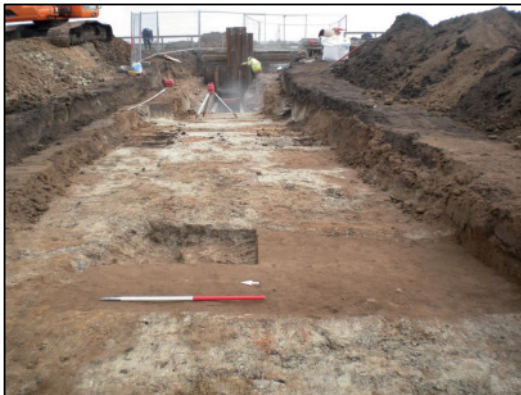
Plate 3: Feature 105 in the Zone 1 pipeline strip, looking east.

A single archaeological feature was exposed during the initial topsoil strip, 22.6m to the east of the road crossing. Feature 105 was probably an elongated pit, but was not fully exposed in plan: it was roughly rectangular, 2m wide but only 0.30m deep (fig. 6). This feature may have been the base of a retting pit, but its silty sand fill 106 had a notably clean appearance and contained no traces of organic material. No finds were retrieved from it.

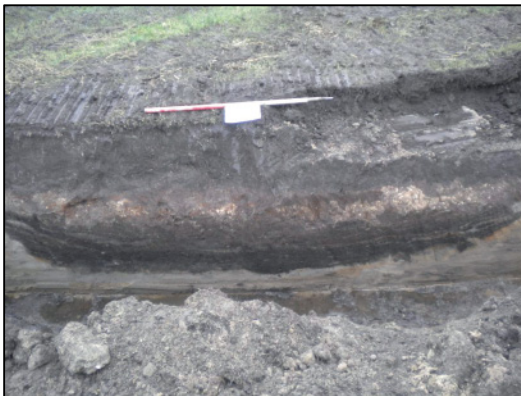
Plate 6: Linear feature 216 in the Zone 2 drain cut, looking north: peat deposit 219 can be seen at the base of the feature.

The most remarkable results of the analysis concern the abundant remains of hemp (*Cannabis sativa*) and flax (*Linum usitatissimum*), which were found in Sample 5, from the bottom layer of ditch 216. The samples contained uncharred stems, capsules (mostly in fragments) and seeds of flax, and stems and seeds of hemp. All the remains were highly decomposed apart from the hemp seeds, which were better preserved than those of flax, possibly due to the harder nature of the seed. Flax seeds were very pale in colour and smaller than mature seeds, suggesting that young plants were being harvested; a common practice when the crop is used for fibres rather than for oil. A very large number of small and microscopic fragments of flax and hemp stems were also recorded.

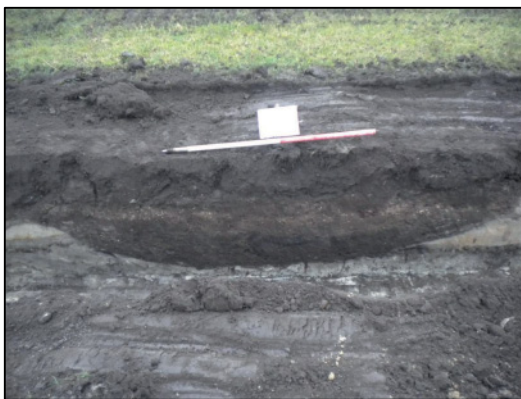
Plate 7: Linear feature 220 in the Zone 2 drain cut, looking north.

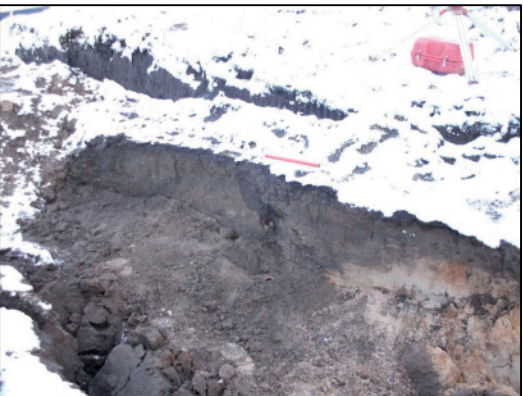
Plate 10: The west end of feature 302 in the Trench 3 cut, looking south-east.

Two linear features were seen in the sections of the pipe-trench. Ditch 302, which crossed the trench at an oblique angle at the point where the trench cut through the end of a track, continued the line of an active drain to the south-east, indicating that it was a relatively modern feature (plate 10). Its fill, 303, was very mixed with lenses of what appeared to be redeposited natural sand, suggesting that back-filling had occurred relatively recently, but it was cut by ceramic field drains, suggesting a date range from the late 19th to the mid-20th century.

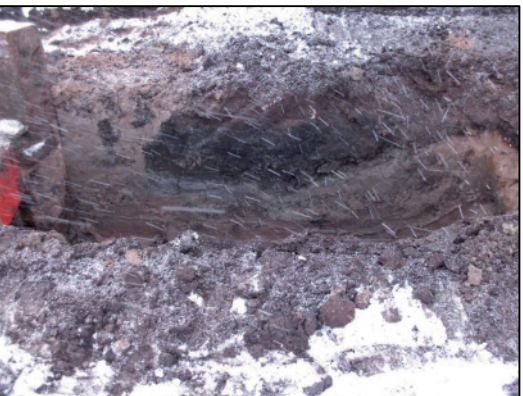
Plate 11: Feature 305 in the section of the Trench 3 cut, looking south-west.

Ditch 305 was approximately 5m wide and 0.8m deep in section, but its apparent width may have been distorted by an oblique angle: it appeared to run north-east to south-west, perpendicular to the pipe-trench, but this was not entirely certain (plate 11). It contained two fills: fragments of natural wood were observed in the lower fill, 306, and so an environmental sample was taken, but there were no results of archaeobotanical significance (appendix 5). A sherd of late 17th to 18th century pottery and a leg bone from a domestic animal of the horse family were also retrieved from this fill (appendices 3 and 4).
