Appendix 1: Photographs

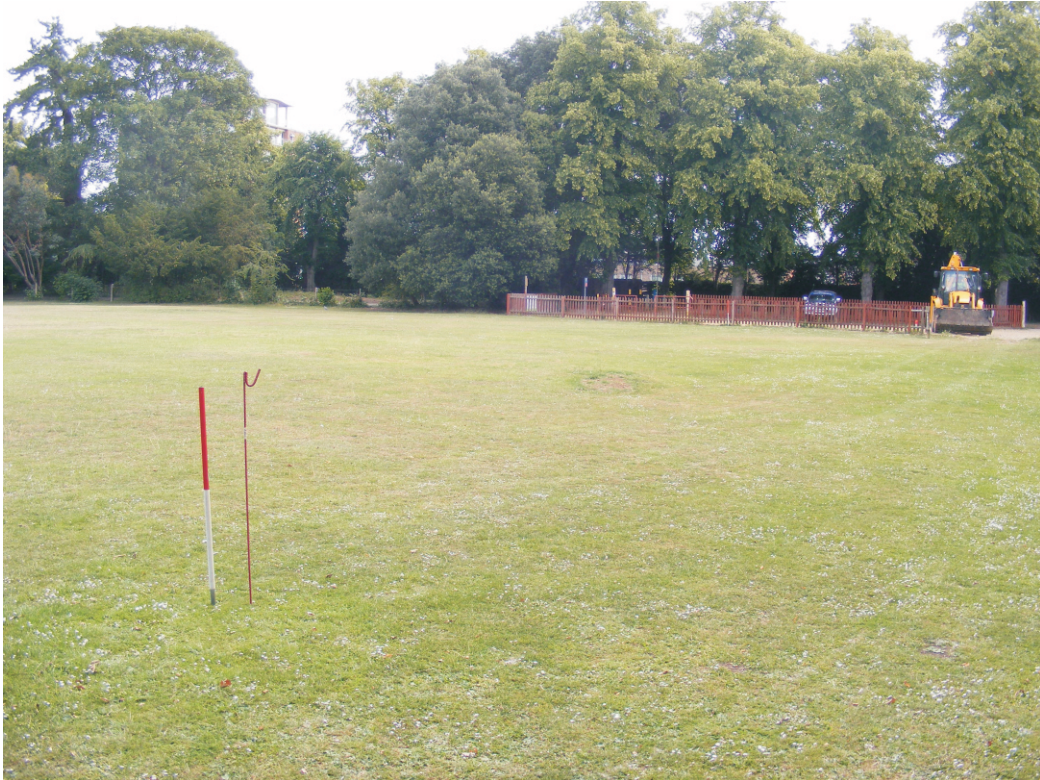
Photo No.1 Location of the proposed new sports hall, at the southern end of the existing playing field. The location of the evaluation trench is marked out with the ranging poles.

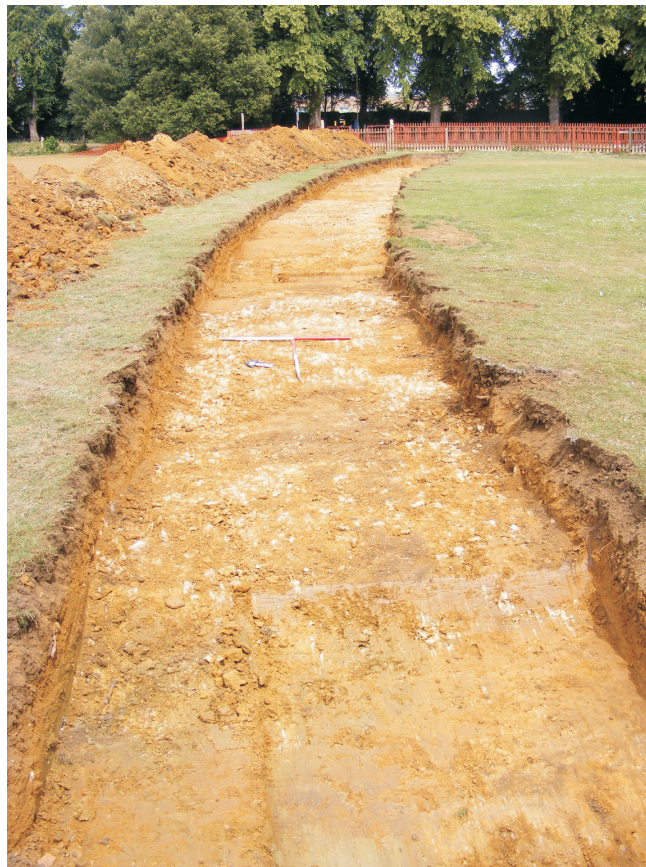
Photo No.2 The evaluation trench excavated. The natural substrate was a mix of limestone brash and silty lenses. Scales: 1m. Looking northeast.

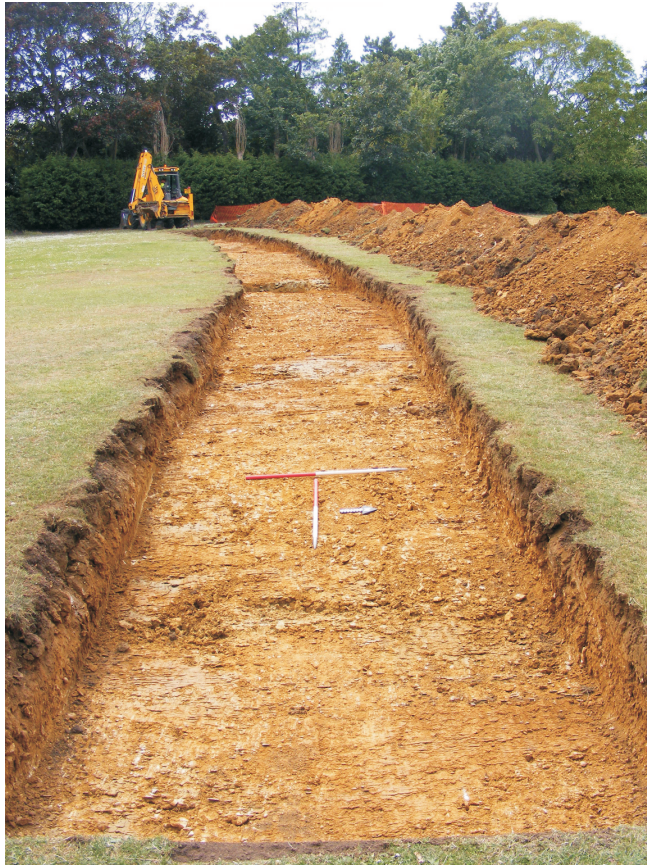
Photo No.3 The evaluation trench excavated. Scales: 1m. Looking west.

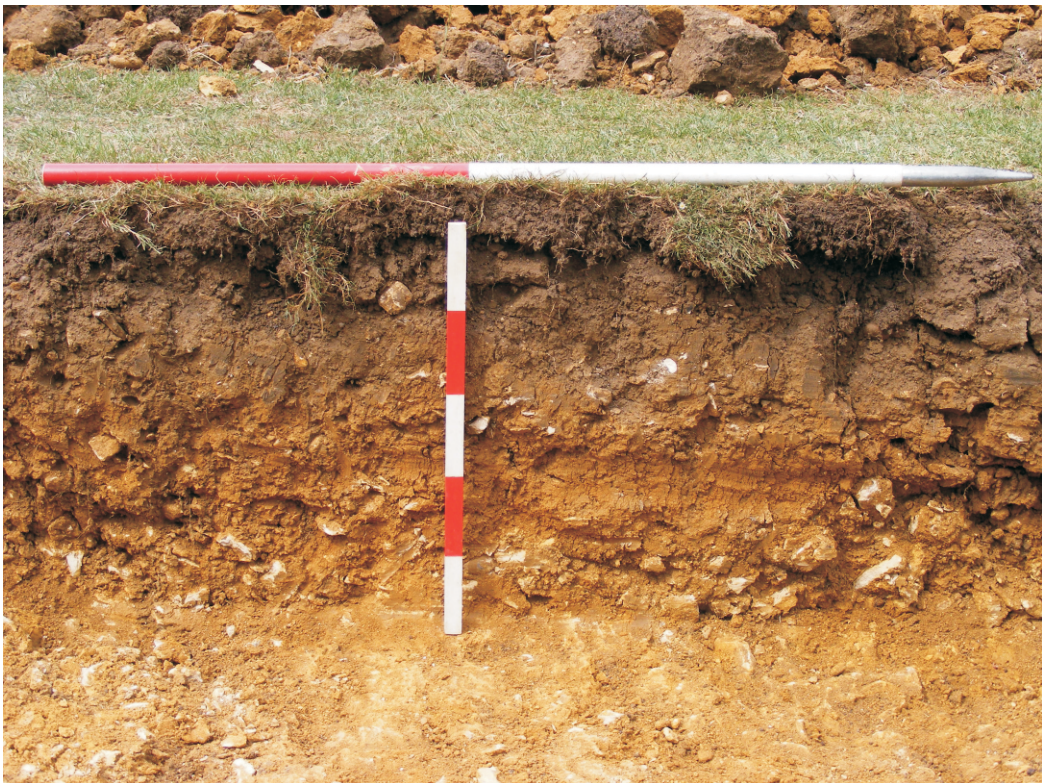
Photo No.4 Sample section through topsoil (101) and sub-soil (102) overlying the natural substrate (103). Scales: 0.5m and 1m. Looking north.
