**LAND TO THE REAR OF 14-18 WILLINGTON ROAD,  
OFF CHURCH MEADOWS, KIRTON, LINCOLNSHIRE**

**SCHEME OF ARCHAEOLOGICAL MONITORING  
AND RECORDING**

NGR: TF 30416 38505  
Planning ref.: B/11/0080/FULL  
PCAS Job No.: 787  
Site code: WRKM 11  
Archive acc. code: 2011.121

October 2011

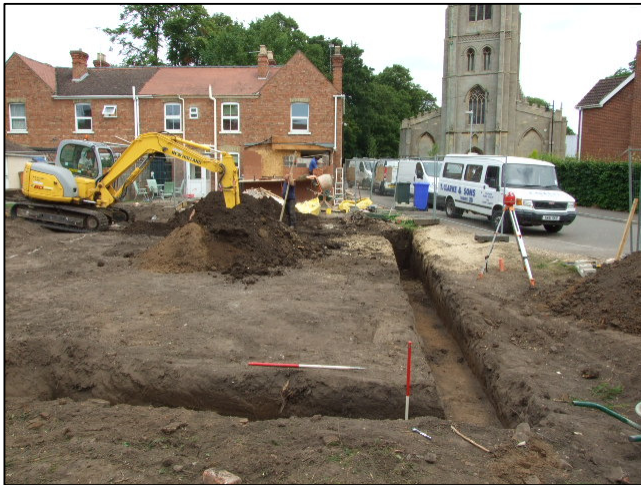
**Plate 1:** General shot of the site during the groundworks, looking north-east from its south-eastern corner.

A vegetation strip, using a 360° excavator with a flat-bladed bucket, was carried out as the first part of the groundworks; initial works also included the felling of a tree in the south-east corner of the site and the demolition of a brick outhouse in the north-east corner. The same machine was then used to excavate the footings trenches for the new building, which were 0.60m wide and a maximum of 1.50m deep (plate 1).

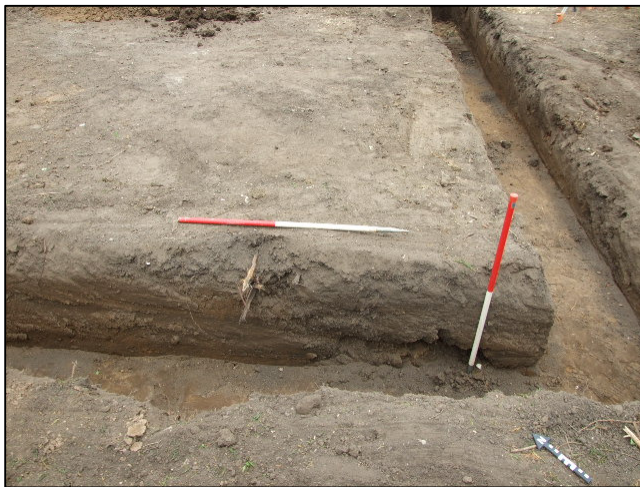
**Plate 2:** The completed trench at the south-eastern corner of the building plot, looking north-east, showing sample section 1.

Natural sand 003 was exposed at the base of the footings trenches on the west side of the site. This was overlain by a subsoil layer 002 (plate 2).

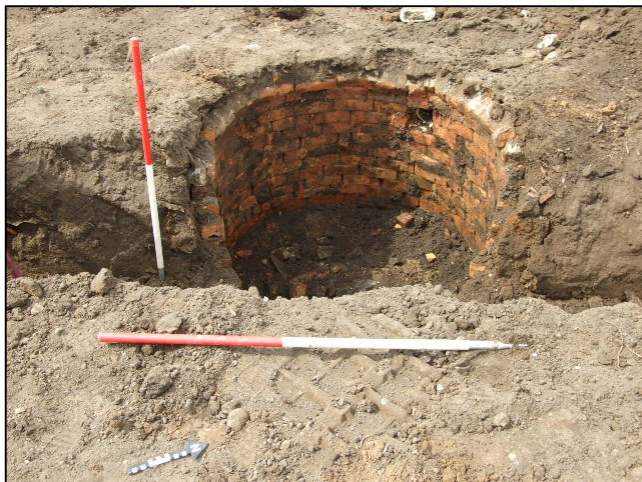
At the north-western edge of the area of groundworks, a circular brick-built structure [005] was encountered. This was 1.35m in diameter, and was filled with a mixture of soil and rubble which was excavated to a depth of 1.50m. The bricks were dry-laid in a single thickness, chiefly in stretcher bond with occasional single headers. A slight curve at the upper edge of the structure suggested that it had originally incorporated a domed cap. The structure was recorded as a well, but a ceramic pipe entering from the north side suggested that it may in fact have been a drainage tank or rainwater cistern, or that it had been adapted for use as one.

**Plate 3:** Brick structure 005, cut by the north-western footings trench and partially excavated, looking north-west.
