**'CHESTERTON', SCOTHERN LANE,  
DUNHOLME, LINCOLNSHIRE**

**SCHEME OF ARCHAEOLOGICAL MONITORING  
AND RECORDING**

NGR: TF 0237 7915  
Planning ref.: 126681  
PCAS Job No.: 758  
Site code: SLDM 11  
Archive acc. code: 2011.48

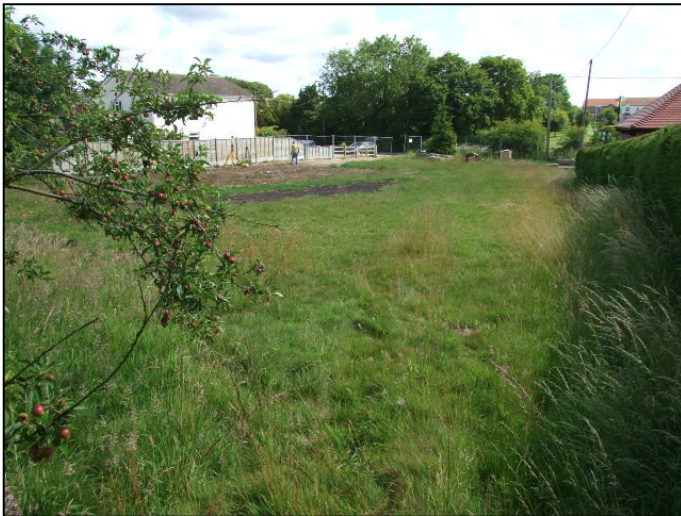
**Plate 1:** General shot of the site before the commencement of groundworks, looking east-north-east from its south-western corner. The position of the former bungalow is visible as an area of disturbed ground on the north side of the site.

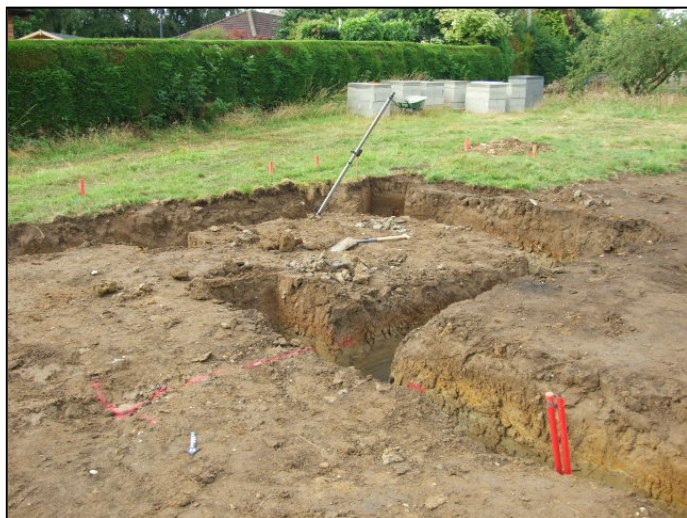
The lowest deposit encountered in the footings trenches was natural clay 103. Over much of the house footprint, the natural clay was overlain by sandy clay subsoil 102; in some areas, this was sealed by topsoil 101, although this layer had been largely truncated or removed by the previous vegetation strip (plate 6). A small amount of pottery and a fragment of CBM were retrieved from the topsoil while vegetation stripping was taking place: the pottery was later identified as post-medieval to modern domestic crockery, and the finds assemblage was discarded without processing.

**Plate 6:** The footings trenches during excavation, looking south from the centre of the house plot.

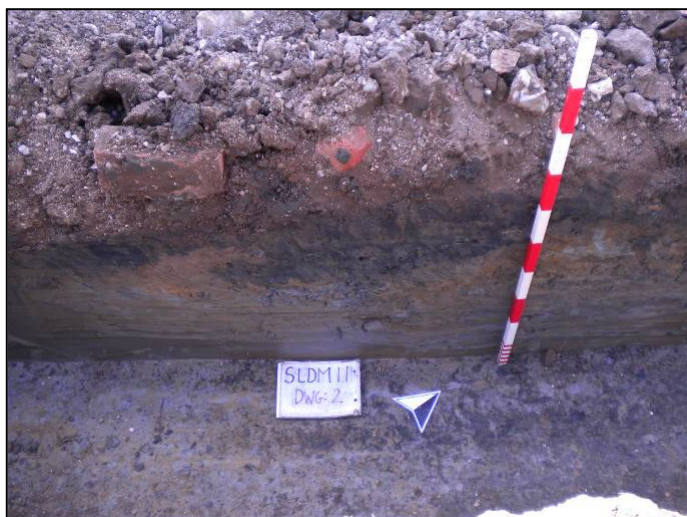
Towards the northern side of the house footprint, topsoil was absent and subsoil 102 was overlain by 104, a demolition deposit from the previous bungalow. A disturbed, contaminated contact horizon between the two layers was separately recorded as deposit 105 (plate 7).

**Plate 7:** Sample section at the north-eastern corner of the house plot, showing the demolition layers 104 and 105.

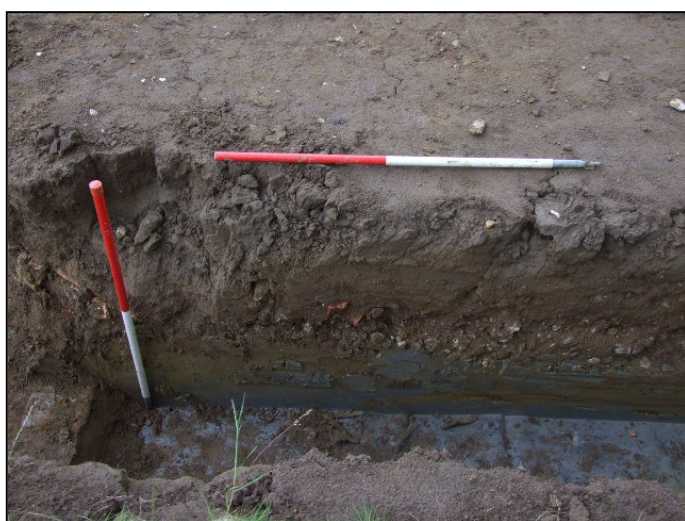
At the south side of the house footprint, a stony clay layer with greenish clay lenses, 106, was seen between the natural clay and the subsoil (plate 8). No dating evidence was retrieved. This deposit was tentatively associated on site with the construction of 'Warren Lodge', the neighbouring house to the south, but this interpretation seems unlikely, as 'Warren Lodge' is a very recent development, post-dating the former bungalow at 'Chesterton', which appears on the 1966-71 1:2500 Ordnance Survey map while 'Warren Lodge' does not (old-maps.co.uk). Earlier OS mapping shows no development in this area, and it seems more likely, considering that several previous evaluations in the neighbourhood have demonstrated that it was wet and unreliable terrain, that deposit 106 represents an area of ground consolidation at an earlier date, possibly a cartload of earth and stones with odd brick fragments, spoil from work elsewhere, tipped into a wet patch in a field.

No finds or features of archaeological significance were encountered during the monitoring and recording programme, suggesting that this plot of land was not occupied prior to the 20<sup>th</sup> century. Deposit 106, which may have represented an improvement to wet ground, suggested that the land may have been put to some kind of use, probably agricultural, in the past, but as no artefactual material was retrieved from the deposit, no further conclusions could be drawn. These findings are in concordance with those of evaluations carried out to the south and south-west of the site, as well as with the results of the most westerly evaluation trench on the Scothern Lane/A46 development site, which indicated that this area had until recently been marginal land, waterlogged and prone to flooding, unsuitable for habitation or arable cultivation and usable at best for seasonal pasture.

**Plate 8:** Sample section at the south side of the house plot, showing possible ground consolidation deposit 106.
