**SIDE EXTENSION, ARDWICK VILLA, 3 CHURCH LANE, BOTTESFORD
NORTH LINCOLNSHIRE**

**ARCHAEOLOGICAL OBSERVATION, ASSESSMENT AND RECORDING
REPORT**

NGR: SE 8983 0702
Planning Ref: PA/2010/0668
NLM Site Code:BOAN
PCAS Site Code: BVAC 10
PCAS Job Ref.: 703

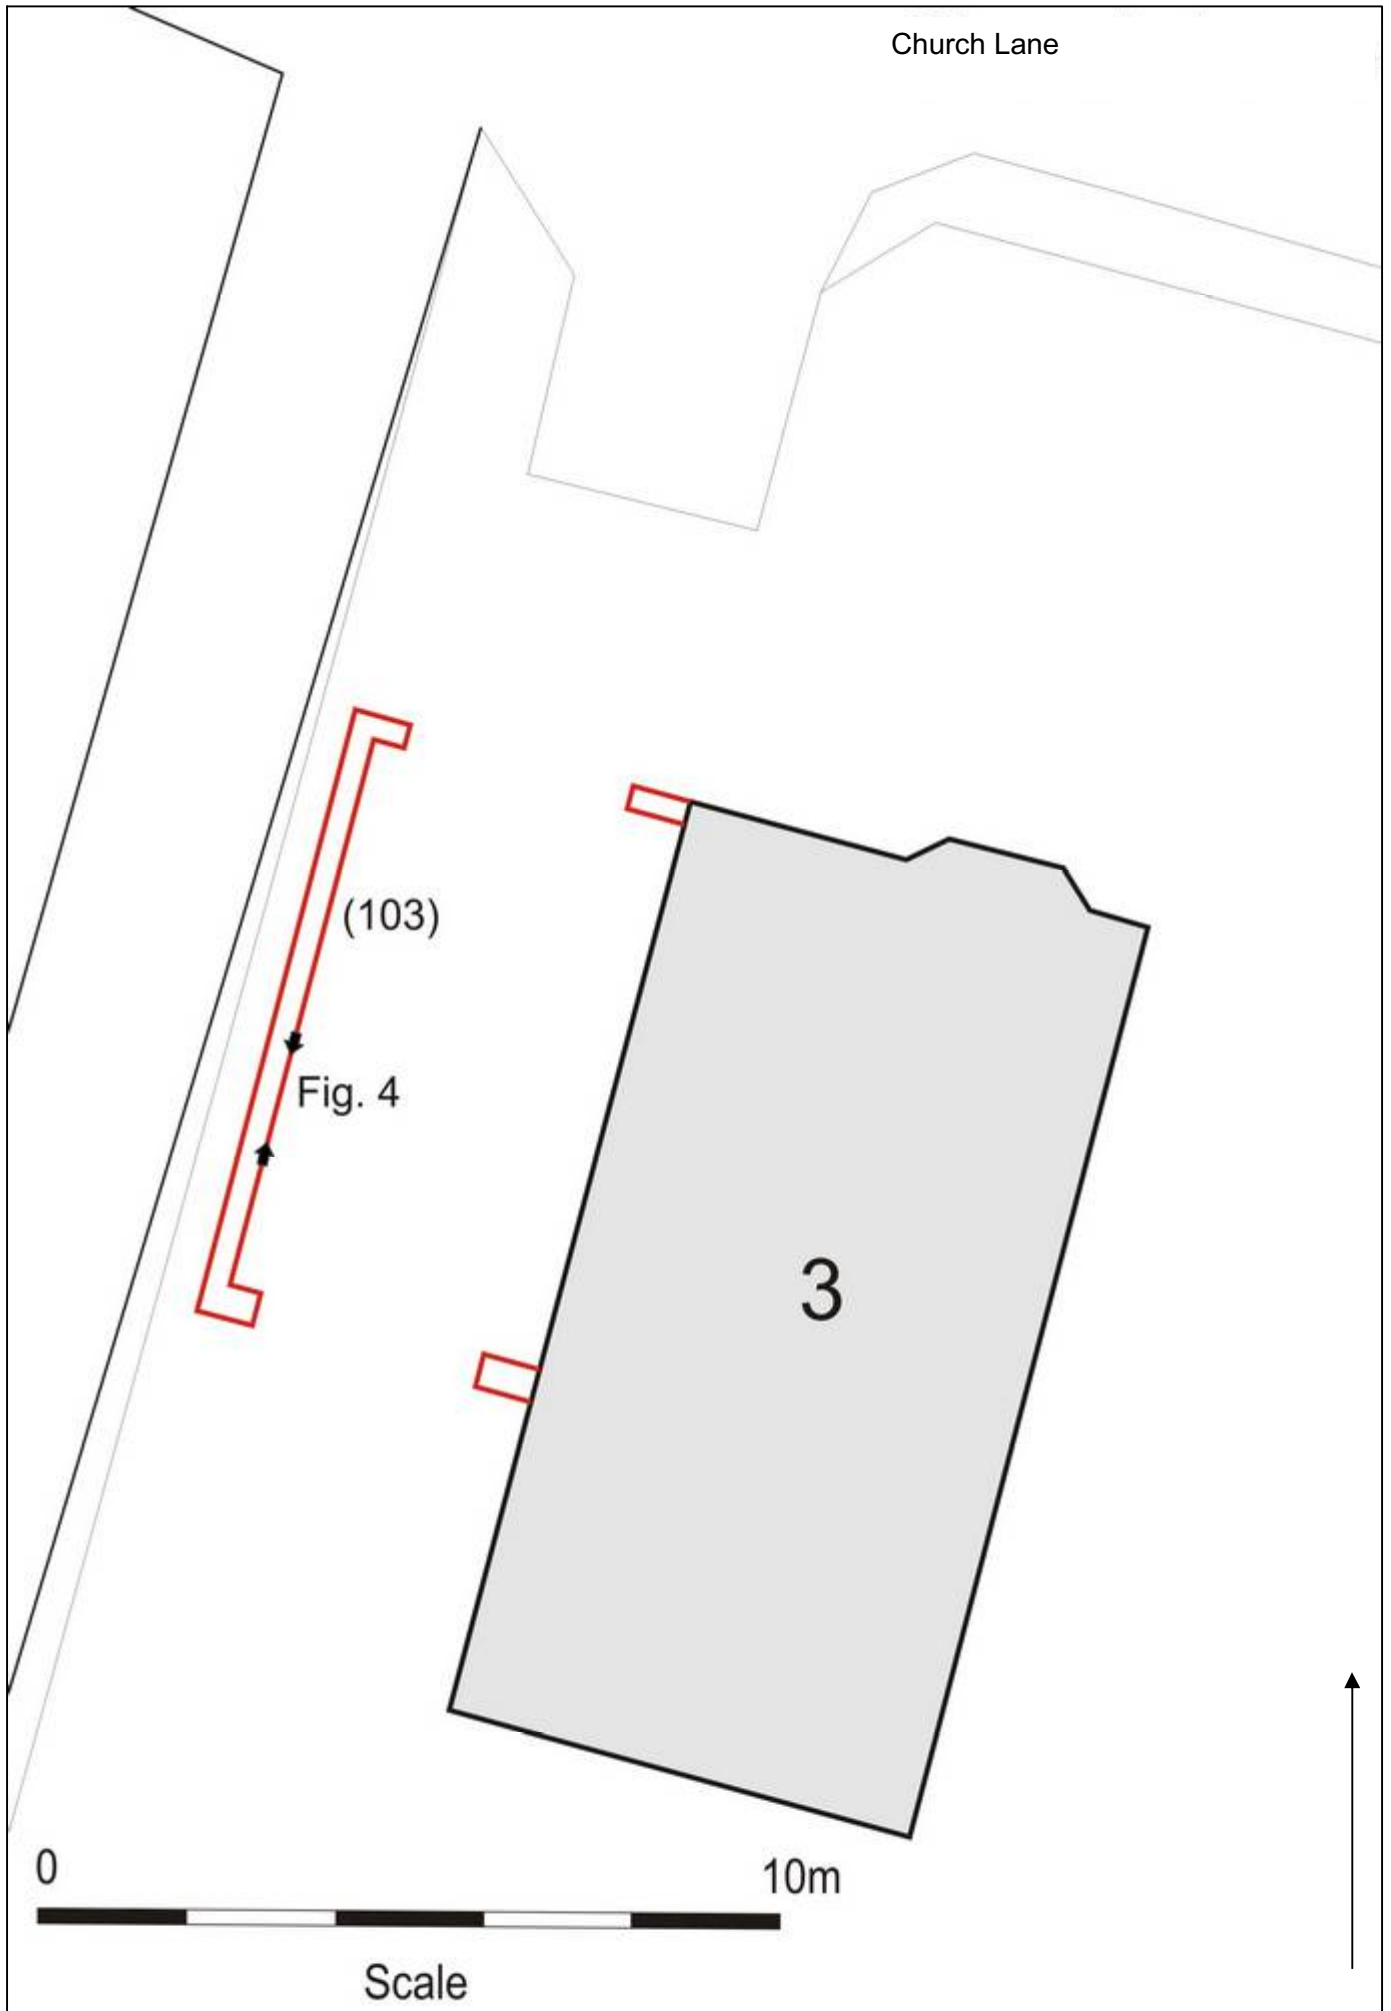
Fig. 3 Location of the monitored trenches of the extension to Ardwick Villa.

The two stub foundation trenches excavated beside the existing house encountered deposits which had been previously disturbed by the house foundation trench and an adjacent lead water service pipe trench (Pl. 3).

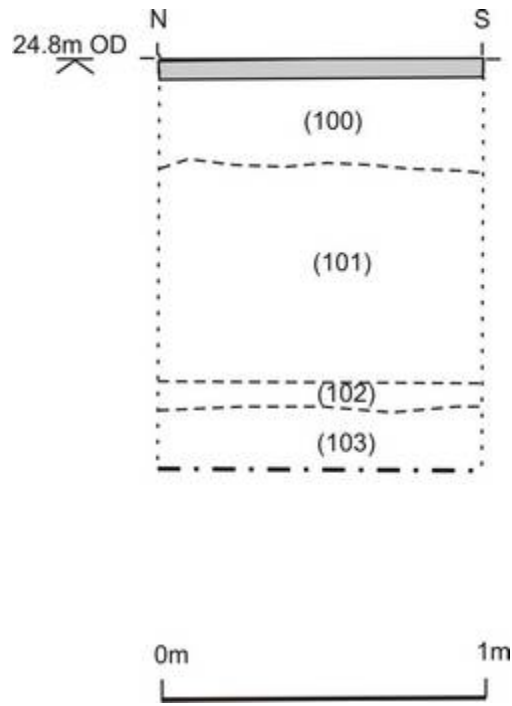
The 1.28m deep and 0.6m wide western foundation trench for the new extension was excavated alongside a public footpath. It cut through a concrete driveway (104) and adjacent low walls retaining a garden border. Beneath the concrete was a 0.24m thick layer of dark brown soil (100) which appeared to be topsoil. No artefacts were found in the layer.

The topsoil covered a yellow clay (101) which became denser and paler in colour with depth (Pl. 2). This 0.68m thick layer has been interpreted as weathered natural clay and mudstone. It covered a 0.09m thick band of grey clay (102) and an underlying layer of orange/brown clay (103).

Fig. 4 Representative section showing deposits in the east face of the foundation trench for the new extension.

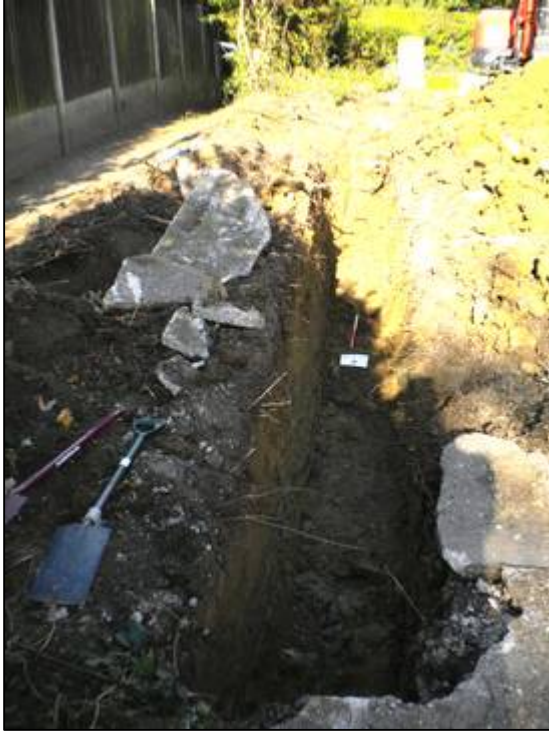
Pl. 1 Western foundation trench of the new extension (looking north).

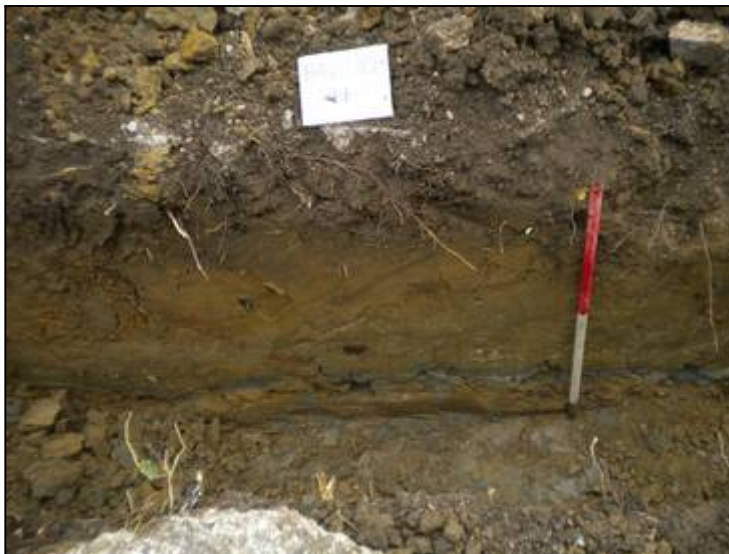
Pl. 2 Deposits visible in the face of the western foundation trench (looking east, scale 1m).

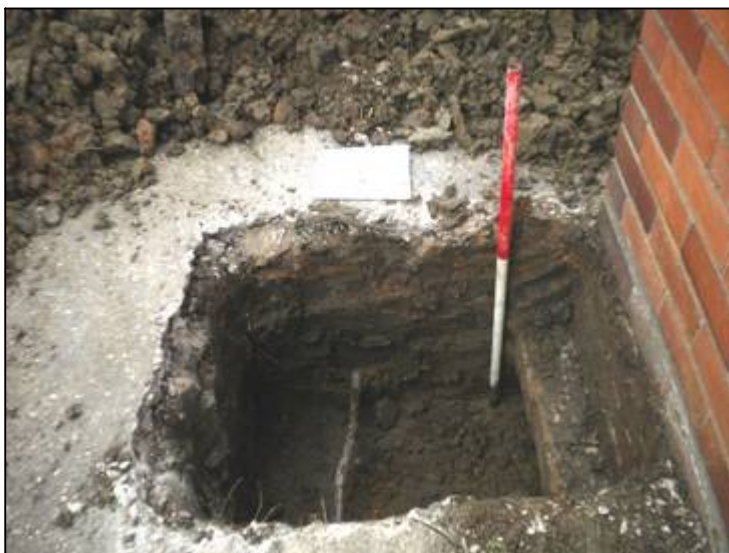
Pl. 3 Ground beside the existing house had been disturbed by the original foundation trench and by an adjacent water pipe trench (looking north at the north-west corner of the house, scale 1m).
