**LAND ADJACENT TO NURSERY GROVE, LINCOLN**

**SCHEME OF ARCHAEOLOGICAL MONITORING  
AND RECORDING**

NGR: SK 9840 7270  
Planning ref.: 2010/0884/F  
PCAS Job No.: 828  
Site code: NGLM 11  
Archive acc. code: 2011.432

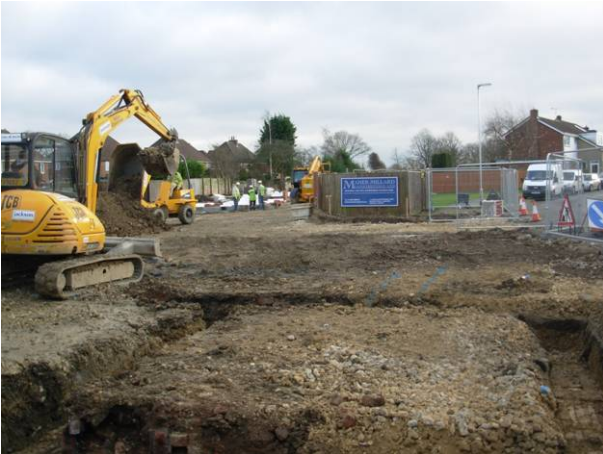
**Plate 3** General site shot showing the excavation of footings in Plot 1

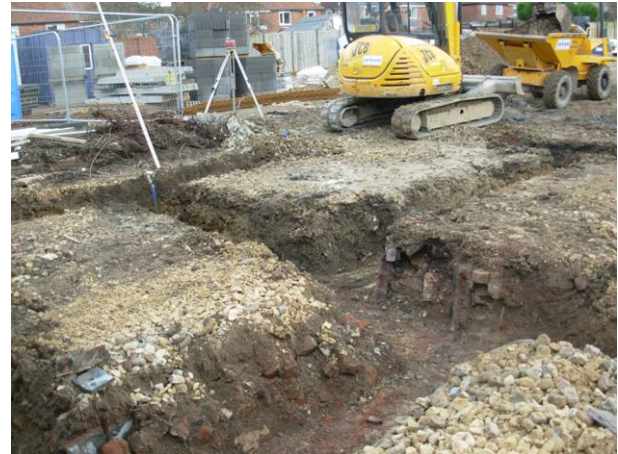
**Plate 4** Footings for Plot 1 showing possible flue of heating duct [103]/[105] in section (shot faces SE)

In order to observe various different stages of the groundworks, the site was visited by a monitoring archaeologist on eight separate occasions between the 21<sup>st</sup> of November 2011 and the 6<sup>th</sup> of February 2012. As expected, observation of the digging of footings for Plots 4 and 5 only revealed what was presumably quarry backfill. This turned out also to be the case with plots 2 and 3, which it had been thought might have been less disturbed, the cut of the quarry being clearly visible at the western extent of plot 2. This left only the area around Plot 1 unaffected by previous quarrying activity. Here, within the footing trenches, a linear brick structure, likely to have been a heating flue [103]/[105/ or drainage culvert associated with the former nursery, was encountered. This was planned and recorded. It appeared to have two phases of construction, a new lining having been added at some stage of its use. The structure survived to six or seven courses of red brick, two courses thick. In its second phase it had been lined with an extra layer of bricks and highly fired grey tiles. No other archaeological features of note were observed.
