**FORMER SUGAR REFINERY,  
SCAWBY BROOK, BRIGG,  
NORTH LINCOLNSHIRE**

**STANDING BUILDING RECORDING  
SUMMARY**

**(LEVEL 2)**

Sitecode: BSRB 12  
NGR: SE 98860 06109 (Centre)  
Planning Application No.: PA/2009/0334  
(Appeal: APP/Y2003/A/10/2133721)  
PCAS Job. Ref.:12-856

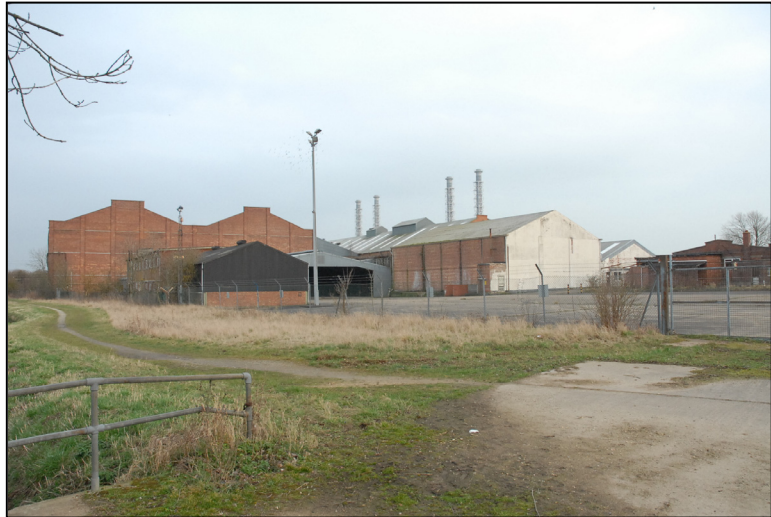
The former Brigg sugar factory buildings occupied the northern half of an approximately rectangular site, aligned east-west. The southern part of the site had obviously been cleared of factory buildings to ground level, but several locations retained the remains of tiled floors, while the bases of circular silos were present in two locations. In one location, the remains of a set of railway points were observed, set in concrete, probably deriving from the railway system used by the factory's own locomotive, which was probably connected to the national railway network. An extensive area in the southwest corner of the site had been raised approximately 2m above the surrounding level and was accessed up concrete ramps on the north side.

Buildings D, E, F, G, H, I, K and L formed a group, with Building C separate on the west side and Building J separate to the northeast. Buildings A and B were clearly of more recent construction and probably represent a reorganisation of the access to the factory in the 1980s. A triangular area of grass, surrounded by a kerb and trees, was

located to the west of Building C and represents the only part of the northern half of the site not covered by an asphalt or concrete apron.

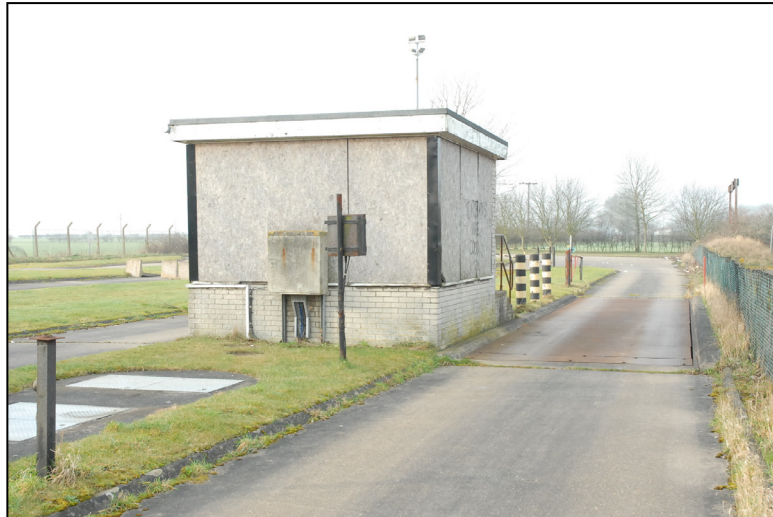
This appears to be one of the most recent buildings on the site and represents the weighbridge control room and office. This was a small single-storey building with a flat roof. It was constructed of a modern white brick in stretcher bond.

This was a small building, 6 x 4m in size, located on the north side of the access to the main site. The floor level appears to be raised some 0.6m above the surrounding ground level and the building was accessed up 4 steps on the north side. The weighbridge occupied the lane to the north of this building.

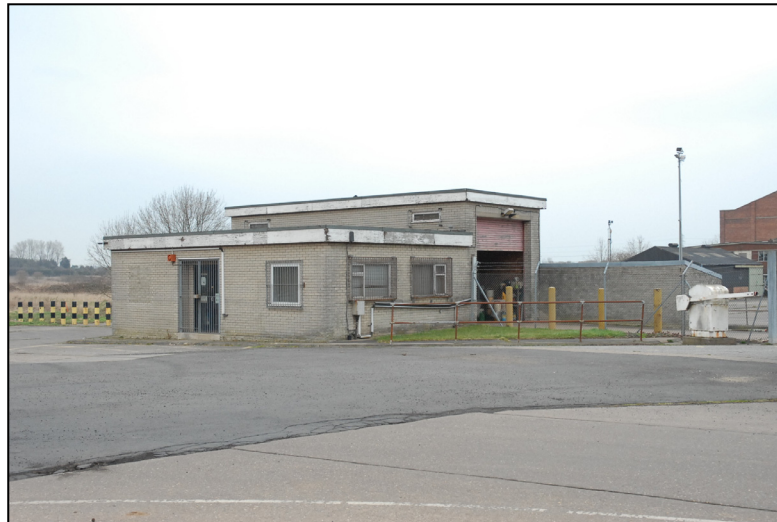
This was a single storey structure with a flat roof located to the north of the main gate into the site. It represented the site security and emergency station. The building was 'L'-shaped in plan and comprised a higher garage structure to the east, with a lower

office building on the west side. White painted timber barge-boards were present at the eaves on all sides. The building was accessed through a pair of glazed timber doors in the centre of the west elevation, and through a part-glazed door at the rear of the garage structure.

A series of modern timber casements occupied the north elevation, while larger square windows were present on the south side. The garage structure had a large roller shutter door on the south side. A boundary wall extended to the north and east from this building, enclosing a yard at the rear which was occupied by a partly outshut bicycle shed.

Building B was constructed in a modern white brick (brick sizes: 8 ½" x 4" x 2 ½", 3 courses = 9") in stretcher bond.

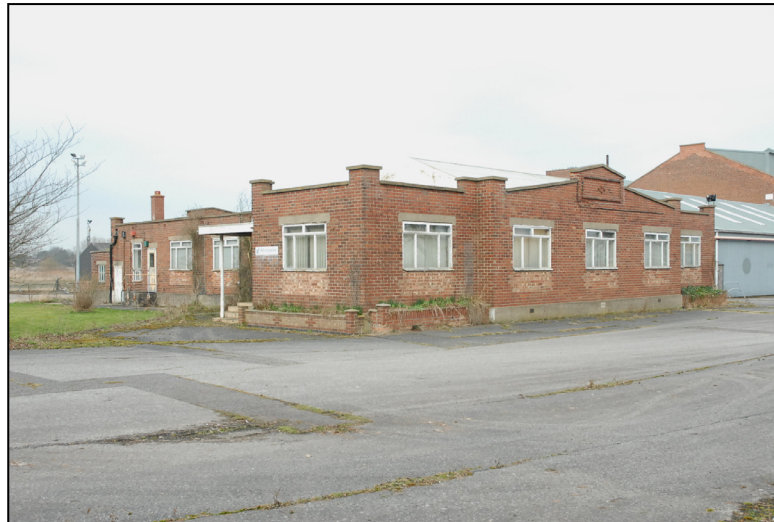
This was a free-standing single-storey structure with a flat roof occupying the southwestern part of the site, adjacent to Building G. It was 28m x 21m in size, on a north-south alignment.

The area to the west of Building C was an approximately

triangular grassed open space, surrounded by a kerb, and with a row of trees on its north and southwest sides. Modern block paving led from the south side to the entrance, with the word 'BRIGG' in darker bricks within the pattern.

Building C was constructed of brick (brick sizes: 8¾" x 4¼" x 3", 3 courses = 10") in stretcher bond. External walls were 9" in thickness and were constructed on a 30" high concrete plinth, some 4" wide. The southern part of the building was more formal, with a brick parapet with a stone coping and raised piers at its corners; at the south side, a brick pediment with a decorative brick panel was present. All windows were metal-framed casements in openings with concrete lintels; those on the east side had bullnosed brick sills. The rear, northern part of the building was considerably plainer.

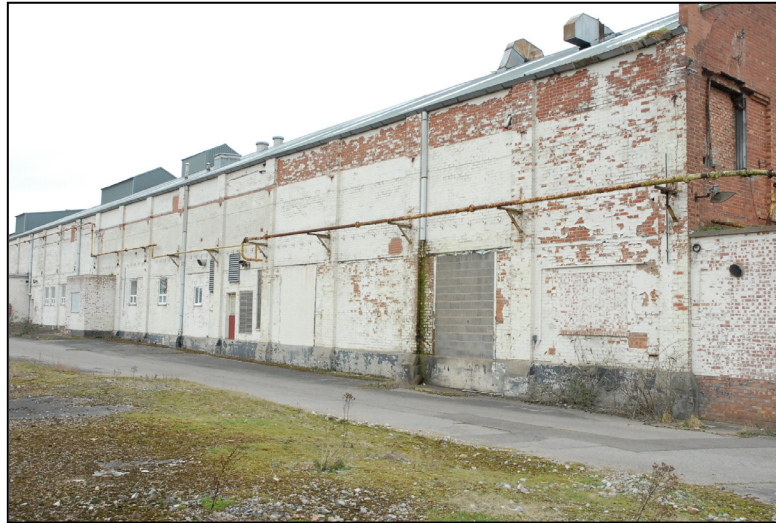
This was a large two-storey structure with a pitched roof of modern corrugated metal panels, occupying the entire southern frontage of the building group. This building represents the only remaining manufacturing building on the site. It measured 88m x 26m and was aligned east-west.

Building D was constructed of a dark red brick (brick sizes: 9-9¼" x 4¼" x 3", 3 courses = 10½") in stretcher bond on a heavy concrete plinth. External walls were 9" in thickness with a series of 28" wide brick piers separating the south side into nineteen bays. Three clerestory rooflights were present in the eastern half of the roof; these had been entirely clad when the modern roof covering was constructed.

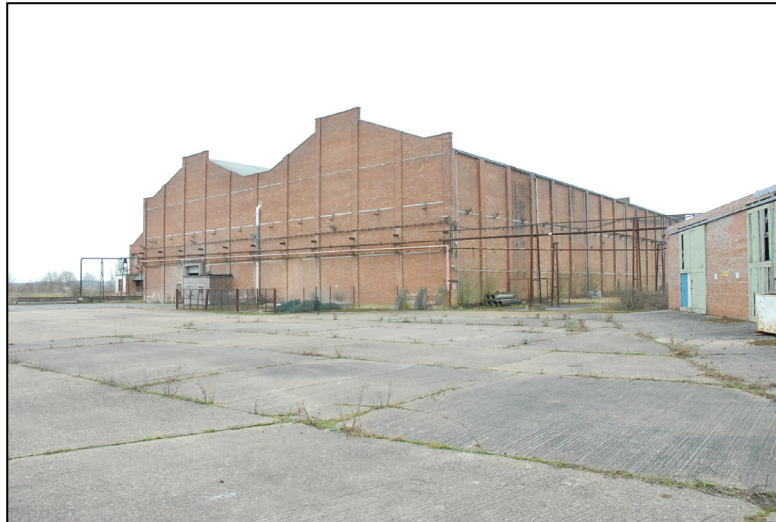
This was a large two-bay structure; each bay having a pitched roof of modern corrugated metal panels. Building E was the largest building remaining on the site and occupied the north-eastern part of the building group, to the north of Building L. It was 73m x 49m in size, aligned east-west.

There are several similarities between this building and Building D in the style of their external appearance. This building was of two east-west bays, and its double gables dominate any view of the site. It is built of brick (brick sizes: 9" x 4¼" x 3", 3 courses = 10½") in stretcher bond.

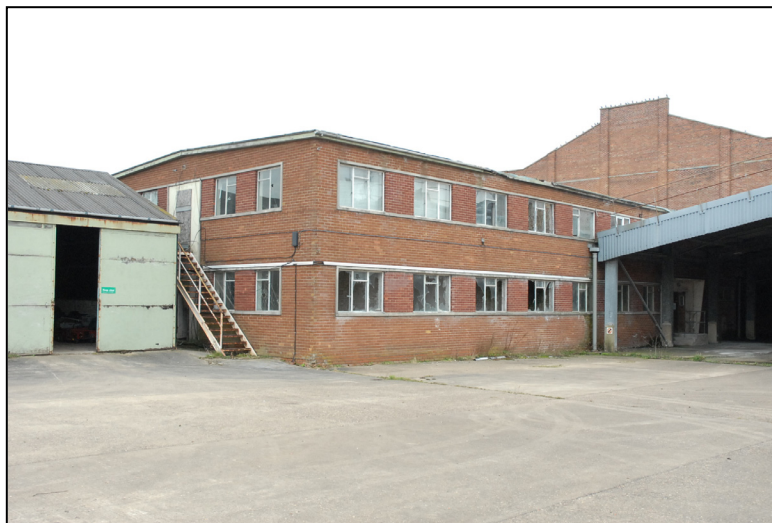
This was a two-storey office structure with a flat roof. It occupied a position near the north boundary of the site 20m to the west of the west side of Building C. Building I was constructed using the eastern half of Building F as part of its north side. It was 30m x 14m in size, aligned E-W)

Building F was constructed of brick (brick sizes: 8 ½" x 4¼" x 2¾", 3 courses = 9") in stretcher bond. External walls were of cavity construction, 10" in thickness.

The north and south elevations were similar in design, the regular windows contained in a common concrete surround, separated by brick infill panels. The walls were topped by a low brick parapet with a concrete coping. The main entrance to the building was through a pair of part-glazed doors on the east side of the north elevation. These had a canted porch structure, painted white. To the east of the main entrance the windows were smaller and the brick panel continued around to the east elevation.

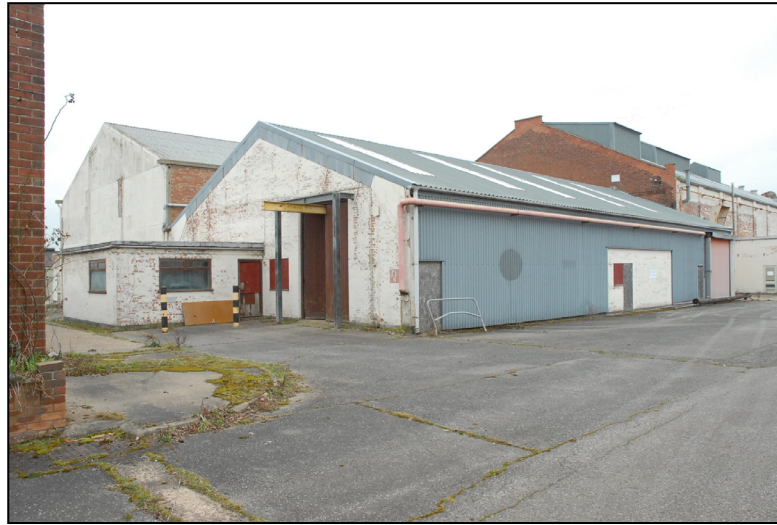
This was a single-storey concrete portal frame structure (27m x 15m, aligned E-W) adjoining the west side of Building D. It had a pitched roof with a covering of modern corrugated metal panels which also clad the south elevation.

Its eastern gable was of white-painted brick

(brick sizes: 8¼"-8½" x 4" x 2½", 3 courses = 9") in stretcher bond. A small single-storey flat-roofed extension was present at the northwest side which had a part-glazed (but boarded) door and a three-light timber casement window in its south side and a similar window on the west. The west gable of Building G was dominated by a loading door with a pair of timber plank doors and a crane support structure of heavy steel I-beams.

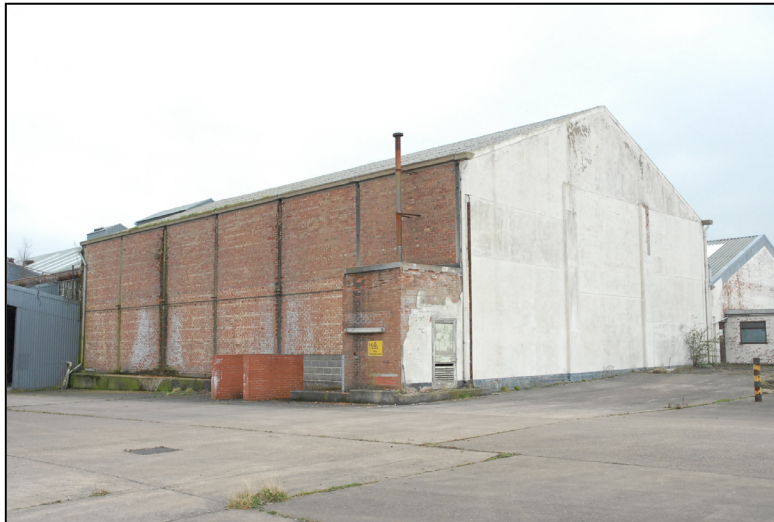
This was a single-storey portal frame structure of six bays, adjoining the west side of Building D and the north side of Building G. It had a pitched roof with a covering of modern corrugated panels. Its north and west walls were of brick (brick sizes: 8½" x 4¼" x 2¾", 3 courses = 9½")

in a 5-course English Garden wall bond (with five courses of stretchers to every course of headers) and were blind. Bays were separated by brick pilasters 28" in width, which projected 4". The building was constructed on a wide concrete plinth, which was increasingly exposed as the ground dropped away to the east. A small flat-roofed extension was present on the west side of the north wall, containing the heating boiler. The building was entirely blind, the east gable painted white, while the north side was of plain brick.

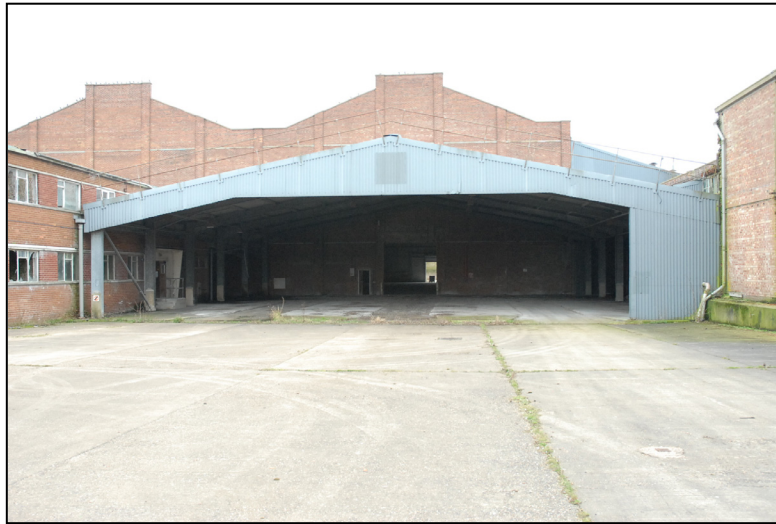
This was a single-storey portal frame structure with a covering of modern corrugated panels adjoining the west side of Building E and enclosing the space between Buildings D and F. The exterior (really only a small part of the north side and the west side, which was largely open) was clad with

the same corrugated metal panels as the roof. The building functioned as a large covered loading bay, open-fronted to the west, and having only a small door in the north wall.

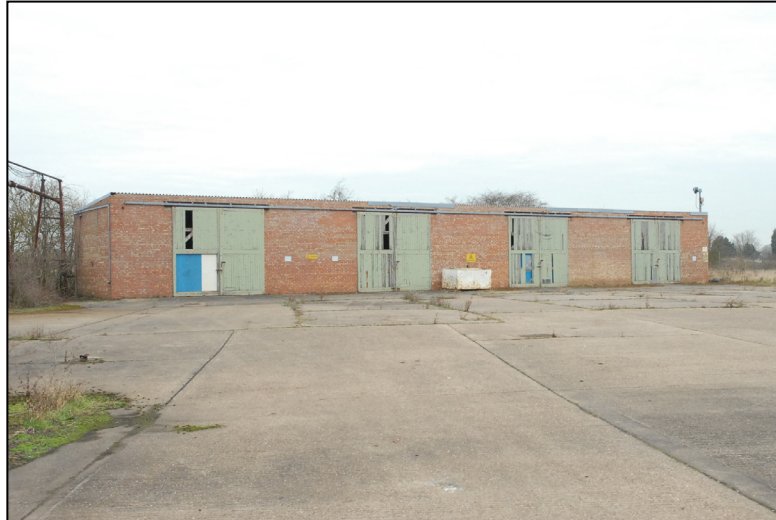
This was a free-standing single-storey brick structure with a shallow monopitched roof of corrugated metal sheets which occupied the northern boundary of the site to the northeast of Building E. It was constructed of an orange brick (brick sizes: 8¼" x 4" x 2½",

3 courses = 8¾") in a 5-course English Garden wall bond. The building was of four bays, each having a pair of ledged plank sliding doors. Its north, east and west sides were blind.

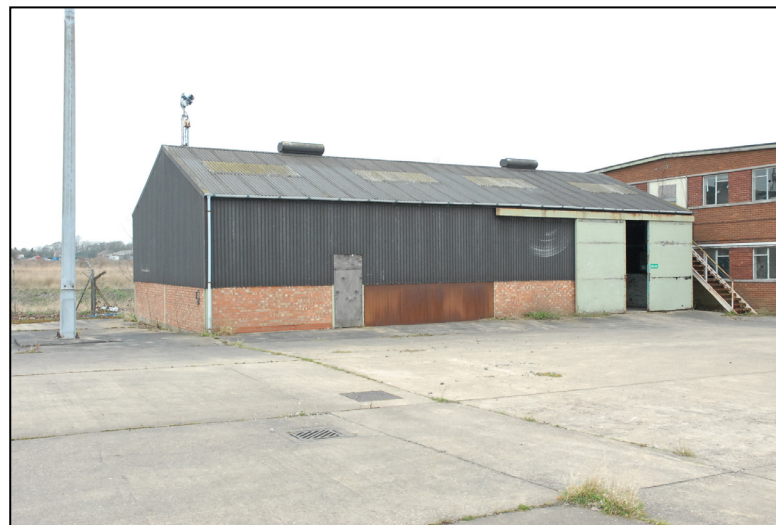
This was a free-standing single-storey portal frame structure of four bays which was located on the northern boundary close to the west side of Building F. It measured 18m (E-W) by 9.5m (N-S). It had a pitched roof with a covering of modern corrugated panels which extended around all sides above a height

of 1m. Below the cladding, a 4" brick dwarf wall was present (brick sizes: 8¼" x 4" x 2½", 3 courses = 9") in stretcher bond. A large door opening, the full height of the wall, was present at the east side of the south elevation with a pair of metal sliding doors; a further boarded door was present at the west side here. To the east of the small door, the lower part of the wall was replaced by untreated steel panels. The building had no other openings.

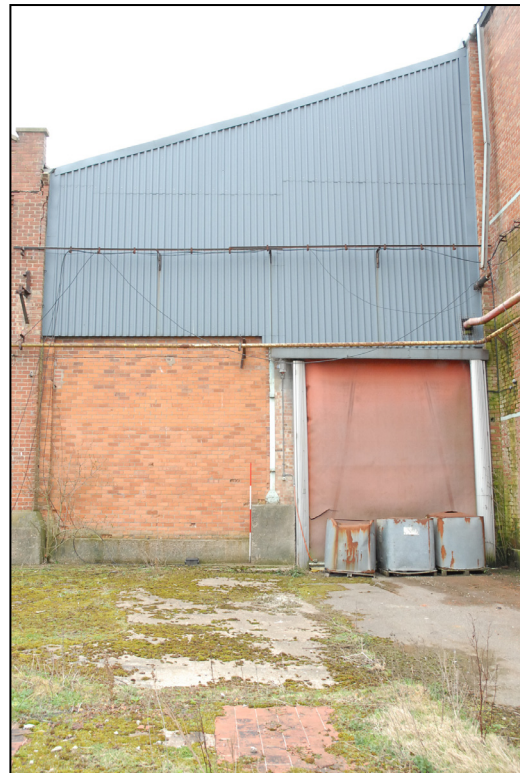
Like Building I, this was a portal frame structure built between Buildings D and E, employing their north and south walls to support a roof of metal framing clad with modern corrugated metal panels. The only exposed exterior wall was at the east side, where the upper part was corrugated panels, while the lower part was of brick (brick sizes: 8½-8¾" x 4¼" x 3", 3 courses = 10¼") in stretcher bond on a concrete plinth, with a large fabric environment control type loading door on the north side.

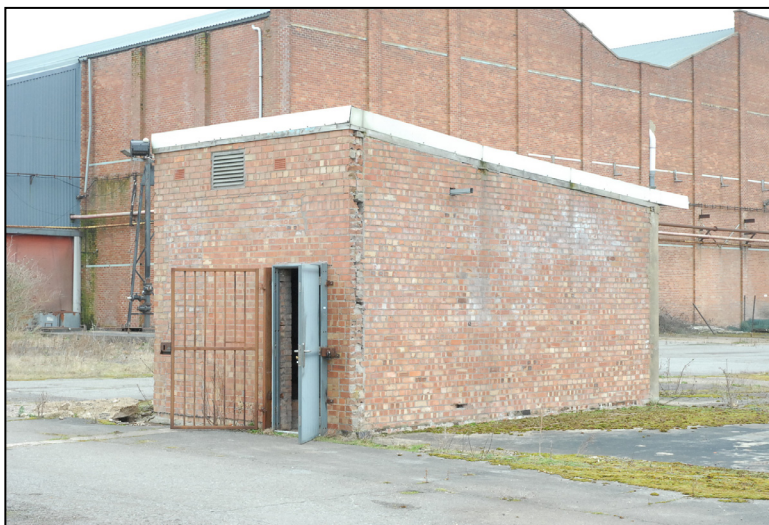
This was a small free-standing single-storey brick structure with a shallow monopitched roof of corrugated metal sheets which located a short distance to the southeast of Building E. It was constructed of an orange brick ((brick sizes: 8¼" x 4" x 2½", 3 courses = 8¾") in a 5-course

English Garden wall bond. The building was clearly converted from the remains of a much larger building, which had been demolished, but whose concrete base remained to the east.

This building housed a large electric pump which pumps waste water from the site to the River Humber.

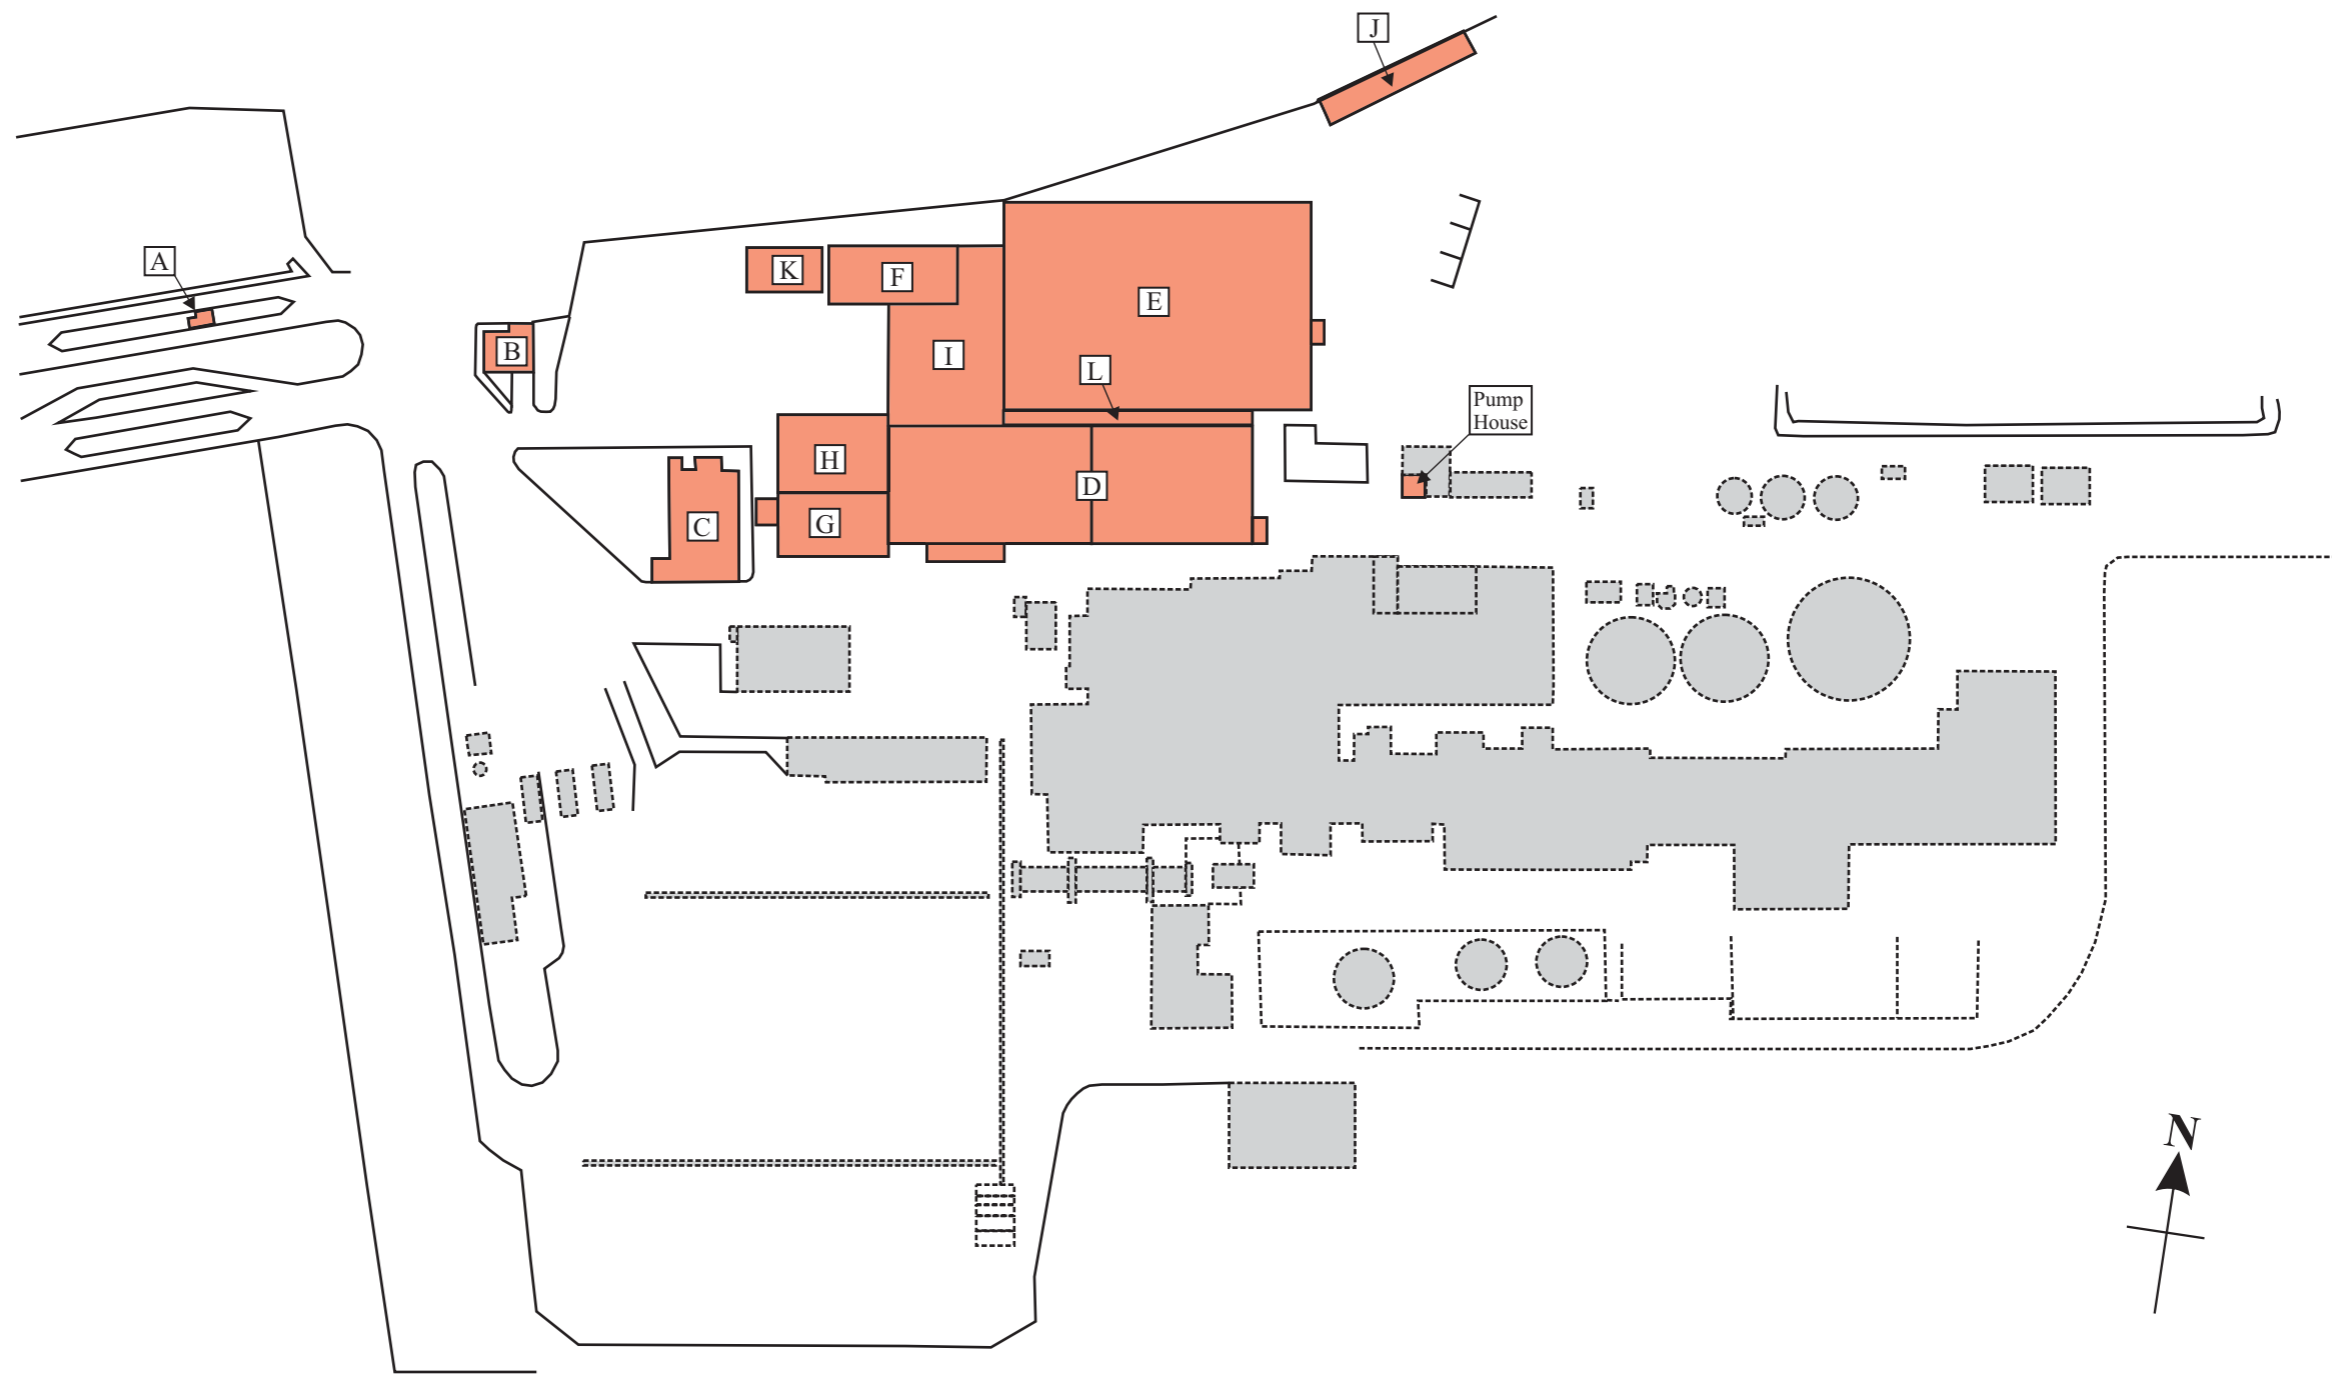
**Fig. 3:** Plan showing the layout of the Buildings (shown in red) and the letters allocated them in this survey. The buildings shown in grey have been demolished. Not to Scale.
