OUTBUILDINGS AT THE OLD RECTORY, WEST END, WINTERINGHAM, NORTH LINCOLNSHIRE

SCHEME OF ARCHAEOLOGICAL MONITORING AND RECORDING

NGR: SE 92426 22398
Planning ref.: PA/2009/0550
PCAS Job No.: 846
Site code: WORM 12
Archive acc. code: WGMDF

May 2012

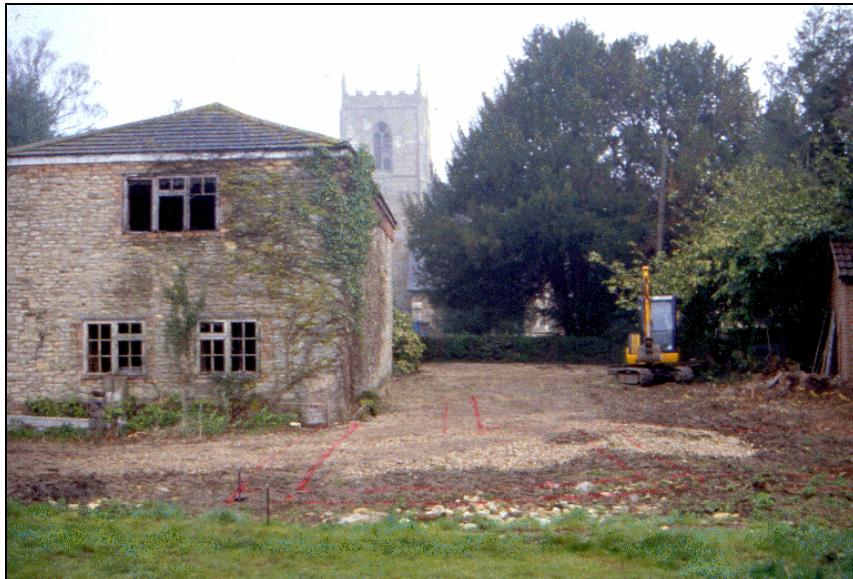
Plate 1 General view of site looking north.

Sealing wall [009] and the made ground was a later levelling layer (002) containing brick and stone rubble. This rubble included demolition material from the brick foundation outbuilding and collapsed stone from the stone wall which forms the eastern site boundary and has been replaced for part of the site boundary by a modern wire fence (Fig 2, Plate 1). Loose gravel chips had been spread on top of levelling layer (002) to form the current driveway.

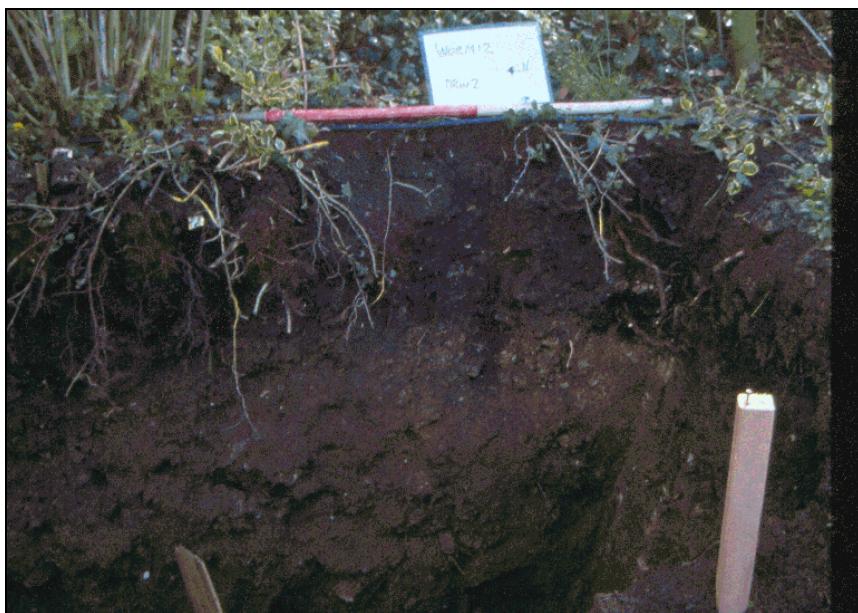
Plate 2 Representative section against eastern site margin

At the eastern site margin was located a surviving layer of topsoil (001) recorded in section against the neighbouring garden. There is a pronounced drop of approximately 0.4m between the two adjoining properties.

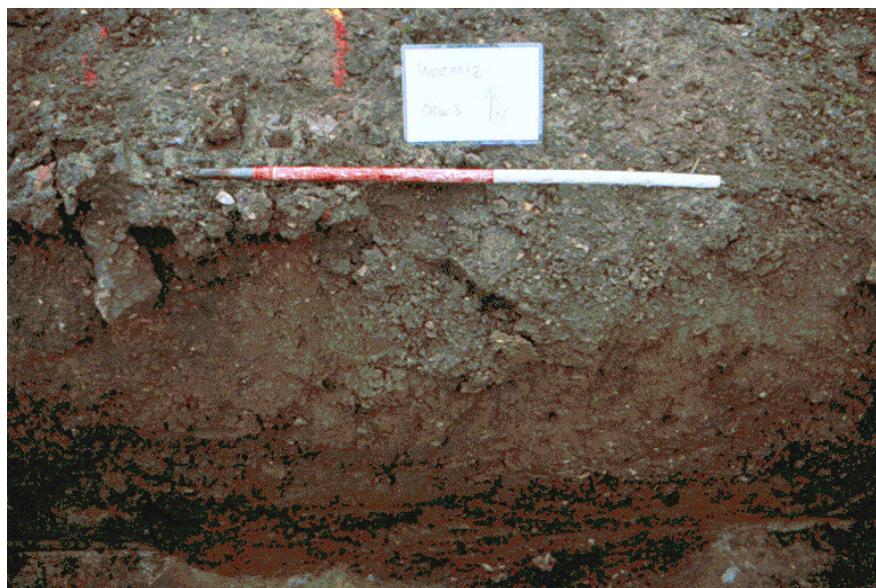
Plate 3 Pit [006] and ditch [008] looking north.

The earliest deposit exposed was clay with limestone pebbles (004), which probably represents glacial drift. A sub-rounded pit [006] was cut into this layer and backfilled with plastic clay containing fragments of oyster shell, charcoal, animal bone and a medieval pot sherd (Appendix 3 and 4). This pit was truncated by a linear ditch [008] aligned approximately north-south and extending north across the foundation trenches (Fig 2 and Plate 3). The ditch contained a similar clay fill to the pit, context (007); however no dateable artefacts were recovered.

A round pit was revealed in the southern end of the footing trenches. While this was fairly shallow and contained few artefacts, a single sherd of medieval pottery was recovered and can give a tentative 11th-13th century date. This probably represents a rubbish pit, with the shallow depth suggesting the feature had been truncated during ground levelling in the 19th century. The limited volume of the deposit, its sterile clay composition and the logistics of hand-excavating within a narrow foundation made the feature unsuitable for environmental sampling. This feature would have been open when the nearby church was in use and suggests at least limited occupation in the vicinity, which would not be unexpected as the medieval settlement is recorded as having been centred on the parish church.

A north-south aligned ditch extended from the southern end of the foundations, truncating the edge of the pit before being removed by the 19th century brickwork foundations. It is unclear whether this feature extends beyond the foundations north towards the church or south into the grassed area. The ditch contained a sterile clay fill and may represent a minor drainage feature, perhaps associated with the documented development of marshland around the settlement in the later middle ages.

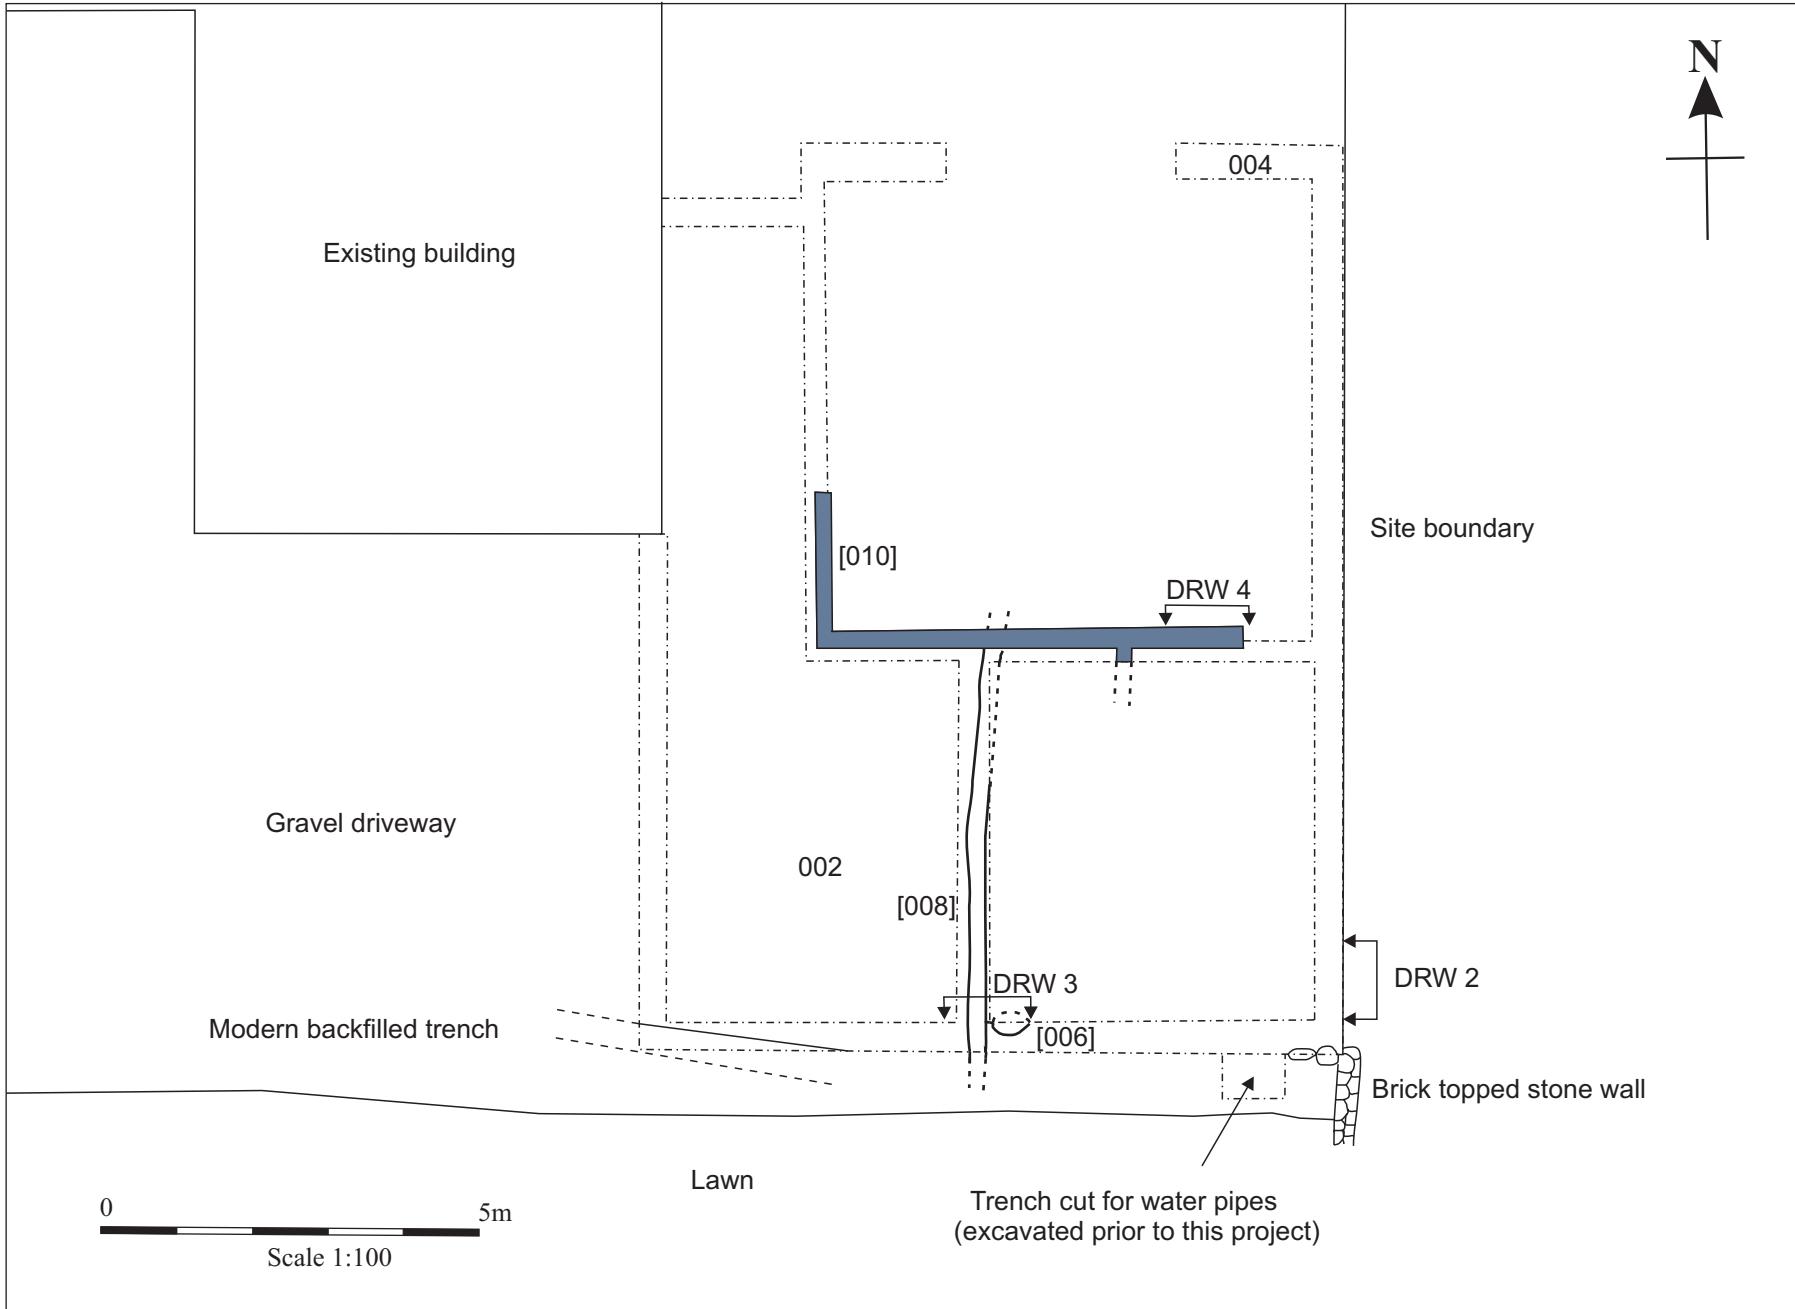
Fig 2 Plan of foundations

The made ground deposit was truncated by a construction cut [010] for a brick foundation [009], which represented a now demolished outbuilding, including disconnected foul water pipes. Map regression suggests this building was constructed by the later 19th century and demolished by the 1970s (See Discussion).

The brickwork foundations appear to represent a now demolished building adjacent to the extension added to the 17th century rectory. Foundations were made from smooth red bricks measuring 3 and 1/8 inches in imperial size, which would fit a late 19th century date for their use. The 1887 1:2,500 Ordnance Survey shows a building in approximately the same position which would suggest a late 19th century date is accurate. This structure, or its replacement, also exists on the 1908 and 1968 1:2500 Ordnance Survey maps but was removed by the 1970s.

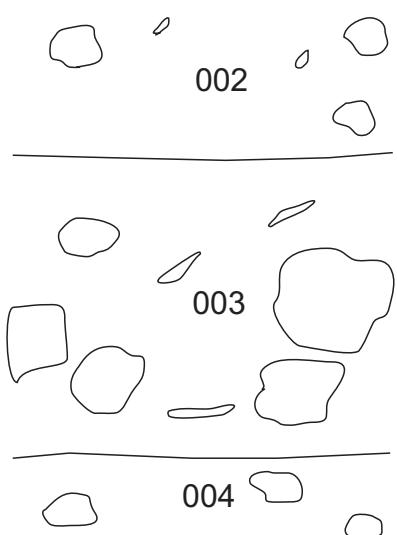
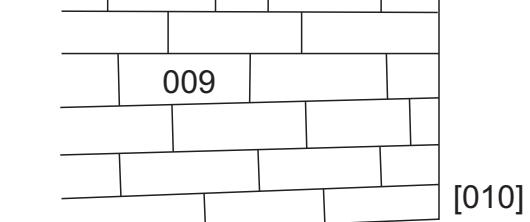
Fig 3 Sections

These features were sealed below a layer of made ground (003) comprising clay silt with occasional limestone pebbles and tile fragments, possibly laid down during ground levelling for the construction of the 1840s Old Rectory. The tile collected from this layer has been dated 16th-18th century (Appendix 3), which would suggest it is not waste from constructing the Old Rectory itself, but more likely from destruction and levelling of structures associated with the 17th century rectory building.
