**THE COACH DEPOT, MORTON,  
NEAR GAINSBOROUGH, LINCOLNSHIRE**

**ARCHAEOLOGICAL MONITORING AND RECORDING**

Prepared for  
Chestnut Homes Ltd.

by  
M. Hobson  
January 2013

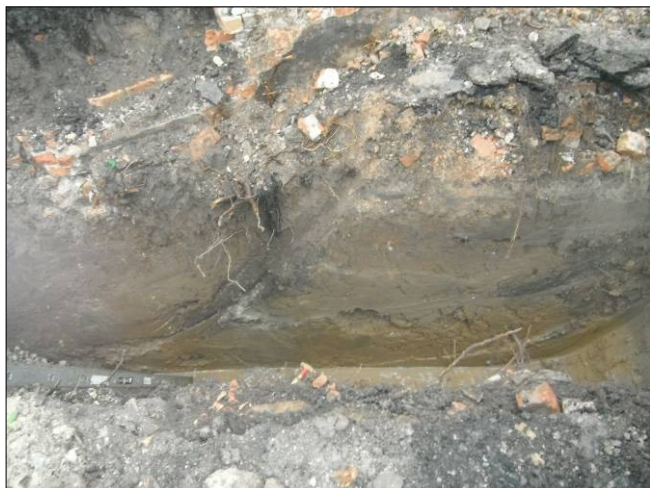
**Plate 3:** Interface between made ground (110) and alluvium (102), looking north.

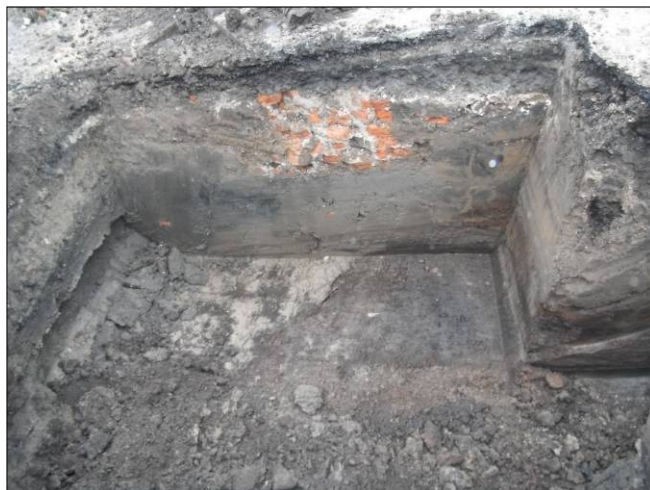
**Plate 4:** Manhole pit 3 showing ditch [115], (Fig: 3.5) looking north.

**3:** On Friday the 19<sup>th</sup> of October work began on the drainage run from the second manhole position eastwards. This work continued on Monday the 22<sup>nd</sup> and culminated in the excavation of a third pit for a manhole to the east (Figure 2). The top of a ditch [115] was revealed in this eastern section, approximately 4m wide and with a distinct dark peaty fill, context no. (116), and oriented NE-SW. This may well be the moated enclosure referred to above in Section 5.0, and confirms the presence of archaeological features sealed by a thick layer of alluvium in this area (Figure 3.5). Unfortunately, however, no dating material was recovered from this upper ditch fill.

The programme of observation and monitoring revealed that archaeological features (pertaining to ditch [115] Fig: 3.5) of an uncertain date remain preserved approximately 1.8m below the current ground level, sealed and presumably preserved below a thick layer of alluvium. In particular the excavation of the drainage trenches revealed the top of a large ditch, which may be part of a moated enclosure, at one time visible as a crop-mark feature.
